# Citizen's Bank 47 Merchants Row Rutland, Vermont

Site Coordinates: 43° 36' 50" North Latitude and 72° 58' 98" West Longitude  
Site Elevation: 560 AMSL  
SMS Site #2012-4346  
KAS Job #412120479

## INITIAL SITE INVESTIGATION REPORT

August 6, 2013

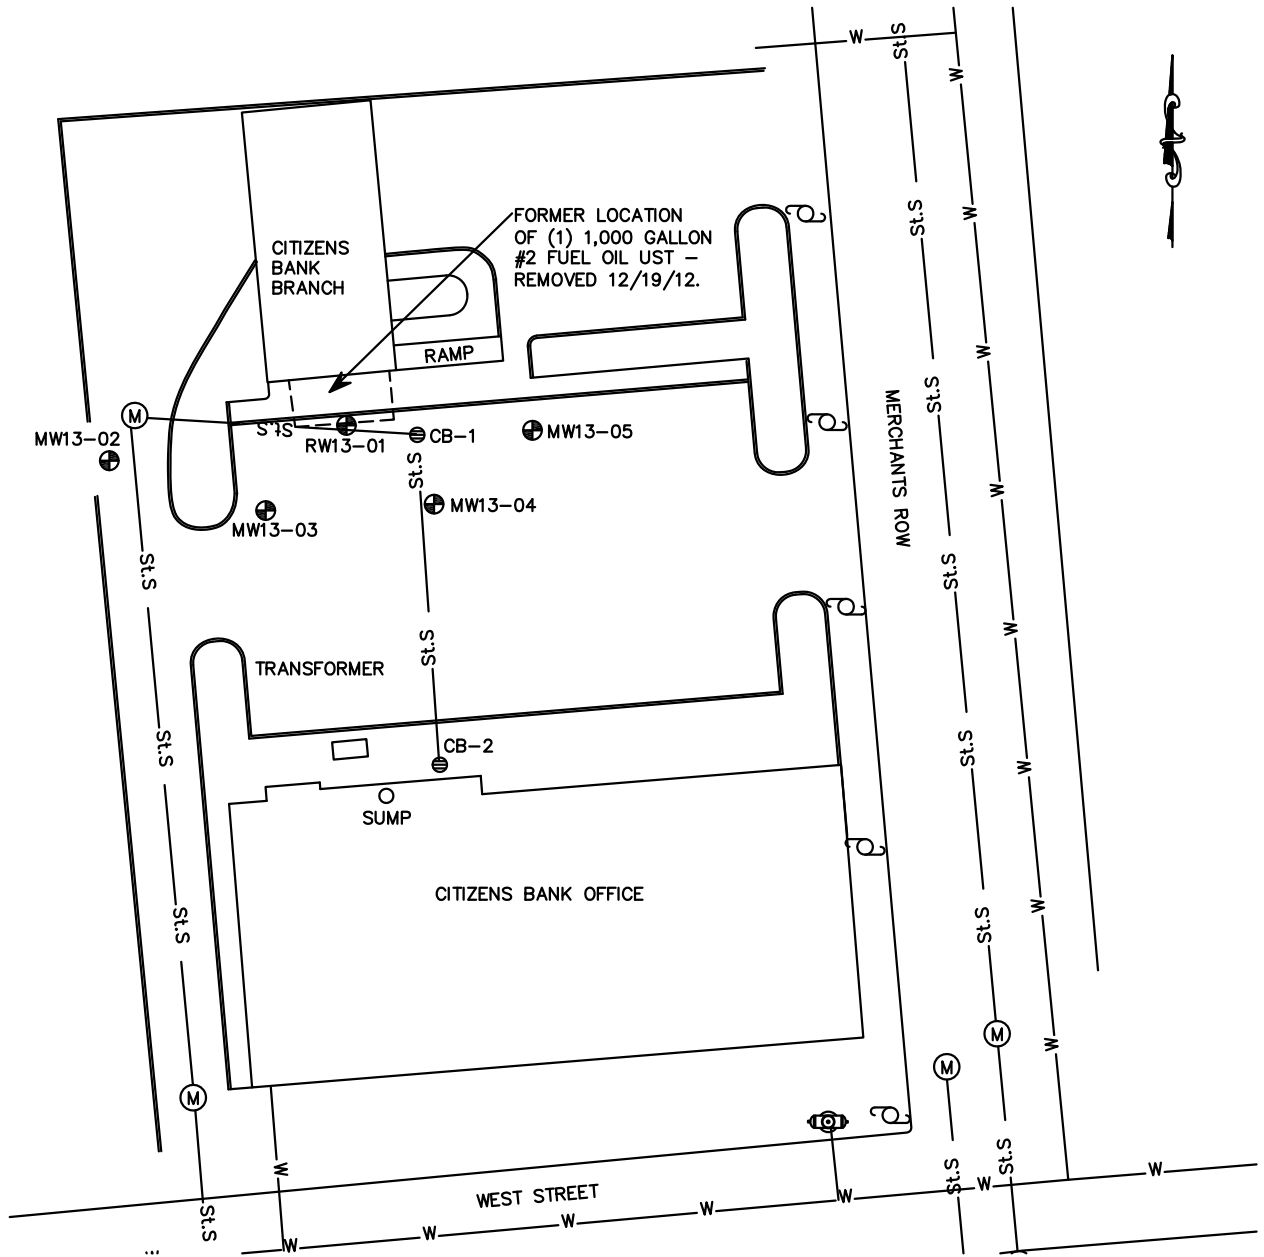
The Site Map (Appendix A) shows the Site and relevant Site features.

Five soil borings, which were completed as monitoring wells RW13-01 through MW13-05, were advanced at the Site on June 10, 2013 by T&K Drilling of Troy, New Hampshire under the direct supervision of a KAS engineer. The soil borings were advanced using a hollow stem auger drill rig. The monitoring well and soil boring locations are indicated on the Site Map (Appendix A).

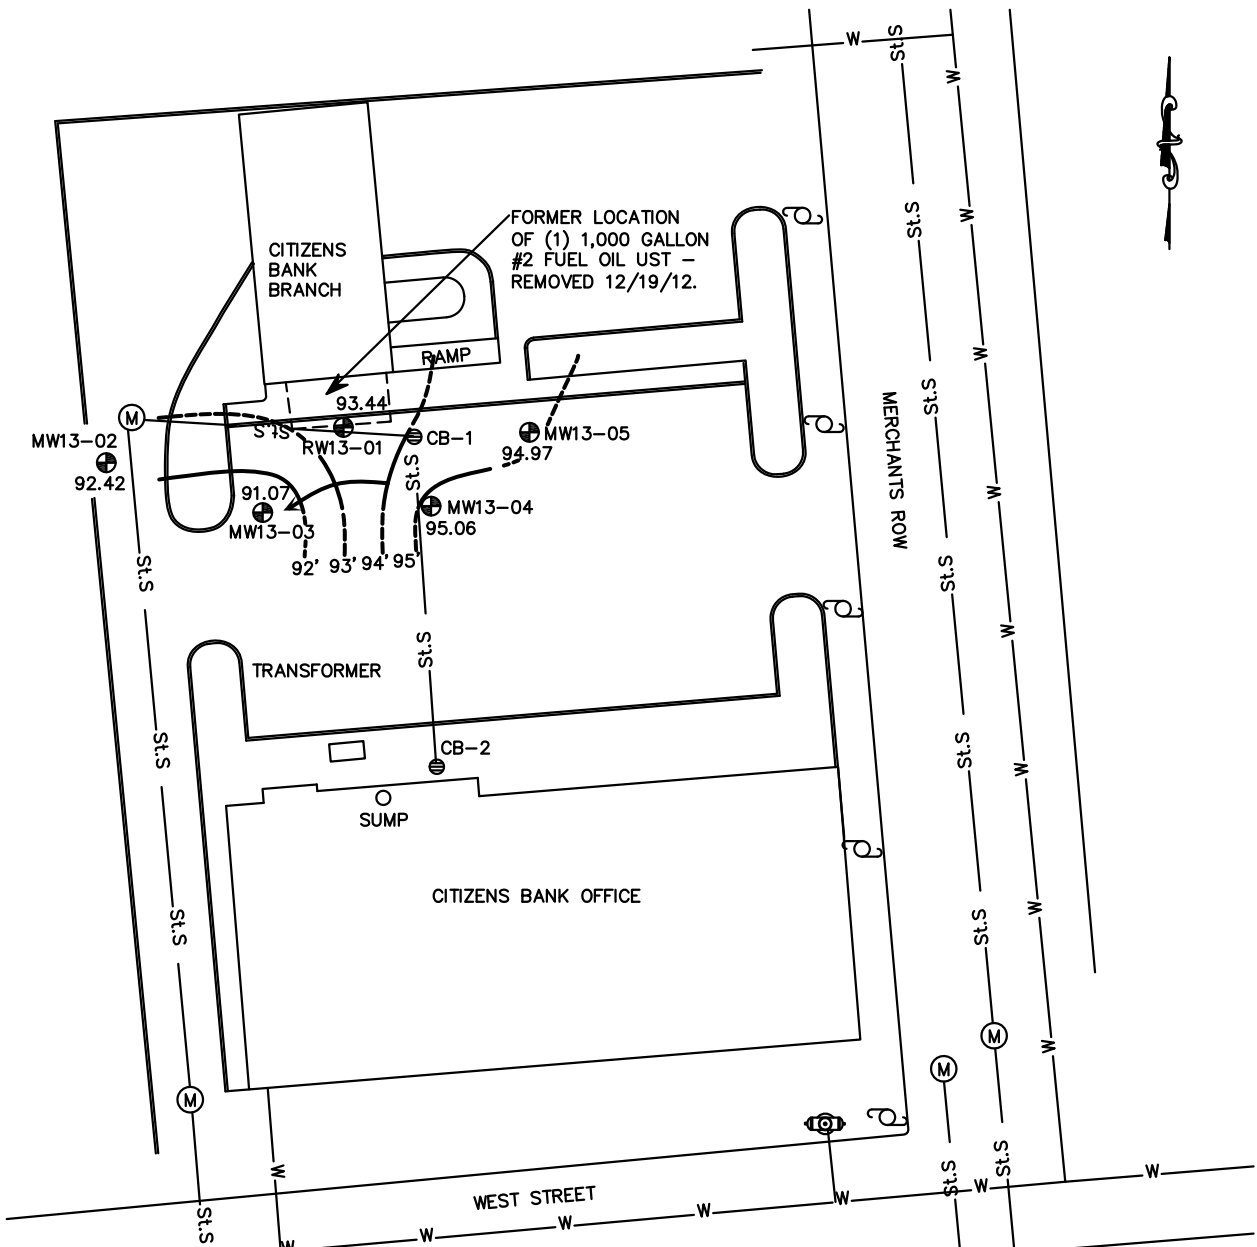
| DATE: 8/5/13 | DWG #: 1 | SCALE: 1"=40' | DRN.: BG | APP.: JR |

Water table elevations were plotted and contoured to illustrate the estimated gradient and direction of groundwater flow beneath the Site (see the Groundwater Contour Map, Appendix A). According to these data, groundwater is flowing to the west/southwest at an average hydraulic gradient ranging from 6.0 – 13.6%. Based on this groundwater flow regime, monitoring well MW13-04 is located crossgradient, monitoring wells MW13-02 and MW13-03 are located downgradient of the former UST, monitoring well RW13-01 is located in close proximity to the former UST pit, and monitoring well MW13-05 is located upgradient to the former UST.

Depth to groundwater beneath the Site was observed to change slightly from west to east and east to west at a depth ranging from 5.28 to 9.02 feet bsg. Groundwater was documented to flow to the west/southwest under a hydraulic gradient ranging from approximately 6.0 – 13.6%.

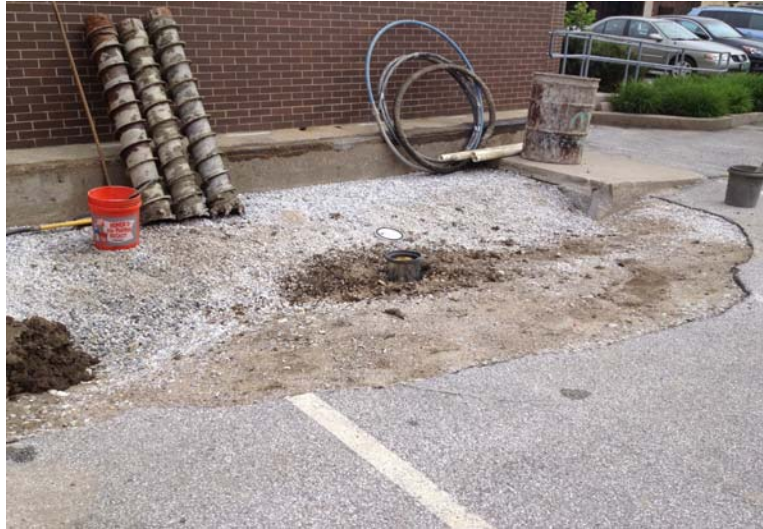
Photograph ID: 001  
Date: June 10, 2013  
Location:  
Citizen's Bank  
Direction:  
Looking north  
Comments:  
View of the former UST location  
and monitoring well RW13-01

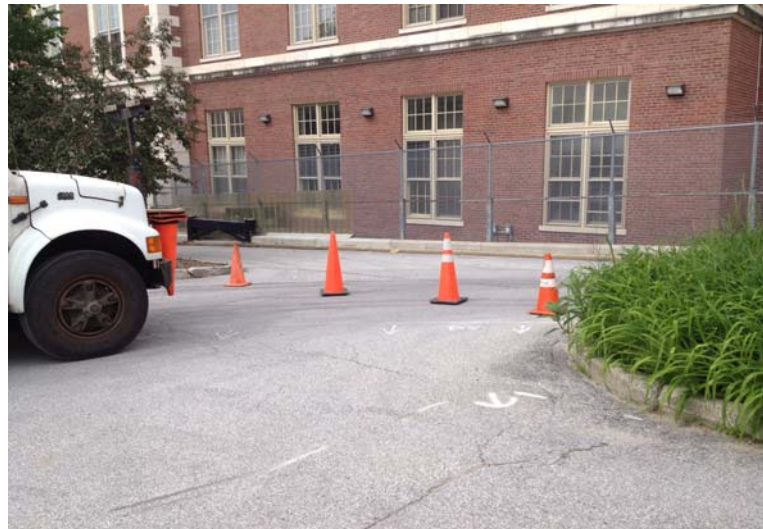
Photograph ID: 002  
Date: June 10, 2013  
Location:  
Citizen's Bank  
Direction:  
Looking west  
Comments:  
View of the area west of the former  
UST location

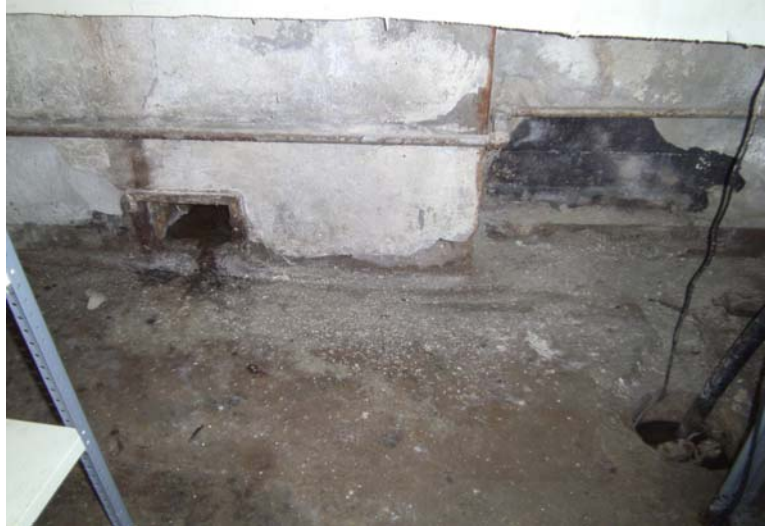
Significant petroleum impact to shallow soils (< 5 feet bsg) on site has not been observed. The on-site structure nearest the source area is slab on grade construction. Although the structure is located in close proximity to the removed UST its slab on grade construction lowers the potential risk for vapor intrusion. The Citizen's Bank office building located to the south of the source area contains a basement. It was reported to KAS on June 10, 2013 during the drilling event by the Citizen's Bank branch manager that petroleum odors have been noted within the office building basement following heavy precipitation. The basement was screened for VOCs using a PID on June 10 and June 20, 2013 and no readings above 0.0 ppmv were recorded. No odors were noted during the building inspections. An opening at the base in the northern basement wall was noted during the inspection. A small amount of water was noted to be draining out of this opening. No sheen or odor was noted on the water (see Photograph, Appendix G).

A sump was noted in the basement along the northern wall. A sample was collected from this location on June 20, 2013 and a concentration of MTBE was reported at 5.3 ug/L. The presence of MTBE in this sample along with the presence of MTBE in the vicinity of the source area suggests the contaminant plume has migrated towards the office building.

Photograph ID: 003  
Date: June 20, 2013  
Location:  
Citizen's Bank Office Building  
Direction:  
Looking north  
Comments:  
View of the opening in the northern  
basement wall and sump within the  
Citizen's Bank office building

Based on the results of the initial site investigation conducted at the Citizen's Bank property, KAS recommends a round of groundwater monitoring be conducted in September 2013 to monitor groundwater impacts and groundwater flow. A groundwater sample should be collected from all five monitoring wells, the building sump and all nearby utility manholes for analysis of the major petroleum compounds via EPA Method 8021B. The basement of the Citizen's Bank office building should be screened for VOCs using a PID.
