RE: Site Investigation
Young Residence
28 North Williams Street
Burlington, VT 05401
SMS Site #2013-4436

**SITE INVESTIGATION REPORT
YOUNG RESIDENCE
28 NORTH WILLIAMS STREET
BURLINGTON, VERMONT
VERMONT SMS SITE #2013-4436**

April 21, 2014

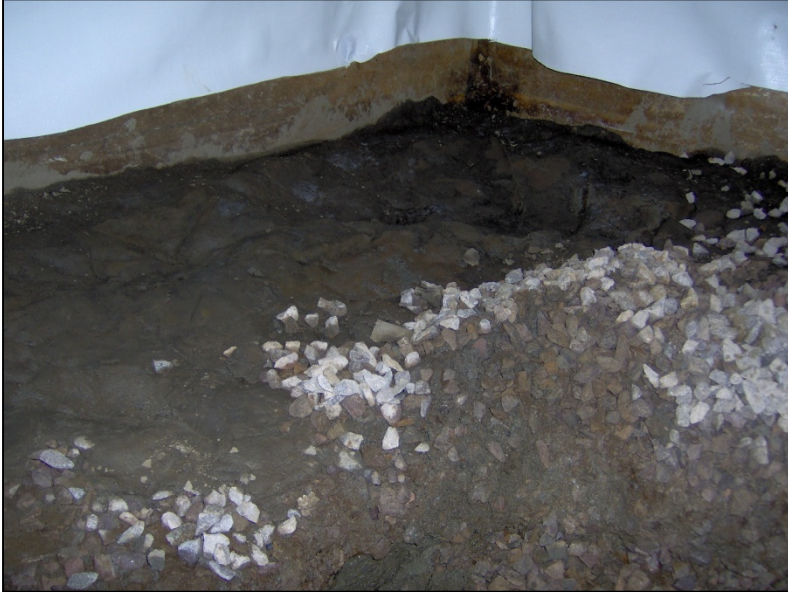
Photo #1: Sump pump removed, beginning of excavation

On January 9, 2014, WHEM oversaw the removal of contaminated source area soils from beneath the Sump South crawlspace area. Contaminated soils were hand-excavated and transported by EP&S while WHEM staff assisted and conducted air monitoring for health and safety purposes. WHEM staff also assisted in the backfilling and reinstallation of the vapor barrier. Personnel from Green Mountain Basement Solutions, LLC re-connected the sump pump on January 10, 2014. Photos of the sump excavation and AST removal have been included in Appendix 3.

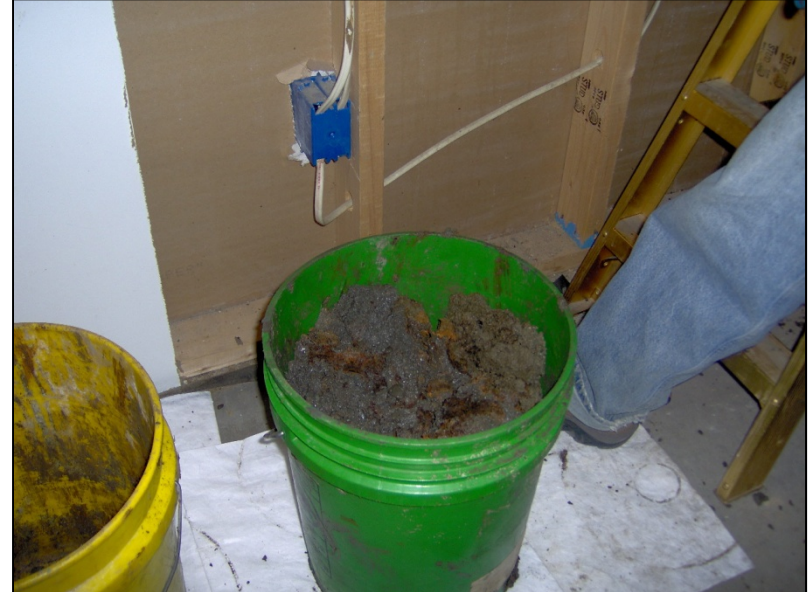
Photo #2: Bucket of contaminated soil from sump

In total, six drums were filled with contaminated soils from underneath Sump South. Based on measurements taken from the sump area, approximately 1.4 cubic yards (cy) were removed from the sump area. This calculation fits well with the approximate drum capacity of 0.25 cy per drum. A composite sample was collected from each of the drums for PID screening via headspace method. The composite sample was minimally disturbed and placed into a plastic bag, then mixed. After an equilibration period of 30 seconds, VOC levels were measured by PID. VOC concentrations ranged from 79.1 ppm in drum 5 to 31.9 ppm in drum 3. The composite sample from the sixth and final drum reported a VOC concentration of 73.1 ppm. The drums of contaminated soil were transported and disposed by EP&S following the completion of excavation activities.

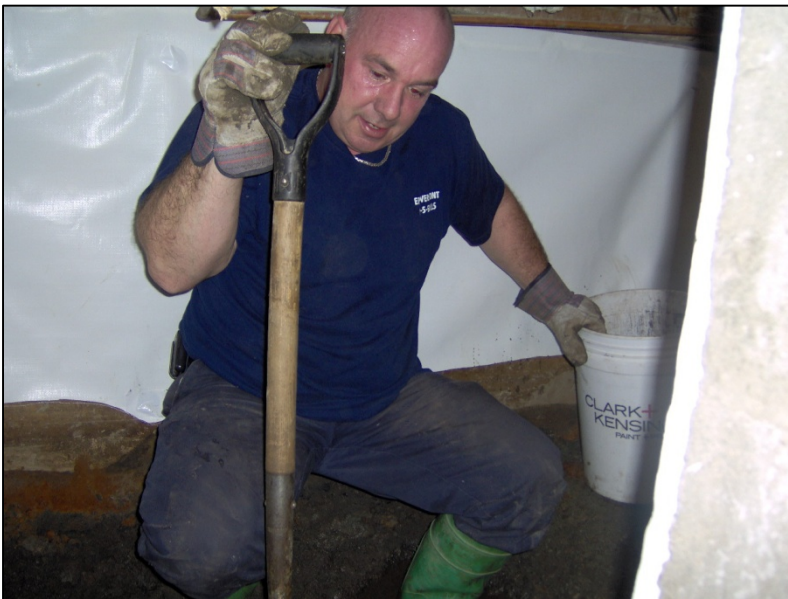
Photo #3: EP&S personnel in sump area for excavation.

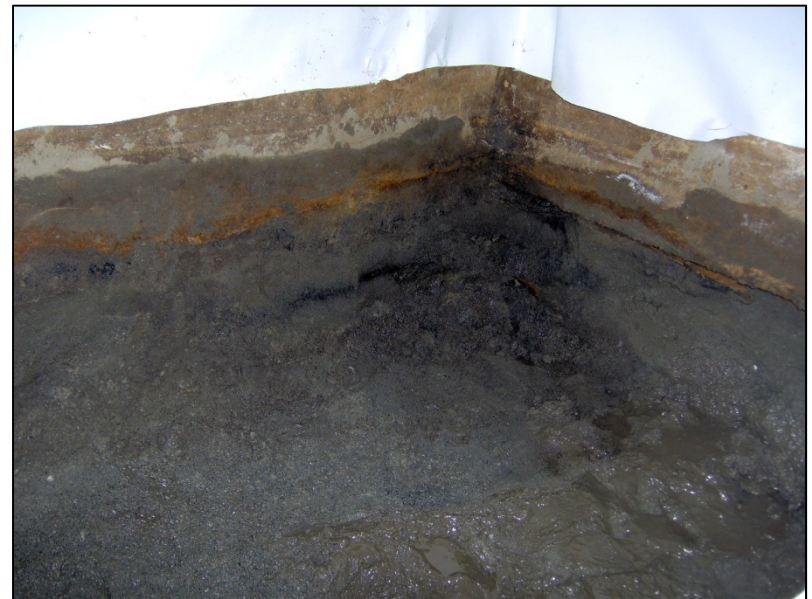
While there was some olfactory evidence of fuel oil contamination remaining at the base of the excavation, it is WHEM's opinion that it would not have been pragmatic to remove additional soils from the sump area due to increasingly saturated conditions and the identification of restrictive soils beneath the sump area.

Photo #4: Dark staining against SE corner, likely related to contamination

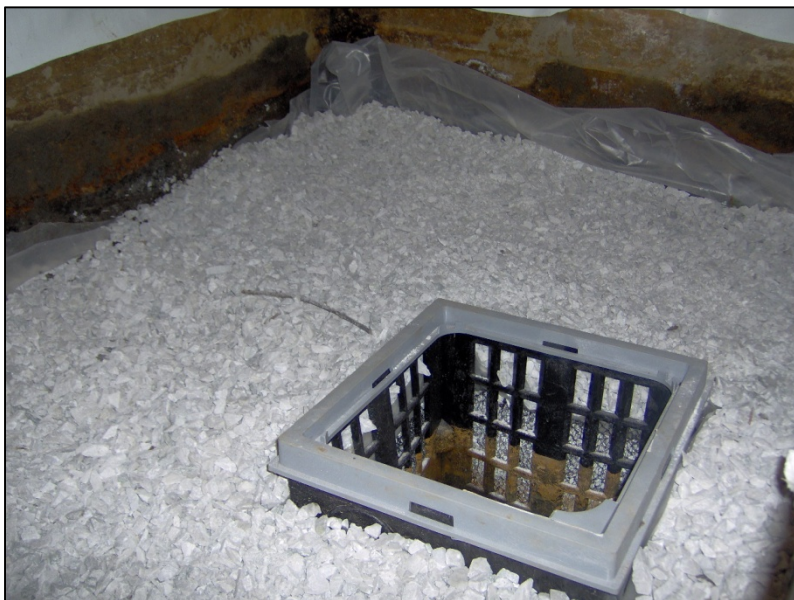
Photo #5: Sump replaced with clean gravel backfill, vapor barrier

Following completion of the excavation, one yard of lime gravel was delivered for backfill. EP&S personnel laid down a layer of gravel followed by a new polyethylene vapor barrier, then additional gravel to original grade. The sump pit was replaced, but the pump was left detached for Green Mountain Basement Solutions personnel to reinstall. By the time the stone was set in place, VOC levels in the sump area had lowered to 3.7 ppm, while basement VOC levels were 1.8 ppm.

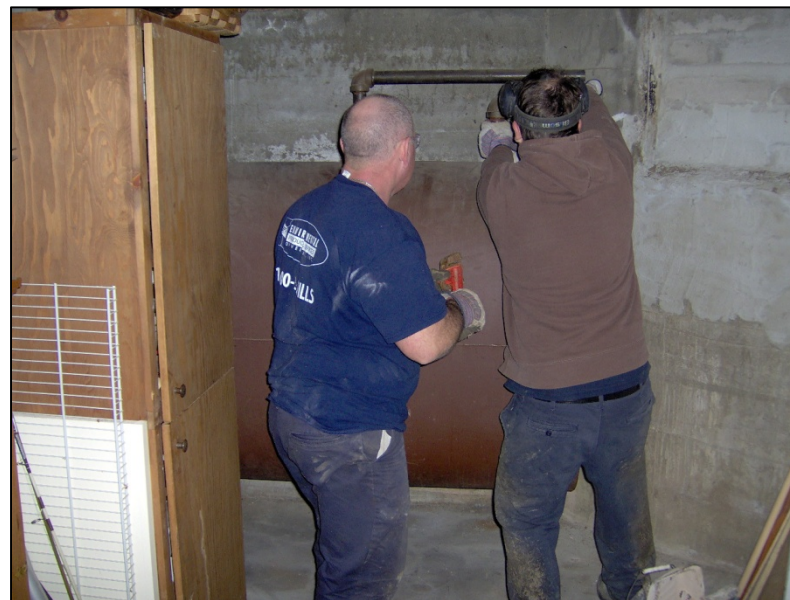
Photo #6: EP&S personnel cutting open AST

In addition to the sump excavation, WHEM also oversaw the removal of an aboveground storage tank (AST) from the basement. EP&S identified an estimated 30 gallons of remnant fuel oil in the AST, along with some sludge material at the base of the tank. By early afternoon, the AST had been fully disassembled and its contents containerized in 55-gallon drums with no spillage. In addition, all piping from the tank had been cut per Bill Young's instructions. EP&S transported and disposed of the recovered sludge and remnant fuel oil. Photographs of the AST removal have been included in Appendix 3.

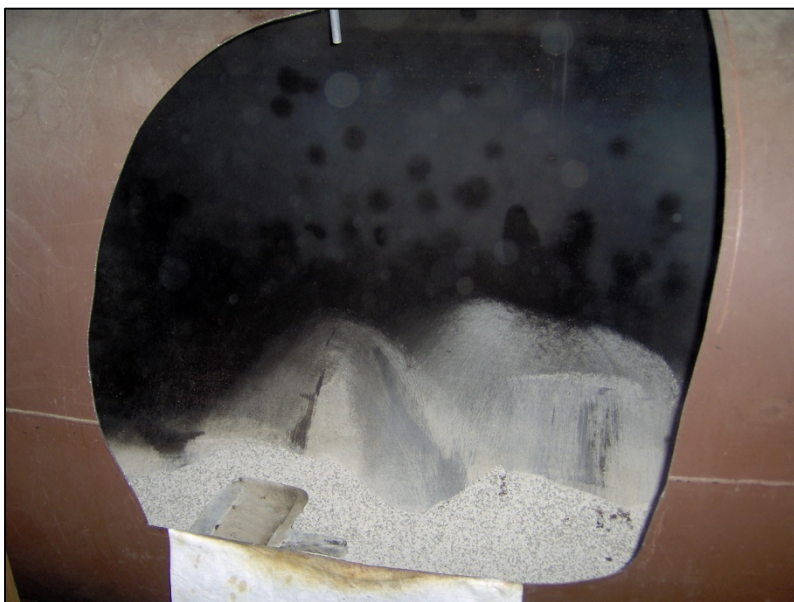
Photo #7: Fluid containerized, adsorbing remaining sludge
