**UNITED CHURCH OF CABOT
2 COMMON WAY
CABOT, VT
JUNE 2015 GROUNDWATER
MONITORING REPORT**

Project No. 08-221382.00
SMS No. 2014-4464
September 2015

Prepared by:
ECS
1 Elm Street, Suite 3
Waterbury, VT 05676
tel: 802-241-4131
www.ecsconsult.com

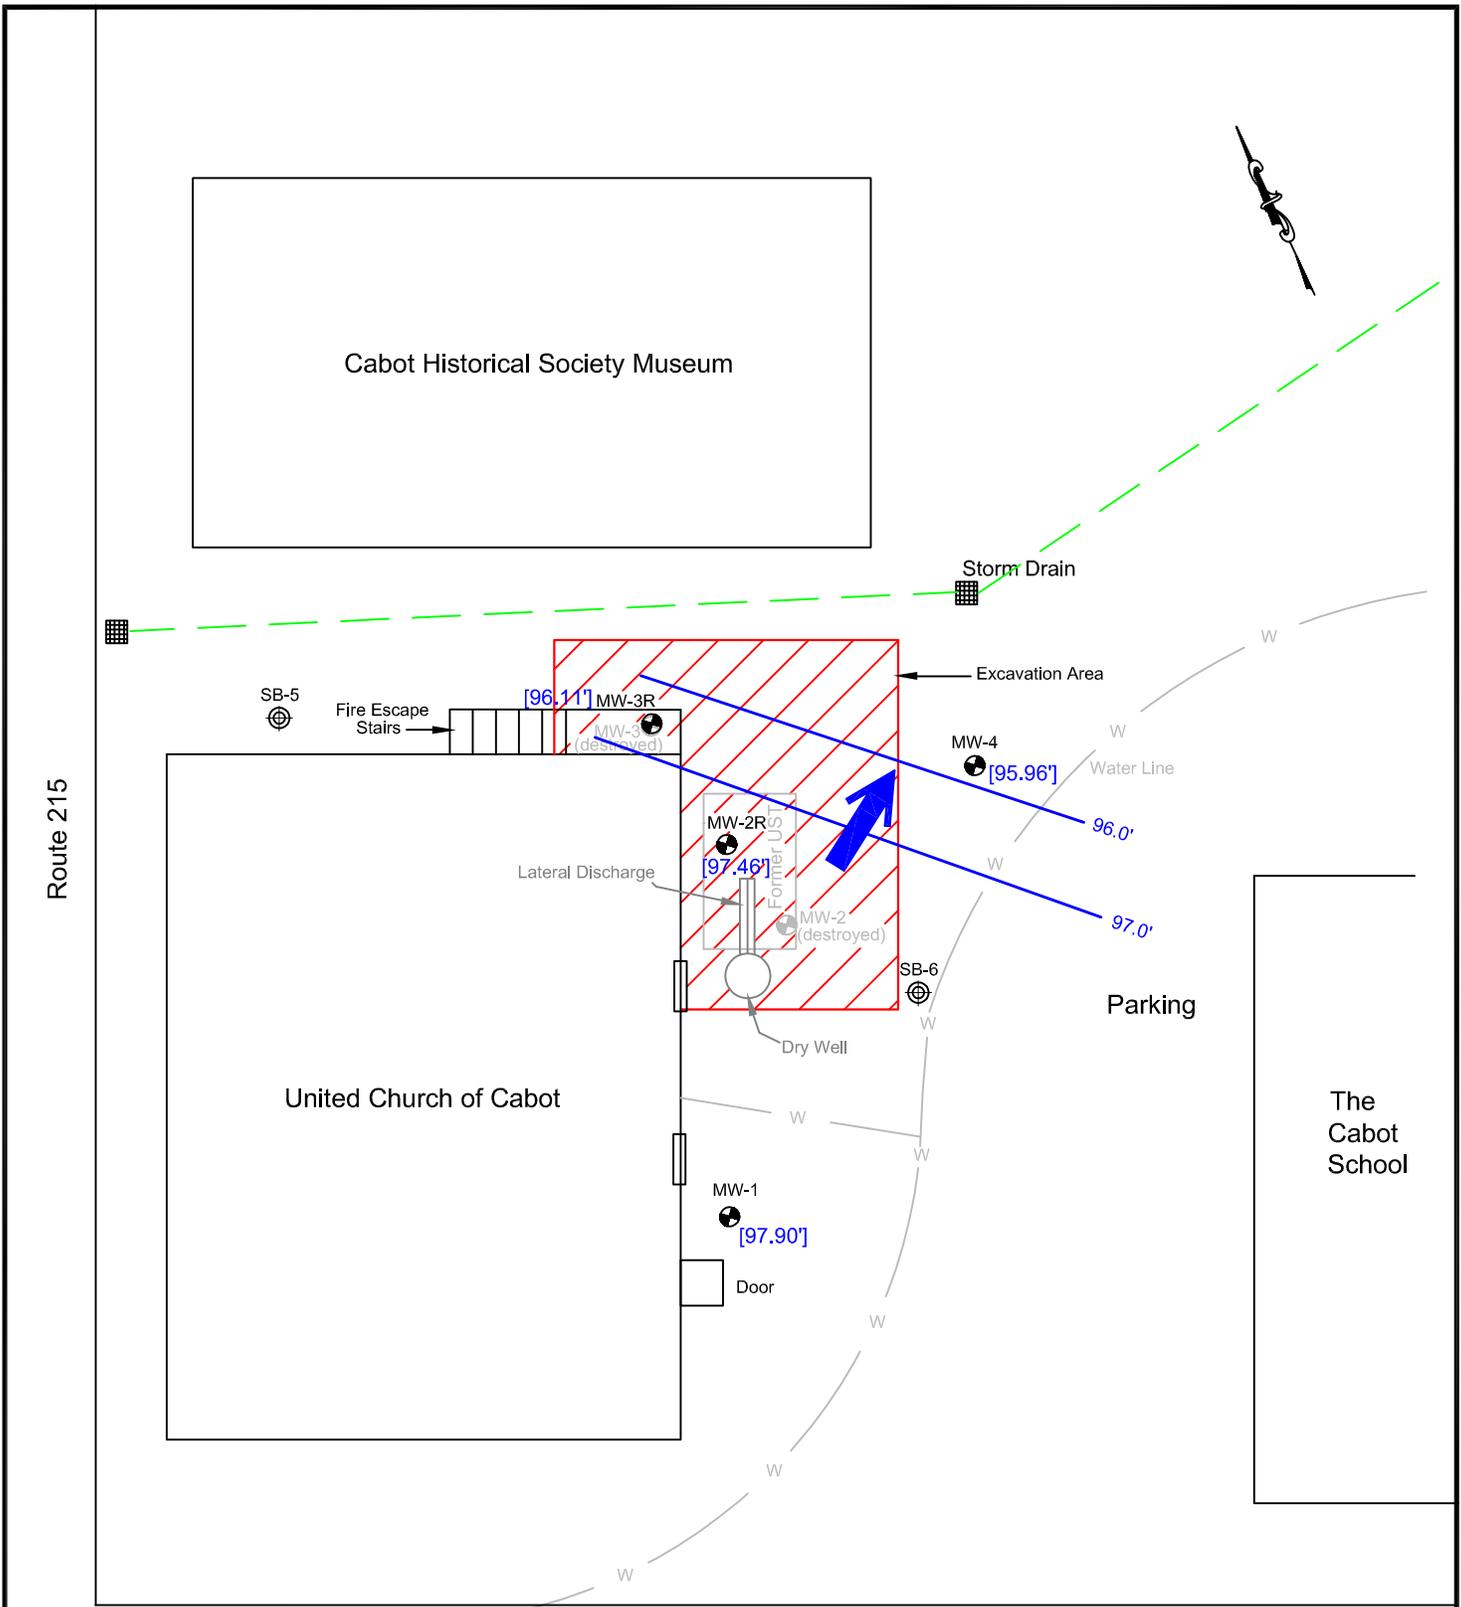
95.5' ——— Water Table Contour (Dashed where inferred)

Flow Direction Indicator
 [95.28'] Groundwater Elevation
 MW-1

PROJECT: **UNITED CHURCH OF CABOT**
 2 COMMON WAY
 CABOT, VT
 TITLE: **Ground Water Flow Direction**
 Sample Date: 6-11-15

Based on the hydrogeologic data, the groundwater in the unconfined surficial aquifer at the site appears to flow generally northeast toward the Cabot Historical Society Museum (Figure 3). Shallow groundwater flow direction may be locally influenced by the Church building foundation and downgradient storm drain and suspected sewer line. The average horizontal hydraulic gradient is approximately 5.1 percent between MW-1 and MW-4. The vertical groundwater flow components at the site, and the hydraulic relationship between the shallow unconfined aquifer and the bedrock aquifer, are currently unknown.

Static water-table elevations were computed for each monitoring well by subtracting the measured depth-to-water readings from the surveyed top-of-casing elevations, which are relative to an arbitrary site datum of 100.00 feet. Water-level measurements and elevation calculations are presented in Table 1. Groundwater flow direction maps were prepared using these data (Figures 3).

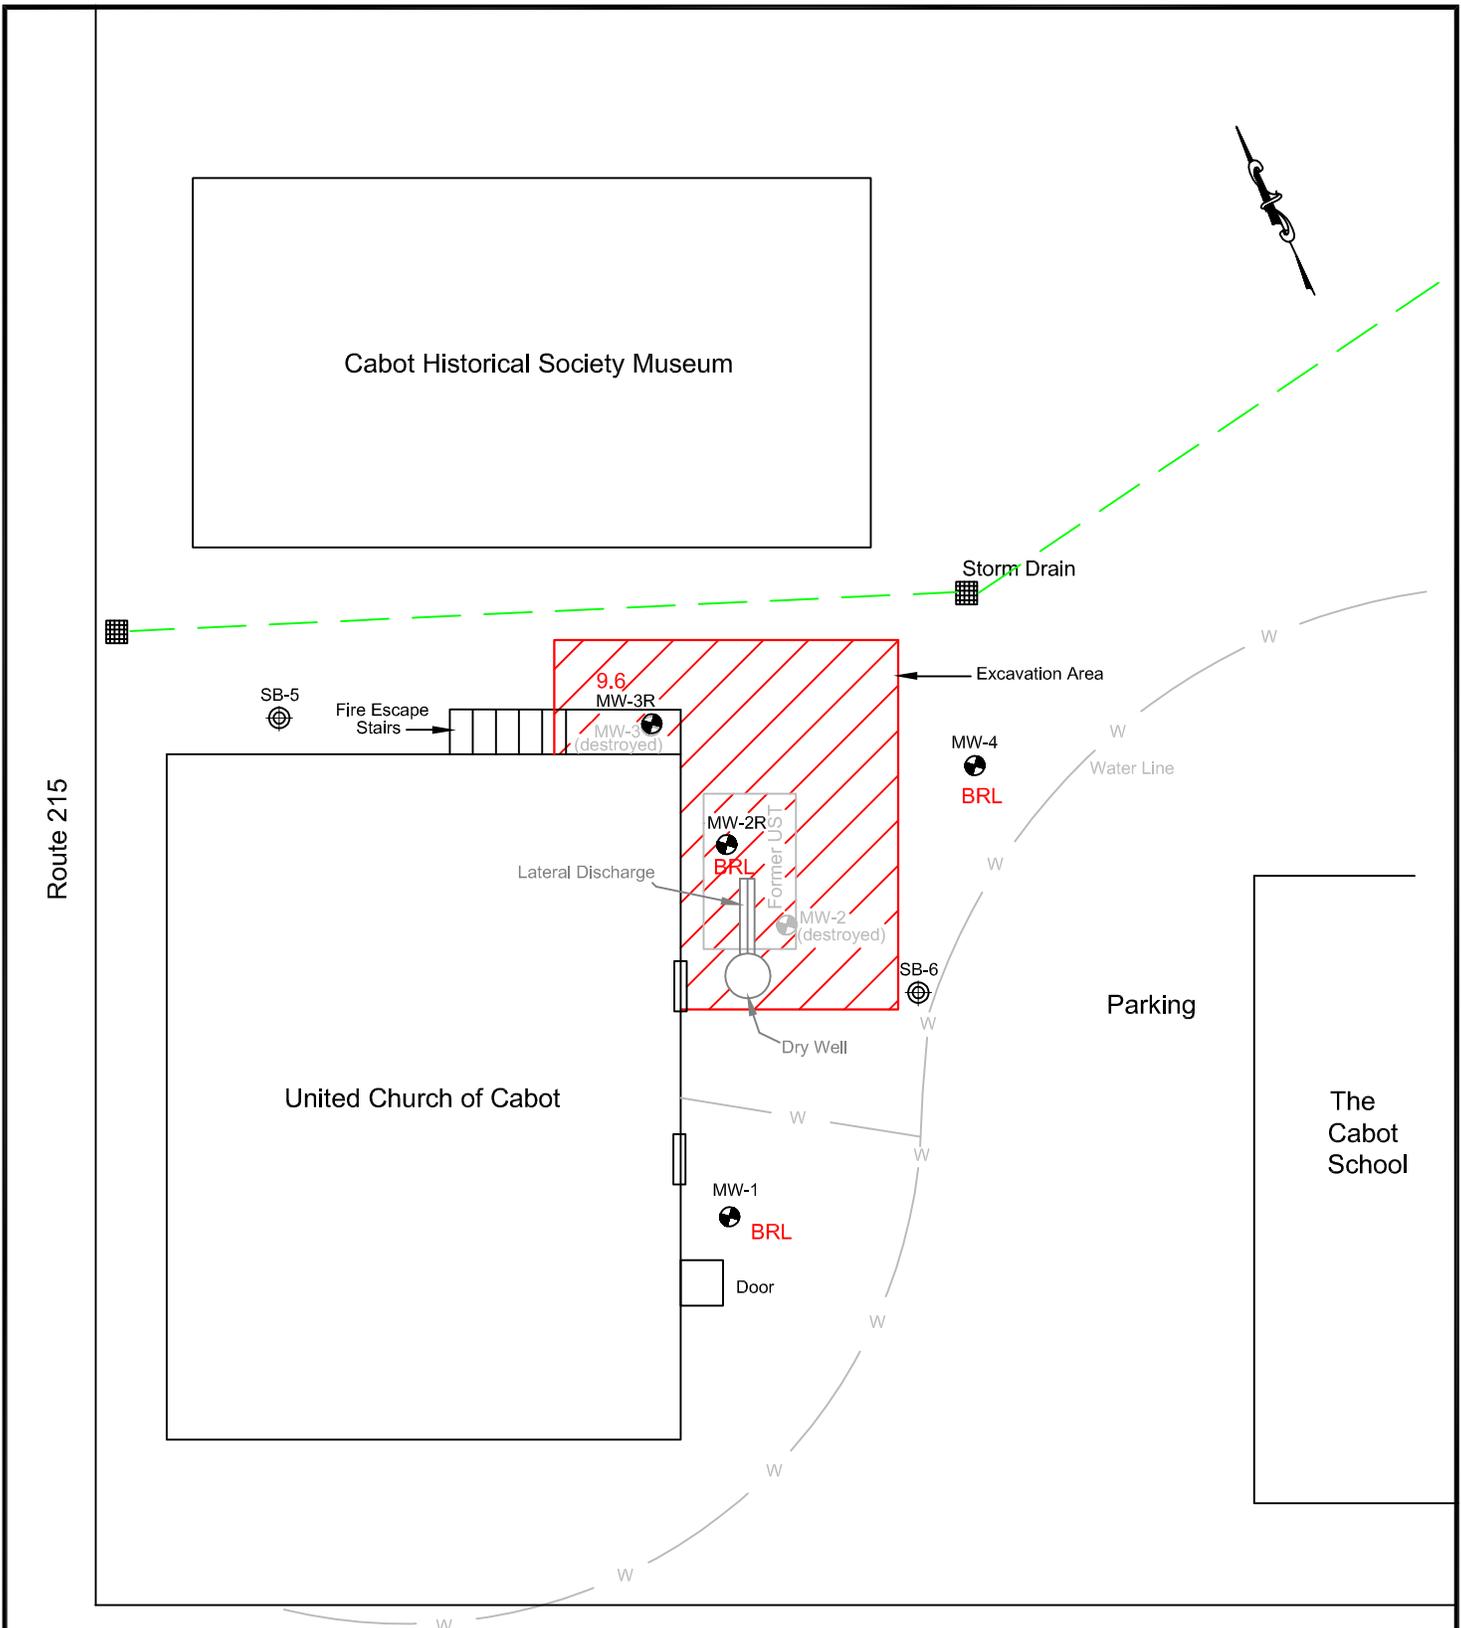
9.6 Total VOCs (Volatile Organic Compounds)
Reported in $\mu\text{g/L}$ (Micrograms per liter)

TITLE:
Sample Date: 6-11-15
Contaminant Concentration Map

VOCs were detected at MW-3R at concentrations below the respective Vermont Groundwater Enforcement Standards (VGES), including ethylbenzene, trimethylbenzene and naphthalene. No VOCs were detected in groundwater samples collected from MW-1, MW-2R, and MW-4 (Figure 4). Contaminant levels decreased significantly at replacement wells within the excavation area when compared with the May 2014 conditions. Concentrations at the MW-2 location went from LNAPL in May 2014 to below reporting limits in June 2015 at MW-2R. Concentrations at the MW-3 location decreased from the presence of LNAPL in May 2014 to concentrations below the VGES in June 2015. Timeseries graphs are presented in Figures 5-8.

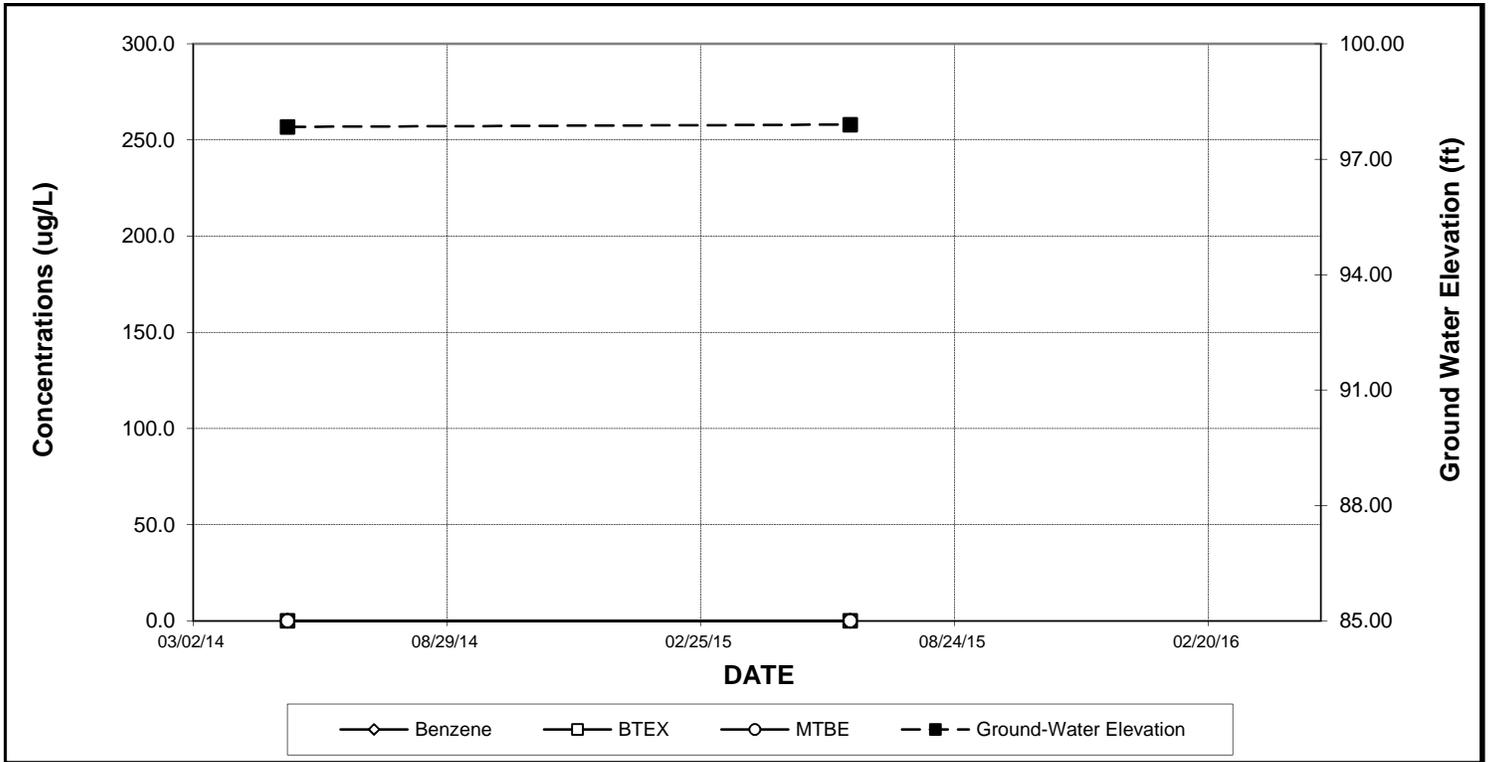
FIGURE 5. MW-1 VOC Concentrations

Date	MTBE	Benzene	Toluene	Ethyl benzene	BTEX	Xylenes	Trimethyl Benzenes	Naphthalene	Ground-Water Elevation
05/08/14	BRL<1.0	BRL<1.0	BRL<1.0	BRL<1.0	BRL	BRL<3.0	BRL<2.0	BRL<1.0	97.84
06/11/15	BRL<1.0	BRL<1.0	BRL<1.0	BRL<1.0	BRL	BRL<3.0	BRL<2.0	BRL<1.0	97.90
<i>VGES</i>	<i>40</i>	<i>5</i>	<i>1,000</i>	<i>700</i>	<i>--</i>	<i>10,000</i>	<i>350</i>	<i>20</i>	<i>----</i>

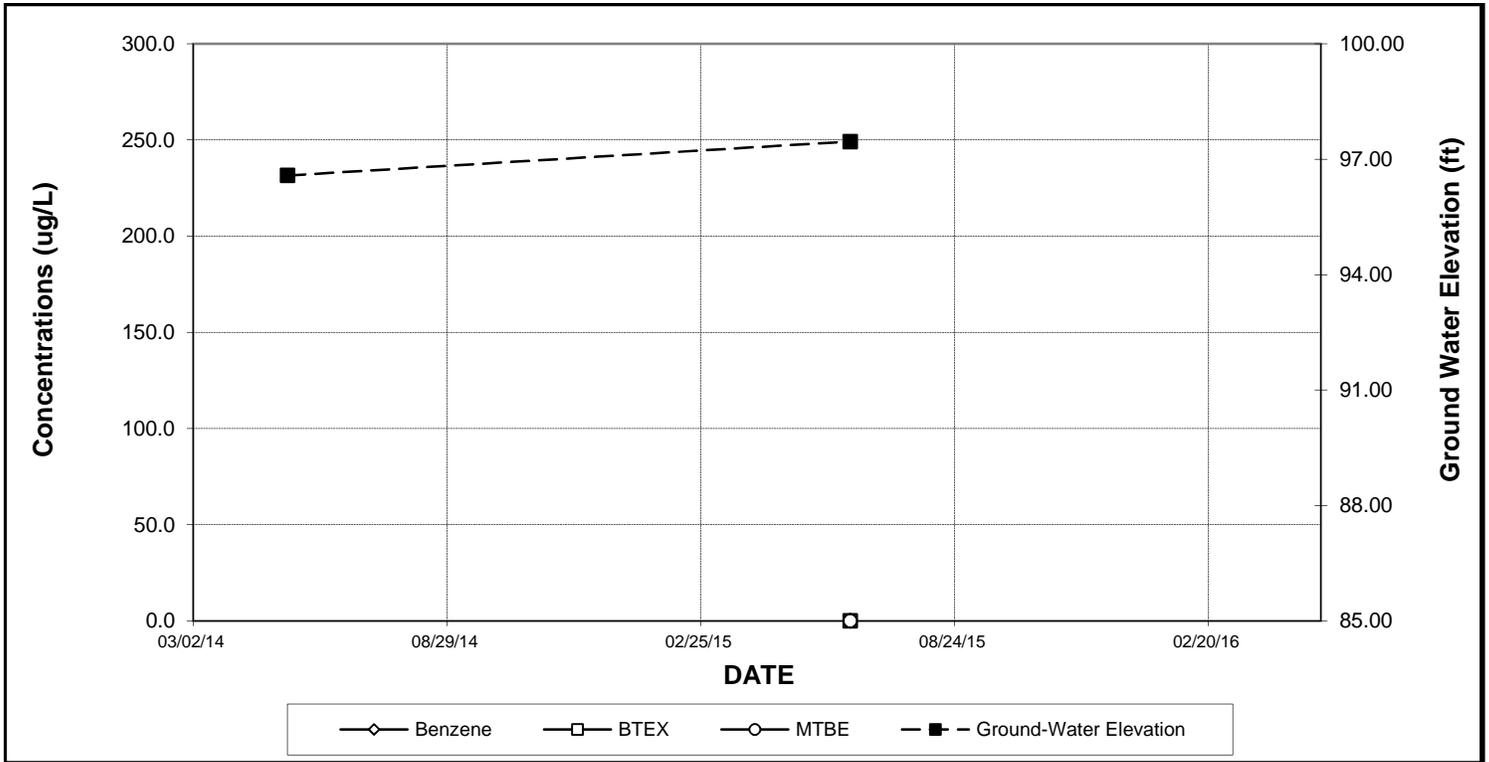
FIGURE 6. MW-2R VOC Concentrations

Date	MTBE	Benzene	Toluene	Ethyl benzene	BTEX	Xylenes	Trimethyl Benzenes	Naphthalene	Ground-Water Elevation
05/08/14	FP	FP	FP	FP	FP	FP	FP	FP	96.58
06/11/15	BRL<1.0	BRL<1.0	BRL<1.0	BRL<1.0	BRL	BRL<3.0	BRL<2.0	BRL<1.0	97.46
VGES	40	5	1,000	700	--	10,000	350	20	----

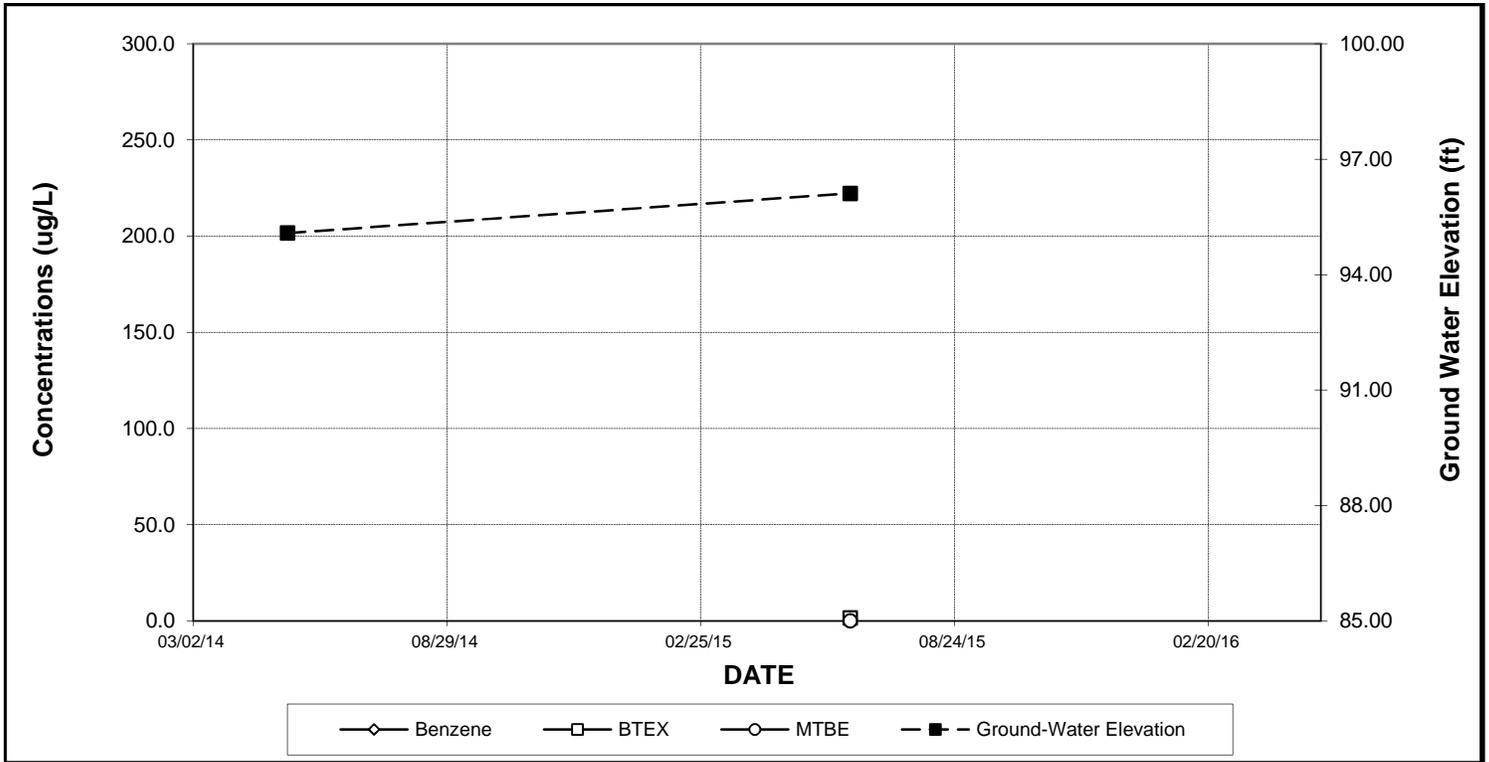
FIGURE 7. MW-3R VOC Concentrations

Date	MTBE	Benzene	Toluene	Ethyl benzene	BTEX	Xylenes	Trimethyl Benzenes	Naphthalene	Ground-Water Elevation
05/08/14	FP	FP	FP	FP	FP	FP	FP	FP	95.08
06/11/15	BRL<1.0	BRL<1.0	BRL<1.0	1.5	1.5	BRL<3.0	5.7	2.4	96.11
VGES	40	5	1,000	700	--	10,000	350	20	----

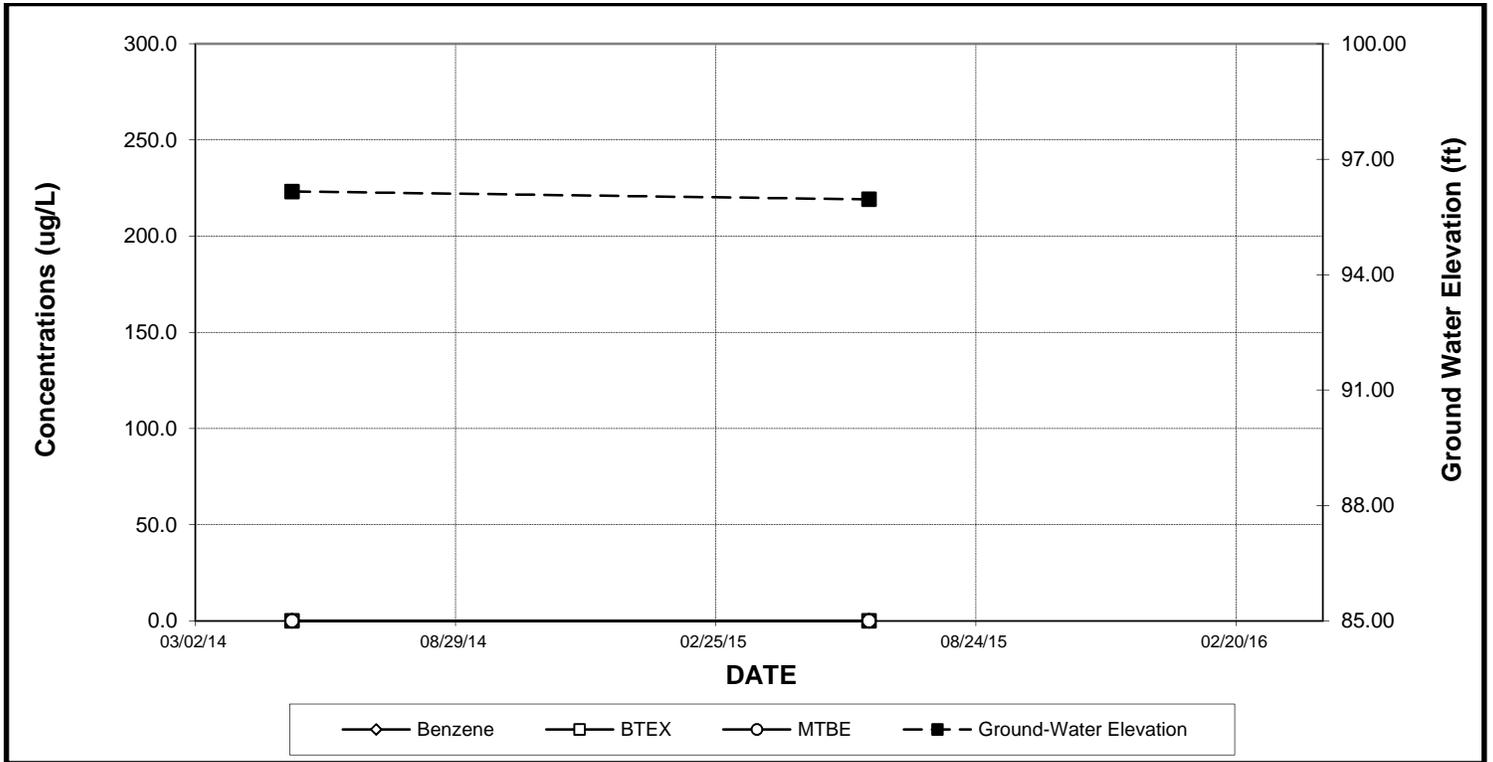
FIGURE 8. MW-4 VOC Concentrations

Date	MTBE	Benzene	Toluene	Ethyl benzene	BTEX	Xylenes	Trimethyl Benzenes	Naphthalene	Ground-Water Elevation
05/08/14	BRL<1.0	BRL<1.0	BRL<1.0	BRL<1.0	BRL	BRL<3.0	BRL<2.0	BRL<1.0	96.16
06/11/15	BRL<1.0	BRL<1.0	BRL<1.0	BRL<1.0	BRL	BRL<3.0	BRL<2.0	BRL<1.0	95.96
VGES	40	5	1,000	700	--	10,000	350	20	----

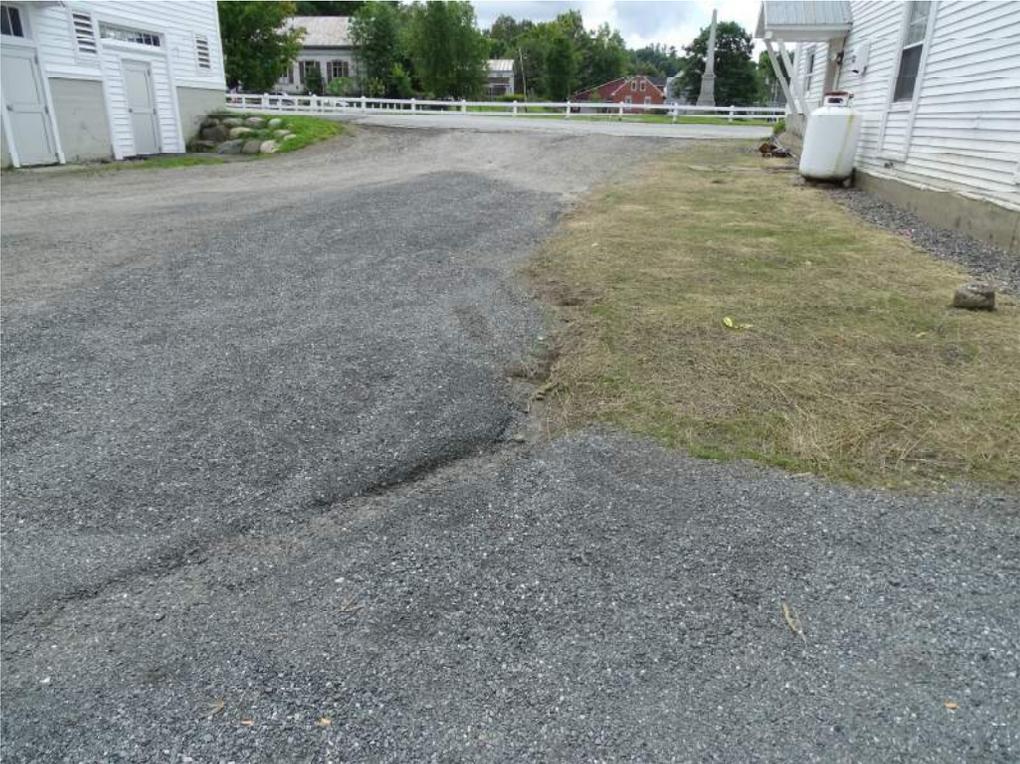
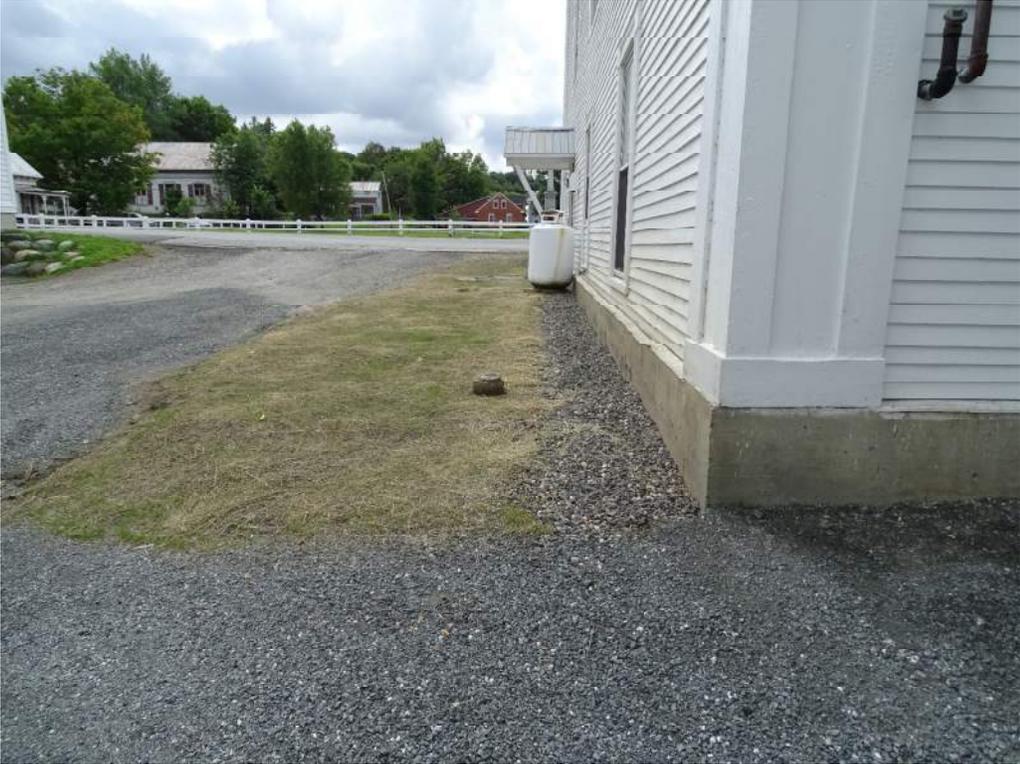
- The foundation had been backfilled and the grass area seeded and mulched.
- There were no signs of foundation movement noted.
- There were no signs of significant settlement of backfill at the exterior of the foundation.
- The seeded area had some grass growing, but the grass was far from robust.
- Several areas of the gravel drive were slightly eroded due to storm runoff.
