LEDDY PARK SOIL STOCKPILE DISPOSAL BURLINGTON, VERMONT DAILY REPORT

Date:	December 30, 2015	Days of Over	sight:	10	
Time On-Site:	07:45	Weather:	Overcast, mostly calm, ~32 °F		
Time Off-Site: Location:	Gordon Paguetta Ica Arana Pag	rking Lot 216 Lode	ing Lot 216 Loddy Dark Bood, Dyrlington, VT		
Personnel On Site					
City of Burlington		Representatives:	Jon A	dams-Kollitz (~14:30)	
The Johnson Company (JCO)		Representatives:	Jeremy Matt		
ENPRO:		Representatives:	Bob, l	Kyle, asphalt cleaning crew (3 laborers)	
VTDEC:		Representatives:	ves: Hugo Martinez-Cazon (~8:30 & ~14:30)		
Other:		Representatives:	None	None

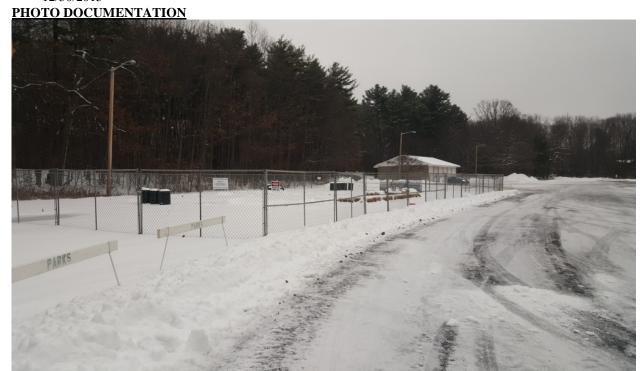
Photo 1: The stockpile area at the beginning of the day

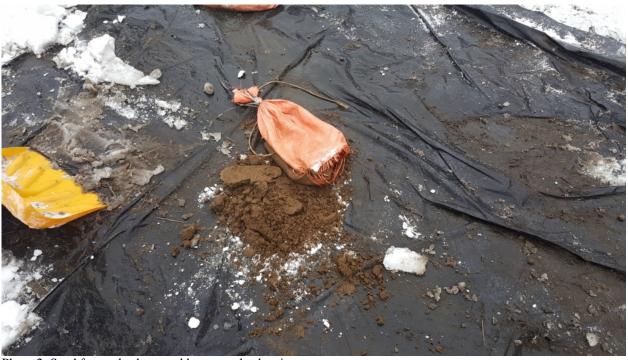
- 1. Prior to the start of work, ENPRO shoveled snow from the top of the poly sheeting. This snow had not come in contact with Stockpile soils. Several sand bags had been damaged causing clean sand to be released from the bags. This resulted in some minor discoloration of the snow that was removed from the plastic (see the photos section below).

Photo 2: Sand from a broken sand bag on poly sheeting

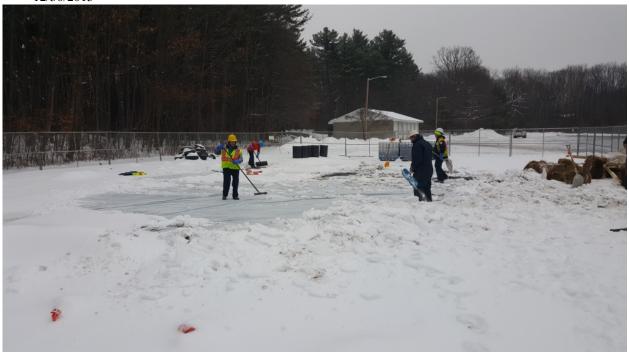
Photo 3: Shoveling snow from the poly sheeting over the final area to be cleaned.

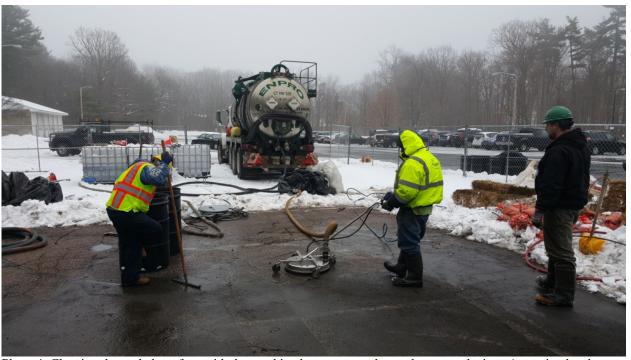
Photo 4: Cleaning the asphalt surface with the combined pressure washer and vacuum device. A rotating head sprays water onto the asphalt, loosening the dirt while the vacuum from the vacuum truck collects the wash water.

- 2. ENPRO completed pressure washing the asphalt in the former stockpile areas to the satisfaction of the VTDEC. The area which was cleaned is indicated on Figure 1, below. The pressure washing effectively removed residual soil from the asphalt parking lot. In areas where the pavement was suitably flat, a combination pressure washer and vacuum was used to clean the asphalt. However, this tool was less effective at collecting wash water in areas where the asphalt surface was uneven. Therefore, these areas were cleaned with the standard pressure washer with squeegees to direct the water to a central collection area. The wash water was then collected using a vacuum truck. These approaches were effective in collecting the soil containing wash water no soil-laden water was observed to be escaping the area. Based on the collection volumes of the previous days, it is estimated that approximately 300-gallons of water and 70-gallons of solids were collected during the cleaning effort. Once the cleaning effort was complete, ENPRO used the vacuum truck to collect the liquids from the drums and from the 275-gallon totes.

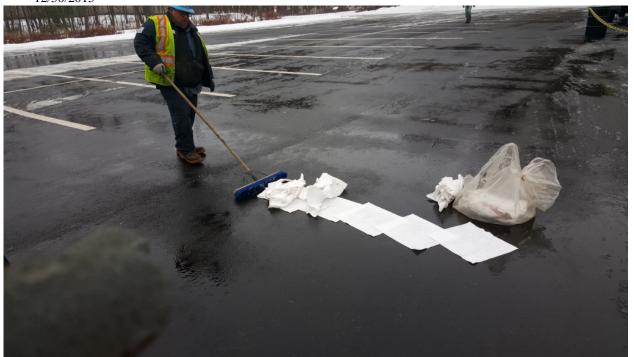
1. Faint sheens were noted on the parking lot surface outside the former stockpile area. These sheens were caused by oil drips from the dual-axle dump truck that was used to collect the sand bags, poly sheeting, and hay bales. Sorbent pads were used to collect the sheens (see the photos section below).

Photo 5: Collecting the sheen on the parking lot which resulted from oil drips from the dual axle dump truck

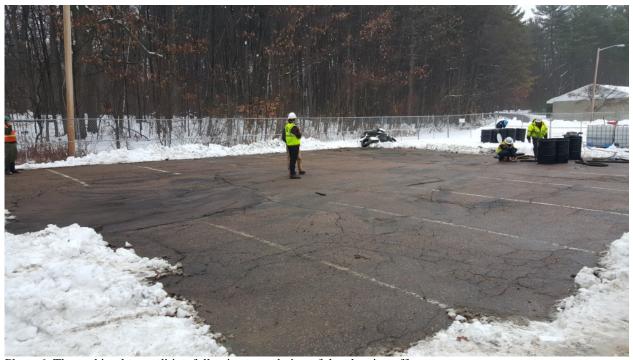
Photo 6: The parking lot condition following completion of the cleaning effort.
