**LEDDY PARK SOIL STOCKPILE  
BURLINGTON, VERMONT  
WEEKLY INSPECTION REPORT**

<b>Date:</b>	October 22, 2015	<b>Time On-Site:</b>	15:15-15:30
<b>Location:</b>	Gordon Paquette Ice Arena Parking Lot, 216 Leddy Park Road, Burlington, VT.		
<b>Condition of Stockpile (upon arrival):</b>	No change since last inspection (see 10/15/15 Weekly Inspection Report). However, the seam tape installed on July 29&30, 2015 appears to be slightly deteriorating and may need to be reinforced.		
<b>General Activities:</b>	On October 22, 2015, Johnson Company (JCO) personnel performed the weekly inspection of the stockpile and its cover.		
<b>Weather:</b>	Clear with temperatures in the upper 50s °F.		
<b>Notable Weather (since last inspection):</b>	Date of last inspection: 10/15/15. Precipitation events since last inspection (from Accuweather.com): <ul style="list-style-type: none"> <li>• 10/15/15, 0.02 inches of rain</li> <li>• 10/16/15, 0.19 inches of rain</li> <li>• 10/17/15, 0.09 inches of rain</li> <li>• 10/19/15, 0.01 inches of rain</li> <li>• 10/20/15, 0.06 inches of rain</li> </ul>

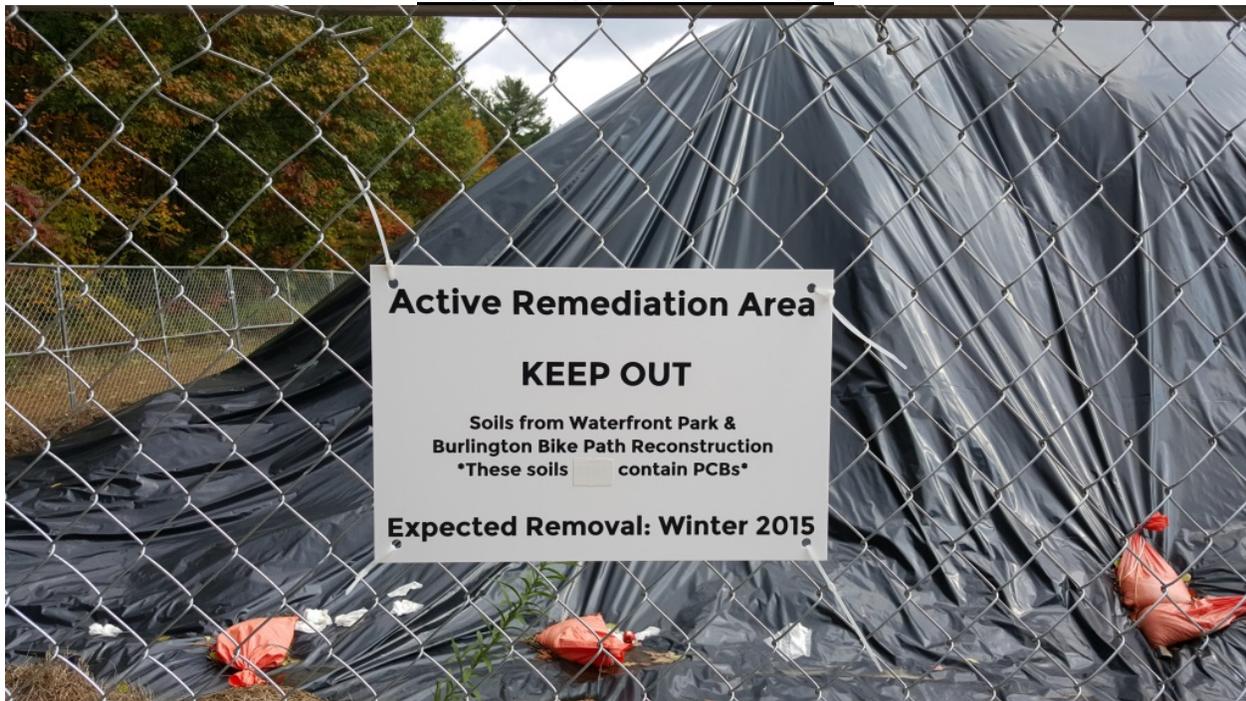
5. Are the warning signs visible, legible and in good condition? Yes, the rigid plastic warning signage installed on 9/10/15 was present and in good condition. However, based on the results of the stockpile sampling effort the soil stockpiles do contain PCBs.

Photo 1: Warning signage modified to read “\*These soils contain PCBs\*”

*Corrective Action: Replacement signage is required to more accurately reflect the PCB contamination that was confirmed to be present in the stockpiles. In the interim while replacement signs are being ordered white tape was neatly placed over the word "may" in the statement "These soils may contain PCBs". The resulting text reads "These soils contain PCBs" (see Photo 1).*

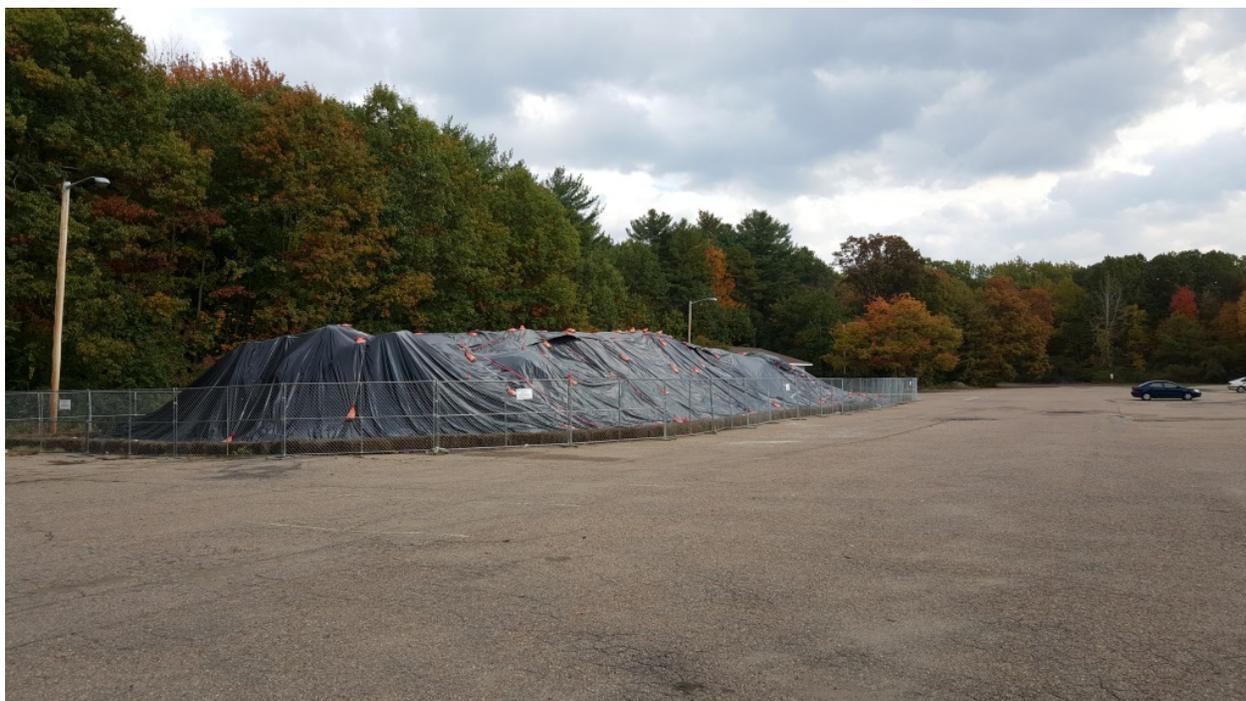
2. Is the plastic covering free of debris and ponded water? Yes it is free of debris and isolated ponding was observed as a result of the recent rain. <i>Corrective Action: The ponding observed appeared due to features beneath the plastic such as tires, divots in the soil pile, and/or the slope of the parking lot asphalt. Ponding was observed on the top ridge of the pile, due to the depression in the upper ridge of the pile that was created to allow safe access for the drill rig during sampling. Action to correct this type of ponding is not considered feasible, and this ponded water appears to pose no risk to the security of the pile, in fact the additional weight from the water is further securing the plastic.</i> <i>Description: See Stockpile Condition</i>

Photo 2: View of the northern and western sides of Stockpile A.

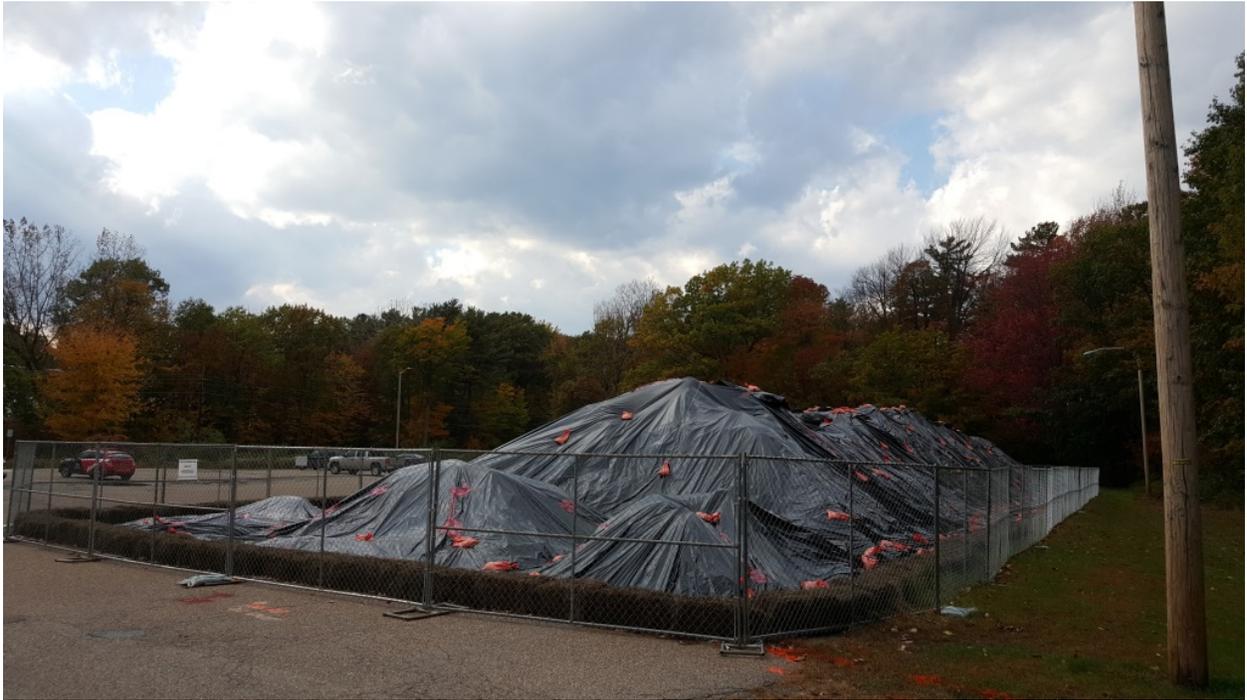
Photo 3: View of the south and east sides of the stockpiles

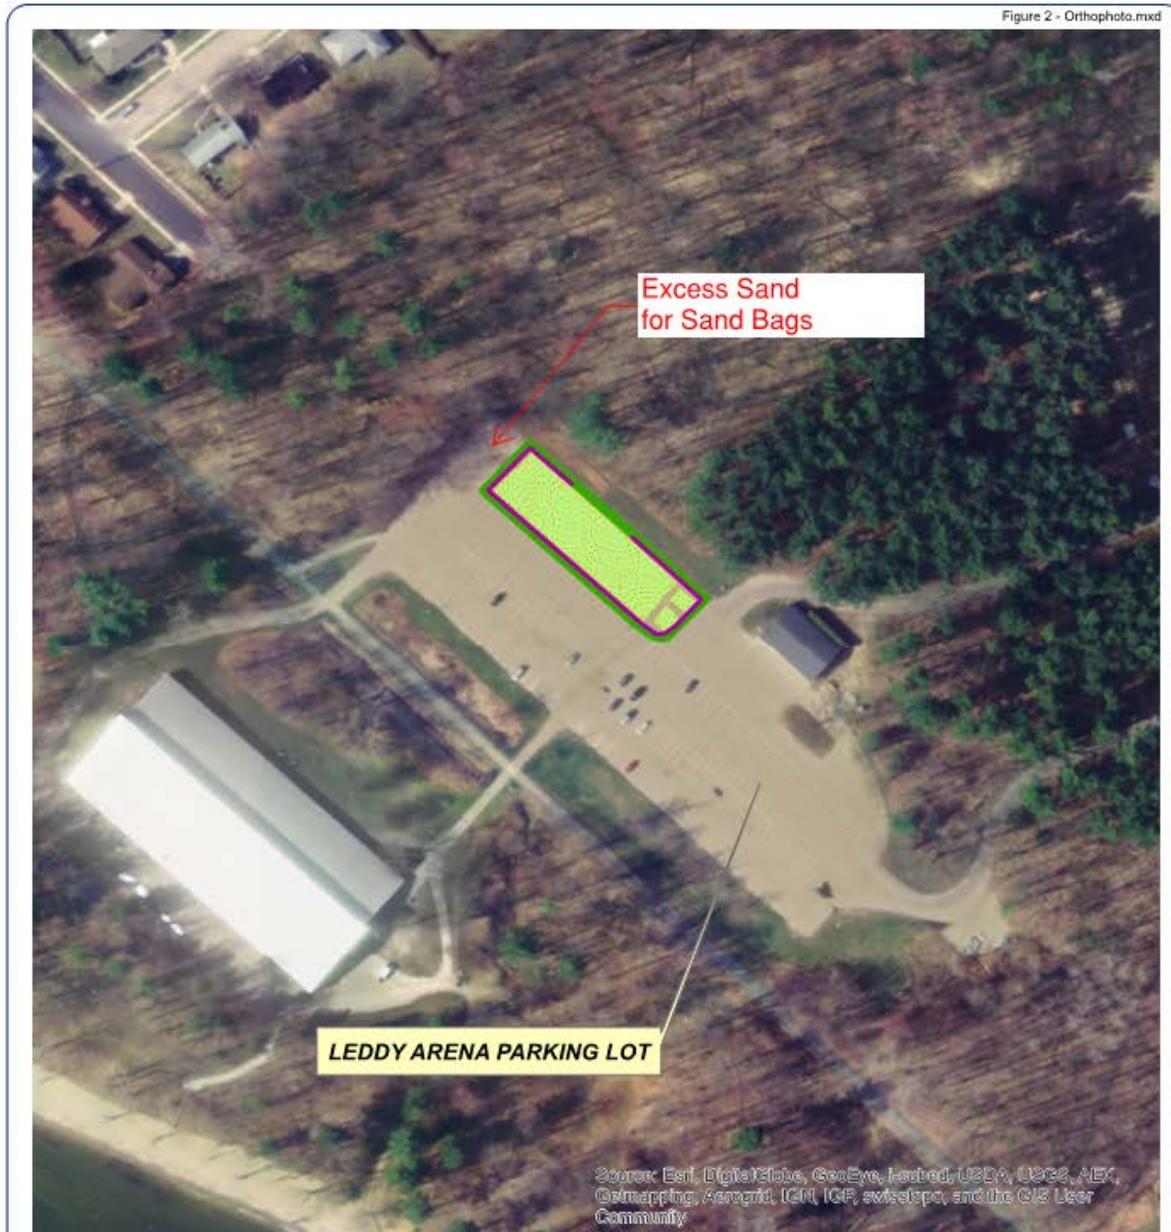
**Figure 1 – Orthophoto & Site Sketch**  
*(Areas of Corrective Action)*

- Hay Bale Berm
- Perimeter Fence
- Soil Stockpiles
