IWMEA APPLICATION FORM FOR DISPOSAL EVENTS

The City of Rutland proposes to replace the aging White Memorial Pool. Under this IWMEA, the City is requesting to place demolition materials on site with an engineered cap in lieu of transport to a RCRA Subtitle D landfill. Part of the cap will include soils that are not structurally suitable, based on a geotechnical study, from around the new pool. Preliminary discussions pertaining to this matter have been discussed with Mr. Jim (Buzz) Surwilo of the Vermont Solid Waste Management Program (VTSWMP) and Ms. Kristi Herzer of the Sites Management Section (VTSMS).

CITY OF RUTLAND - PARKS AND RECREATION DEPARTMENT
 2 AVENUE B, RUTLAND, VERMONT
 WHITE POOL REHABILITATION
**SOLID WASTE AND UNSUITABLE SOILS
 MANAGEMENT PLAN**

Re: **Whites Pool Hazardous Materials Assessment
Rutland, Vermont**

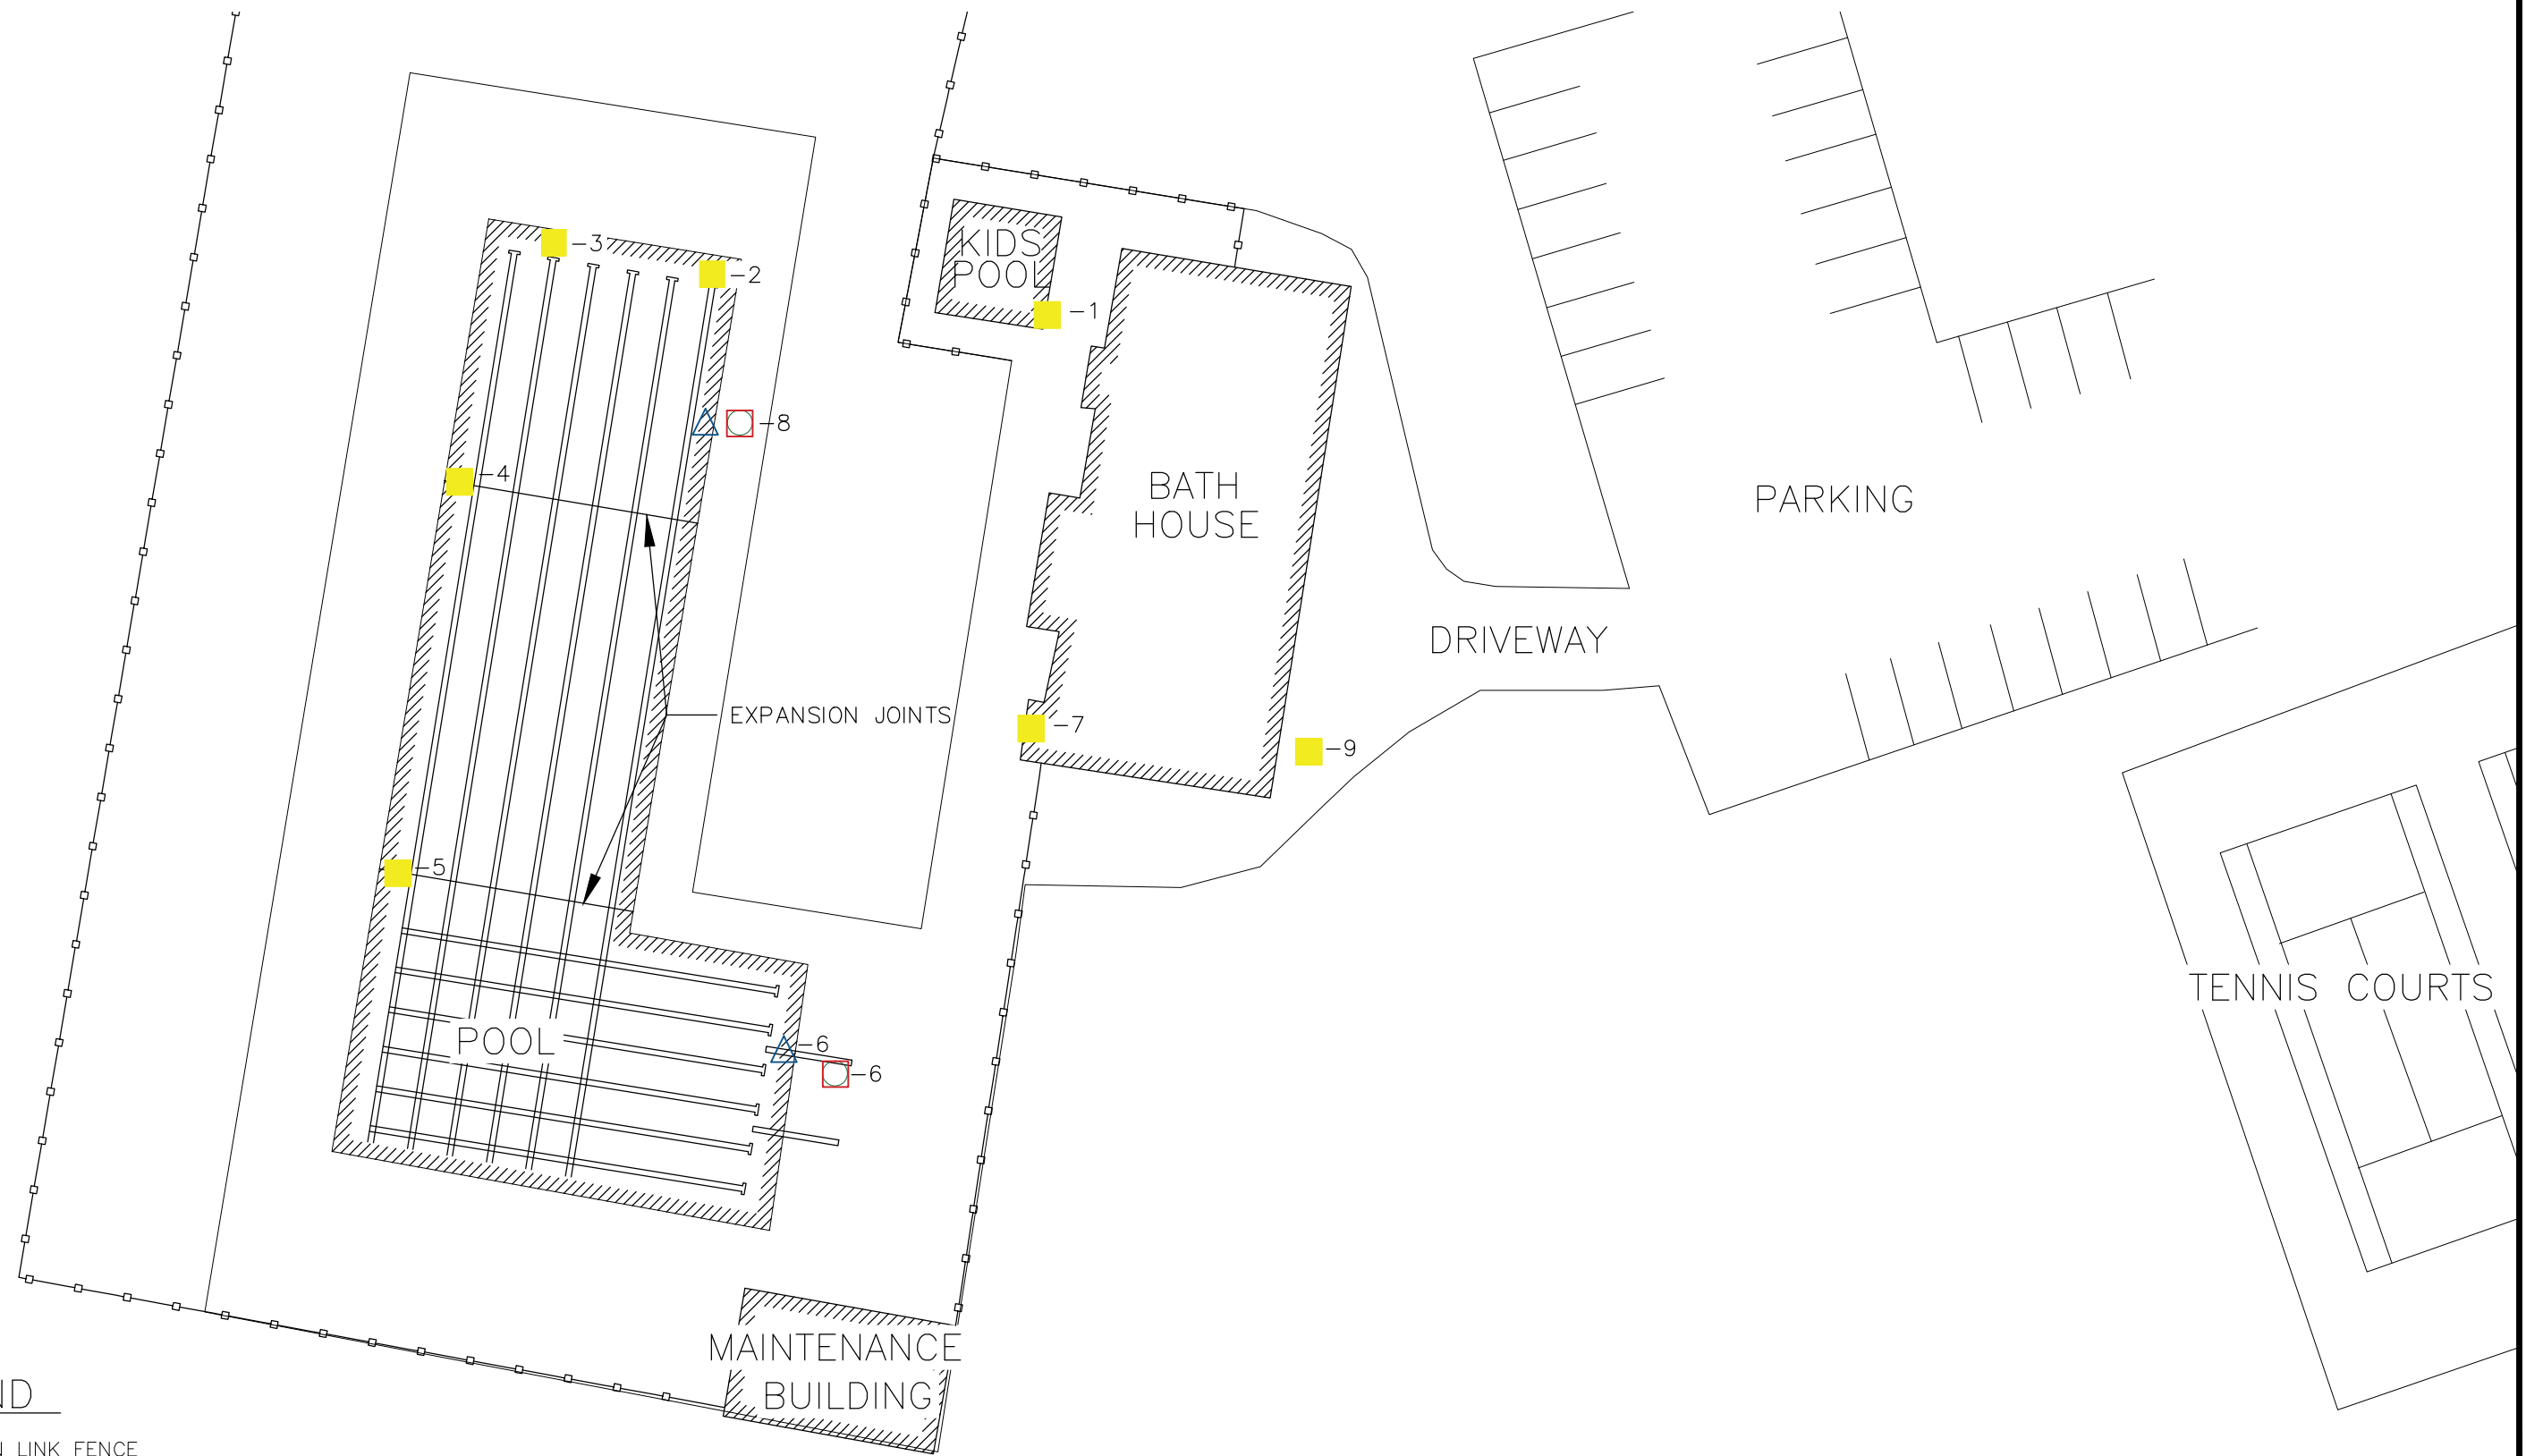
FIGURE 2
SITE PLAN

- CHAIN LINK FENCE
- △-5 PAINT SAMPLES
- 5 CAULK SAMPLES
- 5 CONCRETE SAMPLES
- 5 CO-LOCATED (PAINT,CAULK,CONCRETE)

- gaps between the decking and the pool (Caulk-1)
- horizontal seals between the water return gutter and the pool (Caulk-2 and Caulk-3)
- pool expansion joints (Caulk-4 and Caulk-5)
- pool decking (Caulk 6 and Caulk-8)
- building decking joints (Caulk-7 and Caulk-9)

- Blue children's pool paint (Paint-1)
- Black swimming-lane paint (Paint-2 and Paint-3)
- White marcite plaster (also called whitecoat) pool lining material (Paint-4, Paint-5, Paint-6, and Paint-8)
- Green and yellow building paint (Paint-7 and Paint-9)

To the extent possible, paint, caulk, and concrete samples were co-located. Paint samples were collected in the general vicinity to present appropriate areal coverage of paint materials. Paint and caulk samples were analyzed for PCBs using Soxhlet Extraction (EPA Method 3540C) and EPA Method 8082. Concrete samples were placed on archive at the laboratory, pending the recommendations of this report.
