Phase I
Environmental Site Assessment Report

213 Maple Street
White River Junction, Vermont

January 2021

Pomerleau Real Estate
69 Main Street/PO Box 6
Burlington, VT 05401

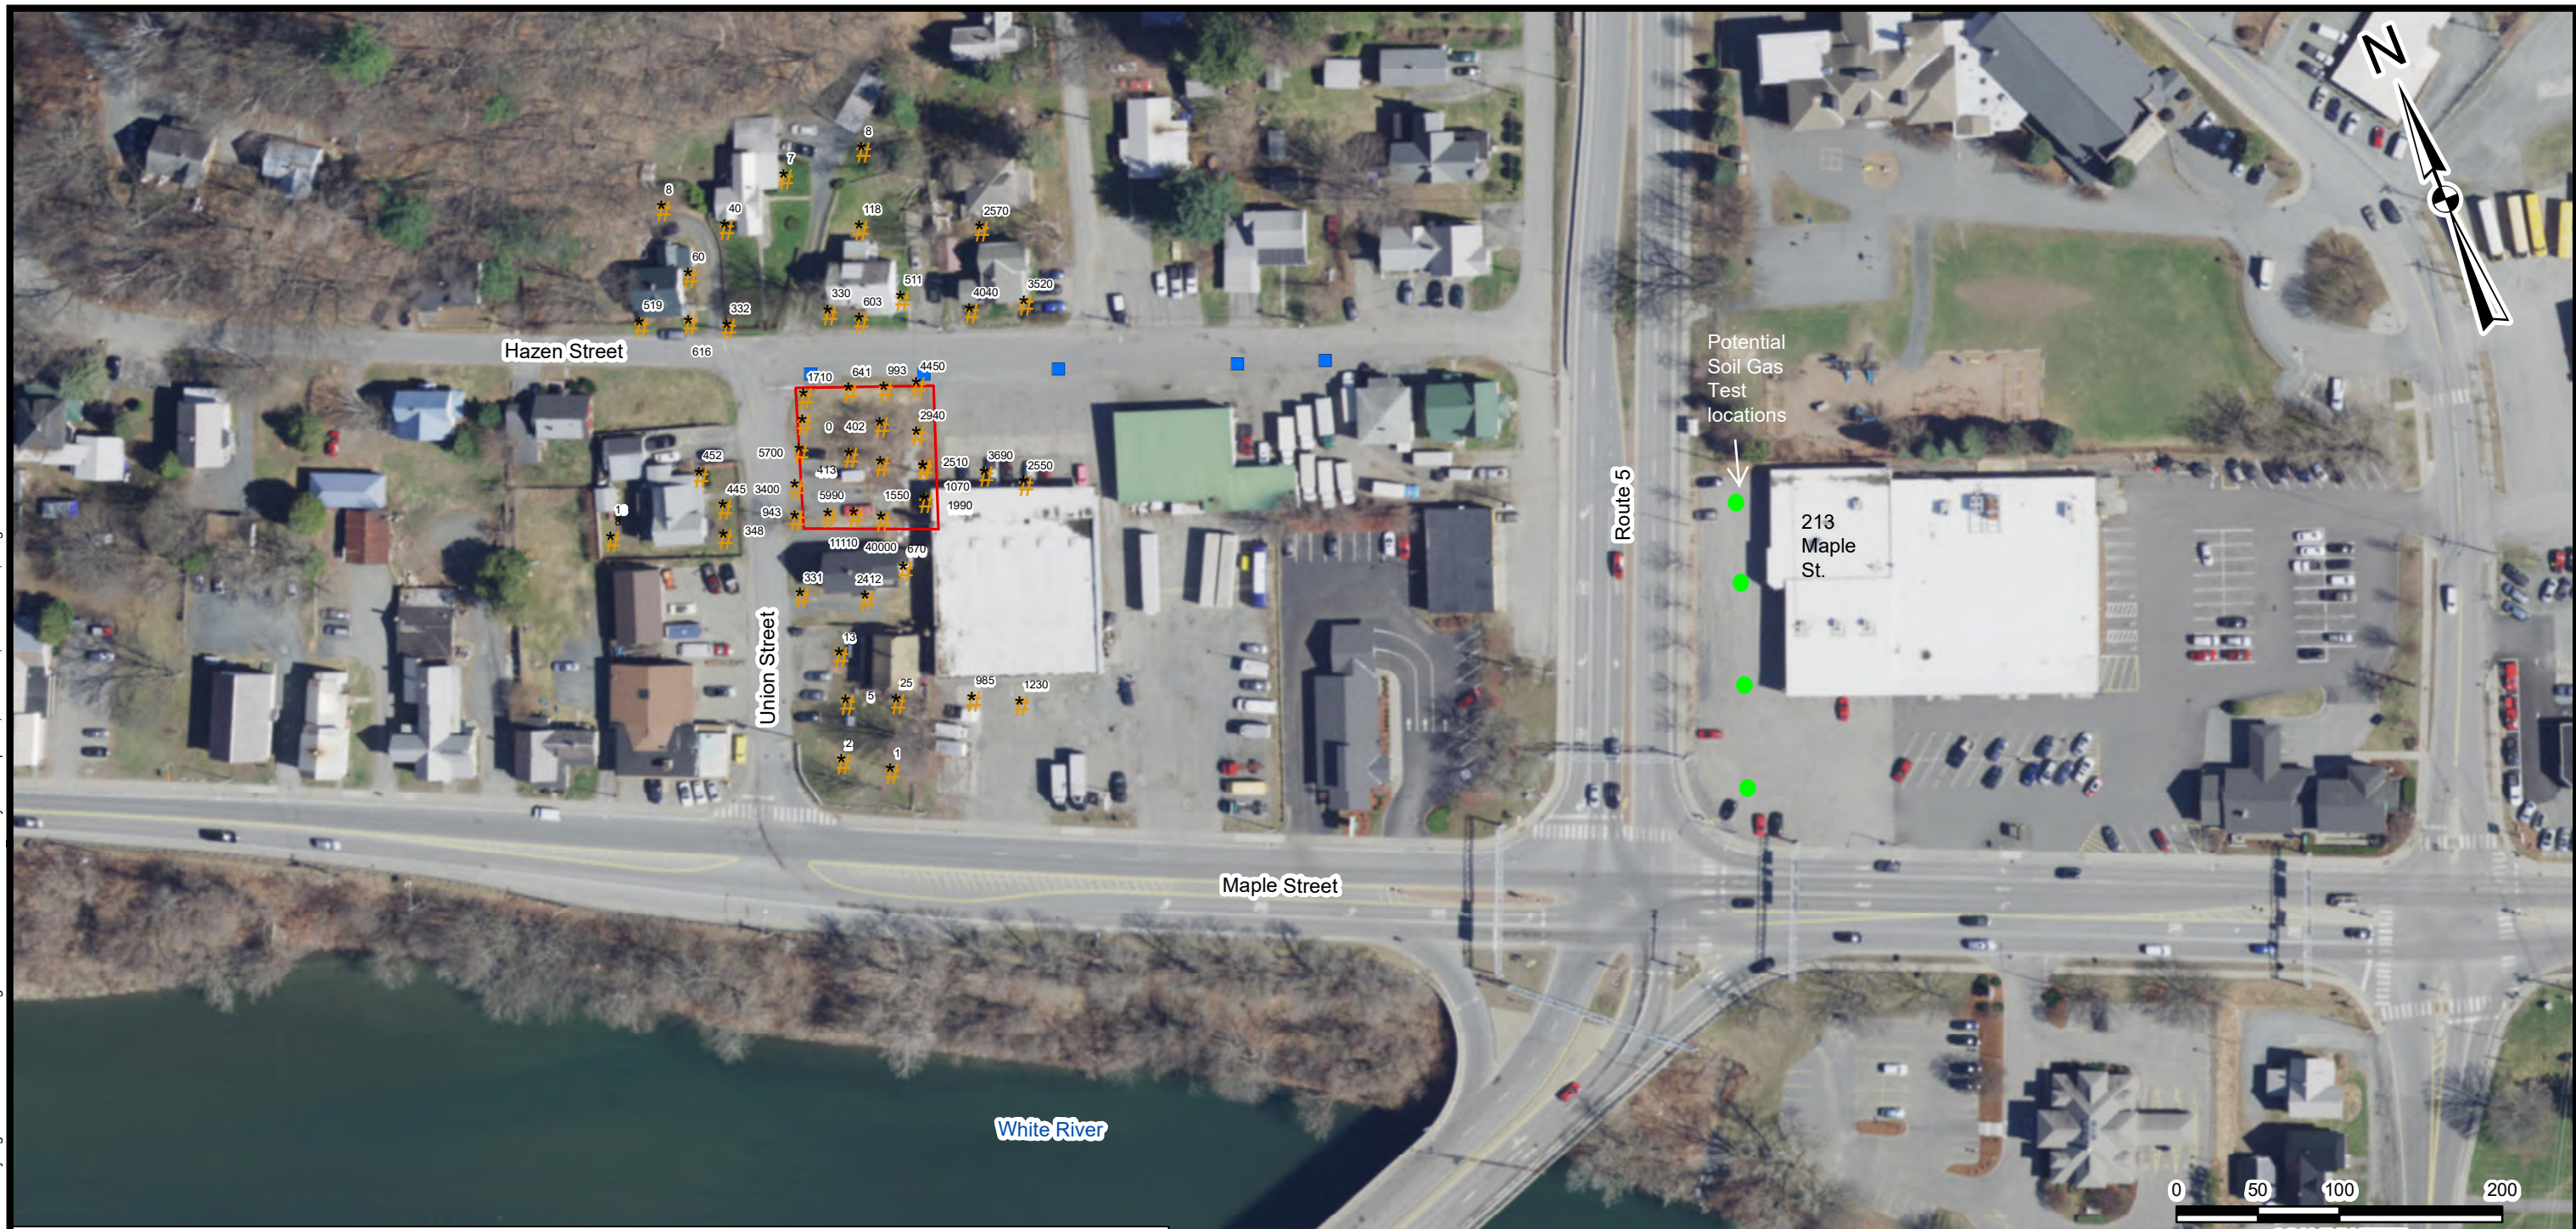
PROJ MGR: GLG	REVIEWED BY: GLG	CHECKED BY: MSR	FIGURE
DESIGNED BY: IPG	DRAWN BY: IPG	SCALE: 1" = 100 FEET	B3
DATE: December 2018	PROJECT NO: 04.0190874.00	REVISION NO: 1	
			SHEET NO. 1 OF 1

Legend

- # Soil Gas Sampling Location (ppbv)
-) Storm Drain
- 18 Union Street Site (Former PDC) Boundary

The presence of PCE-contaminated groundwater also presents a risk of potential Vapor Intrusion into the building and is a REC. At a minimum, Phase II follow-up in the form of soil vapor sample collection at the Property is recommended. A map retrieved from the ANR-ERT website is included in the “Figures” appendix at the end of this report. The map shows results of historic Soil Gas sampling collected at the Parkway site, and potential Phase II sampling locations oriented along the west portion of the Property.

Enforcement Standard (VGES) for PCE (5 µg/l). This indicates there is potential for PCE-contaminated groundwater at concentrations in excess of the VGES to migrate onto the Property at levels. At a minimum, Phase II follow-up in the form of soil gas sampling along the west portion of the Property is recommended (see potential test locations in “Figures” section of this report).

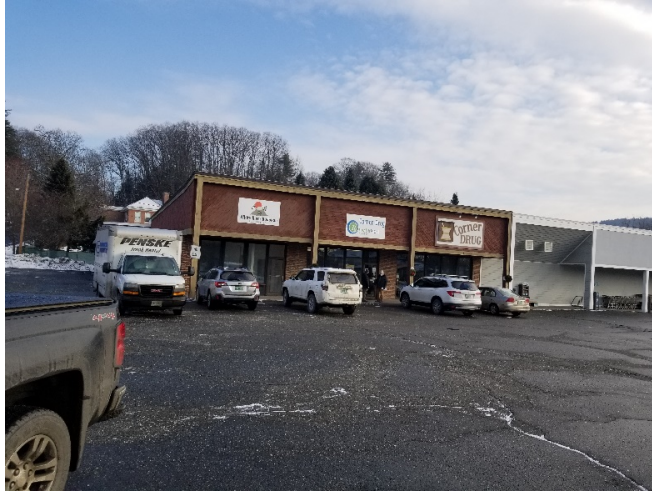
Plate 1. Jan. 22, 2021-Property at 213 Maple Street, White River Jct. VT (WRJ)

View is looking north at South exterior wall and store fronts.

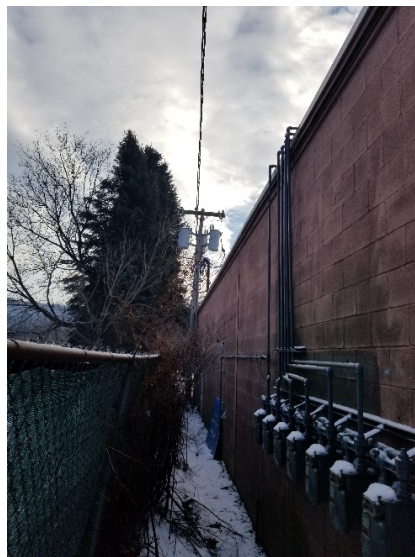
Plate 3. View is looking east along the north exterior wall.

Polychlorinated biphenyls (PCBs) can be associated with older electrical components before 1975-1980. Three electrical transformers were observed mounted on a power pole located immediately outside the north exterior wall of the Property (Plate 3, Appendix A). Bowes Environmental contacted Green Mountain Power regarding the status and age of the transformers. Green Mountain Power informed Bowes Environmental that after reviewing their records, they confirmed these were not PCB-containing transformers (Bowes, 2021b). The electrical components observed in the Utility Room of the Property building all appeared to be of solid-state componentry. Information was not listed about PCBs on the Property on the Environmental Questionnaire

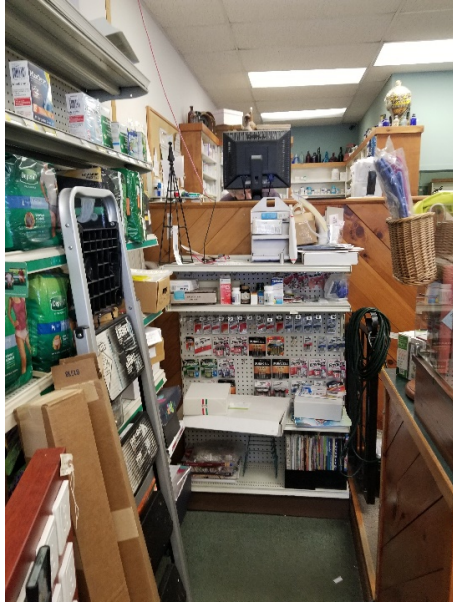
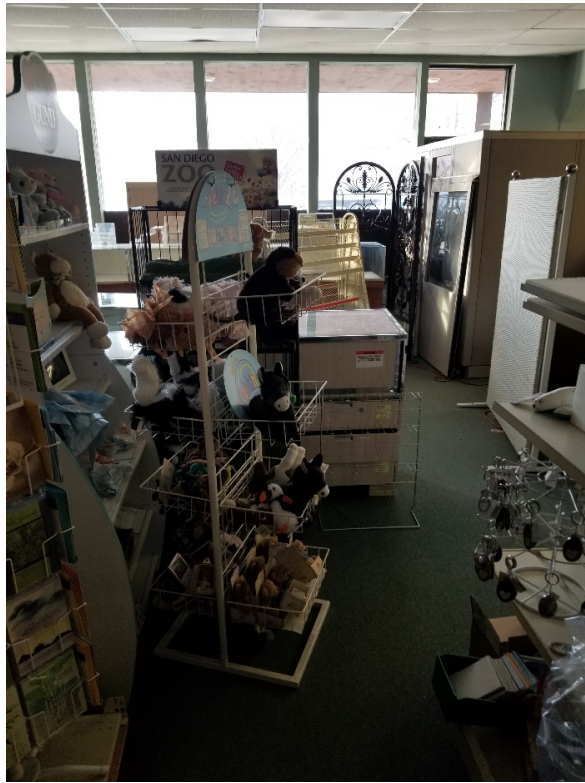
Plates 7, 8. Interior views of Corner Drug, occupant of the southeast storefronts 213 Maple St.

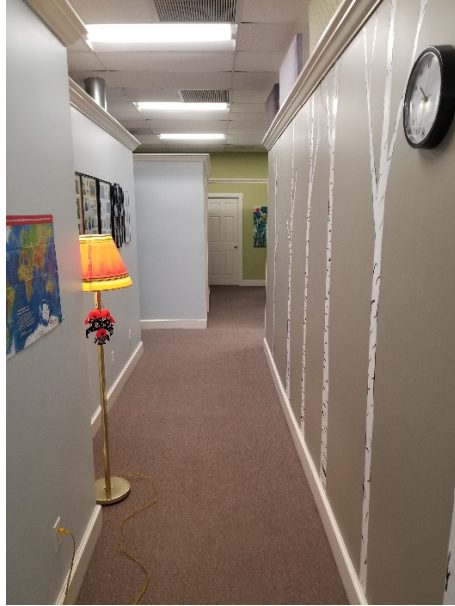
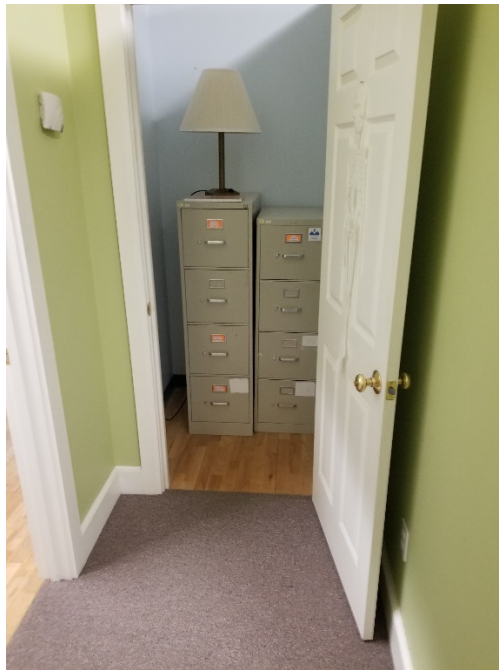
No floor drains or collection pits/basins were observed in the storefronts that were able to be accessed and inspected the day of the Site Reconnaissance. Both store fronts that were inspected were typical of occupied office and retail space. The retail drug store/pharmacy (Corner Drug) occupies two store fronts and is comprised of aisles and shelving for access and storage of merchandise, a prescription processing area, small waiting area, and a restroom (see Plates 7- 8, Appendix A). The Adult Learning Center is comprised of separate classroom/meeting rooms, storage rooms, a central receiving area (see Plates 9-12, Appendix A) restroom, and utility room. According to the employee who works at the Learning Center, on-site visits through the Learning Center have been greatly reduced due to the COVID-19 pandemic, with no regular on-site classroom instruction occurring. The utility room is in the northeast portion of the Learning Center and consists primarily of storage space with storage of several five-gallon buckets of rock salt for spreading on icy portions of the driveway, unused furniture, and wall-mounted electric power switches/controls for distribution throughout the building (Plate 12). Evidence of minor water damage from a leak in the roof was observed in the central portion of the learning center (Plate 11). According to the employee at the Learning Center, repairs have been made to mitigate the leaking roof.

Plates 9, 10. Interior views, Adult Learning Center, occupant of northwest store front, 213 Maple St.

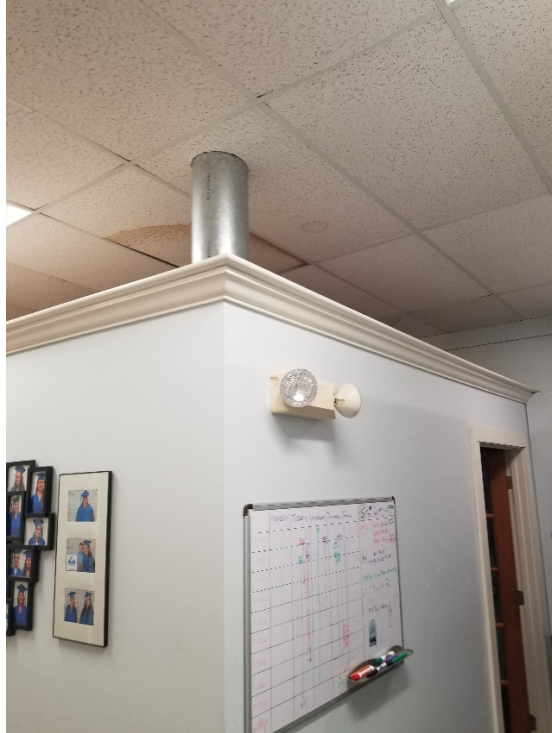
Plate 11. Heating duct work, Adult Learning Center. Note water damage in ceiling tile.

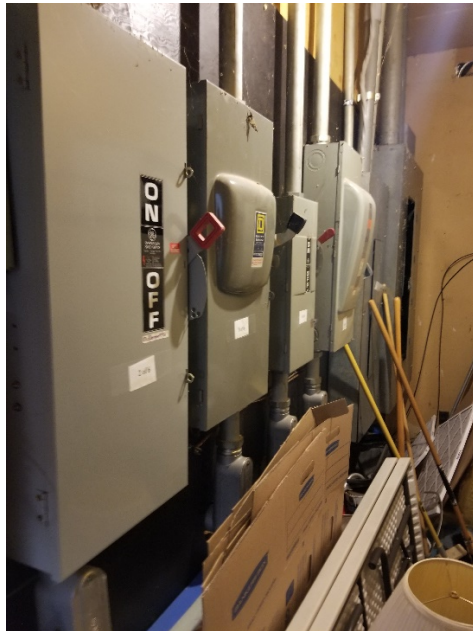
Plate 12. Utility room in Adult Learning Center with electrical power switches.
