September 2017

PFAS SUMMARY REPORT  
Pownal, Vermont

**Prepared for:**  
Vermont Department of Environmental  
Conservation

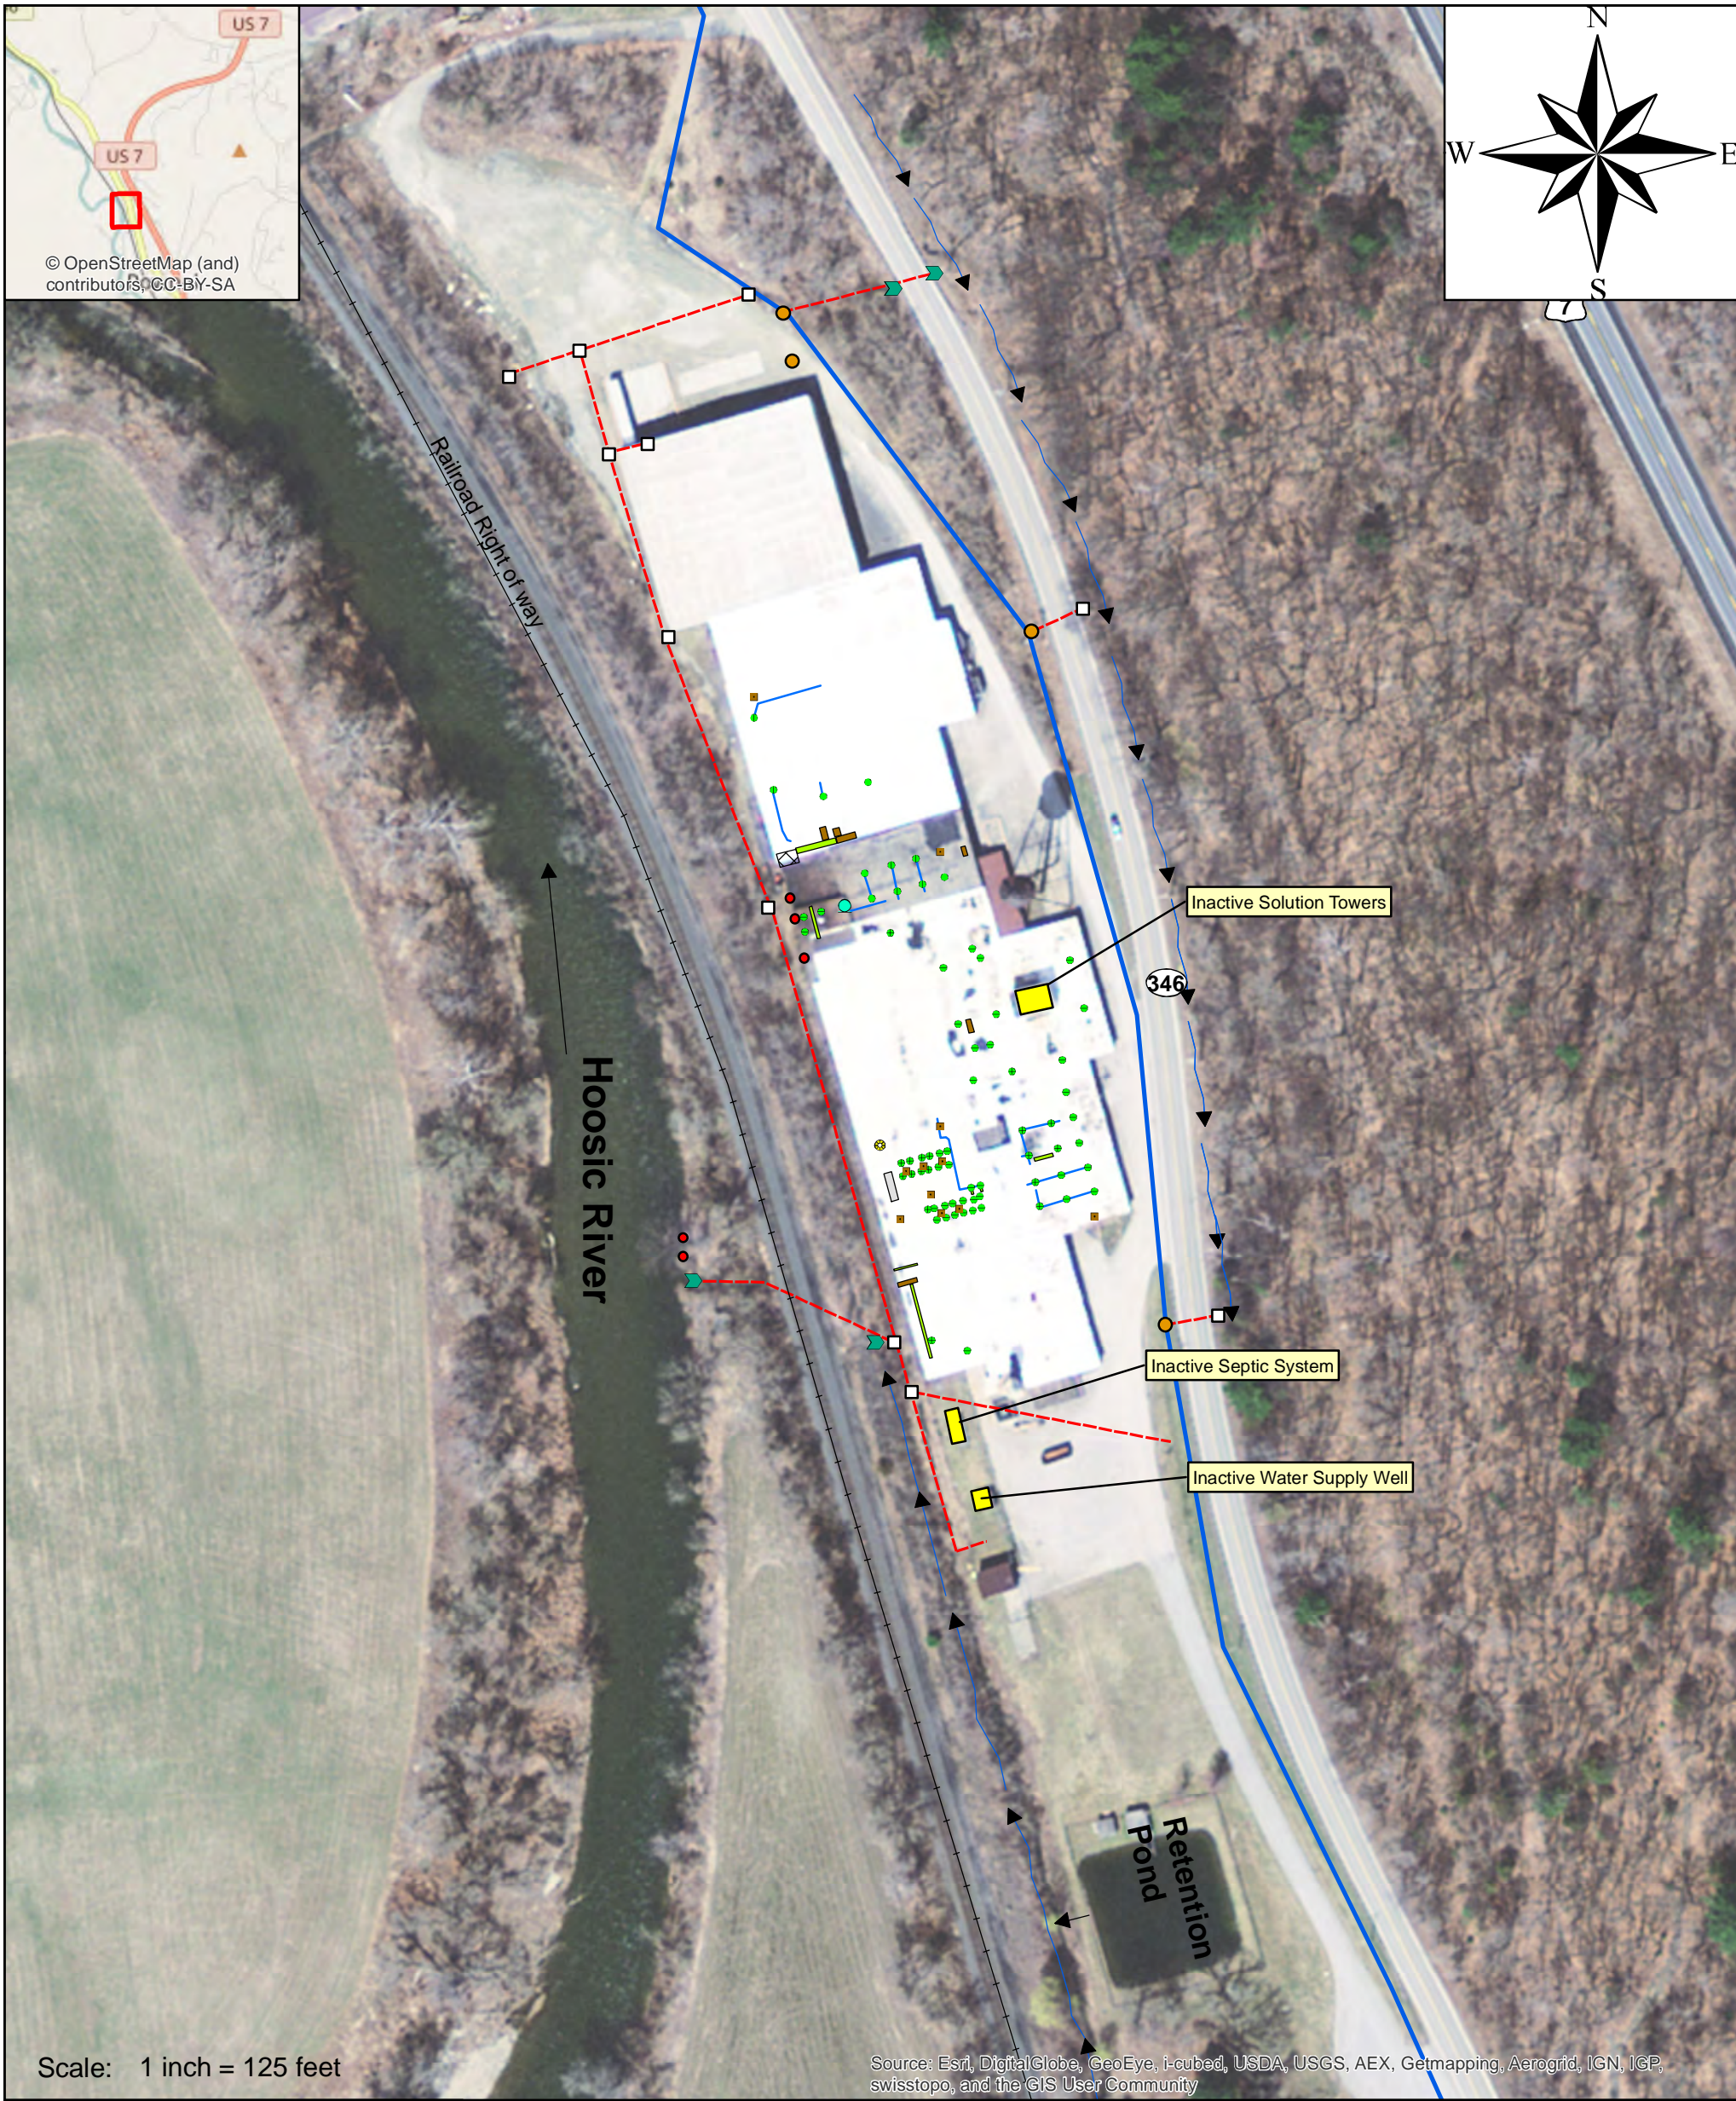
**Figure 3**

The groundwater and surface water samples were submitted for laboratory PFC analysis by USEPA Methods 537 and 537 Modified. Figure 3 depicts the location of monitoring wells installed on the Site property for the purpose of assessing hydrocarbon-related impacts, designated as MW-1 through MW-9; GT-1 through GT-6; and RW-2 and RW-3, and the location of the surface water sample designated as SW-1.

On April 19, 2016, UMC submitted the preliminary groundwater, surface water, soil, and sediment sample results obtained during UMC's March 2016 IRI to the VTDEC via email correspondence. UMC summarized the procedures and findings of the March 2016 IRI activities in an Immediate Response Investigation Report (IRIR), submitted to the VTDEC on May 13, 2016. Figure 3 depicts UMC's March 2016 IRI media sampling locations and a tabulation of the media sample analytical results.

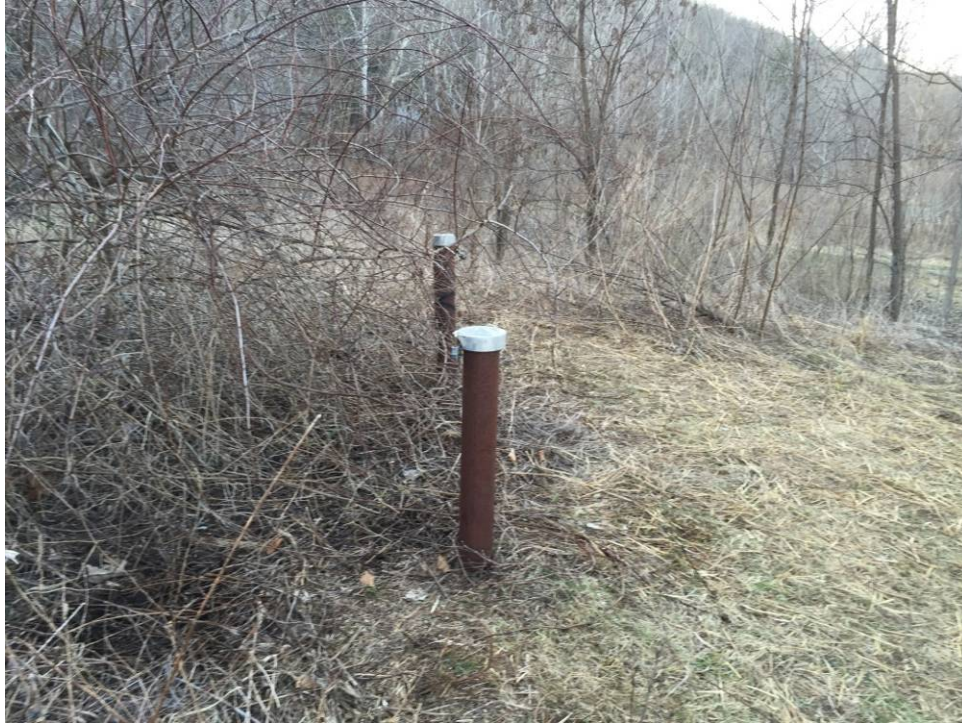
**SCENE:** View of the monitoring wells MW-107R (foreground) and MW-107U (background) located at the Lagoon Area of the Pownal Tannery site. Photograph taken facing northwest.

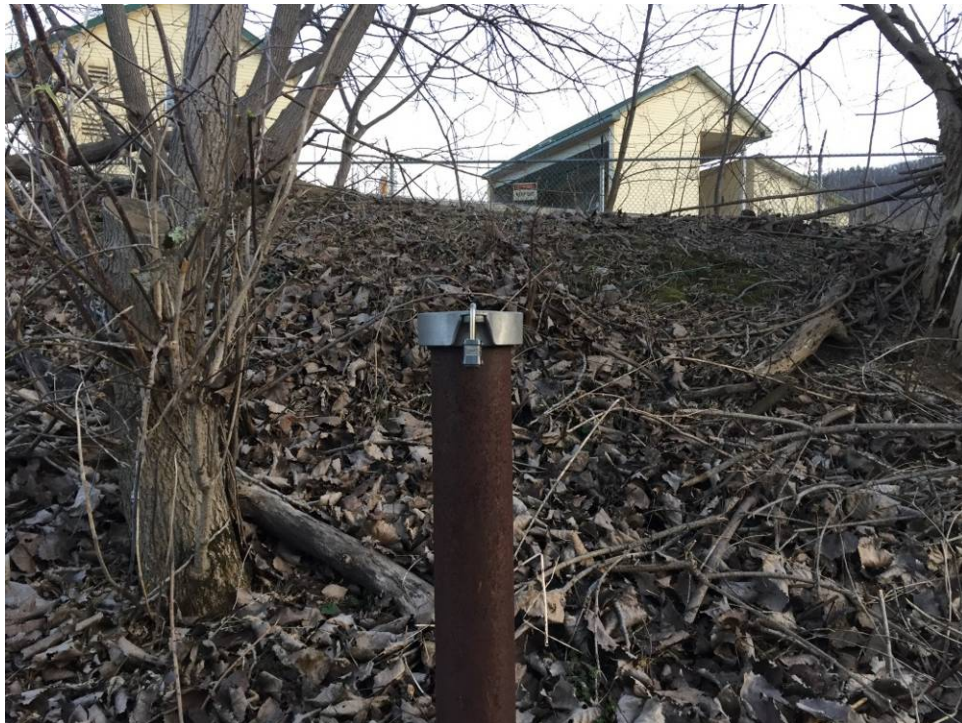
**SCENE:** View of monitoring well MW-L-10 located at the Lagoon Area of the Pownal Tannery site. Photograph taken facing south.

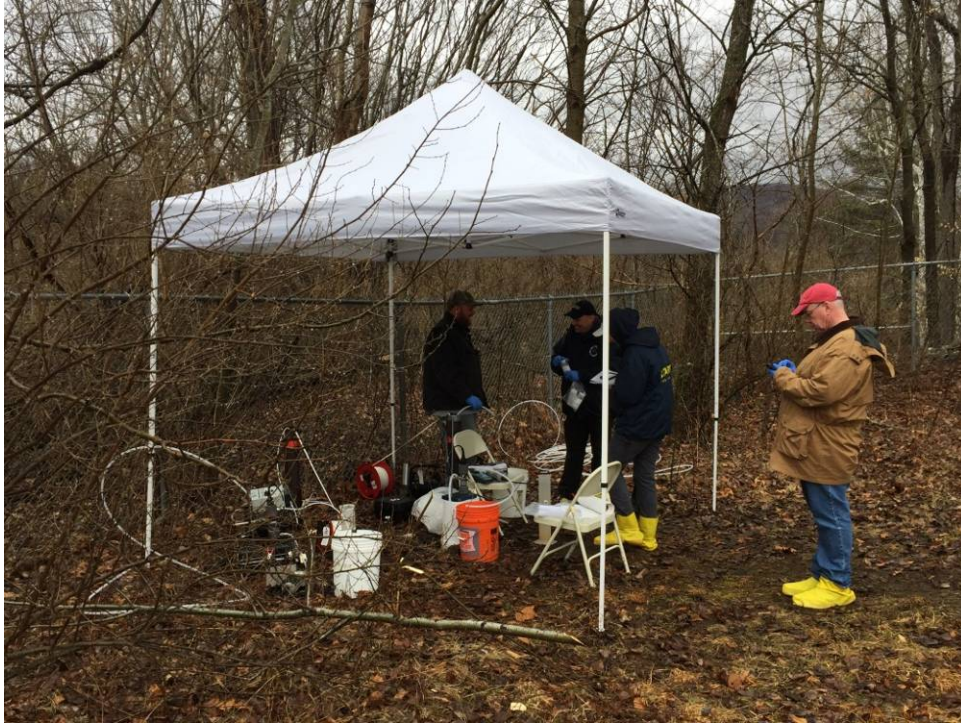
**SCENE:** View of the monitoring wells MW-103U (left) and MW-103R (right), covered by a tent during purging and sampling, located at the Dean Road Landfill Area of the Pownal Tannery site. Photograph taken facing east.

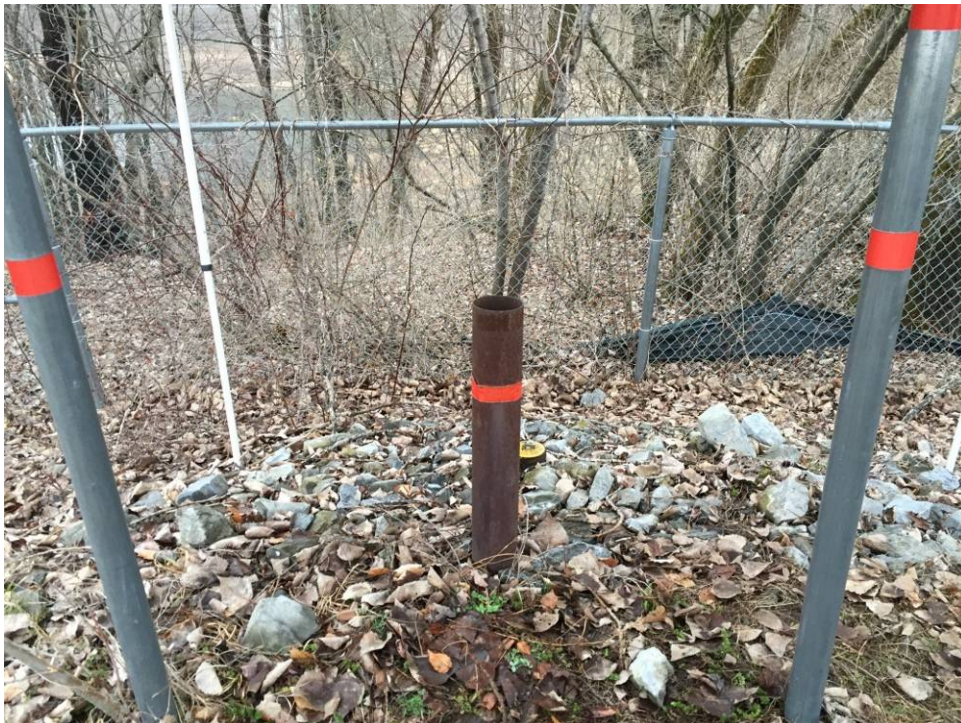
**SCENE:** View of monitoring well MW-101U located at the Dean Road Landfill Area of the Pownal Tannery site. Note well does not contain cap for metal casing. Photograph taken facing northeast.

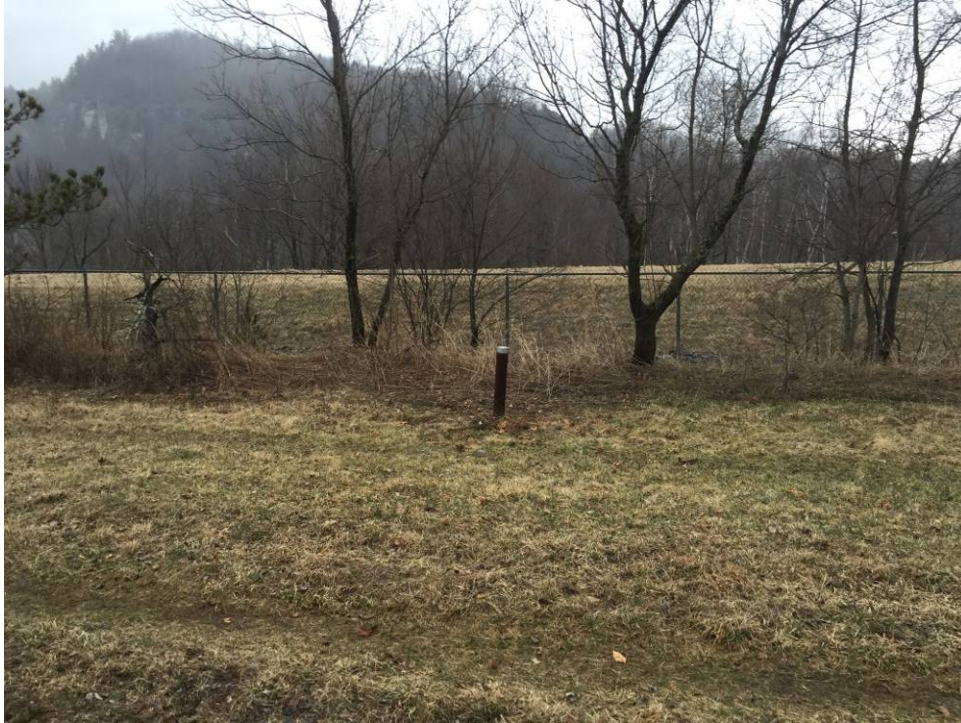
**SCENE:** View of the monitoring well MW-102U. MW-102U is the most upgradient well sampled at the Dean Road Landfill Area of the Pownal Tannery site. Photograph taken facing northeast.

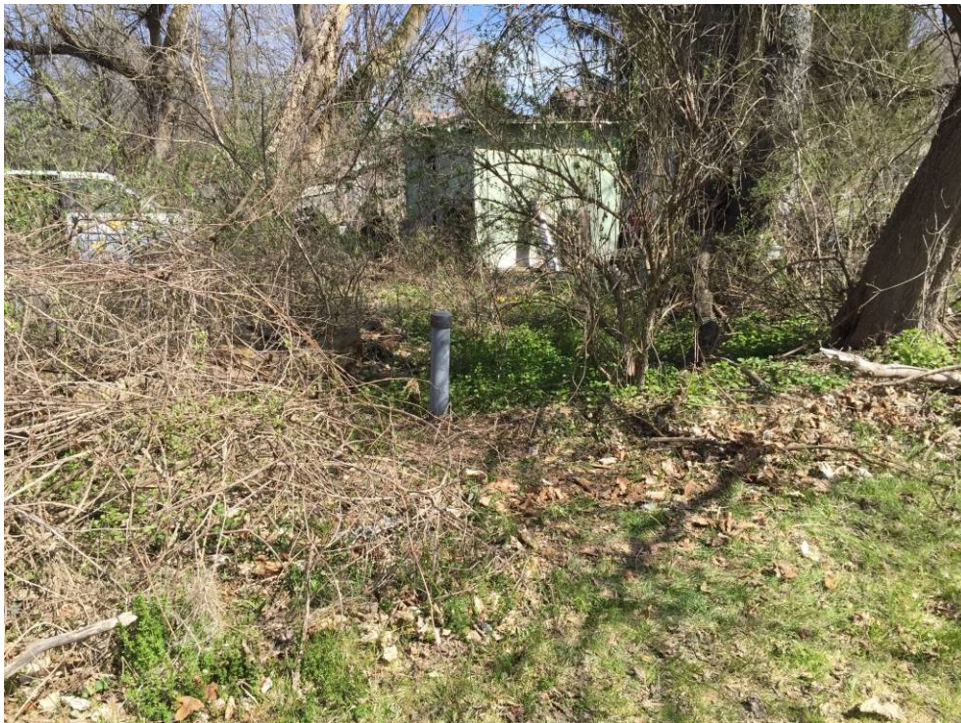
**SCENE:** View of the monitoring well MW-L-7 located at the Lagoon Area of the Pownal Tannery site. Photograph taken facing northeast.

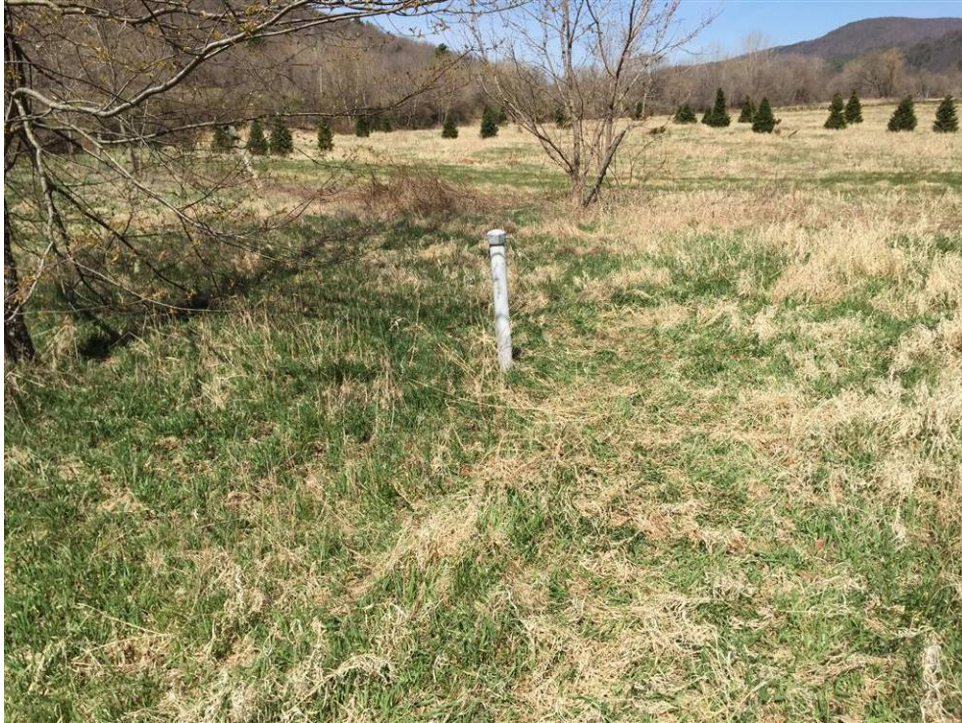
**SCENE:** View of the monitoring well MW-L-9 located at the Lagoon Area of the Pownal Tannery site.  
Photograph taken facing north.

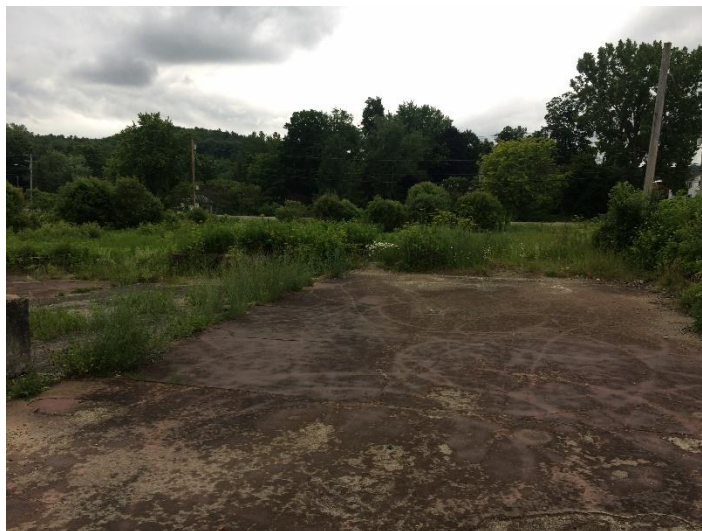
**Description:** A view of the concrete slab facing southwest towards North Pownal Road.

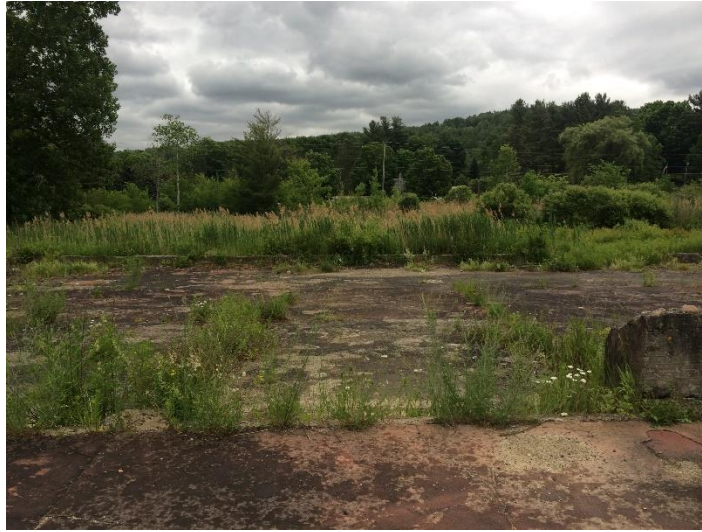
**Description:** A view of the concrete slab and residential properties facing northeast.
