Leicester General Store 1620 US Route 7 Leicester, Vermont

VTDEC #89-0429
KAS #409070287

JULY 2020 GROUNDWATER/DRINKING WATER MONITORING REPORT

September 8, 2020

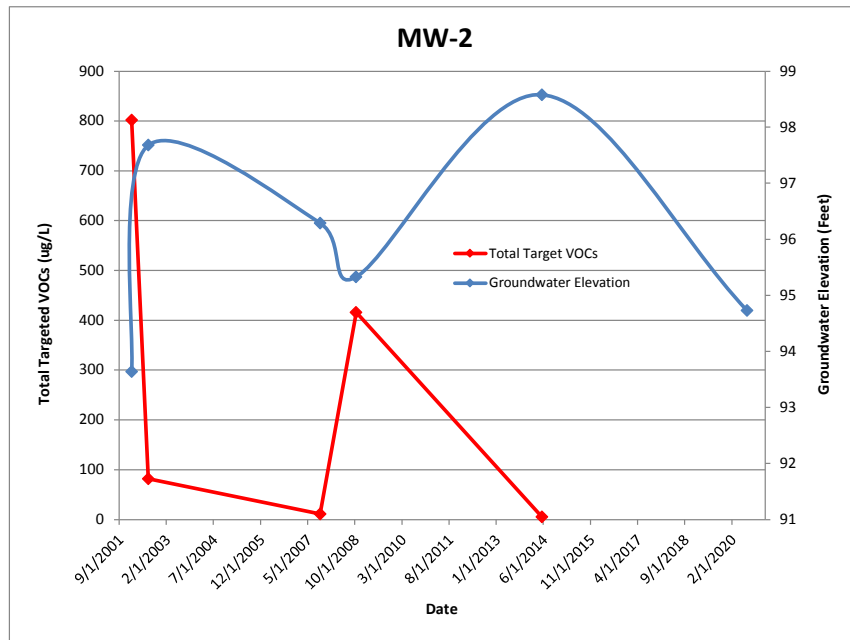
MW-2

PARAMETER	Date of Sample Collection:						VGES
	9/20/2001	1/3/2002	7/12/2002	9/18/2007	3/5/2008	10/7/2008	
Benzene	Well	237.	48.0	3.9	Well	79.2	5
Toluene	Not	47.8	ND(1.0)	ND(1.0)	Not	ND(20.0)	1000
Ethylbenzene	Sampled	129.	6.8	2.3	Sampled	73.3	700
Xylenes		169.	ND(2.0)	ND(2.0)		166.	10,000
Total BTEX:		583.	54.8	6.2		319.	
1,3,5 Trimethyl Benzene		3.3	ND(1.0)	ND(1.0)		ND(20.0)	
1,2,4 Trimethyl Benzene	Well	64.7	1.1	ND(1.0)	Unable to	97.7	350
Naphthalene	Dry	19.5	1.2	ND(2.0)	Locate	ND(40.0)	20
MTBE		132.	24.6	5.0		ND(40.0)	40
Total Targeted VOCs:		802.	81.7	11.2		416.

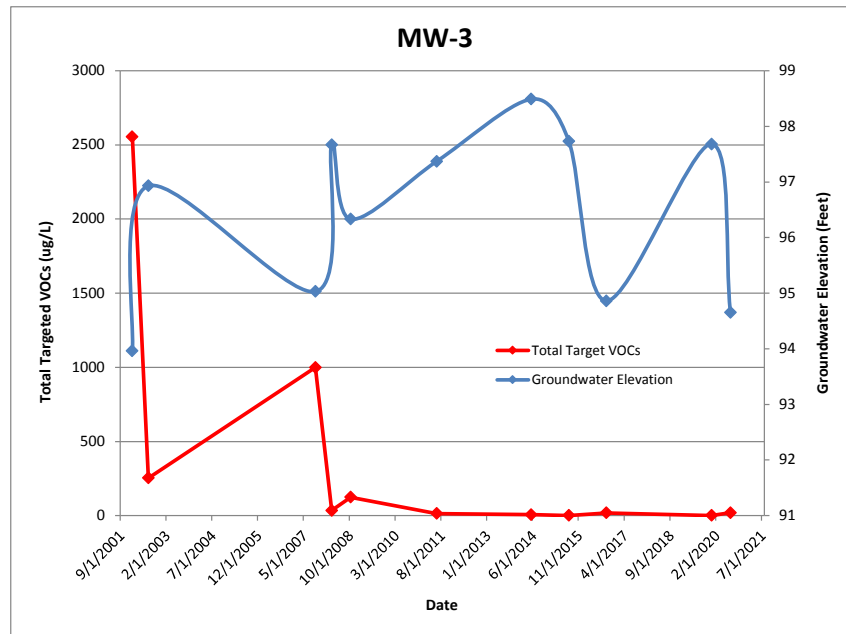
At MW-3 (upgradient well), petroleum VOCs have increased compared to the 2019 levels. However, overall, the levels remain low and are similar to levels reported in 2016 when the water table was also low. MTBE levels at MLMW-2 (middle channel) continue to exhibit a slightly increasing trend (see graph in Appendix C). At MW15-11D, although MTBE was lower than the last sampling event in 2019, levels continue to fluctuate with the groundwater fluctuations, and may be low due to the low water table. A definitive trend has not yet been established at MW15-11D. MTBE levels at MW-10 increased from 2019 but continue to exhibit an overall decreasing trend; however, this decrease may be due to the plume migrating deeper than MW-10's screened length versus natural attenuation or biodegradation. Overall, the trends suggest that the plume is not stable. In order to better evaluate the plume, it is important to replace MW-4, the presumed source area of the plume.

PARAMETER	Date of Sample Collection						VGES
	9/20/2001	1/3/2002	7/12/2002	9/18/2007	3/5/2008	10/7/2008	
Benzene	Well	789.	26.2	290	17.3	44.5	5
Toluene	Not	81.3	3.5	27.5	1.3	3.1	1,000
Ethylbenzene	Sampled	458.	65.6	229	8.5	35.1	700
Xylenes		567.	81.3	230	2.6	12.9	10,000
Total BTEX:		1,895.	176.6	777	29.7	95.6	
1,3,5 Trimethyl Benzene		73.0	4.8	24.9	ND(1.0)	ND(1.0)	
1,2,4 Trimethyl Benzene	Well	372.	53.6	125.	ND(1.0)	9.8	350
Naphthalene	Dry	105.	15.1	43.8	ND(2.0)	4.6	20
MTBE		110.	2.4	28.4	4.2	13.2	40
Total Targeted VOCs:		2,555.	252.5	999	33.9	123.2

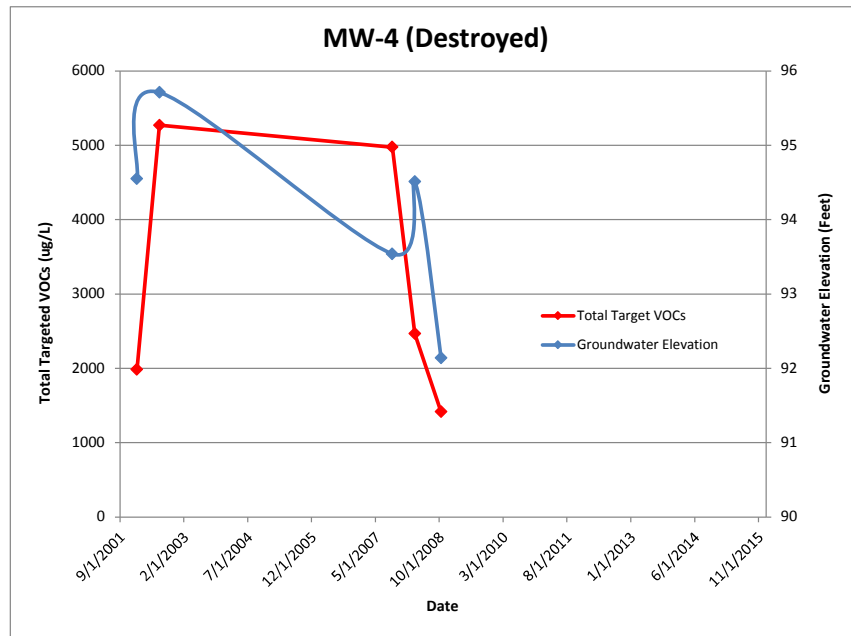
MW-4 (Destroyed)

It is presumed that the source area/plume core is in the vicinity of MW-4; however, MW-4 was destroyed in 2008. The data collected to date indicates that the MTBE plume migration has a downward vertical gradient as it extends off-site. The extent of the MTBE plume has not been fully defined both spatially and vertically. The data collected to date suggests that the plume is unstable. Degradation of MTBE via natural attenuation appears to be occurring at a very slow rate; however, it is difficult to confirm based on the existing monitoring well network.

PARAMETER	Date of Sample Collection:						VGES
	9/20/2001	1/3/2002	7/12/2002	9/18/2007	3/5/2008	10/7/2008	
Benzene	Well	619.	1,300.	486.	311.	465.	5
Toluene	Not	23.0	111.	50.4	22.6	68.3	1,000
Ethylbenzene	Sampled	282.	655.	802.	465.	915.	700
Xylenes		256.	1,440.	1,850.	866.	1,480.	10,000
Total BTEX:		1,180.	3,506.	3,188.	1,665.	2,928.	
1,3,5 Trimethyl Benzene	Could	35.3	91.3	117.	ND(20)	106.	
1,2,4 Trimethyl Benzene	Not	237.	752.	809.	408.	741.	350
Naphthalene	Locate	59.1	229.	245.	121.	290.	20
MTBE		474.	691.	616.	271.	279.	40
Total Targeted VOCs:		1,985.	5,269.	4,975.	2,465.	1,416.

It is presumed that the source area/plume core is in the vicinity of MW-4 based on historical data; however, MW-4 was destroyed in 2008. It is recommended that MW-4 be replaced with a new one (via Geoprobe due to limited clearance by overhead electrical lines).

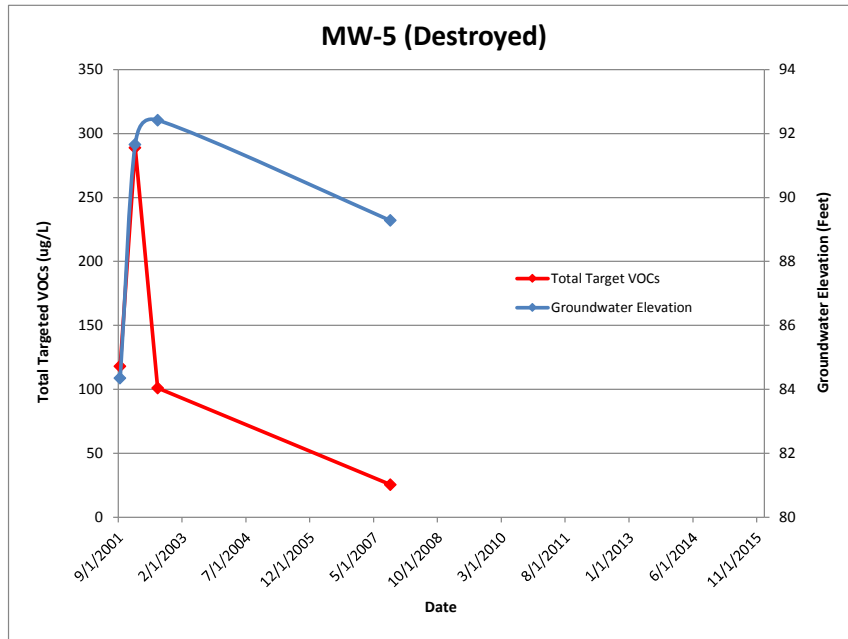
MW-5

PARAMETER	Date of Sample Collection:						VGES
	9/20/2001	1/3/2002	7/12/2002	9/18/2007	3/5/2008	10/7/2008	
Benzene	ND(1.0)	112.	ND(1.0)	ND(1.0)	Well	Well	5
Toluene	ND(1.0)	4.2	ND(1.0)	ND(1.0)	Not	Not	1,000
Ethylbenzene	ND(1.0)	8.1	ND(1.0)	ND(1.0)	Sampled	Sampled	700
Xylenes	ND(1.0)	7.7	ND(2.0)	ND(2.0)		Removed	10,000
Total BTEX:	ND	132.	ND	ND		From	
1,3,5 Trimethyl Benzene	ND(1.0)	ND(1.0)	ND(1.0)	ND(1.0)		Sampling	
1,2,4 Trimethyl Benzene	ND(1.0)	3.2	ND(1.0)	ND(1.0)		Schedule	350
Naphthalene	ND(1.0)	1.6	ND(1.0)	ND(1.0)			20
MTBE	118.	152.	101.	25.5			40
Total Targeted VOCs:	118.	289.	101.	25.5

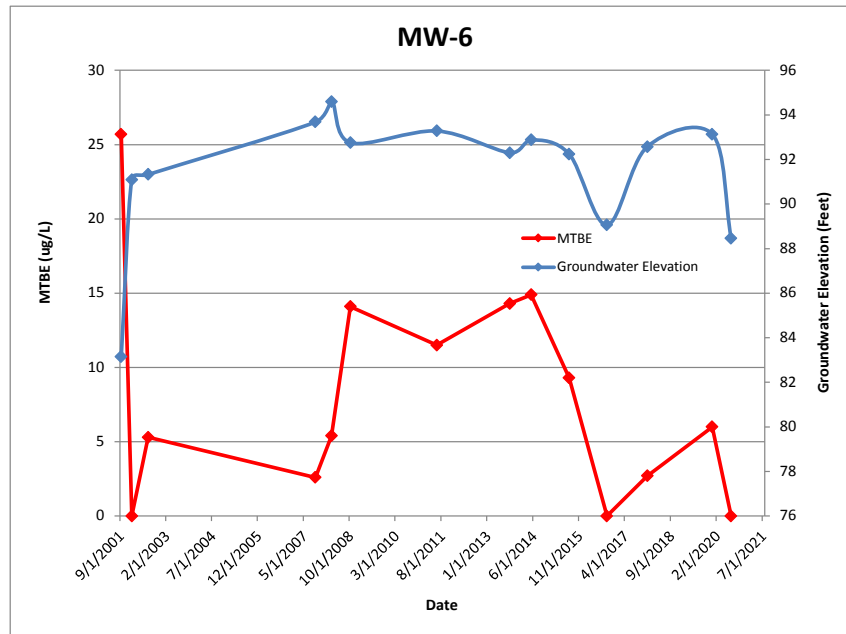
MW-6

PARAMETER	Date of Sample Collection:						VGES
	9/20/2001	1/3/2002	7/12/2002	9/18/2007	3/5/2008	10/7/2008	
Benzene	ND(1.0)	ND(1.0)	ND(1.0)	ND(1.0)	ND(1.0)	ND(1.0)	5
Toluene	ND(1.0)	ND(1.0)	ND(1.0)	ND(1.0)	ND(1.0)	ND(1.0)	1,000
Ethylbenzene	ND(1.0)	ND(1.0)	ND(1.0)	ND(1.0)	ND(1.0)	ND(1.0)	700
Xylenes	ND(1.0)	ND(1.0)	ND(2.0)	ND(2.0)	ND(2.0)	ND(2.0)	10,000
Total BTEX:	ND	ND	ND	ND	ND	ND	
1,3,5 Trimethyl Benzene	ND(1.0)	ND(1.0)	ND(1.0)	ND(1.0)	ND(1.0)	ND(1.0)	
1,2,4 Trimethyl Benzene	ND(1.0)	ND(1.0)	ND(1.0)	ND(1.0)	ND(1.0)	ND(1.0)	350
Naphthalene	ND(1.0)	ND(1.0)	ND(1.0)	ND(1.0)	ND(2.0)	ND(2.0)	20
MTBE	25.7	ND(5.0)	5.3	2.6	5.4	14.1	40
Total Targeted VOCs:	25.7	ND	5.3	2.6	5.4	14.1

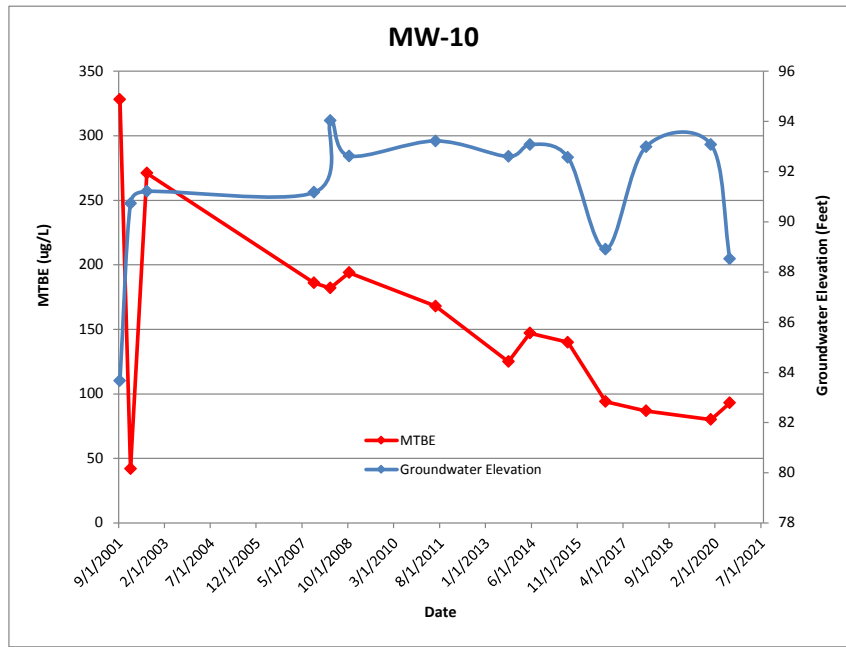
At MW-10, due to well construction, the water table is generally above the screened interval. Therefore, the volatile organic compound (VOC) data reported to date may be biased low. Nonetheless, this well is deemed adequate for long-term monitoring purposes and for establishing overall trends. At MLMW-1, the depth to groundwater among the three levels are essentially the same. This indicates that the integrity of the packer system, which isolates each interval, is likely compromised. This well is no longer included in the sampling plan and is only used to gauge groundwater levels. At MLMW-2, the depths to groundwater are different at each level but are above the screened interval. This may be due the water level meter being sensitive to moisture along the interior of the small diameter pipe.

The downgradient/southeasterly extent of the MTBE plume is not known. MW-10 is the farthest downgradient well, which shows a decreasing trend in MTBE levels; however, this trend may be due to a diving plume. Given that there does not appear to be potentially impacted sensitive receptors farther downgradient and that the water supply well on the 1583 US Route 7 residence is monitored, additional subsurface investigation downgradient of MW-10 is not recommended at this time.

PARAMETER	Date of Sample Collection:						VGES
	9/20/2001	1/3/2002	7/12/2002	9/18/2007	3/5/2008	10/7/2008	
Benzene	ND(4.0)	ND(1.0)	ND(2.0)	ND(2.0)	ND(2.0)	ND(2.0)	5
Toluene	ND(4.0)	ND(1.0)	ND(2.0)	ND(2.0)	ND(2.0)	ND(2.0)	1,000
Ethylbenzene	ND(4.0)	ND(1.0)	ND(2.0)	ND(2.0)	ND(2.0)	ND(2.0)	700
Xylenes	ND(4.0)	ND(1.0)	ND(4.0)	ND(4.0)	ND(4.0)	ND(4.0)	10,000
Total BTEX:	ND	ND	ND	ND	ND	ND	
1,3,5 Trimethyl Benzene	ND(4.0)	ND(1.0)	ND(2.0)	ND(2.0)	ND(2.0)	ND(2.0)	
1,2,4 Trimethyl Benzene	ND(4.0)	ND(1.0)	ND(2.0)	ND(2.0)	ND(2.0)	ND(2.0)	350
Naphthalene	ND(4.0)	ND(1.0)	ND(2.0)	ND(2.0)	ND(4.0)	ND(4.0)	20
MTBE	328.	42.1	271.	186.	182.	194.	40
Total Targeted VOCs:	328.	42.1	271.	186.	182.	194.

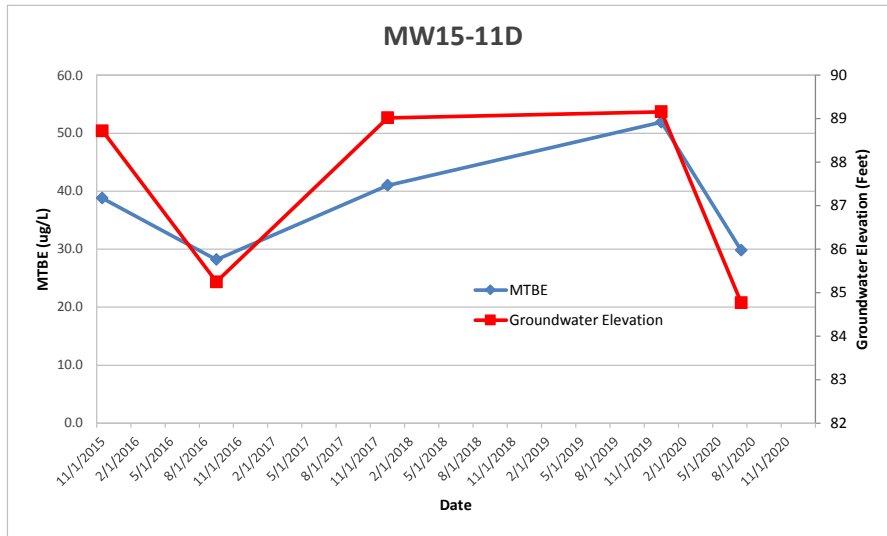
MW15-11D

PARAMETER	Date of Sample Collection:					VGES
	11/20/2015	9/15/2016	12/15/2017	12/5/2019	7/28/2020	
Benzene	ND(1.0)	ND(1.0)	ND(1.0)	ND(0.5)	ND(0.5)	5
Toluene	ND(1.0)	ND(1.0)	ND(1.0)	ND(1.0)	ND(1.0)	1,000
Ethylbenzene	ND(1.0)	ND(1.0)	ND(1.0)	ND(1.0)	ND(1.0)	700
Xylenes	ND(2.0)	ND(2.0)	ND(2.0)	ND(2.0)	ND(2.0)	10,000
Total BTEX:	ND	ND	ND	ND	ND	-
1,3,5 Trimethyl Benzene	ND(1.0)	ND(1.0)	ND(1.0)	ND(1.0)	ND(1.0)	23
1,2,3 Trimethyl Benzene	-	-	-	ND(1.0)	ND(1.0)	
1,2,4 Trimethyl Benzene	ND(1.0)	ND(1.0)	ND(1.0)	ND(1.0)	ND(1.0)	
Naphthalene	ND(2.0)	ND(2.0)	ND(2.0)	ND(0.5)	ND(0.5)	0.5
MTBE	38.8	28.2	41.0	51.9	29.8	11
Total Targeted VOCs:	38.8	28.2	41.0	51.9	29.8	-

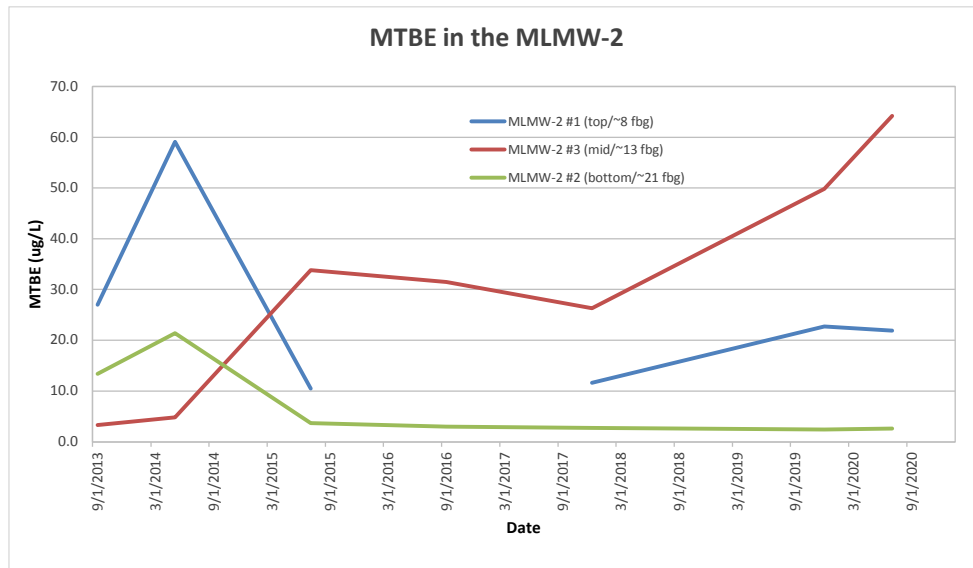
MLMW-2 - Channel #1 (Top)

The vertical distribution of the MTBE plume is described by MLMW-2 and MW15-11S/MW15-11D. At MLMW-2, the MTBE plume appears to be highest in the middle channel (approximately 8 feet below grade). Farther downgradient, at MW15-11S/MW15-11D, MTBE continues to be present only in the deep well (MW15-11D), which is screened at 21 to 24 feet below grade. Therefore, with increased distance from the plume core, there appears to be an increasing downward component. This can be expected given the transition from impervious hardscaping on the gas station site and the road to the grassy (pervious) surface on the residential properties to the south and southeast. The vertical extent of the MTBE plume, at its farthest reach, has not been fully defined to date.

PARAMETER	Date of Sample Collection:							VGES
	9/3/2013	5/9/2014	7/15/2015	9/15/2016	12/15/2017	12/5/2019	7/28/2020	
Benzene	ND(1.0)	ND(1.0)	ND(1.0)		ND(1.0)	ND(0.5)	ND(0.5)	5
Toluene	ND(1.0)	ND(1.0)	ND(1.0)	Not	ND(1.0)	ND(1.0)	ND(1.0)	1000
Ethylbenzene	ND(1.0)	ND(1.0)	ND(1.0)	Sampled	ND(1.0)	ND(1.0)	ND(1.0)	700
Xylenes	ND(2.0)	ND(2.0)	ND(2.0)		ND(2.0)	ND(2.0)	ND(2.0)	10,000
Total BTEX:	ND	ND	ND		ND	ND	ND	-
1,3,5 Trimethyl Benzene	ND(1.0)	ND(1.0)	ND(1.0)	Went dry/ no recharge	ND(1.0)	ND(1.0)	ND(1.0)	23
1,2,3 Trimethyl Benzene	-	-	-		-	ND(1.0)	ND(1.0)	
1,2,4 Trimethyl Benzene	ND(1.0)	ND(1.0)	ND(1.0)		ND(1.0)	ND(1.0)	ND(1.0)	
Naphthalene	ND(2.0)	ND(2.0)	ND(2.0)		ND(2.0)	ND(0.5)	ND(0.5)	0.5
MTBE	27.0	59.1	10.5		11.6	22.7	21.9	11
Total Targeted VOCs:	27.0	59.1	10.5		11.6	22.7	21.9	-

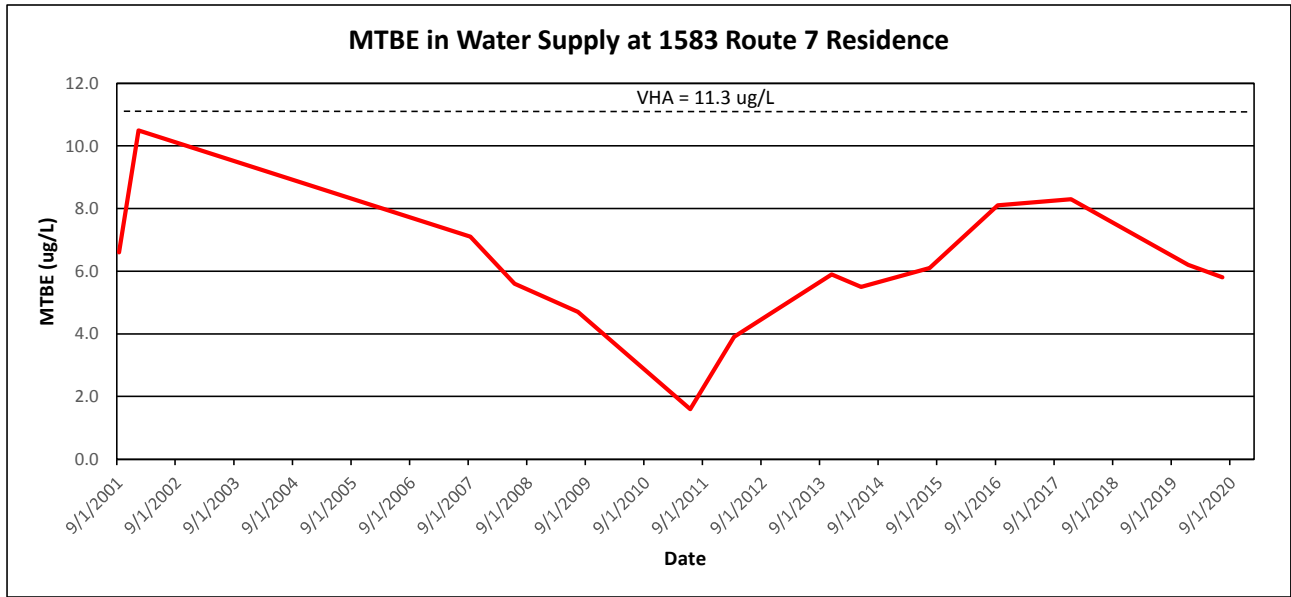
1583 Route 7 Residence

PARAMETER	Date of Sample Collection					DW Standards	
	9/20/2001	1/3/2002	9/18/2007	6/5/2008	7/24/2009	MCL	VHA
Benzene	ND(0.5)	ND(0.5)	ND(0.5)	ND(0.5)	ND(0.5)	5.0	---
Toluene	ND(0.5)	ND(0.5)	ND(0.5)	ND(0.5)	ND(0.5)	1,000.0	---
Ethylbenzene	ND(0.5)	ND(0.5)	ND(0.5)	ND(0.5)	ND(0.5)	700.0	---
Xylenes	ND(1.0)	ND(1.0)	ND(1.0)	ND(1.0)	ND(1.0)	10,000.0	---
1,3,5 Trimethyl Benzene	ND(0.5)	ND(0.5)	ND(0.5)	ND(0.5)	ND(0.5)	---	5.0
1,2,4 Trimethyl Benzene	ND(0.5)	ND(0.5)	ND(0.5)	ND(0.5)	ND(0.5)	---	4.0
Naphthalene	ND(1.0)	ND(1.0)	ND(1.0)	ND(1.0)	ND(0.5)	---	20.0
MTBE	6.6	10.5	7.1	5.6	4.7	---	40.0
Total Targeted VOCs:	6.6	10.5	7.1	5.6	4.7

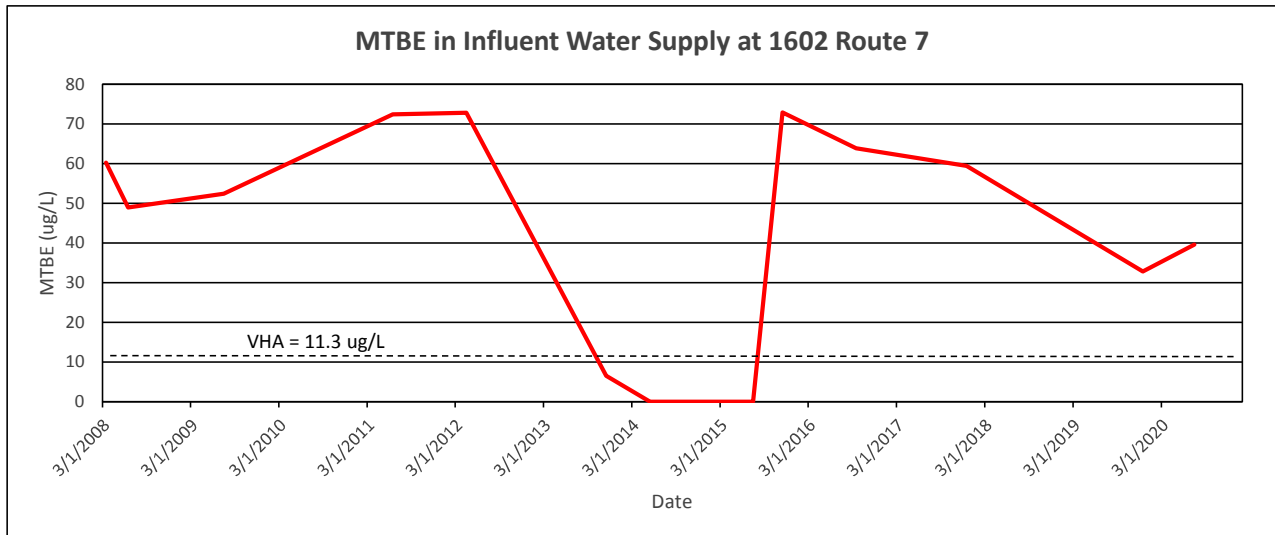
1602 Route 7 Treatment System, Influent

MTBE was reported in the influent (untreated) drinking water sample collected at 1602 US Route 7 at 39.6 ug/L, which is above the VHA standard. Since 2008, MTBE levels have fluctuated significantly. Although a very slight overall decrease may be observed since 2008, no clear trend is evident. No contaminants were reported above laboratory detection levels in the effluent (treated) drinking water sample. Therefore, the water treatment system is effective at removing the constituents of concern and should continue to operate. MTBE was reported in the 1583 US Route 7 residence water sample at 5.8 ug/L, which remains below the VHA standard. Since 2001, low-level MTBE concentrations have continued to fluctuate. Although a very slight overall decrease may be observed since 2001, no clear trend is evident. Analytical results of the supply well samples are tabulated in Appendix D along with the applicable EPA Maximum Contaminant Levels (MCL) and Vermont Health Advisory (VHA)/Vermont Action Levels (VALs) for drinking water. The full laboratory report for the July 28, 2020 sampling data is included in Appendix E.

PARAMETER	Date of Sample Collection					DW Standards	
	3/6/2008	6/5/2008	7/24/2009	6/23/2011	4/10/2012	MCL	VHA
Benzene	ND(0.5)	ND(0.5)	ND(0.5)	ND(1.0)	ND(0.5)	5.0	---
Toluene	ND(0.5)	ND(0.5)	ND(0.5)	ND(1.0)	ND(0.5)	1,000.0	---
Ethylbenzene	ND(0.5)	ND(0.5)	ND(0.5)	ND(1.0)	ND(0.5)	700.0	---
Xylenes	ND(1.0)	ND(1.0)	ND(1.0)	ND(2.0)	ND(1.0)	10,000.0	---
1,3,5-Trimethylbenzene	ND(0.5)	ND(0.5)	ND(0.5)	ND(1.0)	ND(0.5)	---	5.0
1,2,4-Trimethylbenzene	ND(0.5)	ND(0.5)	ND(0.5)	ND(1.0)	ND(0.5)	---	4.0
Naphthalene	ND(0.5)	ND(0.5)	ND(0.5)	ND(2.0)	ND(0.5)	---	20.0
1,2-Dichloroethane	2.0	1.2	1.1	-	1.2	5.0	---
MTBE	60.2	48.9	52.4	72.4	72.8	---	40.0
Total Targeted VOCs:	62.2	50.1	53.5	72.4	74.0		
Well Average Water Usage (gpd)	365.0	-	-	664	714.
