Site Investigation
South Woodstock Country Store
DEC #900522
Rt. 106, South Woodstock, Vermont
GPS: 43° 33' 54.37" N, 72° 31' 59.25" W

January 25, 2010

SUBJECT: Results of the Subsurface Investigation at the South Woodstock Country Store, 10673 South Road/Route 106, South Woodstock, VT

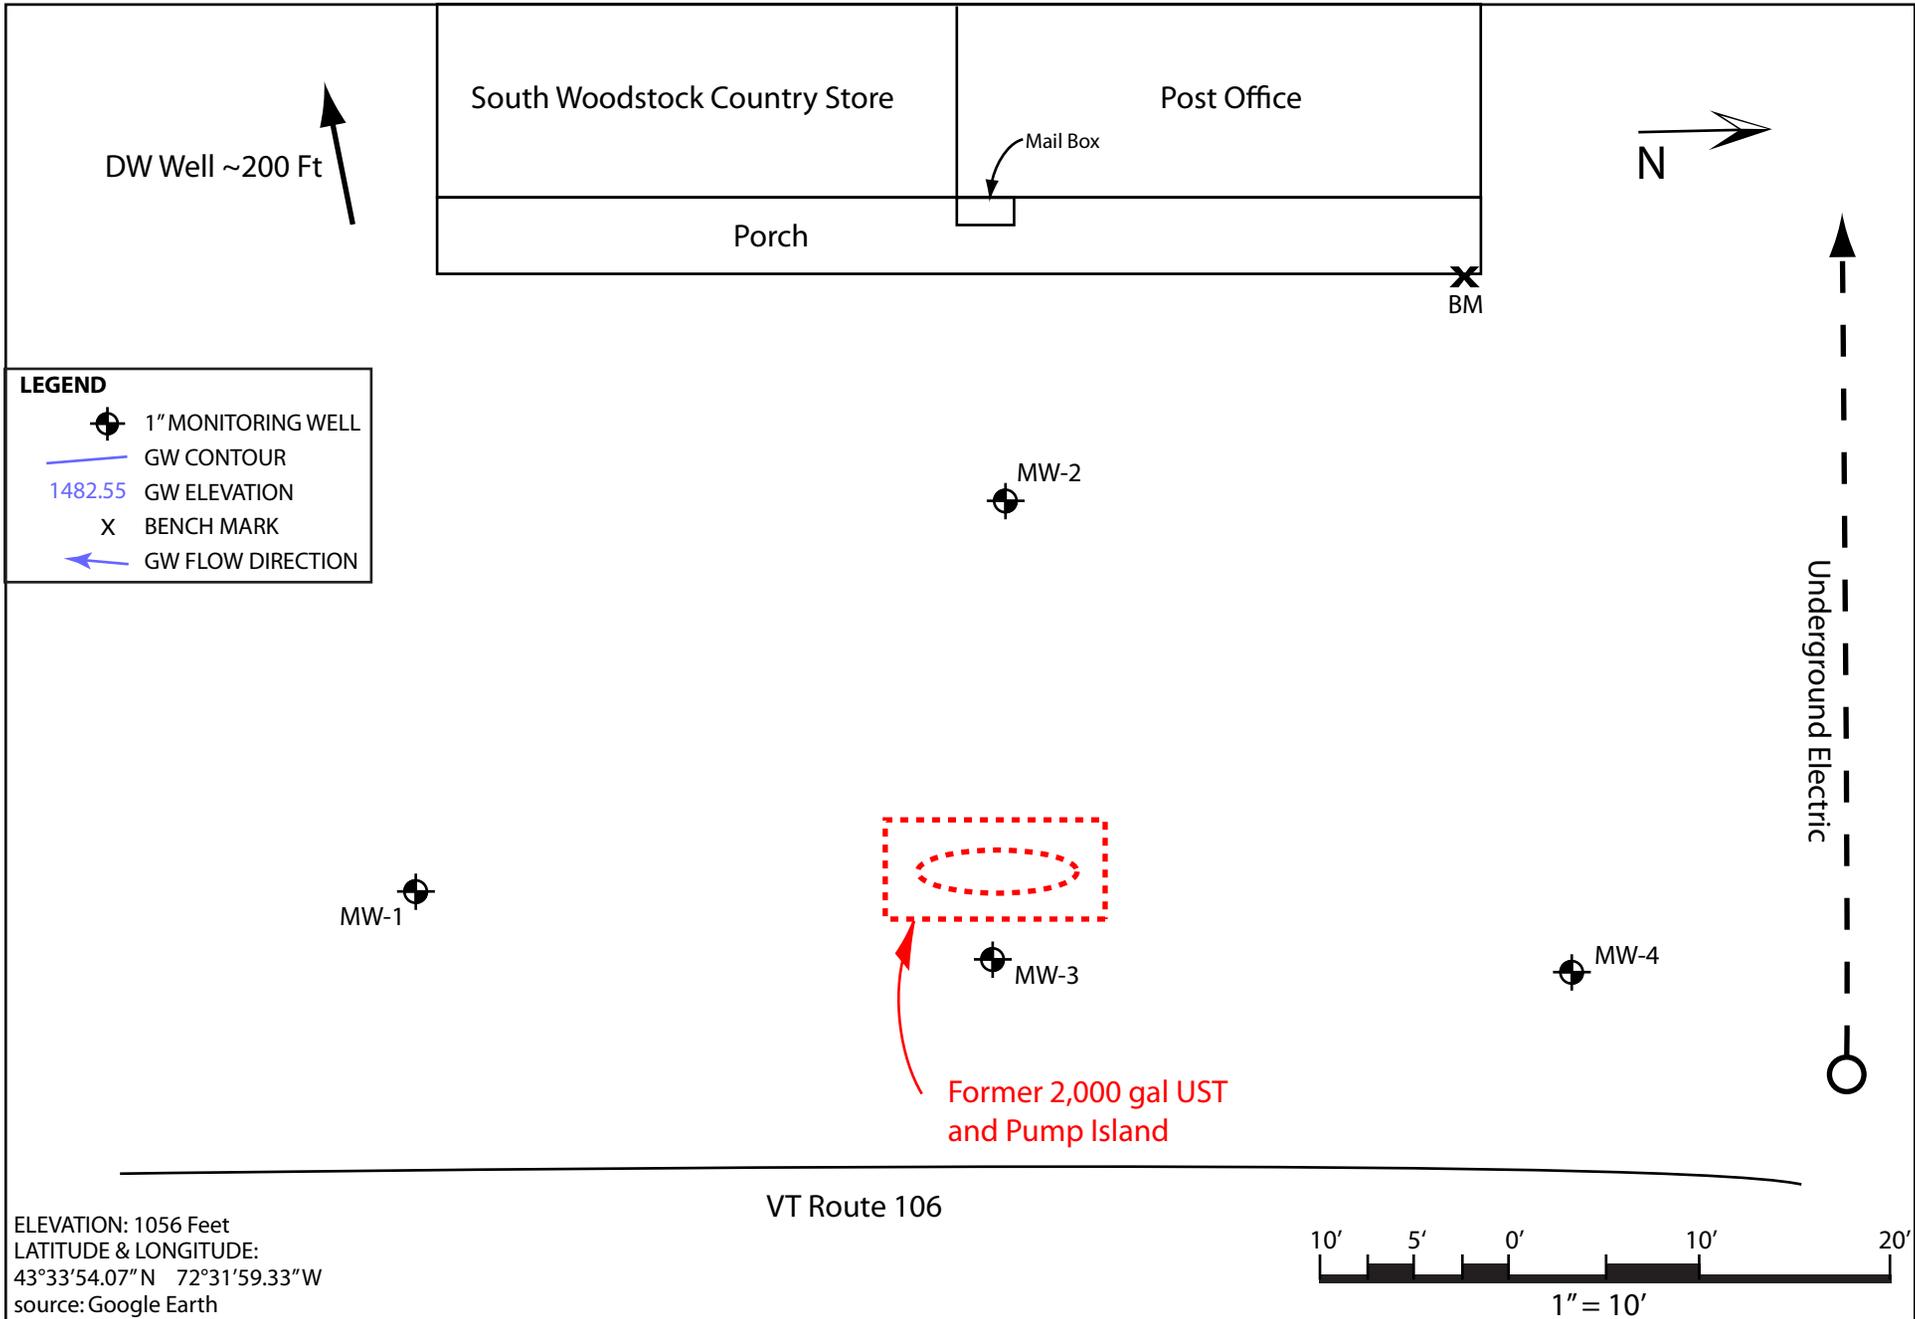
FIGURE
2

On December 4, 2009, HEA supervised the completion of four soil borings and four monitoring well installations at the site. The location of each soil boring/monitoring well is depicted on Figure 2, Site Map. All borings (MW-1 - MW-4) were completed on the property around the site of the former UST. Drill logs were completed for each of the borings and can be found attached to this report.

No municipal drinking water wells found in this area. The site is supplied by an onsite bedrock drinking water well. The location of the well is indicated on Figure 2. The

Subsurface electric lines service the Store. The approximate locations of the subsurface utilities can be seen on Figure 2. Monitoring well MW-4 was placed between the subsurface utilities and the former UST location. No soil or groundwater contamination was detected in MW-1 therefore subsurface utilities do not appear to be impacted by the gasoline release.

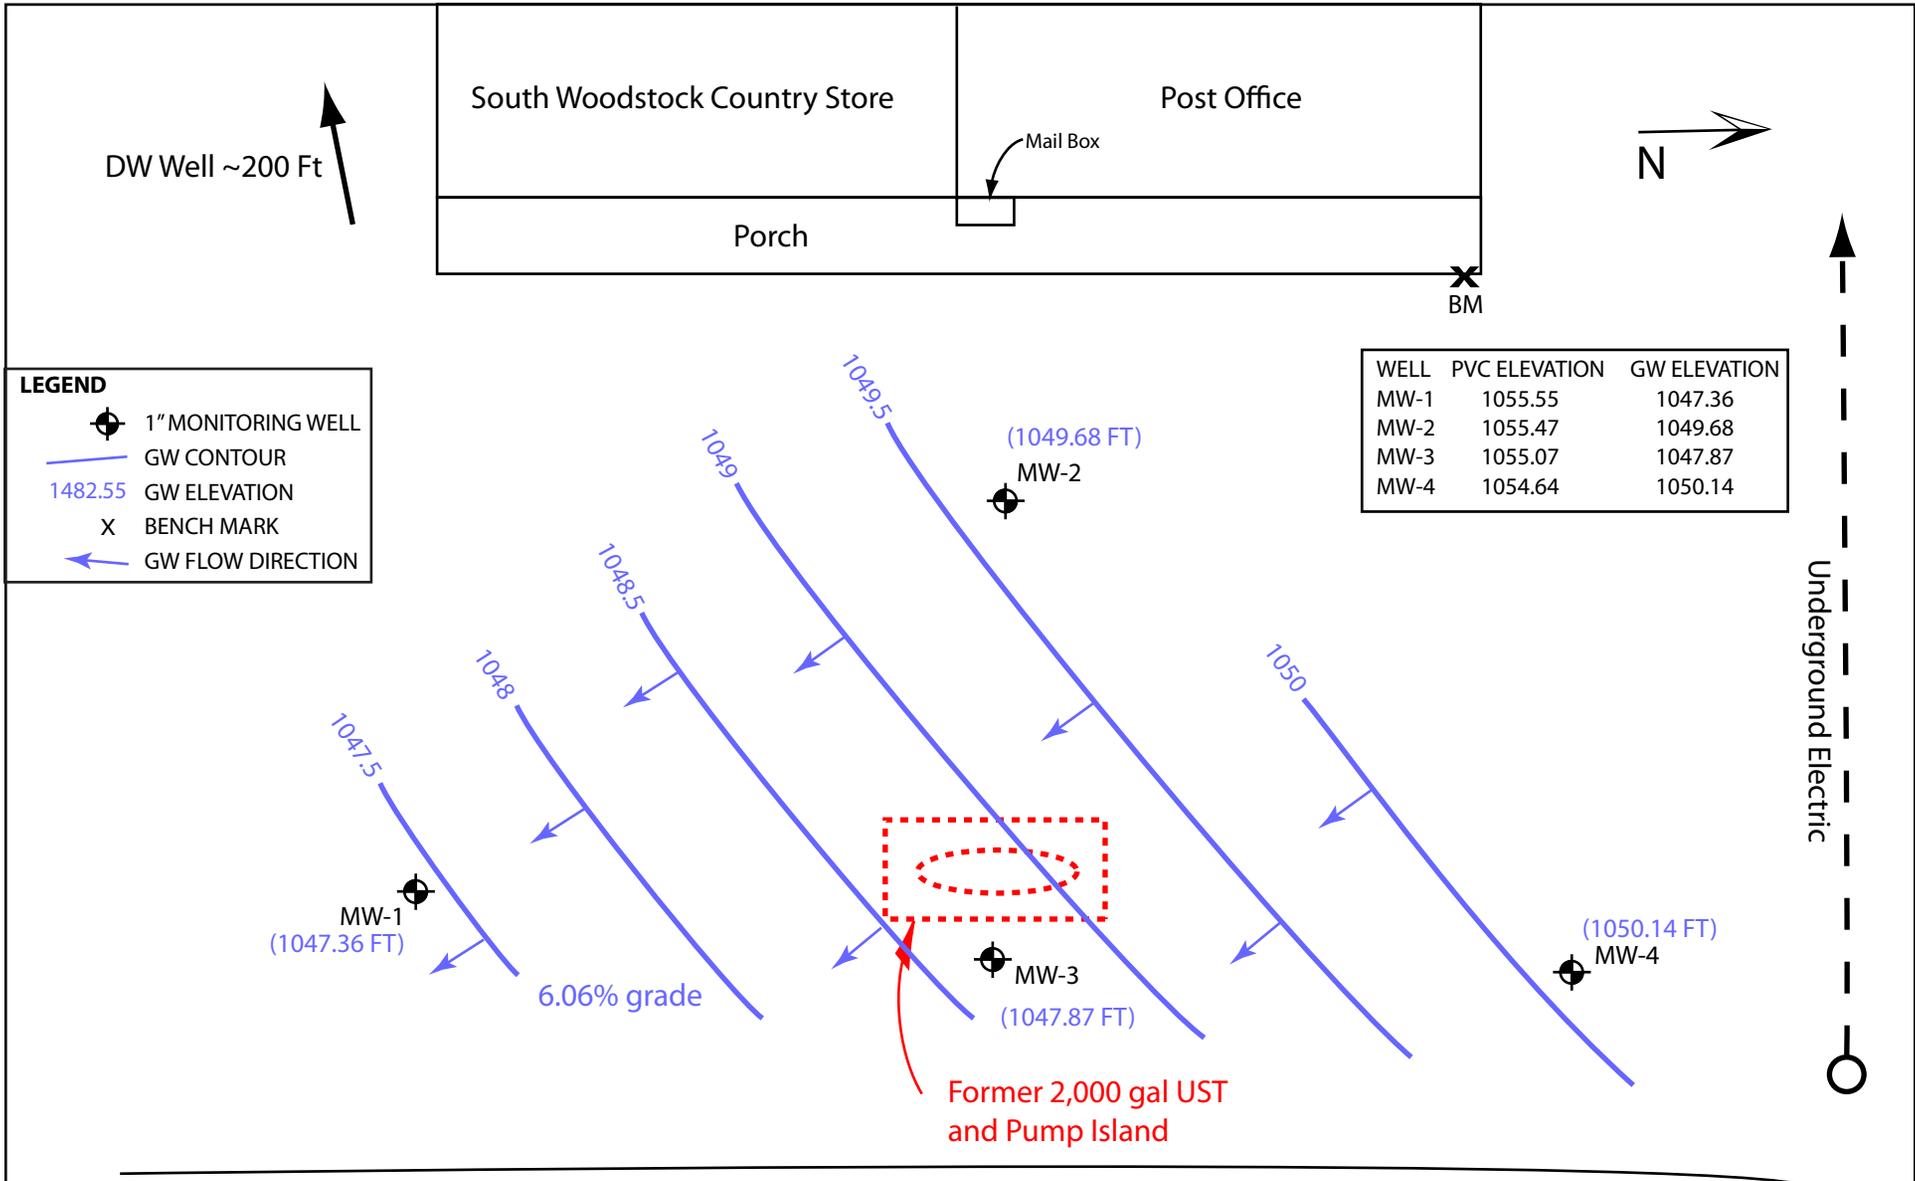
FIGURE
3

The anticipated groundwater gradient, based on surface water observation and the surface topography, was expected to move towards the north-northeast from the site. The groundwater gradient at the site is relatively steep, at 6%, and travels from the center of the property towards the southeast.

Groundwater was observed in all of the four borings during the well installation and in the UST excavation pit during the UST closure activities. Four groundwater MWs were installed and all four were found to contain water ranging in depth from 4.5 to 8.2 feet below grade. A groundwater gradient map was produced from depth to water readings taken during the December 23, 2009 groundwater sampling event. The groundwater contour map is provided as Figure 3.

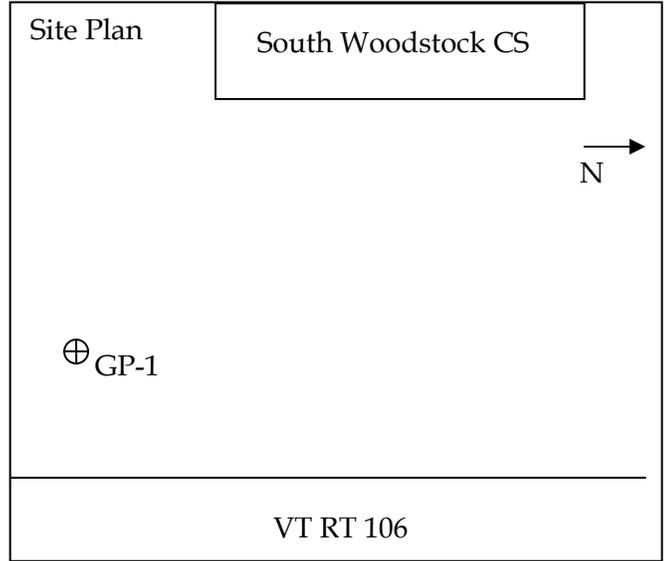
Well Number: GP-1

Depth (feet)	Well As-built Detail	Notes	Soil Screening	Description of Soil Classification (Color, Texture, Structures)
-0 - - - - -4' - - - - - - - - - - -10'10"	<p>The diagram shows a vertical cross-section of the well. At the top is a 'Road box'. Below it is a section of 'PVC' casing. This is followed by a section of 'bentonite' seal. Below the bentonite is a section labeled 'Blank'. At the bottom of the casing is a 'Screen' section. Below the screen is the 'sand' layer. The well extends to a depth of 10 feet 10 inches.</p>		All PID readings were 0.0 ppm	<p>Location: Well is located in the south end of the parking lot near Rt 106.</p> <p>Soils: 0-4": hardpack 4'-6': brown, clayey silt 6"-10'10": silt with fine sand</p> <p>Soil Sampling: were screened the length of the boring by Harper Environmental. PID readings were 0.0 ppm at all depths.</p> <p>Groundwater: wet soils at 9'</p> <p>Monitoring Well: a monitoring well was installed at this location.</p>

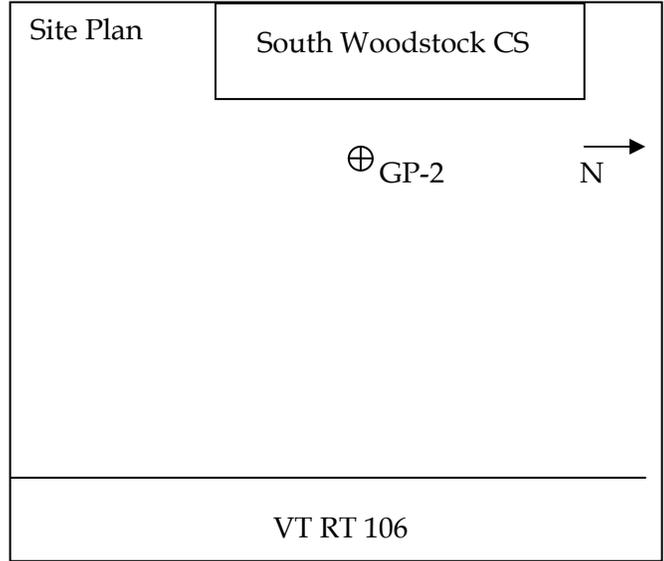
Well Number: GP-2

Depth (feet)	Well As-built Detail	Notes	Soil Screening	Description of Soil Classification (Color, Texture, Structures)
-0 - - - - -4' - - - - - - - - - - - -12'		Road box PVC bentonite Blank Screen sand	All PID readings were 0.0 ppm	<p>Location: Well is located in the parking lot directly in front of the store</p> <p>Soils: 0-4": hardpack 4'-6': brown, clayey silt 6"-12': silt with fine sand</p> <p>Soil Sampling: were screened the length of the boring by Harper Environmental. PID readings were 0.0 ppm at all depths.</p> <p>Groundwater: wet soils at 9'</p> <p>Monitoring Well: a monitoring well was installed at this location.</p>

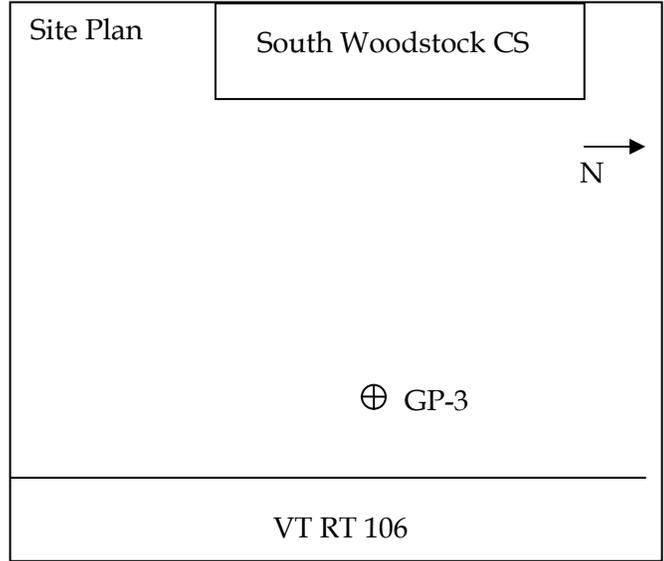
Well Number: **GP-3**

Soils were screened using the PID during the installation of the soil borings on December 4, 2009. PID readings up to 5,182 ppm were detected in MW-3 at a depth of 5-6 feet below grade. Soil screenings during the installation of MWs 1, 2 and 4 had PID readings of 0 ppm throughout the borings.

Depth (feet)	Well As-built Detail	Notes	Soil Screening	Description of Soil Classification (Color, Texture, Structures)
-0 - - - - - -3' - - - - - - - - - - - - - - -9'	<p>The diagram shows a vertical cross-section of the well. From top to bottom, it labels: 'Road box' (at the surface), 'PVC' (the upper casing), 'bentonite' (a sealant layer), 'Blank' (the upper part of the screen), 'Screen' (the lower part of the screen), and 'sand' (the material at the bottom of the well).</p>	Road box PVC bentonite Blank Screen sand	PID readings 5182ppm @5-6'	<p>Location: Well is located in the parking lot directly in front of the store near Rt. 106.</p> <p>Soils: 0-1.5': hardpack 1.5-5': sandy silts with pebbles and clay mottles 5-6': wet clay (petroleum odor) 6-6.5': sandy wet clay with pebbles 6.5-9': wet clay</p> <p>Soil Sampling: were screened the length of the boring by Harper Environmental. PID readings were 5182 ppm at 5-6'.</p> <p>Groundwater: wet soils at 5'</p> <p>Monitoring Well: a monitoring well was installed at this location.</p>

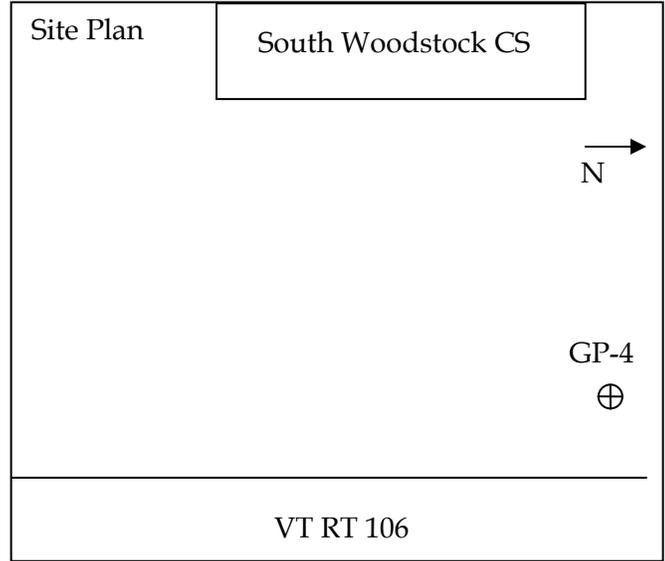
Well Number: GP-4

Depth (feet)	Well As-built Detail	Notes	Soil Screening	Description of Soil Classification (Color, Texture, Structures)
-0 - - - - - -3' - - - - - - - - - - - - - - - -9'	<p>The diagram shows a vertical cross-section of the well. At the top is a 'Road box'. Below it is a 'PVC' casing. A layer of 'bentonite' is shown between the casing and the borehole wall. Below the bentonite is a 'Blank' section. Further down is a 'Screen' section, and at the bottom is 'sand'.</p>	Road box PVC bentonite Blank Screen sand	All PID readings were 0.0 ppm	<p>Location: Well is located in the north end of the parking lot in front of the store near Rt. 106.</p> <p>Soils: 0-7": hardpack 7" - 11": dark, sandy silt 11" - 2.5': light, sandy silt with pebbles 2.5-3.5': dark, sandy silt with pebbles 3.5-6': dark, sandy silt 6-9': dark, wet, sandy silt</p> <p>Soil Sampling: were screened the length of the boring by Harper Environmental. PID readings were 0.0 ppm at all depths.</p> <p>Groundwater: wet soils at 6'</p> <p>Monitoring Well: a monitoring well was installed at this location.</p>
