# Lone Rock Geoscience

February 15, 1995

Re: Summary of Site Cleanup Activities at Claussen's Enterprises, Inc., Colchester, VT (Site # 94-1706)

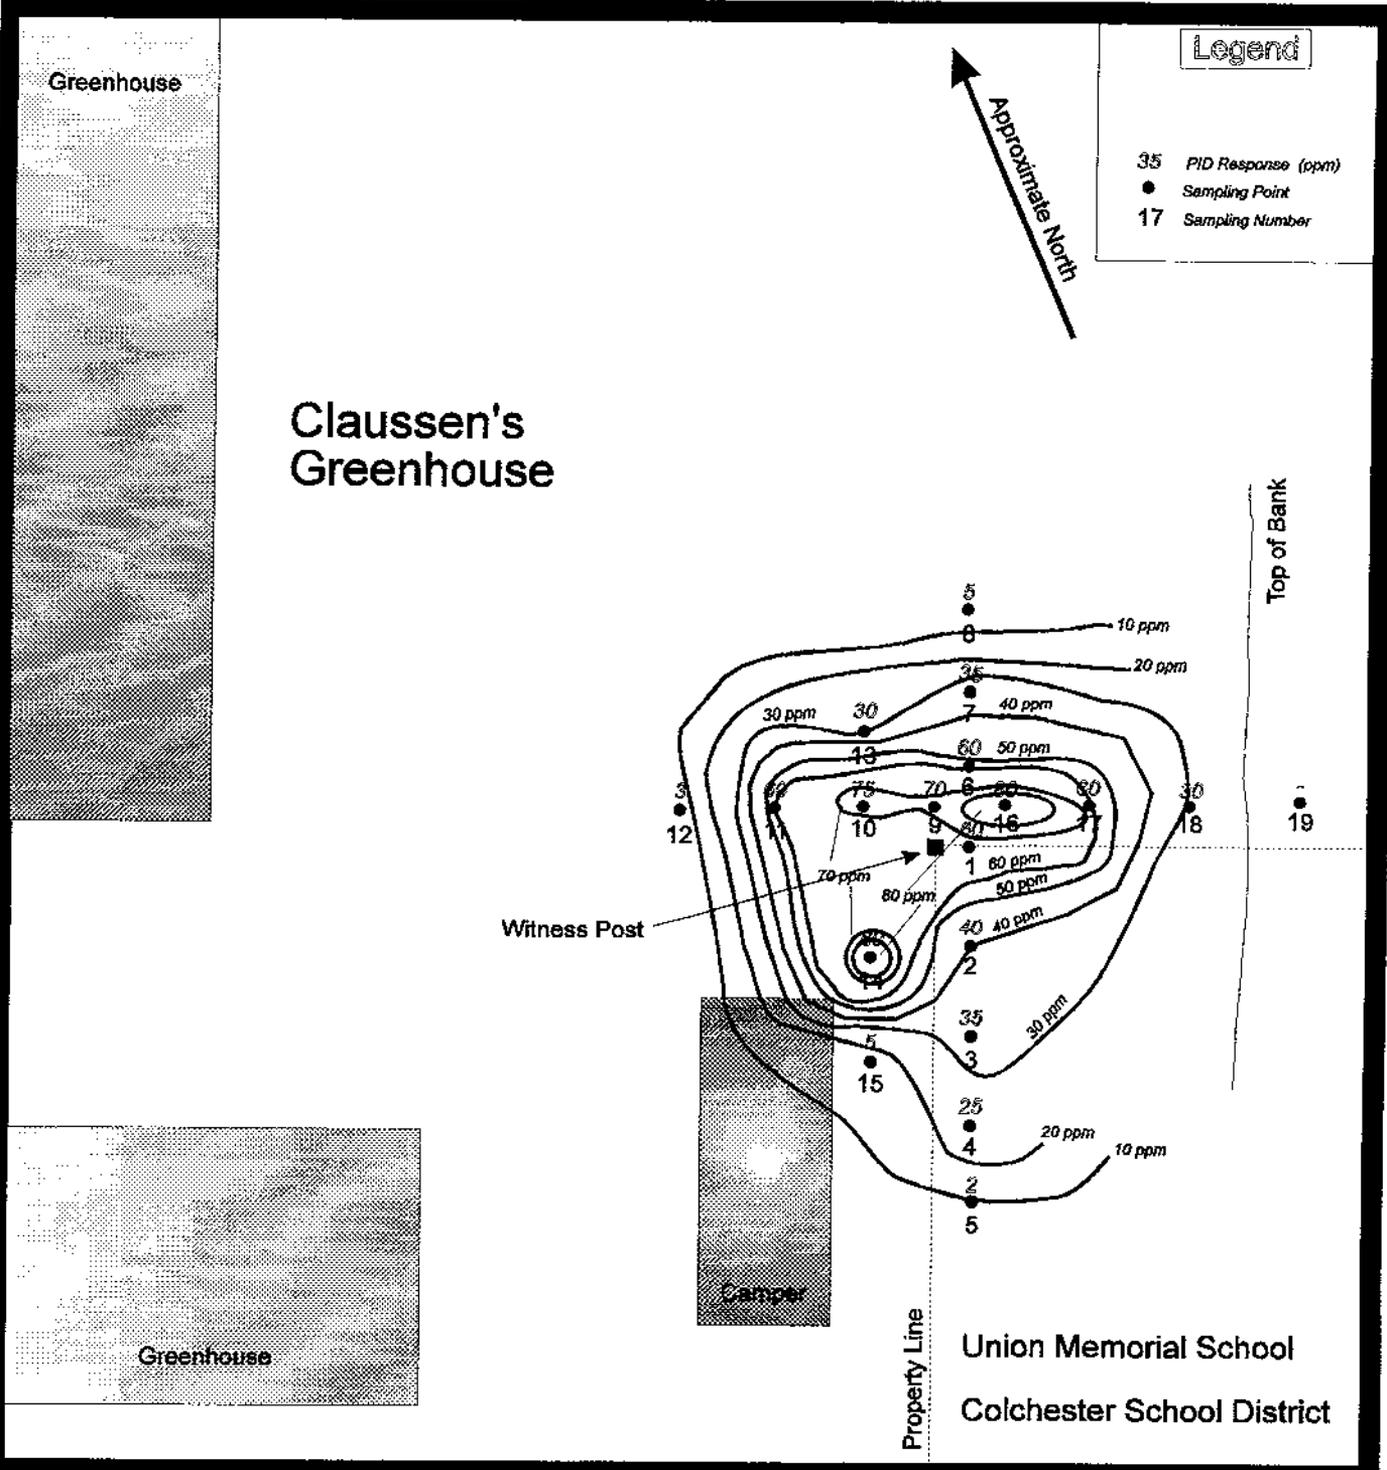
**FIGURE 3**

PID Response Data Contoured from the Map Entitled  
 Claussen's Florist and Greenhouse Complaint Investigation  
 dated October 20, 1994, by Tim Cropley (VT DEC)

sampling points and the relative PID response to recovered soils. A reproduction of this map (with concentration values contoured) is included as 3. A copy of the 10/24/94 memorandum appears in Appendix I.

The lateral dispersion of the contamination from inferred points of original introduction is the likely consequence of the permeability contrast between the sand and the silt. Rather than penetrate the slowly permeable silt, the contaminated perched water would tend to flow laterally within the more permeable medium sands. During the excavation, it appeared as though the contact between the sands and the silts was relatively flat-lying. The flat-lying nature of the top of silt may explain the crude "bull's-eye" pattern displayed by the contoured relative concentration data (Figure 3).

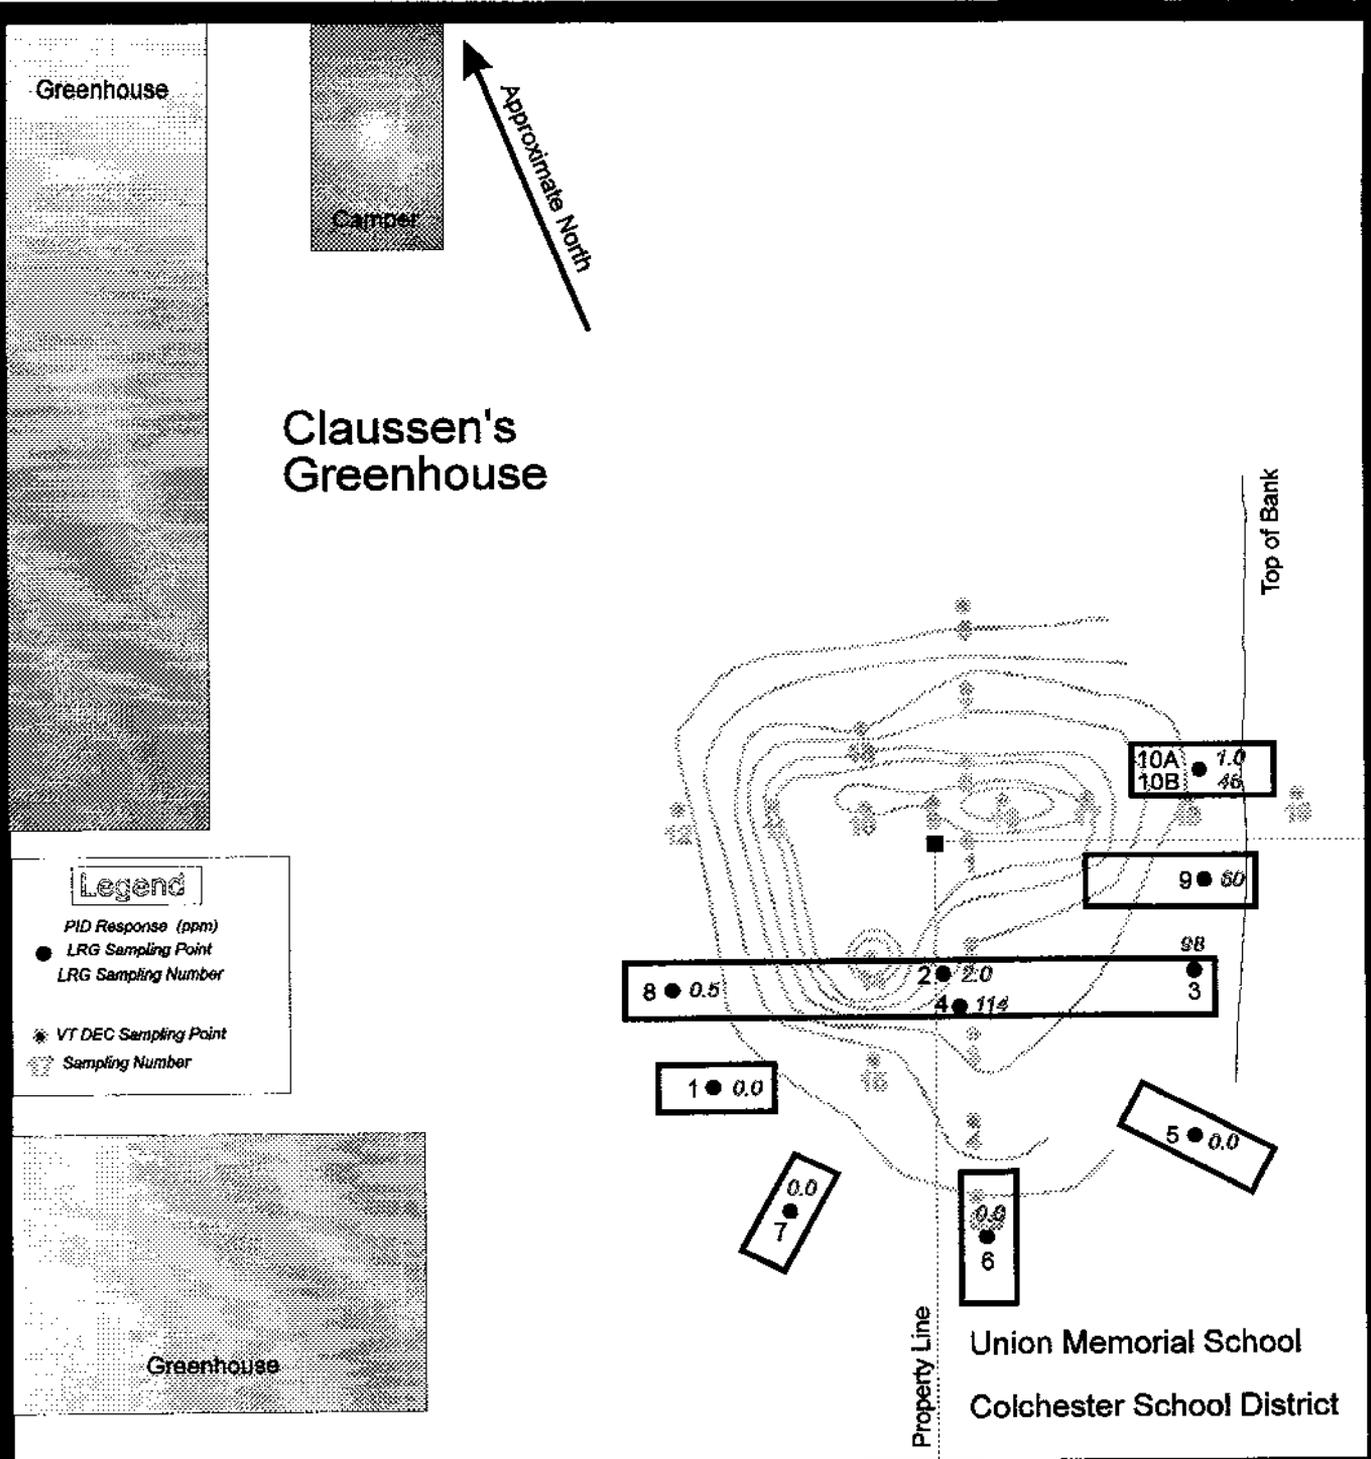
**FIGURE 4**

Initial Investigatory Test Pits Installed December 19, 1994 at the Onset of the  
 Petroleum Contaminated Soil Excavation  
 Claussen's Greenhouse Property, Colchester, Vermont

Initial test pits with soils registering a PID response greater than 10 ppm (Figure 4) were excavated laterally and connected to begin the soil excavation (Photo 2). Soils greater than 10 ppm on the PID were excavated from the pit and stockpiled at the pit edge. During stockpile growth, bark mulch and dehydrated cow manure were added to the pile in an effort to provide additional nutrients and substratum to enhance microbially induced degradation of the petroleum contaminating the soil. An estimated mass of approximately 2 tons of manure and 3 tons of bark mulch were added and incorporated into the soil stockpile. After a sufficient volume of soil amended with bark mulch and manure had piled up on the side of the pit, the soils were relocated onto a large sheet on 6-mil polyethylene (measuring 100 ft X 50 ft). Adding the mulch and manure during excavation allowed mixing when the contaminated soils were moved to the poly.

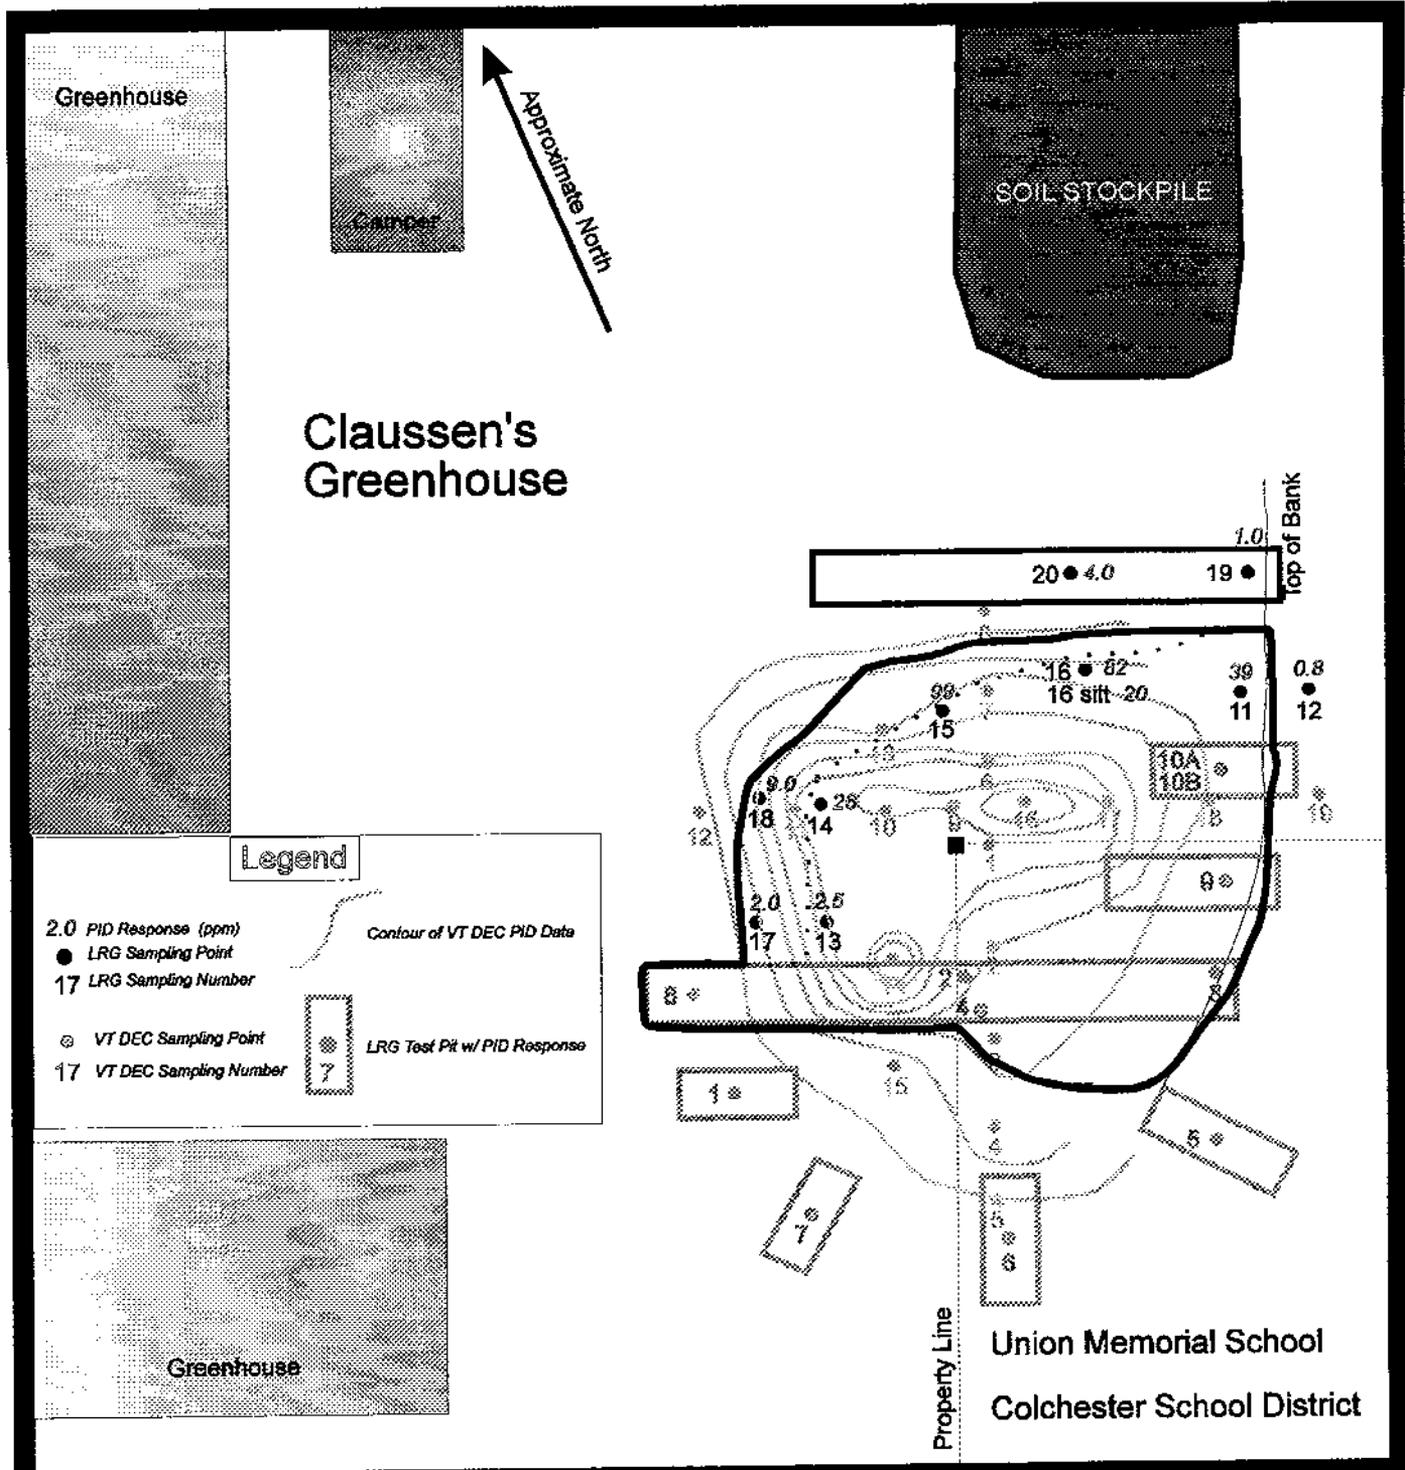
**FIGURE 5**

Limits of the Petroleum Contaminated Soil Excavation  
 Claussen's Greenhouse Property, Colchester, Vermont

December 19th and 20th, 1994

The only receptors appeared to be the subsurface soils and ground water beneath the area of the release. The absence of substantial sensitive receptors was consistent with Mr. Cropley's determination that "No receptors seem to be present." (10/24/94 letter). In light of the apparent absence of sensitive receptors, a place was located immediately to the north of the release site for the construction and maintenance of a polyencapsulated soil pile. This location was selected because it is located away from the public-accessible portions of the Claussen's property, is "out of the way" of normal greenhouse operations, is easily accessed from the Claussen's property for the purposes of monitoring petroleum degradation and the integrity of security fencing and because it afforded easy transfer of contaminated soil from the excavation area to the treatment area. The location of the stockpile is depicted in 5 and Photos 9 and 10.

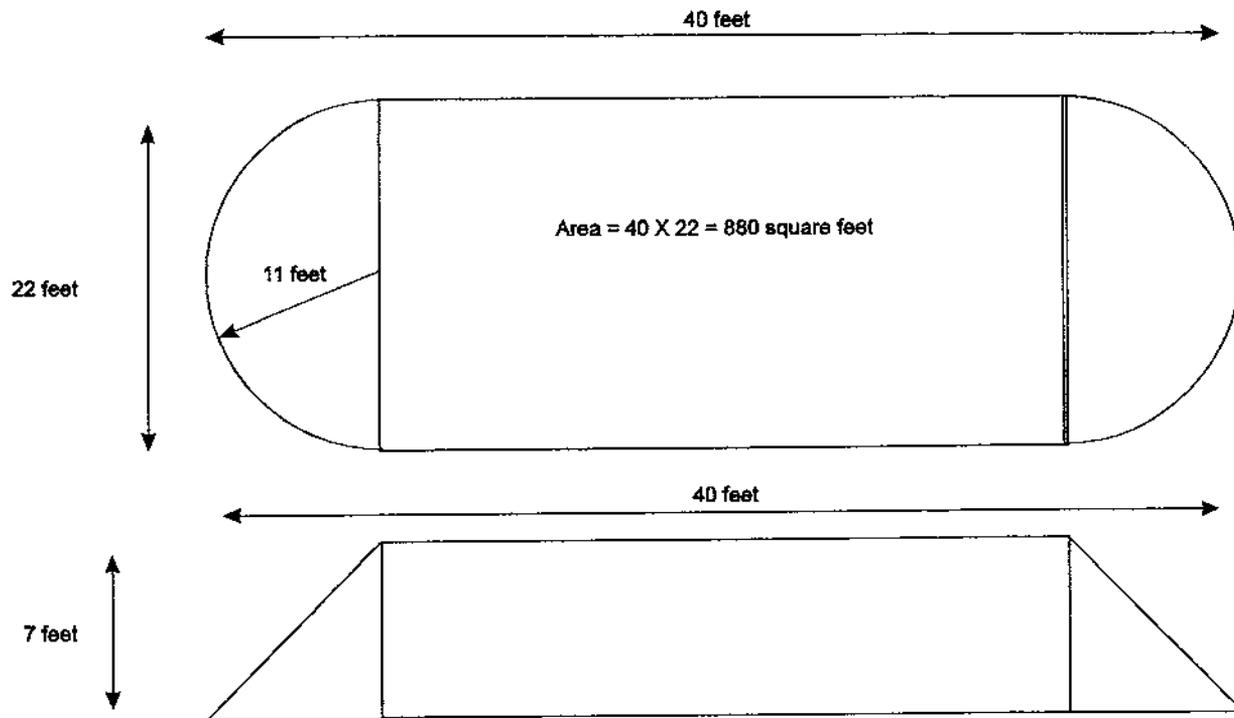
## FIGURE 6

Volume of conical ends of the pile are calculated by placing each end together to form a single cone:

The volume of a right circular cone is given by:  $V = \frac{1}{3} \pi r^2 h = 1.047 r^2 h$

The volume of the center of the pile is given by  $\frac{1}{2} bh \times l \times w$

$$886 + 1540 = 2426 \text{ cubic feet} \times \frac{\text{cubic yard}}{27 \text{ cubic feet}}$$

$$= 89.9 \text{ cubic yards}$$

### Stockpile Volume Calculations Based upon Field Measurements of Dimension

The soil stockpile generated as the result of the excavation activities measured approximately 40 feet X 22 feet with a height of about 7 feet. Based upon an angle of repose of 40 degrees (steepened relative to dry soil by the presence of the silty material, the moisture content and the added bark mulch and dehydrated manure), a calculation of the volume of soil removed can be estimated at approximately 84 cubic yards (Figure 6). This is approximately equivalent to the volume estimated in the 10/24/94 Cropley letter (35 feet X 35 feet X 2 feet = 2450 ft<sup>3</sup> = 90.74 yds<sup>3</sup>).

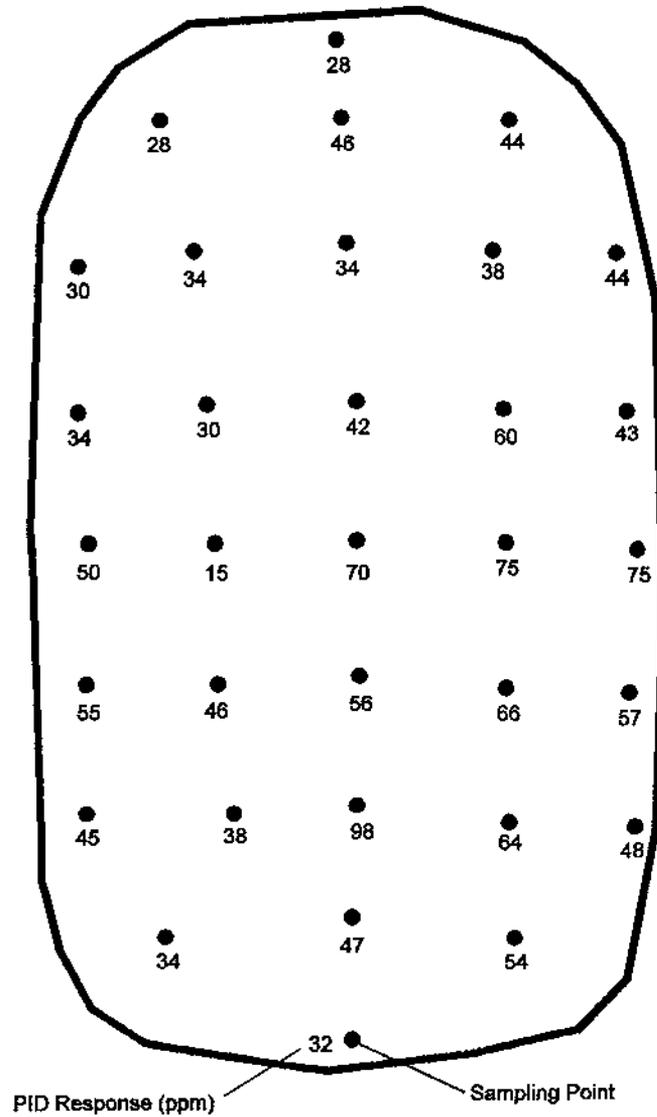
**FIGURE 7**

**Stockpile Initial Vapor Concentration Map**

After completion of the soil excavation, the stockpiled soils were surveyed for vapor concentration using the PID. The methodology for sampling involved penetrating the soil stockpile with a stick approximately 18 inches into the soil pile, withdrawing the stick and then placing the tip of the Hnu probe into the resulting hole. PID response maxima were then recorded. The distribution of vapor concentrations so obtained are depicted in Figure 7.

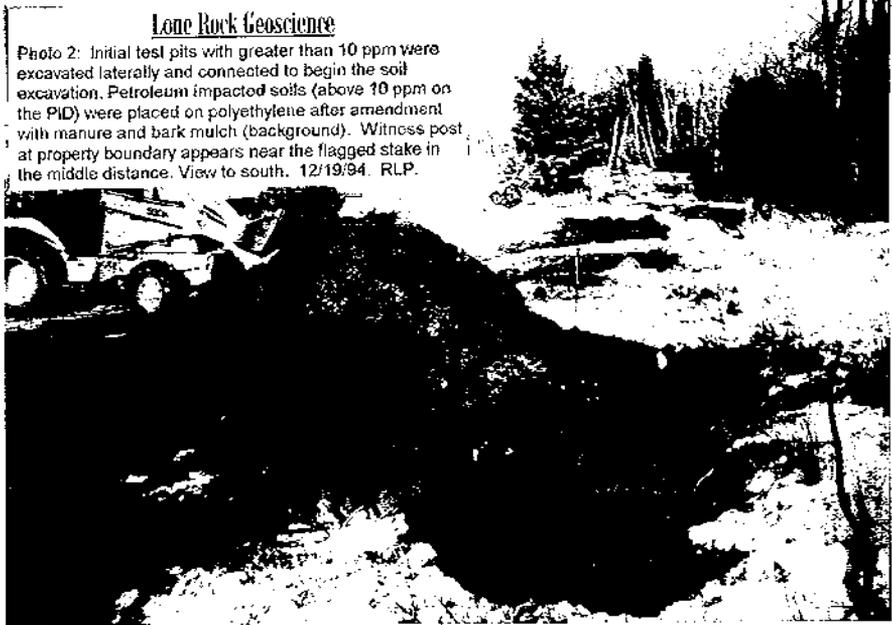
Photo 2: Initial test pits with greater than 10 ppm were excavated laterally and connected to begin the soil excavation. Petroleum impacted soils (above 10 ppm on the PID) were placed on polyethylene after amendment with manure and bark mulch (background). Witness post at property boundary appears near the flagged stake in the middle distance. View to south. 12/19/94. RLP.

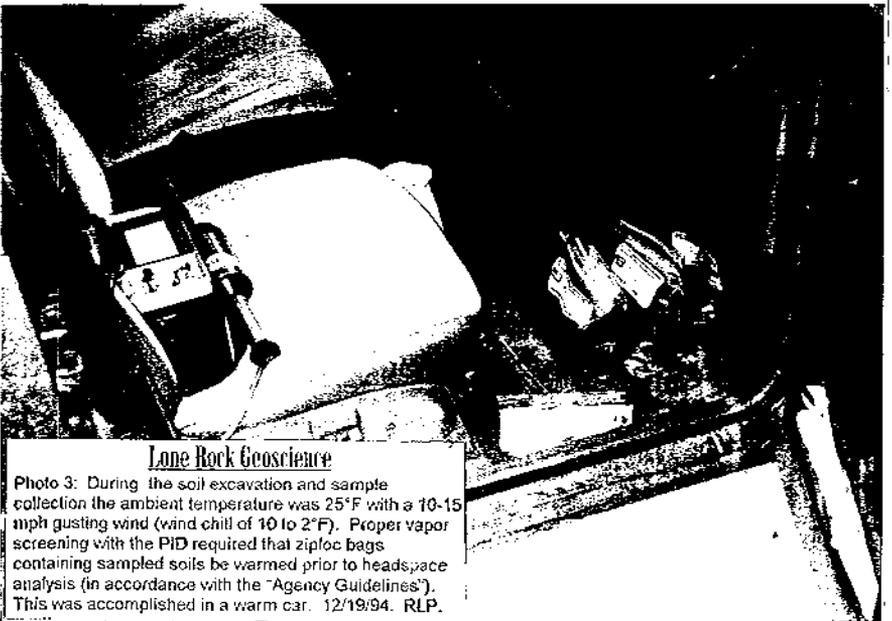
Photo 3: During the soil excavation and sample collection the ambient temperature was 25°F with a 10-15 mph gusting wind (wind chill of 10 to 2°F). Proper vapor screening with the PID required that ziploc bags containing sampled soils be warmed prior to headspace analysis (in accordance with the "Agency Guidelines"). This was accomplished in a warm car. 12/19/94. RLP.

A PID was used to measure the relative concentrations of organic vapors from the soils recovered from the excavation. The PID used was an Hnu @ PI-101 with a 10.2 electron volt (eV) UV ionization lamp. Prior to use each day, the Hnu was calibrated to a benzene reference using 100 ppm isobutylene calibration standard gas. During the soil excavation and sample collection the ambient temperature was 25°F with a 10-15 mph gusting wind (wind chill of 10 to 2°F). In order to ensure proper operation of the PID, it was placed in a warm automobile during excavation activities (Photo 3). Soil samples were recovered from the excavation and were placed into new ziploc freezer storage bags. Approximately one-half of the bag volume was filled with soil. Proper vapor screening with the PID required that ziploc bags containing sampled soils be warmed prior to headspace analysis (in accordance with the *Guidelines*). Ziploc bags with soils were placed on the floor of the car near the heater (Photo 3). After five minutes time, the maximum vapor concentration of the headspace in the ziploc bags was recorded.

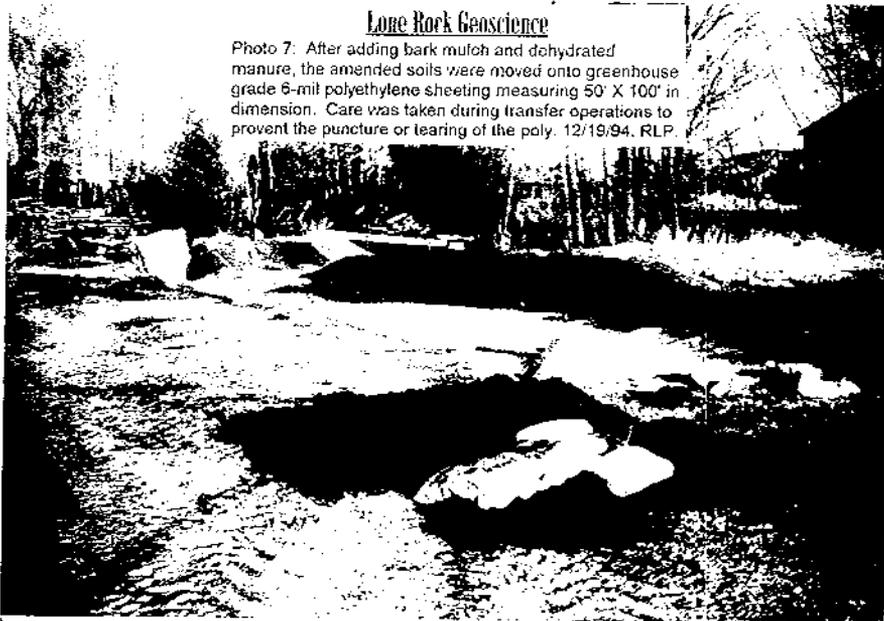
Photo 7: After adding bark mulch and dehydrated manure, the amended soils were moved onto greenhouse grade 6-mil polyethylene sheeting measuring 50' X 100' in dimension. Care was taken during transfer operations to prevent the puncture or tearing of the poly. 12/19/94. RLP.

The completed soil stockpile was covered by the remaining portion of the polyethylene sheeting. The Prior to covering, the polyethylene sheeting exposed at the base of the stockpile was folded up onto the pile and secured in place with clean soil. Then the cover sheeting was draped over the pile and secured, covering and protecting the underlying polyethylene folded around the base of the pile. This configuration completely envelops the soil pile allowing it to shed precipitation without allowing seepage to enter the stockpile base. *excellent!*

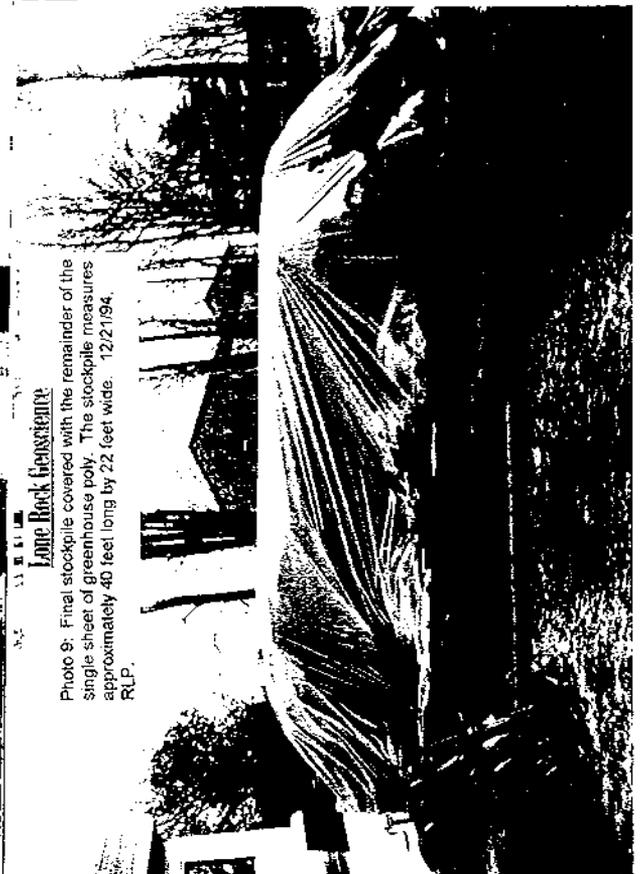
Photo 9: Final stockpile covered with the remainder of the single sheet of greenhouse poly. The stockpile measures approximately 40 feet long by 22 feet wide. 12/21/94. RLP.
