Re: Spillanes Texaco on 125 Battery Street, Burlington, Vermont  
Site #94-1722

## SPILLANE'S TEXACO BURLINGTON, VERMONT

### SITE INVESTIGATION Battery Street Facility

August 15, 1996

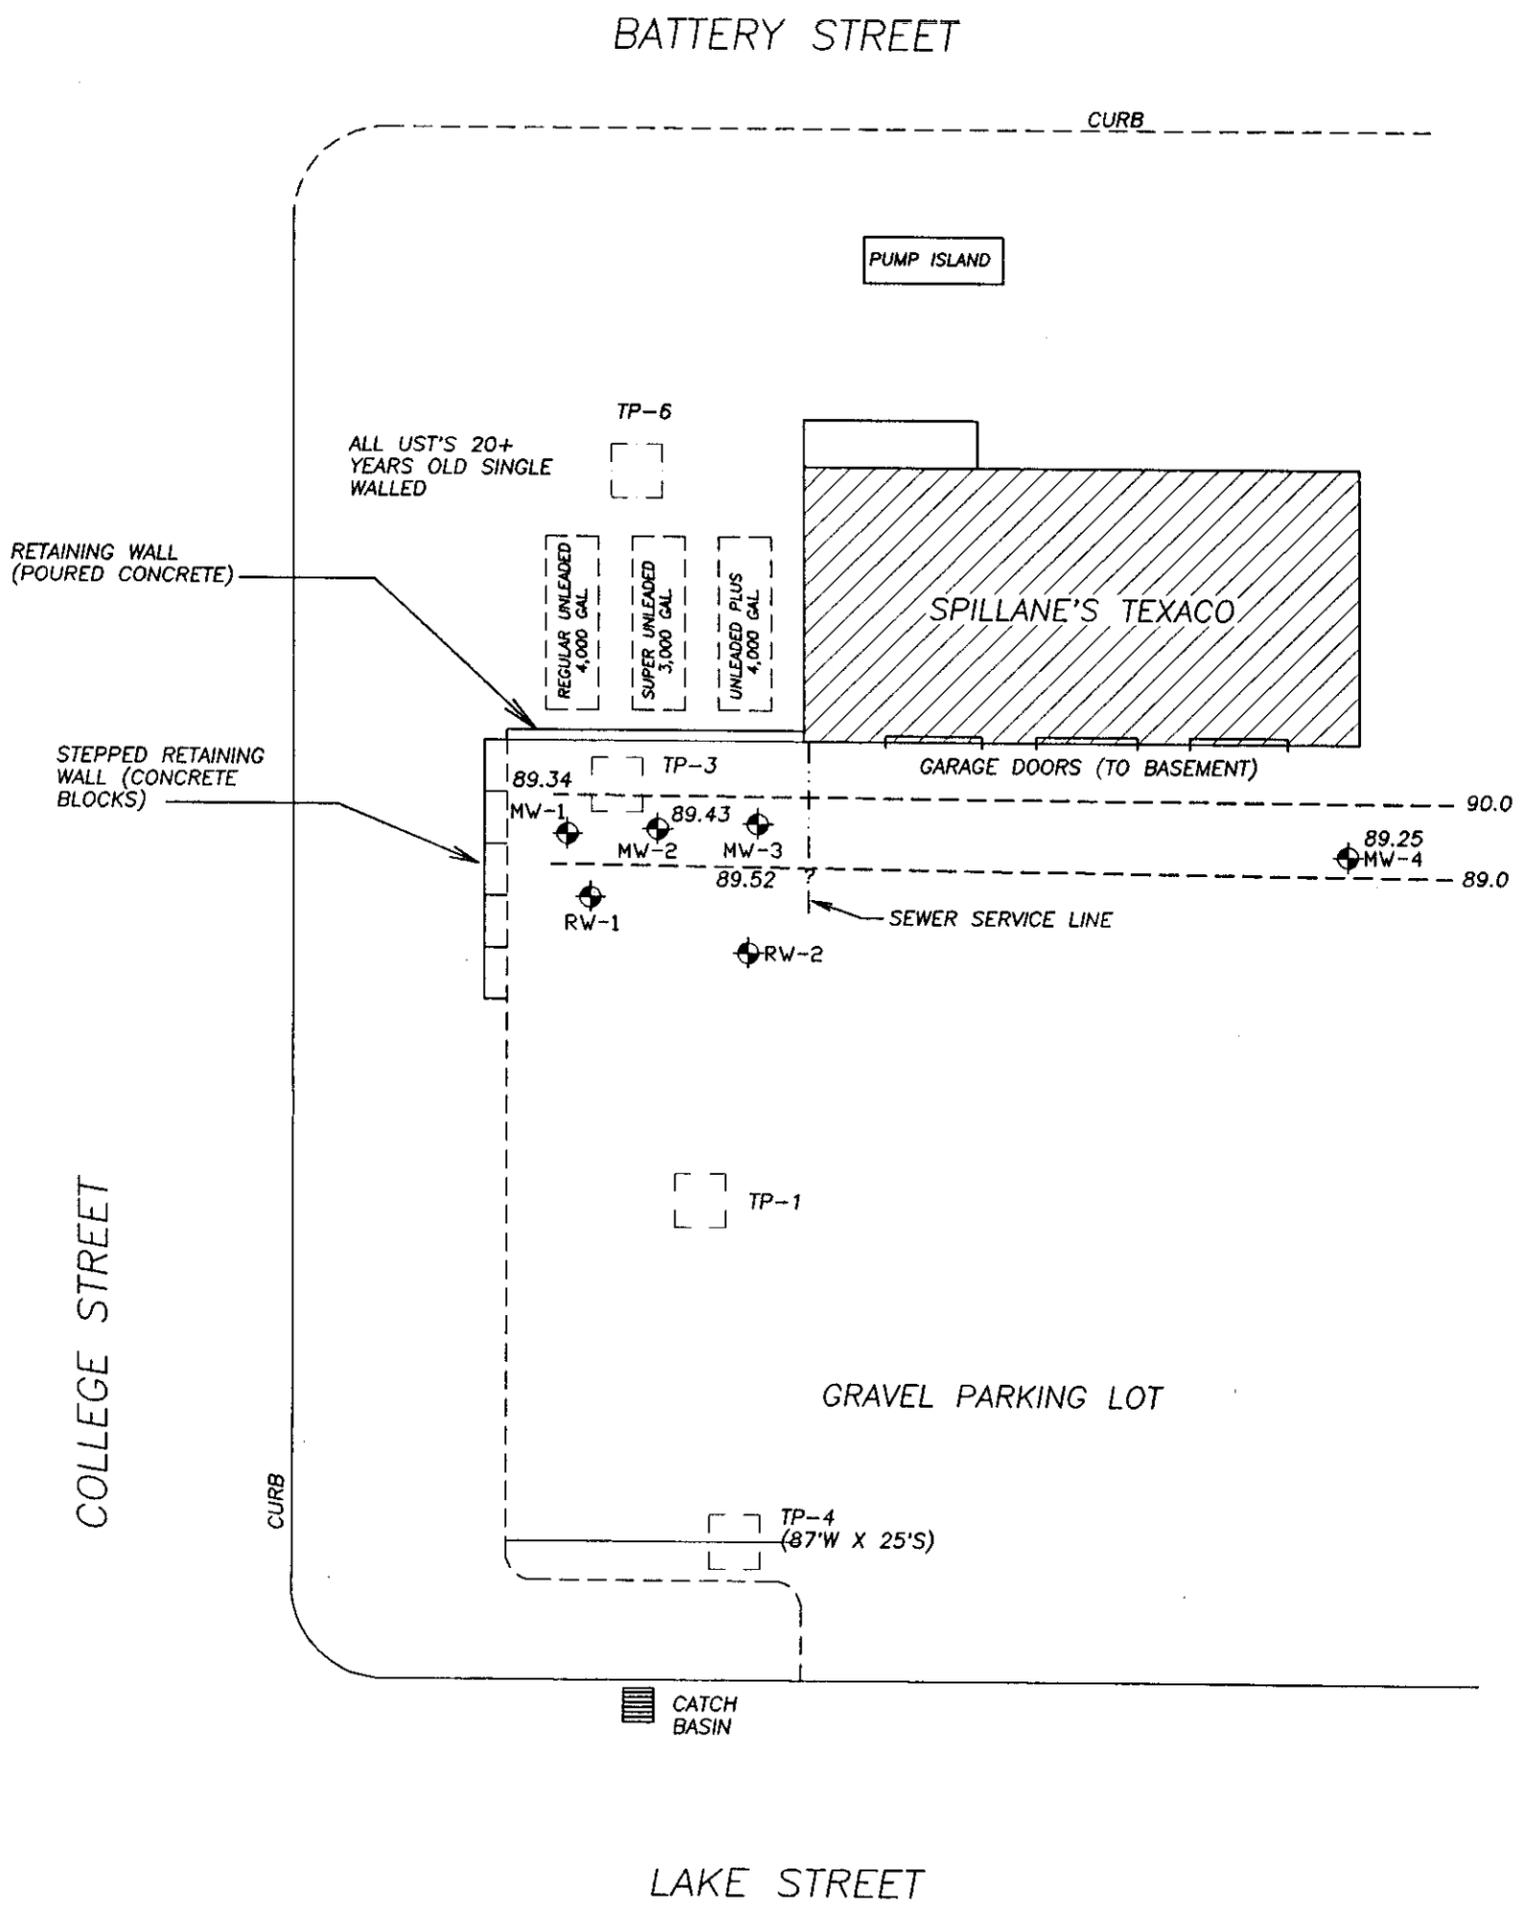
- TP-2 EXCAVATED AT LOCATION OF RW-1.
- TP-5 EXCAVATED AT LOCATION OF RW-2.
- MW-1 THRU MW-4 ARE 2" DIAMETER MONITORING WELLS.
- RW-1 AND RW-2 ARE 18" DIAMETER RECOVERY WELLS.

WELL #	T.O.P. ELEV. (FT)	DEPTH BELOW T.O.P. (FT)	WATER TABLE ELEV. (FT)
MW-1	99.21	9.87	89.34
MW-2	99.26	9.83	89.43
MW-3	99.13	9.61	89.52
MW-4	98.81	9.56	89.25

Monitoring well locations and top-of-pipe (TOP) elevations were surveyed on July 22, 1996. As shown on the Groundwater Elevation Map (Appendix 1, page 3), groundwater flow is to the west. The alignment of the wells on a near north-south axis prevents further characterization of the direction of groundwater flow. Based on groundwater level measurements, the water table is approximately 18-feet below the former USTs.

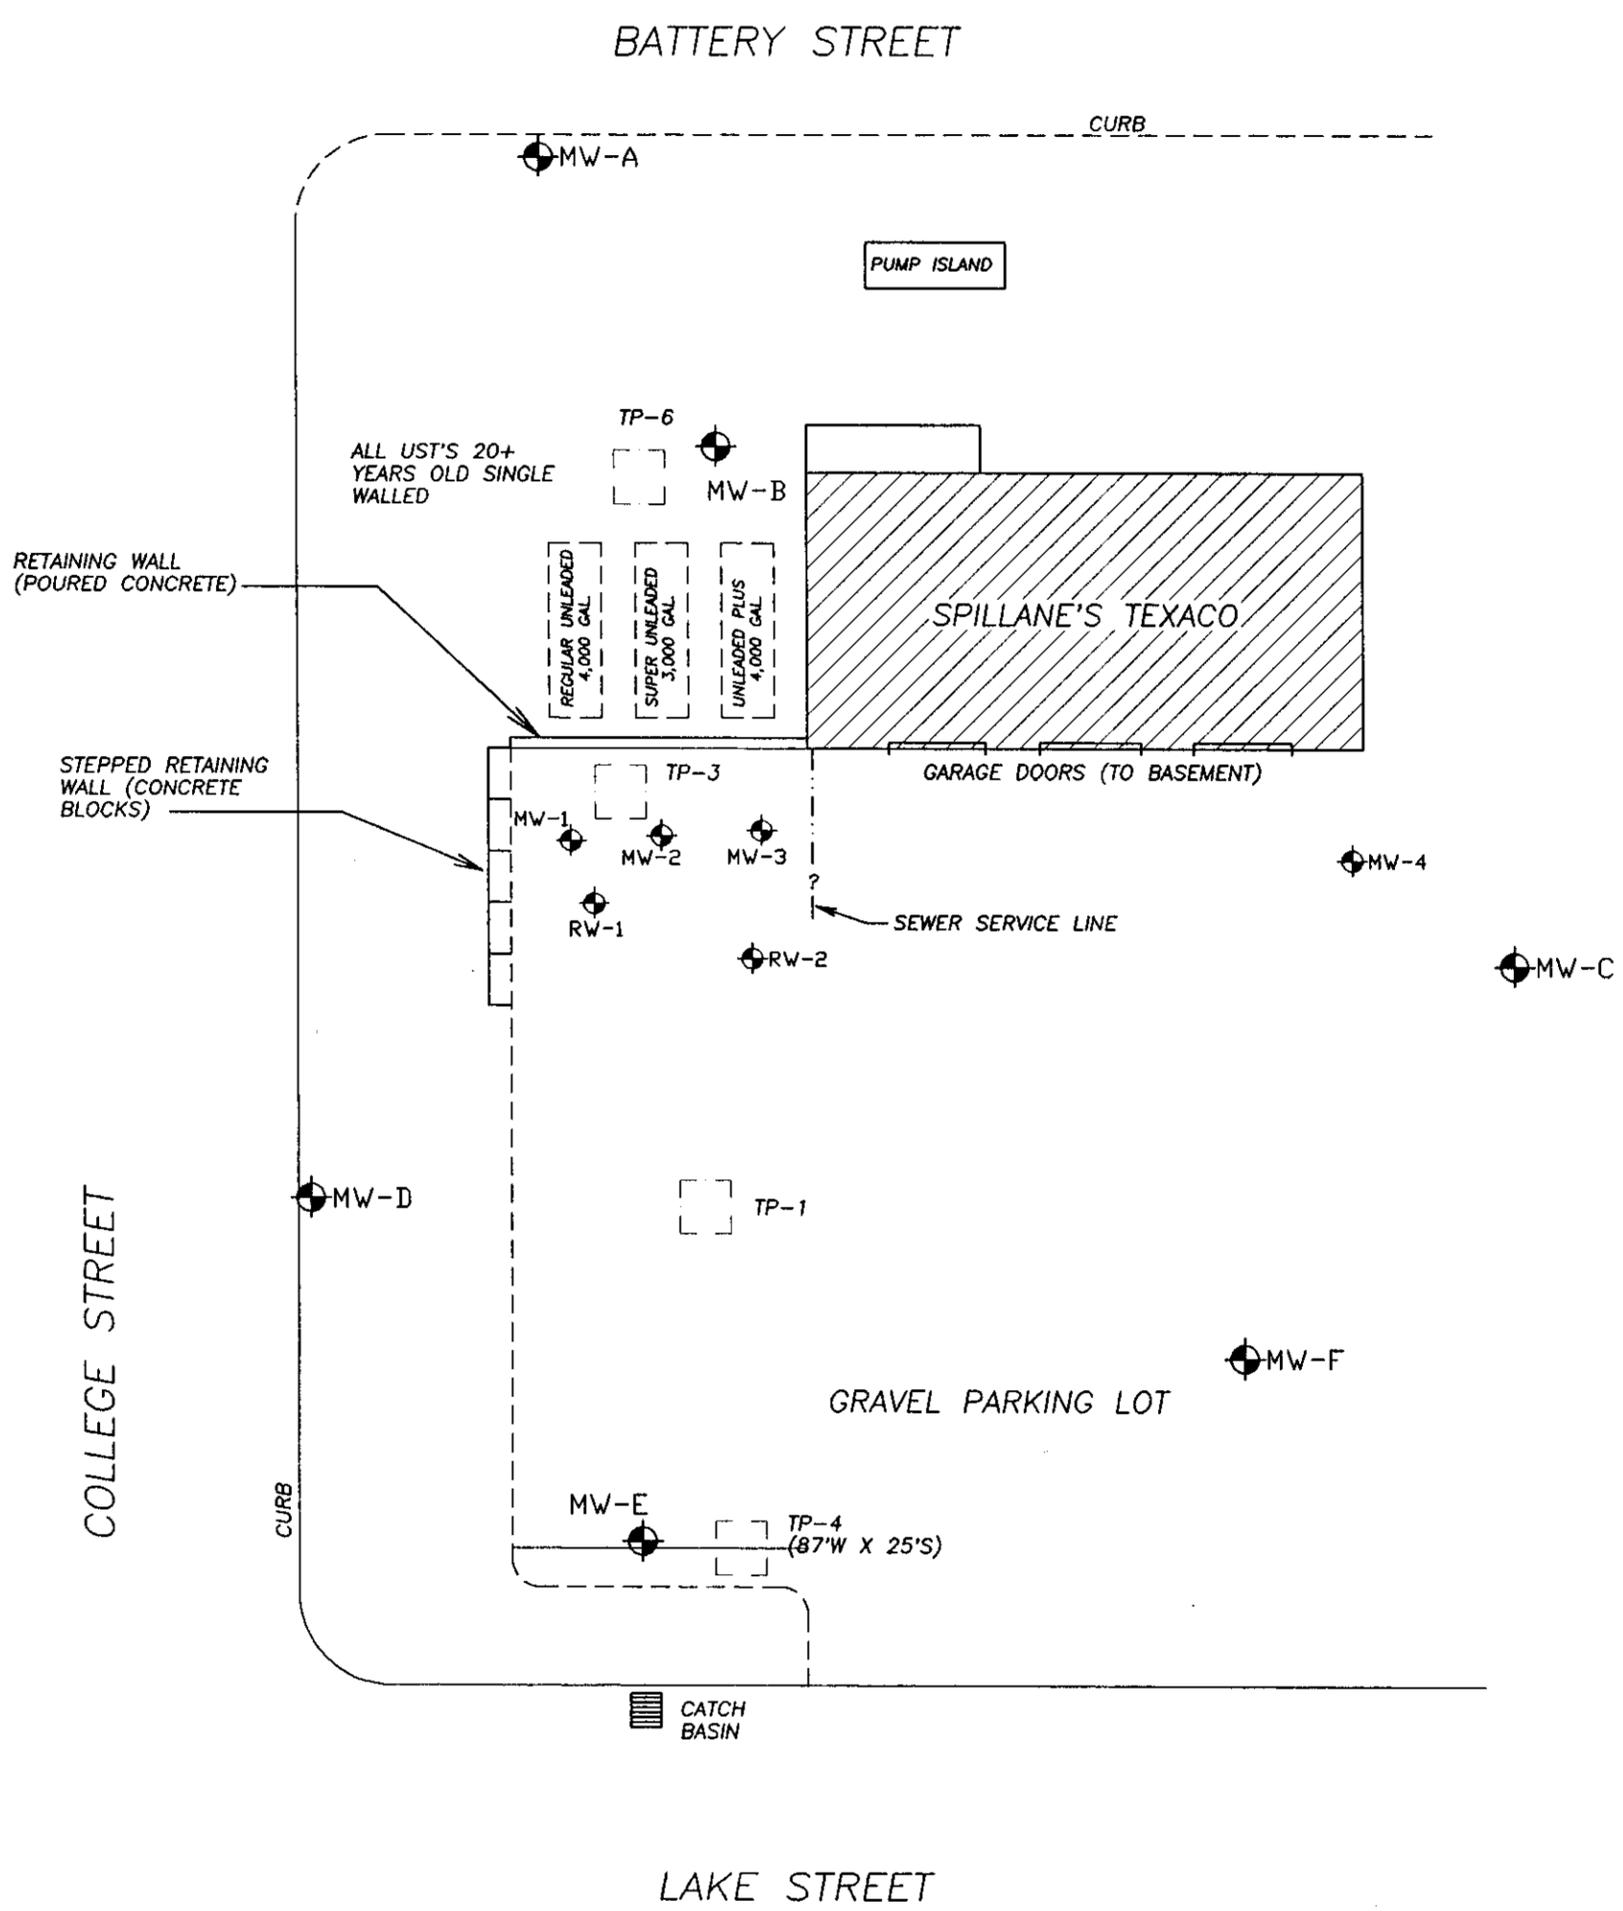
- MW-A PROPOSED NEW MONITOR WELL LOCATION
- TP-2 EXCAVATED AT LOCATION OF RW-1.
- TP-5 EXCAVATED AT LOCATION OF RW-2.
- MW-1 THRU MW-4 ARE 2" DIAMETER MONITORING WELLS.
- RW-1 AND RW-2 ARE 18" DIAMETER RECOVERY WELLS.

Based on the continued presence of elevated BTEX levels in at least two of the on-site monitor wells, and the discovery of additional petroleum contamination in the soil in the vicinity of the three gasoline USTs removed on July 9, 1996, H&N proposes the installation of an additional six wells to better characterize the extent and degree of contamination. The following is an explanation for the locations of the six proposed monitoring wells, shown on the proposed monitor well locations sketch (Appendix 1, page 4):

- MW-A upgradient well to determine quality of groundwater entering the site,
- MW-B to establish water quality beneath the product line,
- MW-C & D to determine the lateral extent of contamination,
- MW-D will also evaluate whether contamination has moved down utility trenches along College street,
- MW-E & F to determine the downgradient extent of contamination.

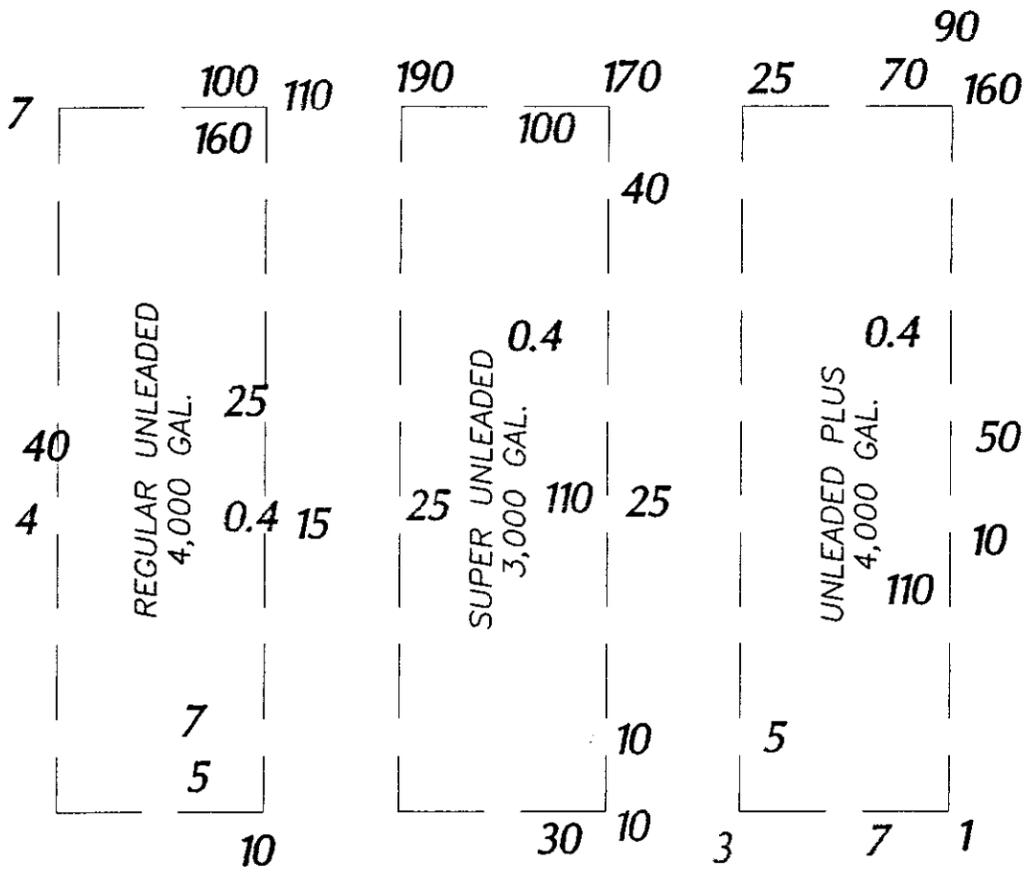
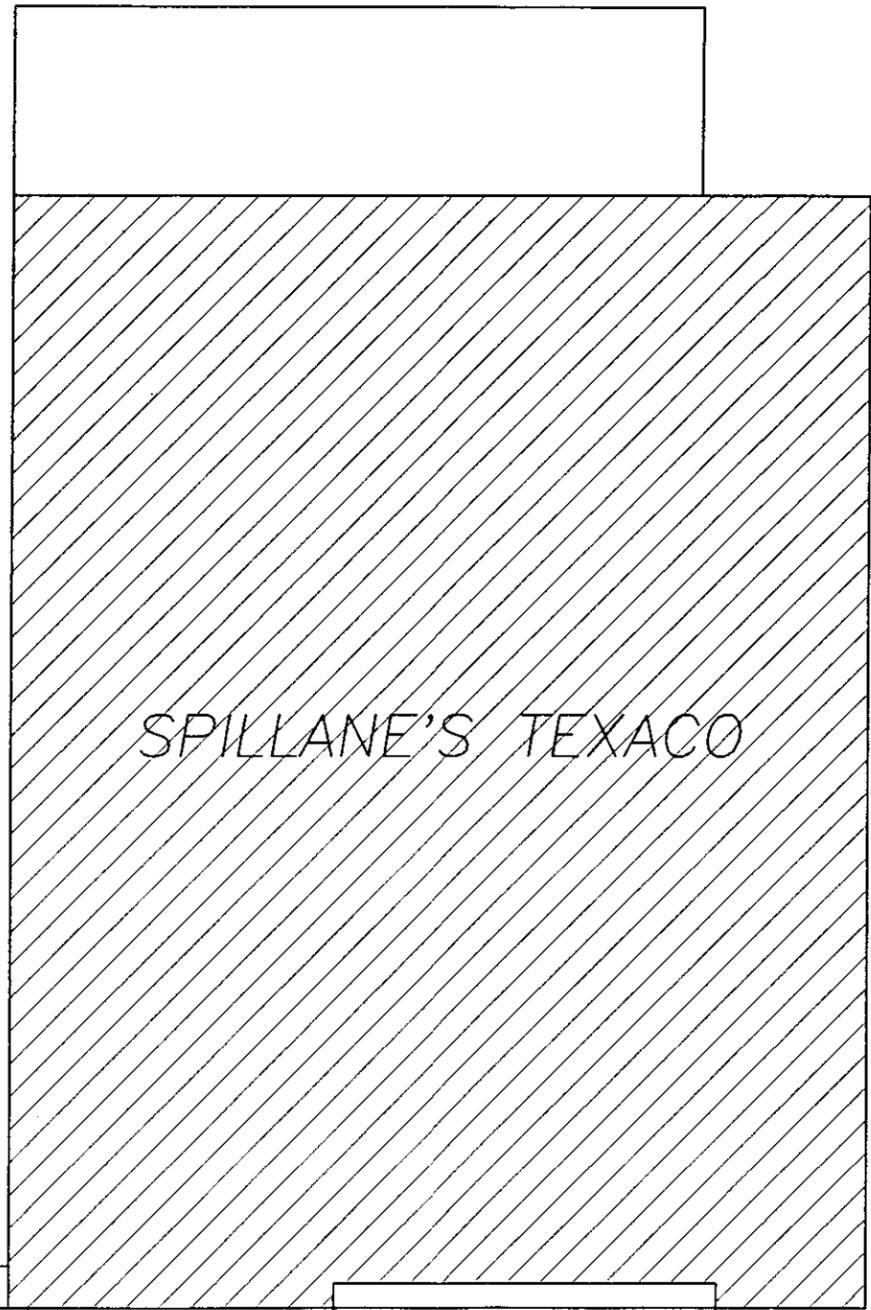
ALL UST'S 20+ YEARS OLD SINGLE WALLED

RETAINING WALL (POURED CONCRETE)

Sketch maps of the test locations are shown in Appendix 1 (page 5).

Analysis of PID soil-screening results indicate significant levels of petroleum contamination in the vicinity of the former USTs. Contamination levels were highest along the east end of the tanks, in the vicinity of product delivery pipes. Elevated PID readings in the vicinity of the piping upgradient of the USTs indicates a line or fitting failure (the lines to two tanks were pressure tested and failed in 1994). Although elevated PID readings were recorded directly under all three USTs, these levels were lower than would be expected if the USTs were leaking. Elevated PID levels directly under the former USTs are most likely a result of contamination from line or fitting leakage migrating near and under the former USTs. Compacted soils directly under the USTs may have also served to retain contamination, thus resulting in higher PID levels.

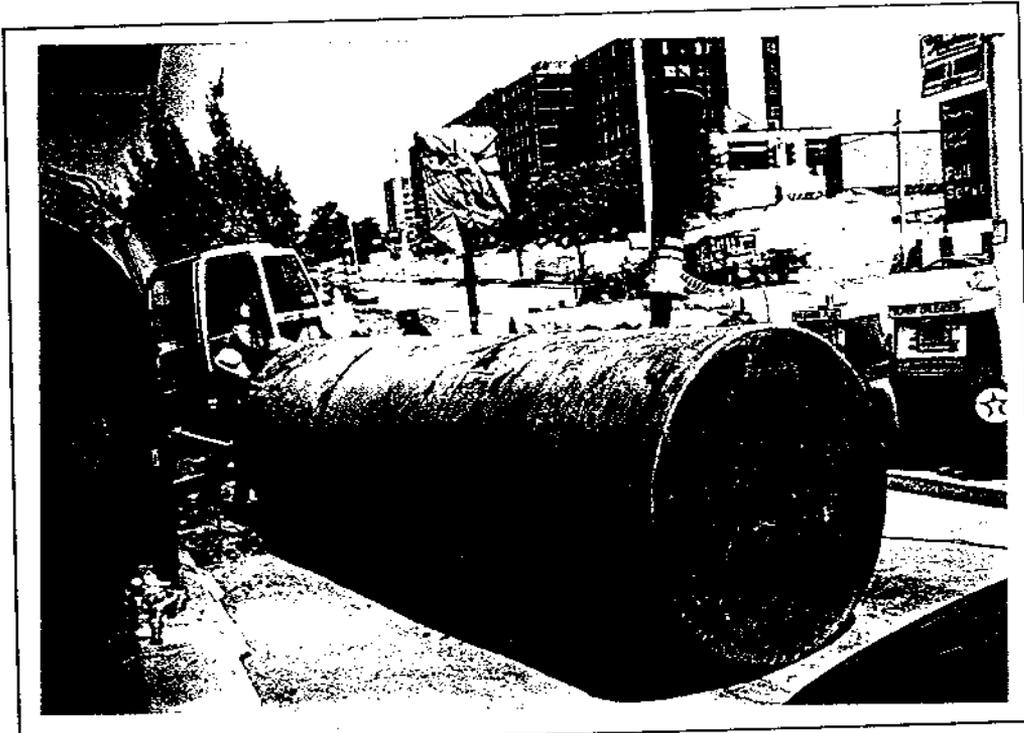
The second tank removed was the 3,000-gallon super unleaded gasoline UST, located between the two other tanks. Approximately twenty-gallons of rust colored liquid were removed from the UST. Although minor pitting was observed on both ends of the tank, the tank appeared to be in good condition with no evidence of perforations or leakage.

3,000-gallon super unleaded UST, facing northeast (7/9/96).

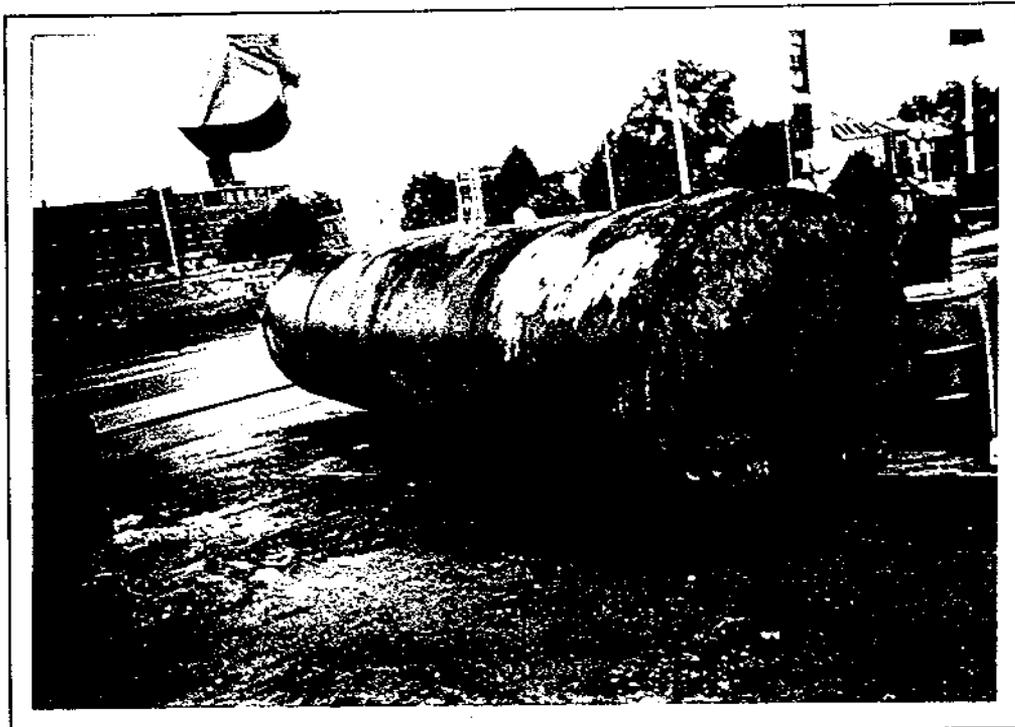
The first tank removed was the 4,000-gallon regular unleaded gasoline UST, located furthest from the service station building. Approximately forty-gallons of rust colored liquid were removed from the UST. The UST was observed to be in good condition with no pitting, perforations, or leakage.

4,000-gallon regular unleaded UST, facing southwest (7/9/96).

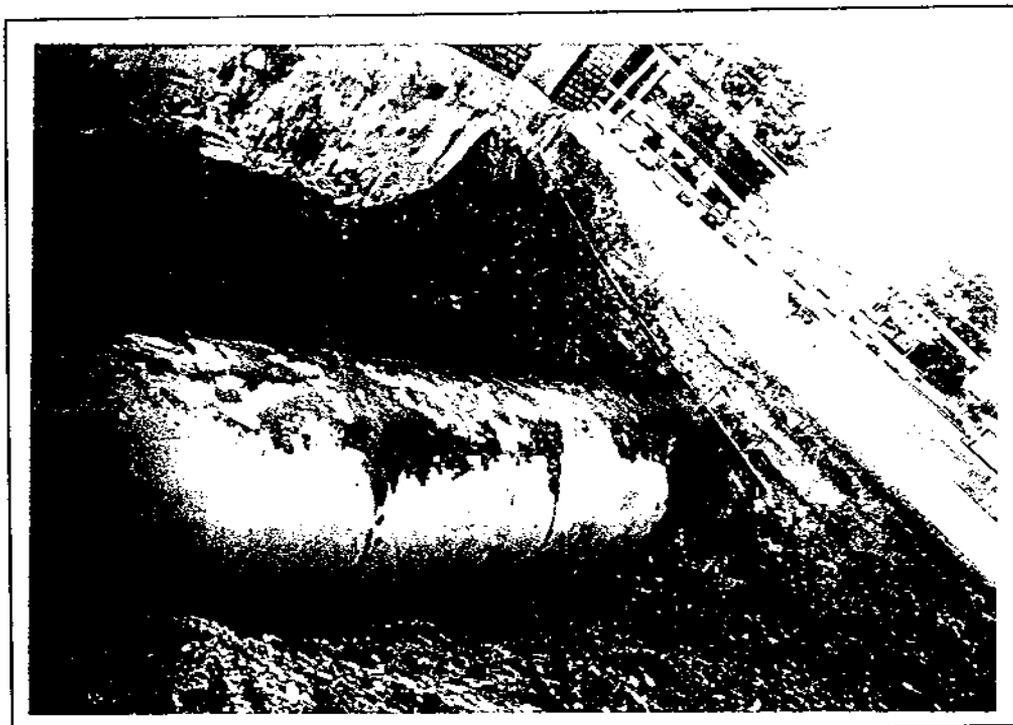
The third tank removed was the 4,000-gallon unleaded plus gasoline UST, located adjacent to the service center building. Approximately seventy-gallons of rust-colored liquid were removed from the UST. The UST was observed to be in good condition with no pitting, perforations, or leakage. Approximately 3-inches of water were observed on the western half of the bottom of the excavation. The water appeared to be impounded due to clayey fill material and the proximity of the building and retaining wall. The depth to groundwater is approximately 18-feet below the bottom of the UST.

4,000-gallon unleaded plus UST, facing west (7/9/96).
