RE: Initial Site Investigation, Mayo Health Care, Northfield, VT

**INITIAL  
SITE INVESTIGATION REPORT**

**MAYO HEALTH CARE  
1 Richardson Street  
Northfield, VT**

October 1996

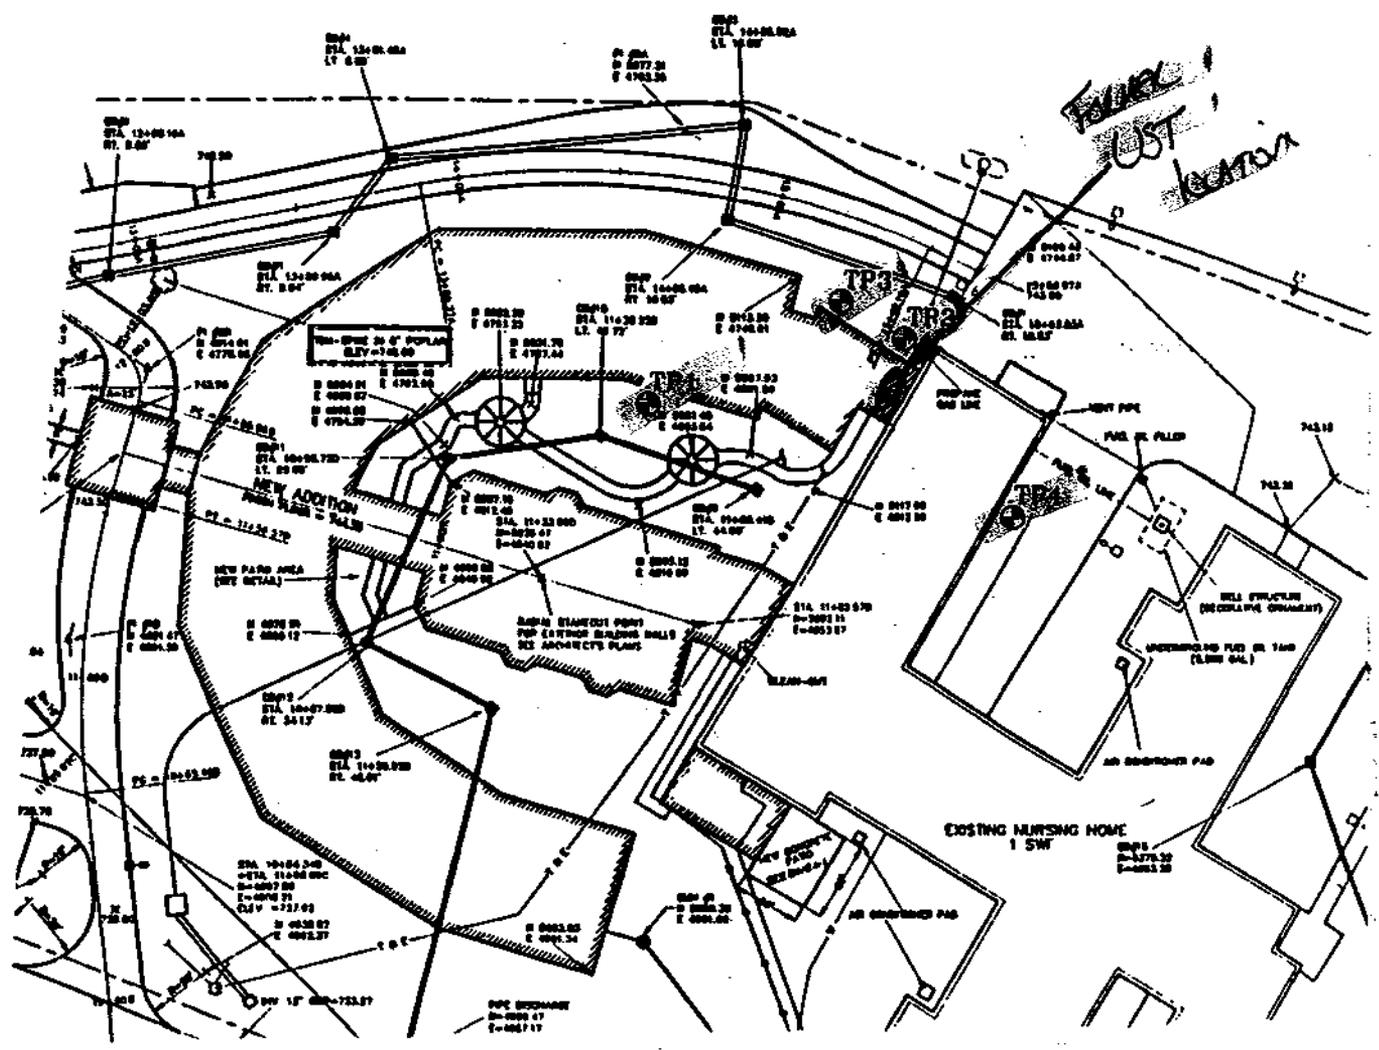
**MAYO HEALTH CARE FACILITY**  
**NORTHFIELD, VERMONT**  
**SITE SKETCH**

Four test pits were excavated with a backhoe on July 30, 1996 by Tomco, under the direct supervision of a Griffin hydrogeologist. Test pit locations were selected to best characterize the site hydrogeology, given the site accessibility constraints. TP1 was excavated on the east side of the new addition, southeast and in a direction presumed to be partially downgradient from the former UST pit. TP2 and TP3 were excavated on the west side of the new addition. TP2 was directly west and presumed to be upgradient of the former UST pit. TP3 was southwest and assumed cross-gradient from the former UST pit. TP4 was excavated north and assumed cross-gradient from the former UST pit, on the opposite side of the existing facility. Test pit locations are indicated on the Site Sketch in Appendix A.

SITE SKETCH CREATED FROM PHOTO COPY OF SITE SURVEY PROVIDED BY OWNER AND GRIFFIN FIELD DATA.

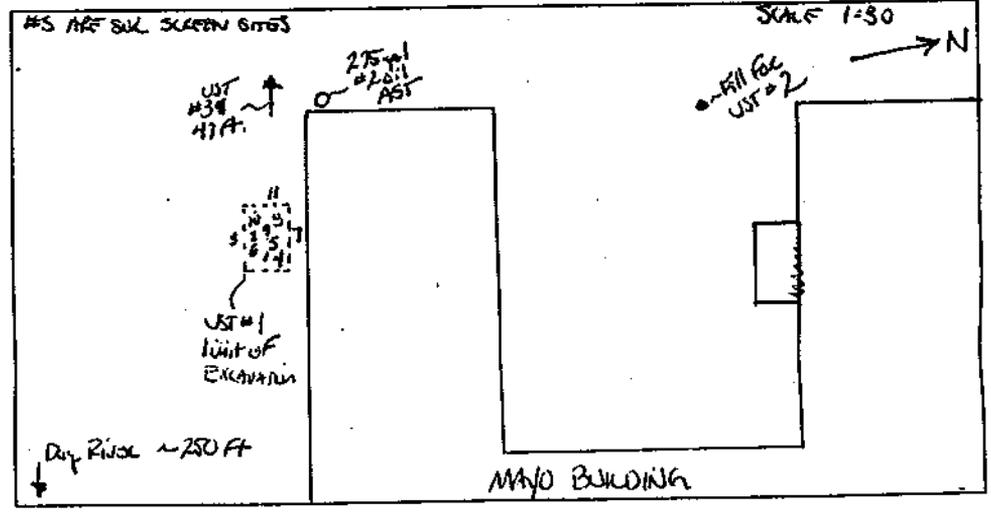
**SITE DIAGRAM**

The following table lists the eleven soil samples collected during this inspection, the depths of collection, and the VOC concentrations detected in each. The locations of each soil sample are shown on the site sketch, on page two of the UST closure form.

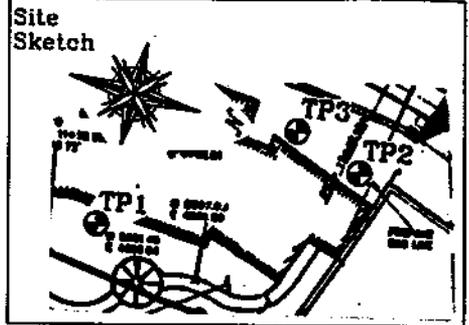
WELL NUMBER TP1

Sand and gravel fill material was encountered in TP1 to a depth of 8 feet, in TP2 to a depth of 3.5 feet, and in TP3 to a depth of 4 feet. Native sediment, consisting of well sorted, silty sand, was encountered under the fill material. TP1 was excavated to a depth of 12 feet, TP2 to 10 feet, and TP3 to 11 feet. TP4 consisted of fill material to a depth of 6 feet, underlain by native sands and gravels. TP4 was excavated to a depth of 9 feet. Each of the test pits was extended to the full extent of the small backhoe, under physical site constraints. Bedrock was not encountered in any of the test pits.

DEPTH IN FEET	WELL CONSTRUCTION	NOTES	DEPTH INTERVAL & PID READINGS	DESCRIPTION/SOIL CLASSIFICATION (COLOR, TEXTURE, STRUCTURES)	DEPTH IN FEET													
0	[Hatched area representing backfill]	NATIVE BACKFILL	1'-2' ND	Brown SAND and GRAVEL with cobbles. Slightly moist.	0													
1					2'-4' ND	Same as above.	1											
2							4'-6' ND	Same as above.	2									
3									6'-8' ND	Same as above.	3							
4											8'-9' ND	Fine grayish/yellow SAND, slightly moist, well sorted, high silt content.	4					
5													9'-12' ND	Same as above.	5			
6															END OF EXPLORATION AT 12'	6		
7																UNDISTURBED NATIVE SOIL	7	
8																		8
9																		
10		10																
11			11															
12				12														
13					13													
14						14												
15							15											
16								16										
17									17									
18										18								
19											19

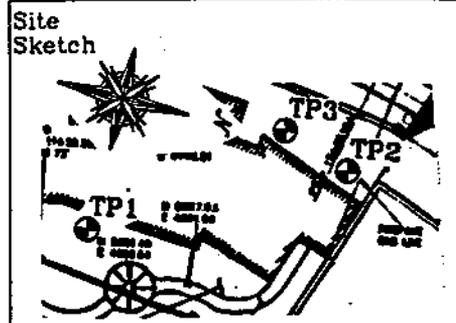
WELL NUMBER TP2

DEPTH IN FEET	WELL CONSTRUCTION	NOTES	DEPTH INTERVAL & PID READINGS	DESCRIPTION/SOIL CLASSIFICATION (COLOR, TEXTURE, STRUCTURES)	DEPTH IN FEET	
0					0	
1	[Hatched area representing backfill]		1'-2' ND	Brown SAND and cobble fill, slightly moist, highly compacted.	1	
2					2	
3				2'-3.5' ND	Same as above.	3
4		NATIVE BACKFILL			4	
5					5	
6				3.5'-9' ND	Gray, moist to damp, silty SAND, well sorted, native unconsolidated materials.	6
7					7	
8					8	
9					9	
10			9'-10' ND	Gray, very moist, silty SAND, well sorted, native unconsolidated materials.	10	
11	[Screened area representing casing]	UNDISTURBED NATIVE SOIL		END OF EXPLORATION AT 10'	11	
12					12	
13					13	
14					14	
15					15	
16					16	
17					17	
18					18	
19					19	
20					20	
21					21	
22					22	
23					23	
24					24	
25					25

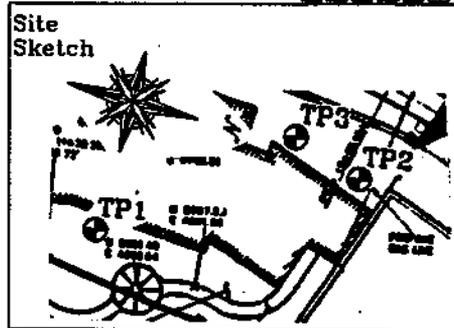
WELL NUMBER TP3

DEPTH IN FEET	WELL CONSTRUCTION	NOTES	DEPTH INTERVAL & PID READINGS	DESCRIPTION/SOIL CLASSIFICATION (COLOR, TEXTURE, STRUCTURES)	DEPTH IN FEET
0		NATIVE BACKFILL	ND	Brown, moist, SAND, GRAVEL and COBBLES, tightly compacted.	0
1					1
2					2
3					3
4					4
5					5
6					6
7					7
8					8
9					9
10					10
11		UNDISTURBED NATIVE SOIL	ND	Same as above.	11
12					12
13					13
14					14
15					15
16					16
17					17
18					18
19					19
20					20
21					21
22					22
23					23
24					24
25					25

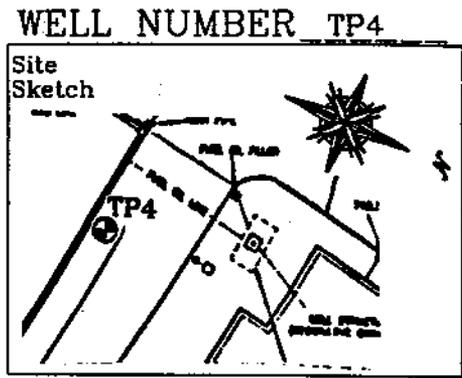
PROJECT MAYO HEALTH CARE FACILITY  
 LOCATION NORTHFIELD, VERMONT  
 DATE DRILLED 7/30/96 TOTAL DEPTH OF HOLE 9.0'  
 DIAMETER NA  
 SCREEN DIA. NA LENGTH NA SLOT SIZE NA  
 CASING DIA. NA LENGTH NA TYPE NA  
 DRILLING CO. TOMCO DRILLING METHOD BACK HOE  
 DRILLER \_\_\_\_\_ LOG BY E. HODGES

DEPTH IN FEET	WELL CONSTRUCTION	NOTES	DEPTH INTERVAL & PID READINGS	DESCRIPTION/SOIL CLASSIFICATION (COLOR, TEXTURE, STRUCTURES)	DEPTH IN FEET
0	[Hatched area representing backfill]	NATIVE BACKFILL	0'-1' ND	Organic topsoil, slightly moist.	0
1			1'-3' ND	Brown, slightly moist, SAND, GRAVEL and COBBLES, poorly sorted, highly compacted.	1
2			3'-5' ND	Same as above.	2
3			5'-6' ND	Same as above.	3
4			6'-7' ND	Brown, slightly moist, coarse SANDS of medium grading, gravel and small cobbles, native glacial outwash.	4
5				Same as above.	5
6				END OF EXPLORATION AT 9'	6
7	[Stippled area representing native soil]	UNDISTURBED NATIVE SOIL			7
8					8
9					9
10					10
11					11
12					12
13					13
14					14
15					15
16			16		
17			17		
18			18		
19			19		
20			20		
21			21		
22			22		
23			23		
24			24		
25			25
