RE: Site Investigation Report for the Olde Windsor Apartments  
in Windsor, Vermont

**SITE INVESTIGATION REPORT**  
**Olde Windsor Apartments**  
**Windsor, Vermont**

SEI PROJECT # 00-1134

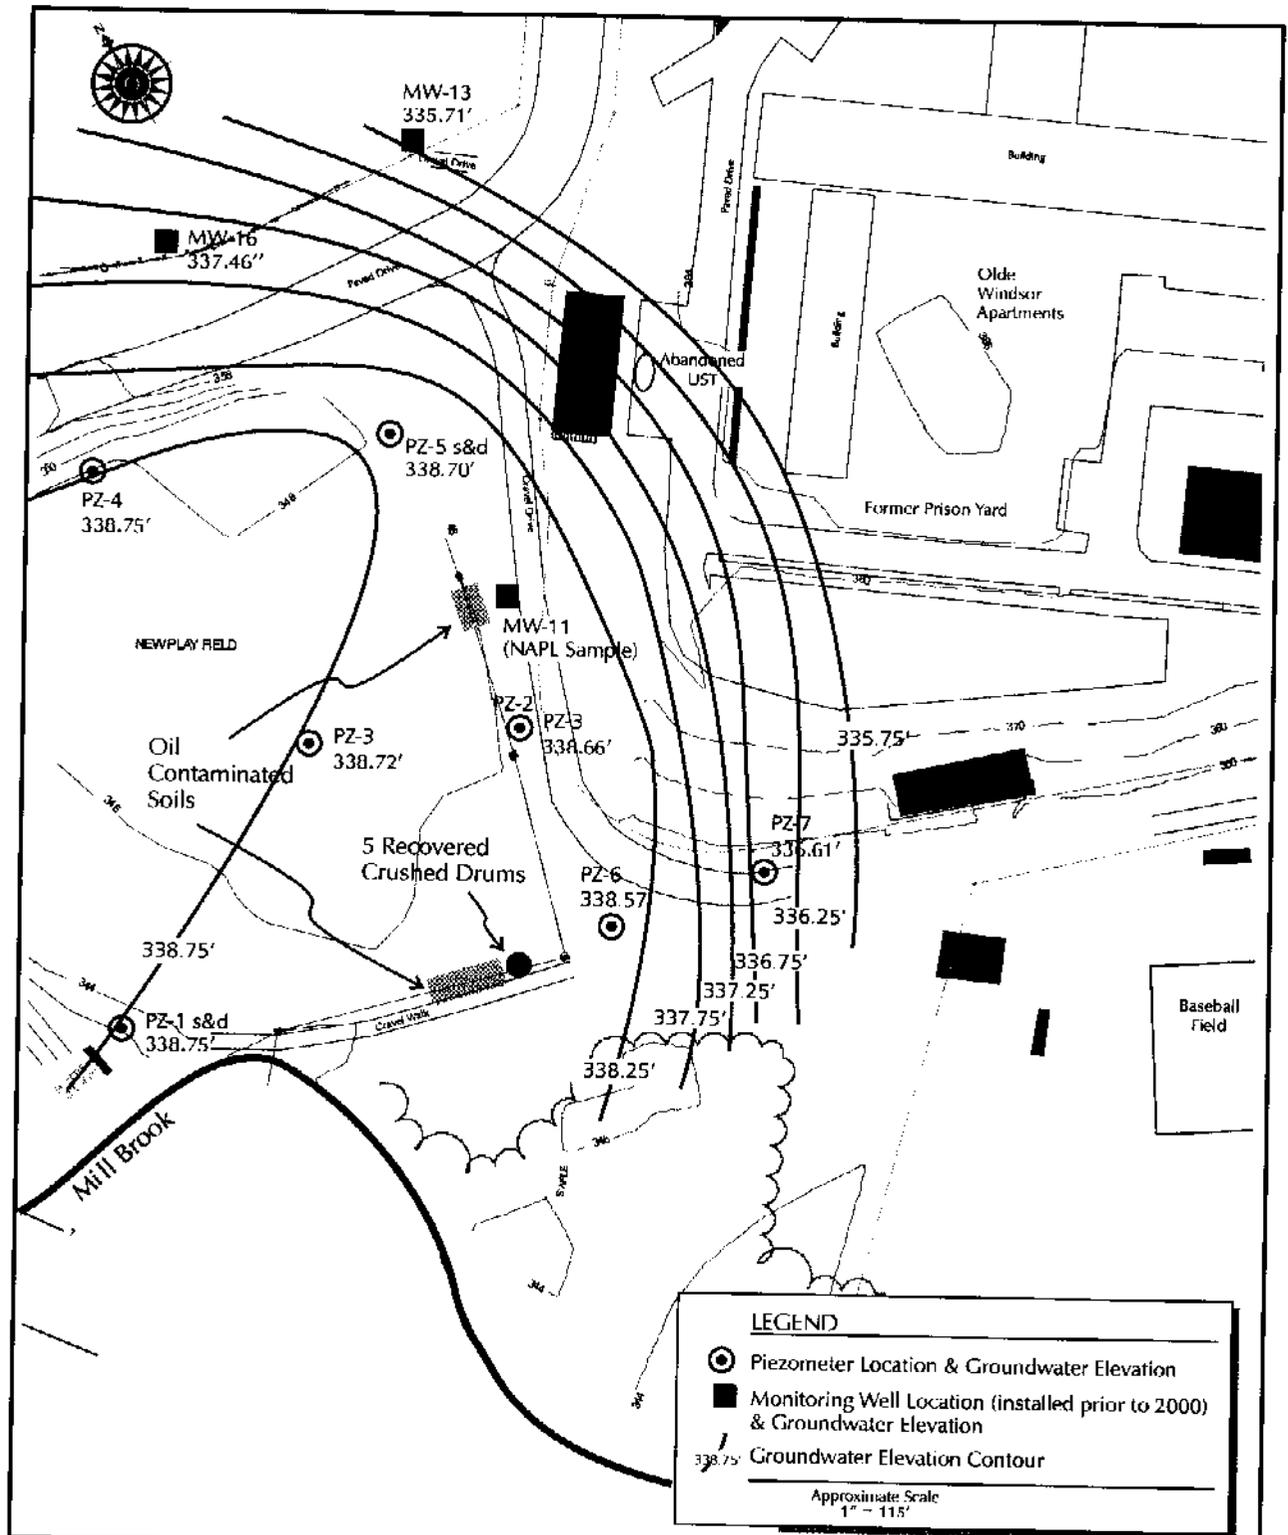
**FIGURE 3: GroundWater Elevation Contour Map - September 5, 2000**  
**Olde Windsor Apartments, Windsor, Vermont**

In general, the site is comprised of the following three hydrostratigraphic units from top to bottom: 1) topsoil and construction debris; 2) fine silts and sands and; 3) coarse gravel. There appears to be a relatively weak horizontal hydraulic gradient over the central portion of this site. Data collected from the piezometer clusters suggest there is no vertical component to the hydraulic gradient however, due to these wells not being properly sealed with bentonite grout, this finding is questionable at this time. As shown on Figure 3, the central area is believed to represent a hydraulic divide between three discharge points. To the north the water flows north towards Lake Runnemede and to the south the water discharges to Mill Brook. The eastern component to the hydraulic gradient is probably caused by the Connecticut River, which is approximately one half of a mile away.

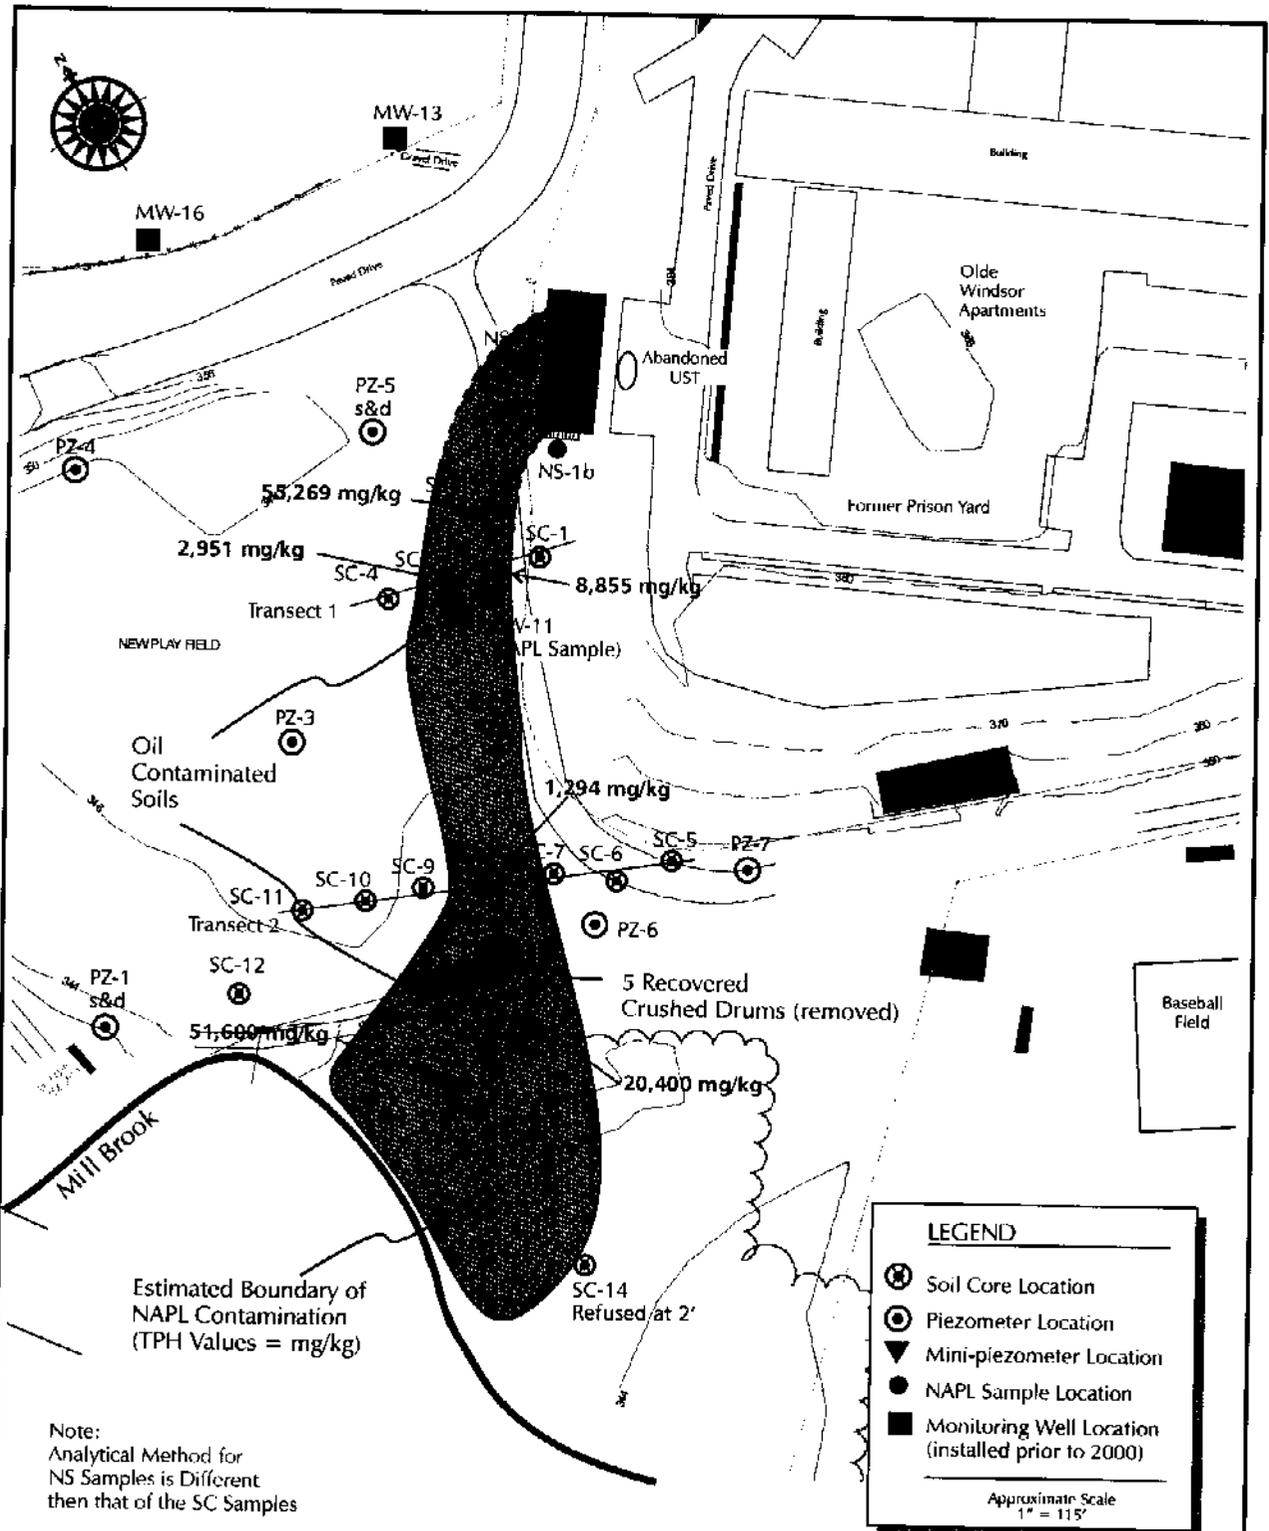
**FIGURE 4: Aerial Extent of NAPL Contamination  
Olde Windsor Apartments, Windsor, Vermont**

TPH contamination exists over a large portion of the site. The highest degree of contamination is located in the areas of MW-11 and Mill Brook where NAPL contamination is known to exist. Prior to this investigation only sheens of oil in MW-11 were reported to exist however, at the time of this study approximately 2.5 feet of black NAPL was present. The TPH contamination found in the soil cores along transect #1 and SC13 was present as a thick, oily liquid. A previous investigation, performed by The Johnson Company in 1998, determined that a narrow band of NAPL contamination was present in the wooded area beside Mill Brook at approximately five feet BGS.

This contamination starts in an area just west of the boiler building and terminates at a point very close to the bank of Mill Brook. The source zone of this contamination was not found during this work. However, assuming that this contamination originated at the boiler building, the northern extent of the contamination is probably not far from SC13. The horizontal extent of the contamination is shown in Figure 4. The width of this contamination is greatest in the wooded area beside the brook (approximately 175 feet) and becomes less wide in the area of Transect #1 (approximately 60 feet). The contamination is present as a relatively thin band of NAPL within a fine sand and silt layer. In soil core #13, where multiple samples were collected within a small vertical distance, the band was found to be no more than 1.6 feet thick. Dissolved phase contamination above and below this NAPL contamination was not found at levels above the 2,000 mg/kg detection limit however, a previous investigation (JCO 1998) determined that a significant amount of dissolved phase contamination (i.e. BTEX compounds) was present above and below the NAPL zone. It is worth noting that trends in the TPH values of these grossly contaminated soils across this site are not reliable due to the different analytical methods used during these separate investigations. Specifically, JCO TPH values for the Mill Brook area samples are based on a fresh kerosene calibration standard while the SEI TPH values for the northern contamination are based on a site derived (MW-11) NAPL calibration curve.

Based on historical reports of a fuel release and the results of the NAPL fingerprinting results, it is believed that the NAPL contamination found in the area in and around MW-11 is directly associated with the contamination beside Mill Brook. However, the area between these two areas (along transect #2) appears to be significantly less contaminated; only one sample (SC08 at 3.8 feet BGS) contained a measurable amount of TPH contamination (1,294 mg/kg, estimated value below the 2,000 mg/kg detection limit). Also, as mentioned above in Section 2.2, the contamination found in this sample appears to be of a different nature than that of the MW-11 contamination. Considering that this site has experienced many changes to its landscape and the number of different practices that have taken place over the last 50 years, there are many plausible scenarios that might explain why this area is less contaminated and why there appears to be more than one type of contamination. One likely scenario is this: at the time of the spill this area along transect #2 may have experienced a more thorough cleanup and recovery effort than that of other areas, only to be subsequently contaminated by some other

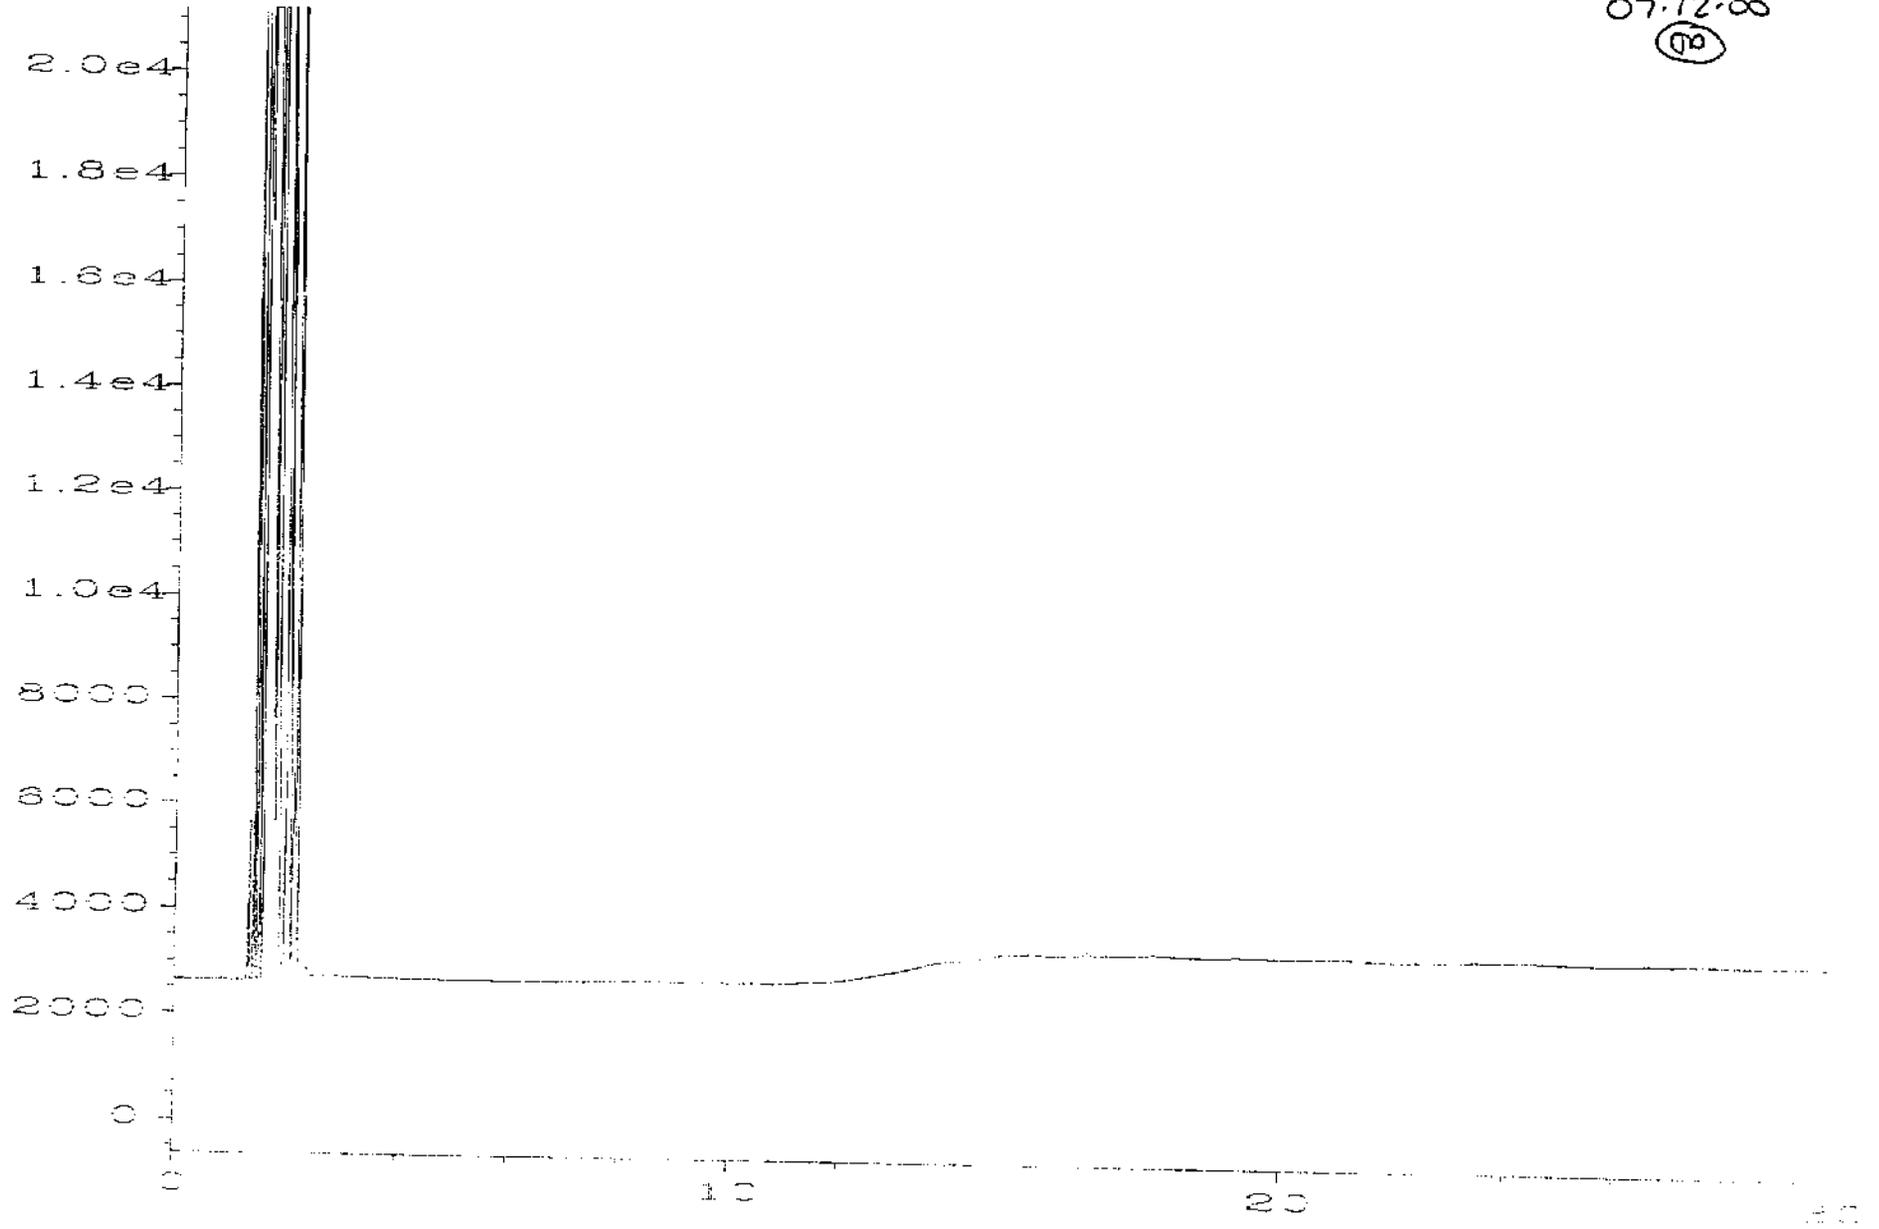
Fig 1 in C:\MSDCHEM\INDATA\FID\NO7120017.D

TPH DR0  
8015  
C<sub>17</sub>/Pristane & C<sub>18</sub>/Phytane  
RTs  
07.10.00  
07.12.00  
9b

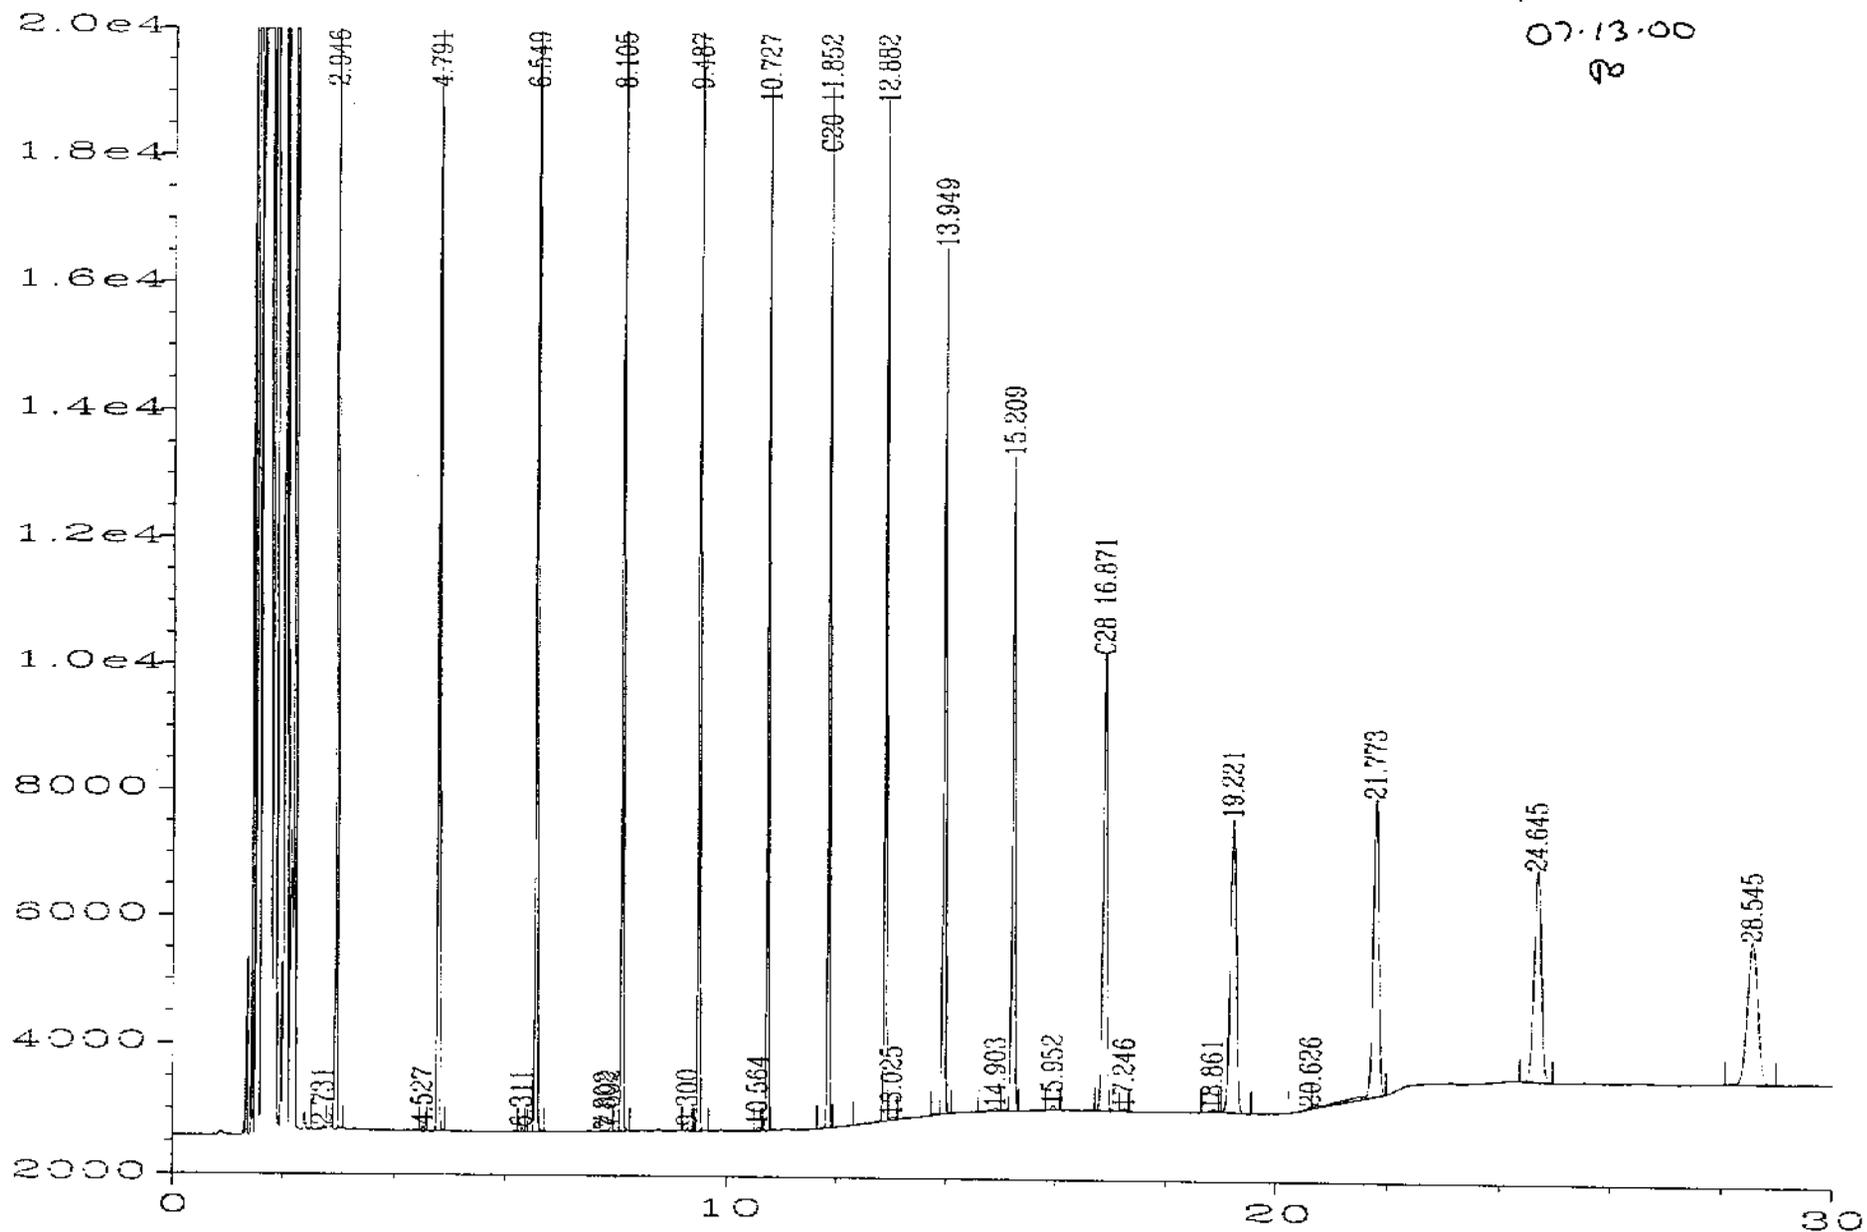
#2 Fuel Oil  
 Reference Chromatogram  
 X: 0-30 min  
 07.13.00  
 JB

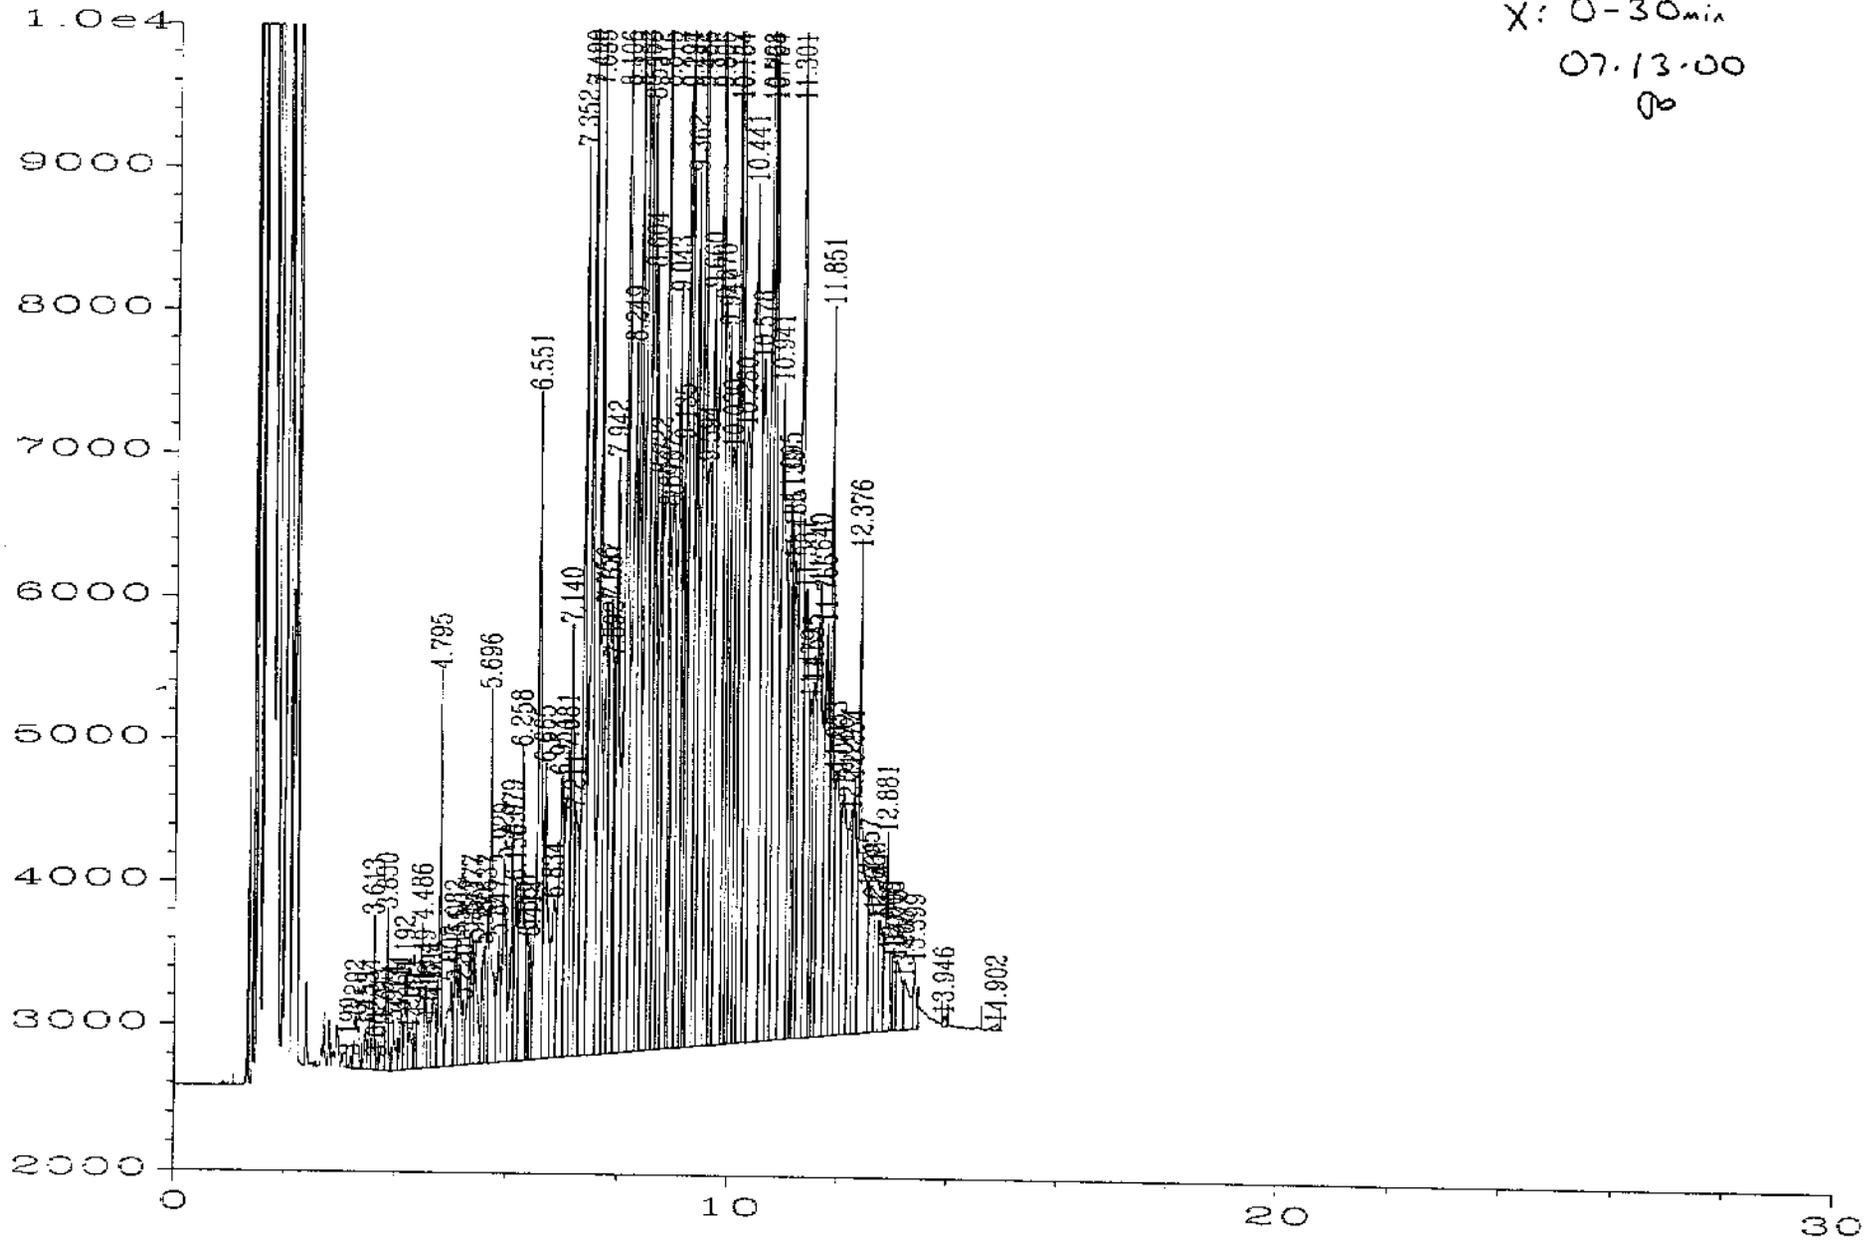
#6 Fuel Oil  
 Reference Chromatogram  
 X: 0-30 min  
 07.13.00  
 00

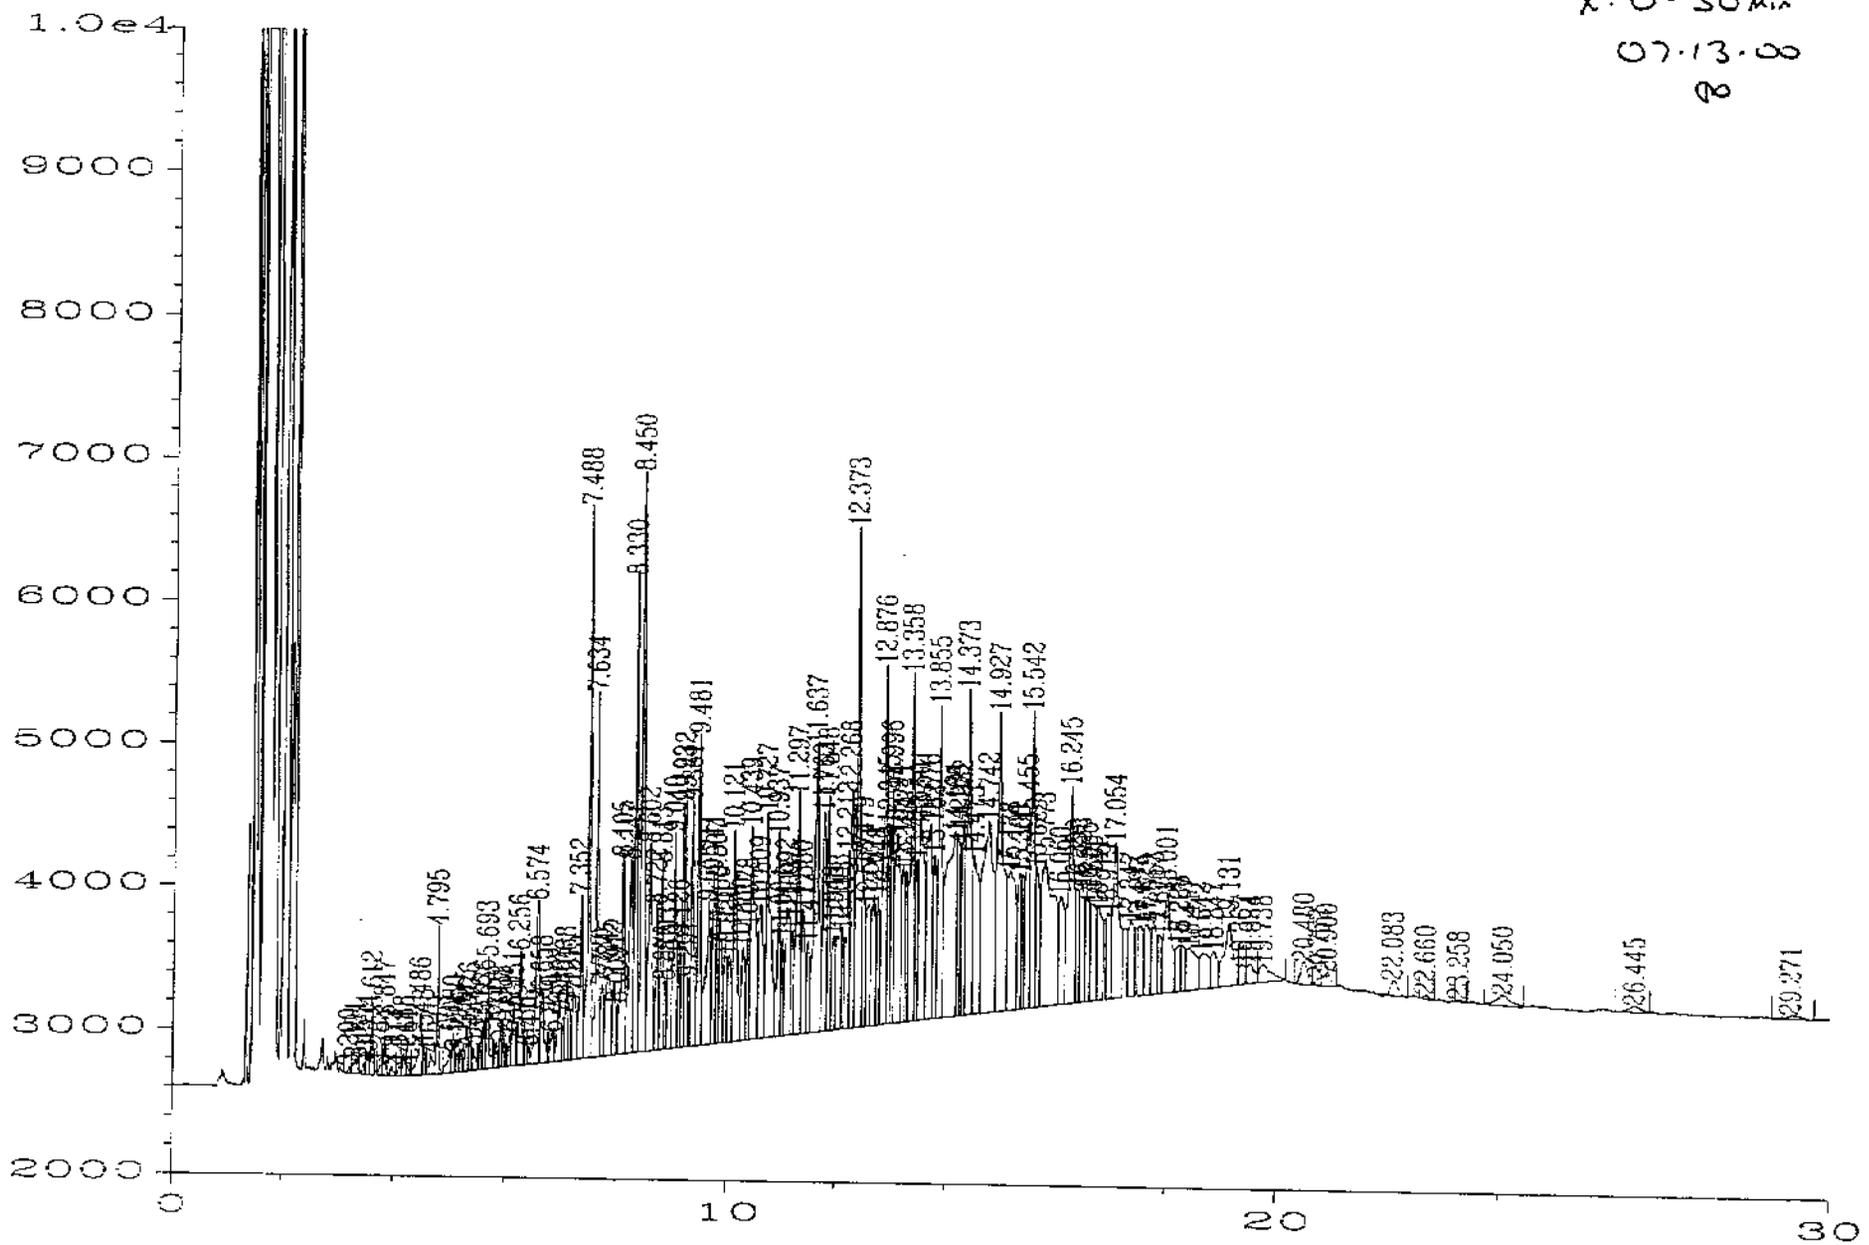
Kerosene  
Reference Chromatogram

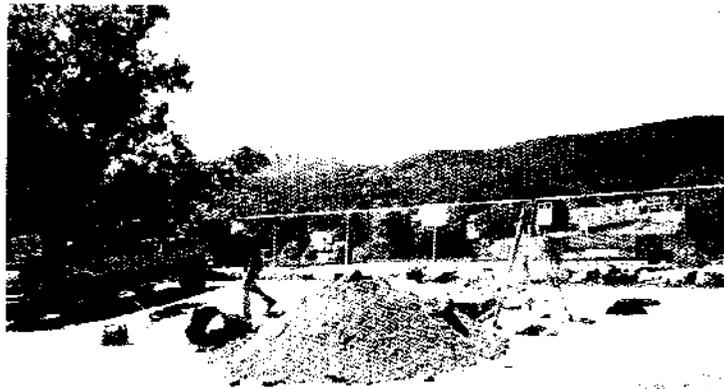
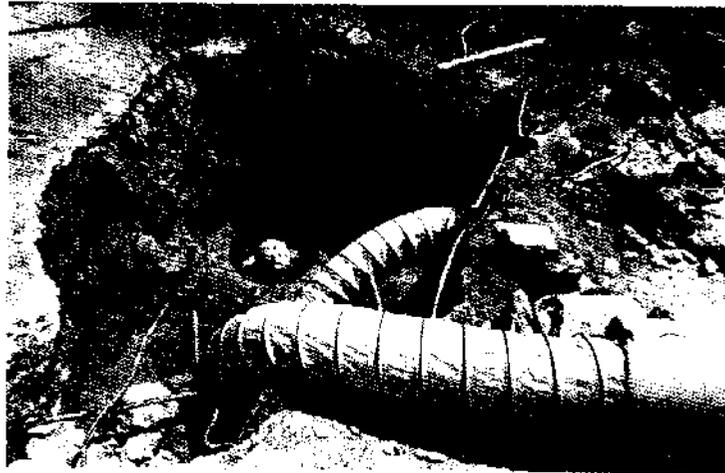
TANK INVESTIGATION  
Olde Windsor Apartments, Windsor, Vermont

Access to the tank was achieved using a backhoe. Efforts to dig in the area east of the tank were thwarted by the presence of a thick, steel reinforced, concrete surface. Instead, the area located directly over the center of tank was excavated to gain access to the main opening in the tank. Precision Industrial Maintenance (PIM) was contracted to enter the tank and assess its contents and condition. Once accessed, the tank was flushed with ambient air to ensure that permissible levels of oxygen were present upon entry. The tank was then checked for flammable gasses and oxygen concentration prior to entry. All necessary rescue and monitoring equipment were used throughout the time in which the PIM technician was in the tank. Photographs of this tank investigation are supplied in Appendix 4.

At the start of the tank investigation it was believed that two abandoned USTs were present in the area due east of the boiler building. Upon closer inspection of the premises and an interview with the former boiler room manager (Smokey Powers), it was determined that only one 20,000 gallon tank was used to supply the boiler heating system. According to Mr. Powers, the tank had catastrophically failed sometime in the early 1970s and efforts were made to repair the tank. The tank was pressure tested with water only to find more leaks were present. The tank was then cleaned to remove all residual oil and subsequently filled with sand. At this point the prison brought in an above ground storage tank to store the fuel oil. What this tank investigation found is consistent with what Smokey Powers reports: the tanks were partially filled and the bottom sands were devoid of oily deposits. Because the sand was delivered through two relatively small opening (one in the middle and one on the southern end of the tank) the sand did not completely fill the tanks and was present as sloping mounds beneath each of the fill holes. The headspace of the two sand samples was tested as a qualitative measure to ensure that no volatile contamination was present in this tank.

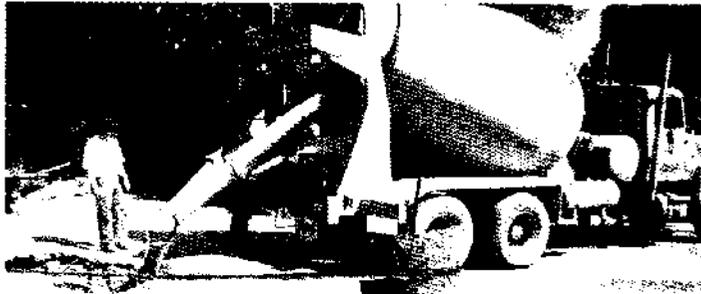
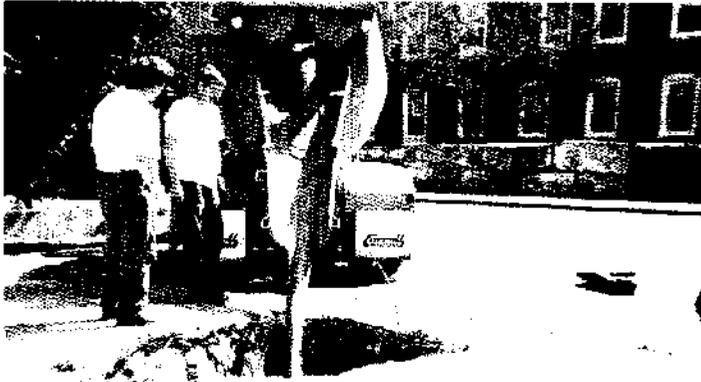
**TANK CLOSURE**  
**Olde Windsor Apartments, Windsor, Vermont**

The first part of this investigation consisted of non-aqueous phase liquid (NAPL) sampling and analysis and a tank investigation. Although NAPL was not present in the UST, samples were collected in several areas between the UST and the bank of Mill Brook where the overland flow was anticipated to have reached. Two and a half feet of NAPL was present in MW-11 at the time of this investigation; this well was reported to have only sheens present in the past. Analyses of the NAPL samples indicate that the contamination found in MW-11 (located near the UST area) appears to be of the same nature (#2 fuel oil) as the contamination found in a sample collected beside Mill Brook. Analytical results also suggest that there are two distinct classes of petroleum contamination (#2 fuel oil and a heavier #4 or #6 oil) present in the area immediately north of Mill Brook. Also, the presence of several biomarking compounds (i.e. pristane and phytane) in these samples indicates that this contamination does not contain a significant amount of kerosene. An inspection of the tank's interior determined that no residual fuel was present and the tank was still structurally intact. After notifying the State of Vermont Site Management Section of these findings, it was decided to close the tank in place by completely filling it with a cement slurry.
