# WATER QUALITY SUMMARY REPORT FOR DECEMBER 11, 2006

CLARENCE BROWN PROPERTY  
CORNER OF MAQUAM SHORE ROAD AND HATHAWAY POINT ROAD  
ST ALBANS BAY, VT 05481

44° 48.614'N, 73° 09.229'W  
SMS SITE #: 1998-2519

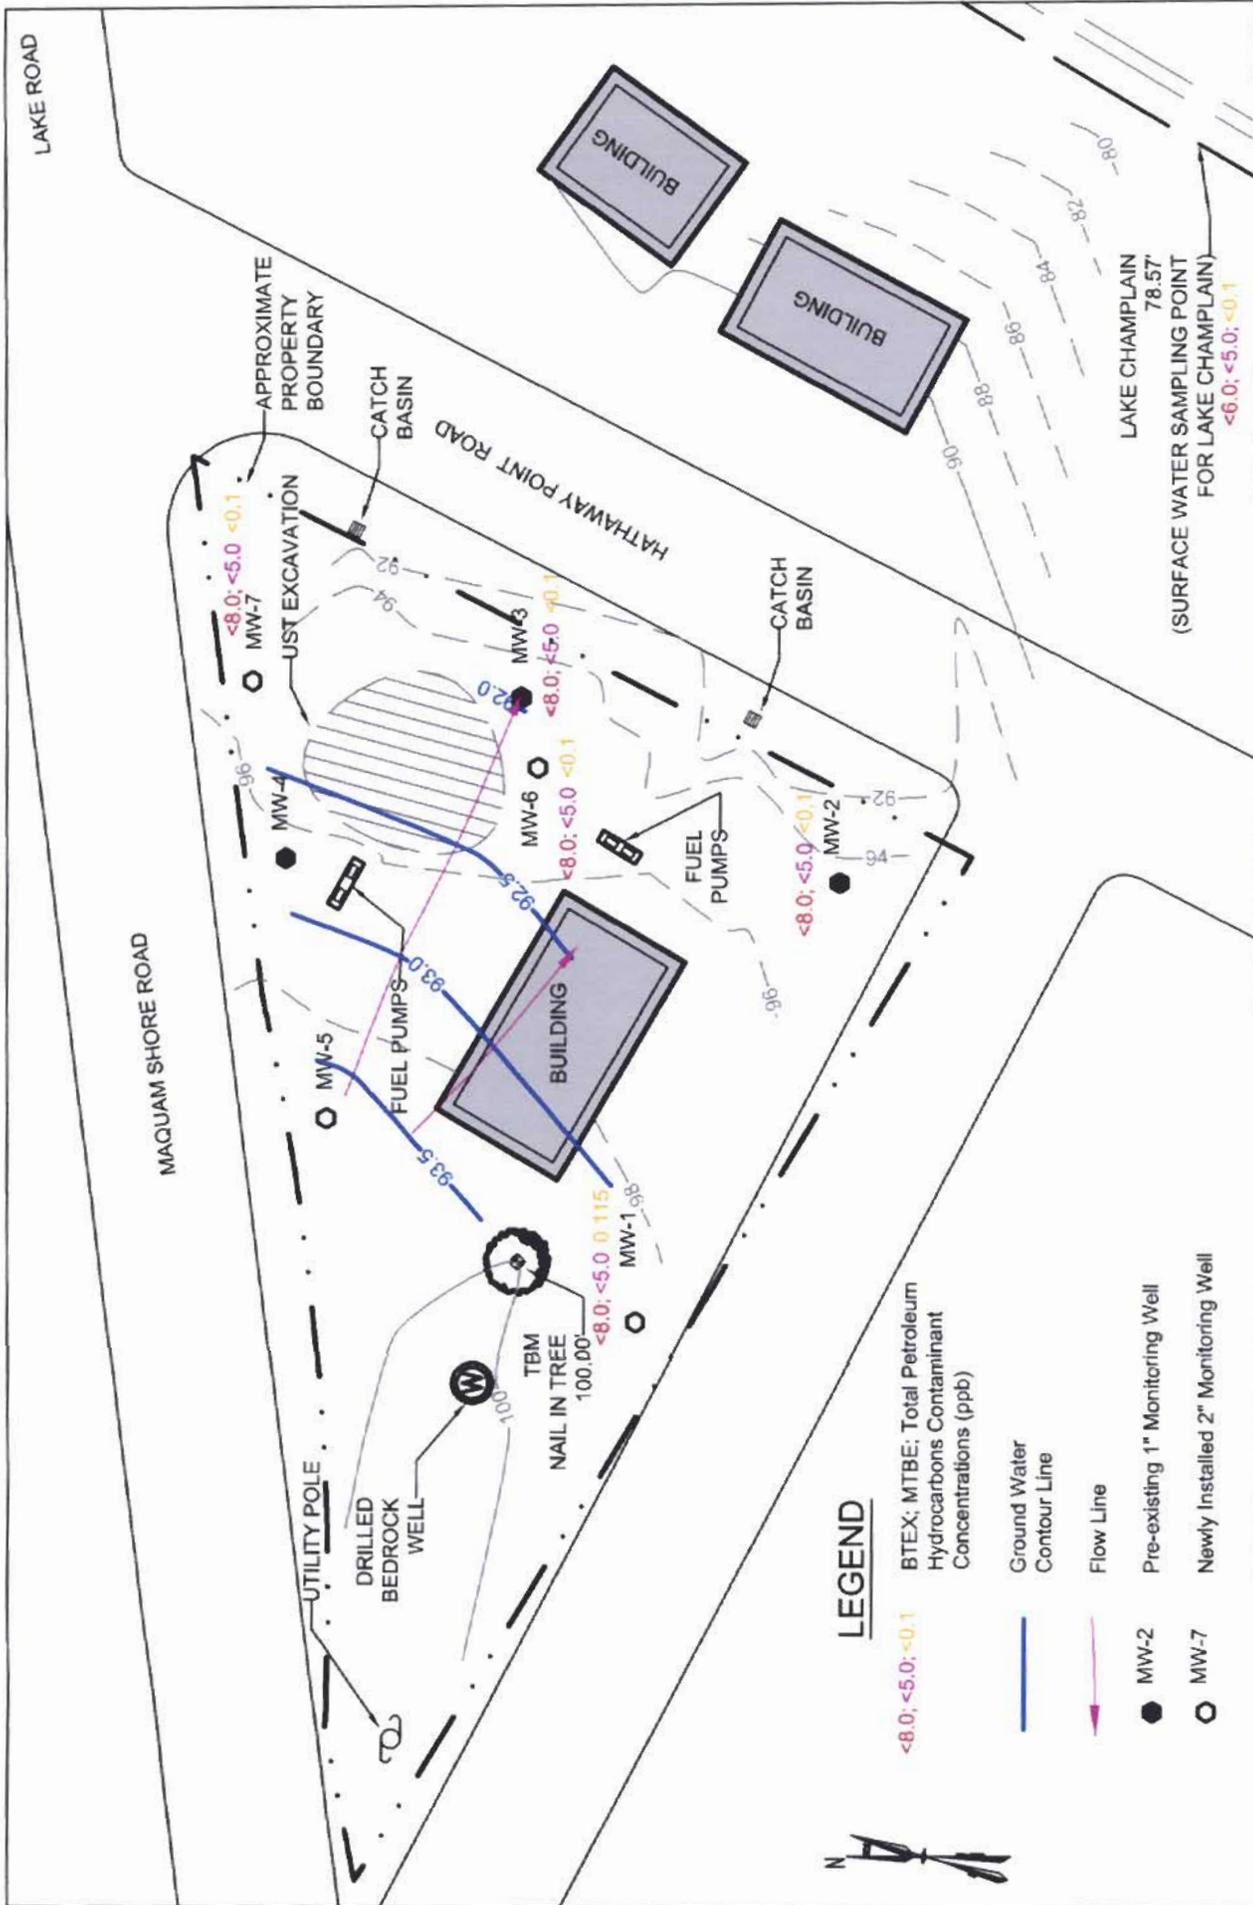
<b>CLARENCE BROWN</b> SMS SITE # 1998-2519 St. Albans Bay, Vermont Groundwater Elevation and Water Quality Summary Map for December 11, 2006		Project # V8714
		Surveyors KBC/KAC	Date DEC2006	Figure # 2

The groundwater data for December 11, 2006 is presented in **Table 1**. The depth to groundwater was between six and ten feet below grade. Based on the data collected, groundwater flow is generally to the east at a gradient of 0.041 feet/foot. A groundwater elevation and water quality summary map is included as **Figure 2**.

Groundwater Elevation  
(in feet)

Data Point	TOC	12/11/2006
MW-1	98.36	93.30
MW-2	94.55	90.74
MW-3	95.47	92.18
MW-4	95.27	
MW-5	95.14	90.02
MW-6	96.33	92.94
MW-7	98.82	95.88

Well Headspace  
Photoionization Detector Assay Results  
in parts per million

Data Point	12/11/2006
MW-1	0.8
MW-2	0.3
MW-3	2.1
MW-4	BG
MW-5	0.6
MW-6	BG
MW-7	BG

Water Quality Results  
 (parts per billion)

Data Point	Compound	GQES*	12/11/2006
MW-1	Benzene	5	<2.0
	Toluene	1,000	<2.0
	Ethylbenzene	700	<2.0
	Xylenes	10,000	<2.0
	1,3,5- Trimethylbenzene	4	<2.0
	1,2,4-Trimethylbenzene	5	<2.0
	Napthalene	20	<5.0
	MTBE	40	<5.0
	BTEX		<8.0
	TPH DRO (in mg/L)		0.115
MW-2	Benzene	5	<2.0
	Toluene	1,000	<2.0
	Ethylbenzene	700	<2.0
	Xylenes	10,000	<2.0
	1,3,5- Trimethylbenzene	4	<2.0
	1,2,4-Trimethylbenzene	5	<2.0
	Napthalene	20	<5.0
	MTBE	40	<5.0
	BTEX		<8.0
	TPH DRO (in mg/L)		<0.100
MW-3	Benzene	5	<2.0
	Toluene	1,000	<2.0
	Ethylbenzene	700	<2.0
	Xylenes	10,000	<2.0
	1,3,5- Trimethylbenzene	4	<2.0
	1,2,4-Trimethylbenzene	5	<2.0
	Napthalene	20	<5.0
	MTBE	40	<5.0
	BTEX	40	<8.0
	TPH DRO (in mg/L)		<0.100

EPSVT recommends an additional sampling event in the spring of 2007. EPSVT will also screen each well for VOCs utilizing a properly calibrated 10.6 eV PID and measure depth to water to generate a new groundwater flow map for the spring event. EPSVT will collect water quality samples from all monitoring wells and the drilled bedrock well on site, which will be analyzed via EPA method 8021B and 524.2, respectively; and
