Initial Site Investigation Report

**Danville Town Garage
Peacham Road
Danville, Vermont**

SMS Site No. 98-2557

**R.E.A. Project No. 99-008
R.E.A. Document #: 99008ISI**

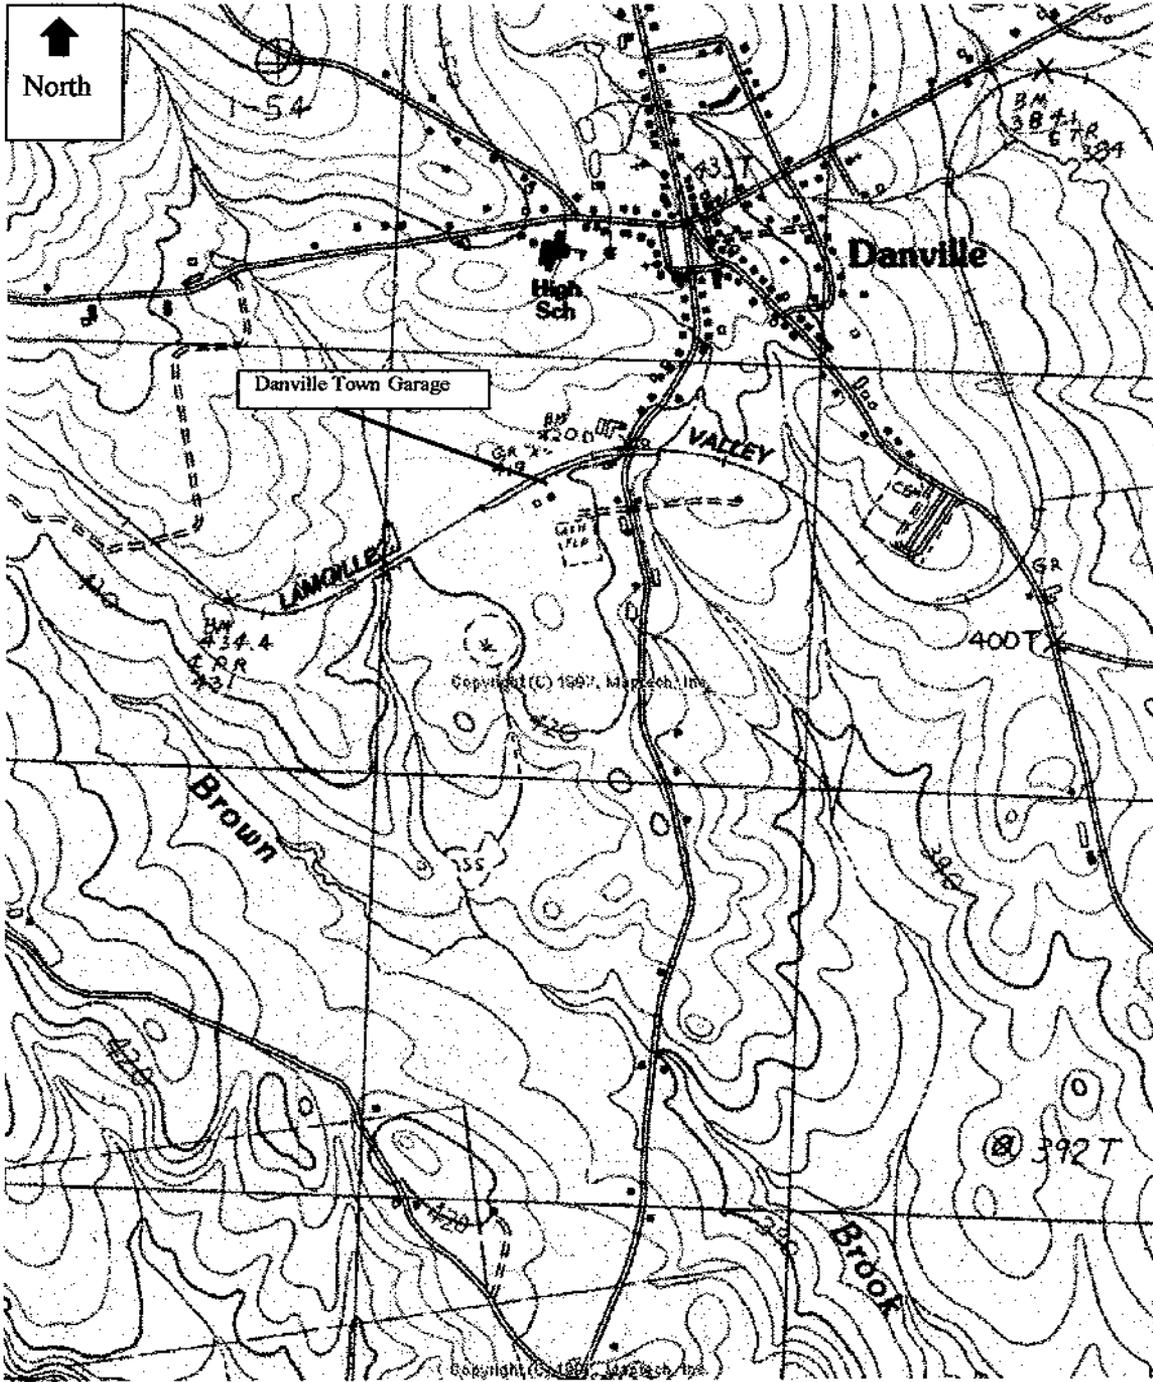
Figure 1
 Site Location Map
 Danville Town Garage
 Danville, Vermont

Scale: 1:25,000
 Source: USGS 1983. St. Johnsbury, VT
 Topographic map, (7.5 x 15 min. series)
 Provisional Edition. 1983. Maptech, Inc.
 R.E.A. Project No. 99-008

The Danville Town Garage is located on Peacham Road, approximately 0.4 miles south of the intersection of Route 2 and Peacham Road (Figure 1, Appendix A). The site encompasses approximately 7 acres, which is occupied by five buildings: a two-bay garage, a four-bay garage, a salt storage shed, and two utility storage sheds. The former USTs were located approximately 50 feet north of the two-bay garage. The former pump-island for the former USTs was situated over the southern end of the tanks. Photographs of the site and surrounding area are included in Appendix B.

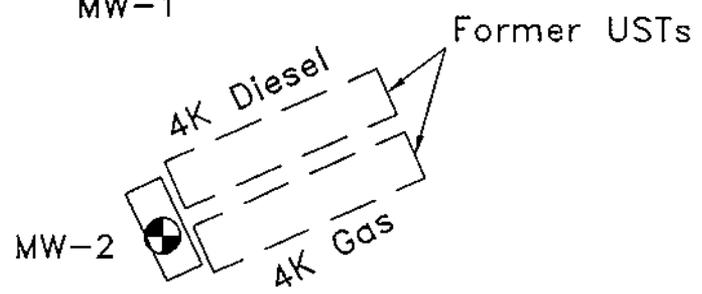
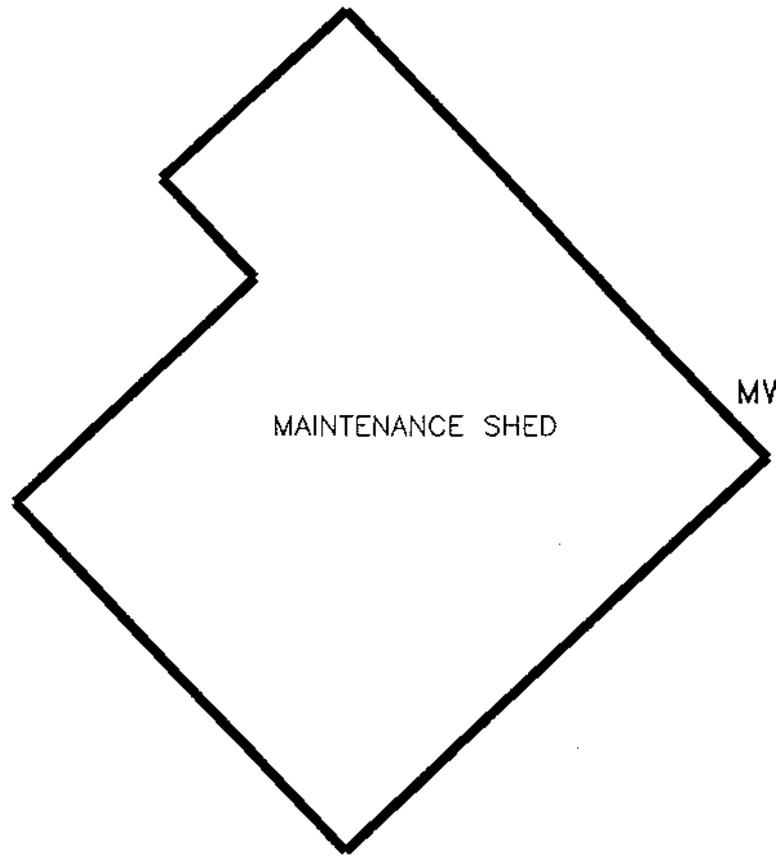
FIGURE 2.
SITE MAP

MW-1

MW-4

MW-3

MAINTENANCE SHED

With Monitoring Well Locations

R.E.A.'s field investigation included: the installation of three soil borings/monitoring wells (MW-1, MW-3, and MW-4); field screening of subsurface soil samples for the possible presence of volatile organic compounds (VOCs); sampling and analysis of ground water from four on-site monitoring wells, including the existing monitoring well (MW-2) installed during the UST closure; and a receptor survey to identify potential risks to the environment and human health. Approximate monitoring well locations and significant site features are shown on Figure 2 in Appendix A.

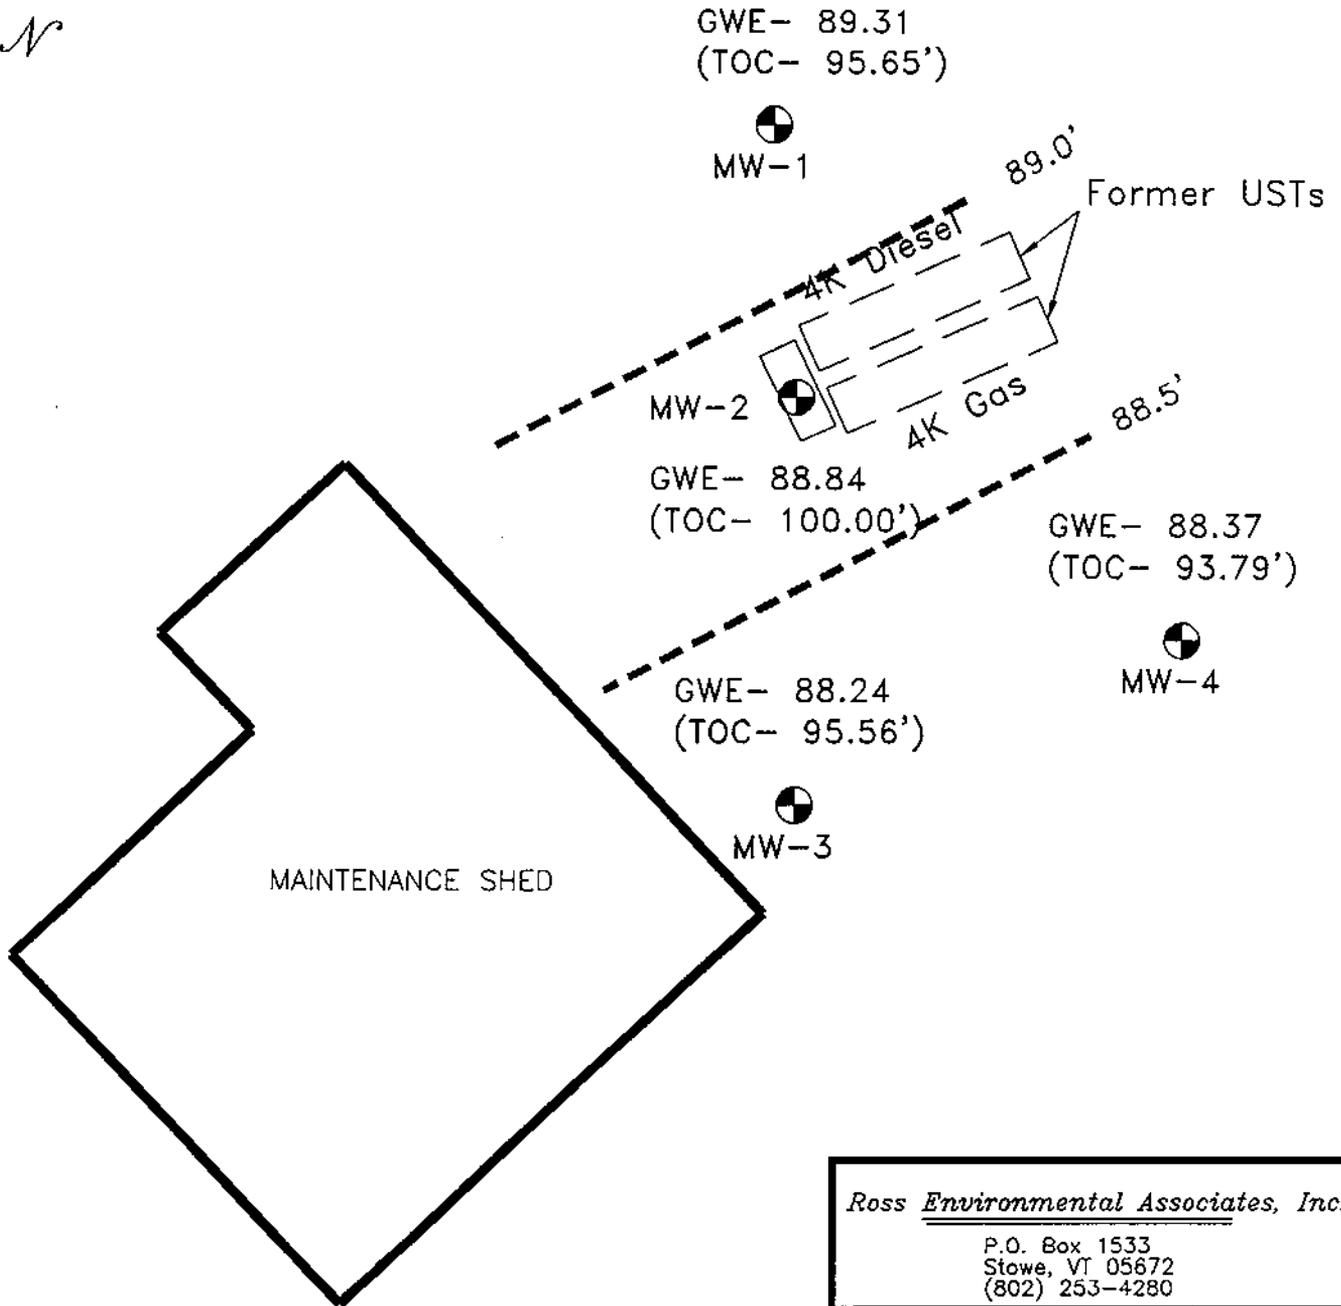
FIGURE 3.
GROUND-WATER CONTOUR MAP
MONITORING DATE: 9 JULY 1996

GROUND-WATER CONTOUR

On 18 March 1999, ground-water flow in the unconfined surficial aquifer at the site was toward the south-southeast, with an estimated hydraulic gradient of approximately 1.5 percent. Water-level measurements and elevation calculations for 18 March 1999 are presented in Table 1 and the ground-water contour map prepared using this data is presented as Figure 3, Appendix A.

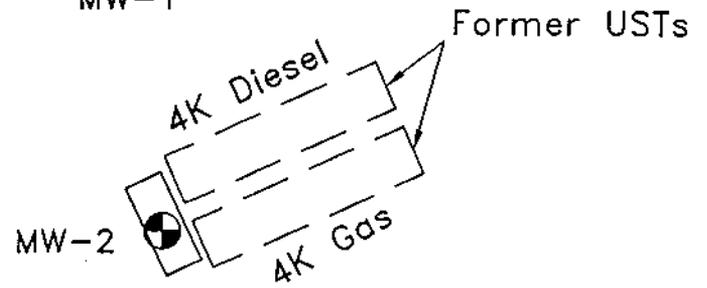
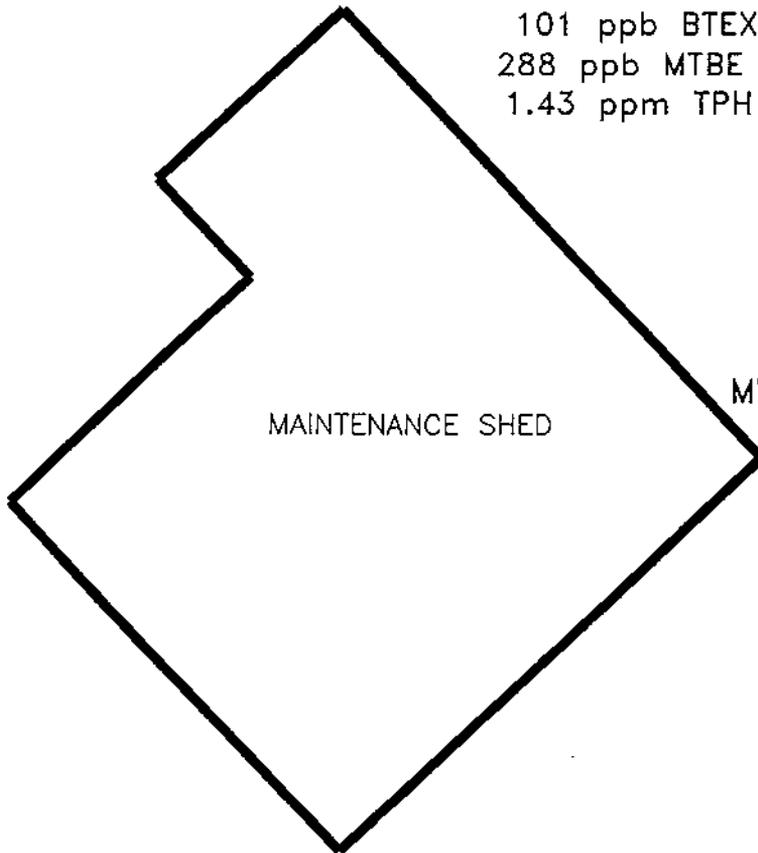
FIGURE 4.
CONTAMINANT DISTRIBUTION MAP
MONITORING DATE: 18 MARCH 1999

2.5 ppb BTEX
ND<2 ppb MTBE
ND<0.10 ppm TPH

101 ppb BTEX
288 ppb MTBE
1.43 ppm TPH

5.4 ppb BTEX
9.3 ppb MTBE
0.14 ppm TPH

25.7 ppb BTEX
ND<2 ppb MTBE
0.13 ppm TPH

- The VGESs for MTBE, benzene, 1,3,5-trimethyl benzene, 1,2,4-trimethyl benzene, and naphthalene were exceeded in the ground water sample collected from MW-2, located in the excavation of the former USTs.
- The VGES for 1,2,4-trimethyl benzene was exceeded in the sample collected from MW-3, which is located approximately 40 feet downgradient of the former USTs.
- No VGESs were exceeded in the upgradient monitoring well (MW-1) or in the downgradient monitoring well (MW-4), located approximately 40 feet east of the former USTs.
- No free-phase gasoline or diesel fuel was observed on the water-table beneath the site.
- The extent of dissolved-phase contamination in the shallow ground water formation has been reasonably well defined and does not appear to have migrated off-site.
- None of the identified receptors are likely to be impacted by petroleum contamination originating from the site.

1. Ground water samples should be collected from the on-site monitoring wells in May 1999 to confirm the findings of the initial sampling event. The samples should be analyzed for the possible presence of volatile organic compounds (VOCs) and total petroleum hydrocarbons (TPH) by U.S. EPA Methods 8021B and 8015B, respectively.

2. Petroleum contaminated soils (PCS) at the former UST location should be removed to reduce the long-term impact to the underlying ground water formation. Excavation and stockpiling of the PCS should be performed in accordance with procedures outlined in the "Agency Guidelines for Petroleum Contaminated Soil and Debris." Vermont Agency of Natural Resources, Waste Management Division. August 1996. At this time, it is estimated that less than 100 cubic yards of PCS will need to be excavated and poly-encapsulated on-site.
3. A summary report should be completed following the completion of the ground water sampling and soil excavation activities.

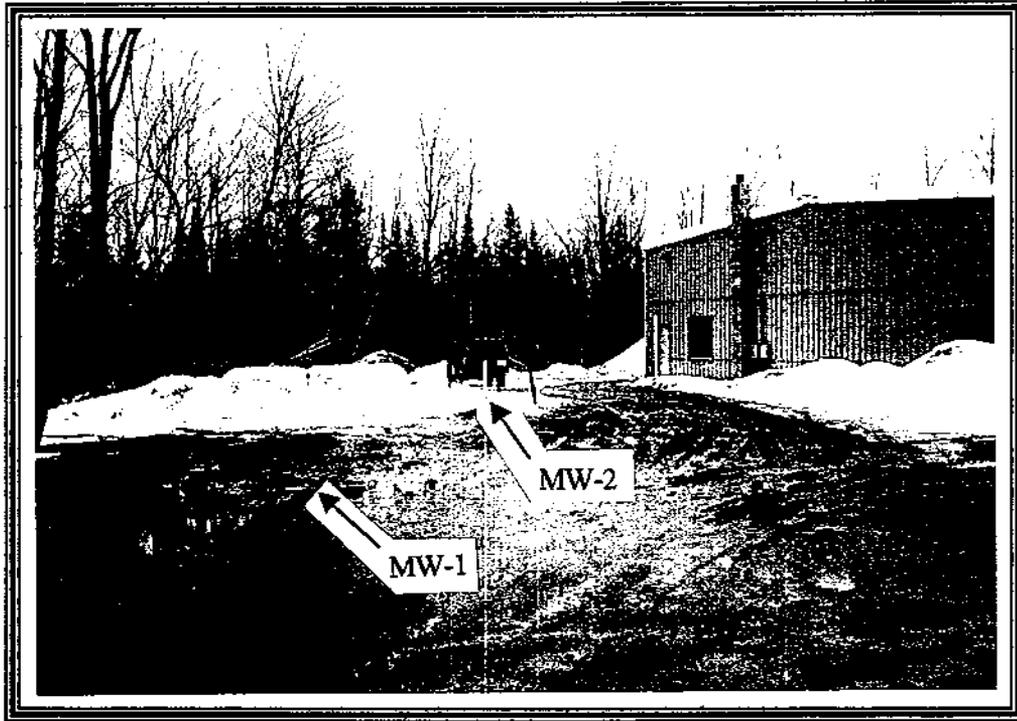
DANVILLE TOWN GARAGE
(Overview Former UST Location - View Toward East)

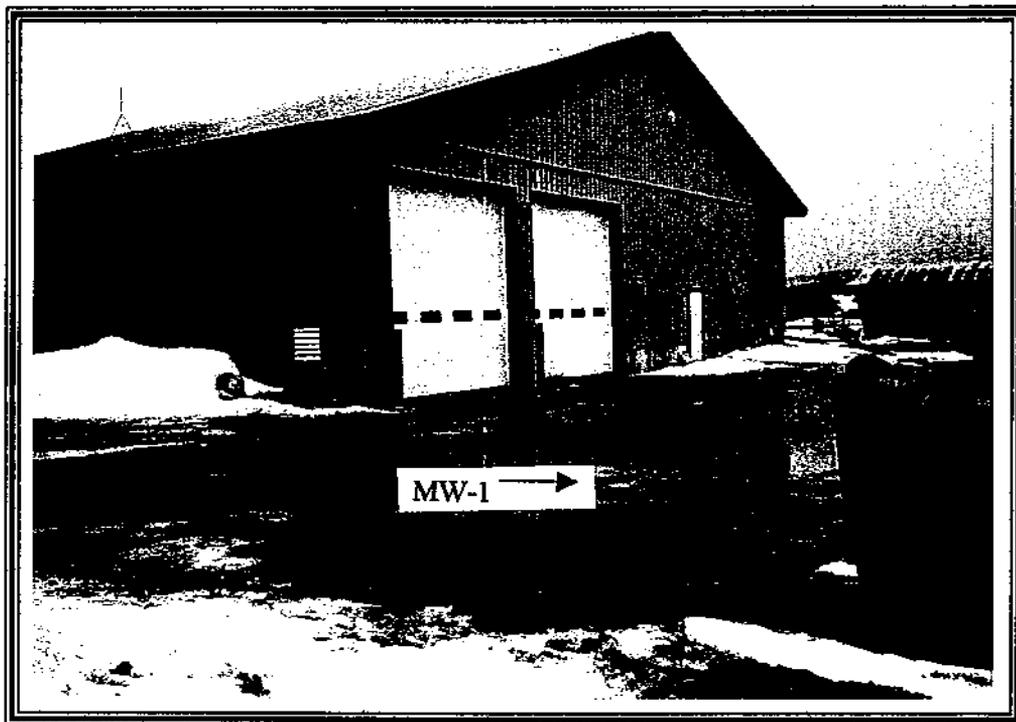
DANVILLE TOWN GARAGE
(MW-1 - View Toward Southwest)

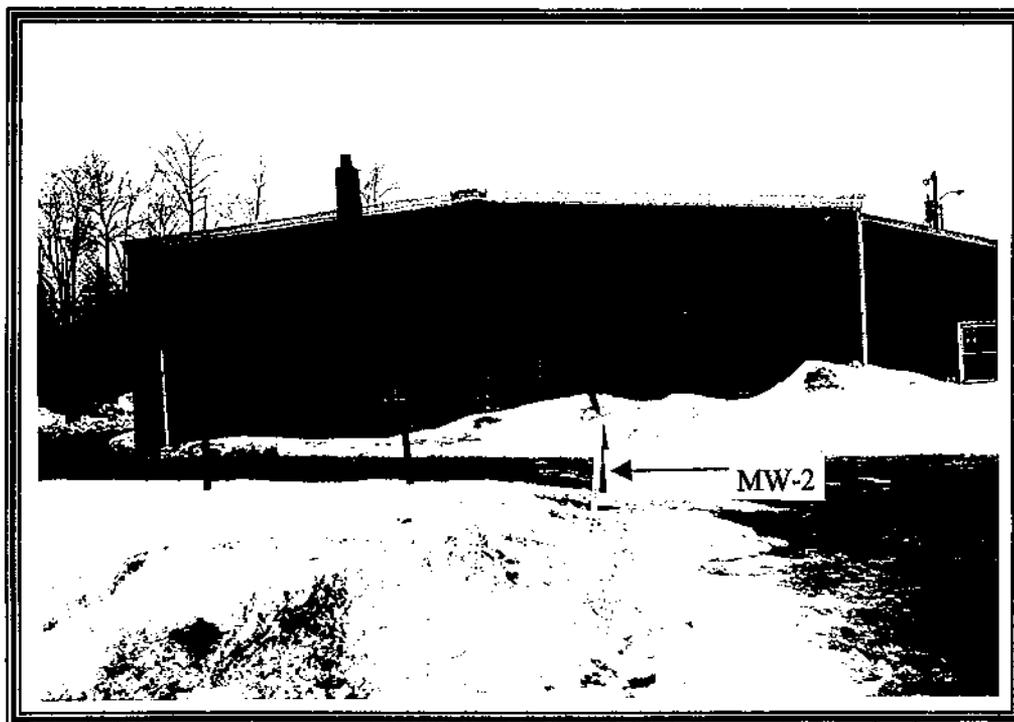
No free-phase petroleum was observed in any of the wells; however, MW-2 exhibited a strong petroleum odor. Static water-table elevations were computed for each monitoring well by subtracting the measured depth-to-water readings from the surveyed top-of-casing (TOC) elevations, which are relative to an arbitrary site datum of 100.00 feet.

DANVILLE TOWN GARAGE
(MW-2 - View Toward South)

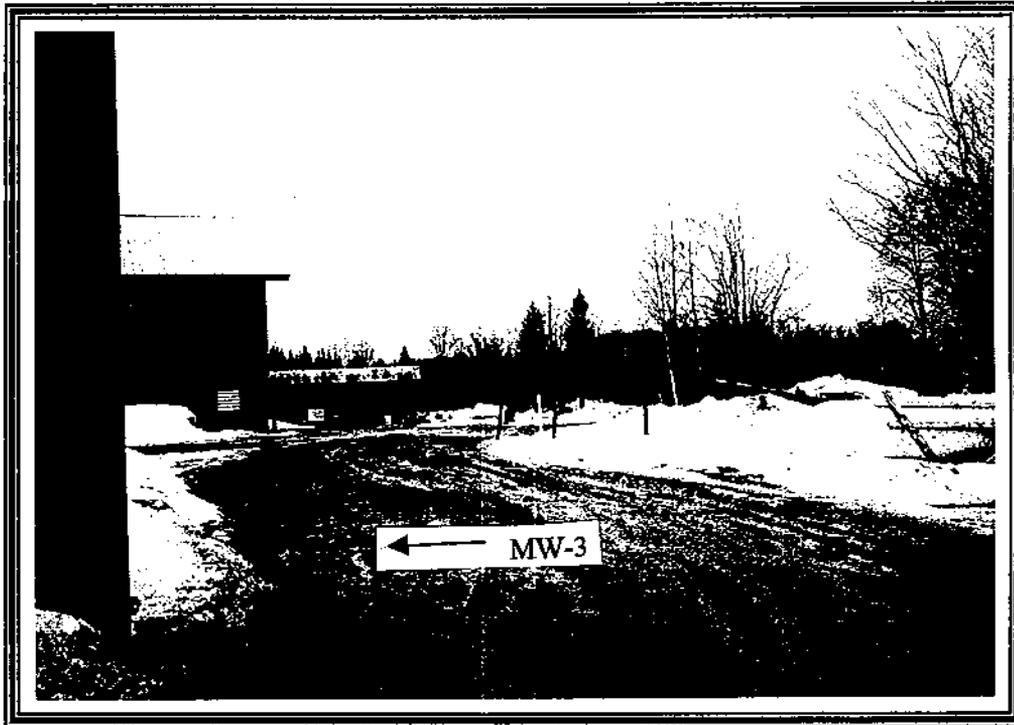
DANVILLE TOWN GARAGE
(MW-3 - View Toward West)
