## **SITE INVESTIGATION REPORT**

**WSYB/WZRT TRANSMITTER SITE  
250 DORR DRIVE  
RUTLAND, VERMONT 05701**

**EPS PROJECT NO. V1919**

**DATE ISSUED: NOVEMBER, 1999**

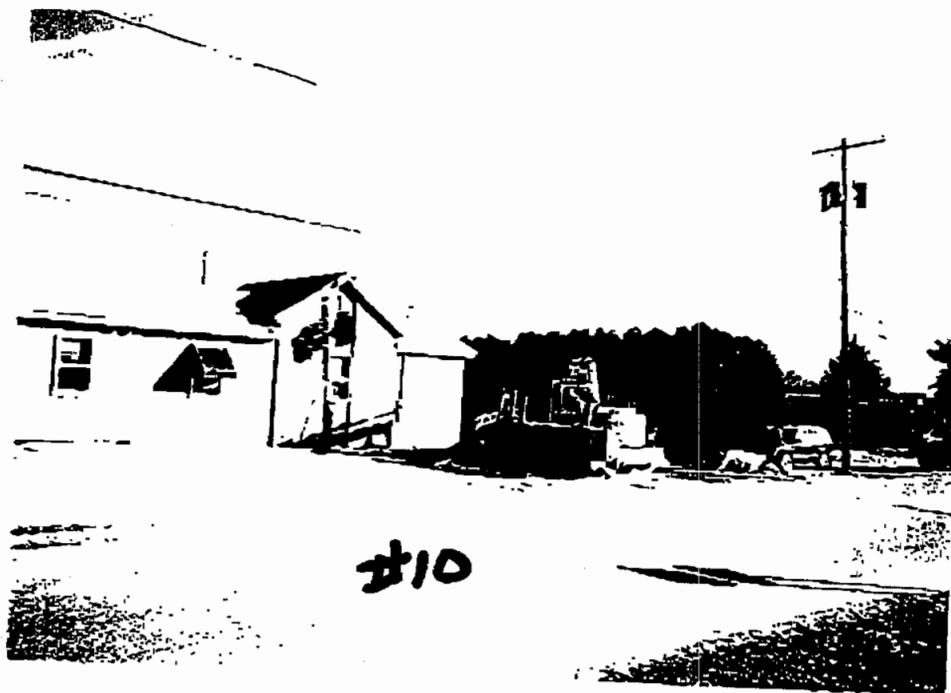
This tank was located approximately 4' from the building housing the generator, approximately 50' off of Dorr Drive, and 500 yards from the Otter Creek River. The tank was situated under asphalt with a concrete pad above the tank which housed the manholes for the fill pipe, fuel supply piping, and the cathodic protection test wire (see photo's #1, #2 & #3). The tank was covered with peastone to a depth of approximately 2.5' to 3', with the surrounding soils being clay which went to the limits of the tank and an approximate depth of 5.5'. Groundwater was encountered at a depth of approximately 5' with a trace amount of free phase product observed on the water (see photo's #4, #5 & #6). Soils were screened for petroleum contamination using a PID and using the zero head space method. PID readings and soil samples were taken from the sides and ends of the excavation with PID results being a high of 162 parts to a low of 62 parts. Due to the level of contamination identified in the soil and the groundwater, the State of Vermont was notified (Mr. Ted Unkles) at which time Mr. Unkles requested that all soil be placed back in the excavation. Some visual signs of stained soils were observed on the eastern side of the tank. The tank and piping upon inspection were in excellent condition with no visual holes and/or signs of leaks (see photo's #7-#10).
