# SPOILS MANAGEMENT PLAN

## BENNINGTON PFOA REMEDIATION TRENCH SPOILS DISPOSAL SITES

MS&K, Inc.  
P.O. Box 139  
Bennington, VT 05201

October 17, 2017

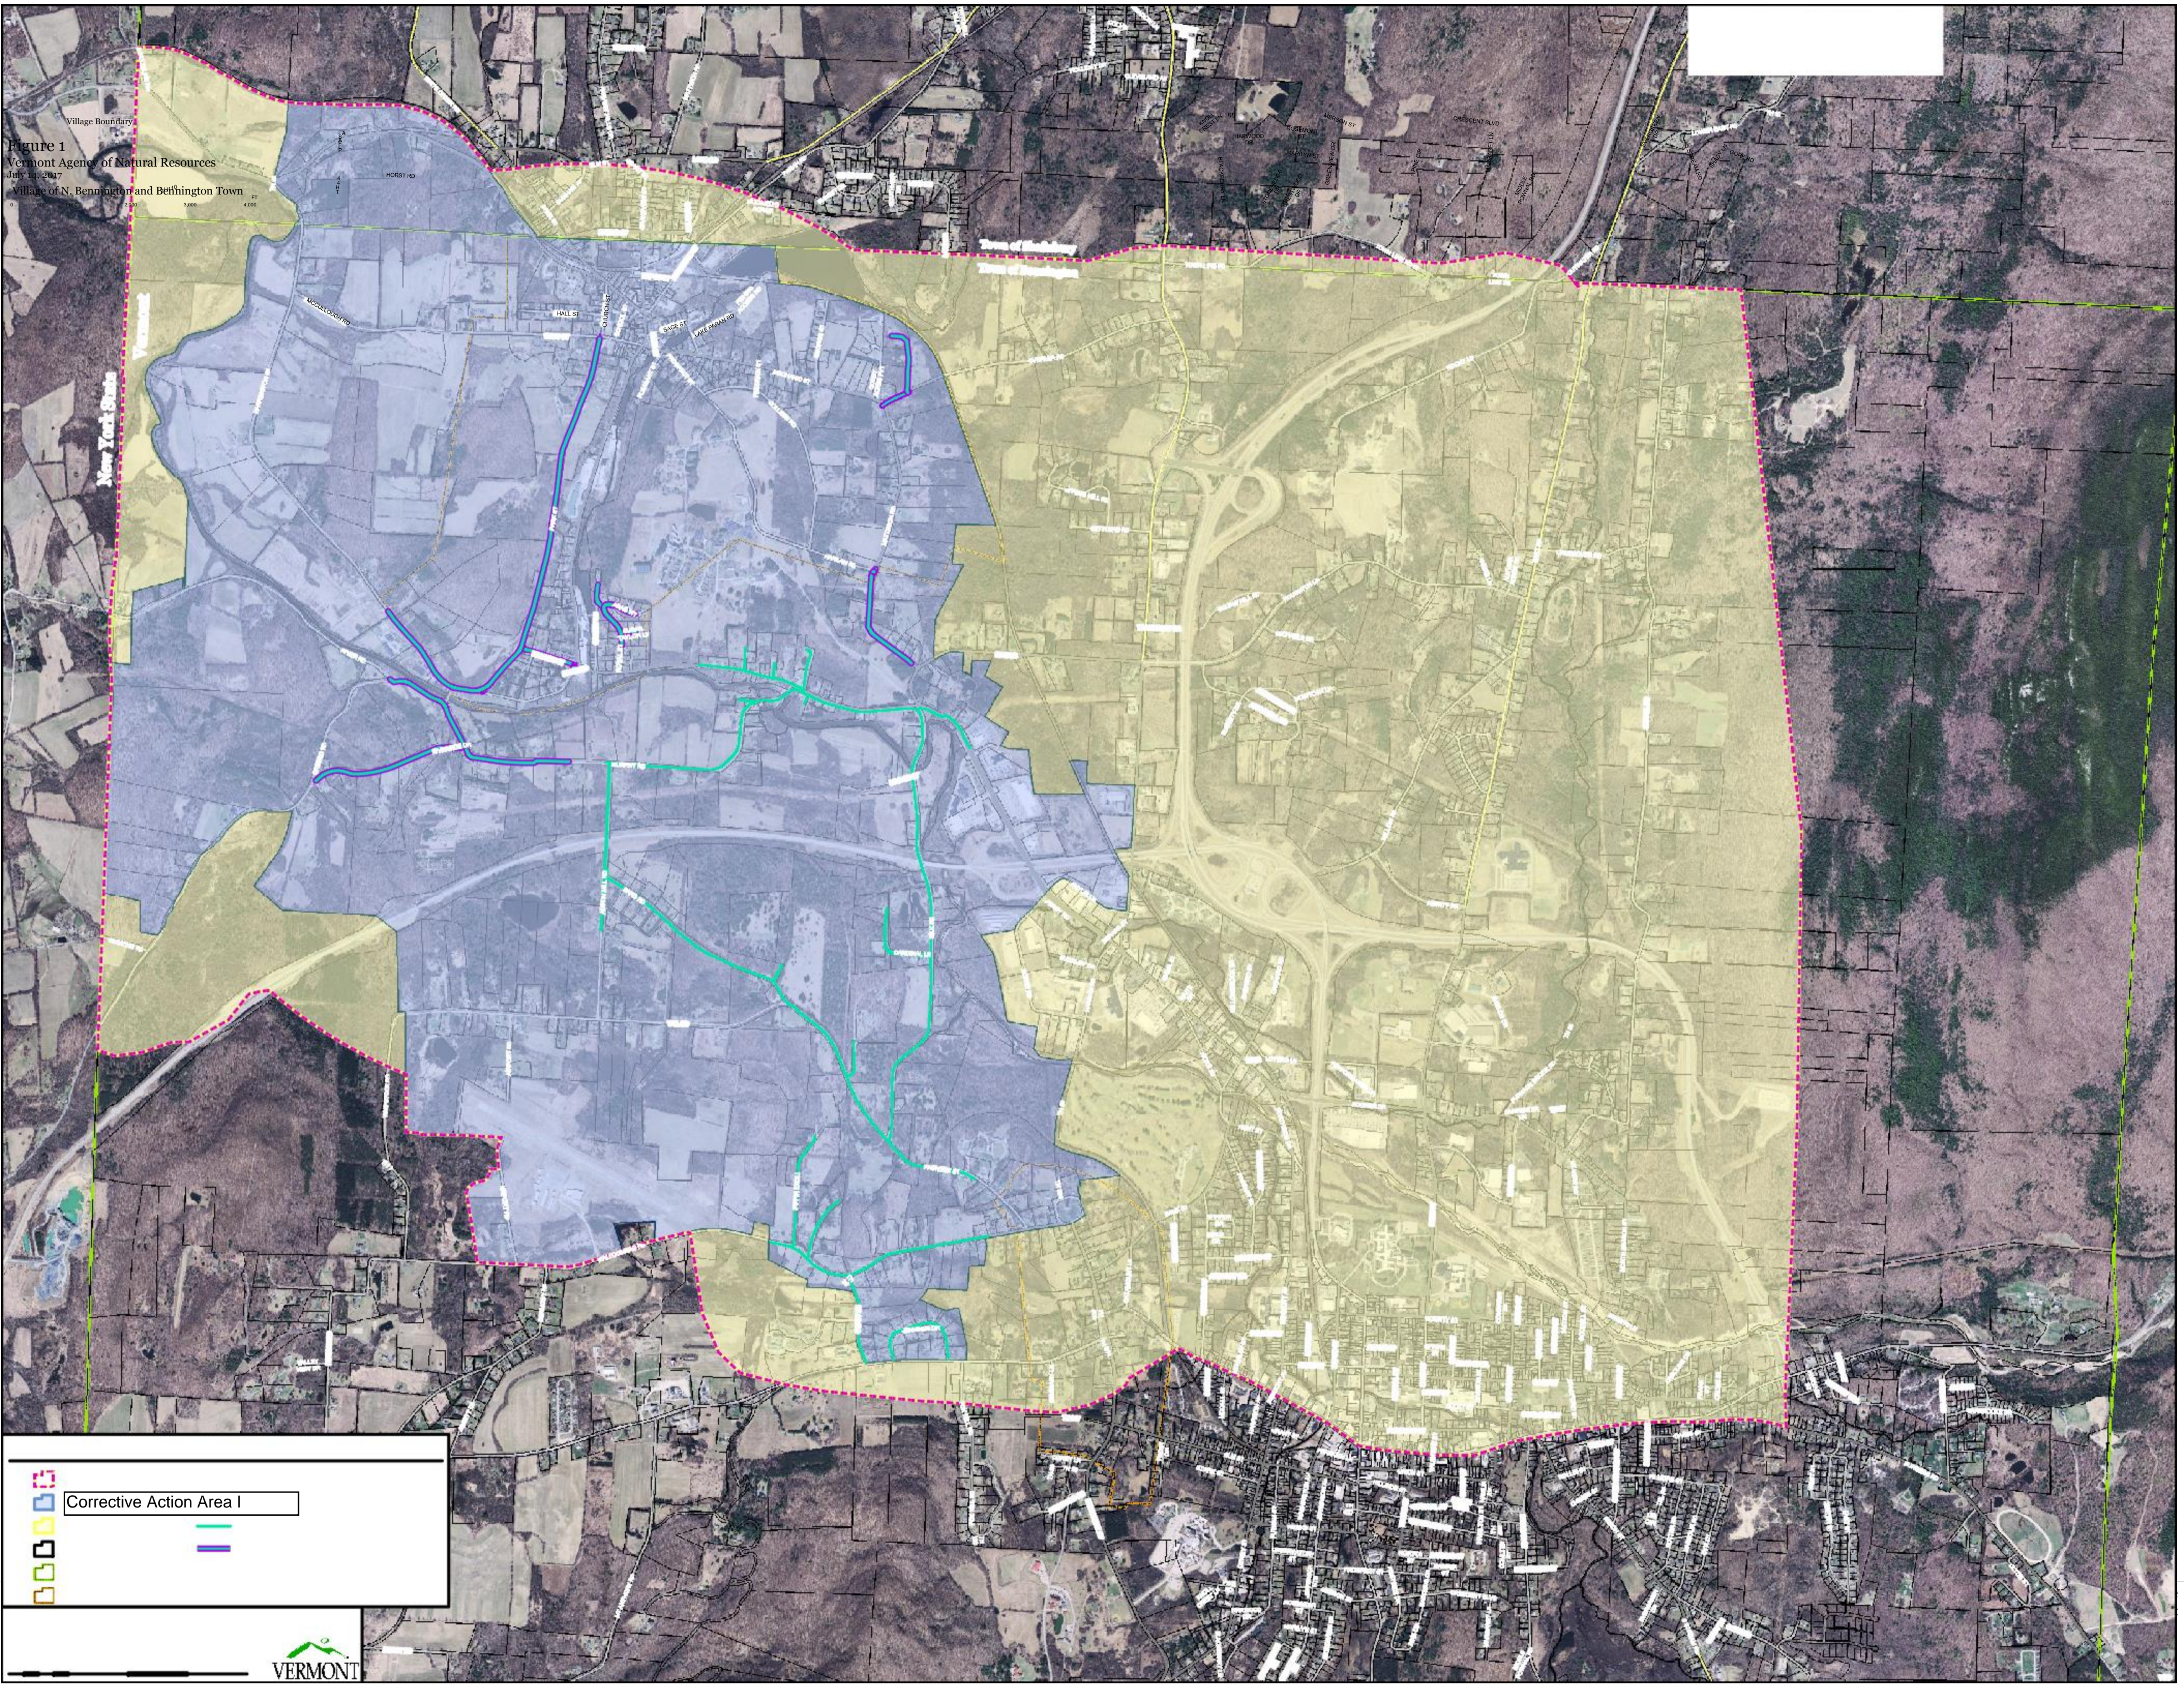
Figure 1  
Vermont Agency of Natural Resources  
July 14, 2017  
Village of N. Bennington and Bennington Town

APPENDIX A  
CORRECTIVE ACTION AREA I

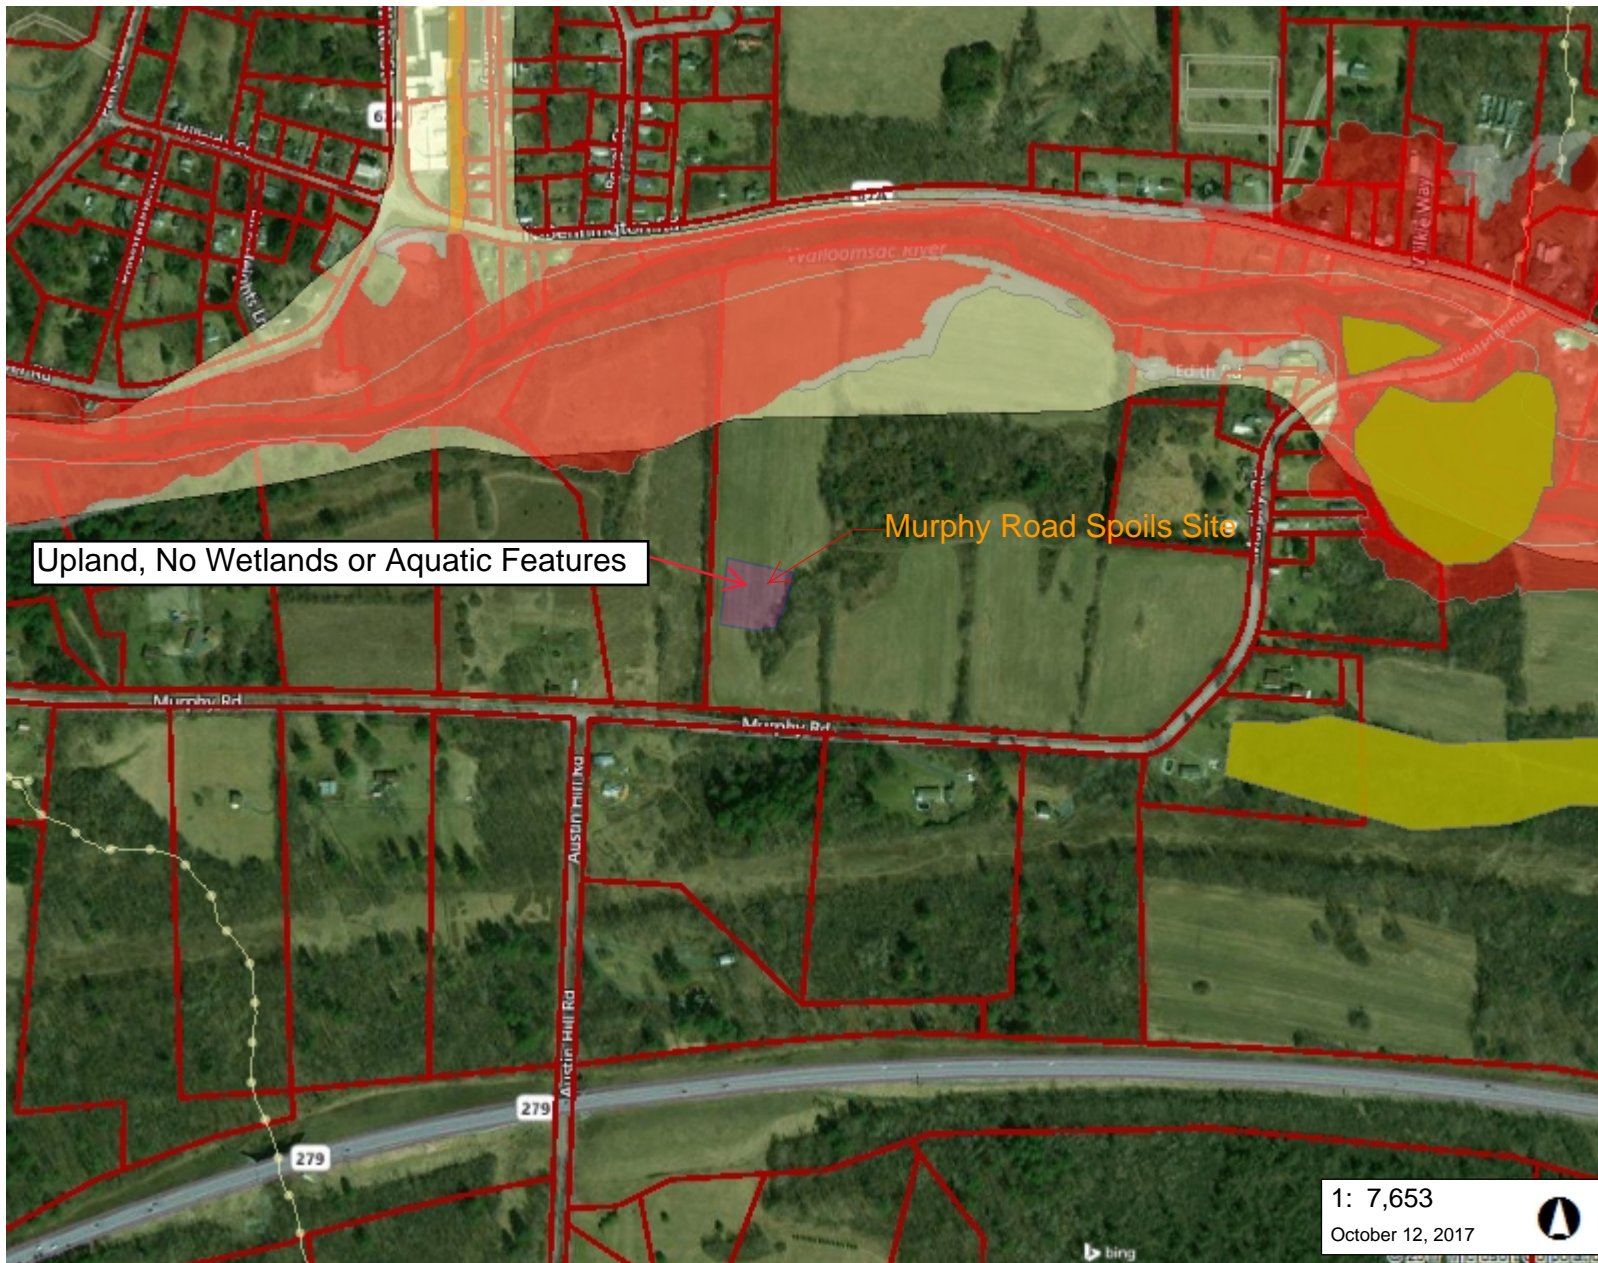
Murphy Road Spoils Site

Upland, No Wetlands or Aquatic Features

A qualified environmental scientist assessed the site for potential state and federal wetlands utilizing the methodology set forth in the U.S. Army Corps Federal Manual for Identifying and Delineating Jurisdictional Wetlands, as amended, and in supplemental guidance documents. No hydrophytic vegetation, hydric soils, nor hydrological features were found at the proposed site. No Class I, II, III, or federal wetlands were found at this proposed spoils site. Streams and other aquatic features were not found at the proposed site. Drainage from this site is from the east to the northwest.

Topography slopes gently down to the northwest with a slope mapped between 8% and 15%. NRCS has mapped this site to include the Galway-Nellis-Farmington complex, 8 to 15% percent slopes, rocky (12.5% of the proposed site), and the Stockbridge loam, 8 to 15% percent slopes (87.5% of proposed site) (Appendix B). Erosion potential is slight for 87.5% of the proposed area with an increase to moderate for approximately 12.5% of the site.

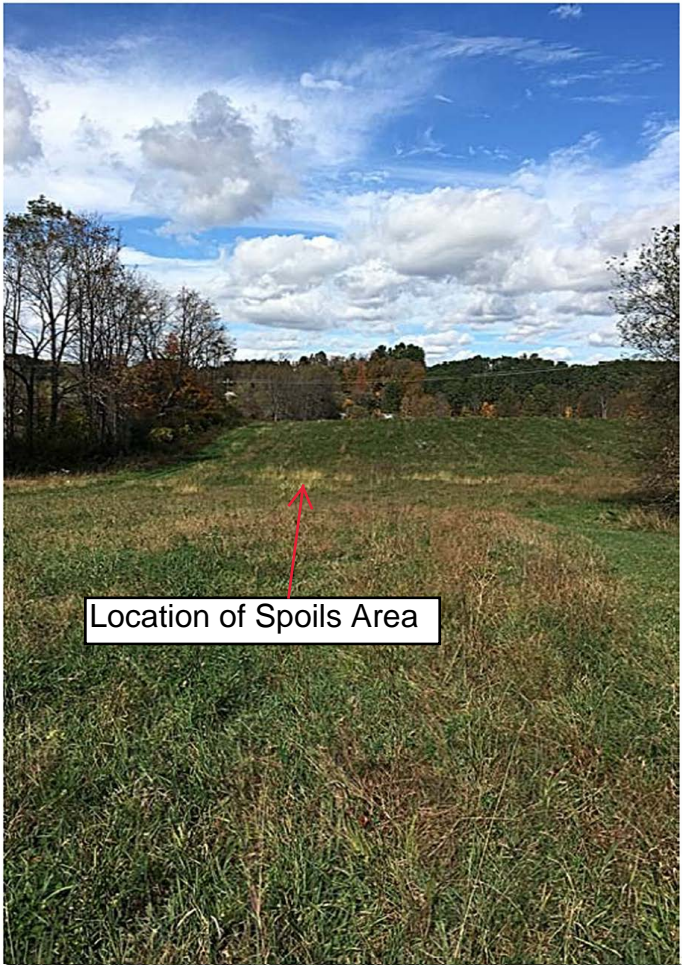
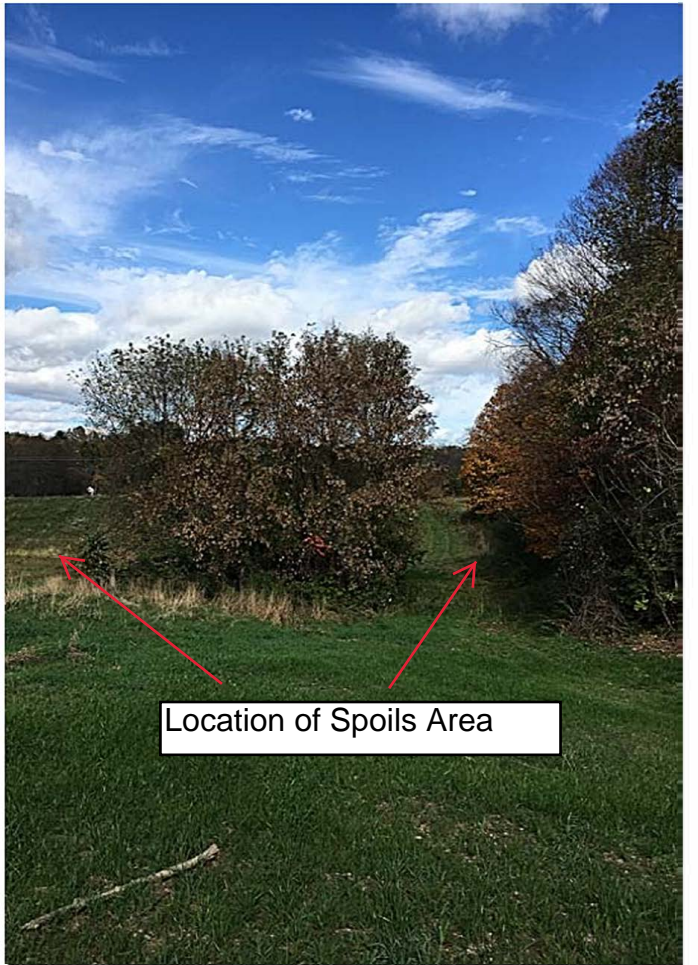
Murphy Road Spoils Site

Location of Spoils Area

View to a northerly direction

The majority of this spoils site has been mowed and is primarily vegetated with field and meadow grasses with a small (1/2 acre) area of forested area to be removed (approximately 15-20 trees).

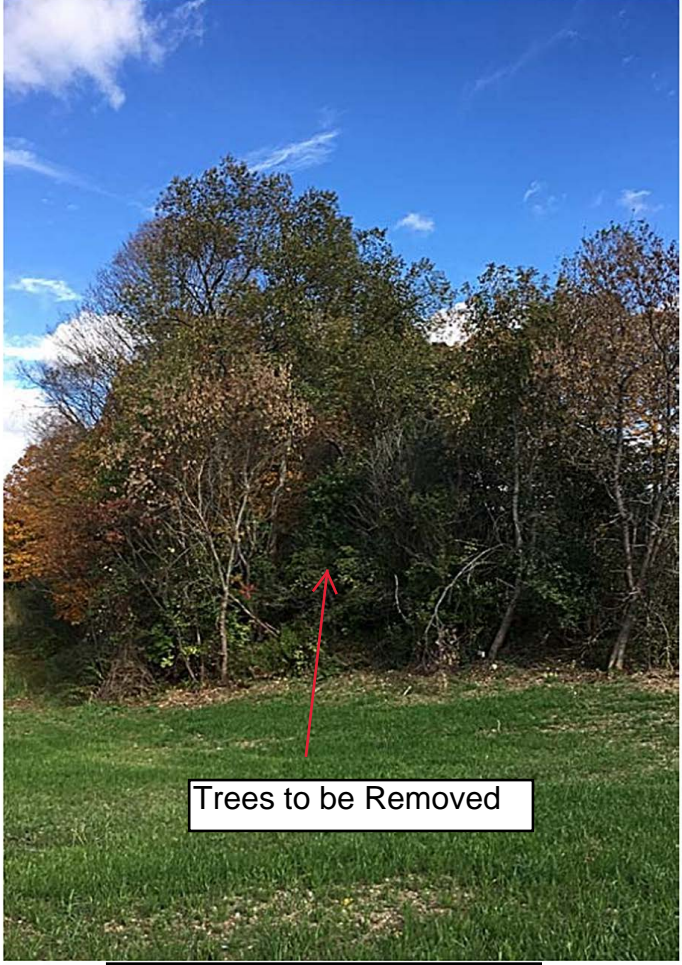
Trees to be Removed

View to a northerly direction

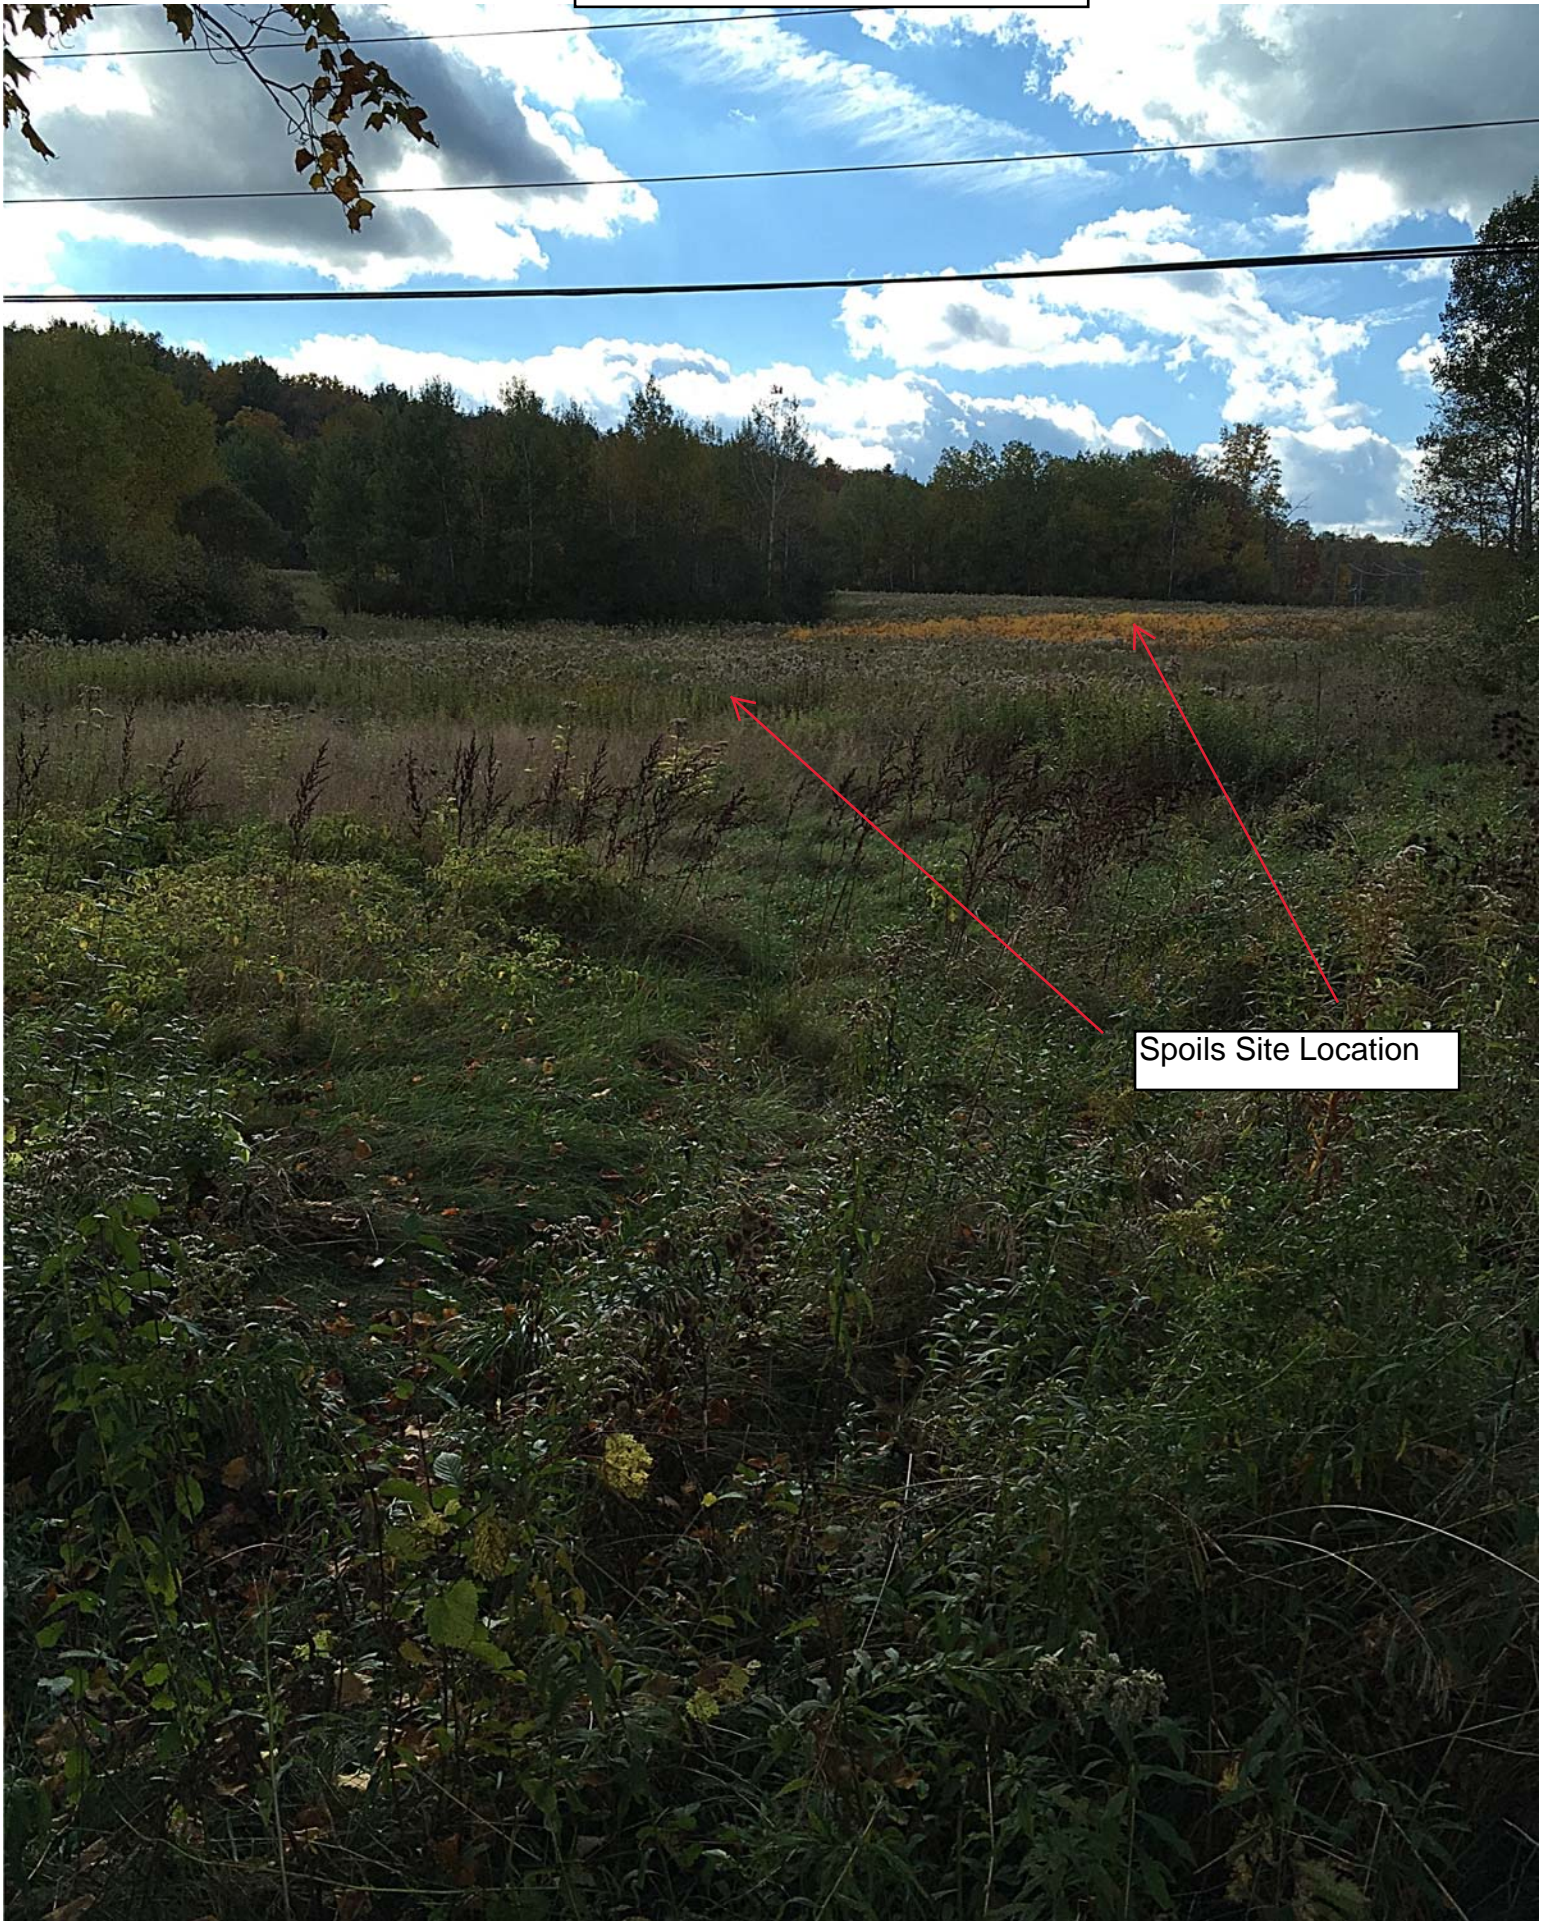
Silk-Bridge Roads Spoils Site

Spoils Site Location

View to a westerly direction

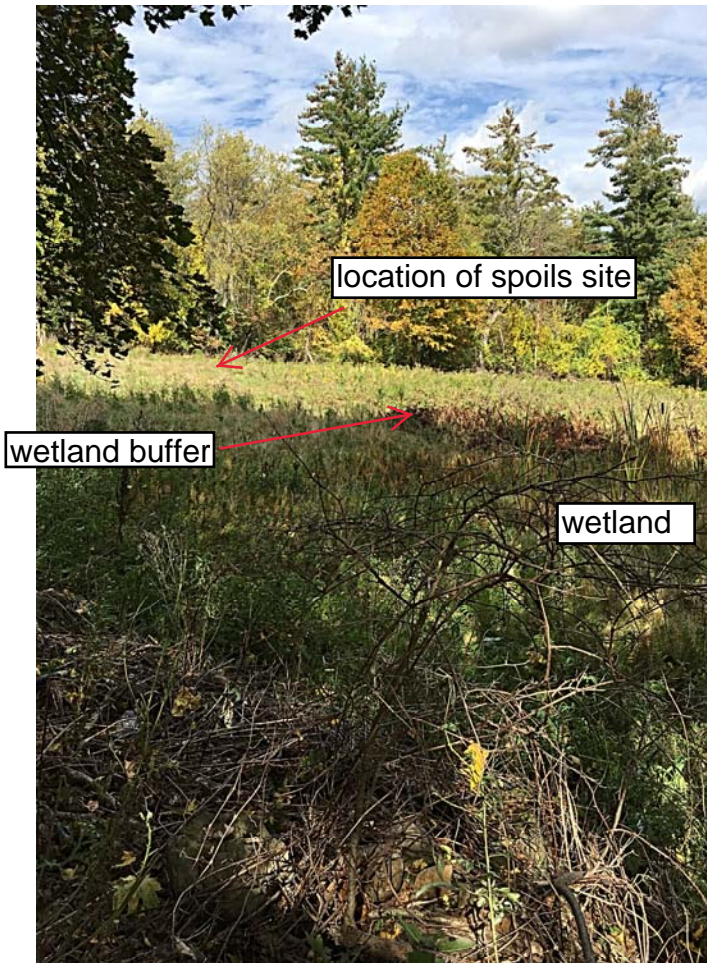
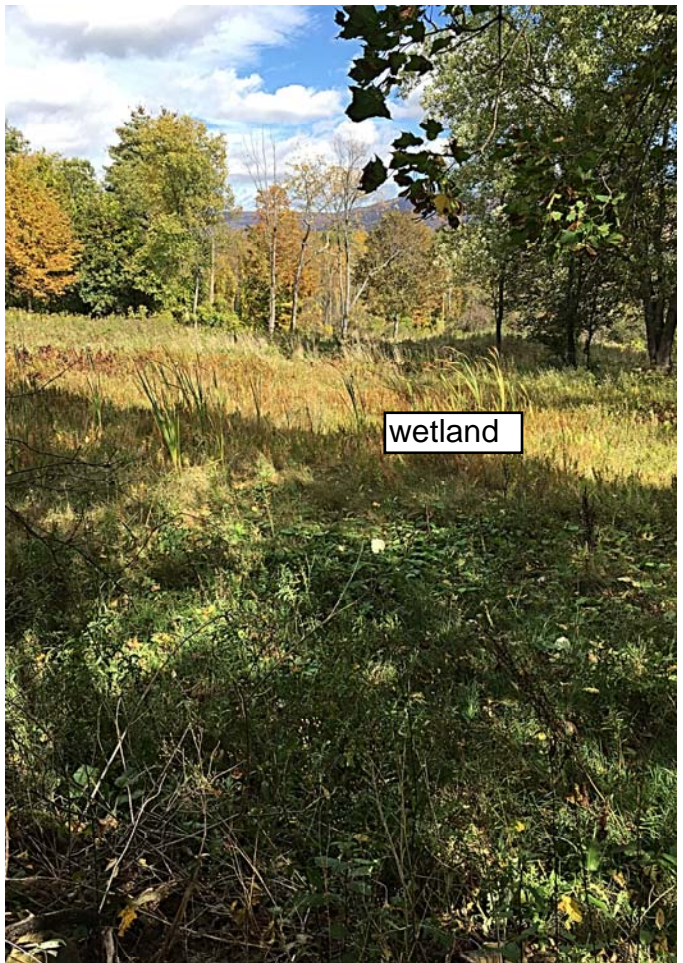
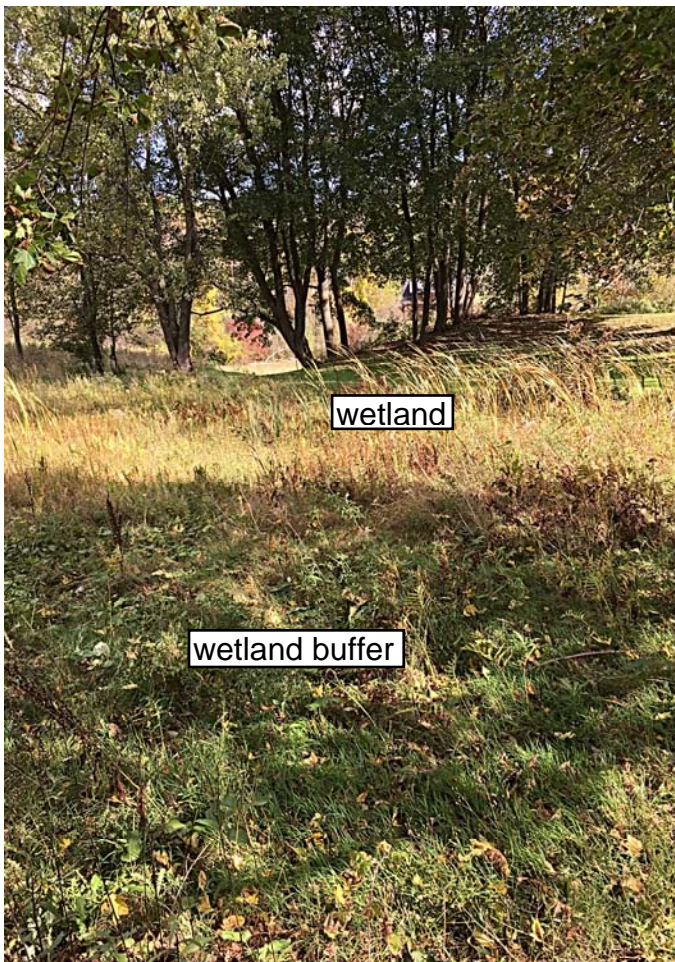
Vail Road Spoils Site

View to a northwesterly direction

View to a northeasterly direction

View to an easterly direction

The majority of this spoils site is primarily vegetated with field and meadow grasses and herbaceous material indicative of upland areas. A federal jurisdictional emergent wetland exists immediately southeast of the proposed spoils area.

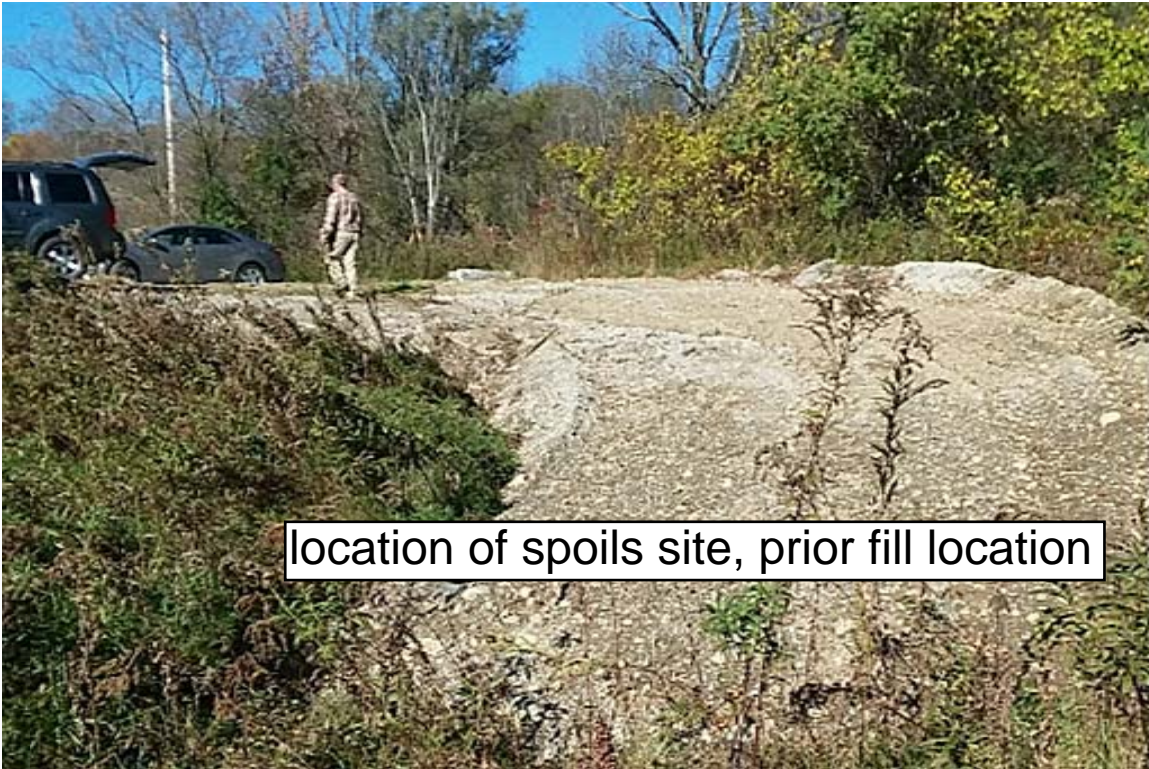
## Harrington Road Spoils Site

location of spoils site, prior fill location

View to a northwesterly direction

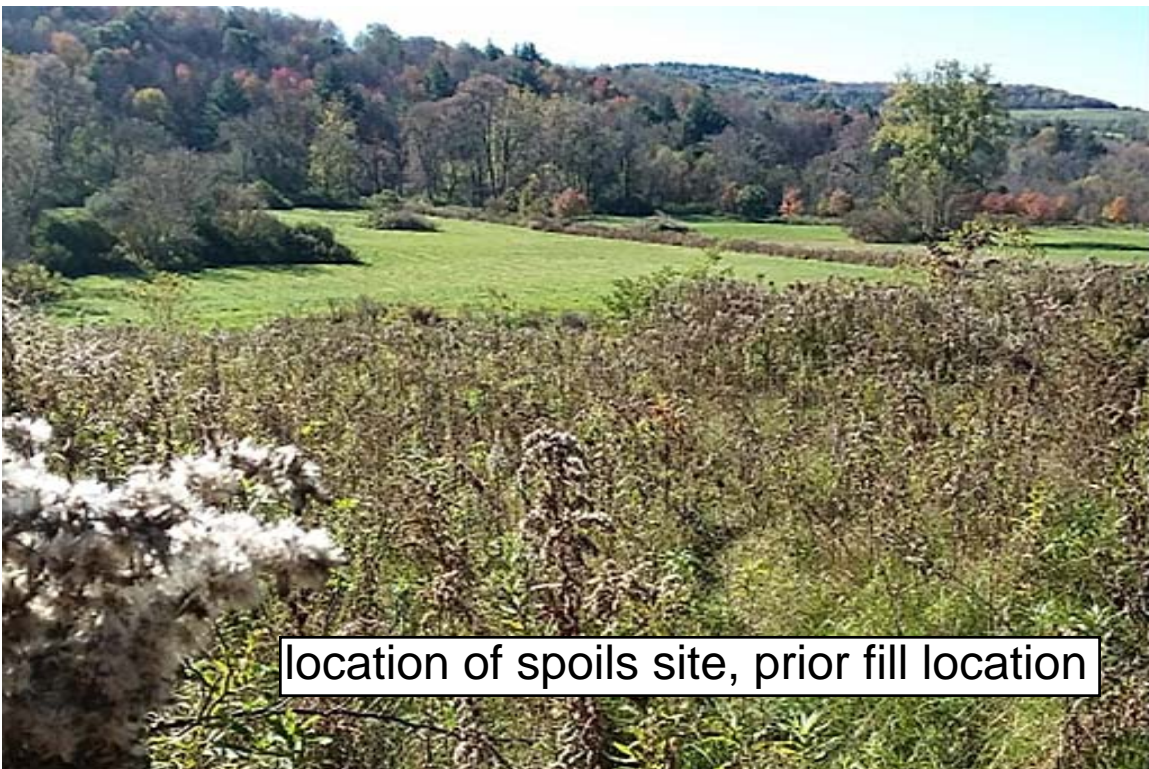
location of spoils site, prior fill location

View to a southwesterly direction. Mowed area contains the 100 year floodplain.

The majority of this spoils site is primarily vegetated with field and meadow grasses and herbaceous material indicative of upland areas. The 100 year floodplain for the Walloomsac River exists downslope of this spoils site separated by a 100 ft. buffer.

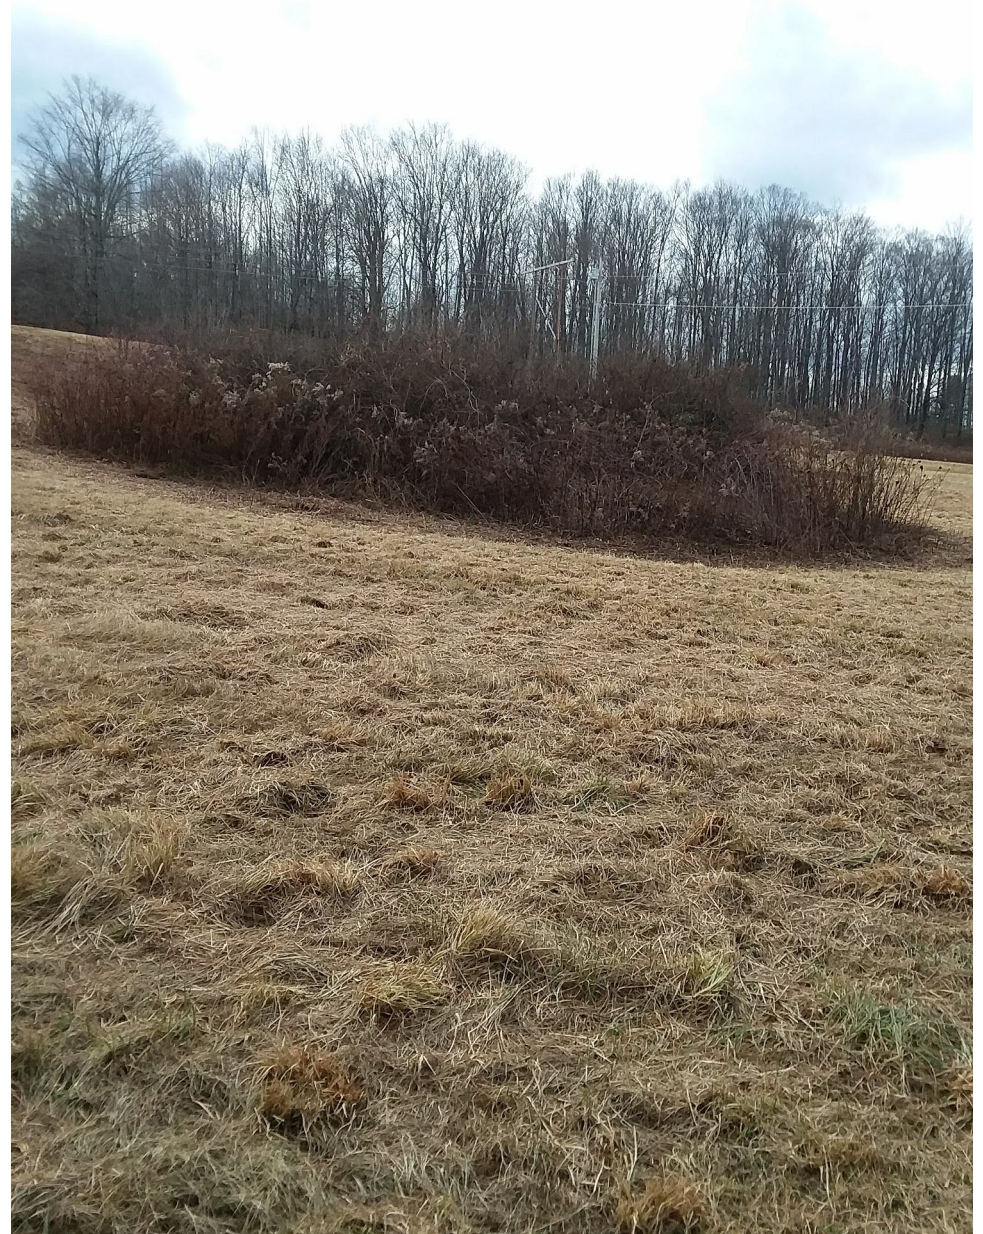
**Spoils Site, Riverside Drive, Photo 1**

View looking southeast to northwest where spoils would be placed.

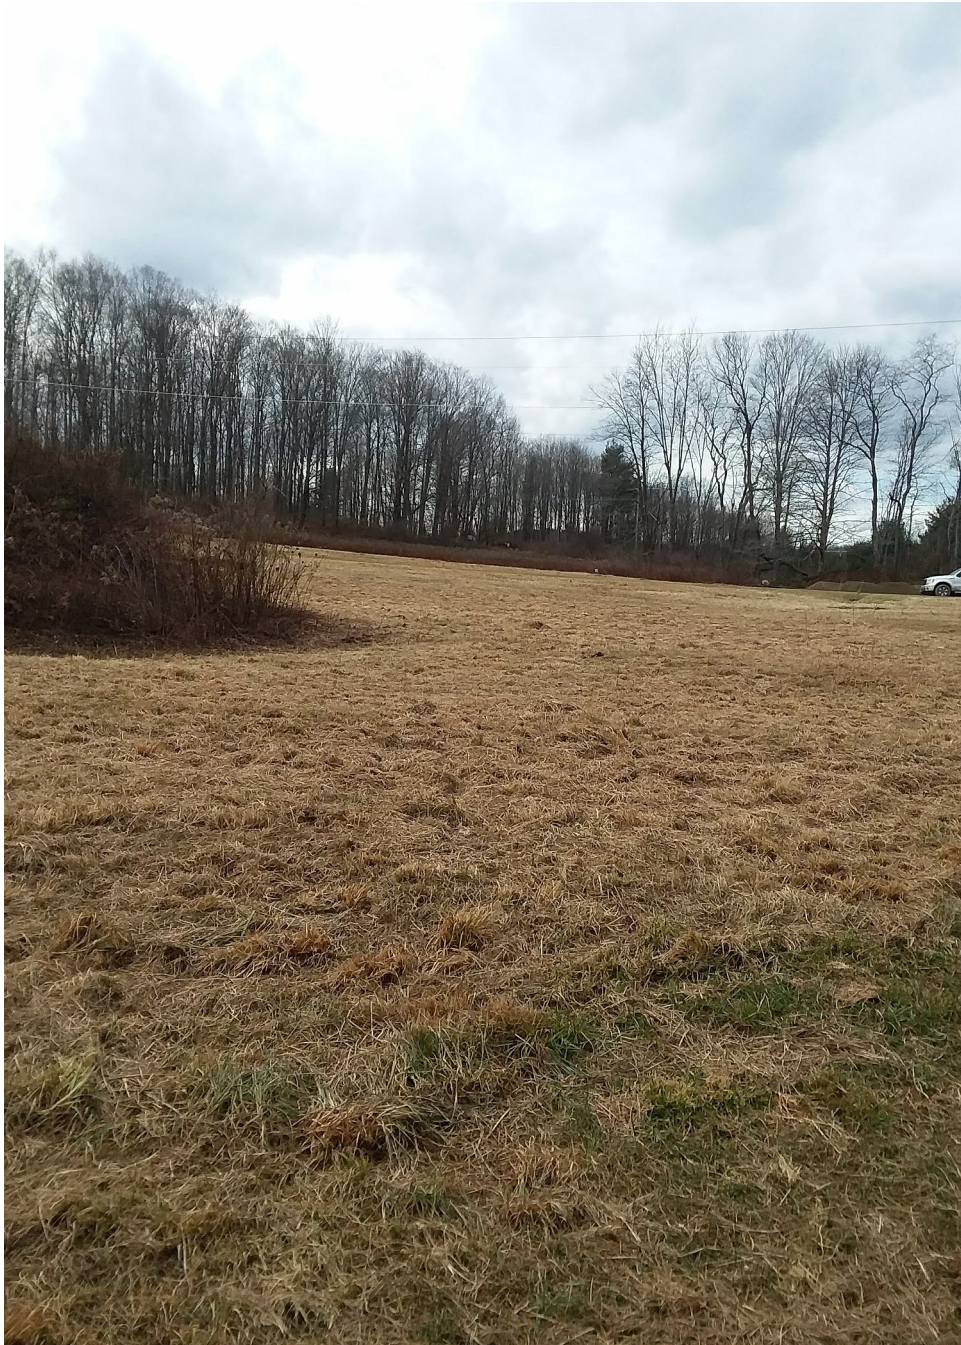
**Spoils Site, Riverside Drive, Photo 2**

View looking southeast to northwest where spoils would be placed.

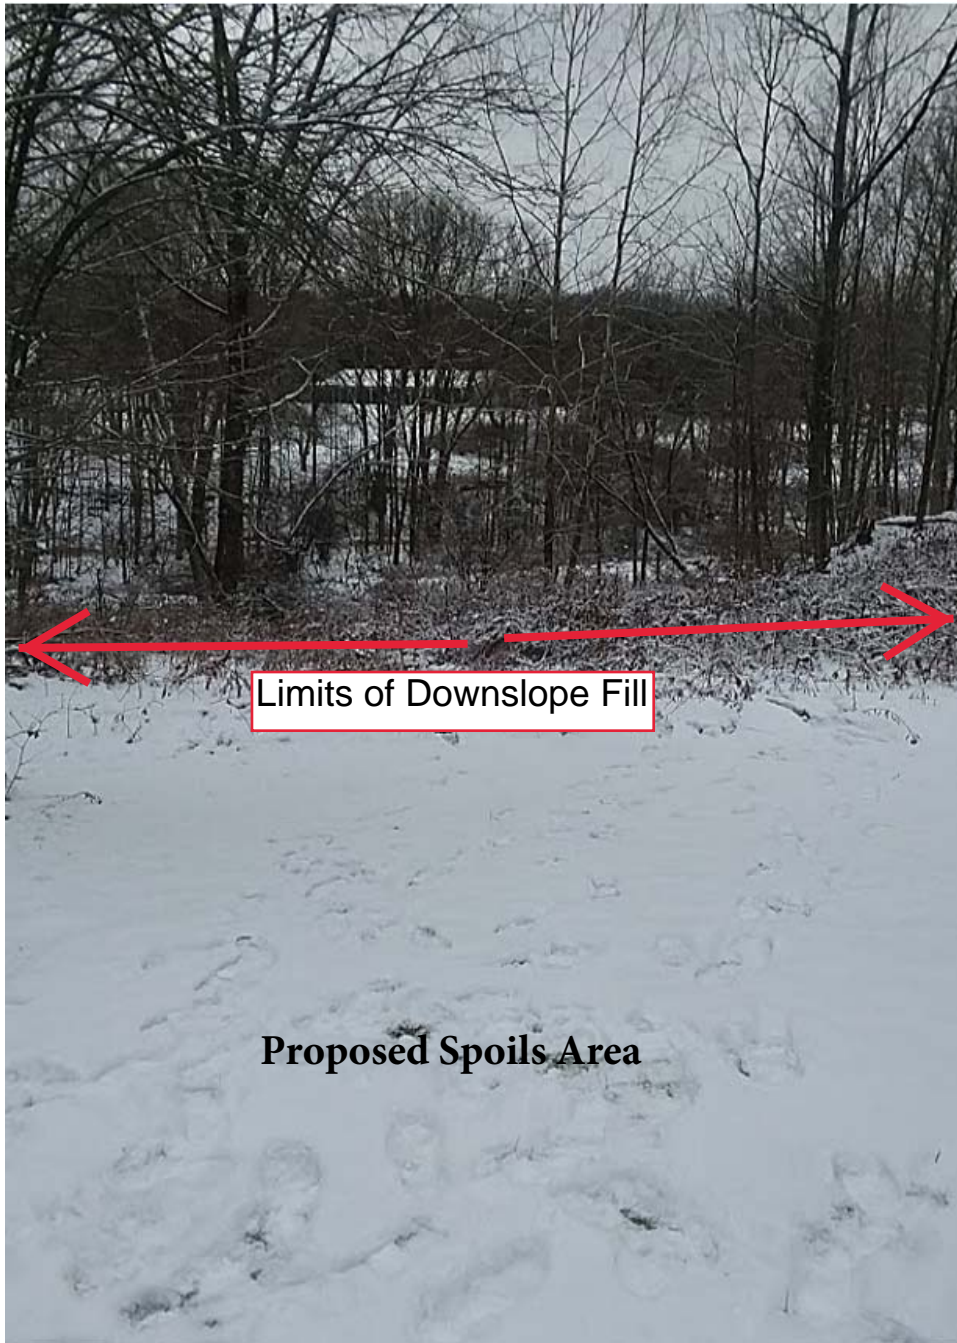
**Proposed Spoils Area**

View from Riverside Drive looking southeast.

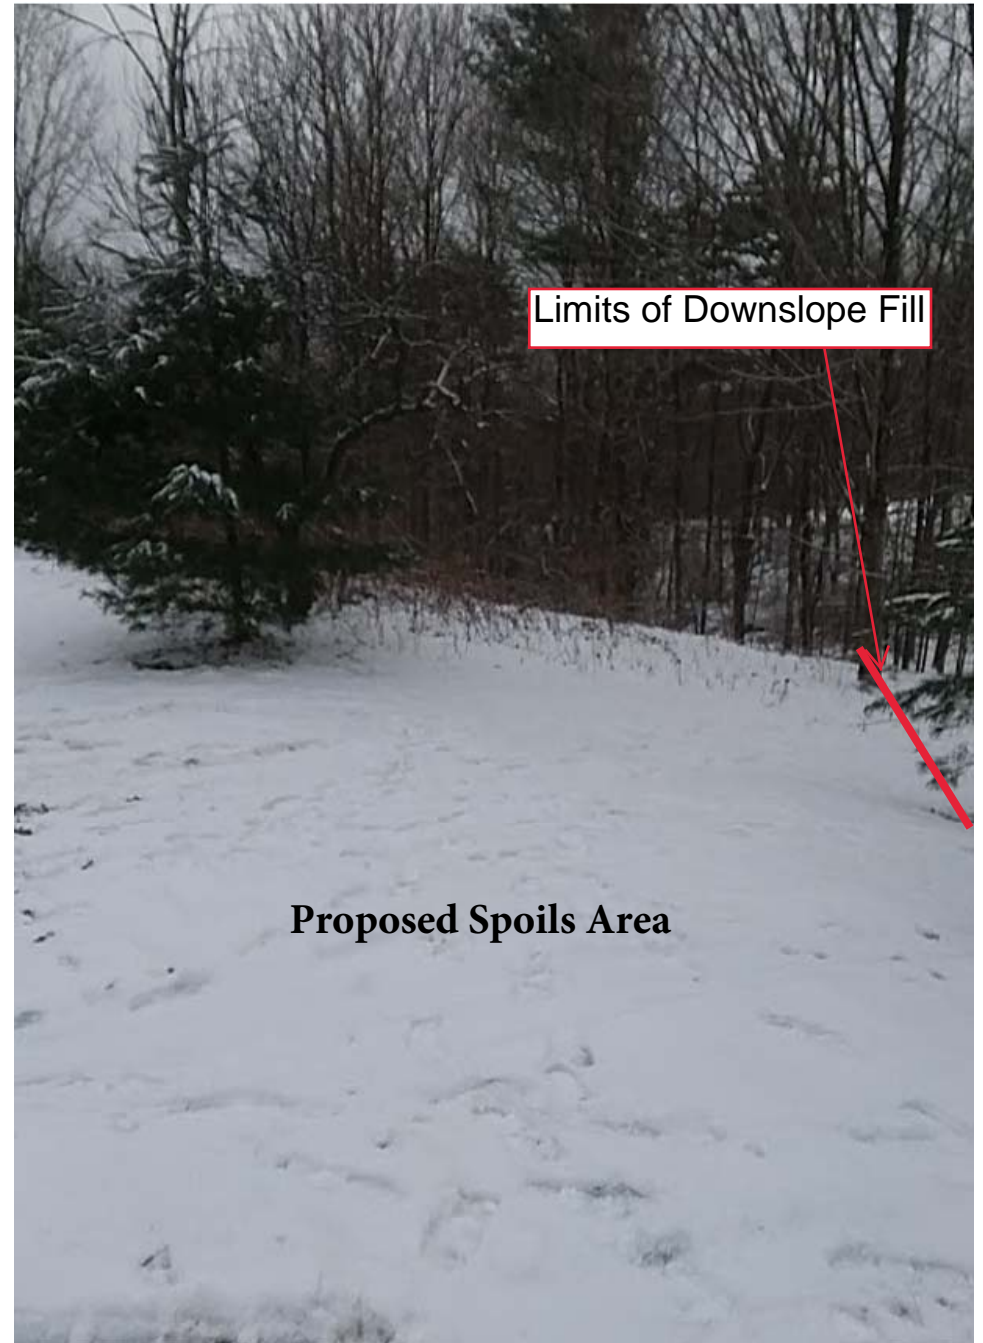
**Proposed Spoils Area**

View to the east.
