SPOILS MANAGEMENT PLAN

BENNINGTON PFOA REMEDIATION TRENCH SPOILS DISPOSAL SITES

MS&K, Inc.
P.O. Box 139
Bennington, VT 05201

SPOILS MANAGEMENT PLAN
BENNINGTON NW EXTENSION PFOA REMEDIATION TRENCH SPOILS DISPOSAL SITES
TABLE OF CONTENTS

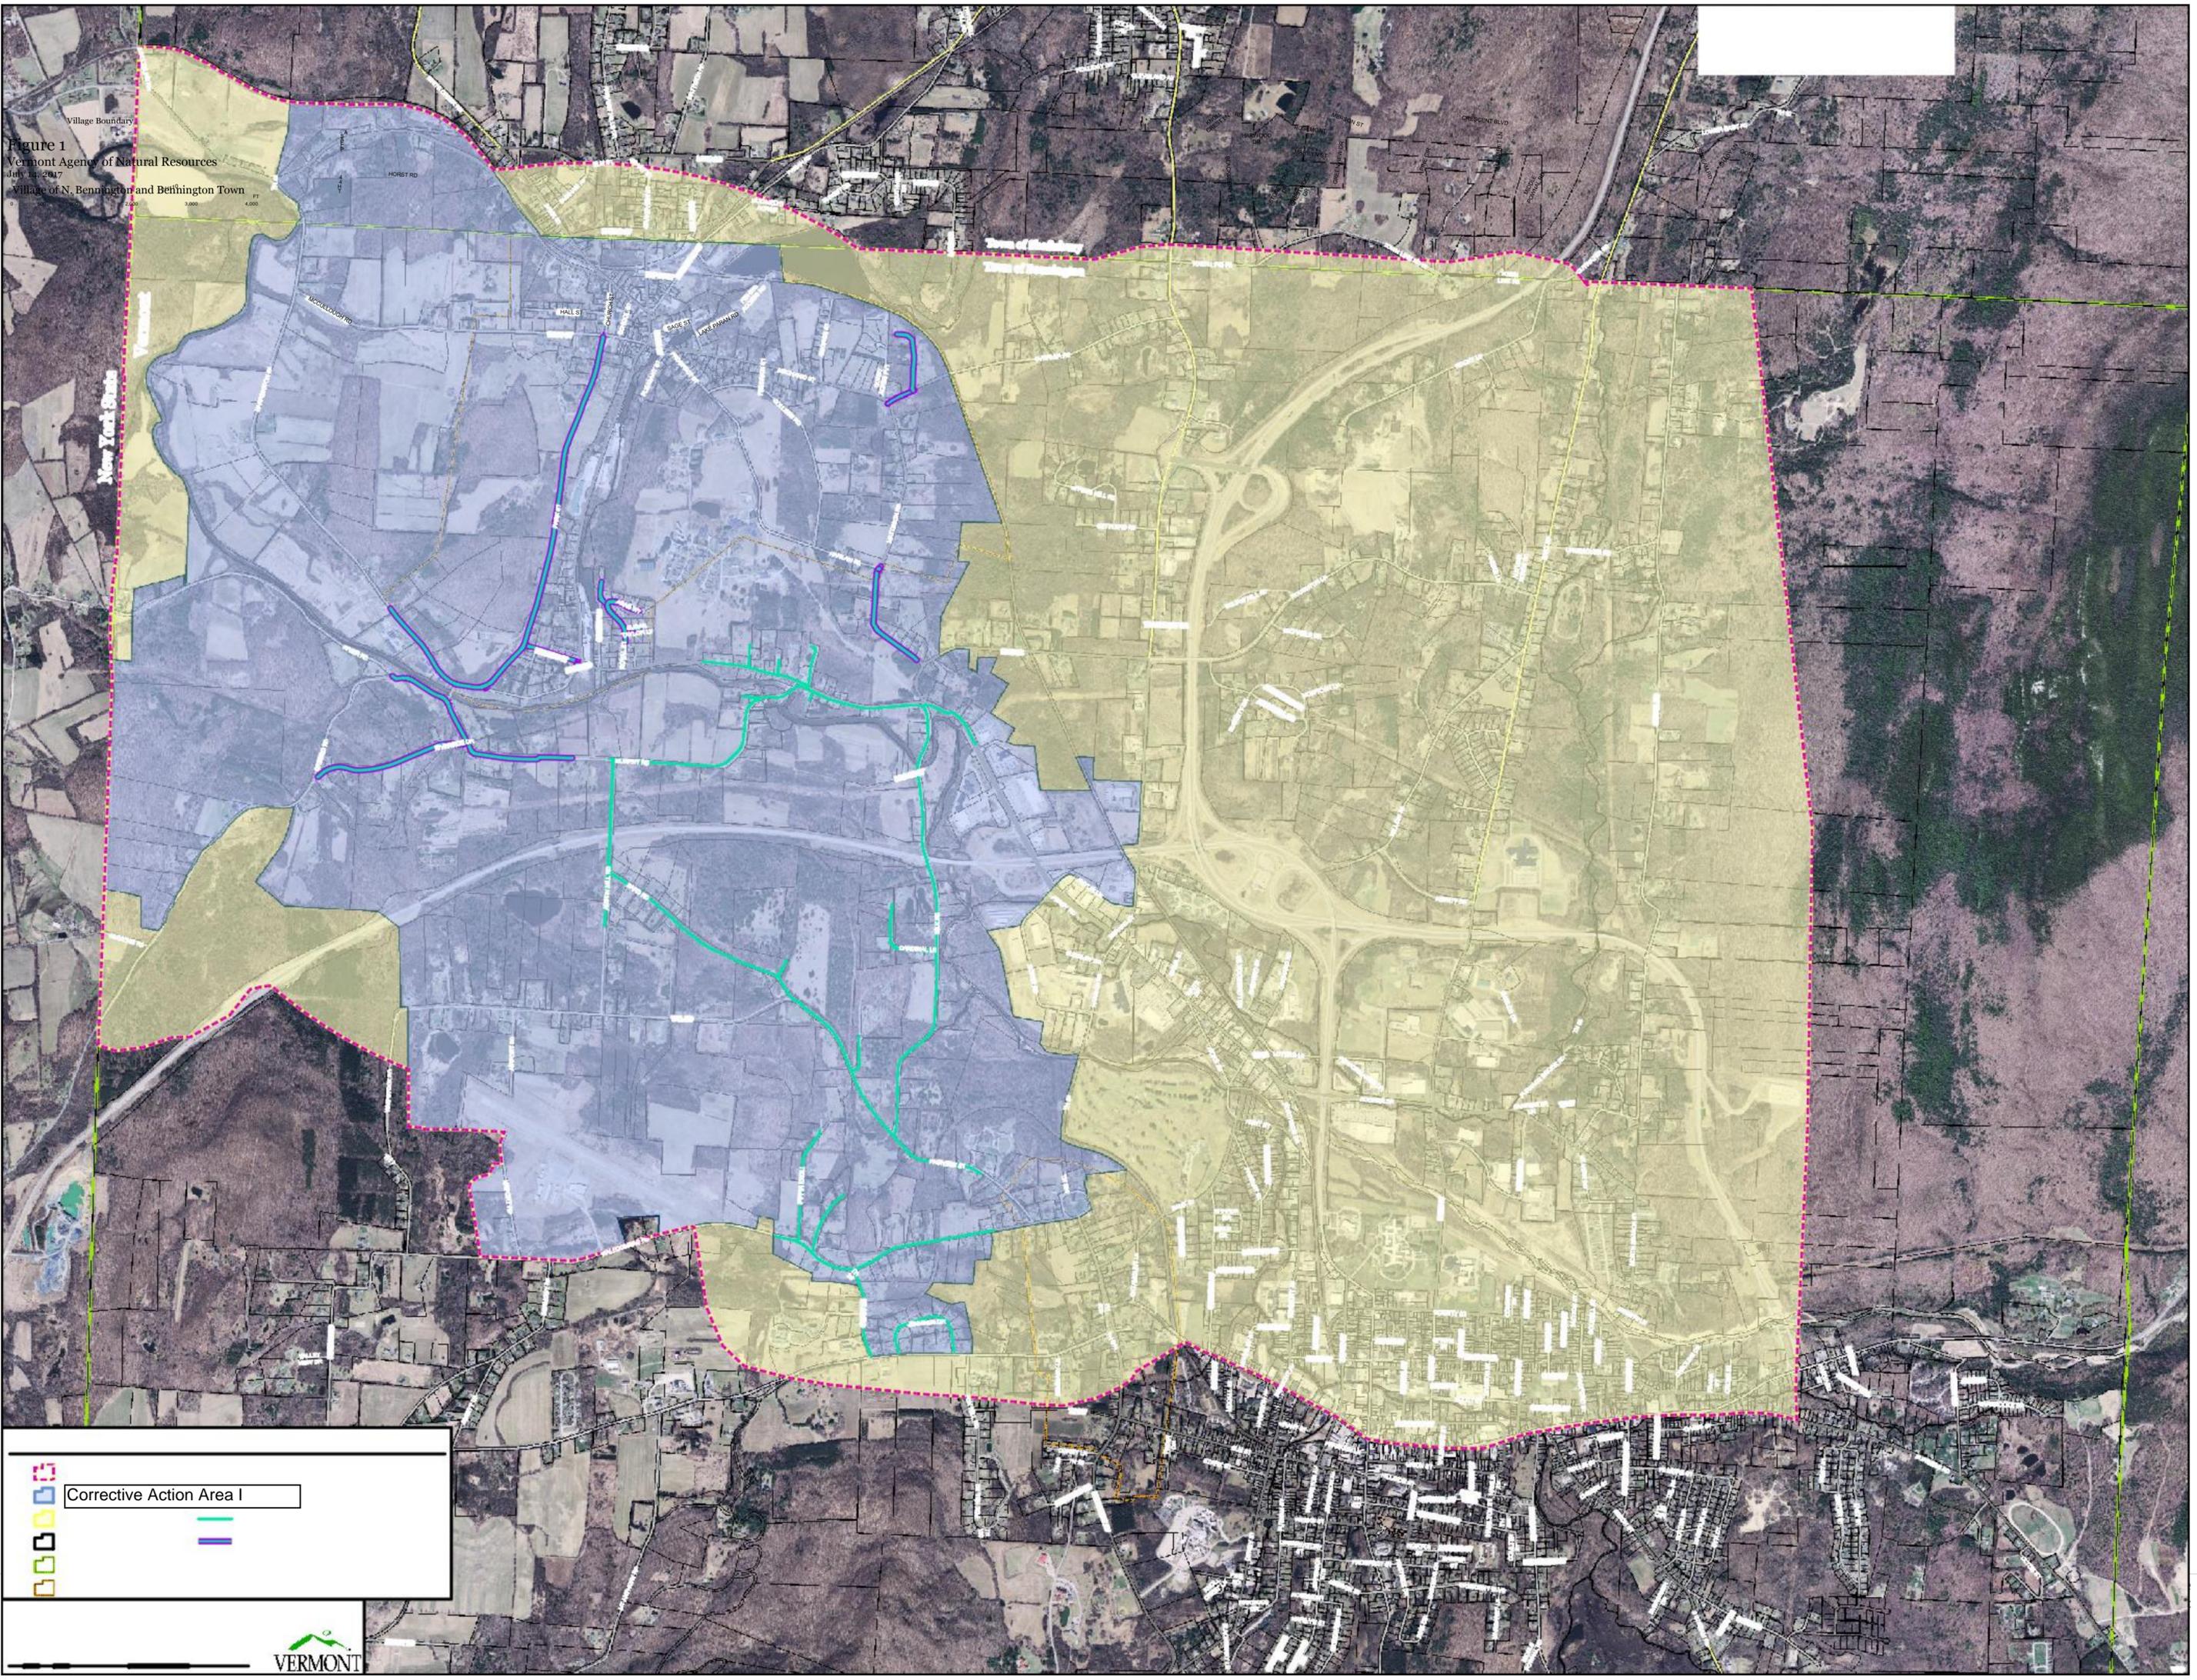
Figure 1
Vermont Agency of Natural Resources
July 14, 2017
Village of N. Bennington and Bennington Town

APPENDIX A
CORRECTIVE ACTION AREA I

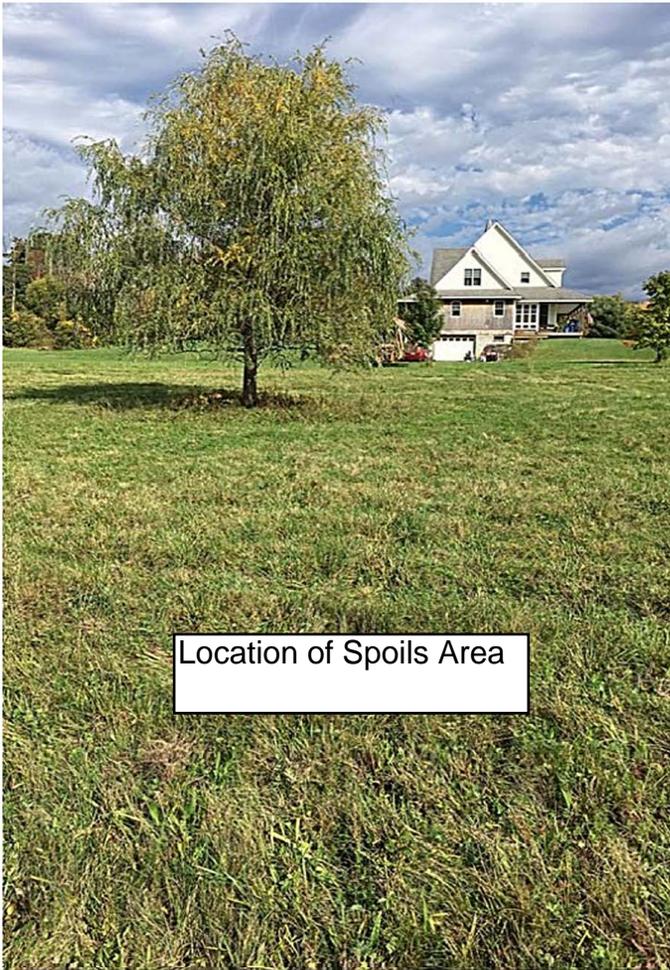
Walloomsac (east) Road Spoil Site (north of Walloomsac Road)

Location of Spoils Area

View to an easterly direction

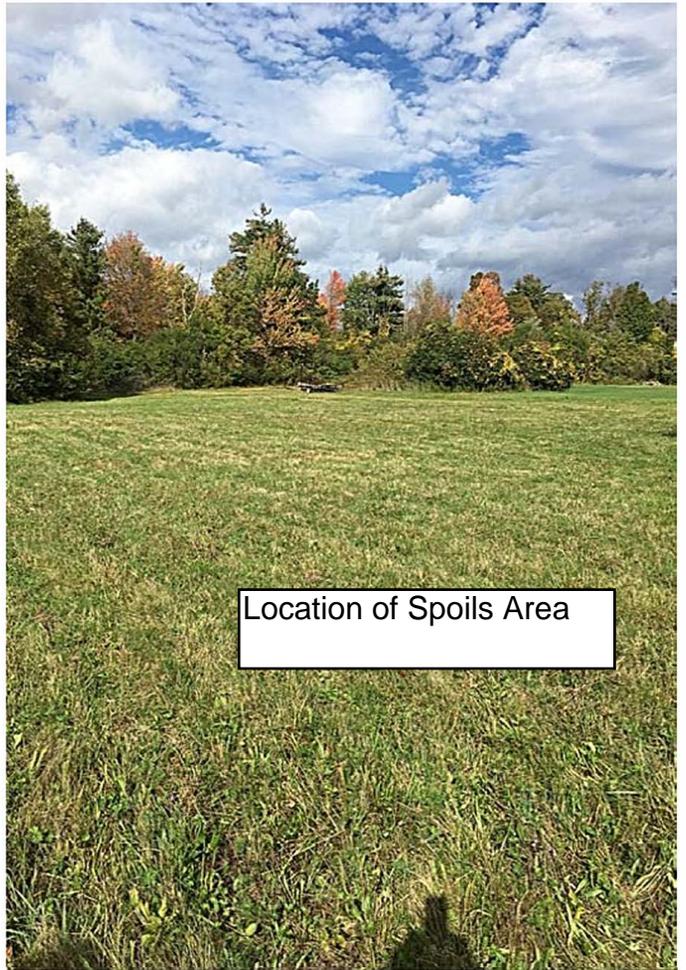
Location of Spoils Area

View to a northerly direction

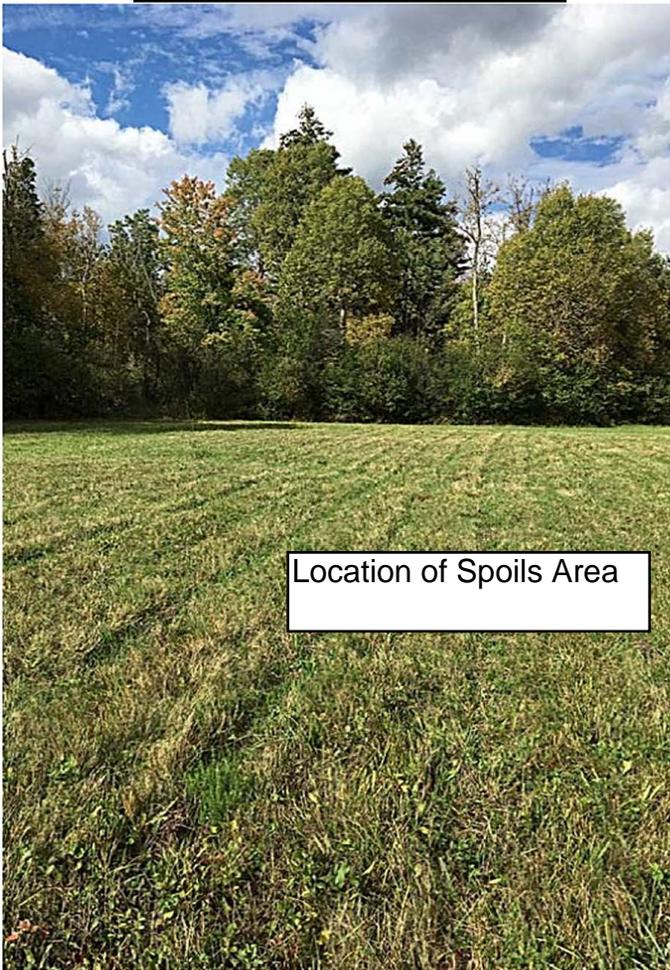
Location of Spoils Area

View to a northerly direction

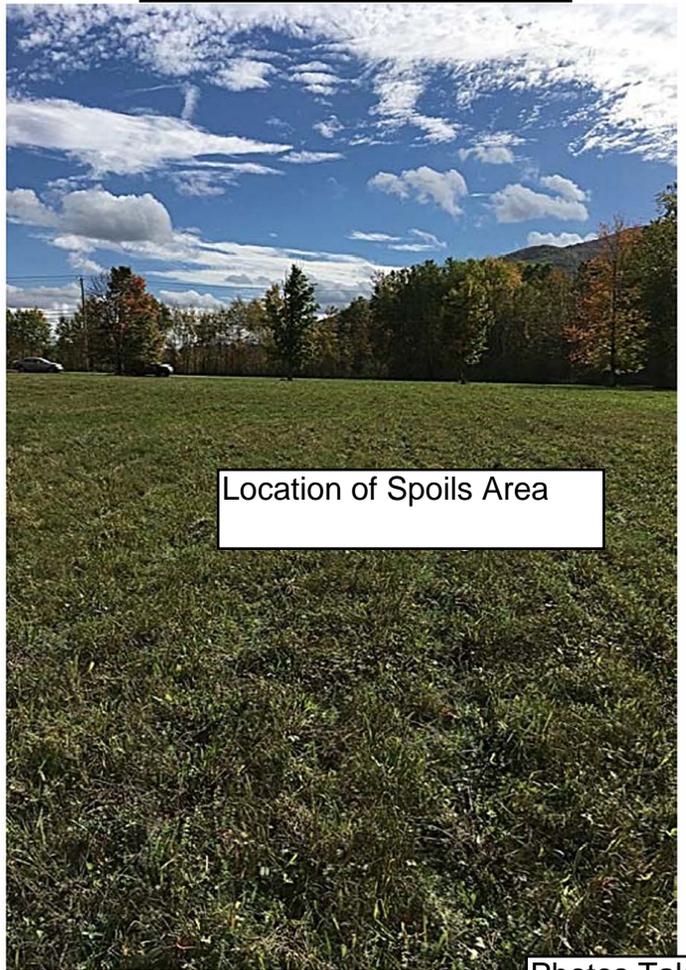
Location of Spoils Area

View to a southerly direction

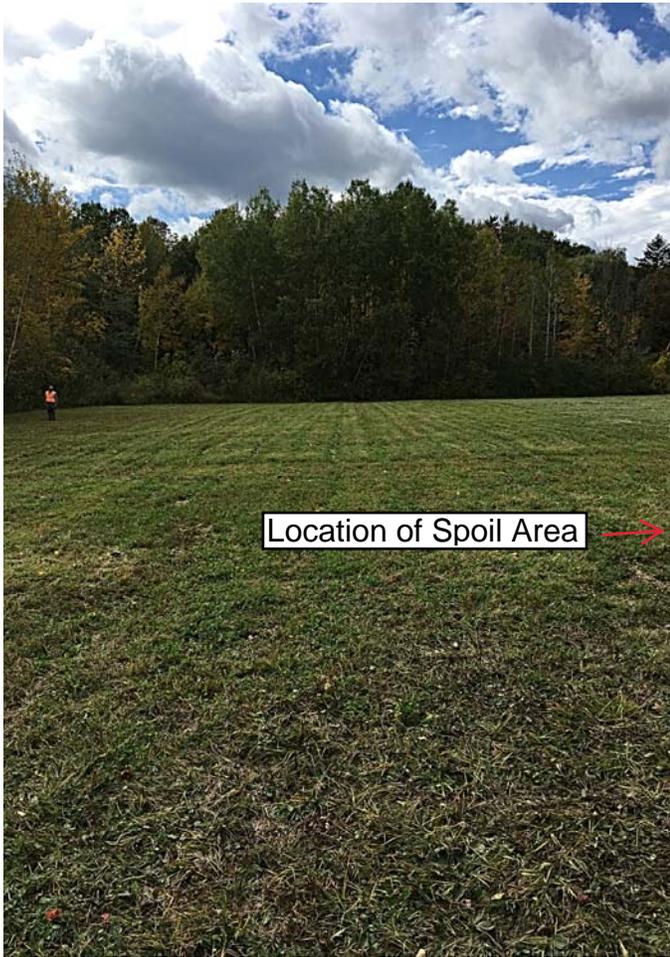
Walloomsac (east-a) Road Spoils Site (south of Walloomsac Road)

View to a westerly direction

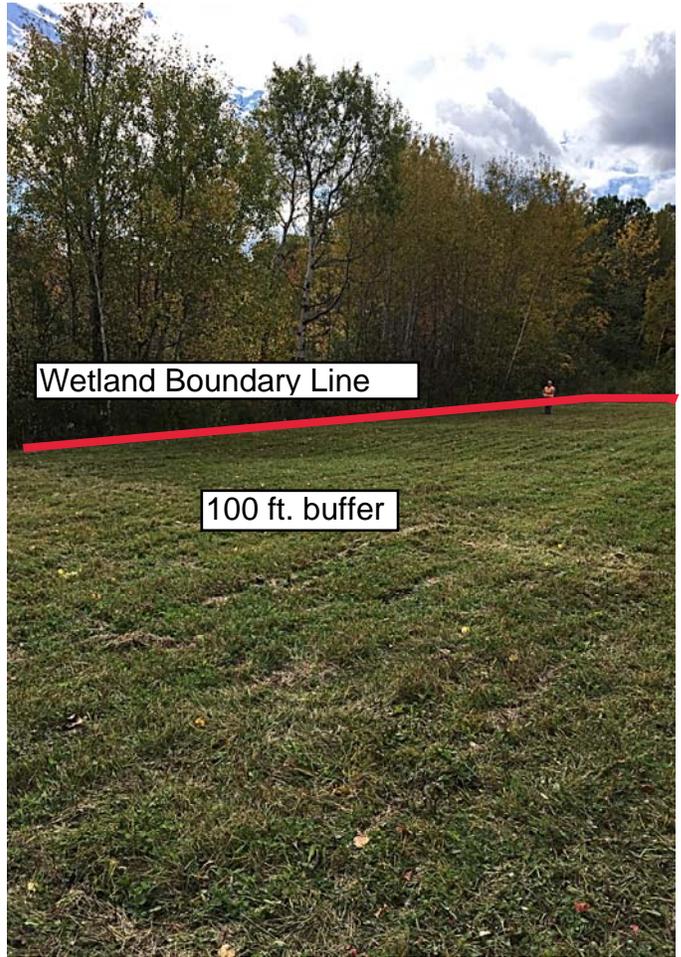
View to a southwesterly direction

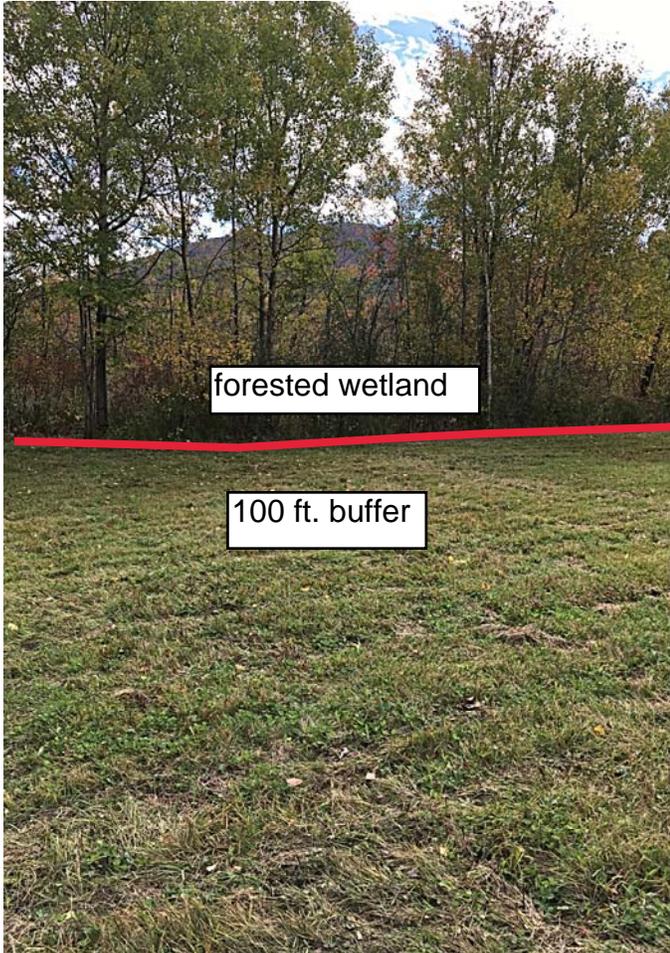
View to a southerly direction

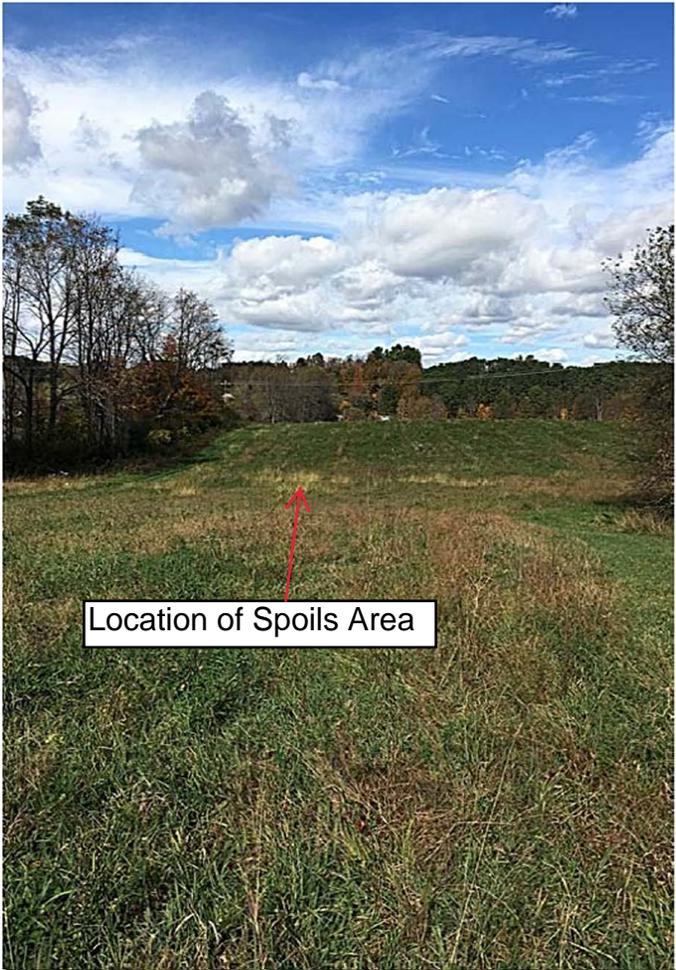
Murphy Road Spoils Site

Location of Spoils Area

View to a northerly direction

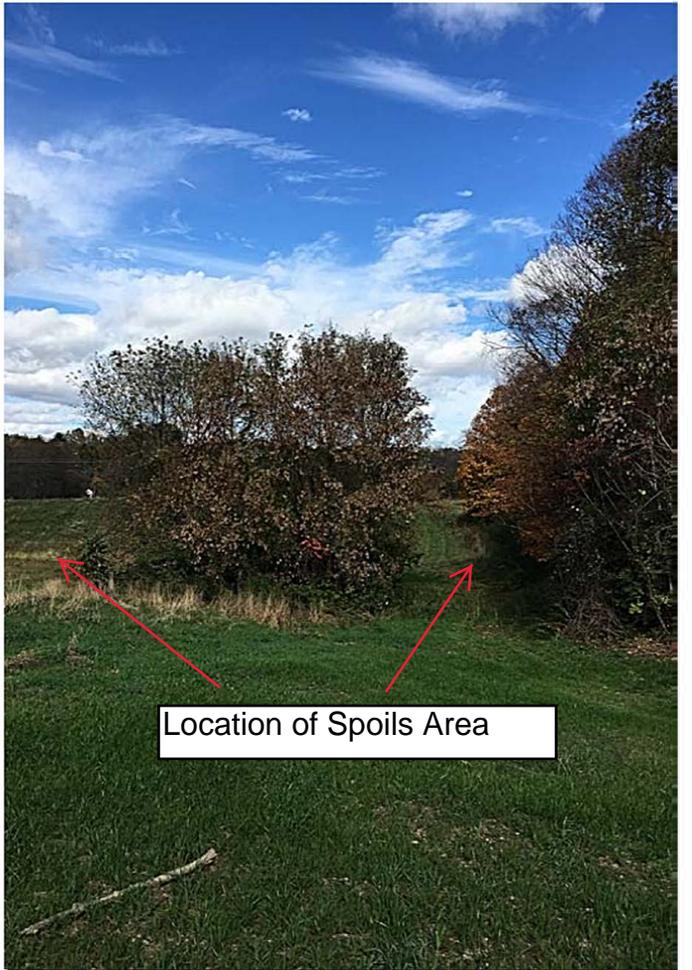
Location of Spoils Area

View to a northerly direction

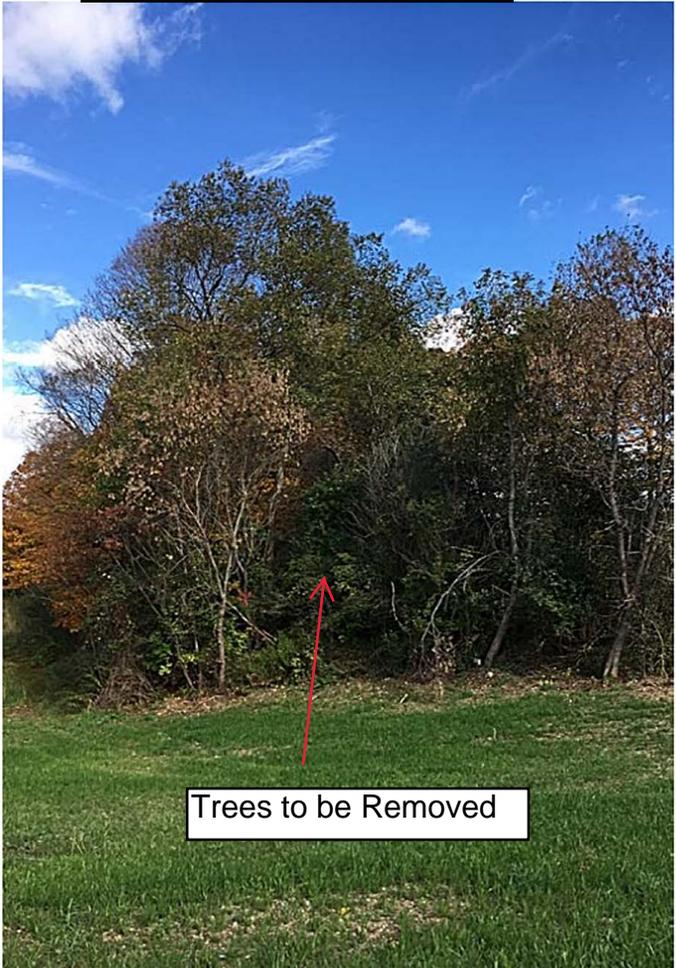
Trees to be Removed

View to a northerly direction

The majority of this spoils site has been mowed and is primarily vegetated with field and meadow grasses with a small (1/2 acre) area of forested area to be removed (approximately 15-20 trees).

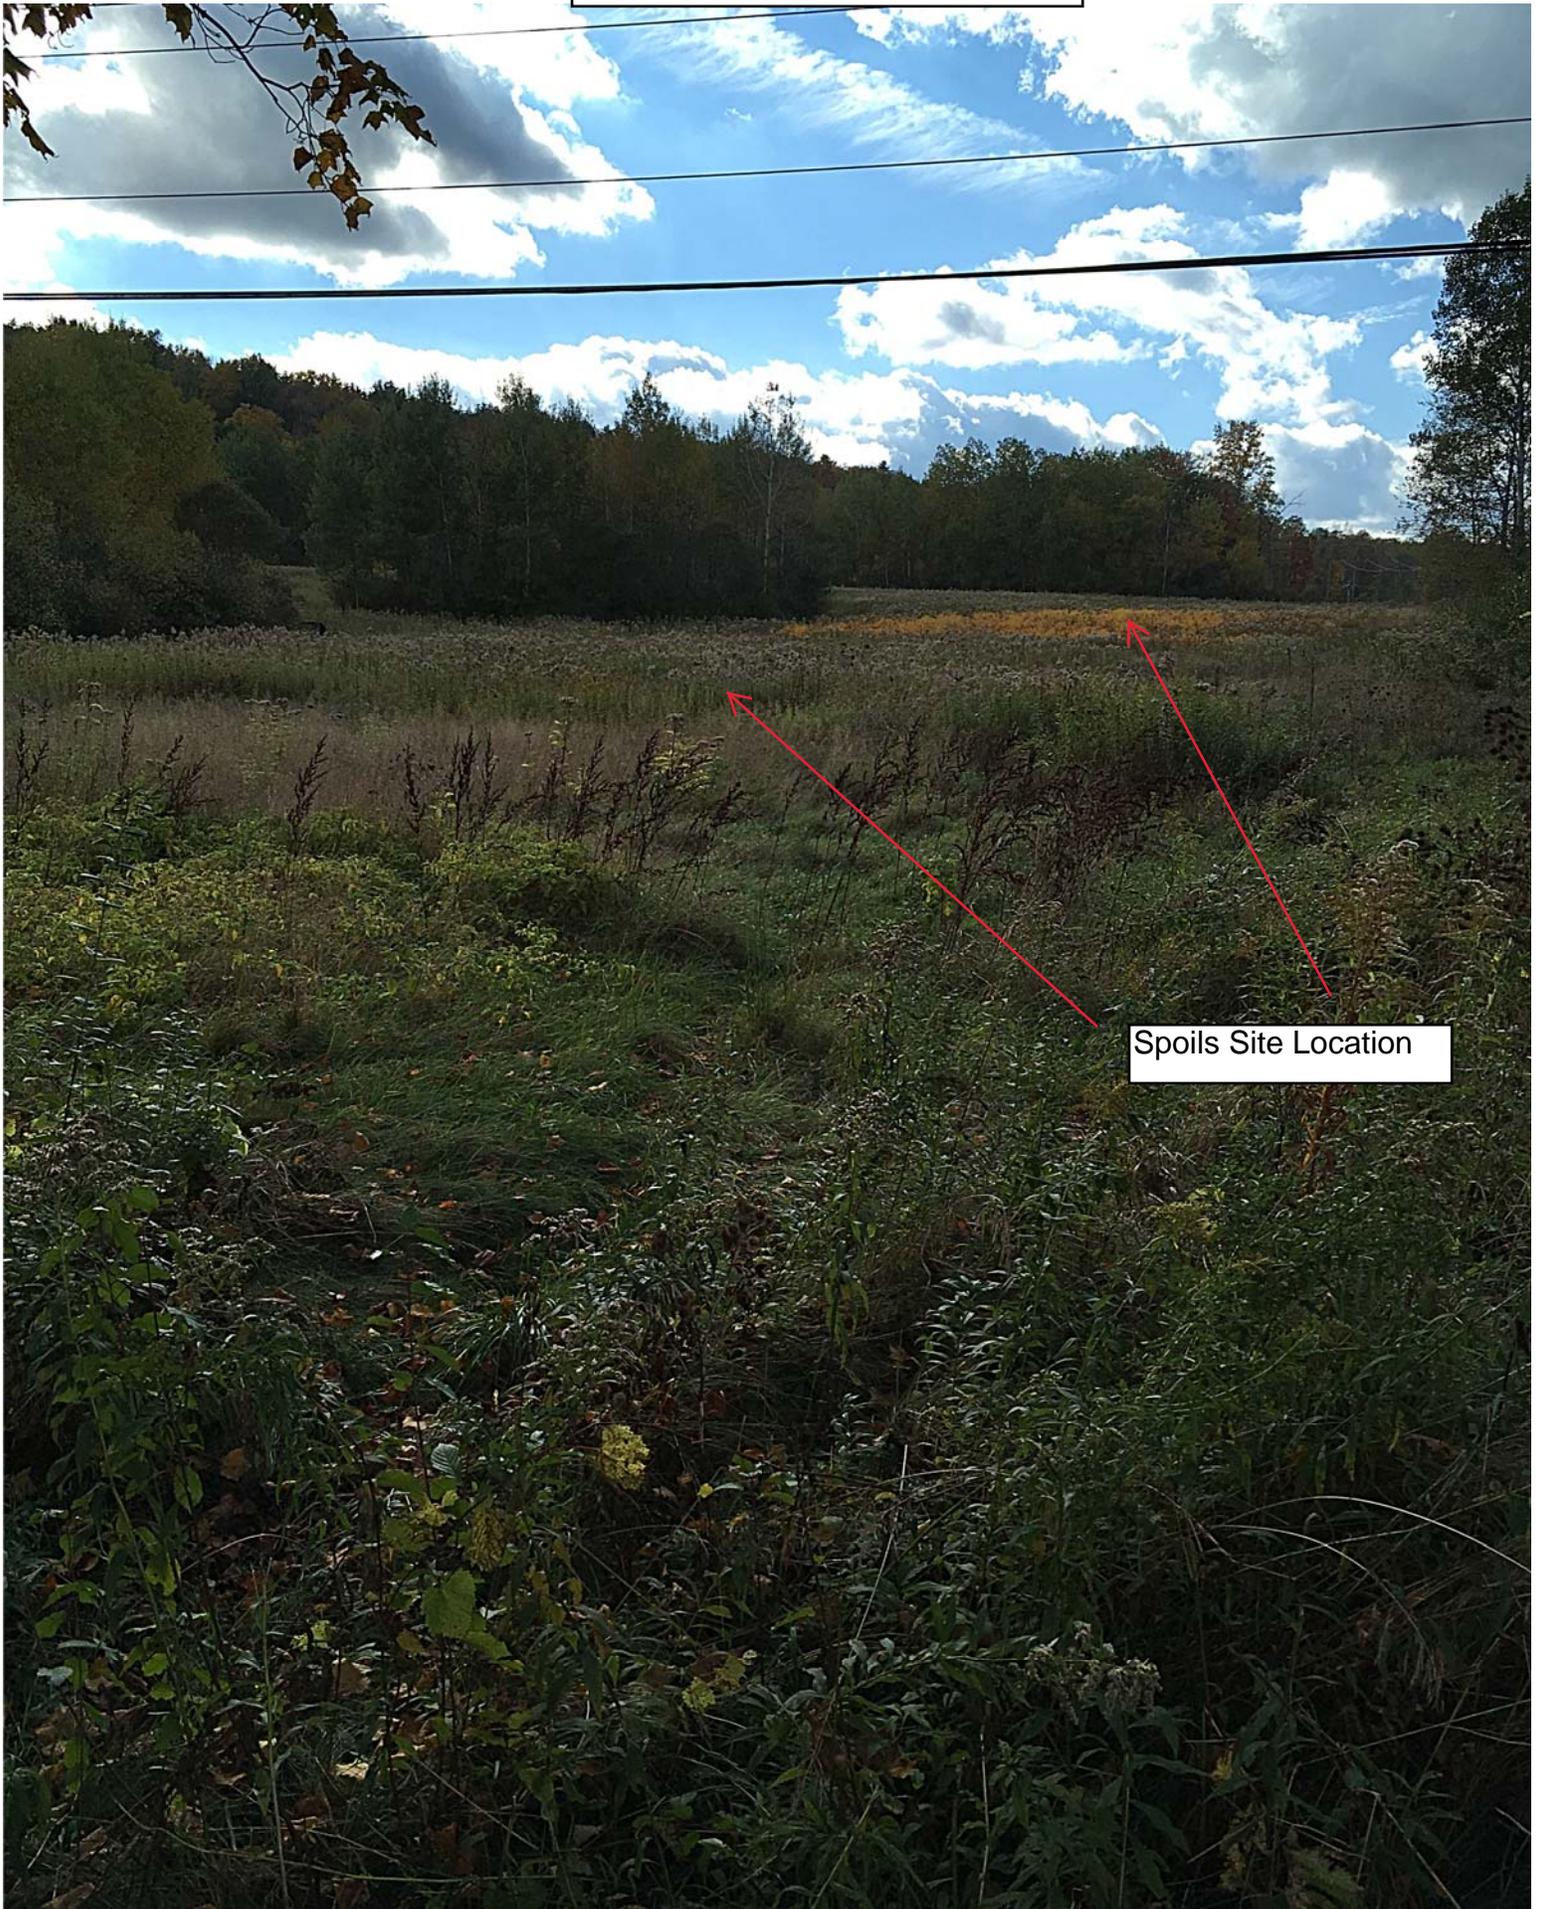
Silk-Bridge Roads Spoils Site

Spoils Site Location

View to a westerly direction

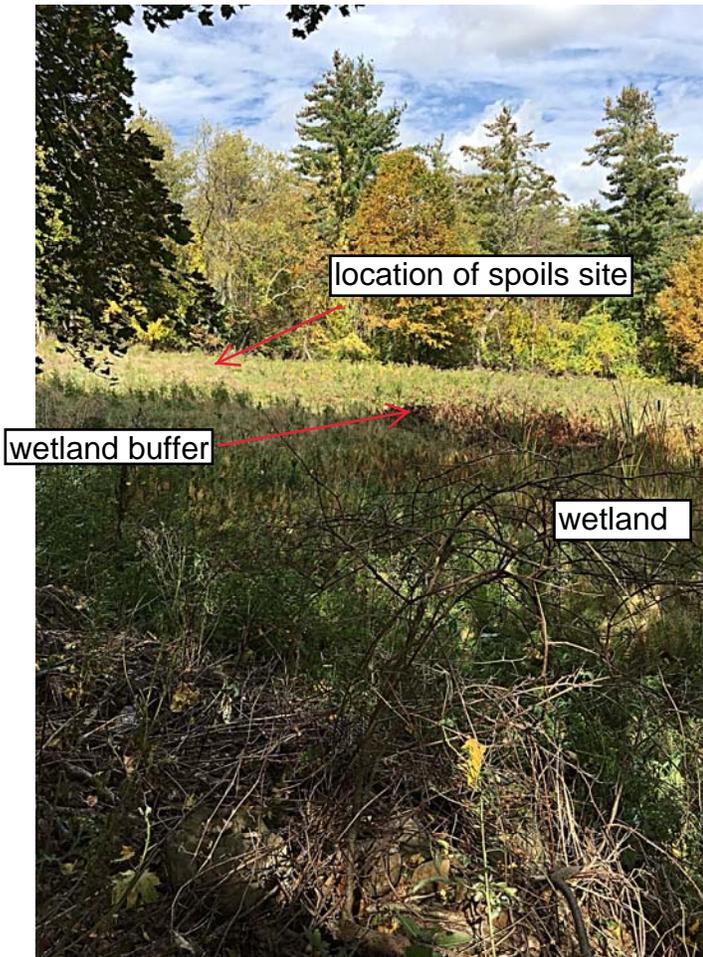
Vail Road Spoils Site

View to a northwesterly direction

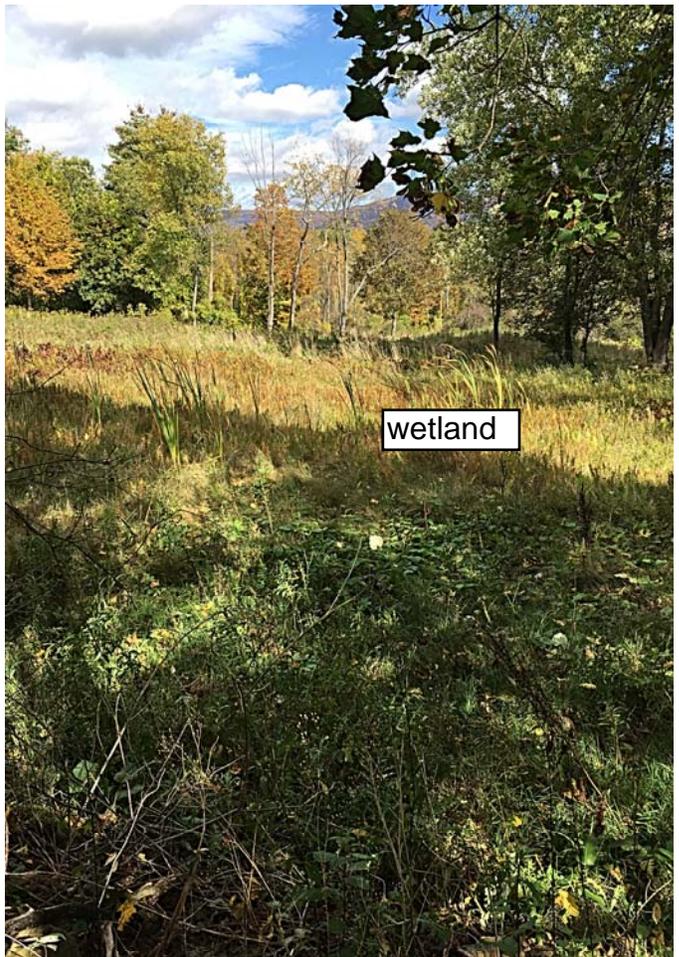
View to a northeasterly direction

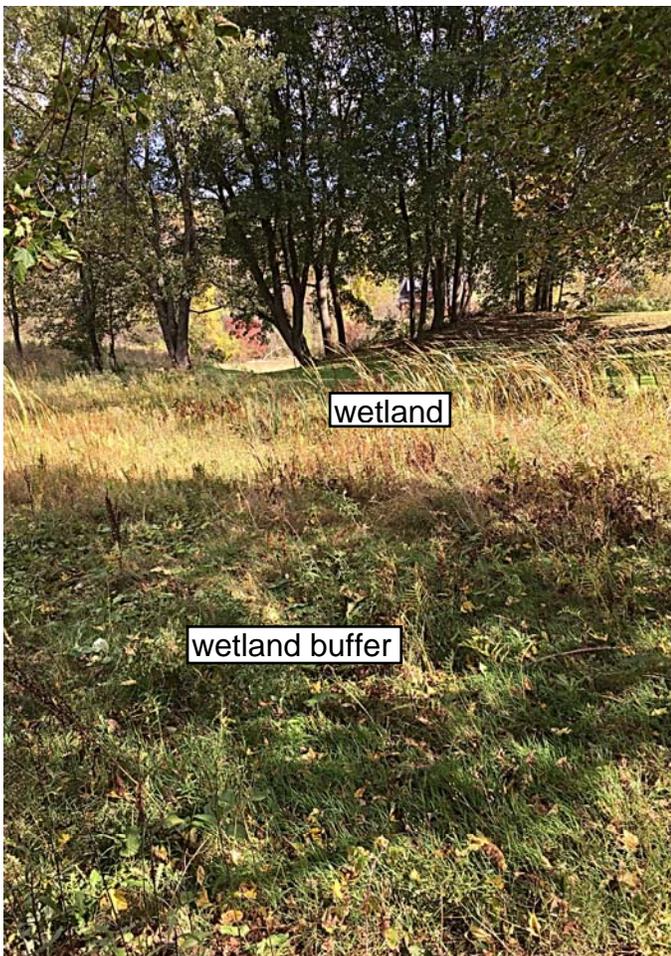
View to an easterly direction

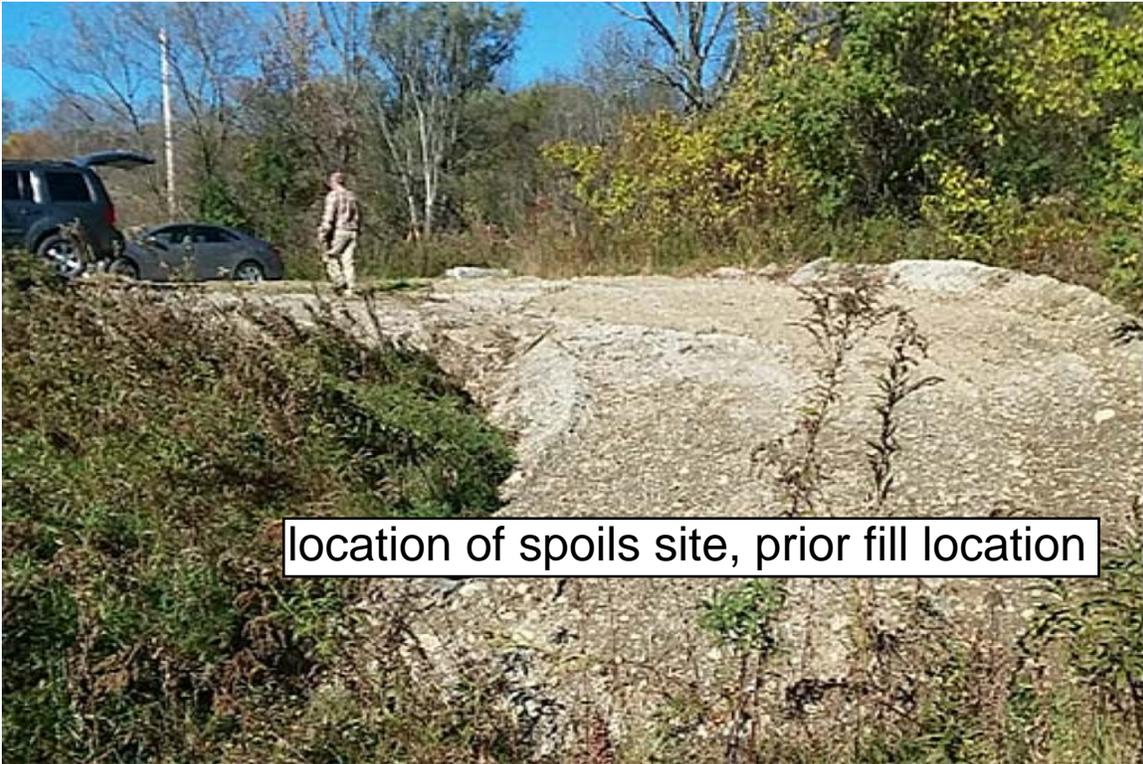
Harrington Road Spoils Site

location of spoils site, prior fill location

View to a northwesterly direction

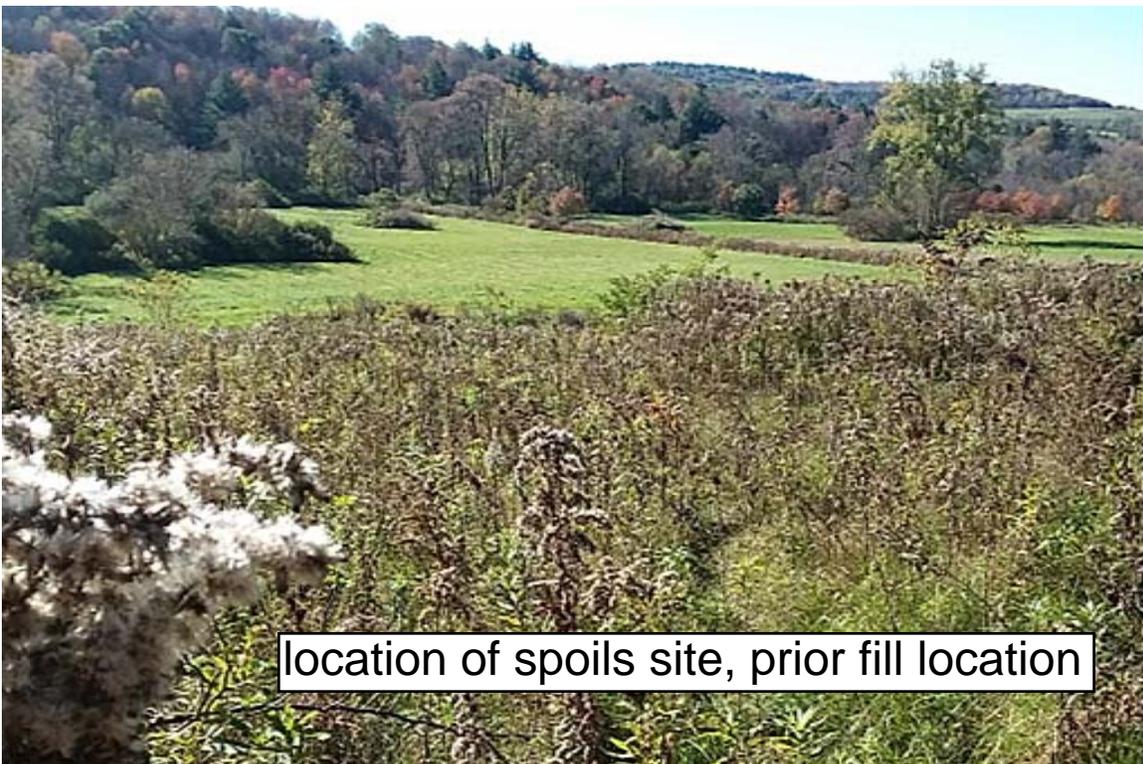
location of spoils site, prior fill location

View to a southwesterly direction. Mowed area contains the 100 year floodplain.

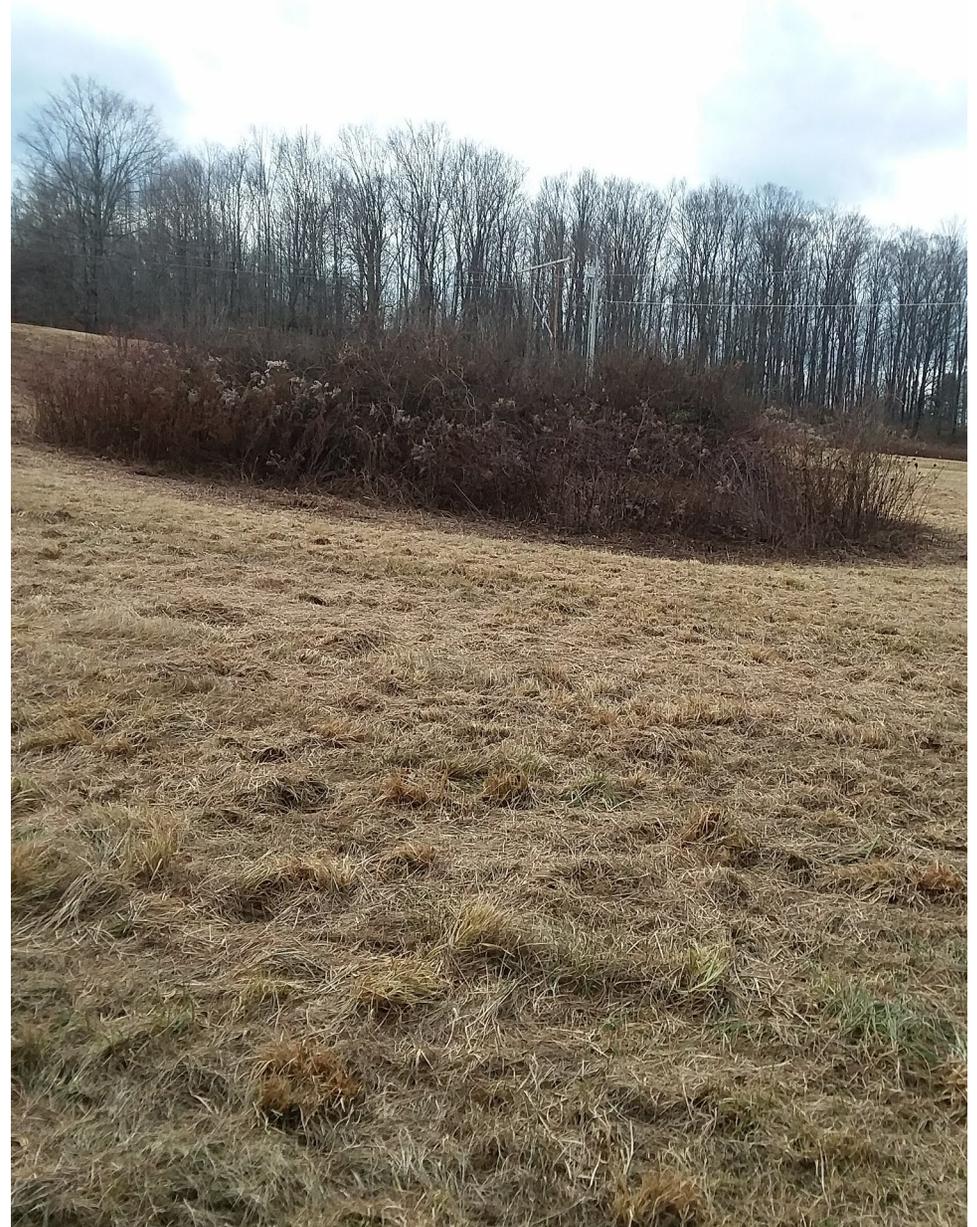
Spoils Site, Riverside Drive, Photo 1

View looking southeast to northwest where spoils would be placed.

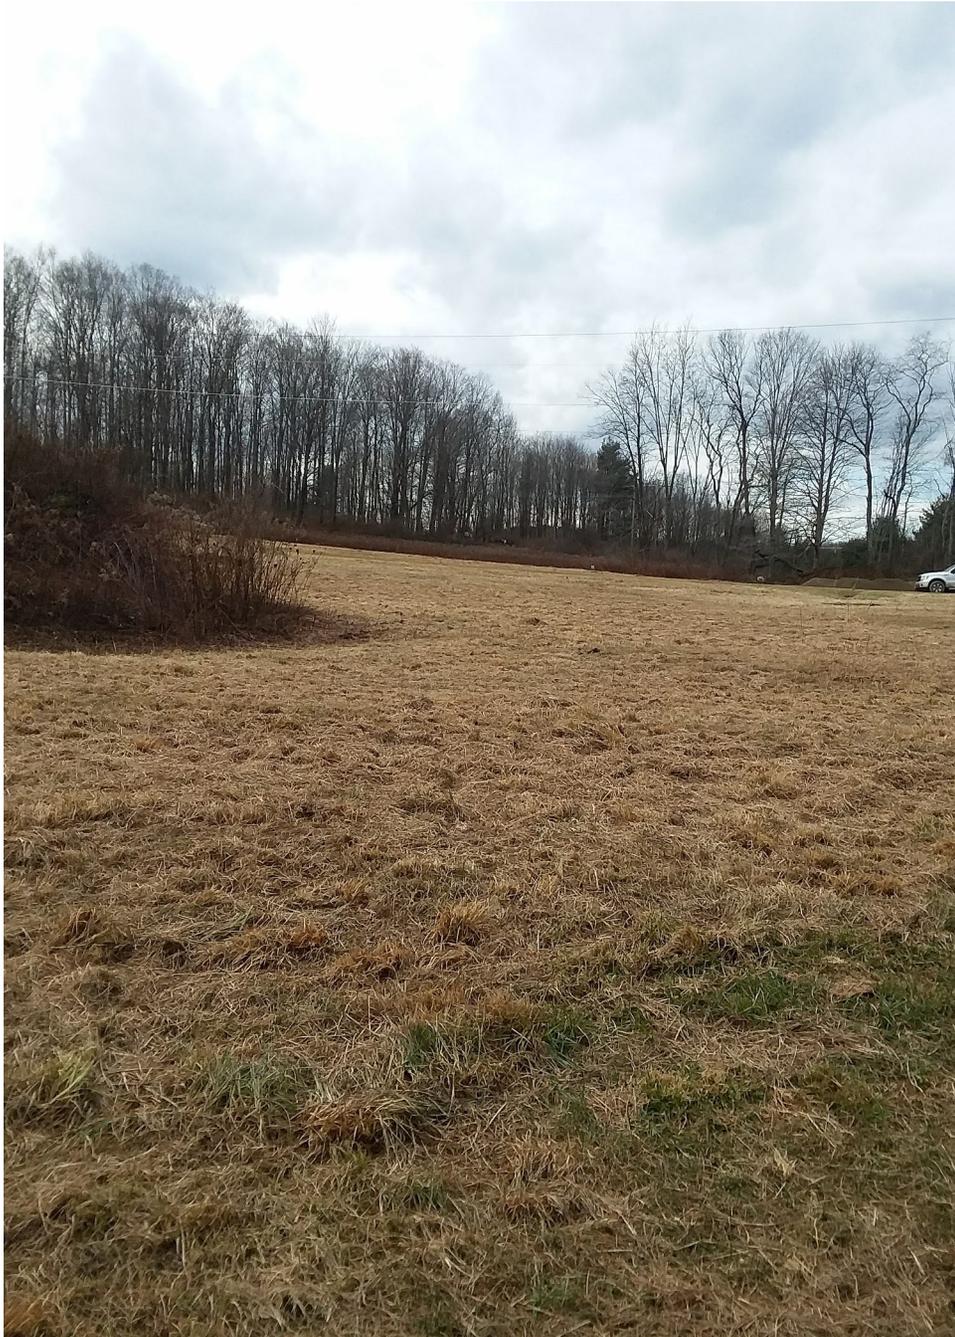
Spoils Site, Riverside Drive, Photo 2

View looking southeast to northwest where spoils would be placed.

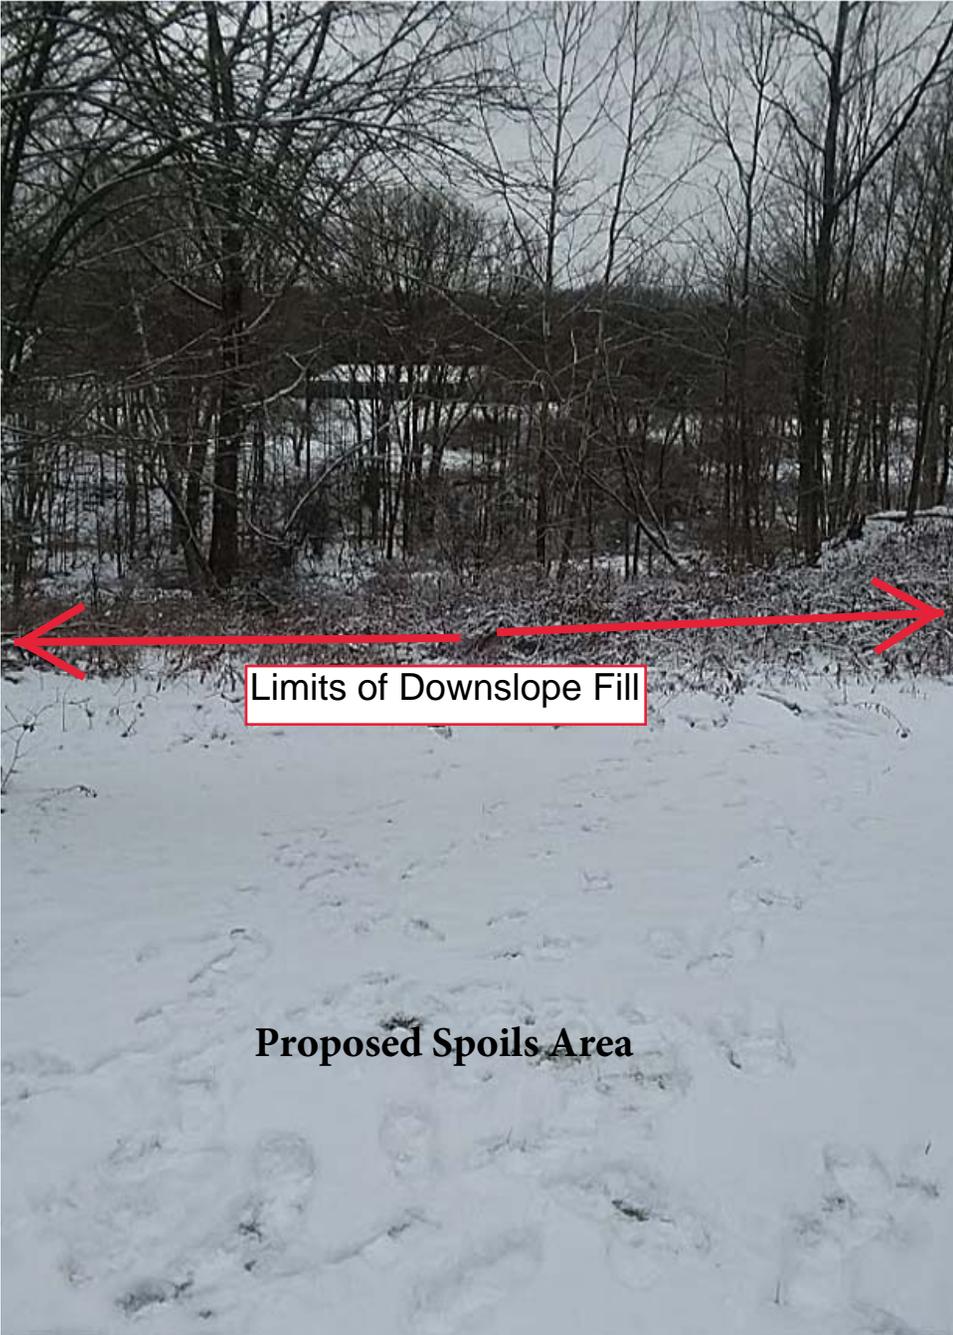
Proposed Spoils Area

View from Riverside Drive looking southeast.

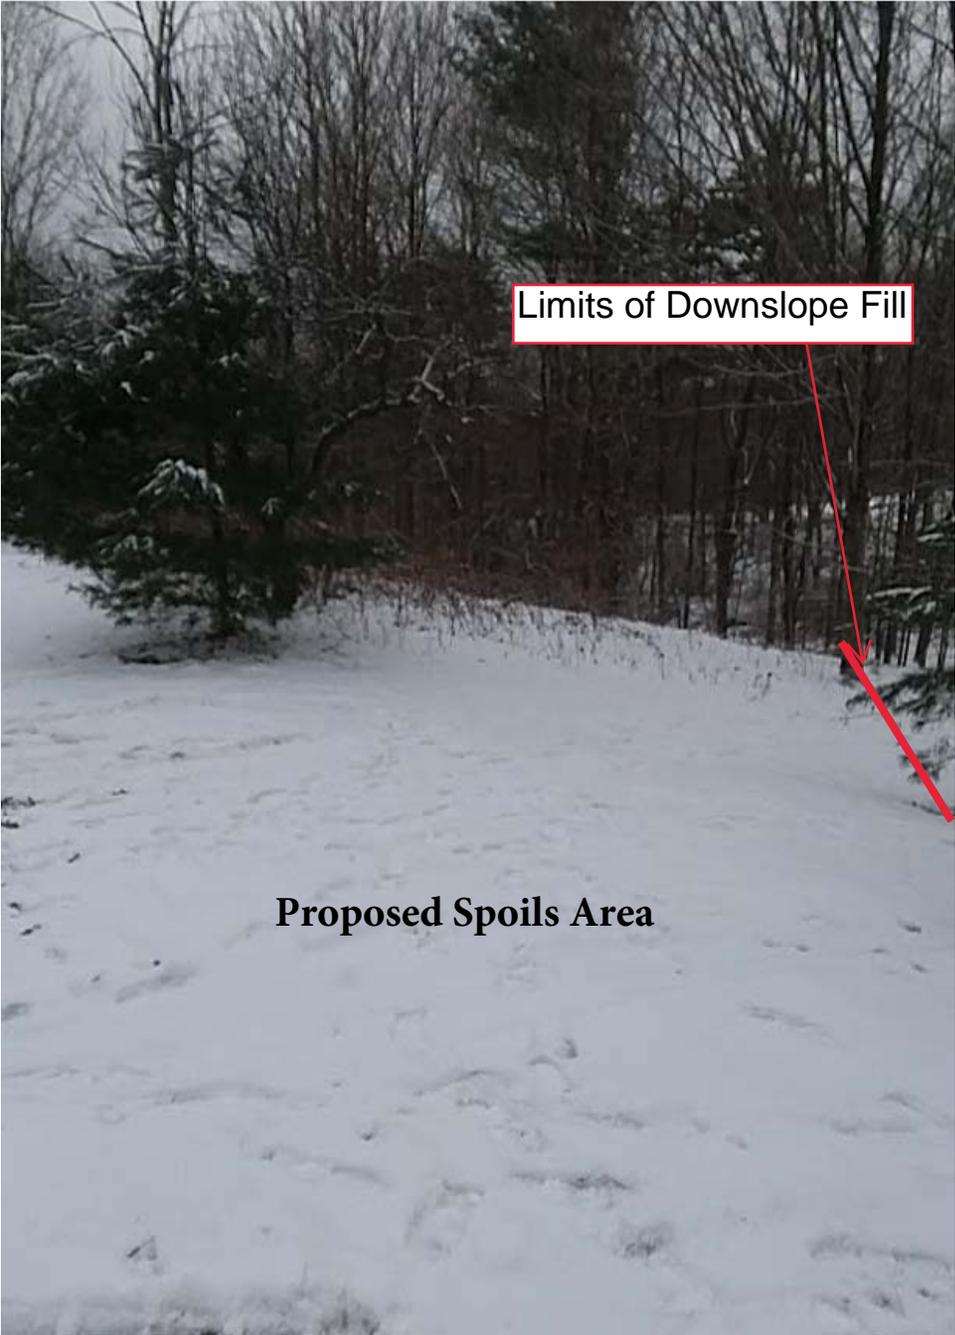
Proposed Spoils Area

View to the east.
