SPOILS MANAGEMENT PLAN

BENNINGTON PFOA REMEDIATION TRENCH SPOILS DISPOSAL SITES

MS&K, Inc.
P.O. Box 139
Bennington, VT 05201

SPOILS MANAGEMENT PLAN
BENNINGTON NW EXTENSION PFOA REMEDIATION TRENCH SPOILS DISPOSAL SITES
TABLE OF CONTENTS

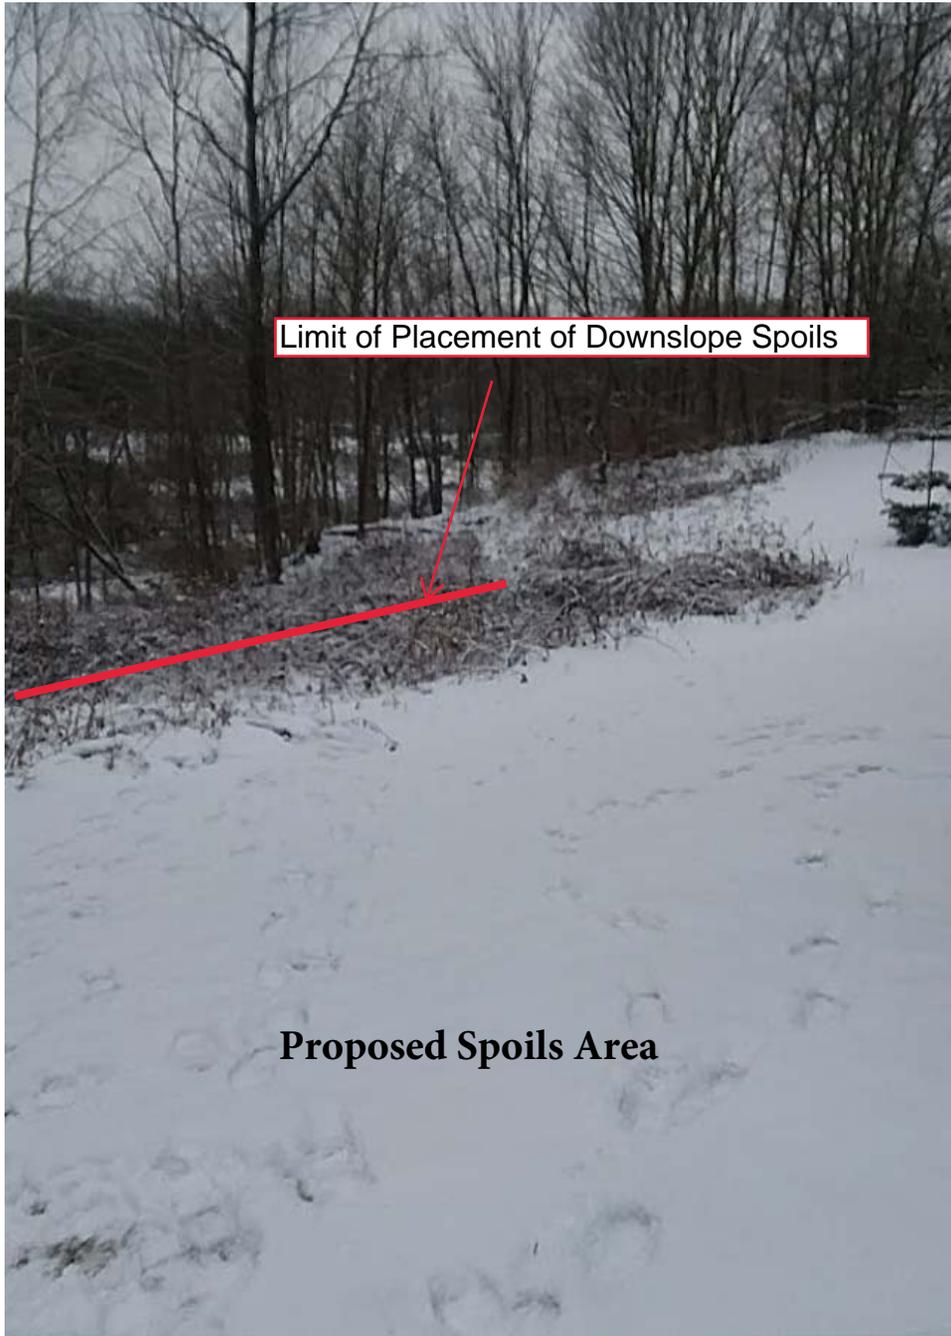
View to the southwest.

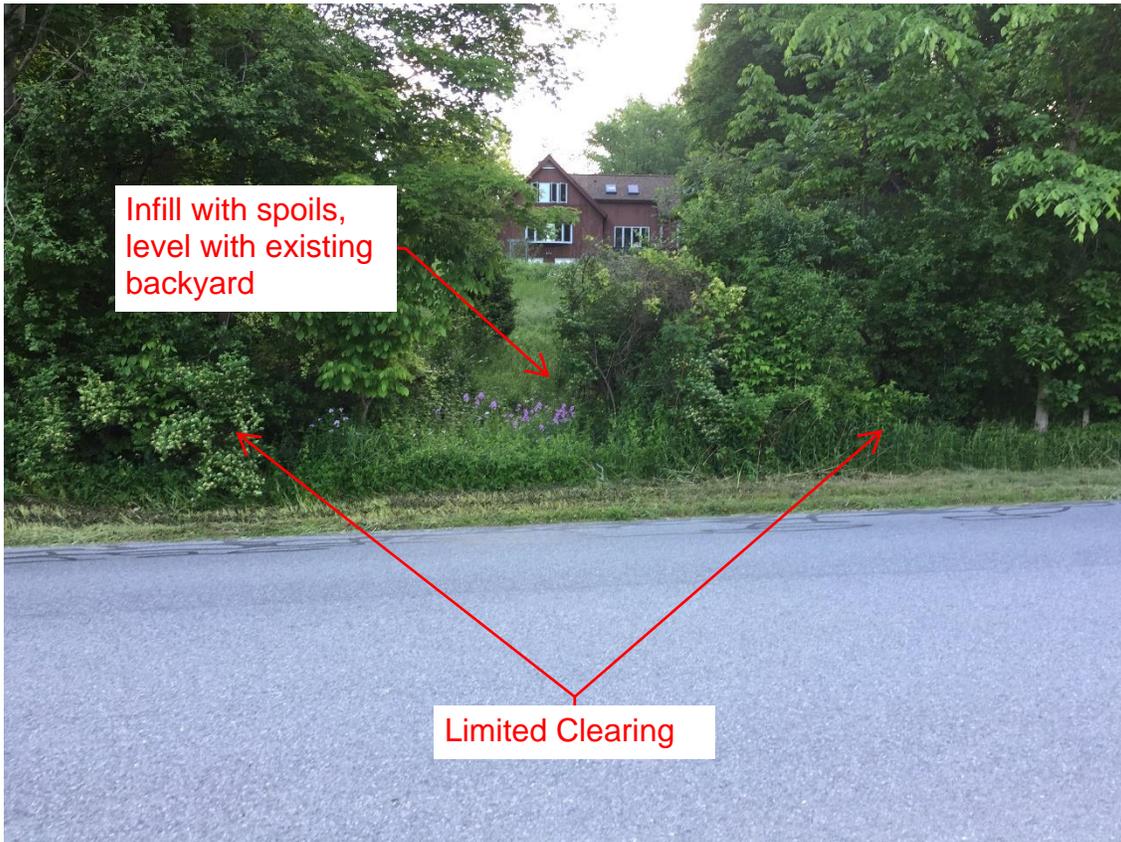
From River Road, Looking North Towards 15 Polygraphic Lane

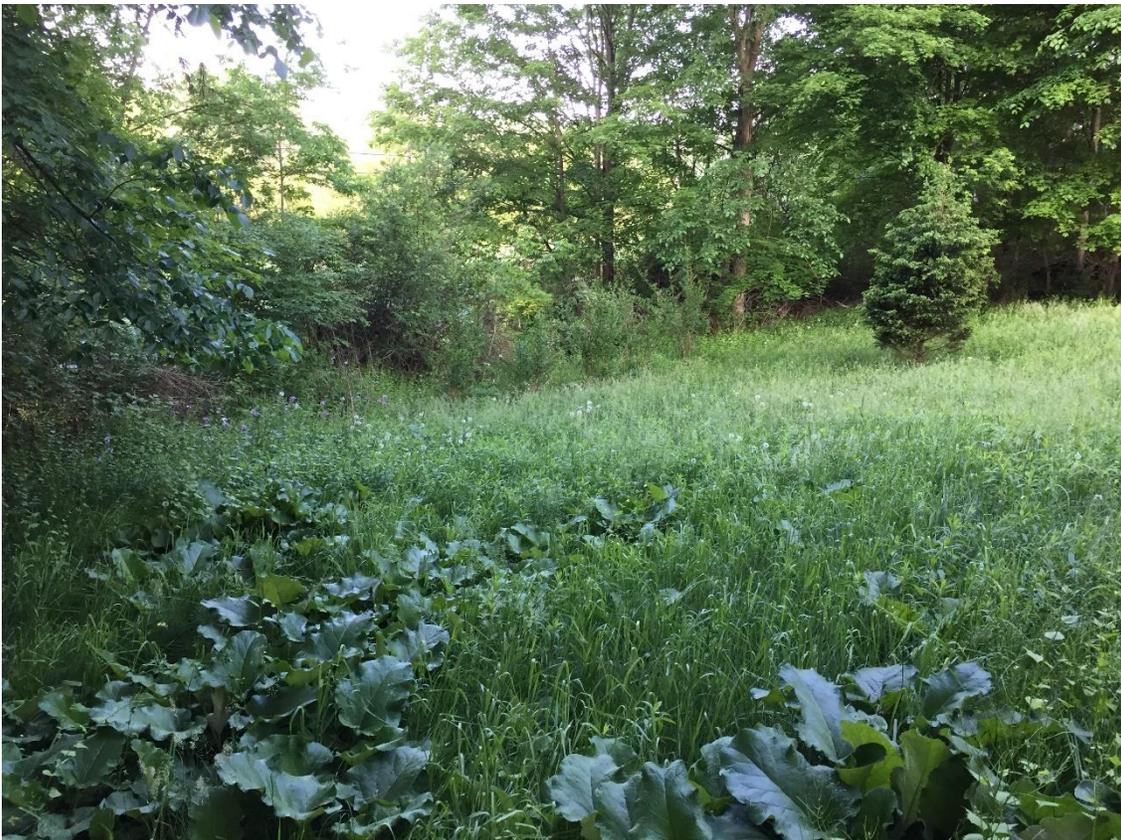
Looking West

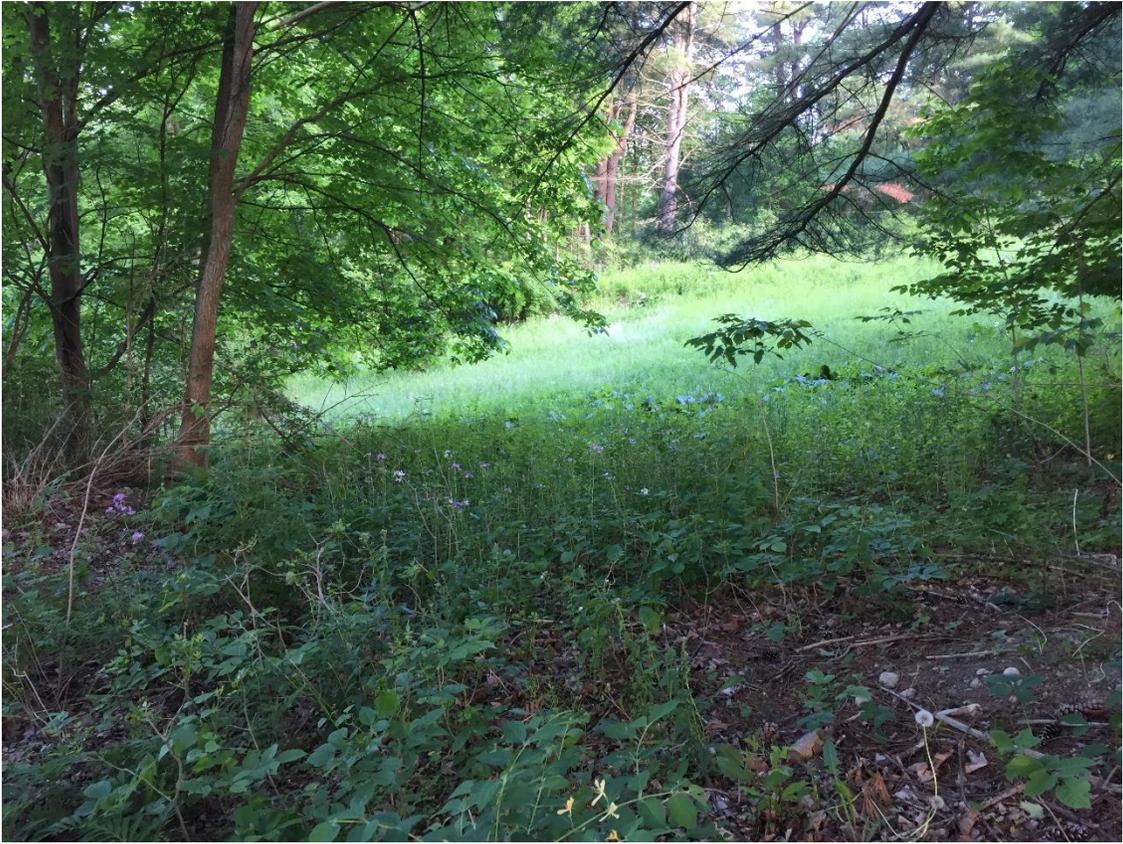
Looking West

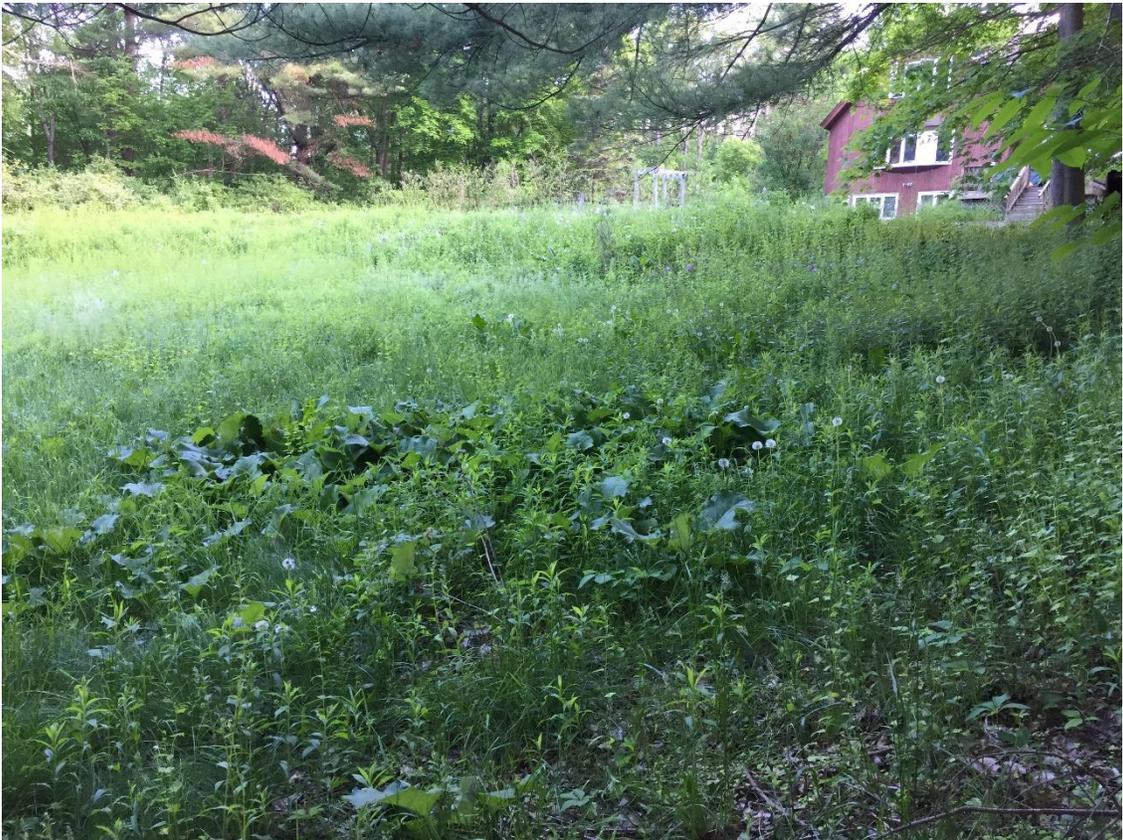
Looking Northwest

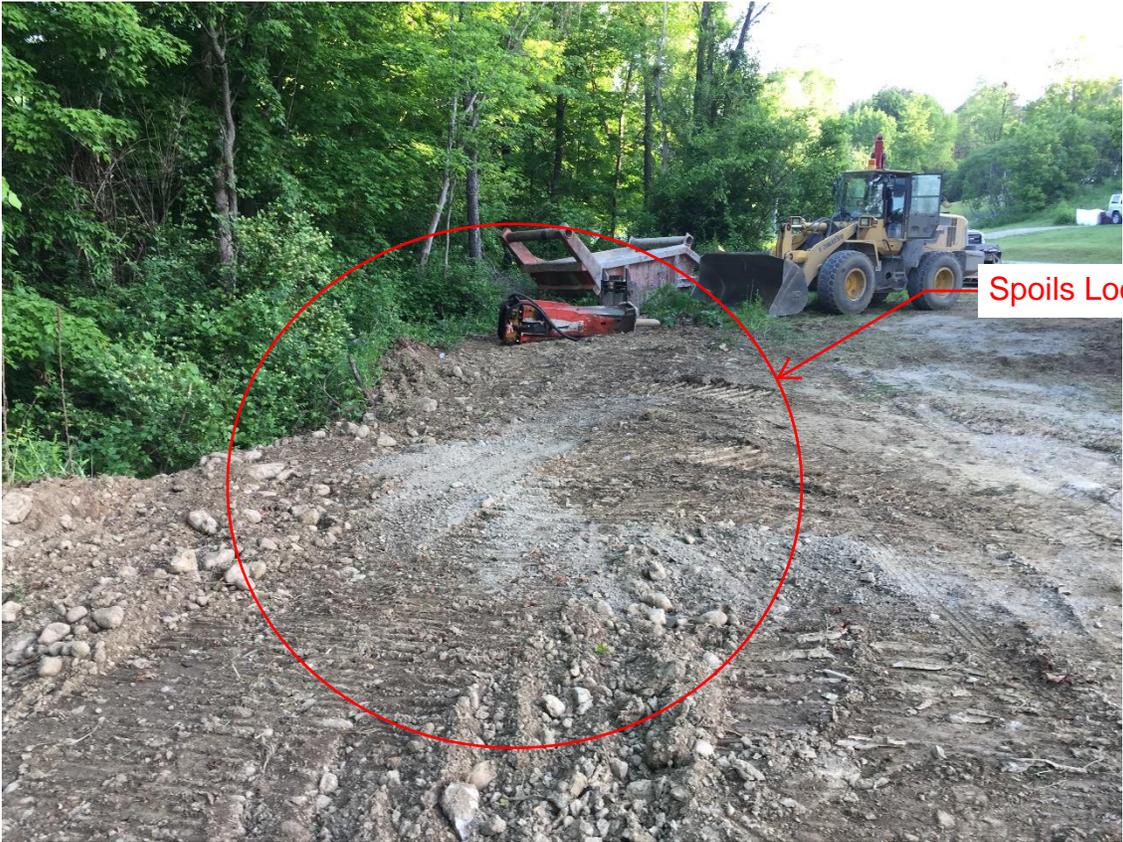
From west side of site, looking north

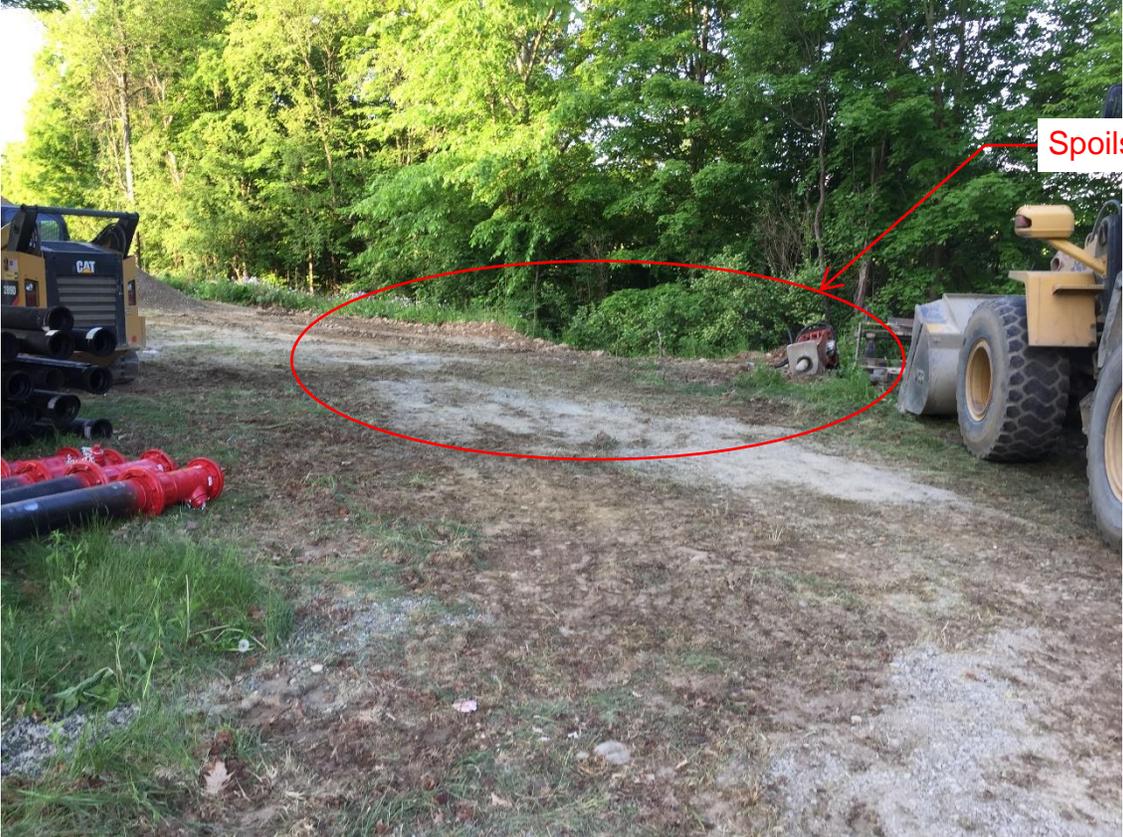
From Asa Way, looking southwest

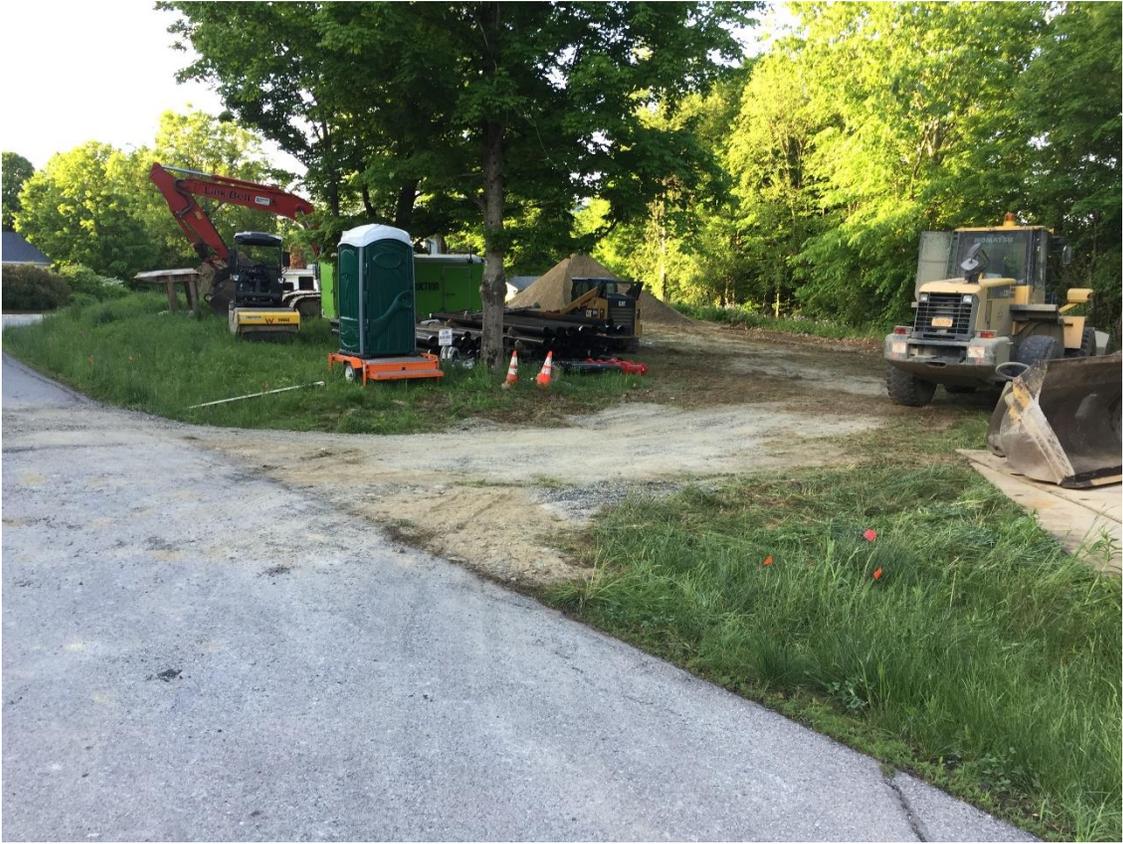
From Asa Way, looking southwest

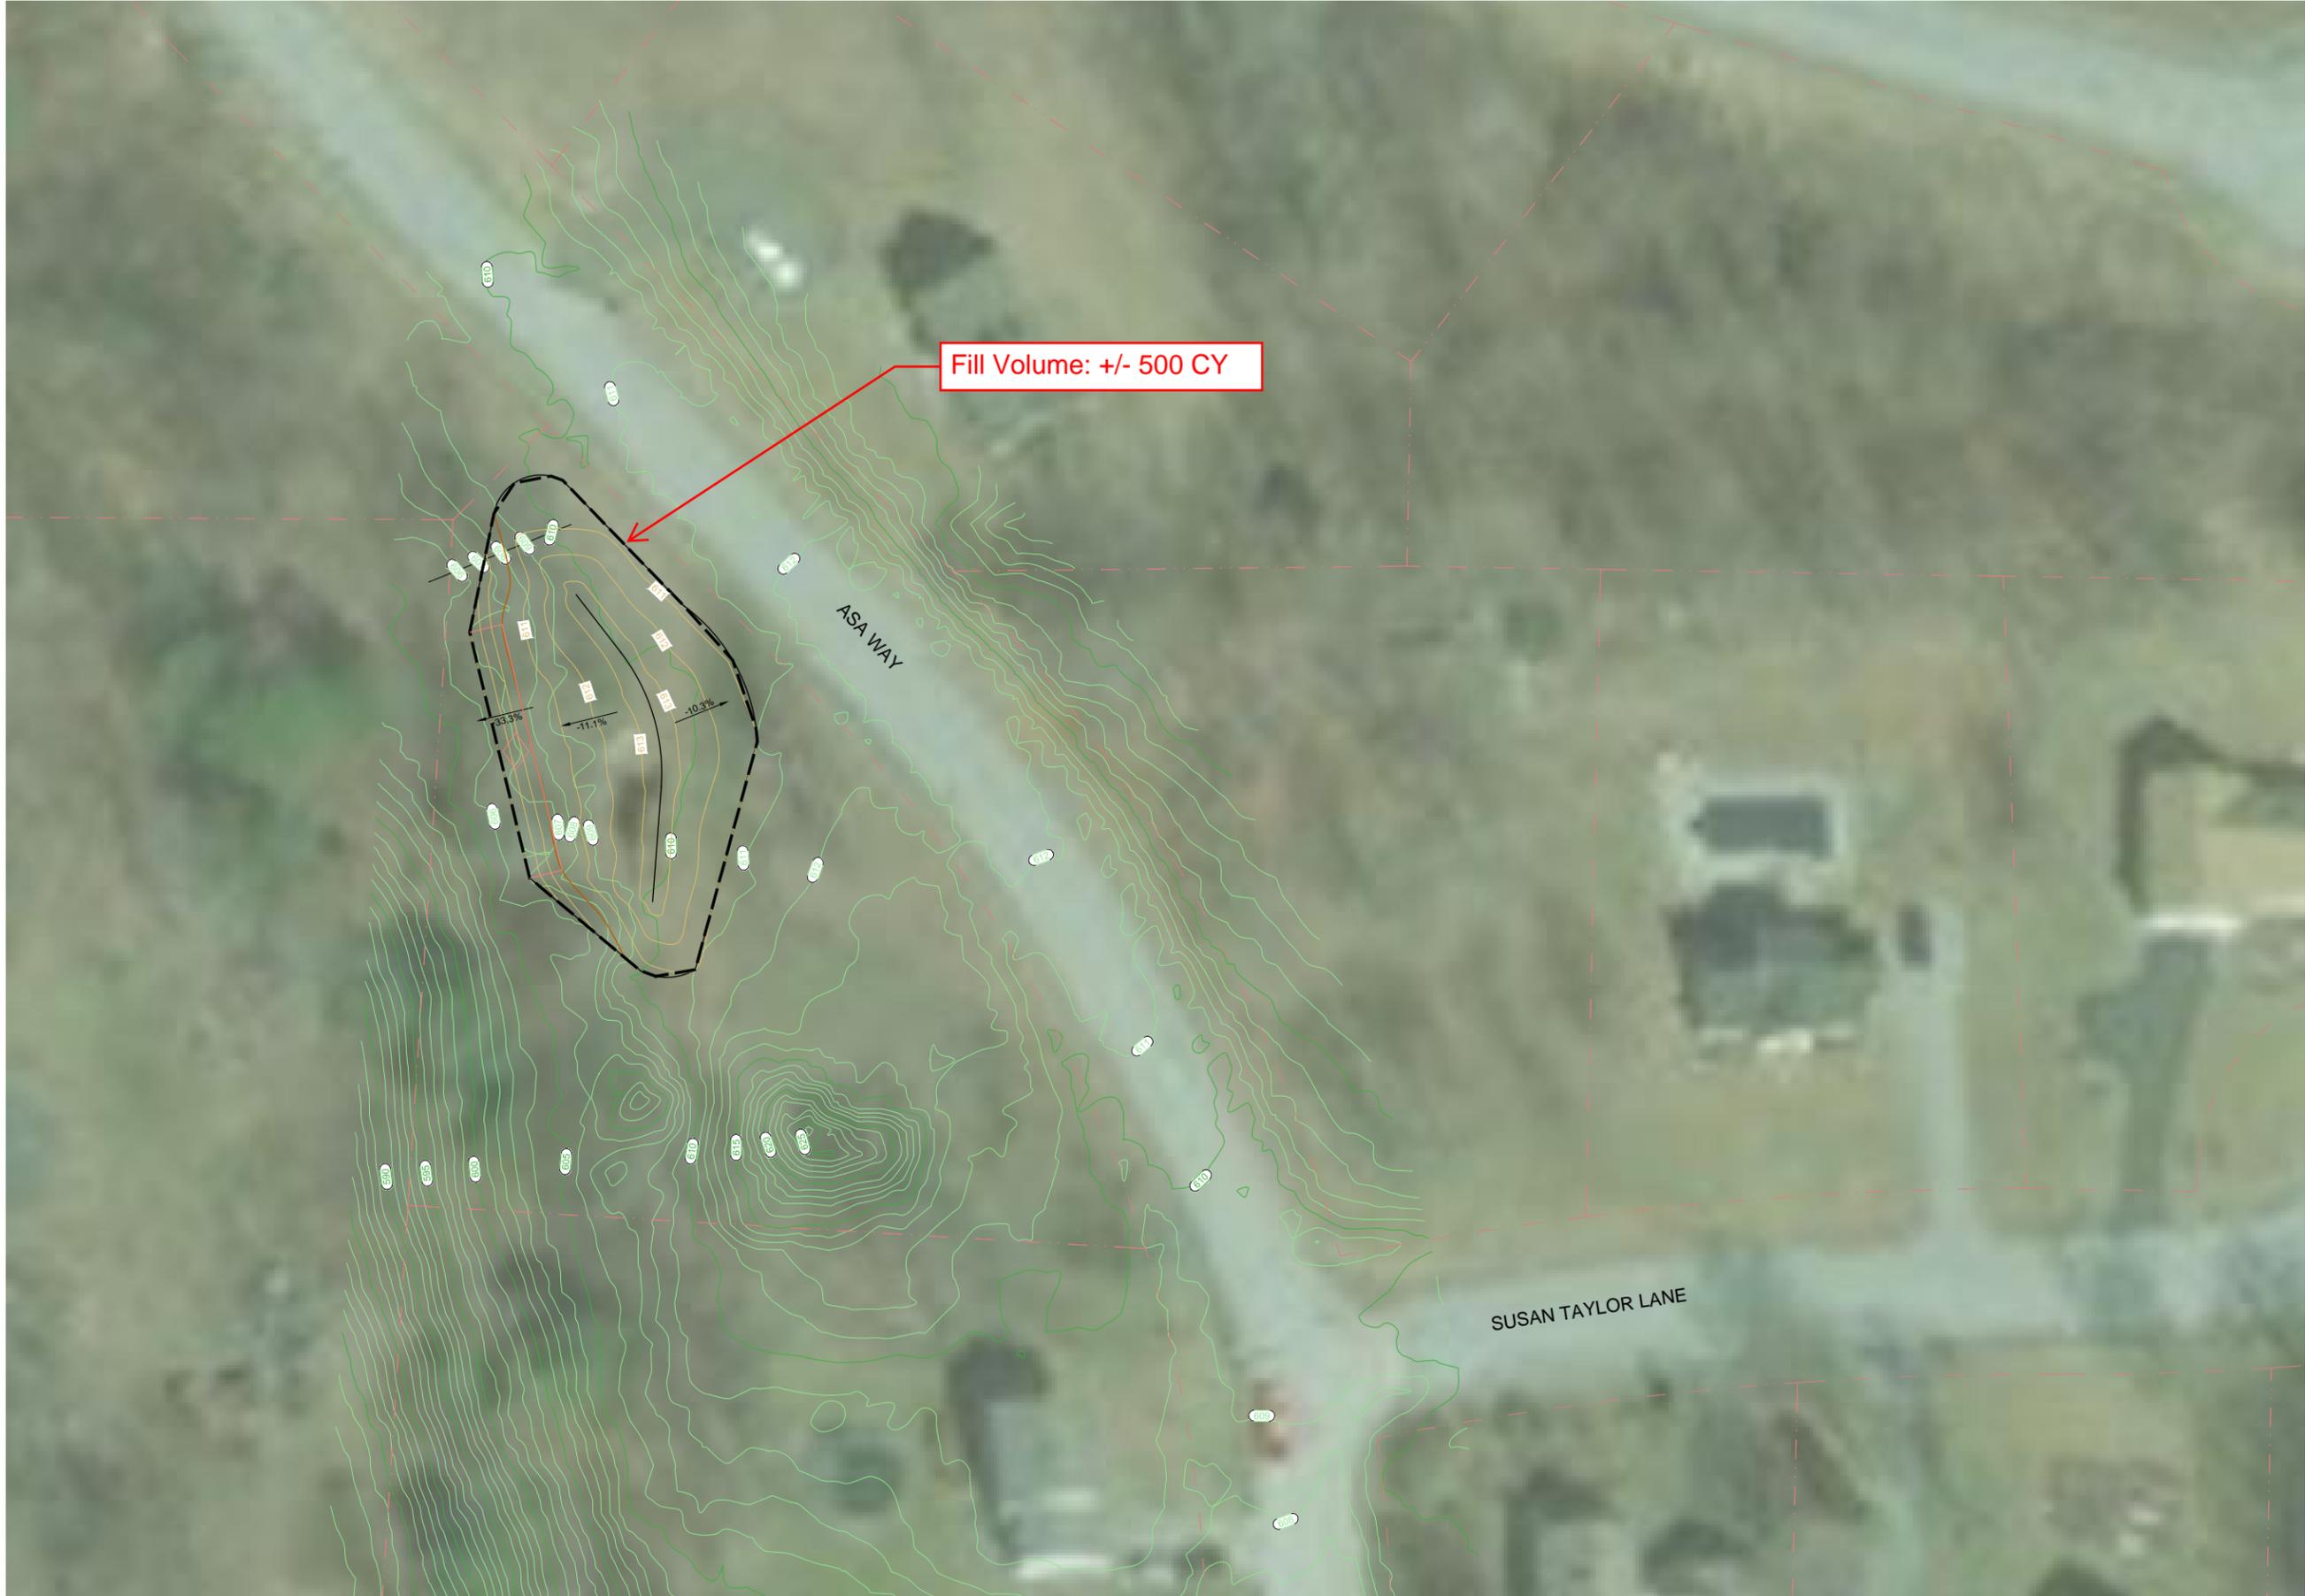
ASA WAY SPOILS SITE
 0 30 60 Feet

Fill Volume: +/- 500 CY
