## Memorandum

**To:** Richard Spiese - VTDEC  
**From:** Alec Danielson and Mary Sands – Barr Engineering Co.  
**Subject:** Former Chemfab Facility, 1030 Water Street – Building Materials Corrective Actions  
**Date:** September 25, 2019  
**Project:** 45021004.01  
**c:** Chris Angier – SGPP, Kirk Moline – CT Male

**ATTACHMENT A**  
**PHOTO DOCUMENTATION**  
BENCH TESTING OF  
CLEANING METHODS  
1030 Water Street  
North Bennington, VT  
Saint-Gobain

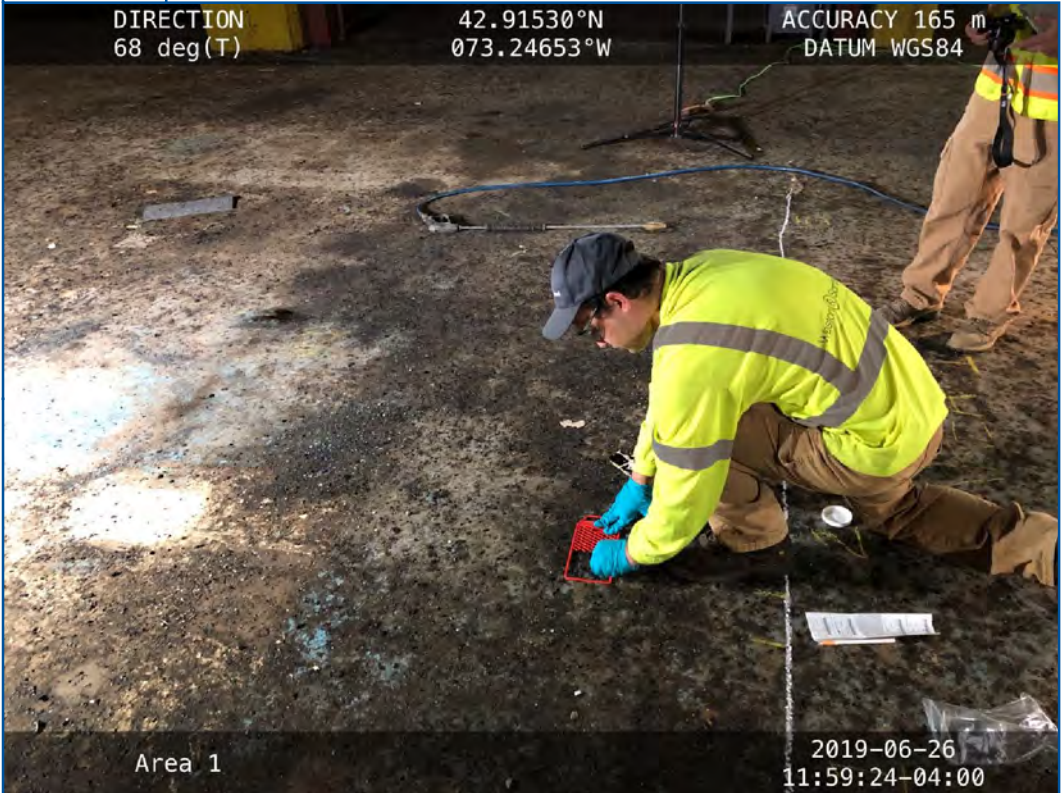
**PHOTO 4**

**Caption:** Weston collecting pre-cleaning wipe sample

During the building cleaning evaluation, VTDEC coordinated with Weston & Sampson to collect pre- and post-cleaning wipe samples for PFOA. Based on cleaning removal efficiencies calculated by Weston & Sampson using the wipe sample results, Weston & Sampson also concluded that hot water pressure washing with the degreaser was the most effective cleaning option. The Weston & Sampson wipe results and analysis are provided in Attachment B.

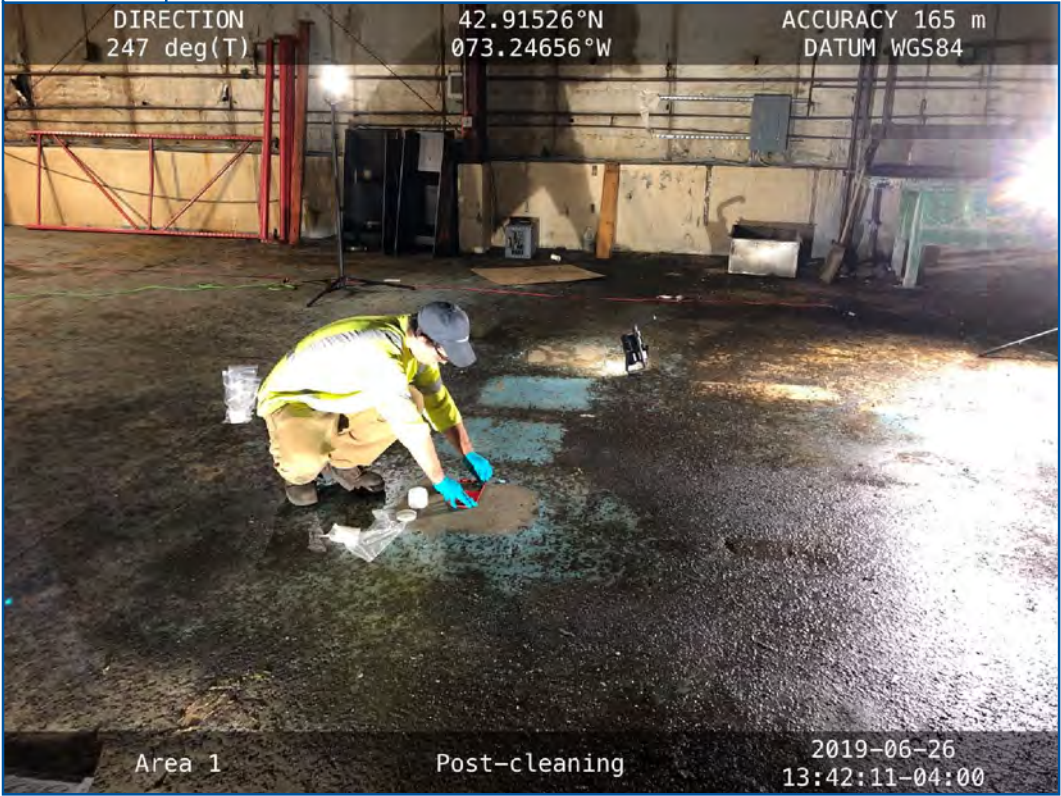
**PHOTO 16**

**Caption:** Weston collecting post-cleaning wipe sample

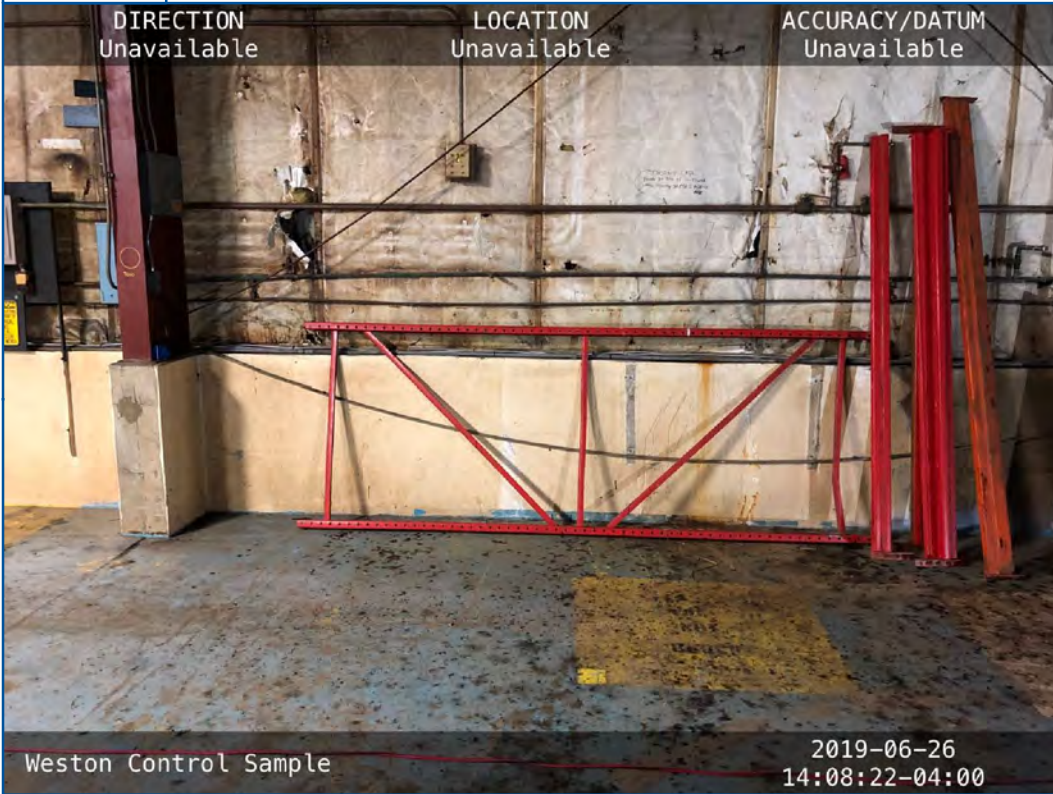
**PHOTO 17**

**Caption:** Location of Weston control sample on 6/26

A “control” sample was collected from a 4” x 4” area of the concrete floor from an area distal to the cleaning test area. A total of three (3) wipe samples were collected sequentially from this single location of concrete to determine PFAS sampling efficiency of each media.

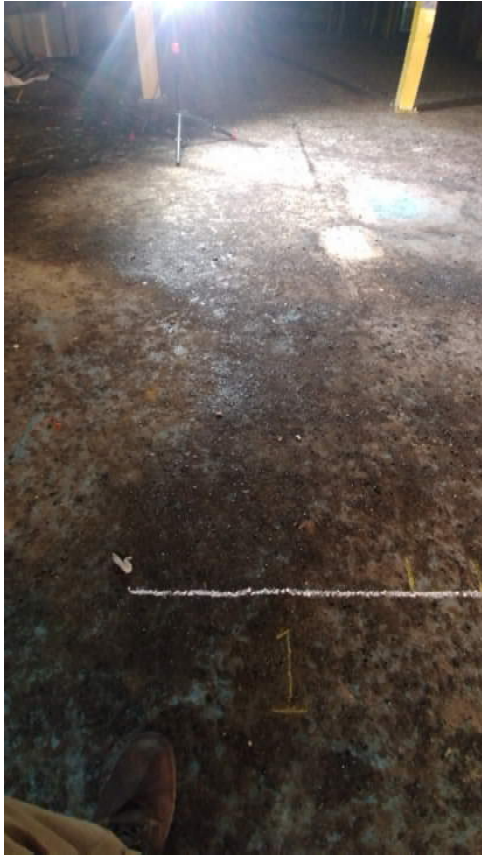
Photo #1  
Concrete Floor Sampling Area

The wipe samples were collected on June 26 and 27, 2019. The owners contractor selected an area of concrete floor and ceiling I-beam that appeared to be uniformly stained. The flooring area was divided it into 4 roughly 2 foot by 2 foot cleaning test sections. The I-beam test area was roughly 1 foot by 6 feet divided into 4 cleaning test sections.

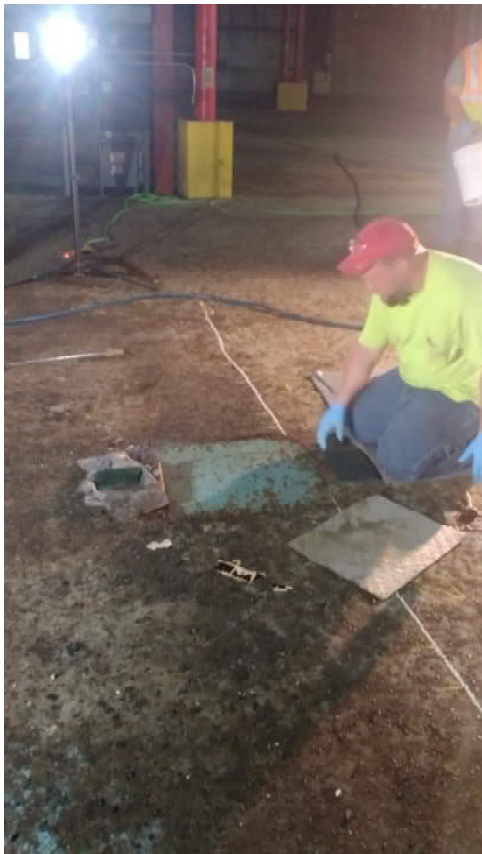
Photo #2  
Concrete Floor Being Cleaned

Four (4) cleaning methods were tested. The methods utilized by the owners contractor were 1) physical scraping with warm water and nylon pads, 2) pressure washing, 3) physical scraping with a degreaser and woven pads and 4) combined pressure washing followed by degreaser.

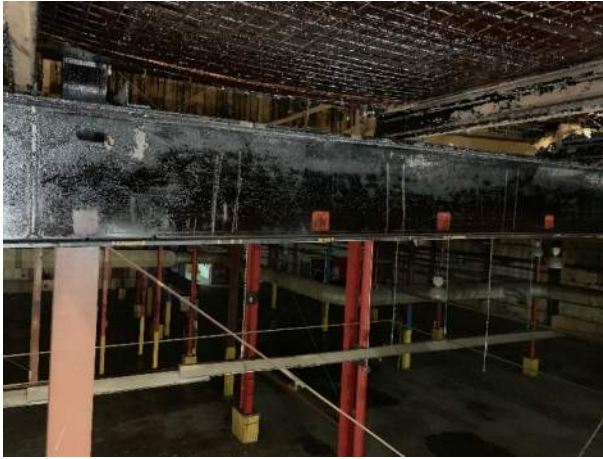
**Photo #3**  
I-Beam Test Area – Pre  
Cleaning, after Sampling

The vertical surface of the I-Beams had lower initial PFOA concentrations and much lower post cleaning concentrations between 0.5 and 4 ug/wipe, equating to an average 94% PFOA concentration reduction. The steel also appeared to be cleaner overall due to its non porous surface and vertical orientation. A duplicate sample was collected after cleaning from the degreaser area and showed excellent correlation

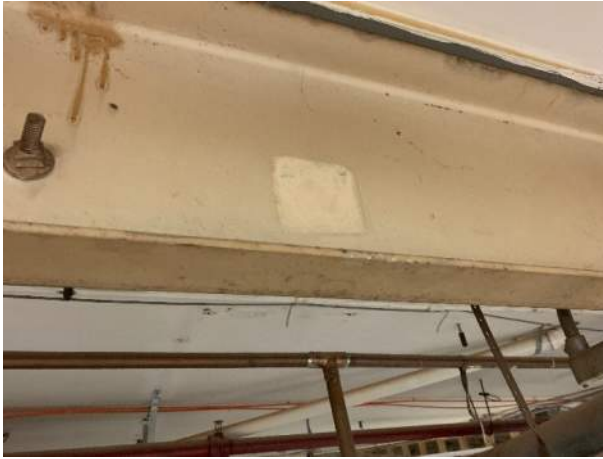
**Photo #6**  
Common Room I-Beam

Two (2) samples were collected from the “common area” in the 940 Water Street building (wall and I-Beam). The areas sampled appeared to be “original” building surfaces of brick and painted steel.

The “common room” in the adjoining building reported PFOA concentrations of 0.175 ug/wipe from the brick wall and 0.488 ug/wipe from the ceiling I-beam. The photographs of the sample locations attached do show some debris/dirt was removed from each location by the solvent wipes.
