**Whetstone Brook Watershed
Stream Geomorphic Assessment
And River Corridor Plan
May, 2008**

Prepared by:

Landslide Natural Resource Planning
P O Box 311
East Middlebury, VT 05740

Windham County Natural Resources Conservation District
28 Vernon Street
Brattleboro, VT 05301

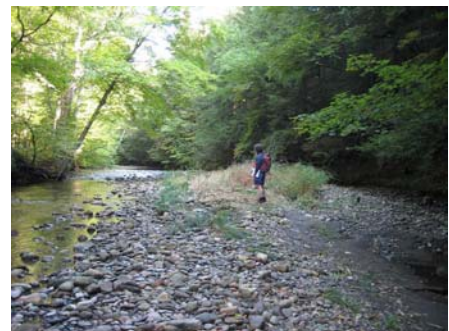
M05B

future. There is potential for floodplain restoration/conservation in segment B.

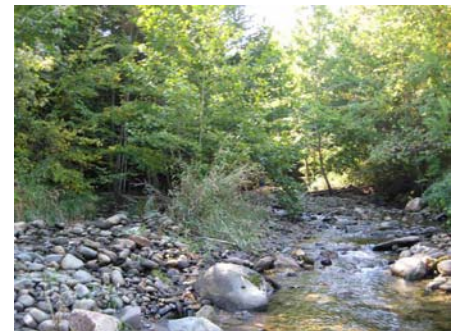
M07 – This reach is a Cb Riffle Pool by reference, located in a very broad valley type. It is currently a B4 with aggradation, widening and planform adjustments on-going. There is human caused change in the valley confinement to semi-confined due to Route 9. There are two bridges on the reach, both of which have deposition above and one of which has deposition below and is skewed to the stream, though not undersized. The other structure is both a channel and

M07 – Aggradation u/s of first bridge.

floodplain constriction. Geomorphic and habitat condition are both fair and there are six large point bars in the reach. The dominant soil type is highly erodible alluvium and the reach is 92% straightened. This reach is 47% developed with residential development being extensive in the river corridor.

Addressing the undersized and misaligned structures in this reach would allow for increased sediment transport. There is an eroding bank heading toward a private resident that needs to be stabilized. Otherwise, no additional development should be allowed to occur within the river corridor on this reach.

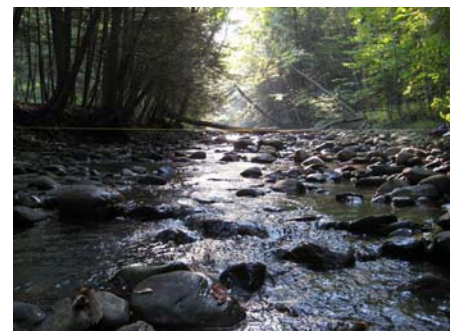
M08A

M08 – This reach is a Cb Plane Bed in a Broad valley type by reference. It was segmented twice due to

planform and slope. Segment A is currently a Cb Plane Bed and Segment B is a C Riffle Pool. Segment B is the downstream end of major planform adjustment that is occurring on Reach M09 due to historic straightening upstream and a dramatic change in channel slope. There are multiple flood chutes and meander migrations in the segment. Segment A is located on highly erodable alluvium though the right bank has extensive ledge along it and there is a natural constriction in the valley type. Both habitat and geomorphic condition are good for Segment A. Geomorphic condition is Fair for Segment B and habitat is Good. There are no storm water inputs on this reach!

This entire reach is a candidate for corridor conservation due to the notable lack of encroachments in the corridor.

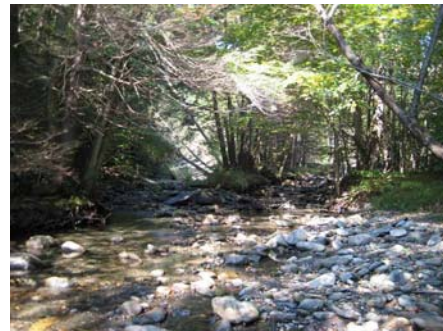
M09A

M09 – This reach is a Cb Plane Bed stream by reference, located in a very broad valley setting. Segment B is a B Plane Bed by reference. The dominant geologic material is highly erodable alluvium, the left riparian buffers are intact and the right buffer is 0-25’ and though the corridor has 30% urban development. Groundwater inputs are abundant and the channel is 51% straightened. The reach was segmented in two during the Phase 2 Assessment due

to planform and slope, channel dimension, substrate size and depositional features. Both segments have a human caused change to valley width, from very broad to narrow for segment A and to semi-confined for segment B, due to Route 9. Segment A is currently a C4 Riffle Pool stream type with very active planform adjustment, aggradation and widening occurring. There is one private bridge that is both a channel and floodplain constriction with deposition above and below it. There are multiple bar features and eight flood chutes in this segment and there are three mass failures on the right bank totaling 403’ in length. There is recent windrowing and dredging at the upstream end of the segment. Both habitat and geomorphic condition are fair.

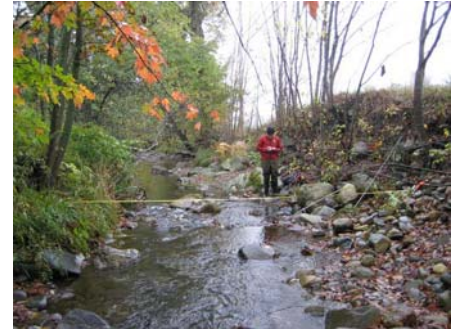
T1.02C

Segment C is departed to an F step pool. It is almost 100% straightened and bermed and lacks riparian buffers. There is an old meander scar on the left terrace. Both habitat and geomorphic conditions are fair.
