River Corridor Planning on the Batten Kill, Vermont

Prepared by:
John J. Field
Field Geology Services
Farmington, ME

Submitted to:
River Management Program
Department of Environmental Conservation
Vermont Agency of Natural Resources

March 2007

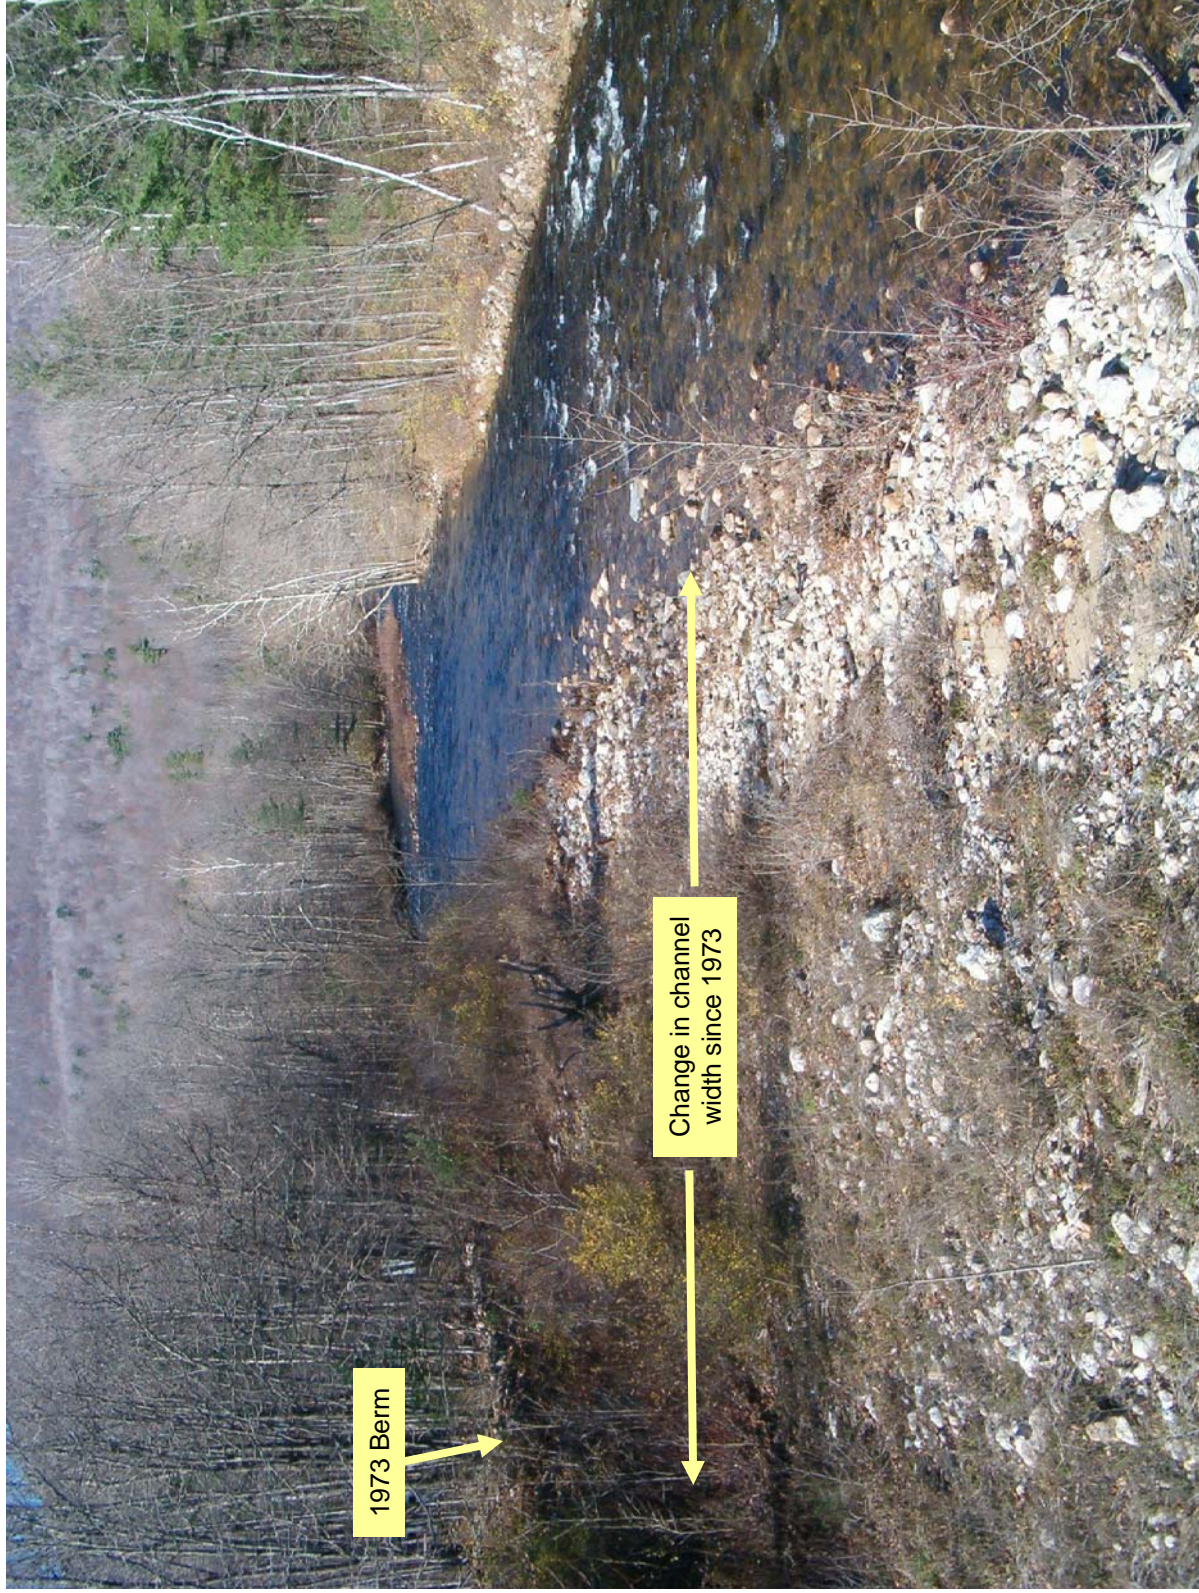
Figure 3. Gravel bar deposition has narrowed Roaring Branch since berming was completed in 1973.

Sediment supplied from croplands is considered insignificant compared to what is supplied from the upper watershed via the tributaries, although the croplands may increase the supply of fine silts and clay. While quantifying tributary inputs is difficult, the delivery of that sediment to the mainstem is evident from the numerous gravel bars found at the lower ends of tributaries (Figure 3),

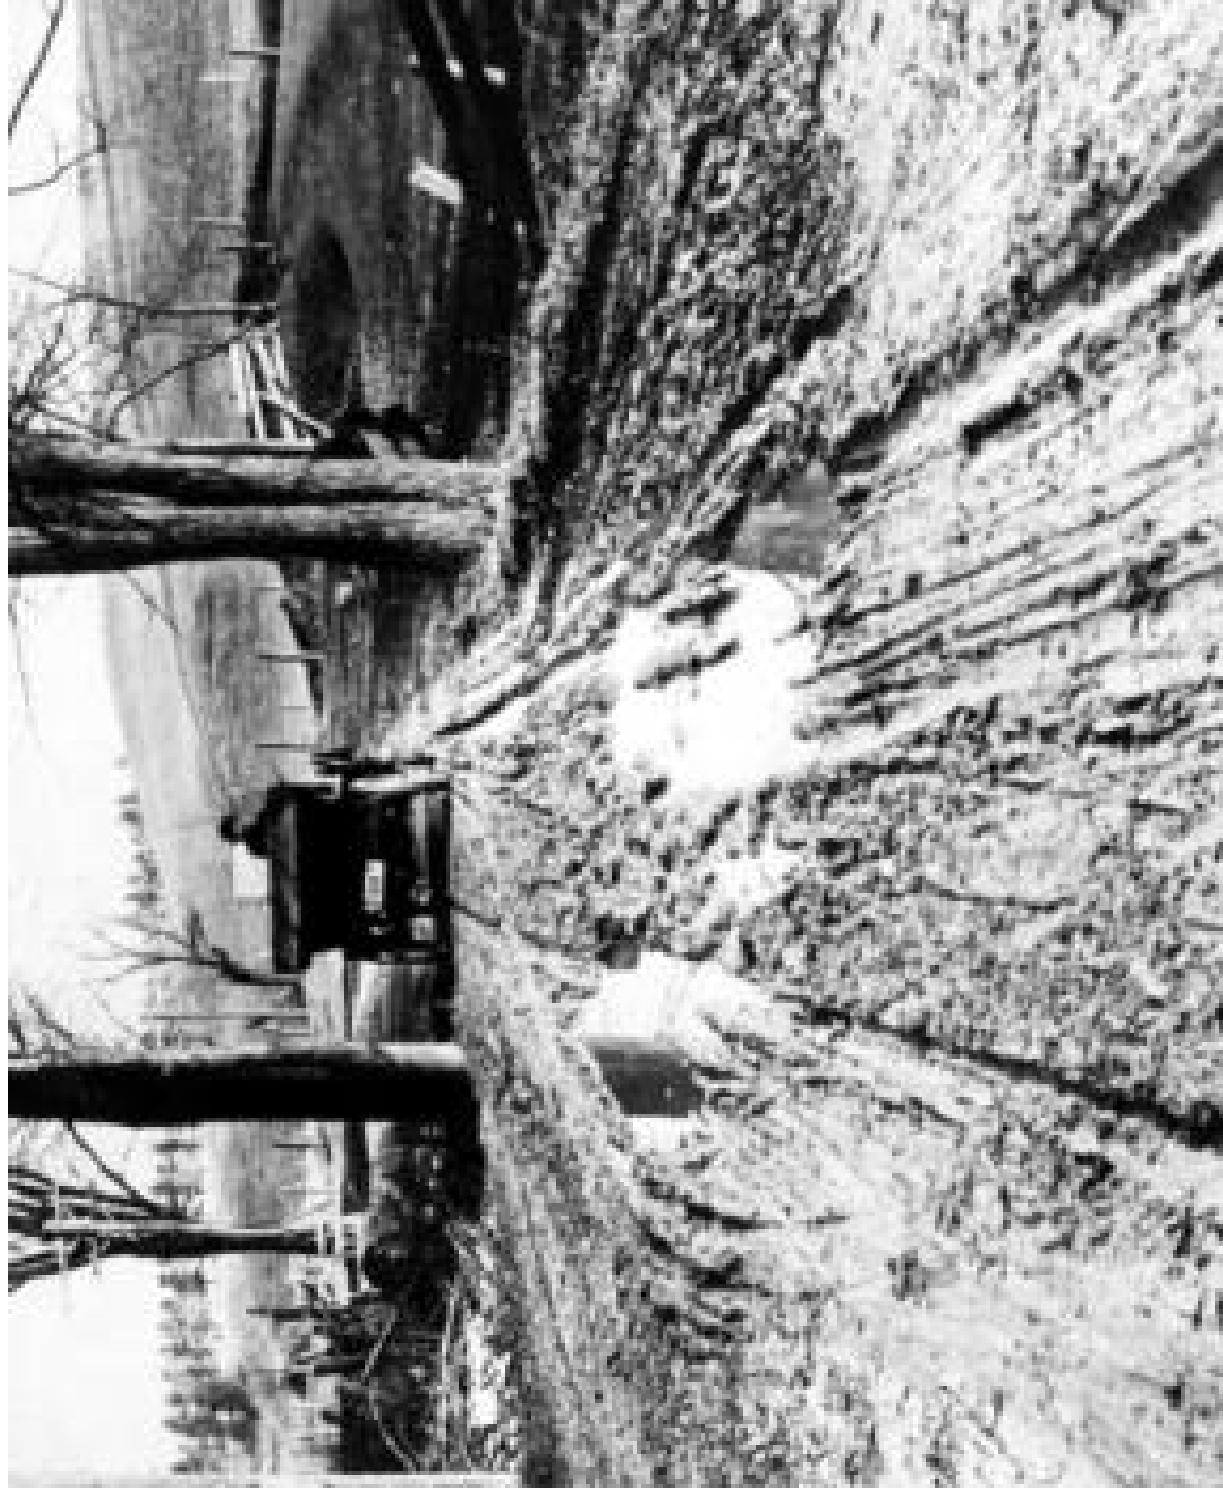
Figure 6. 1913 ground photograph in Arlington, VT showing cleared hillslopes that contributed large quantities of sediment to the valley bottom.

Although difficult to quantify, the greatest impact on the hydrologic regime in the Batten Kill watershed is related to the extensive deforestation that occurred over 100 years ago (Figure 6). The loss of interception and evapotranspiration afforded by the tree cover likely resulted in significant increases in runoff to the river channel. With subsequent reforestation over most of the watershed during the past several decades, runoff has declined and returned closer to the natural condition. This

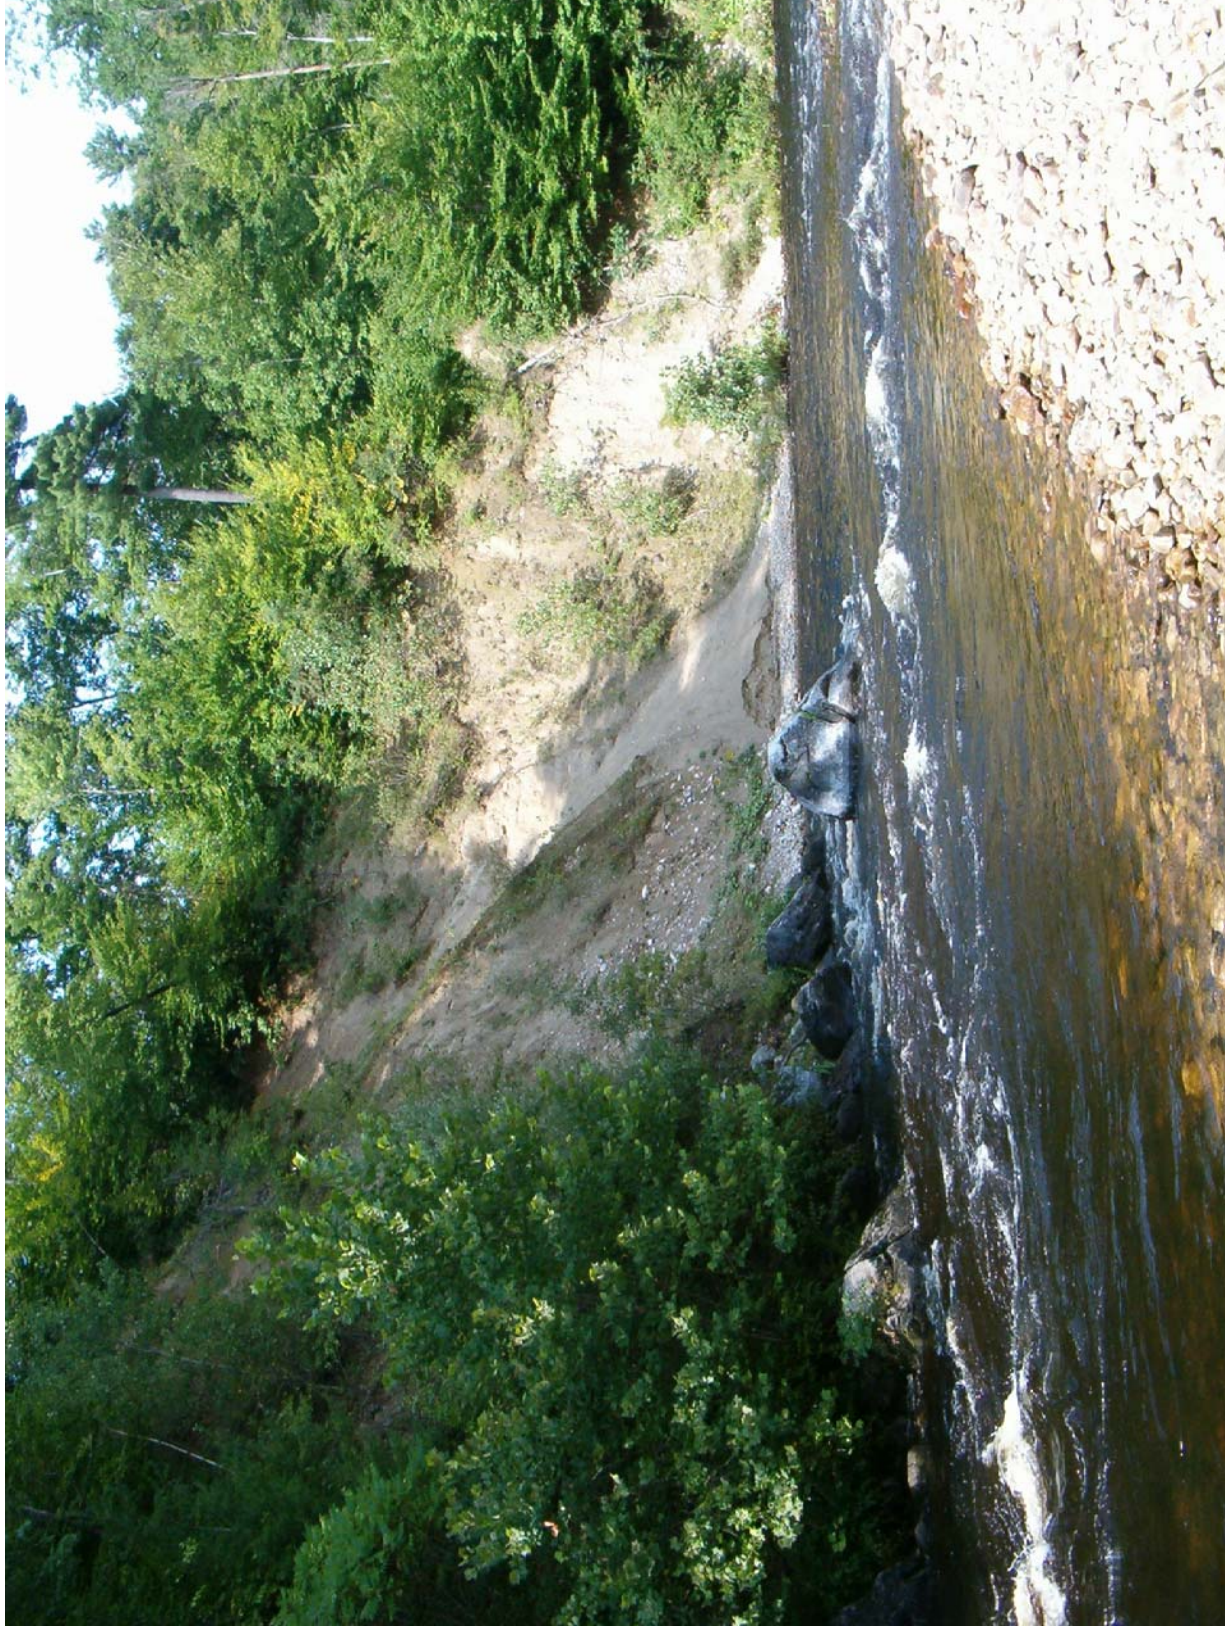
Figure 8. Mass wasting at confluence of Roaring Branch. A portion of the gravel delta bar at the mouth of the bermed tributary bar is visible in the right foreground.

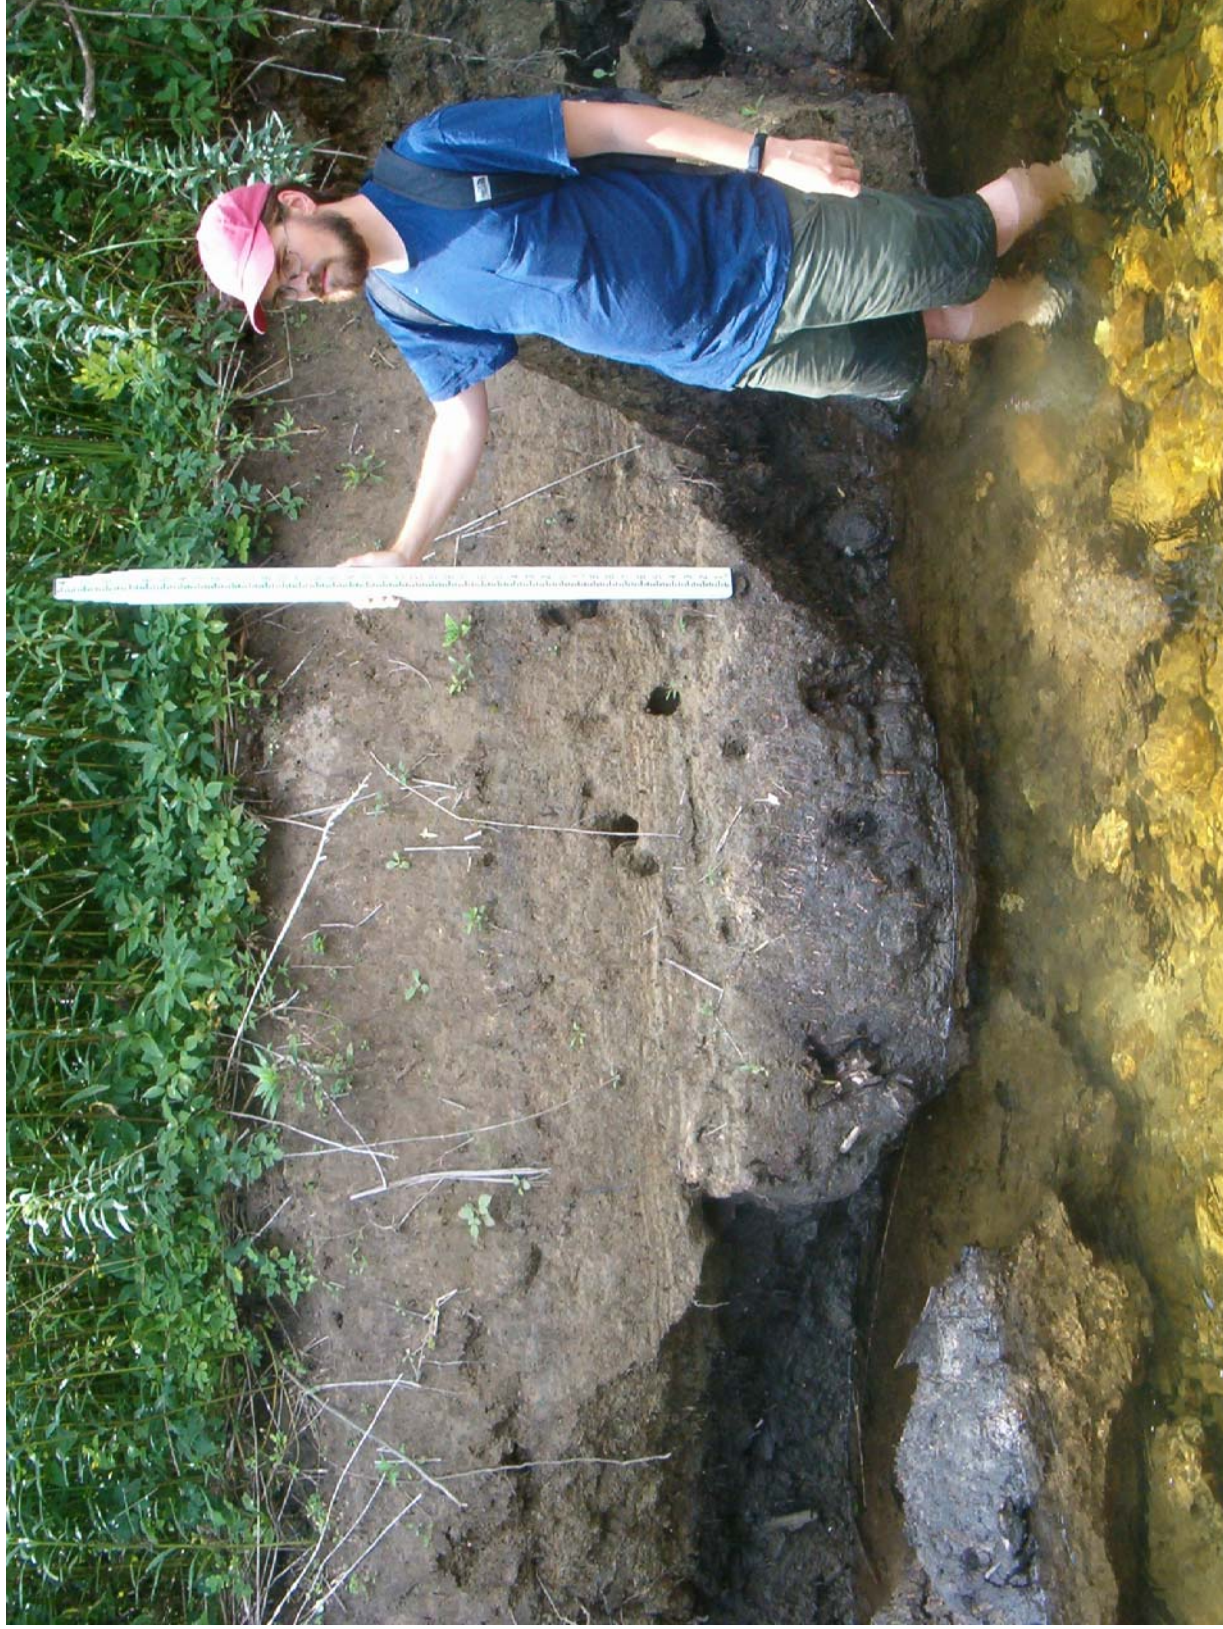
Figure 9. Historic sediments (light colored) deposited over older floodplain sediments (dark colored) in response to post-European settlement land clearance. Base of stadia rod is on contact between 2 deposits.

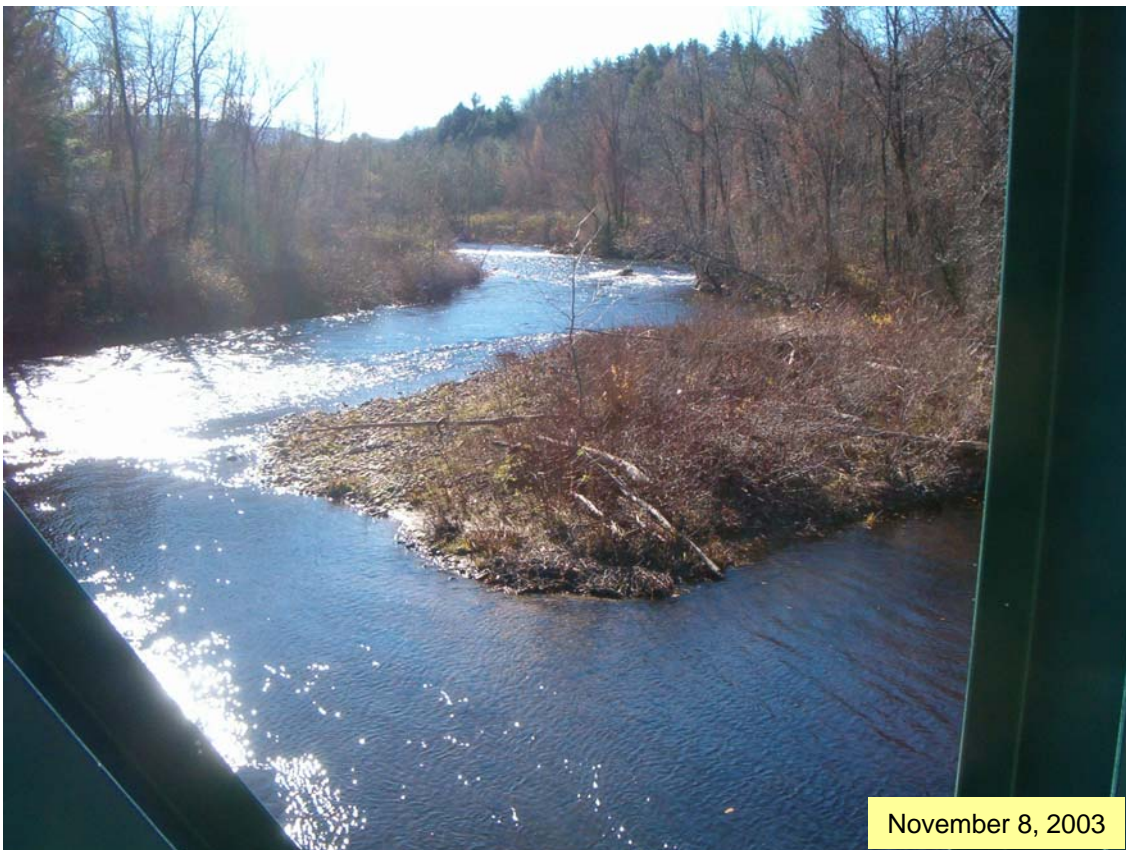
Figure 12. Photographs from the same position looking upstream from the West Mountain Bridge in Arlington (Reach M3) showing growth of gravel bar and meander in backwater of bridge due to excess sediment delivered from breached dam (visible in old photograph) and Roaring Branch after construction of berms in 1973.

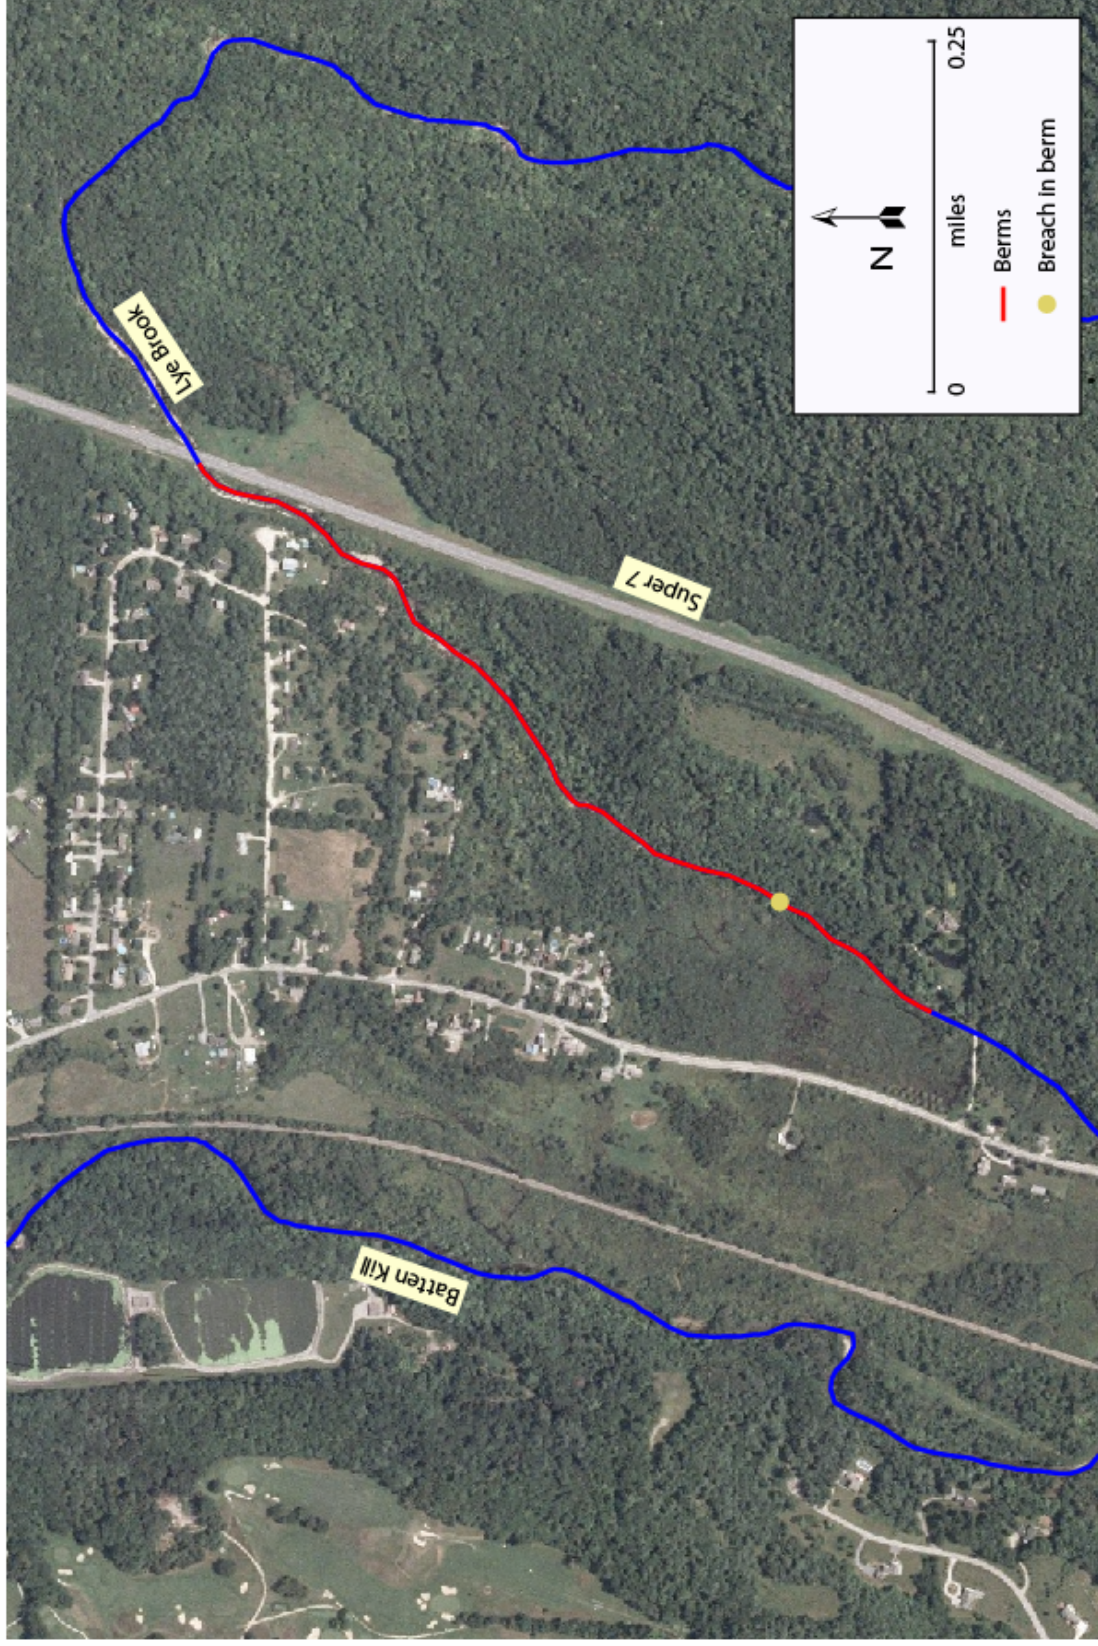
Figure 16. Close up of Lye Brook alluvial fan showing location of berms relative to human developments.

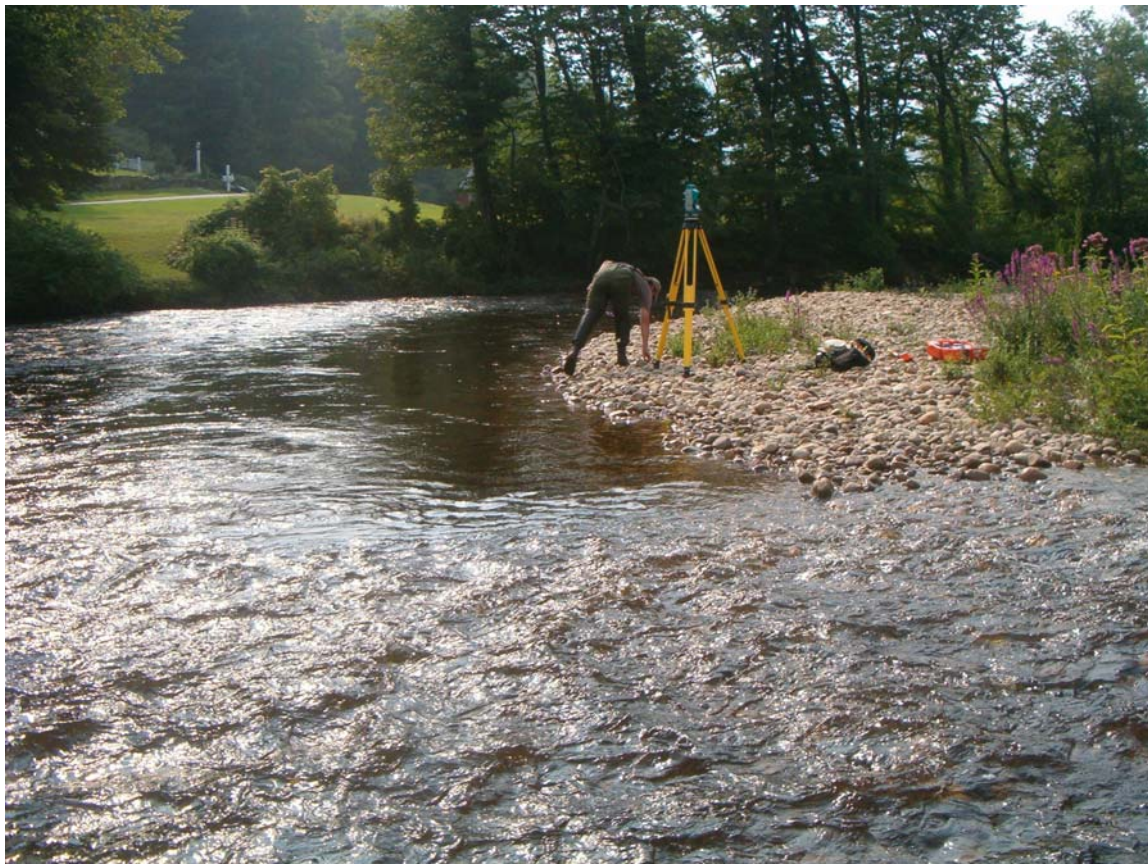
Figure 18. a) Unvegetated gravel bar on inside bend of recently formed meander at “break out” point in Segment M3-B. b) Vegetation covering older gravel bar formed when formerly straightened channel (shown) was formed to create a meander (not shown) in Reach M9.
