River Corridor Plan
Lewis Creek: Reaches M14 – M18
Towns of Hinesburg, Monkton, and Starksboro
Chittenden & Addison Counties, Vermont

February 2008 (Revised March 2008)

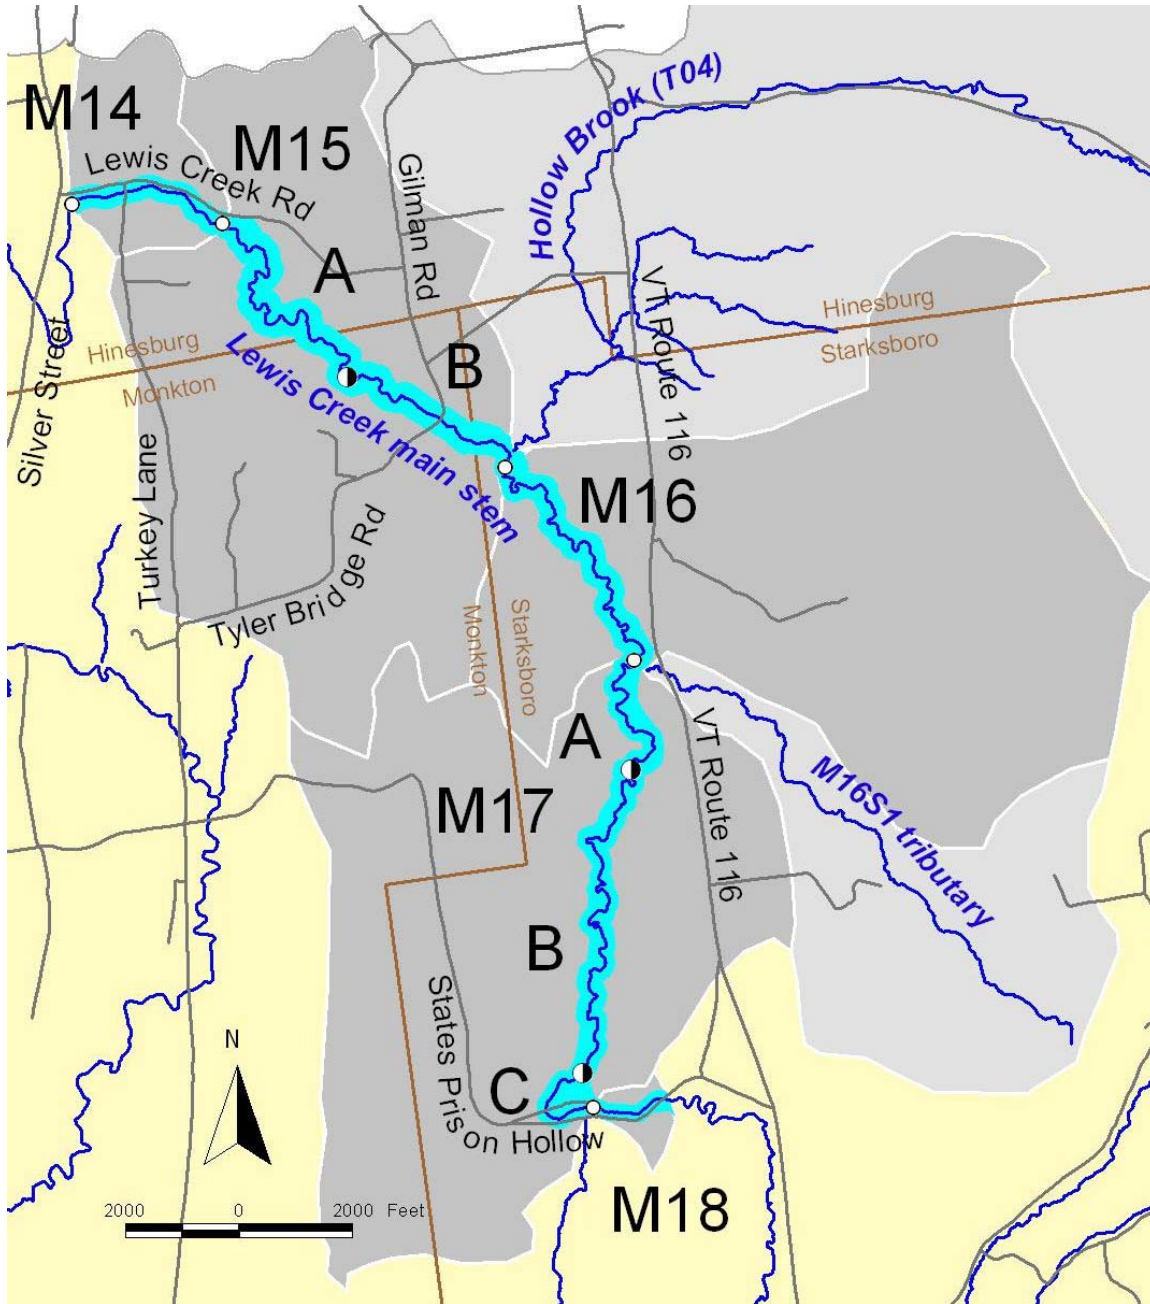
Figure 3. Corridor reaches, M14 – M18, and segments.

These five reaches comprise a 6.7-mile section of the main stem from the States Prison Hollow Road crossing in Starksboro downstream to the intersection of Lewis Creek Road and Silver Street in Hinesburg (Figure 3).

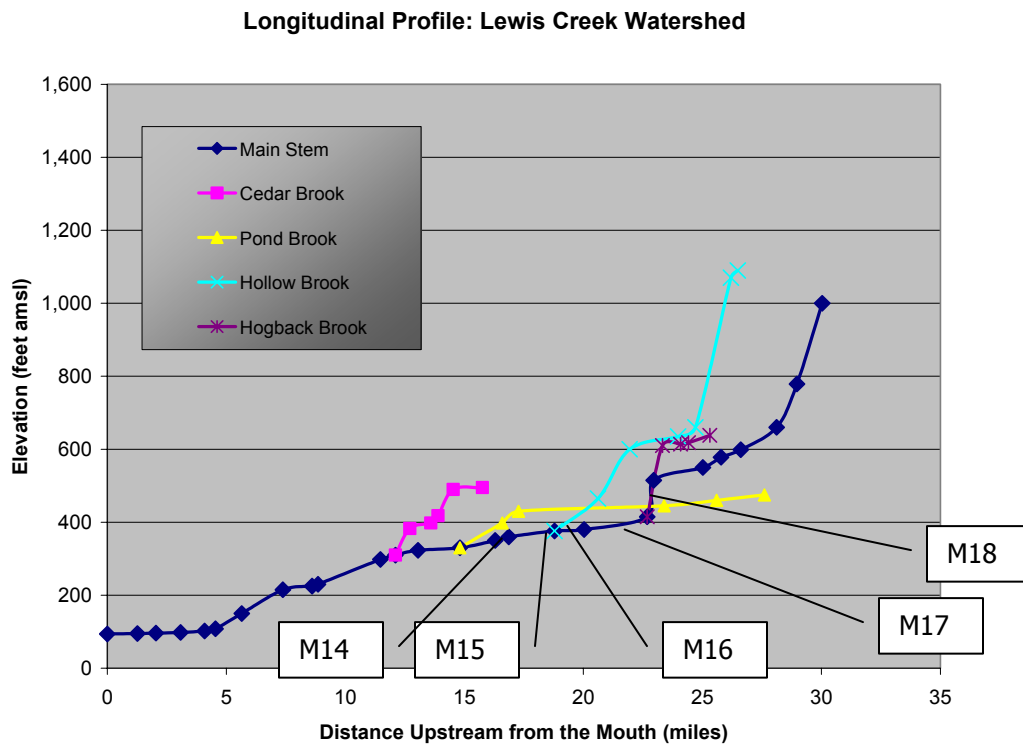
Figure 5. Longitudinal profile of Lewis Creek main stem and select Major Tributaries.

The corridor reaches vary in elevation from 515 ft amsl (upstream end of reach M18) to 350 ft amsl (downstream end of reach M14). Reach M18 is a steep (6.9%) bedrock gorge located in a semi-confined, forested valley along the States Prison Hollow Road in Starksboro. The channel bed consists of a series of cascading bedrock waterfalls and alternating bedrock and boulder steps and pools. This channel form is classified by geomorphologists as a B-step pool stream type (Rosgen, 1996; Montgomery-Buffington, 1997). In contrast, the Lewis Creek channel downstream of this gorge is generally low-gradient (less than 0.5%), unconfined by the valley walls, and meandering through a very broad floodplain setting (C and E stream types after Rosgen, 1996). Near the downstream end of the corridor in reach M14, the channel is once again partly-confined by steep, bedrock-controlled valley walls, but maintains a shallow slope (0.3%); this stream type is classified as a Bc-channel.

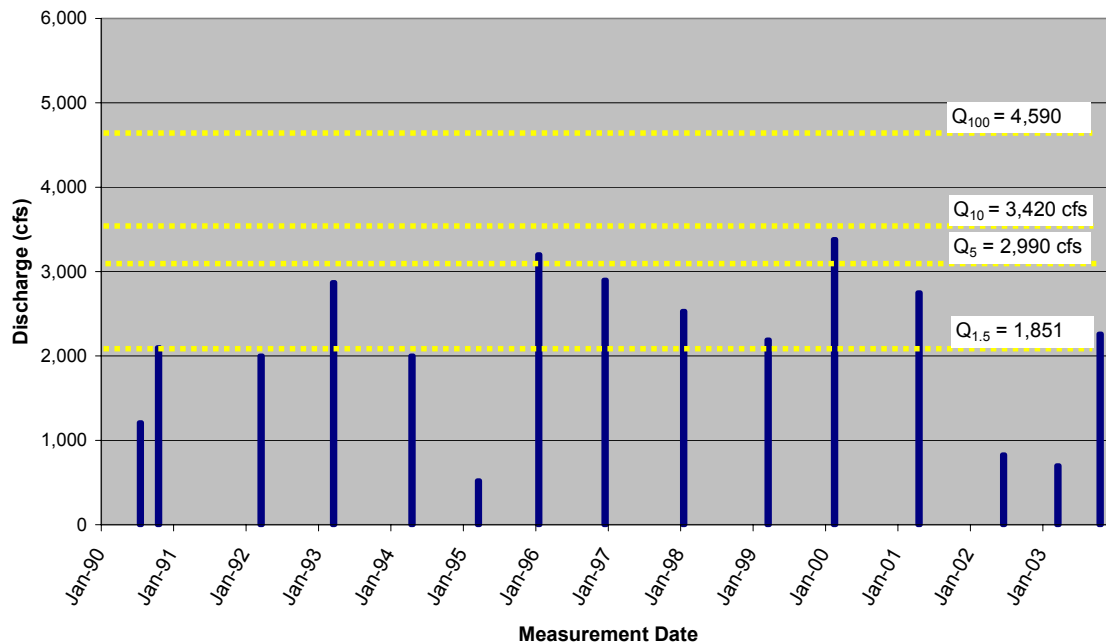
Figure 7. Recorded Peak Flows for Lewis Creek, Route 7 Gage Station #04282780 (compared to estimated flood peaks after Olson, 2002)

**Peak Discharges, Lewis Creek at North Ferrisburg, VT
USGS Stn #04282780, 77.2 square miles, Reach M05**

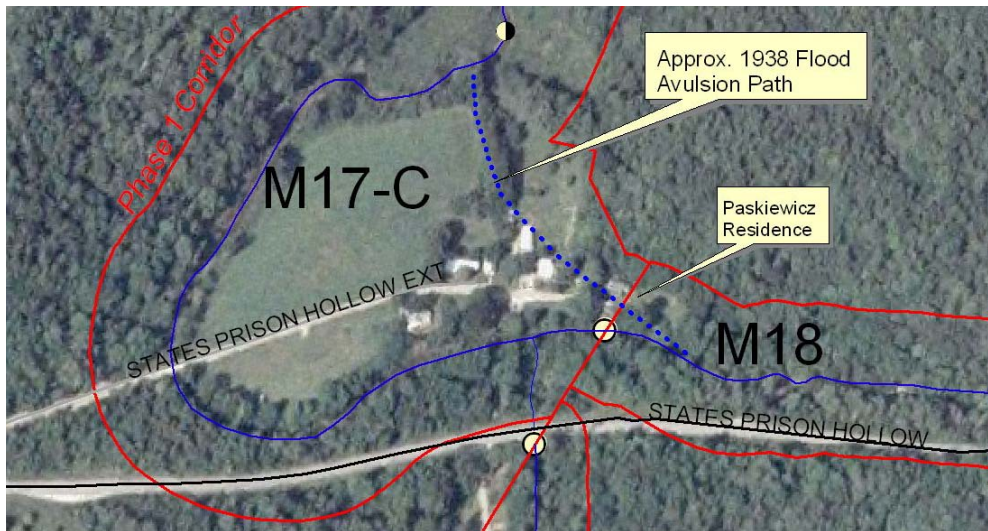
Figure 8. Avulsion site on reaches M18 and M17 (Segment C) in 1938 flood.

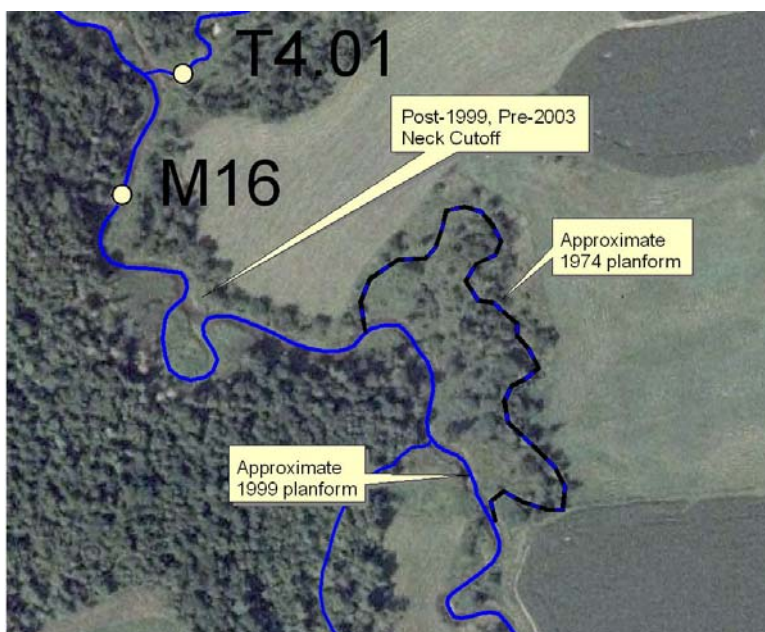
Figure 10. Localized slope reductions related to sedimentation at the confluence of Hollow Brook tributary (T4.01) may have contributed to recent lateral adjustments in the Lewis Creek main stem. A post-1974, pre-1999 avulsion resulted in a large abandoned meander northeast of the present channel. A post-1999, pre-2003 neck cutoff has created a small oxbow south of the channel.

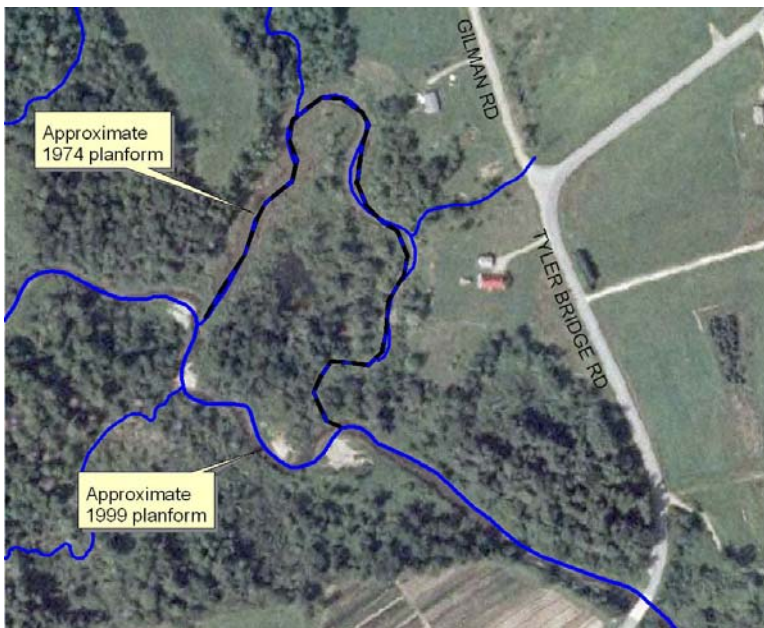
Figure 12. Abandoned meander at mid-section of reach M15 (Segment B) downstream of the Tyler Bridge Rd bridge. Review of annual fly-over images at the NRCS Middlebury office indicates that this avulsion occurred over a period of time from 1994 to 1995. Cut off of this broad meander resulted in a loss of 1000 ft of channel length. The avulsion and subsequent channel adjustments may have contributed to recent aggradation in Segment A. (Base image is dated 2003)

On the other hand, reaches/segments M17-B, M17-A, M16, and M15-A have experienced increased sediment attenuation in recent years, related to the upstream and in-reach production of sediments. These reaches are minimally constrained or largely unconstrained by infrastructure such as roads and development. They have maintained reasonable access to the floodplain ($IR_{RAF} = 1.0$ to 1.25 ; $ER = 9$ to 36). In locations of previous channelization, substantial lateral adjustments have occurred (meander extension, meander translation, neck cut-offs, avulsions), facilitated in discrete locations by absence of woody buffers and erodible streambank sediments. Sediment attenuation has been increased in vicinity of beaver dams which tend to persist for a few to several months each year, and then wash out during bankfull or higher storm events. Sediment deposition at the confluence of Hollow Brook may be contributing to aggradation and lateral adjustments at the downstream end of M16 (Figure 10). In the case of M15-A, the transition from a Very Broad confinement to a bedrock-controlled Semi-confined valley in reach M14, has probably contributed to aggradation and planform adjustments in M15-A (Figure 11). Enhanced aggradation has been associated with a recent (1994-1995) avulsion in segment M15-B (Figure 12).

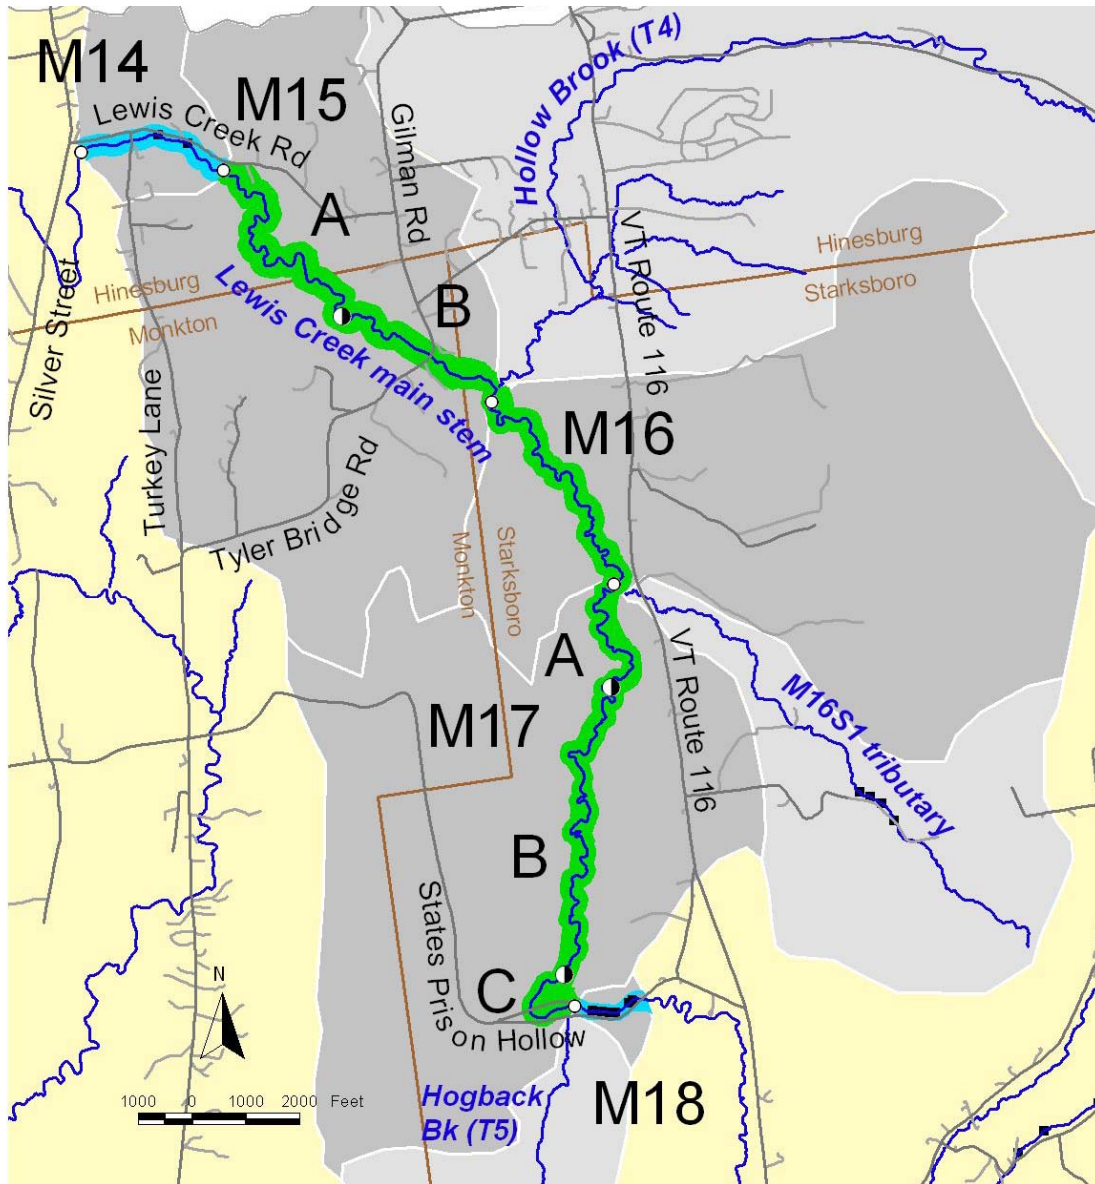
Reach / Seg	Phase 1 Reference Stream Type
M18 --	B2a-S/P
M17 C	C4-R/P *
M17 B	E4-R/P
M17 A	E4-R/P
M16 --	E4-R/P
M15 B	C4-R/P
M15 A	E4-R/P *
M14 --	B3c-R/P

Figure 13. Phase 1 (Reference) Sediment Regime Map
Lewis Creek Corridor Reaches M14 through M18

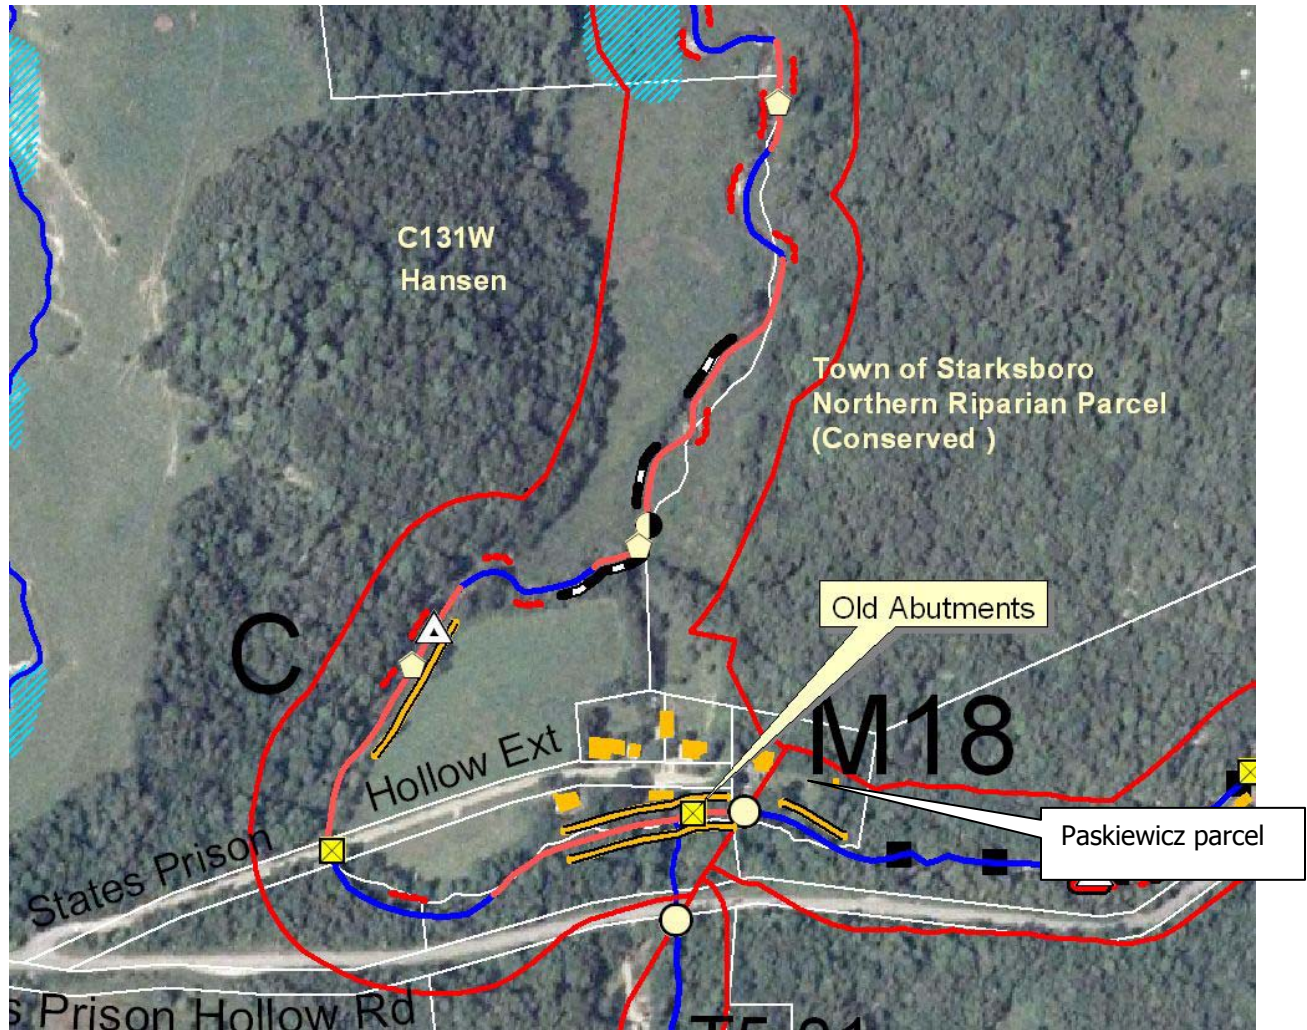
Figure 3. Phase 2 stream geomorphic assessment data for Segment C of reach M17 in vicinity of Paskiewicz residence. *Old abutments are present, just downstream of Paskiewicz residence at the location of the former crossing of States Prison Hollow Road, a portion of which now remains as States Prison Hollow Extension. White lines indicate parcel boundaries. Base photograph, dated 2003.*

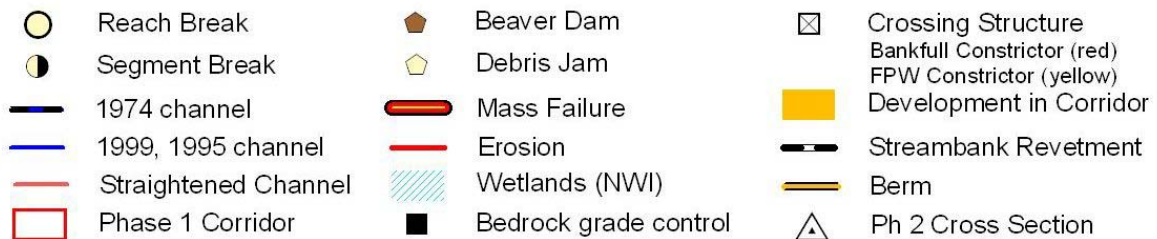
Starksboro C131W – Reach M17, Segments C, B - Hanson

| | 1974 channel | | Mass Failure | | FPW Constrictor (yellow) |

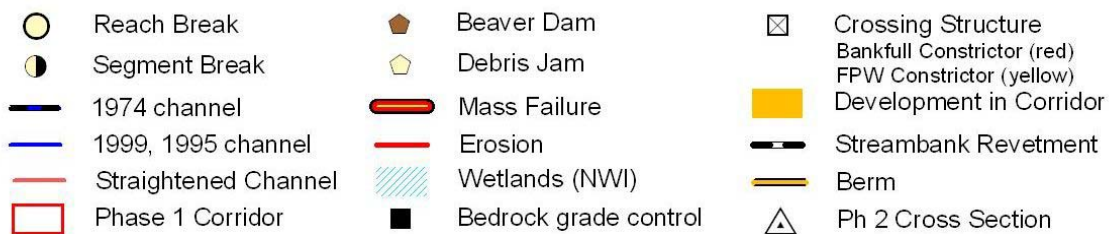
Description: Former Cota Farm lands – fallow agriculture and forest - along right and left banks downstream of States Prison Hollow Road Extension. Bordered on south by Hanson Farm and on north by LaRue lands. Limited armoring and historic channelization, especially near southern extent of parcel. Conservation easement held by Vermont Land Trust.

Figure 1. Northern Riparian Parcel, Lewis Creek Reach M17-B.

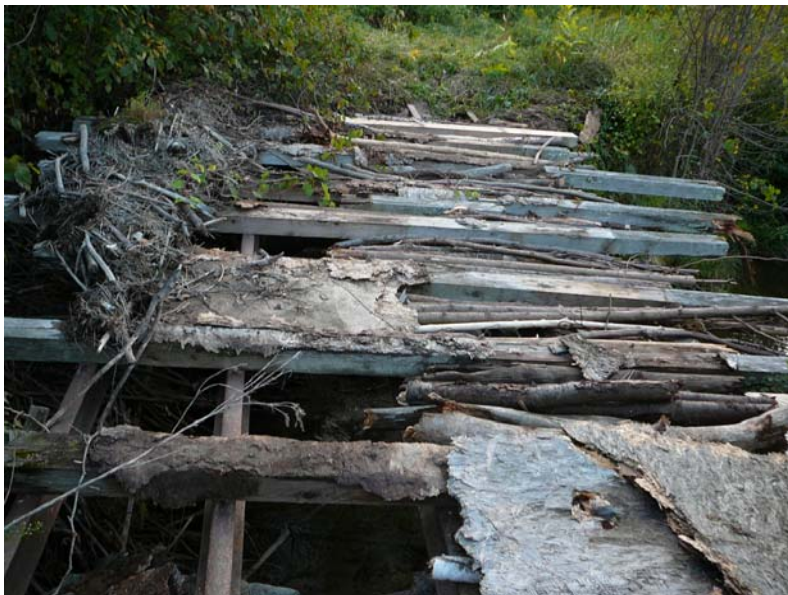
Figure 3. LaRue private bridge,
Reach M17, Segment B
10 September 2007

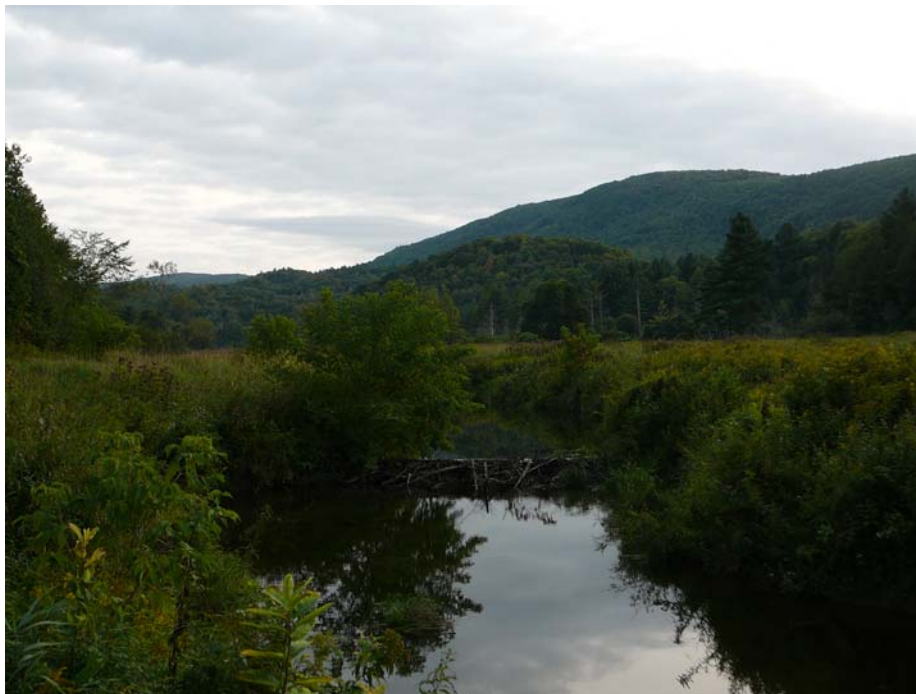
Figure 4. View upstream (south) from center of LaRue property; beaver dam in foreground; Hogback Mountain in background.

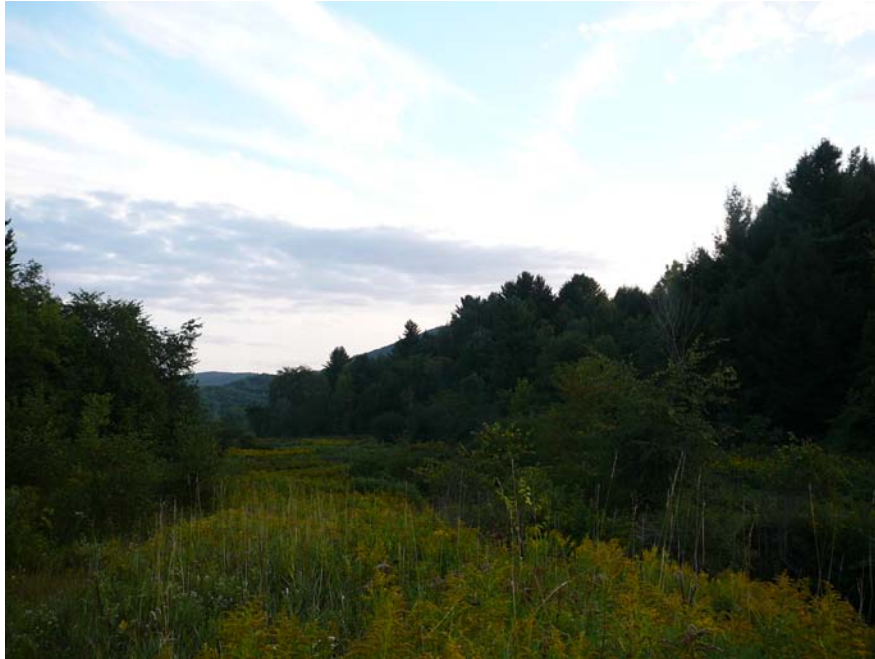
Figure 5. View upstream (south) from vicinity LaRue private bridge.

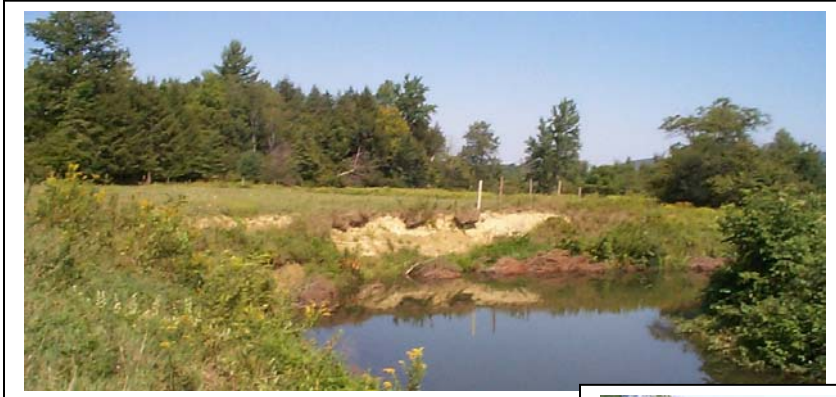
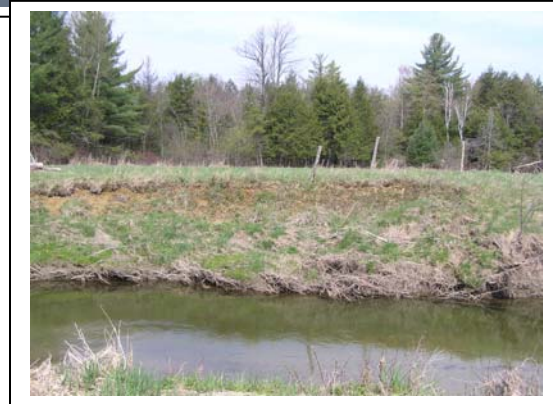
Figure 2. Meander Bend A at Clifford site (reference Map 1). (Above) - meander in August 2001 exhibiting active slumping and erosion; note cedar revetments along water line. (Right) - meander in May 2005, erosion mostly healed.

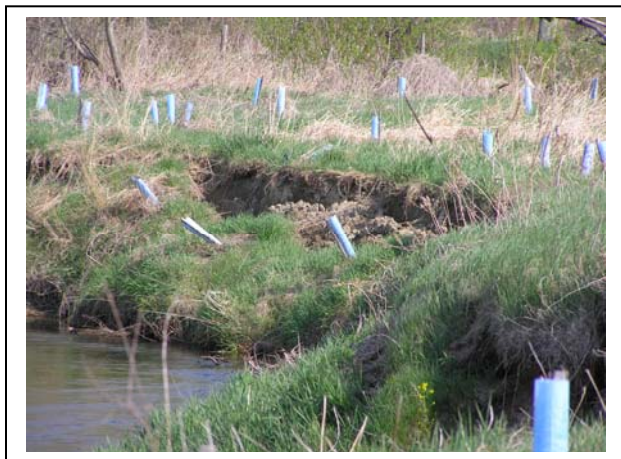
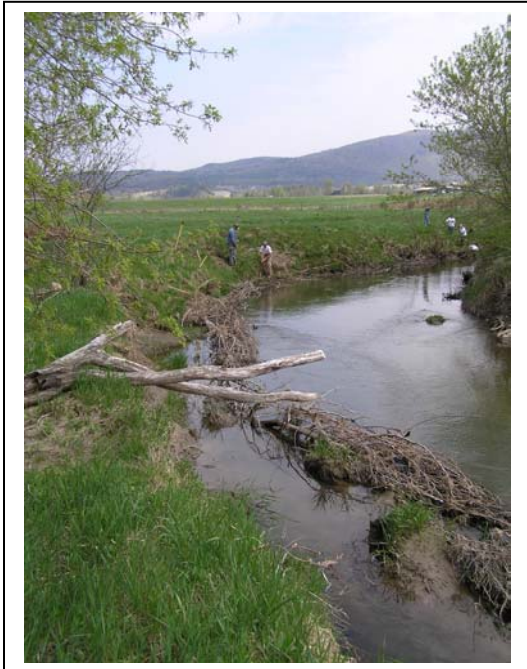
On some streambank sections (for example on approach to Meander Bend B in Map 1), the cedar revetments installed in 2003 were noted to be laterally outflanked (Figure 4). This bend is one of four bends along the profile that have radii of curvature much less than regime equations would predict for the given channel width (see Attachment A). Meanders are continuing to broaden and migrate, and the radius of curvature calculations detailed in Attachment A indicate those tighter meander bends (i.e., ones with very small radius of curvature) can be expected to erode more severely than others along the profile. Such increased erosion on approach to this tight meander bend may have contributed to lateral outflanking of the cedar revetments. It is also possible that vertical scour would have lead to undermining of the revetments in this location.

Figure 4. View upstream from Meander B in Map 1 (May 2005). Cedar revetments along right bank (facing downstream) installed in 2003 were laterally outflanked. Background: volunteers installing willow waddles along top of cedar revetments.

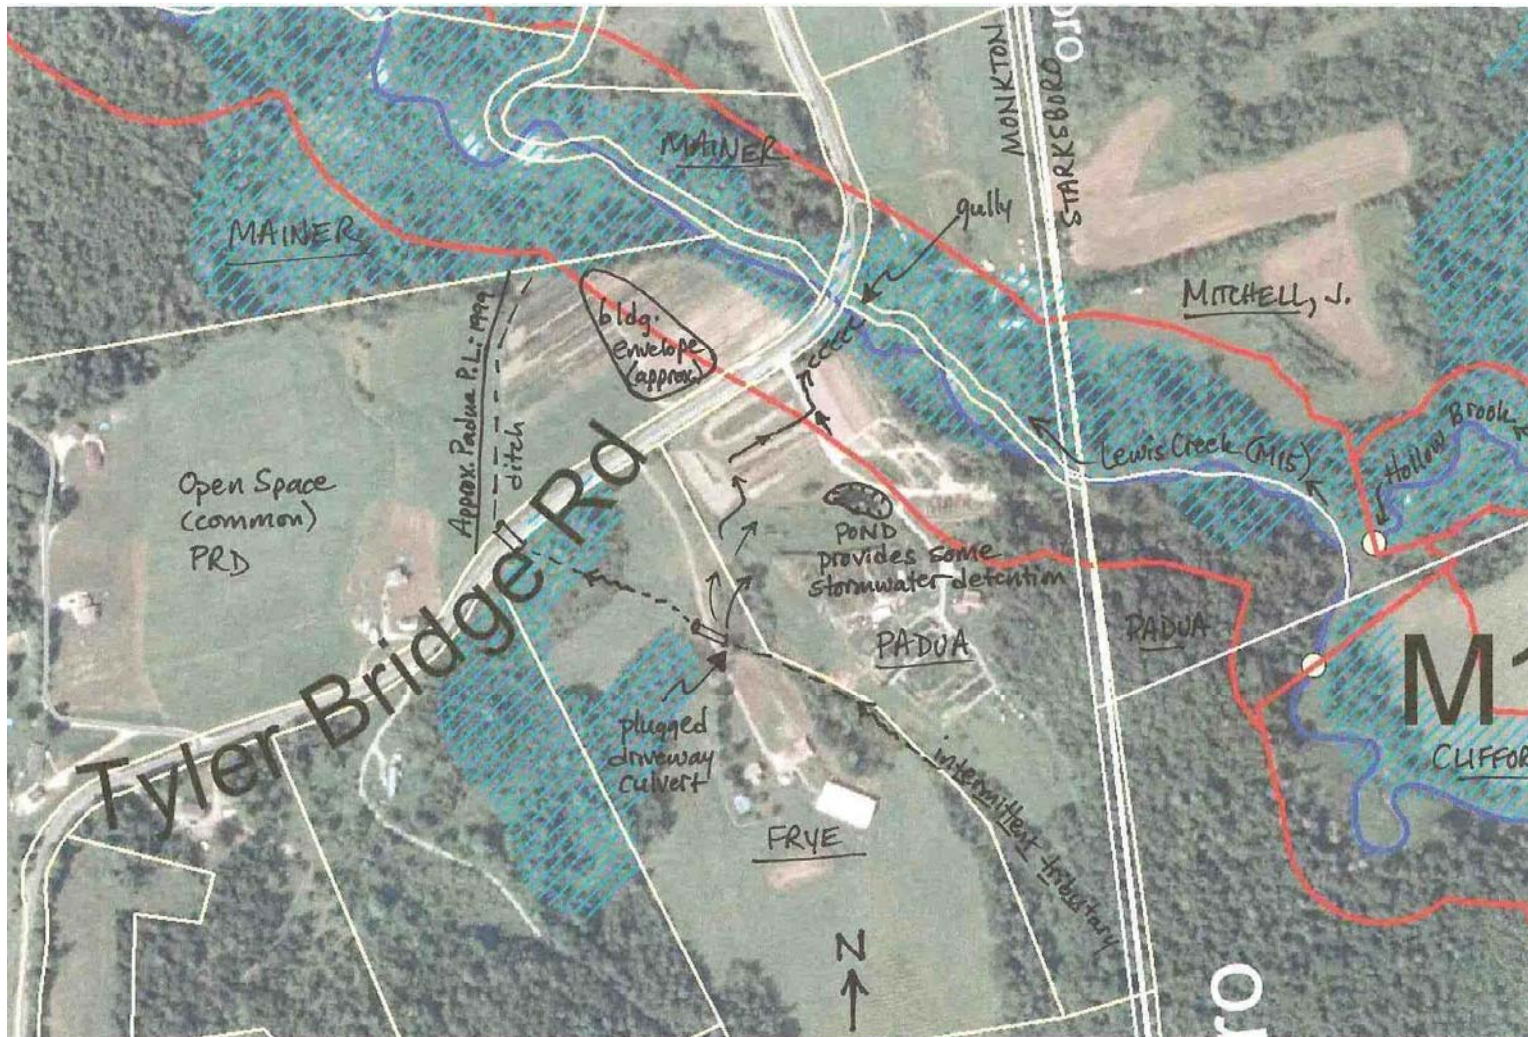
Figure 2. Drainage features in vicinity of Padua property (notes from 3 Dec 2007 meeting w/ John Padua – not field-verified). (2003 NAIP base image; red line indicates Phase 1 corridor [SGAT v.4.50]; turquoise hatched lines depict NWI wetlands; white lines are Monkton and Starksboro approximate parcel boundaries [not current]).

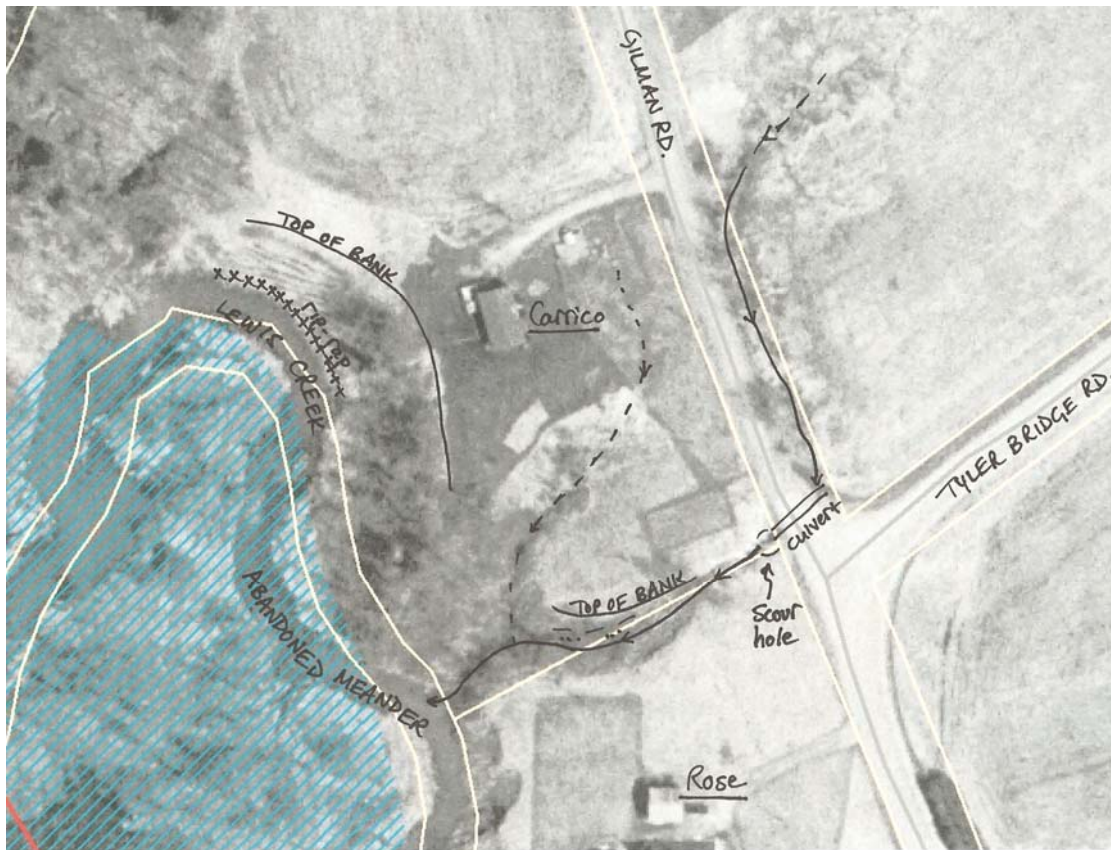
Figure 2. Drainage features in vicinity of Carrico property.

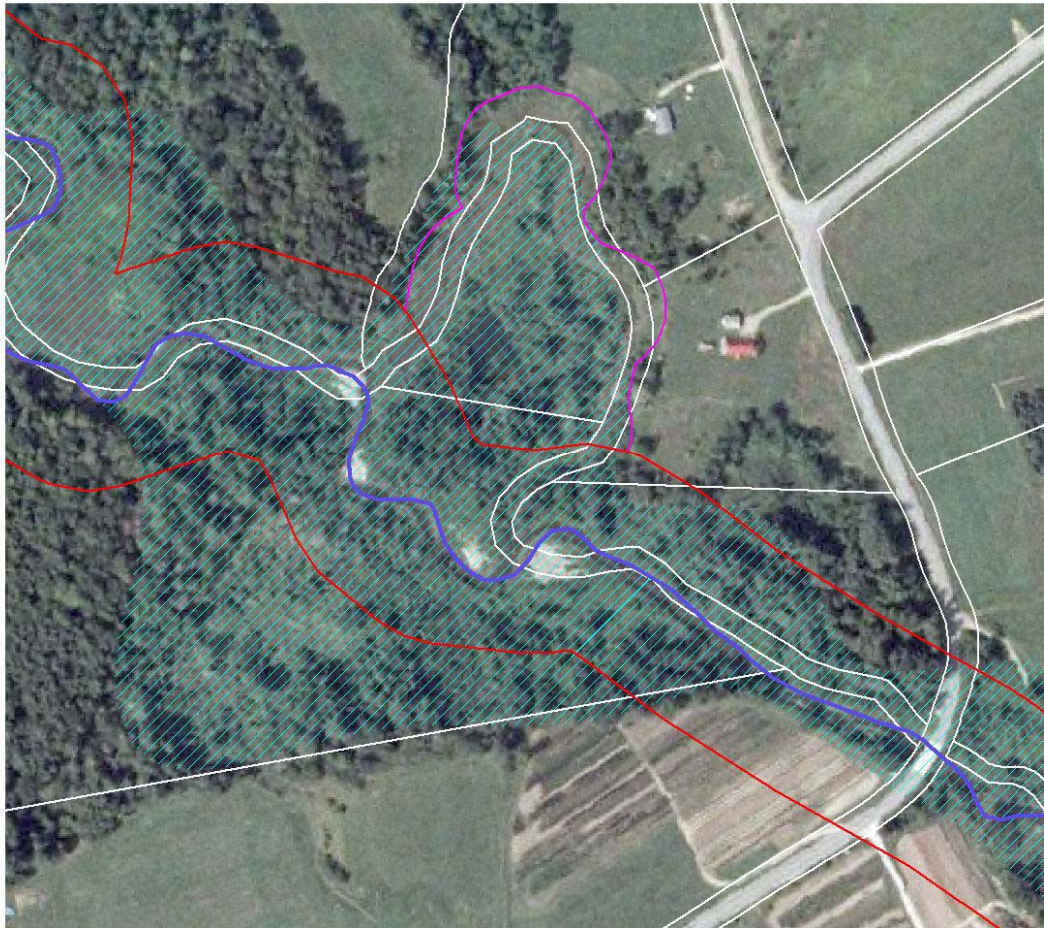
Figure 3. Potential extension of Lewis Creek corridor (in purple) to the top of the valley wall to encompass the abandoned meander.

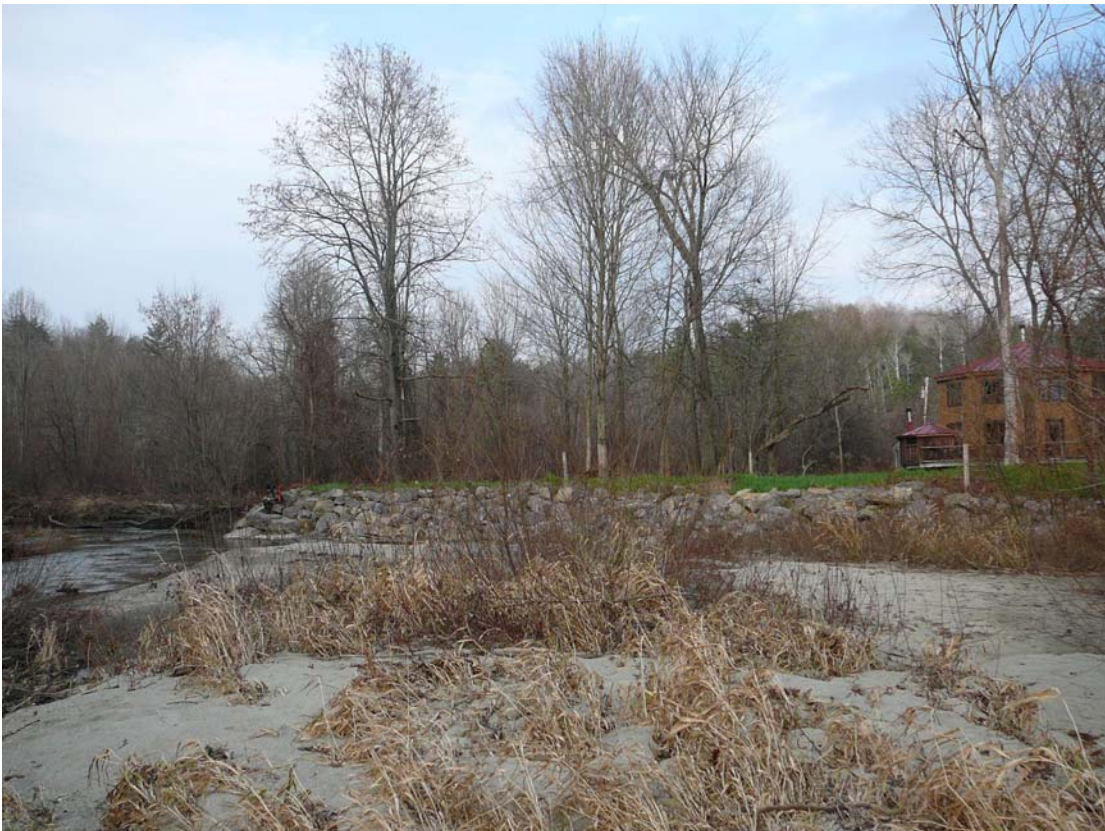
Figure 2. Rip-rap armoring installed circa 2006 along right bank at Dexter Lorange property off Lewis Creek Road in Hinesburg (Segment M15-A). View downstream, 29 November 2006.

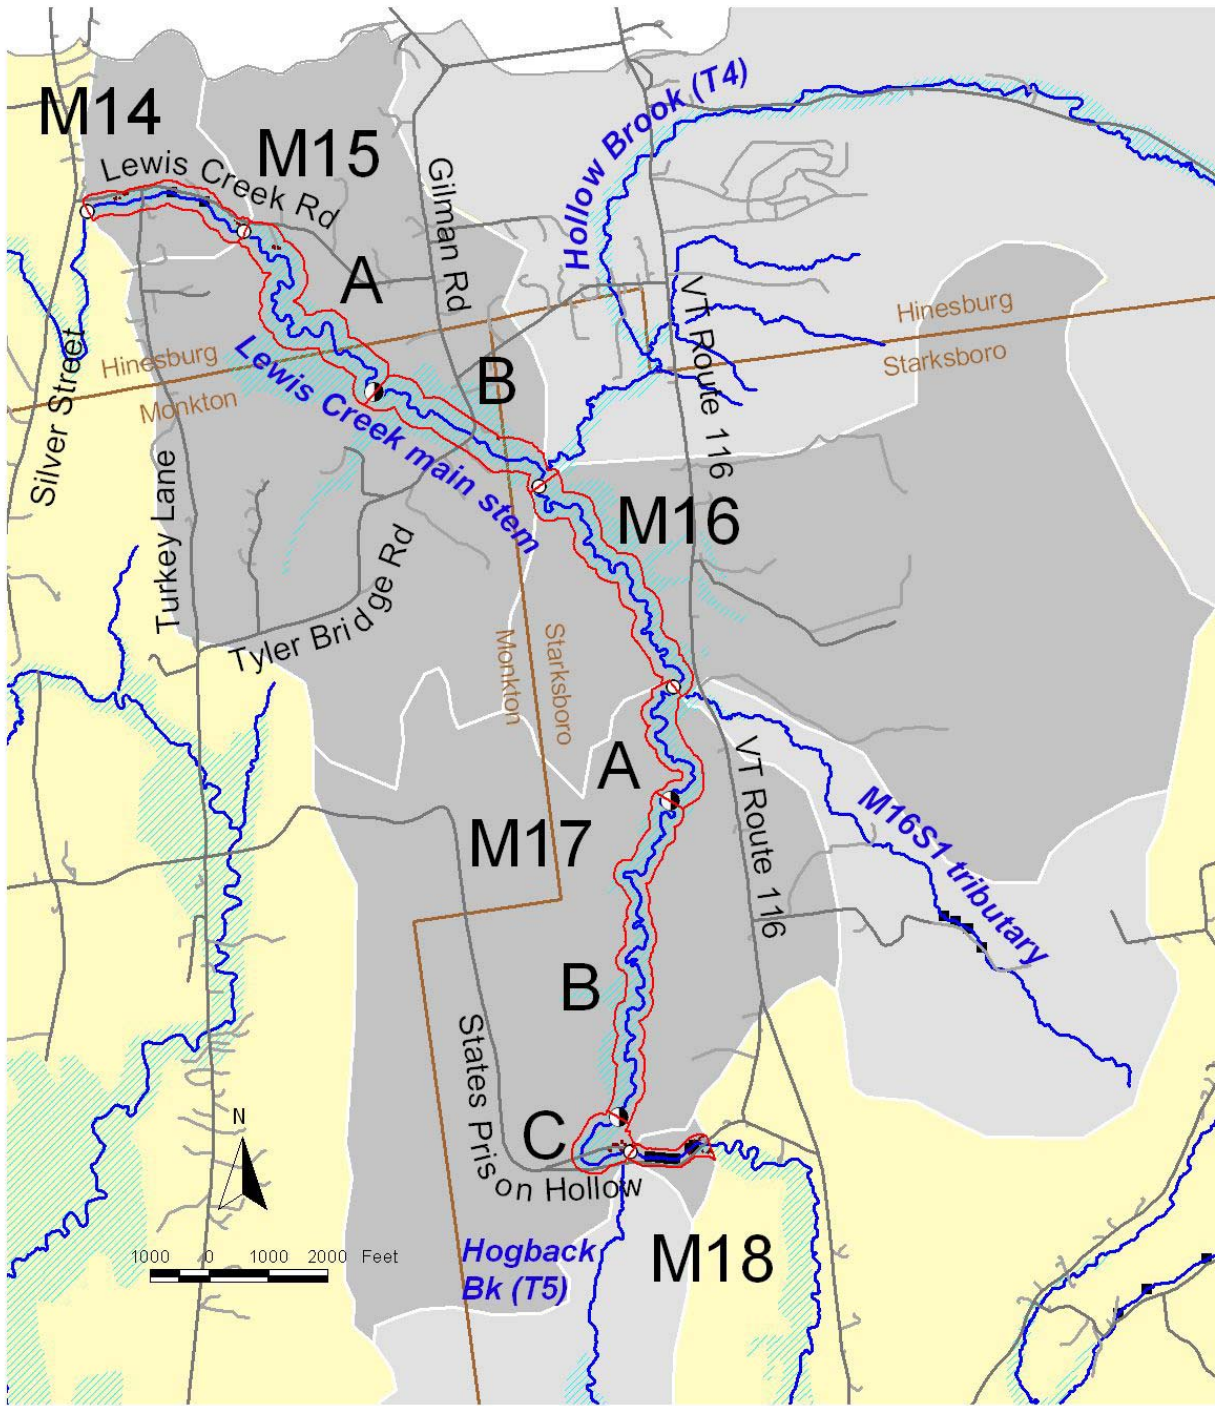
Figure 1. FEMA-FIRM floodway (blue hatched pattern) versus Lewis Creek M14-M18 Corridor (outlined in red); towns of Starksboro, Monkton, Hinesburg, Addison & Chittenden Counties, VT.
