**GATEWAY MOTORS
EMERGENCY RESPONSE**

**190 SYKES MOUNTAIN AVE
HARTFORD, VERMONT**

DEC SPILL #2011WMD325

**ECS Project No.04-219848
April 1, 2013**

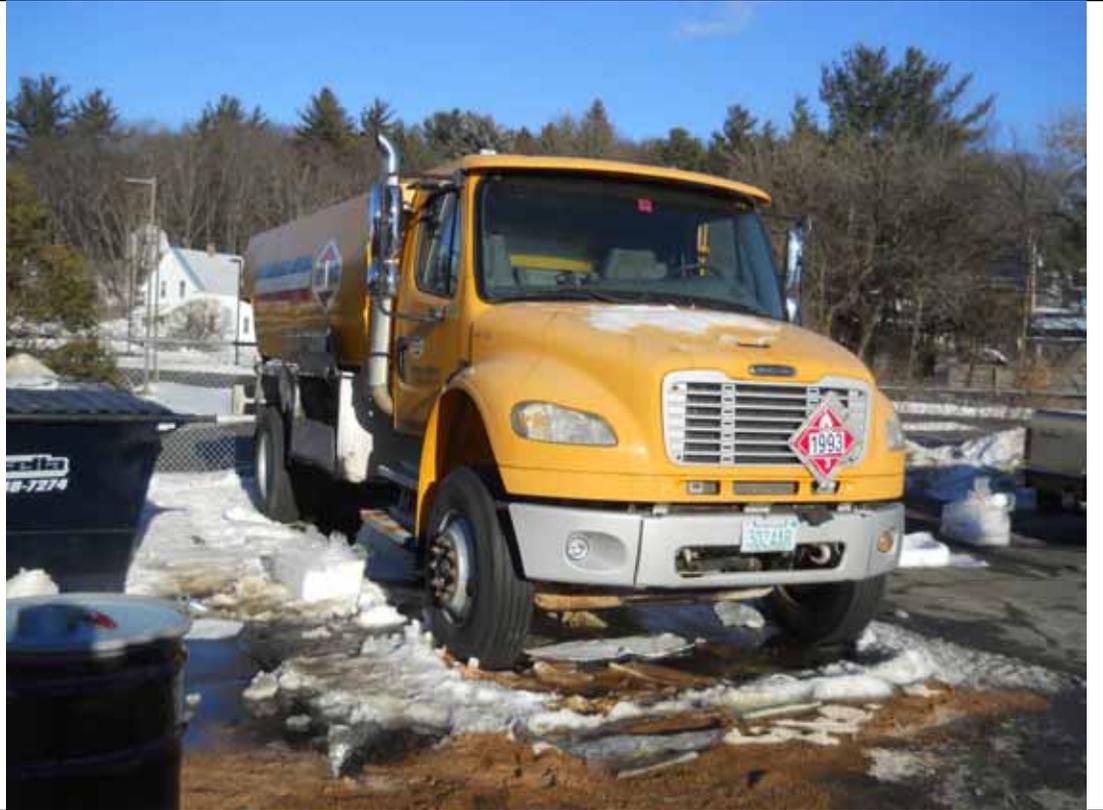
Photograph #1

Description:
Source of spill, out-of-service Irving oil truck.

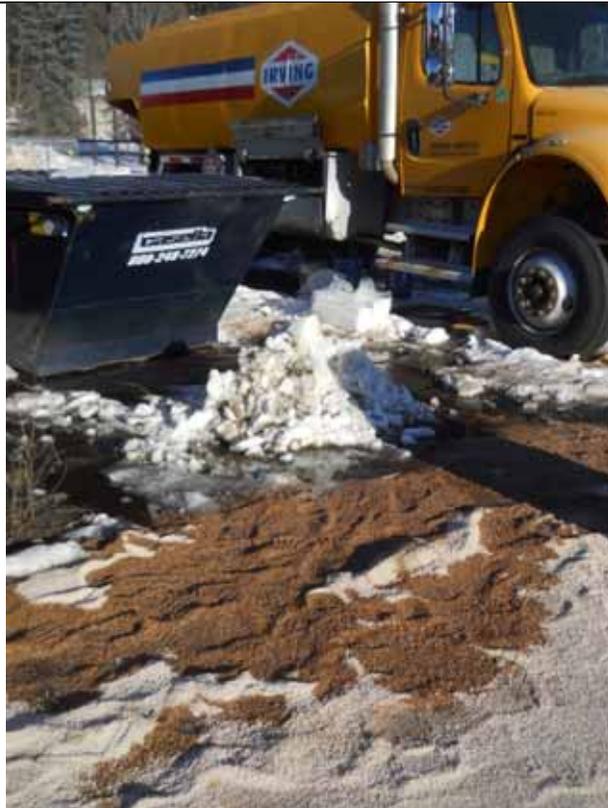
Photograph #2

Description:
View of the truck, impacted granular sorbent material and sand

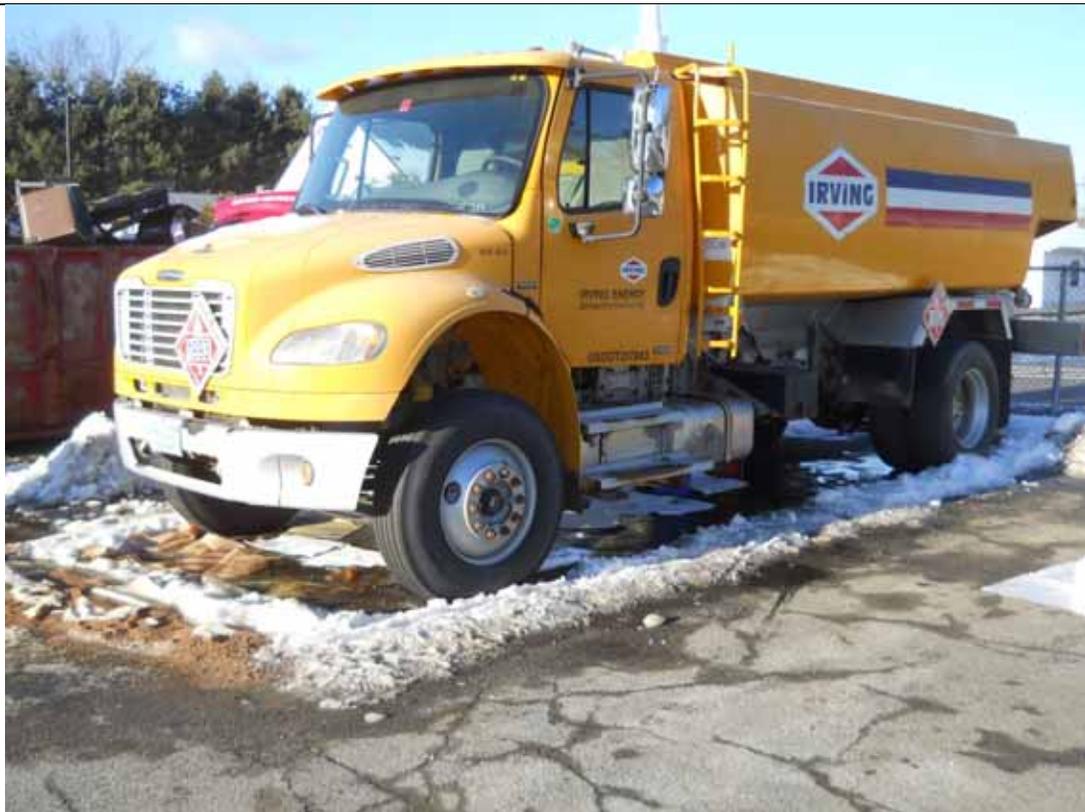
Photograph #3

View of truck looking north, sorbent pads seen underneath the truck

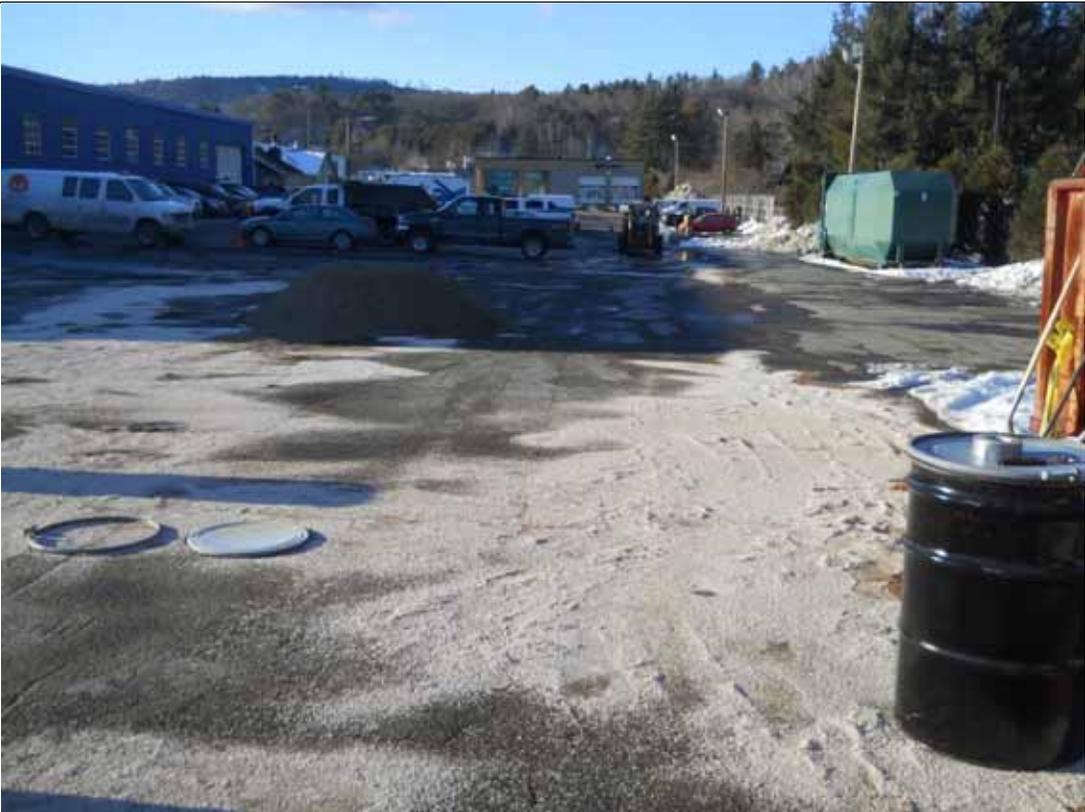
Photograph #4

View looking west towards area of the catch basin

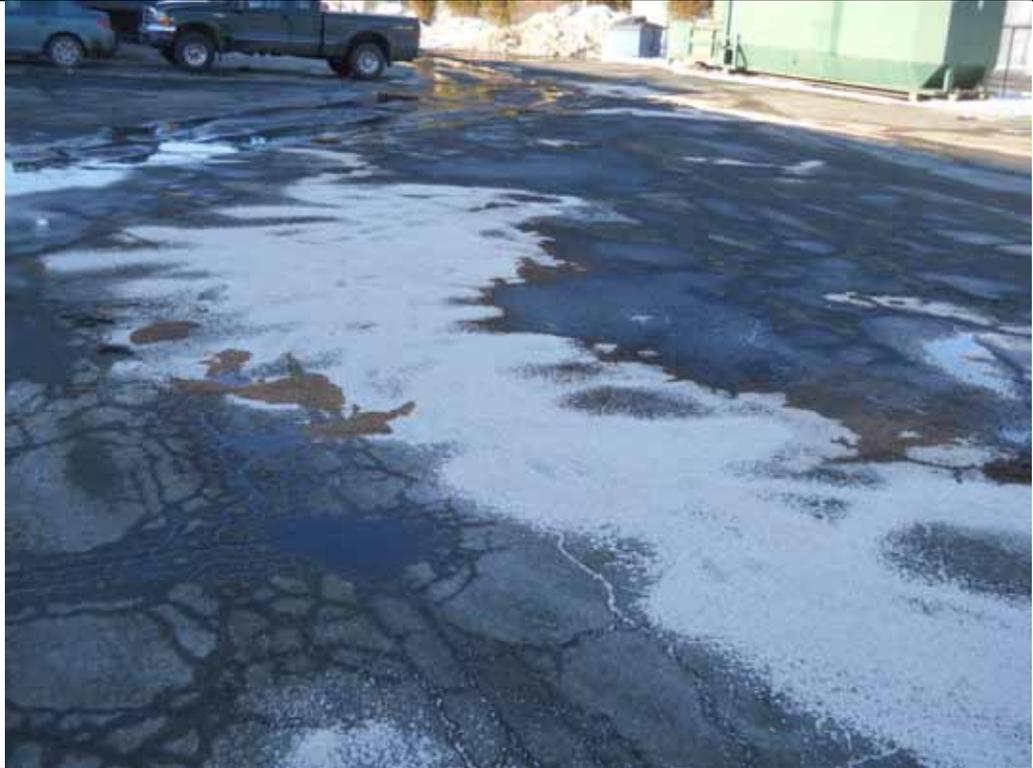
Photograph #5

Description:
*Sand and sorbent
material capturing
product traveling
through pavement
cracks*

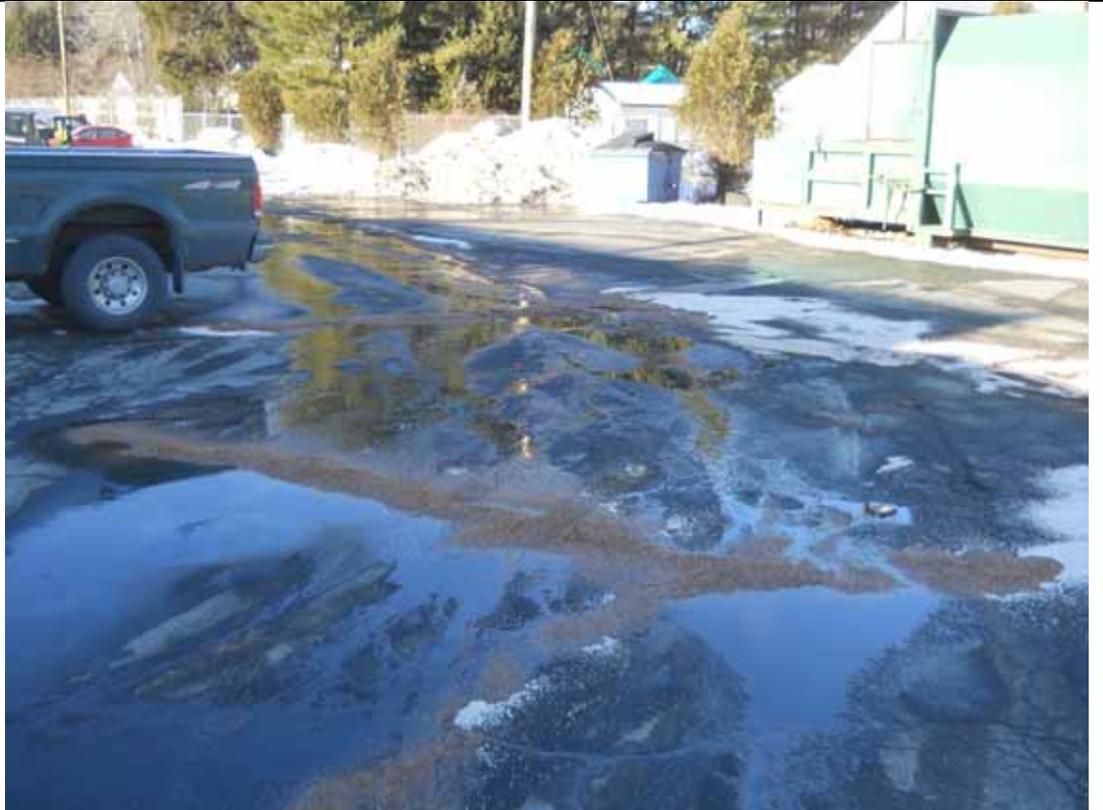
Photograph #6

Description:
*Area of impact looking
west*

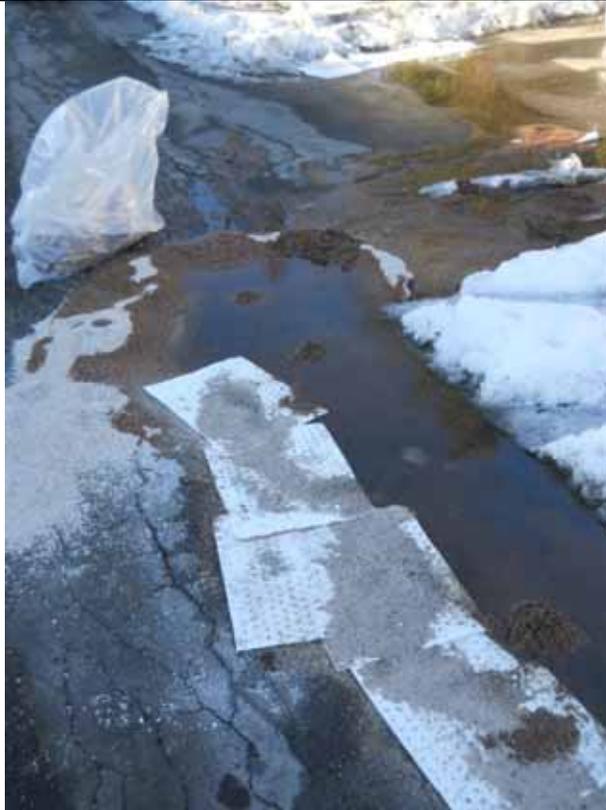
Photograph #7

Description:
Sorbent pads and sand capturing diesel sheen in snow melt runoff

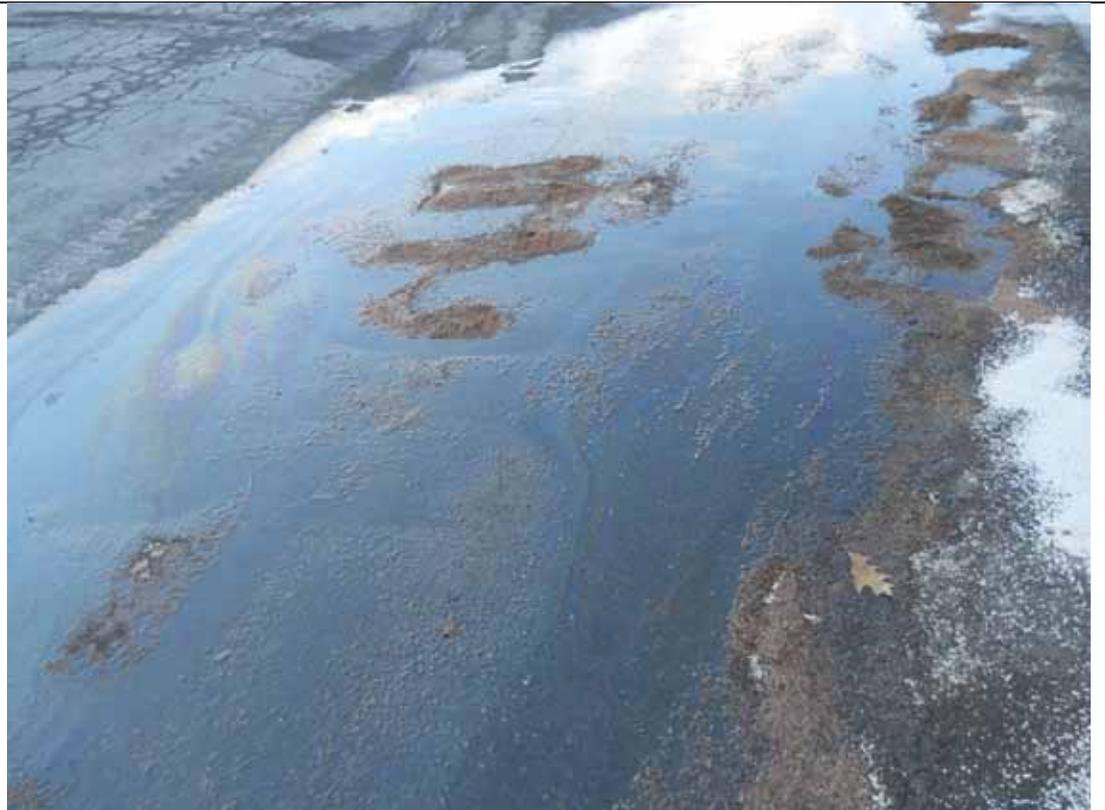
Photograph #8

Description:
Sheen in snow runoff

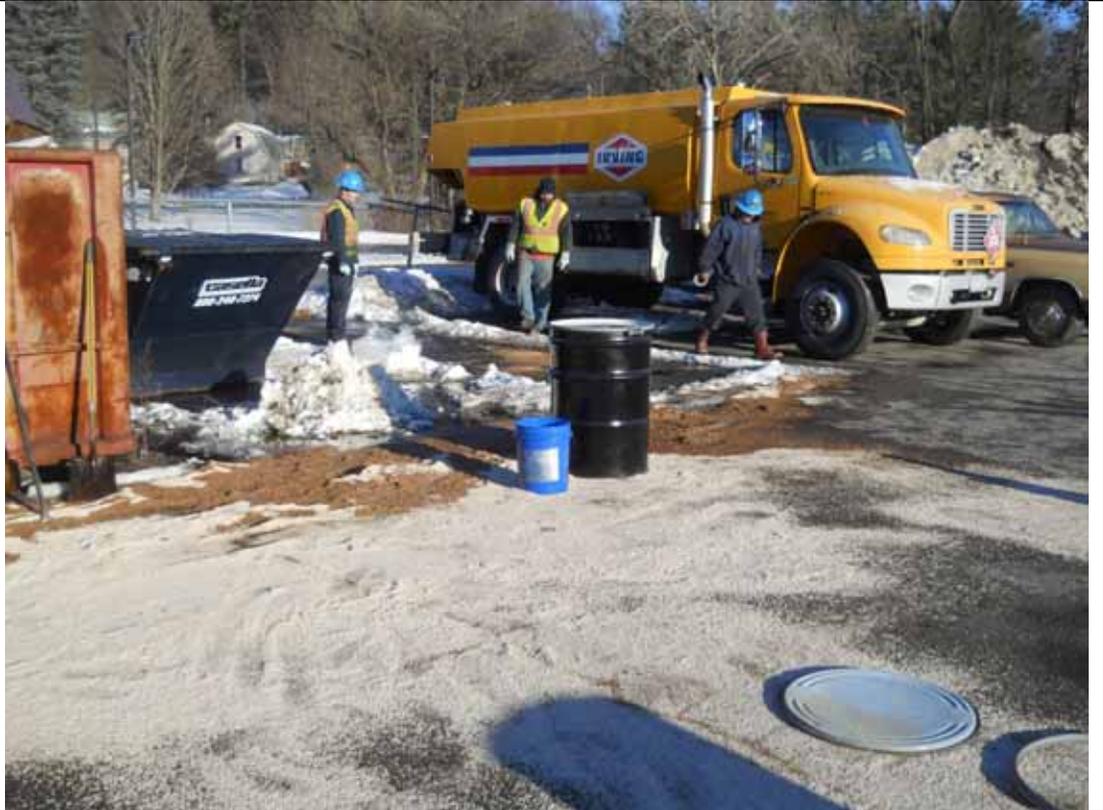
Photograph #9

Description:
*Cleaning up area of
release after truck was
pumped out and moved*

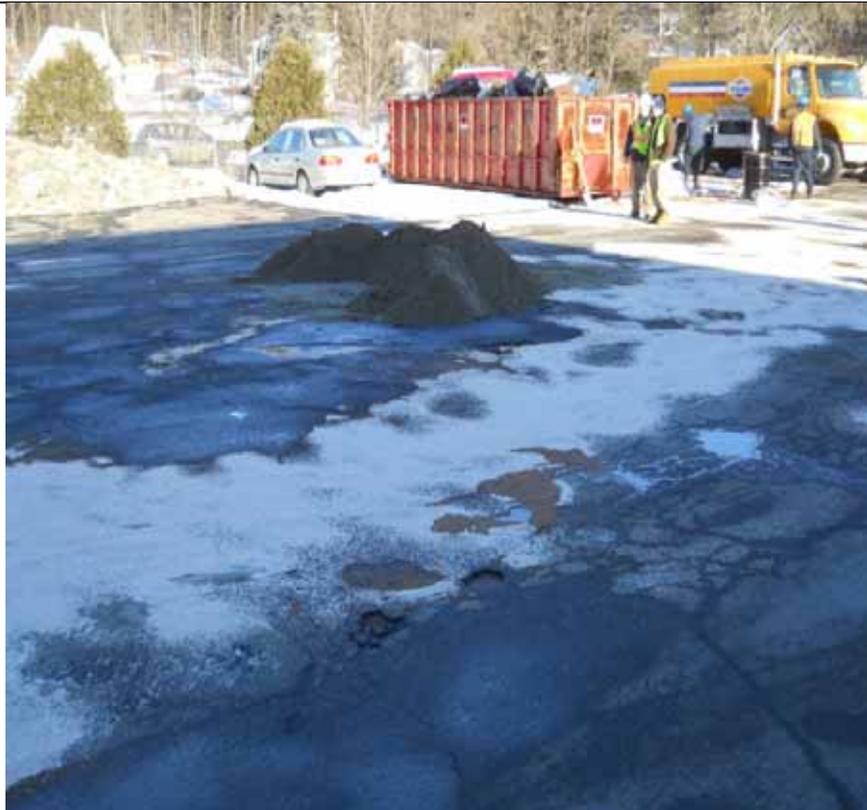
Photograph #10

Description:
*Granular sorbent
material and sand pile*

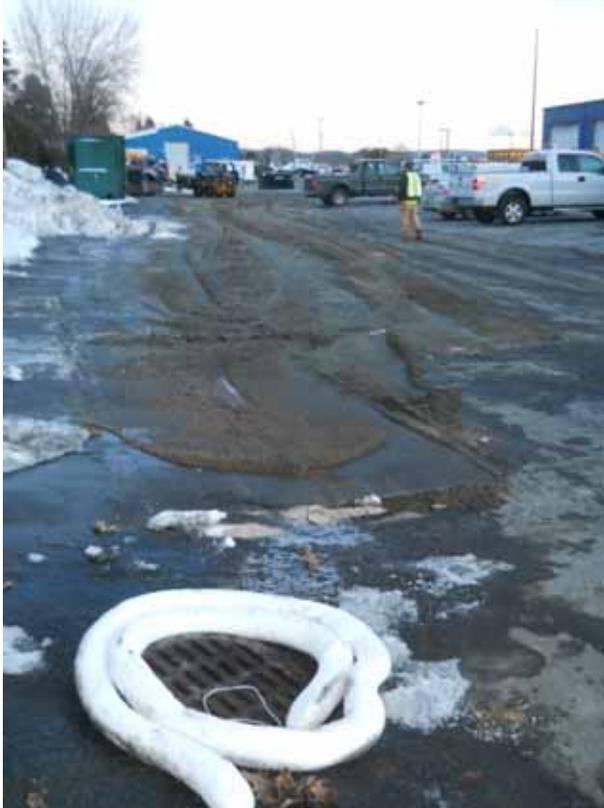
Photograph #11

Description:
Sorbent booms and sand capturing product before the catch basin

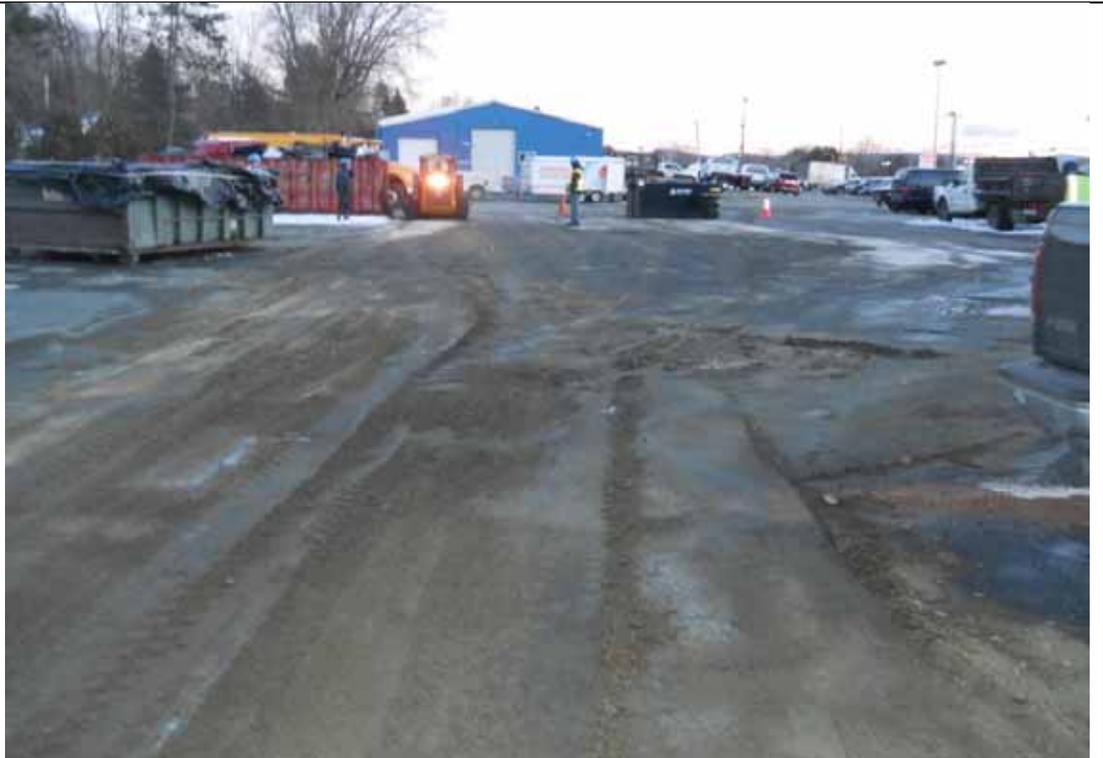
Photograph #12

Description:
Bobcat sweeping up impacted sorbent material and sand

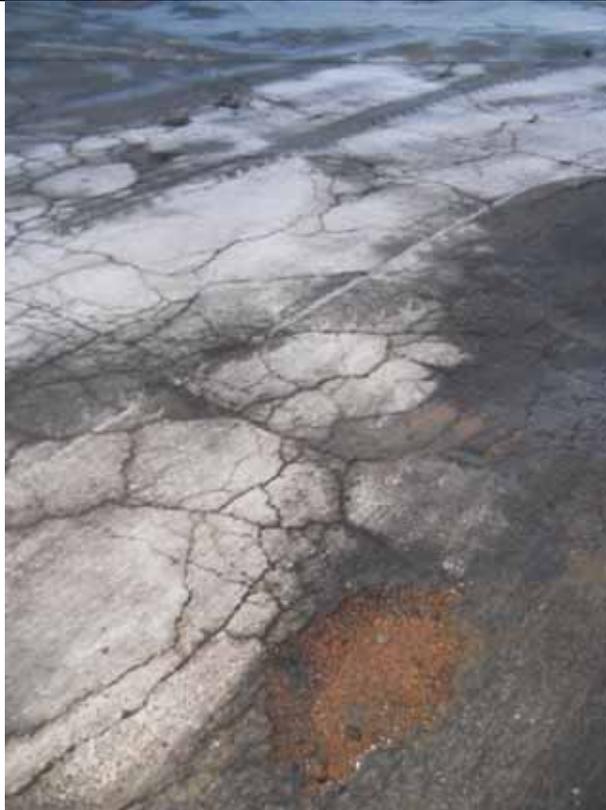
Photograph #13

After all sand, snow and granular sorbent material was removed from the ground surface, ECS inspected the area for free product and/or sheen and none was observed. During the inspection ECS observed numerous cracks and potholes which may indicate compromised integrity of the asphalt. ECS also gauged the catch basin using a groundwater interface probe for product and none was observed.

Description:
*Pothole and cracks in
pavement after clean
up*

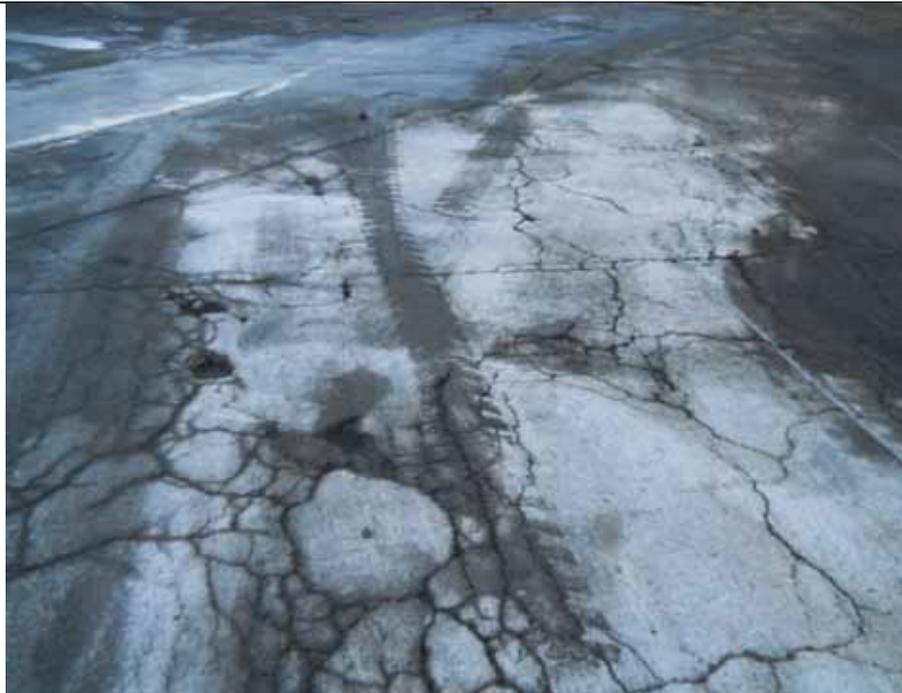
Photograph #14

Description:
*Cracks and potholes in
pavement after clean
up*

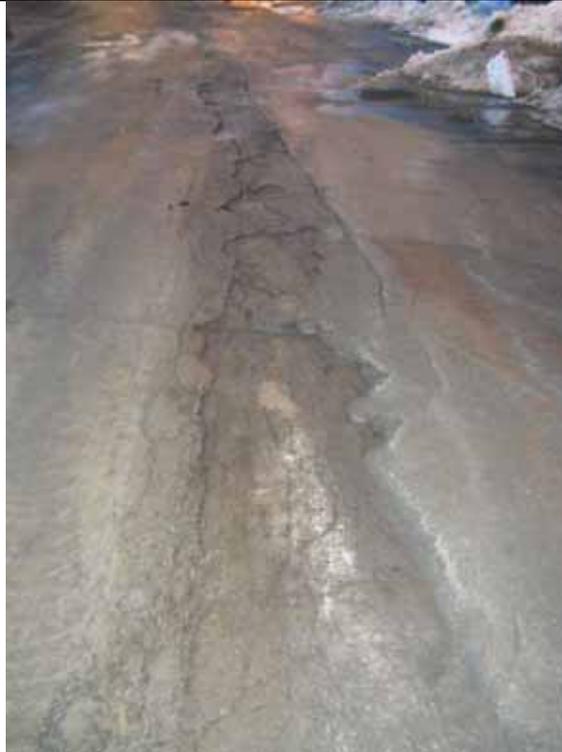
Photograph #15

Description:
*Large patch of
cracked/missing
pavement*

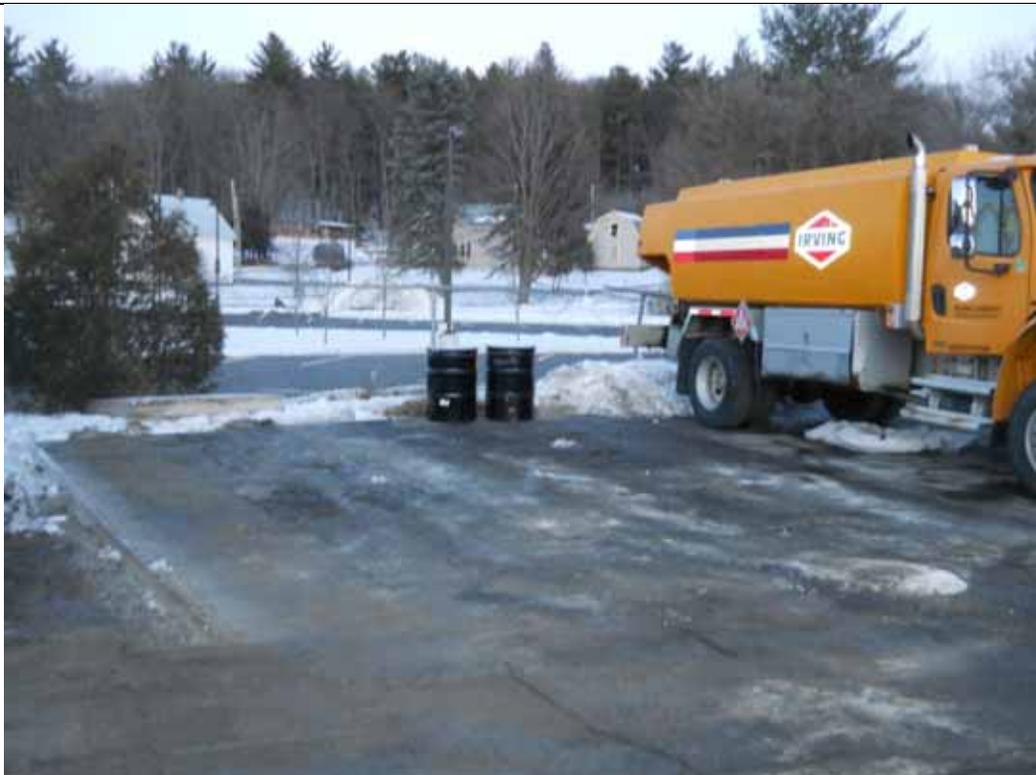
Photograph #16

Description:
*Two 55-gallon drums
of impacted sorbents,
sand and snow*

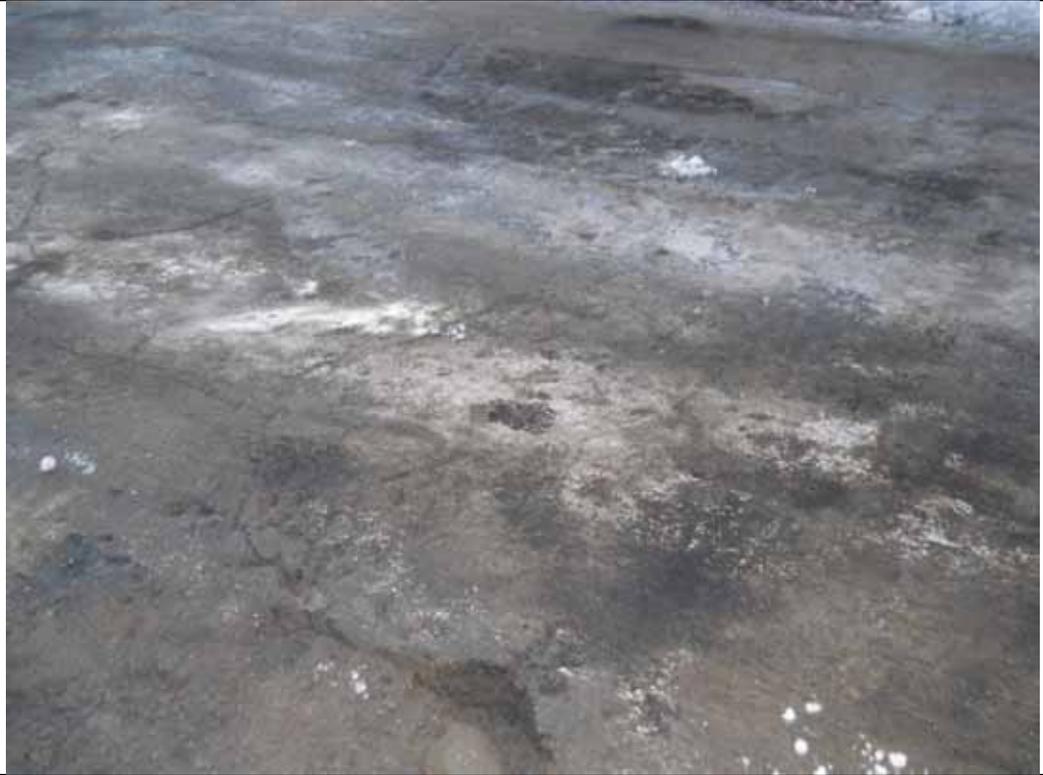
Photograph #17

Description:
*Area of initial release
after clean up*
