Basin 10: Ottauquechee and Black Rivers

Report 60, Cavendish Gorge, Black River, Cavendish, Windsor County, Vermont.

Report 62, Quechee Gorge, Ottauquechee River, Hartford, Windsor County, Vermont.

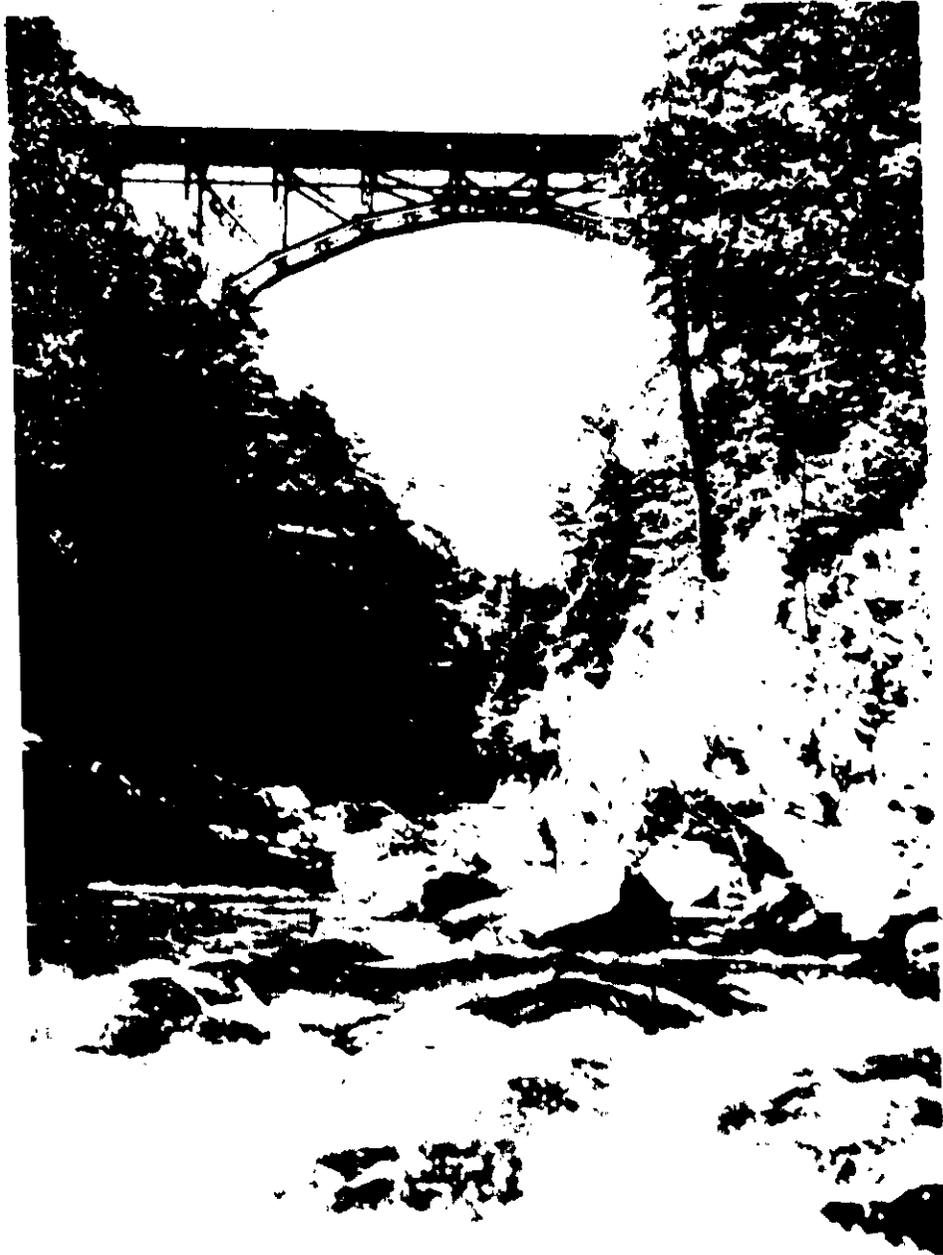
QUECHEE GORGE

The gorge is about one-half mile long and at the deepest somewhat over 150 feet deep. It is 50-100 feet wide at the bottom and perhaps 200 feet wide at the top. The walls are partly dirt and partly rock and probably have an average angle of 45-60 degrees. In places there are vertical or nearly vertical cliffs 30-75 feet high.

The bedrock is the lower Devonian Gile Mountain formation schist; it is uniformly limy. Some of the rock is sculptured and there are a few potholes but the gorge is more memorable for its size than for the rocks themselves.

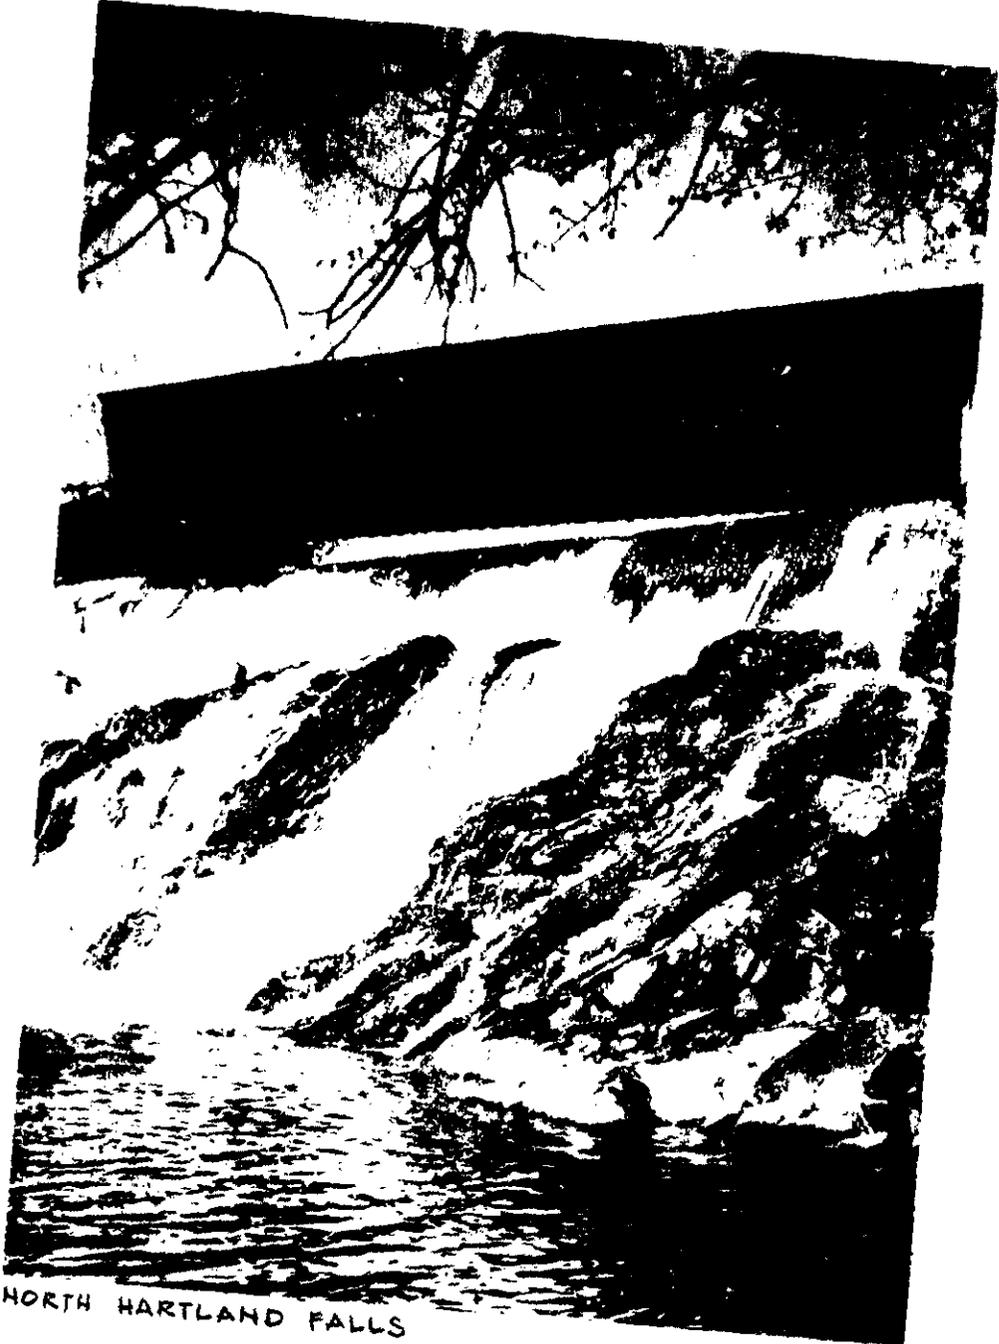
NORTH HARTLAND FALLS

There are two large cascades, both about 25 feet high. The south cascade is the more interesting of the two. It is split into two channels, and has nice carved and rippled rocks. The north cascade splits into about five channels but does not have any carved rocks and is less pretty overall.

From the railroad you can not see the dam, and the two cascades look very nice. The site is used for swimming and fishing and parties, and is a popular tourist attraction, much viewed and photographed. The dam has been in place for a long time. A hydroelectric project has recently been redeveloped at this site.

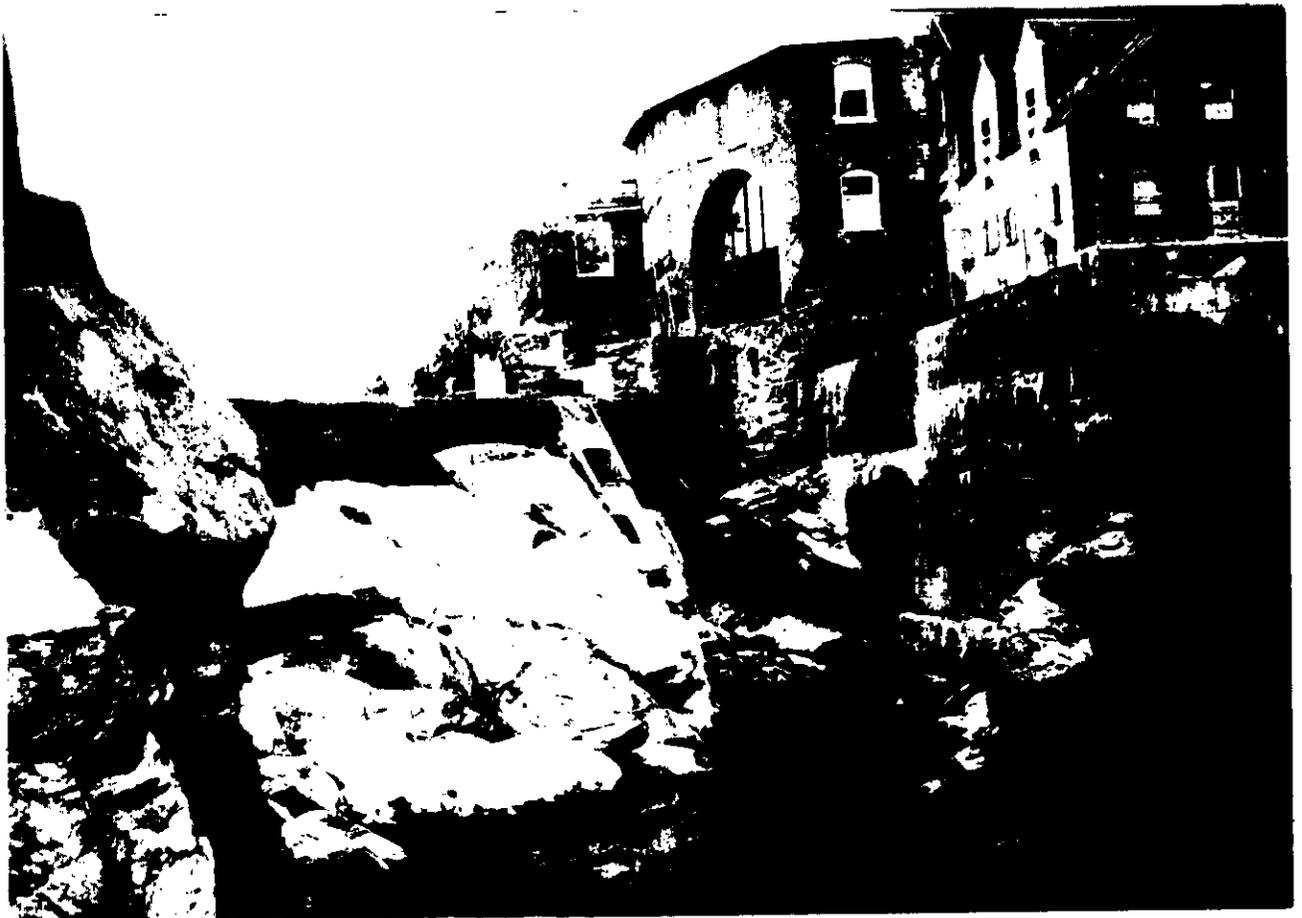
QUECHEE VILLAGE FALLS

The site is urban with buildings and roads all around. There is a concrete dam where the waterfall was. Below the gorge, the surroundings are more natural and the banks of the river have young hardwood forests and open ledge.

The dam is at the head of the site. It is about 15 feet wide by six feet high and is probably on top of the old falls. The gorge begins below this and extends about 100 yards down river with walls from five to 25 feet high. The walls on the north shore slope are at about 30-40 degrees while those on the south shore are steeper and are occasionally vertical.
