Basin 11: Williams, West, and Saxtons Rivers

Report 68, Hamilton Falls, Cobb Brook, Jamaica, Windham County, Vermont.

Report 69, Saxtons River Falls, Saxtons River, Westminster, Windham County, Vermont.

Report 73, Brockway Mills Gorge, Williams River, Rockingham, Windham County, Vermont.

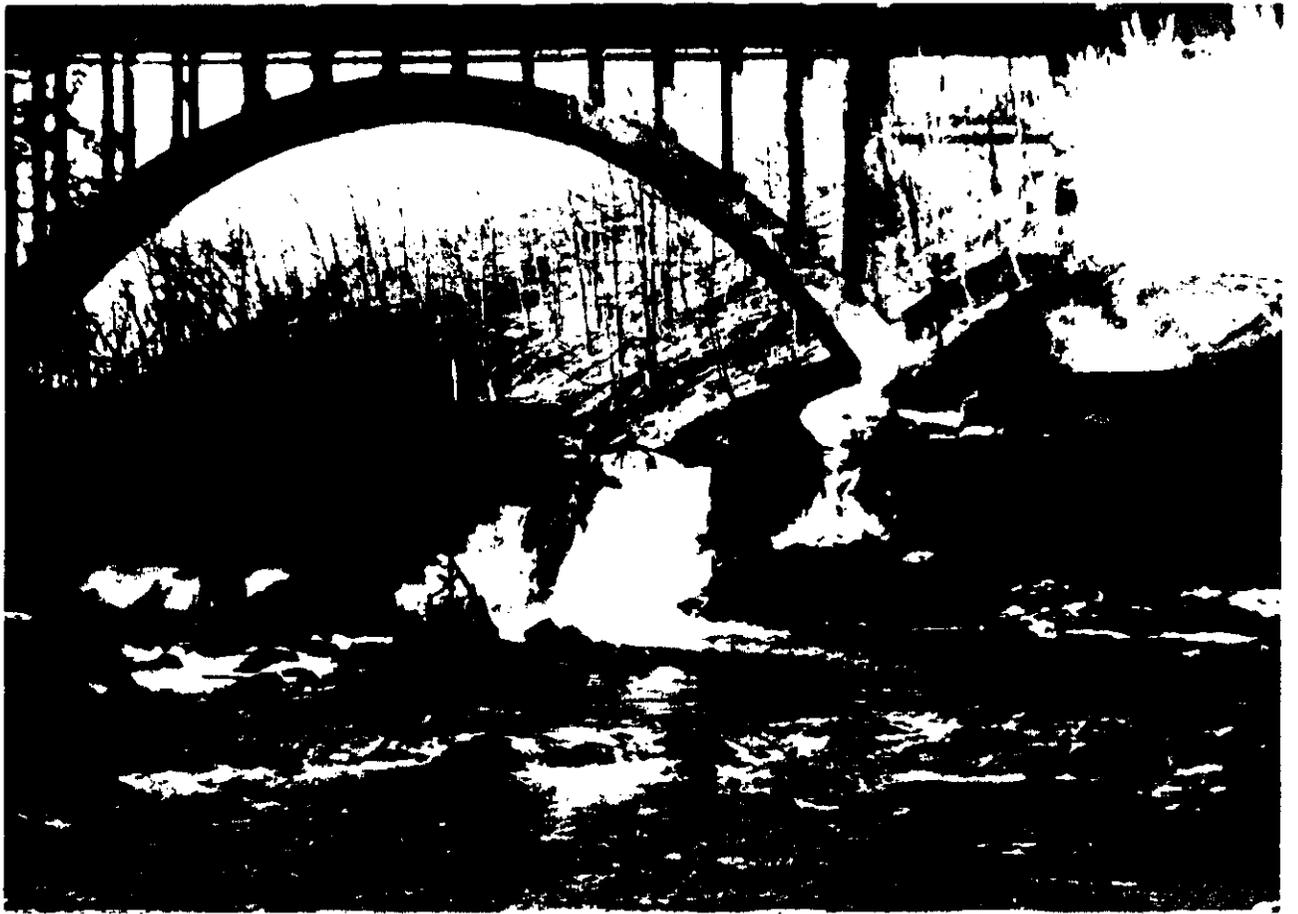
SAXTONS RIVER FALLS

Site consists of an old dam about 100 feet long by 15 feet high, and above that a gorge about 200 feet long with rock walls to 20 feet high. Above the gorge there is a single set of sheer ledges about 50 feet high. The rock is a granitic gneiss of Devonian age. It is acid and makes smooth, plantless cliffs.

There is a pool below the timber crib dam but there are no cascades or pools above the dam. The area is used by fisherman and for swimming, but is not a popular recreation site.
