Basin 3: Otter Creek, Little Otter, Lewis Creek

Report 5, Sutherland Falls, Otter Creek, Proctor, Rutland County, Vermont.

Report 6, Middlebury Gorge, Middlebury River, Middlebury, Addison County, Vermont.

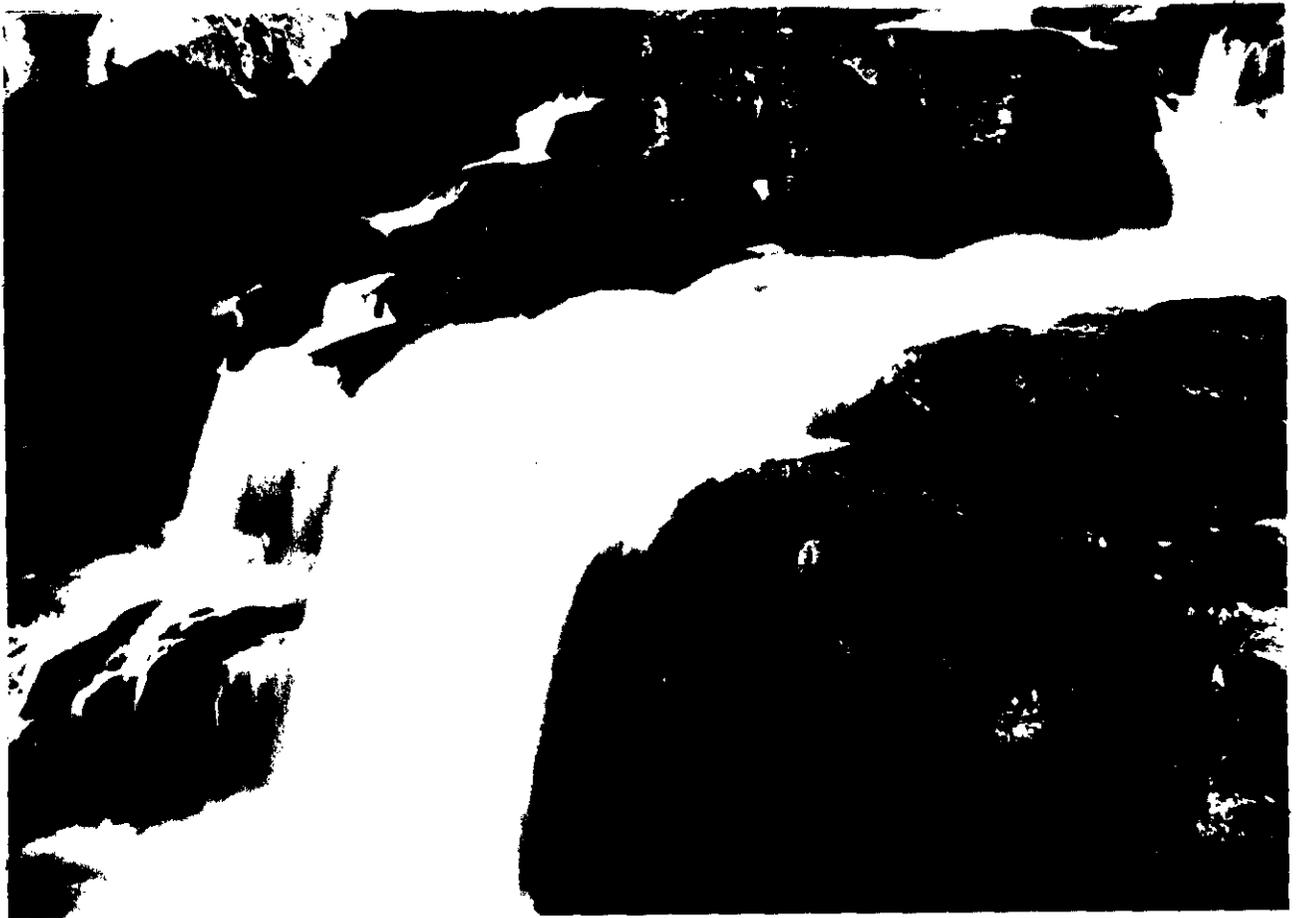
NEW HAVEN RIVER GORGE

The lowest site is a flat cascade over tilted ledges, about 50 yards long.

The next site is a small gorge with a dam and falls. There are rock walls to 30 feet high, some overhanging walls, a falls about 12 feet high, and a nice rock-circled pool below the falls.

The uppermost site has more tilted quartzite ledges with pools and cascades.

The rock is largely the Cambrian Cheshire quartzite, a smooth, hard rock that usually fractures into cubical blocks and so far as we know does not make ripples or potholes. Normally this formation has no lime, but we were surprised to find several plants at the site we think of as limestone indicators and a greater variety of both higher plants and mosses than is usual for quartzite. It is quite possible that, as seems to be the case in the Middlebury Gorge, some of the Forestdale marble which outcrops upstream is mixed or interbedded with the quartzite here.

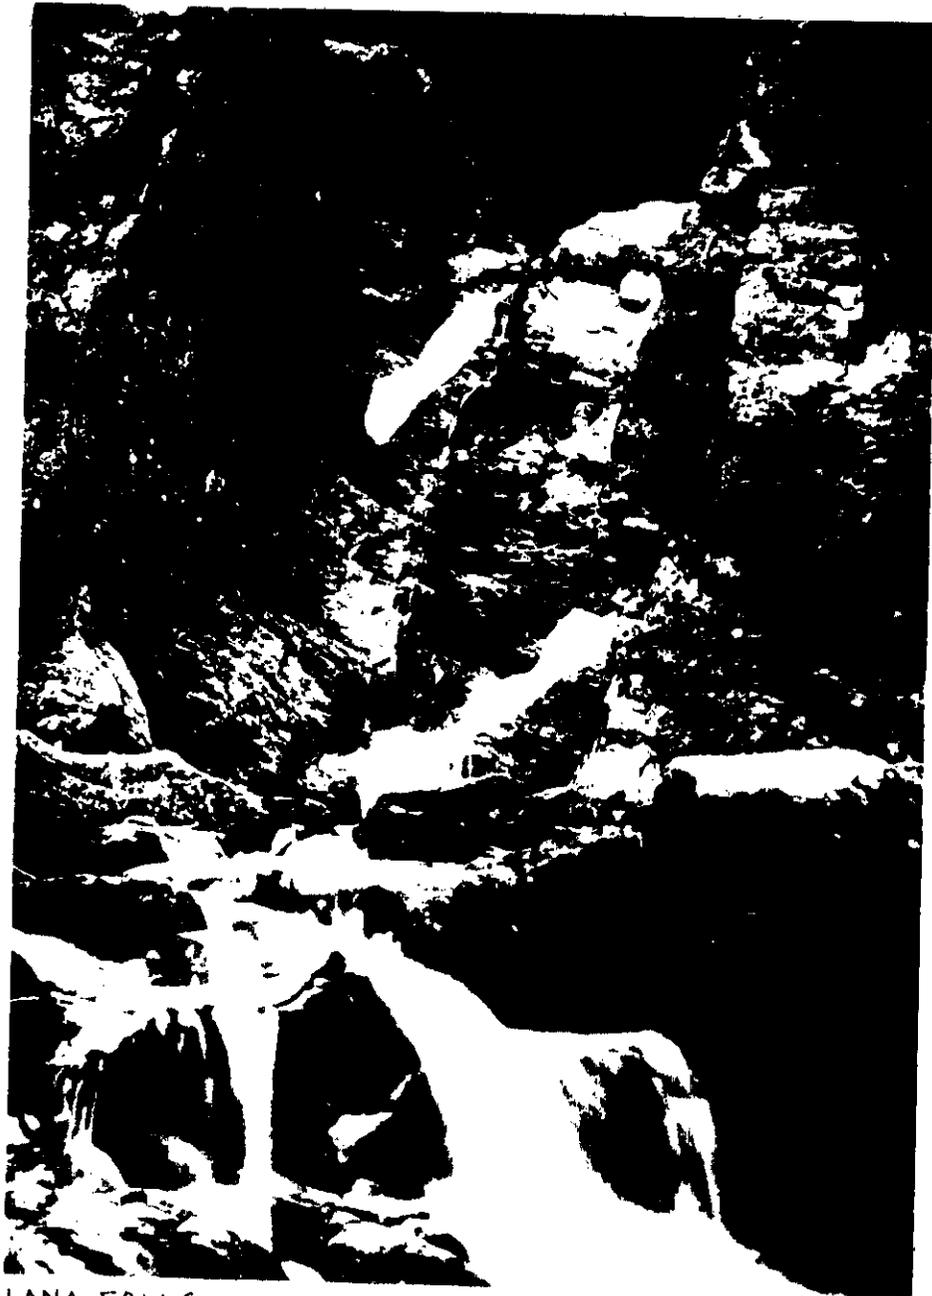
LANA FALLS

The falls are actually two angled cascades ten to 15 feet high in a steep rock chute. Below this is a pool perhaps 25 feet wide and then several very small cascades. The rocks around the stream are sheer in places, varying from ten to 30 feet in height above the water.

The rock appears to be quartzite and is not at all limy. The site is mapped as a probable contact between two Cambrian formations: Moosalamoo phyllite and Forestdale marble. The Forestdale formation is quartzitic in places. Perhaps the map is slightly inaccurate, and the bedrock is actually Cambrian Cheshire quartzite that is common up to the west shore of Silver Lake. Whatever it is, the angular form of the rocks around the main cascades is unusual, and the rocks are very nicely exposed.

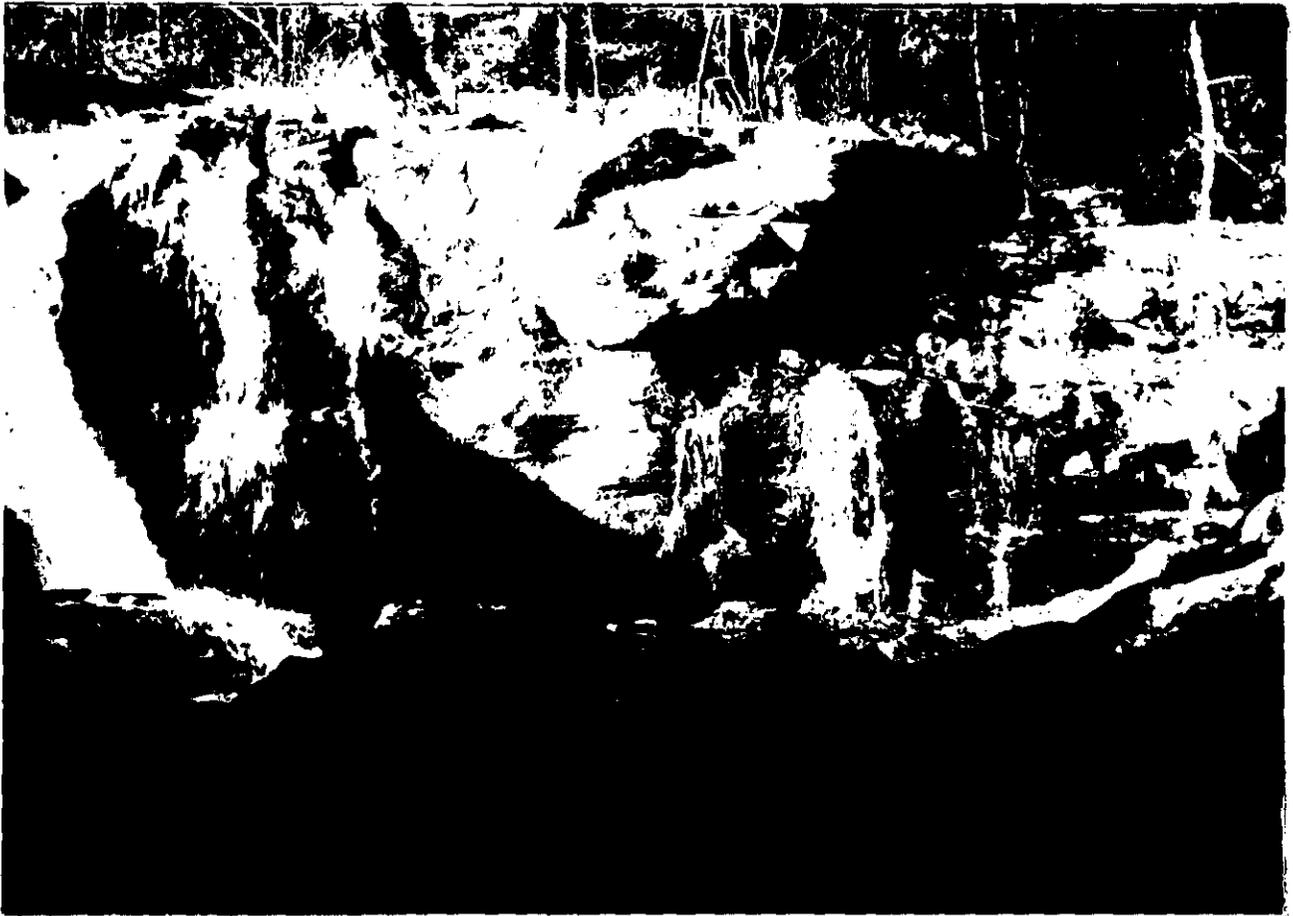
BELDENS FALLS

The dam is about 50 feet wide by 30 feet high, with 30 foot high cliffs to the west of it. There are two rocky islands below it and between them the river has carved a gorge 100 feet long and 15-25 feet high. The walls of the gorge are nearly vertical, and there are a number of eroded caves (less than two feet across) and potholes within the gorge. The western channel of the river ends with two broad potholes, 15 and 20 feet wide.

The eastern island is high and made of broken rock with deep cracks; the water tunnels under it and in places you can look down 30 feet into the rock and see flowing water. The tunnel is about 15 feet wide and reenters the channel between the two islands near the foot of the gorge. Rippled, water-carved rocks occur near the summit of the island, high above the current channel.

The rocks are variously white and grey marbles and an orange dolomite, mapped as the Belden member of the Ordovician Chipman formation. It is possible that the falls are the type locality for this rock. Many of the rocks are rounded, fissured, rippled and carved.

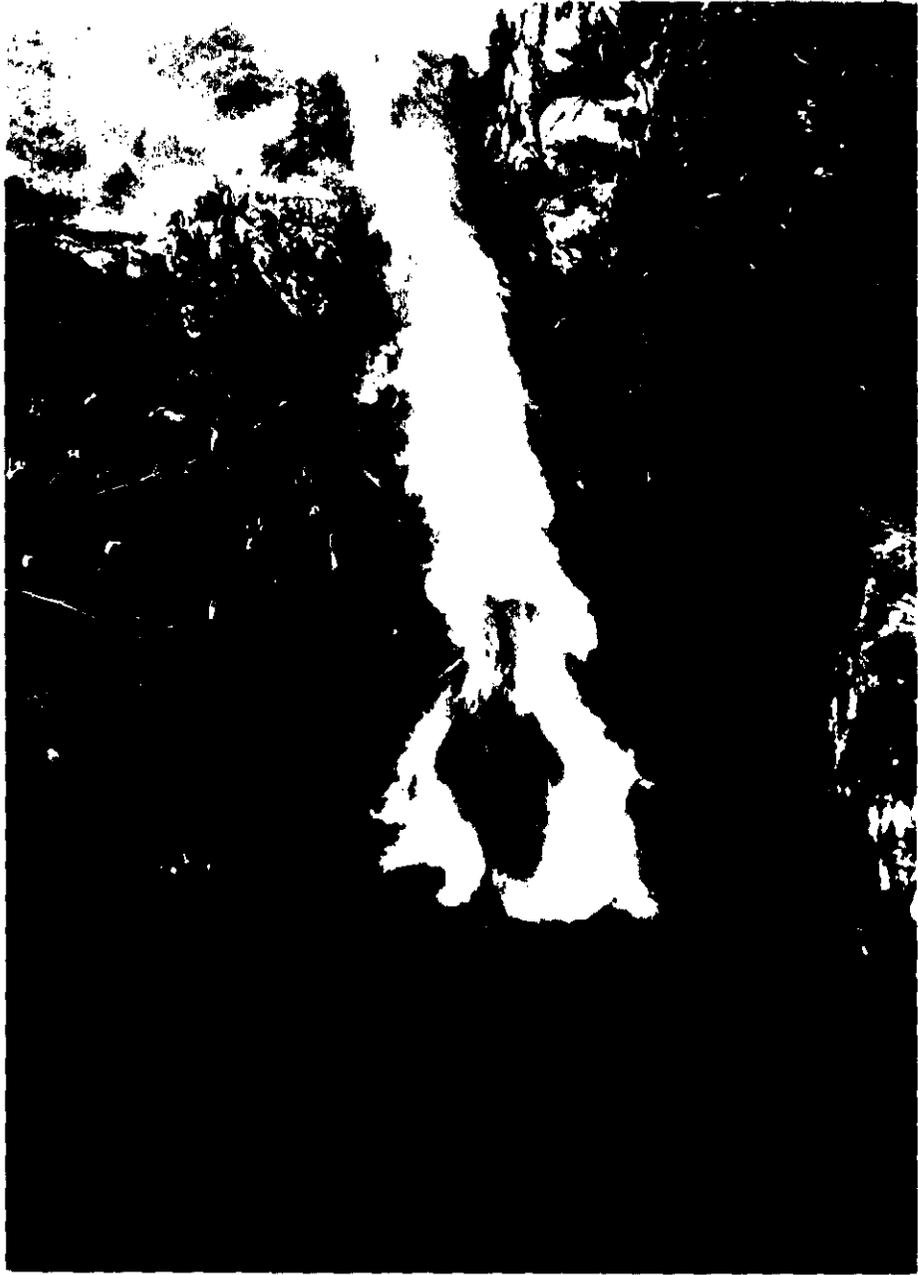
BRISTOL MEMORIAL FOREST PARK GORGE

Along the path from the parking lot, there are several cascades on Baldwin Creek, ranging from one to six vertical feet in height. At the head of the gorge is a ten to 15 foot waterfall. Below the falls the stream is diverted at a right angle and flows through a 35-40 foot high narrow gorge with sheer walls. The gorge is about 120 feet long and ten to 15 feet wide. At the foot of the gorge there is a pool, and then the channel widens and forms nearly continuous riffles until its junction with Beaver Brook.

The bedrock at the site is Cambrian and is somewhat confusing to interpret from the geological map. Most likely the schist of the gorge walls is the Fairfield Pond member of the Underhill formation. Underneath it is a softer rock, perhaps the dolomite or limestone of the Forestdale member. To the east the map shows graywacke of the Pinnacle formation. The rock at the

base of the gorge is a little limy. Some ripple rock is present. There are about six potholes between two and eight feet in diameter along the lower walls of the gorge. One of these is active.
