Basin 6: Missisquoi River Basin

Report 16, Highgate Falls, Missisquoi River, Highgate, Franklin County, Vermont.

Report 17, Sheldon Falls, Missisquoi River, Sheldon, Franklin County, Vermont.

Report 19, Big Falls of the Missisquoi River, Troy, Orleans County, Vermont.

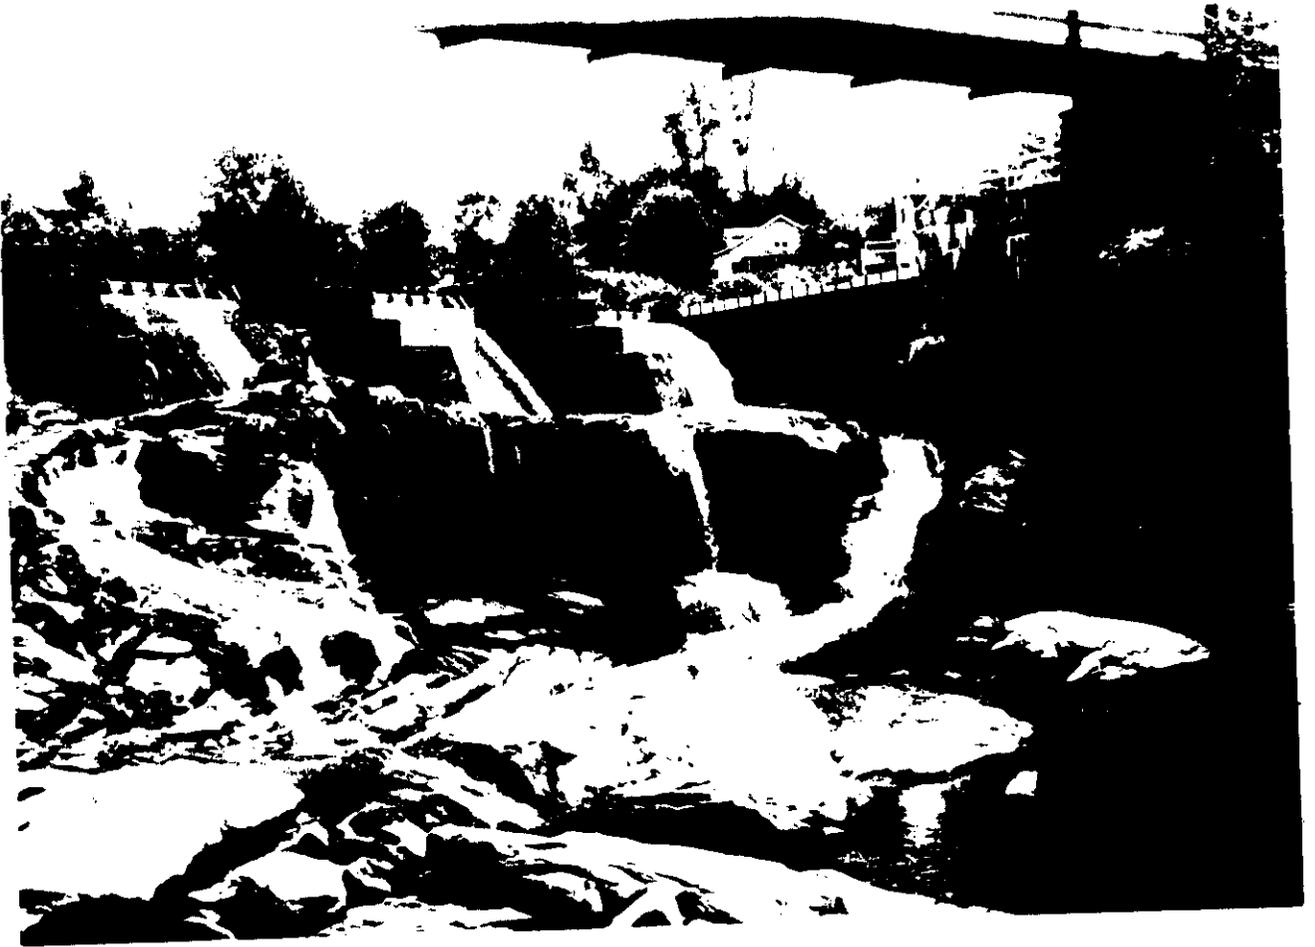
HIGHGATE FALLS

Below the dam, there is a falls about 15 feet high and a cascade of about the same height on either side of the falls. The falls are undercut and have a cave at their base. Below the falls is a gorge about one-third mile long with walls 20-30 feet high. The floor of the gorge is largely boulder-strewn rather than carved, but there are a few potholes and some carved rock near the upper end of the gorge. At one point a 15 foot high cascade enters the gorge from the north. The gorge might be a pretty place with clean water and more of it, but in its present state is smelly, slimy, and unpleasant. The striking features of the site are the cave behind the falls and the fine exposures of bedrock along the walls of the gorge.

The geology is complex, with a number of different formations exposed. At the falls the rock is limestone of the lower Ordovician Highgate formation, and this may be the type locality for this formation. The lower gorge is a dolomitic conglomerate, the upper gorge Cambrian dolomite. The conglomerate continues down the gorge to the new bridge and there meets a dark slate, the Hungerford member of the upper Cambrian Sweetsburg formation. In one area it makes a clear contact with older rocks mapped as the Saxe Brook dolomite, and that formation is mapped as the oldest (middle Cambrian).

Hence, the gorge contains a stratigraphic section including four formations from two different periods; we think that this is one of the most complicated stratigraphies that we encountered at any gorge.
