Vermont Agency of Natural Resources
Watershed Management Division

WHITE RIVER TACTICAL BASIN PLAN

Draft for Public Review, May, 2013

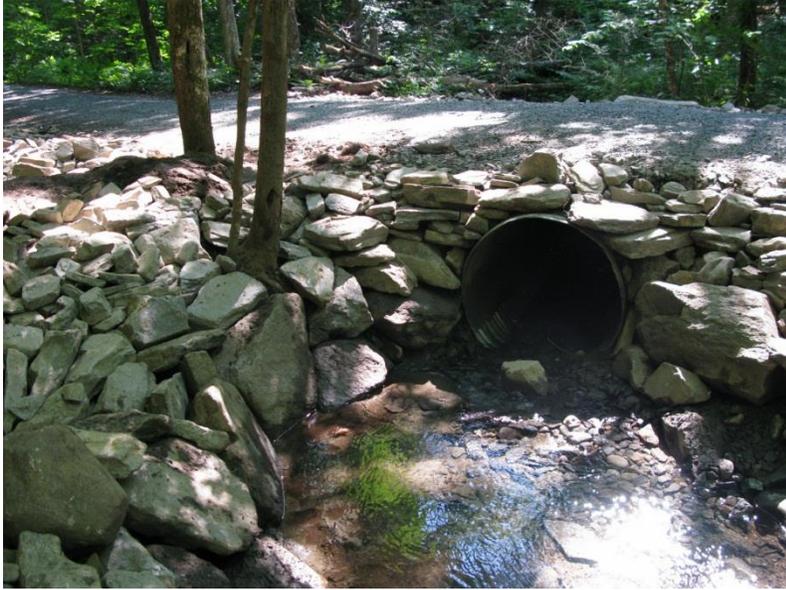
Figure 6.- Class 4 Road culvert header installation

Project partners secured funding from the Ecosystem Restoration Program, Connecticut River Mitigation and Enhancement Fund, and Better Backroads Program. Over a dozen sites have been restored using BMP practices such as culvert headers, culvert outlet stabilization, stone-lined waterways, reinforced stream crossings, and water bar installation. Most of the restored sites withstood the significant precipitation and severity of TS Irene with minimal damage compared to those sites yet restored. Additional sites will be restored as funded is secured.

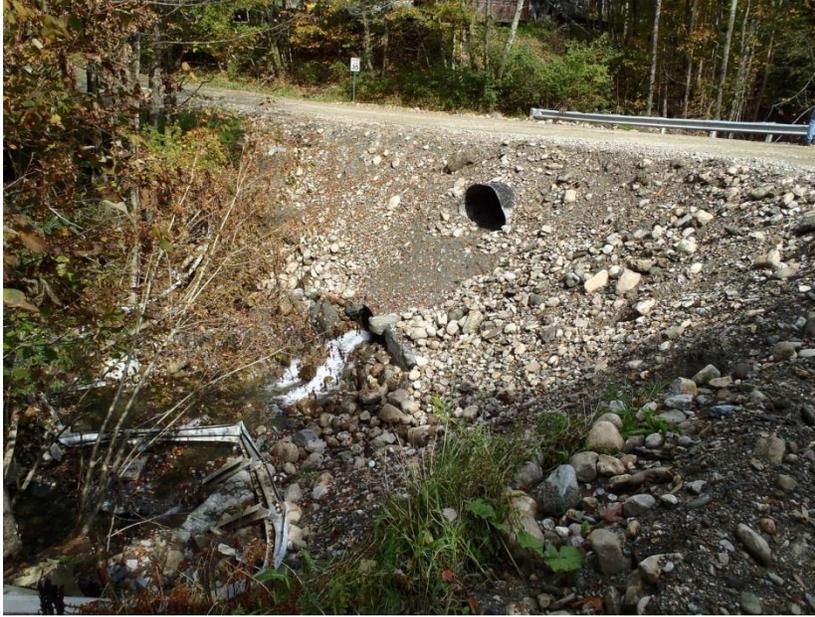
Figure 7.- Marshs Brook Road before photo of double undersized culverts

The Town of Rochester working in collaboration with the White River Partnership, FEMA, USFS, USFWS, DEC, and DFW, identified seven stream crossings to upgrade for both geomorphic equilibrium and aquatic organism passage upgrades. As of this plan writing, two of the seven crossings have been upgraded with the others scheduled for upgrades in the coming field seasons. The Marshs Brook culvert upgrade is shown in the photos below.

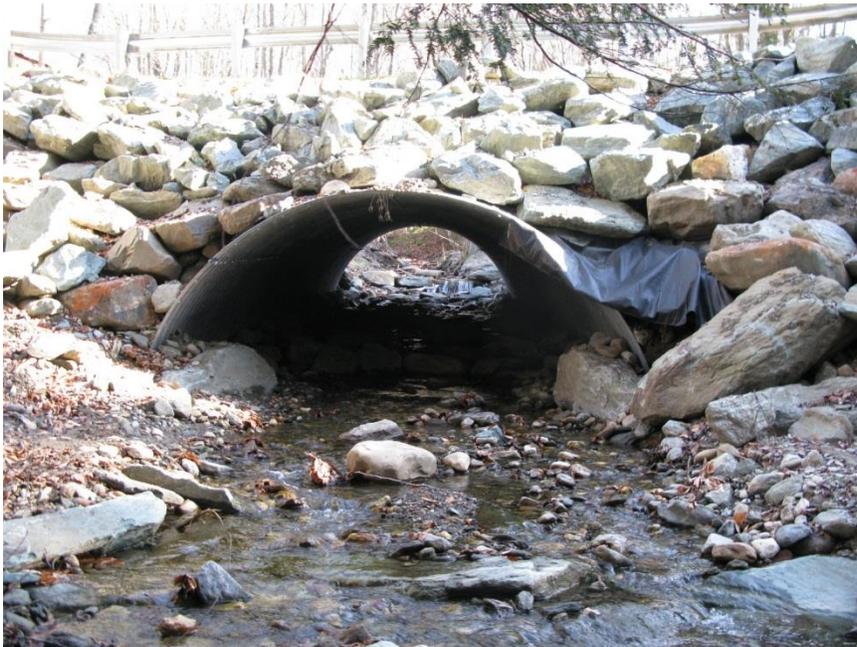
Figure 8.- Marshs Brook Road after the installation of an AOP-friendly crossing

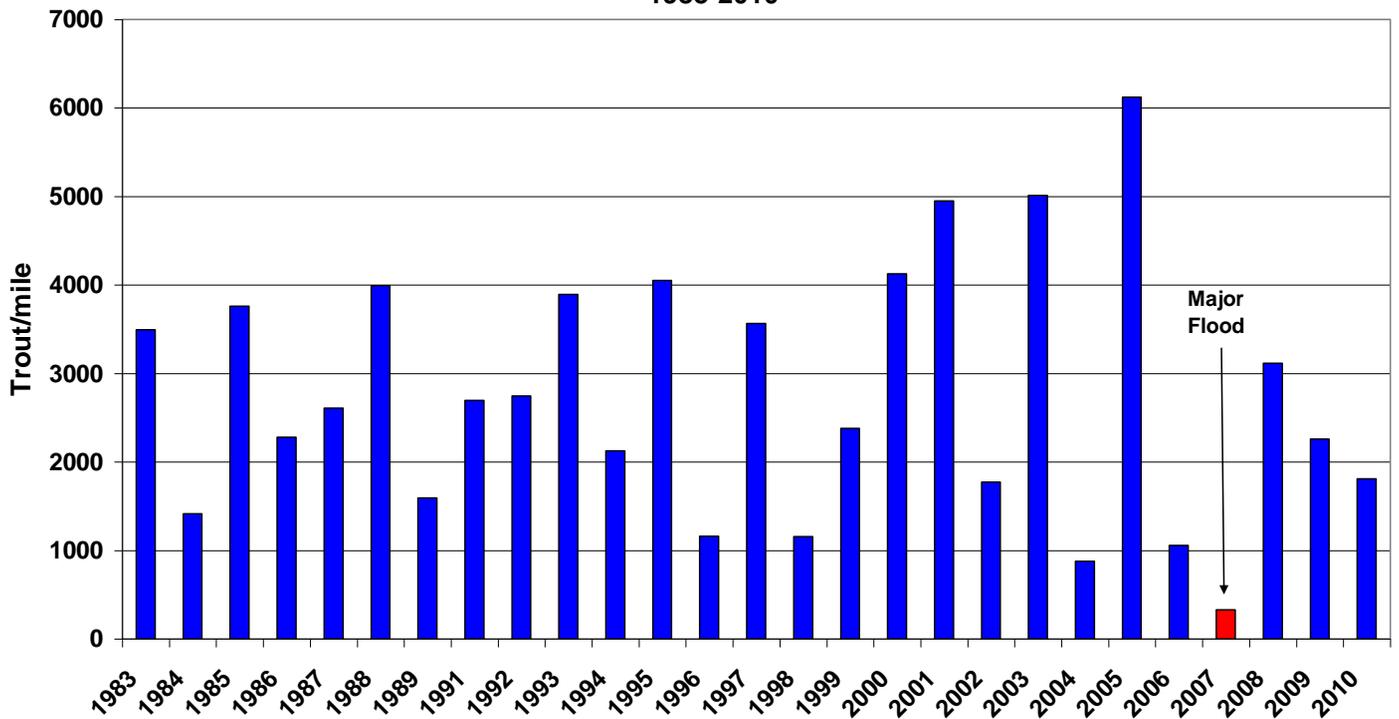
Figure 3. Lilliesville Brook Wild Trout Populations
 Vermont Department of Fish and Wildlife Surveys
 1983-2010
