EMERGENCY PROTECTIVE MEASURE – FINAL AUTHORIZATION

Project Number: EPM-030-2014 Chester Bridge 9 Debris Removal Sewer Crossing

Project Location: Downstream and East of Route 103 Bridge 9

Watercourse: Williams River

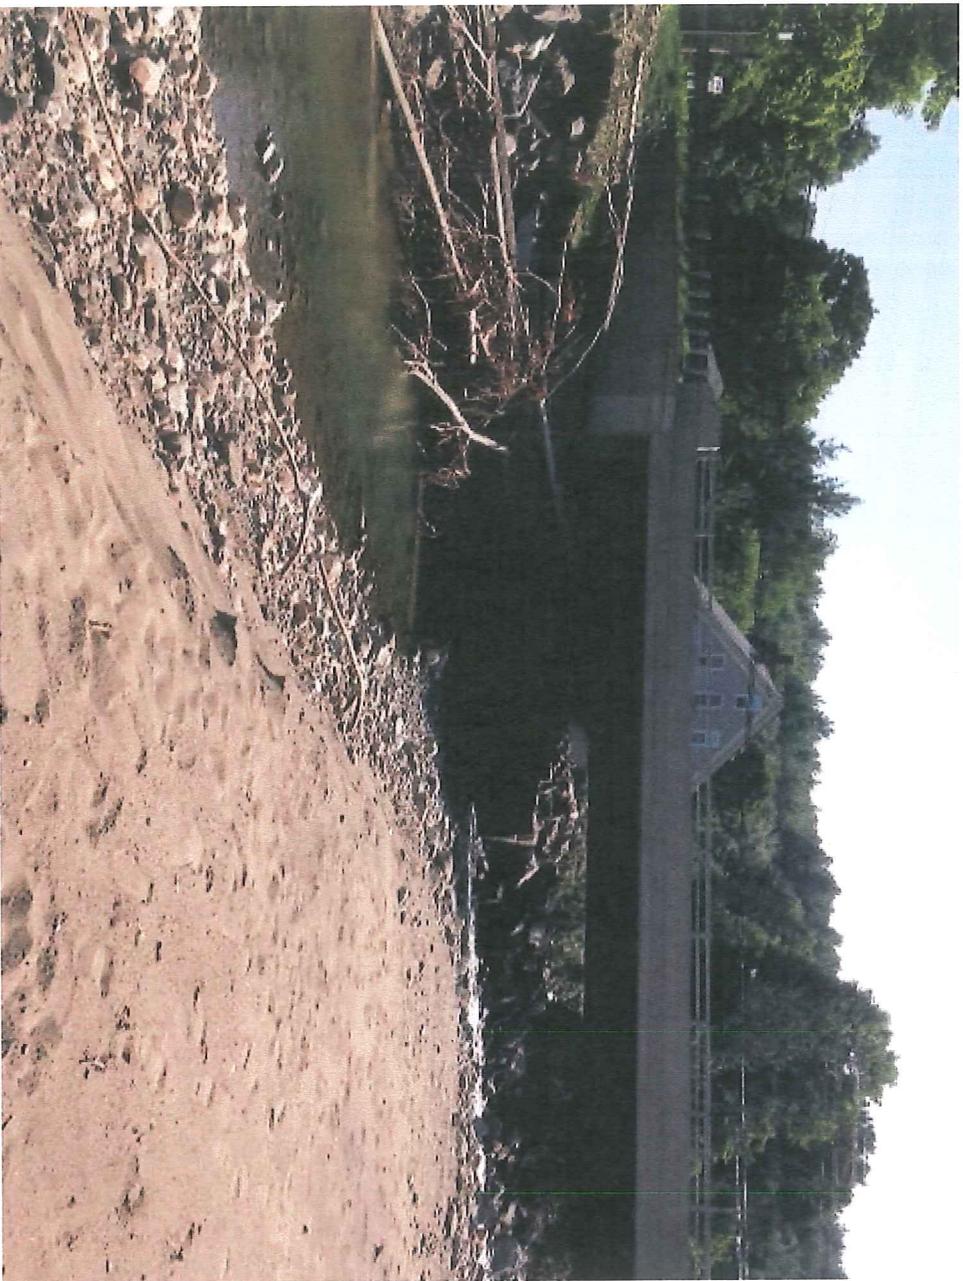
—Rt 103 BR 9 SW overview.jpg

The Route 103 Bridge 9 replacement was just completed in Summer 2011 before Irene and I recall the sewer line issue post-Irene but no bridge related issues. After the 7/28/14 storm the southern abutment footing has been scoured and is exposed in the attached photos. The rip-rap protection on at least 3 of 4 wingwalls were damaged 2 weeks ago, and a gravel deposit underneath the bridge and downstream has diminished the hydraulic capacity of the waterway opening on the order of 20% to 30%.

The sewer line repairs should include pouring concrete beneath the exposed encasement and rip-rap bed armoring upstream and downstream. This can be accomplished after removing the trees and large gravel deposit to redirect flow away from the bridge abutment and pipe crossing. The sewer line repairs are immediately adjacent to the bridge repairs and should be accomplished by a single contractor to afford the best outcome for future flood resiliency. I will make myself available for any site visits this week.

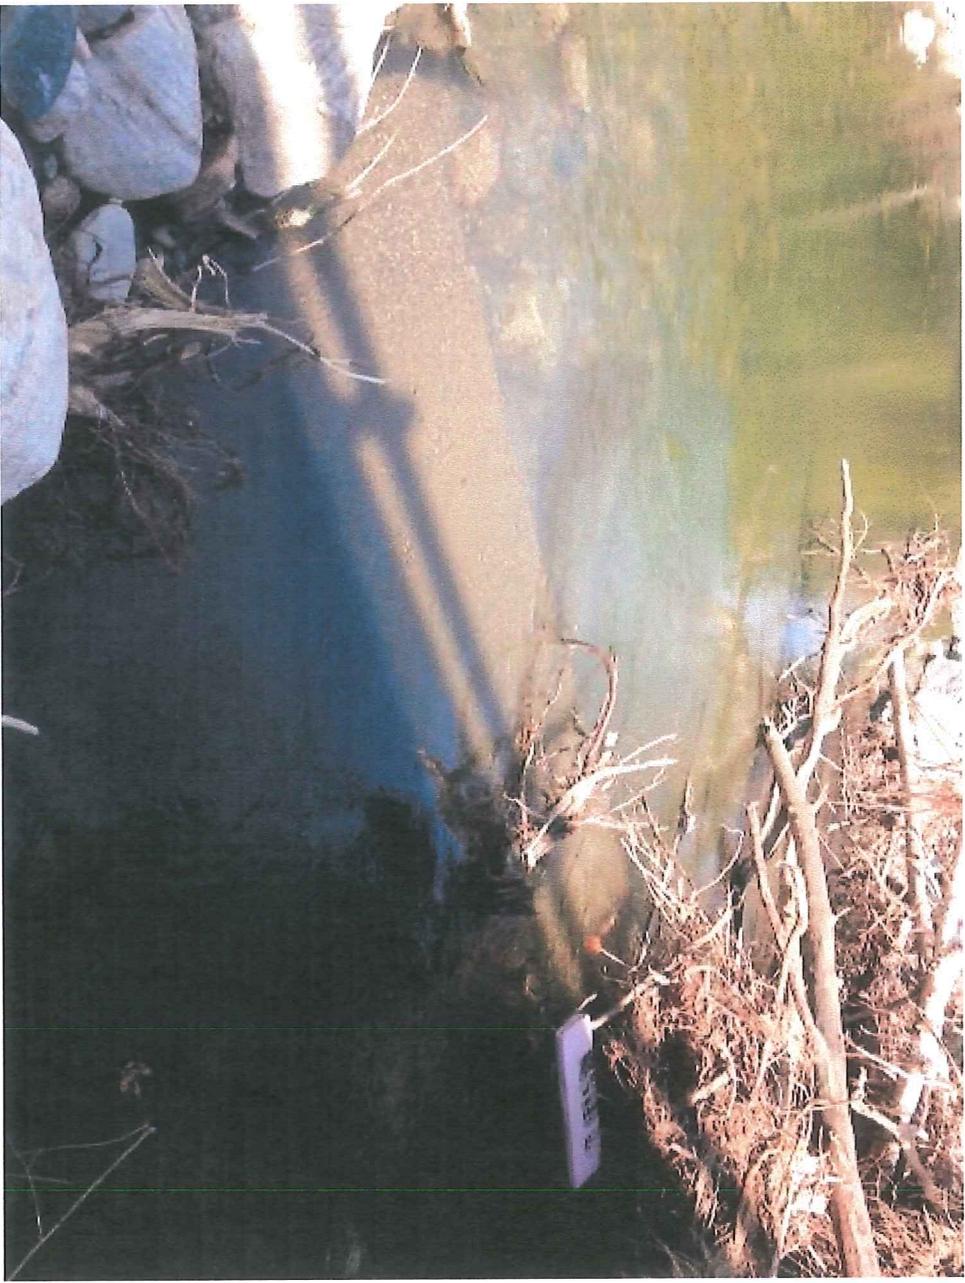
— Rt 103 BR 9 sewer line SE abutment.jpg —

I spoke with Graham Kennedy Road Foreman and Jeff Holden Treatment Plant Operator today, site photos attached. I met earlier with Evan Fitzgerald who just today started field work on a Phase II Stream Geomorphic Assessment of the Williams River and he alerted me to this before Noon today. The town was unaware of the exposed sewer line so I presume this damage from the 7/28/2014 flood is not included in the FEMA damage assessment in the past 2 weeks. This sewer line location was an unprotected sewer line taken out by T.S. Irene flood flows and replaced with DI pipe and encased in the concrete envelope in the attached photo. The 7/28/2014 flood has now exposed the concrete envelope on all four sides.
