Union Brook Timeline

Regulatory Jurisdictions

10/27/2008

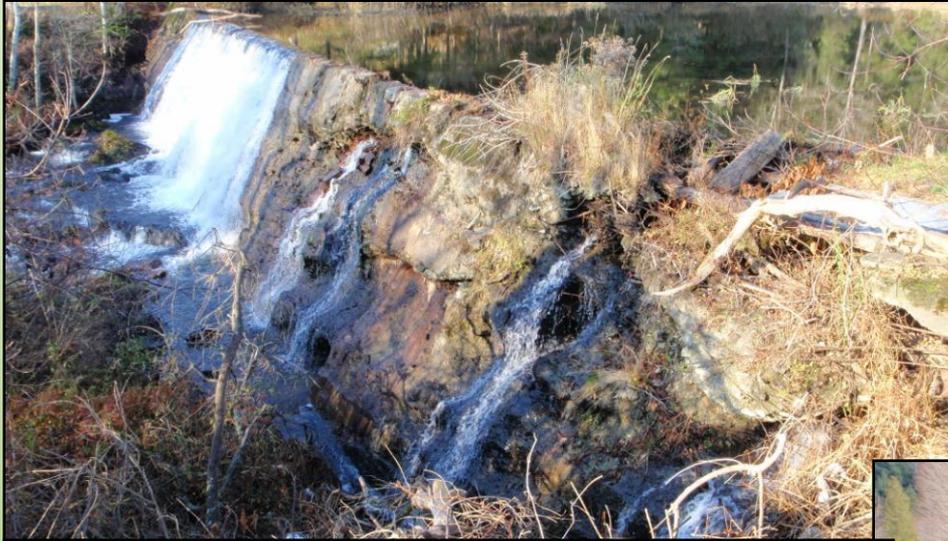
Length: 145 ft.

Height: 18 ft.

Overall condition: Poor

- Severe concrete deterioration and loss of concrete.
- No operational valves or gates, making it difficult to impossible to lower the pond.

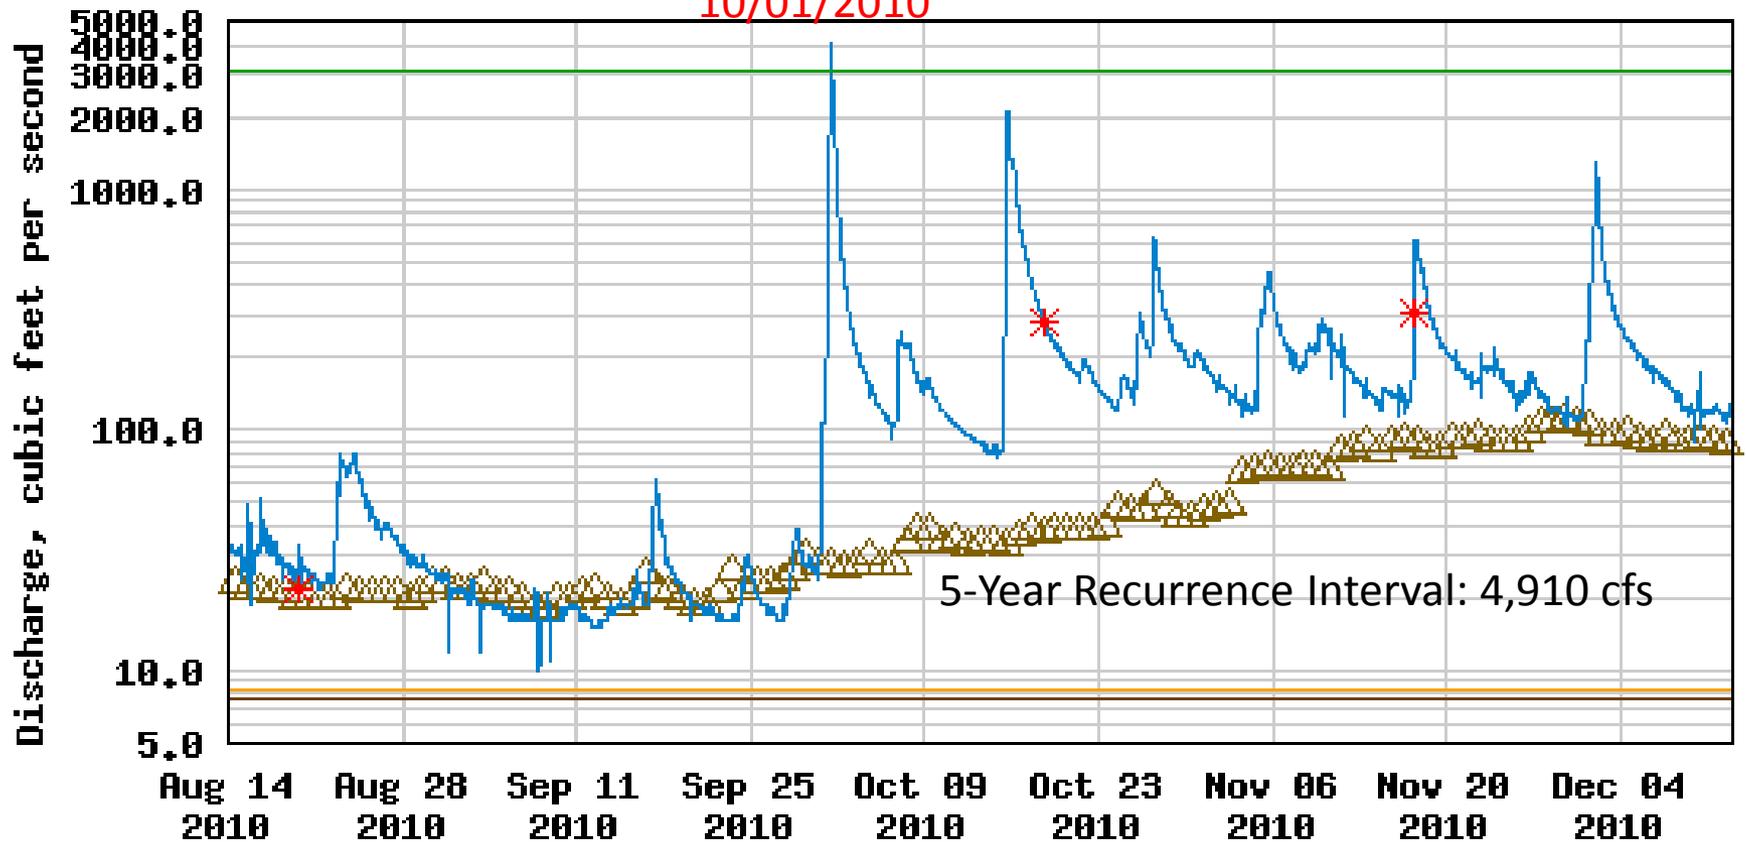
USGS 04287000 DOG RIVER AT NORTHFIELD FALLS, VT

- △ Median daily statistic (74 years)
- Discharge
- * Measured discharge
- 2-Year Recurrence Interval
- 99% Flow duration
- 7-day, 10-year low flow

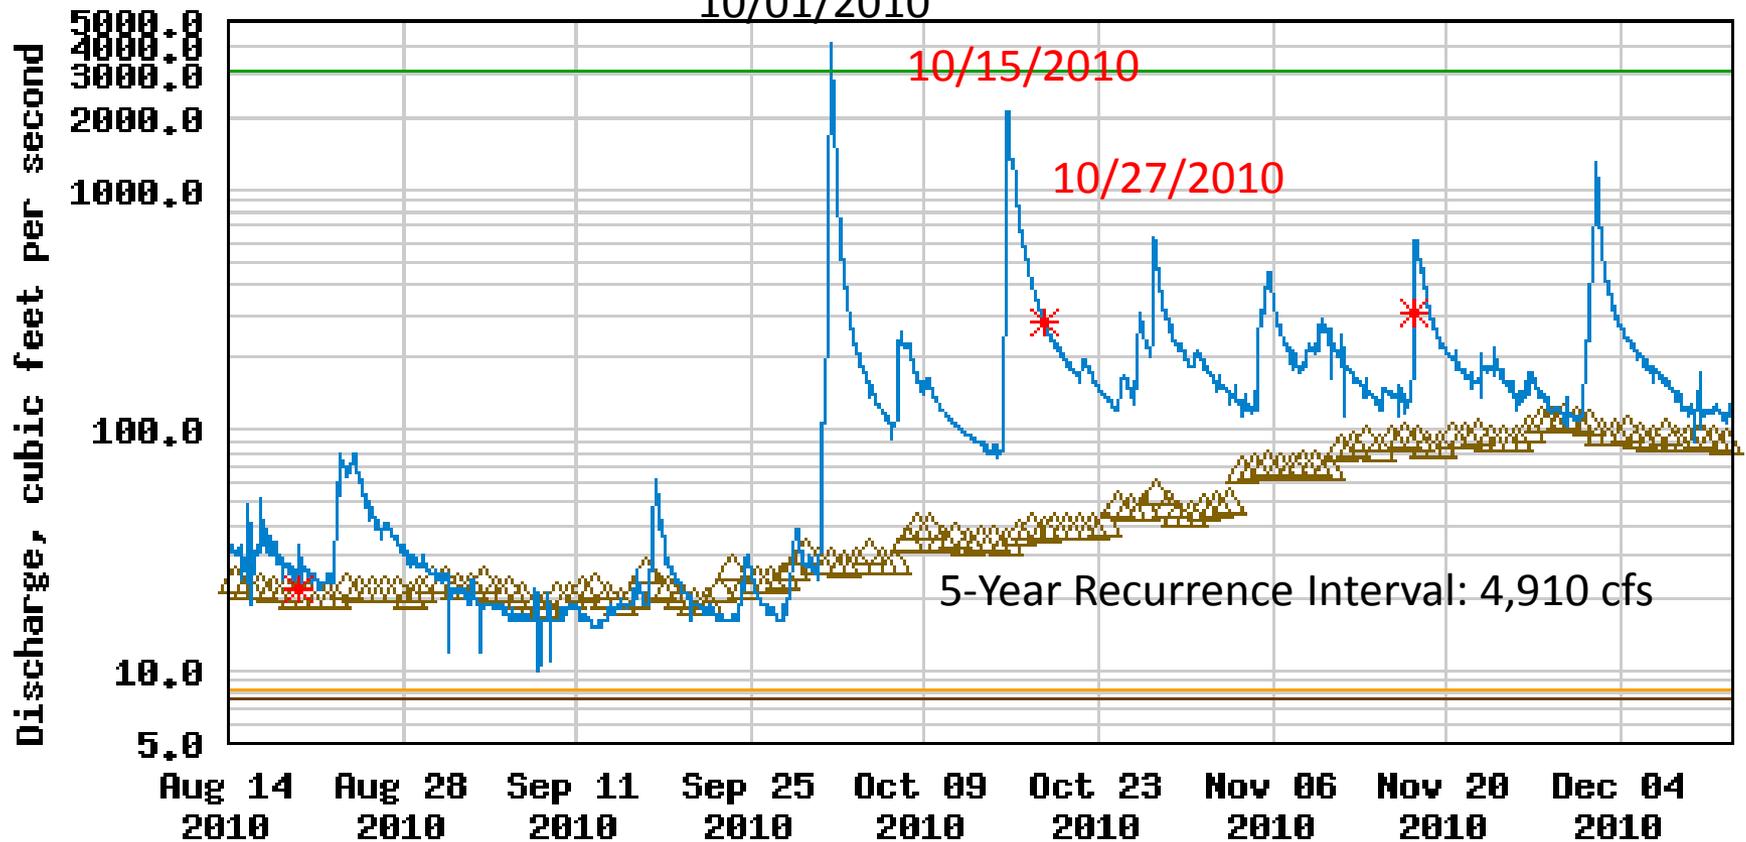
USGS 04287000 DOG RIVER AT NORTHFIELD FALLS, VT
10/01/2010

- △ Median daily statistic (74 years)
- Discharge
- * Measured discharge
- 2-Year Recurrence Interval
- 99% Flow duration
- 7-day, 10-year low flow
