# **Ice-Push Damage on Lake Bomoseen, Vermont**

## **Final Report**

**Lawrence W. Gatto, Michael G. Ferrick, and Darryl J. Calkins**

**May 2001**

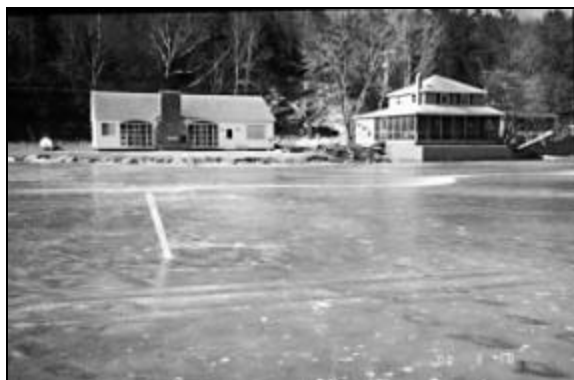
**a. camera location in second story window of house on the right.**

In preparation for an ice push event during the 1999-2000 ice season, we made detailed observations and measurements of the ice to evaluate possible relationships between ice push, weather, and ice conditions. We selected the Cook property (Fig. 2) in the middle of the heavy damage zone along the west shore of Avalon Bay to make observations of ice thickness and conditions, measure temperatures of the air, ice, and water, and record ice push. We installed a digital camera to document site conditions and observe ice push. The camera took up to five pictures a day, which were immediately available for viewing on the CRREL web page from 23 November 1999 to 30 March 2000.

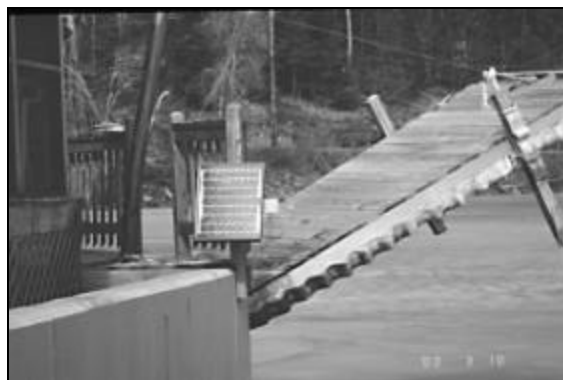
**b. air temperature thermistor.**

Eagle Bay on Lake Bomoseen, and Hooker Hill. We also measured on-site snow depth during site visits. We took ice cores to define the ice type and thickness, and we measured water temperatures about

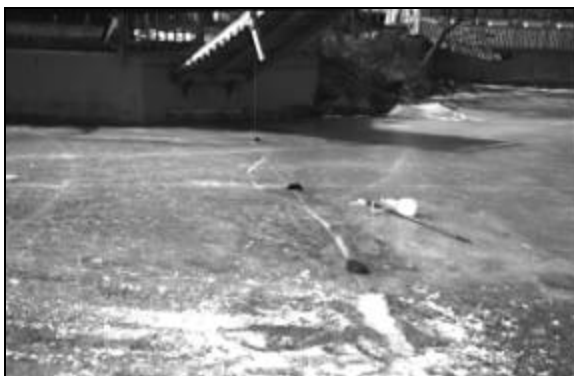
**c. ice temperature thermistor.**

125–135 feet offshore of the Cook property. The water temperatures were measured at the ice-water interface and every 3 feet down to 23 ft.

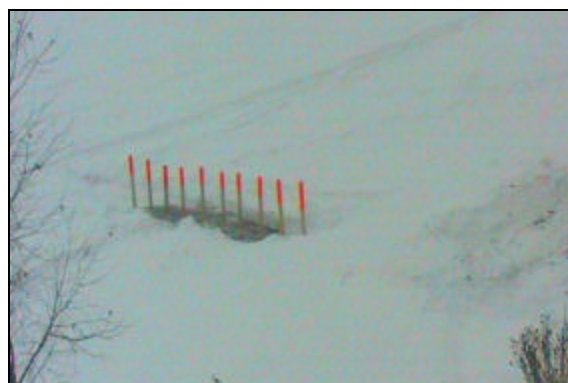
**Figure 2. Cook property site.**

**d. ice-push stakes.**

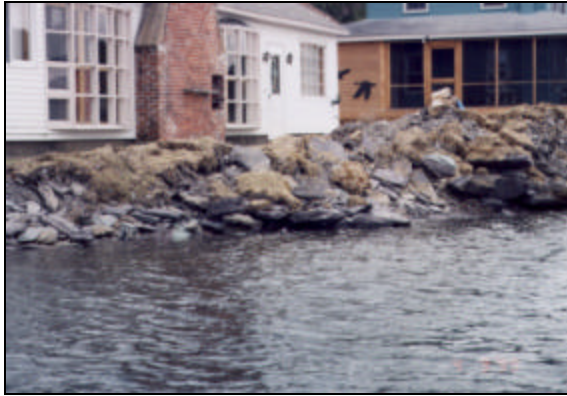
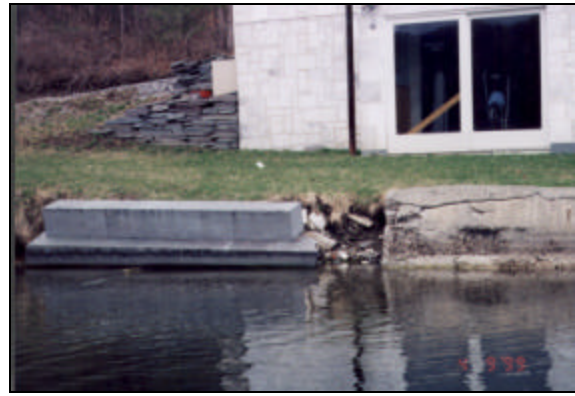
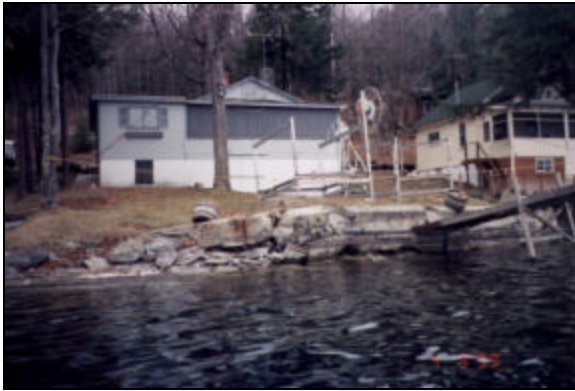
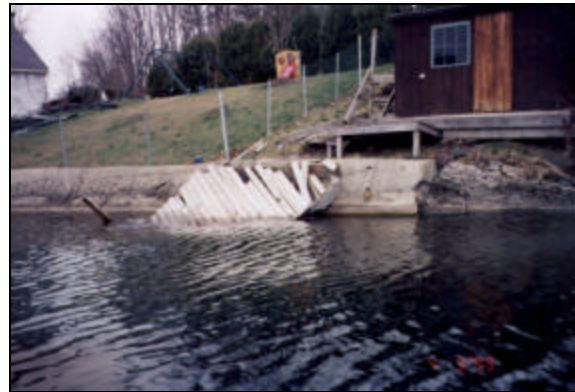
Figure 4. Shorelines and structures where damage has been moderate to heavy.

As follow-up to the field survey of damage, Jim Leamy reported that serious damage, which he defined as “widespread and substantial,” had occurred in 1989-90, 1990-91, 1997-98, and 1998-99. The locations that the LBA identified as having been moderately to seriously damaged are shown in Figure 3. Thus, the five winters for which damage was reported, as determined from the files and the LBA, are 1989-90, 1990-91, 1995-96, 1997-98, and 1998-99. Figure 4 shows some of the shorelines and structures that were damaged in the 1990s.

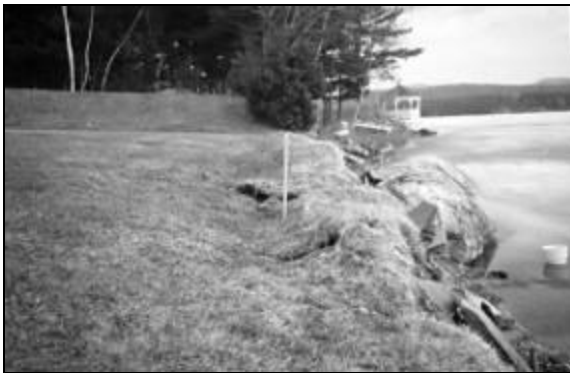
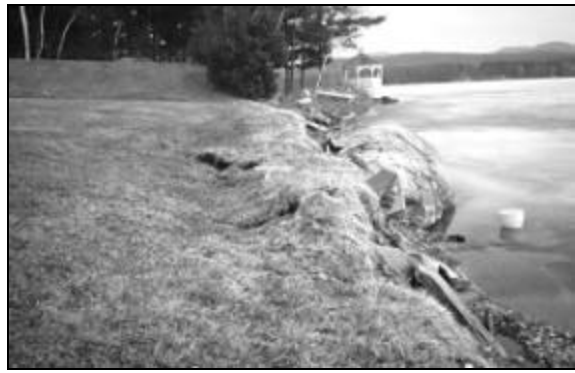
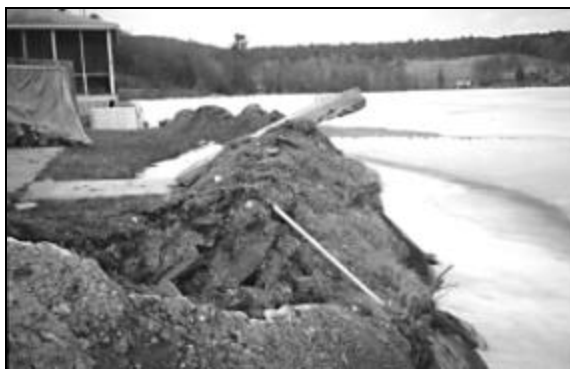
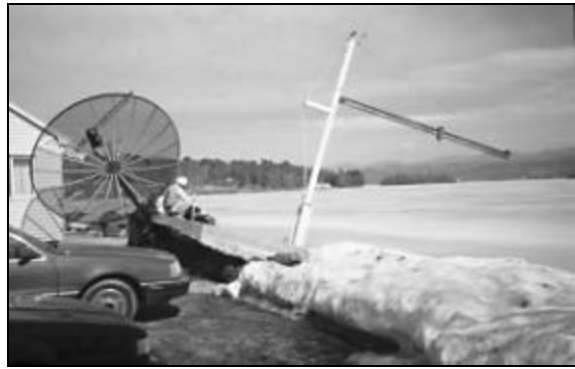
Figure 5. The most severe single-season damage caused by ice push in the 1990s, March 1990 (photos by L. Gatto); a and b. Avalon Beach, c and d. south shore, Avalon Bay.

Damage during a single season along Lake Bomoseen has ranged from none to substantial, depending on how all the factors discussed earlier interacted. For example, during March 1990 ice pushed shoreline soils into 3-foot-high ramparts at some locations along Avalon Beach and completely destroyed a large, concrete platform on the southwest shore of Avalon Bay at what is now the Cook property (Fig. 5). Elsewhere along the bay and the lake, damage was less or did not occur. Conversely, at the Cook property during the 1999-2000 ice season, the only damage was some small patches of grass that were scraped from the soil when a southerly wind drove decayed ice up and onto the southwest-facing shore. The degree of damage that occurs at a given location and the locations where damage occurs are highly variable from year to year, and the degrees of damage that occur along the lake shore during the same season vary significantly.

A letter report in the ANR files describing the damage from the March 1990 ice push event attributed the push to thermal expansion. The ice in the first half of March 1990 completely covered the lake, so wind could not have moved the ice around. The report stated that water levels were between +1 and -2 inches in February and into mid-March, which was very similar to the levels during the previous several years, excluding the legislatively mandated drawdown of 1988-89.

Measurements of the distances that ice moved inland along Lake Bomoseen because of ice expansion in March 1990 were made by Larry Gatto and Devinder Sodhi of CRREL during a visit on 16 March, four days after the damage was first reported. The distances varied from 2 feet near the fishing access on the west shore to 7 feet in Avalon Bay south-east of St. Matthews church. The leading edge of the pushed ice may have partially melted between the time of maximum inland movement and the time measurements were made; the air temperature during the four days was 40–60°F.

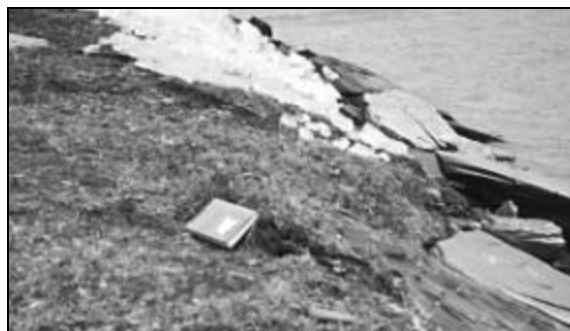
**Figure 12. Scraped soil surface when decayed ice was pushed up and piled on shore.**

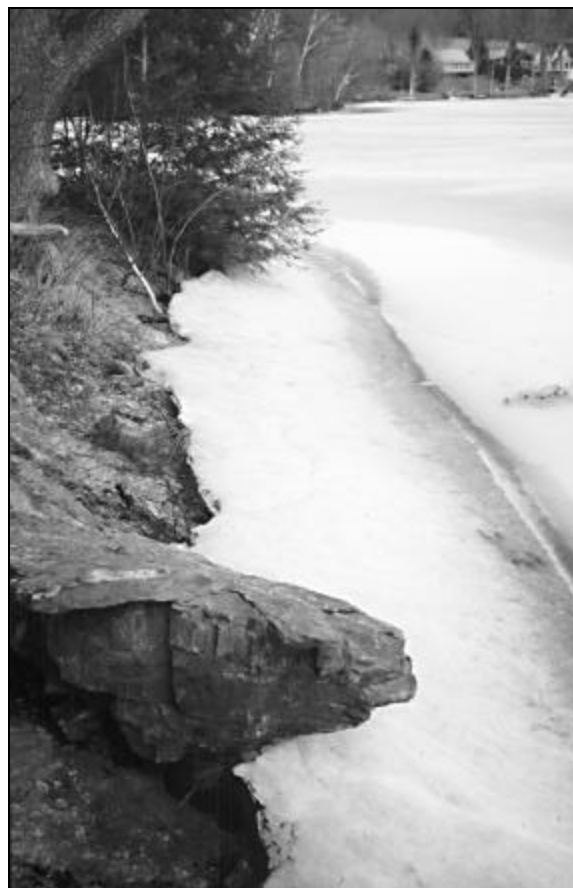
Figure 15. Bedrock shoreline along Avalon Bay.

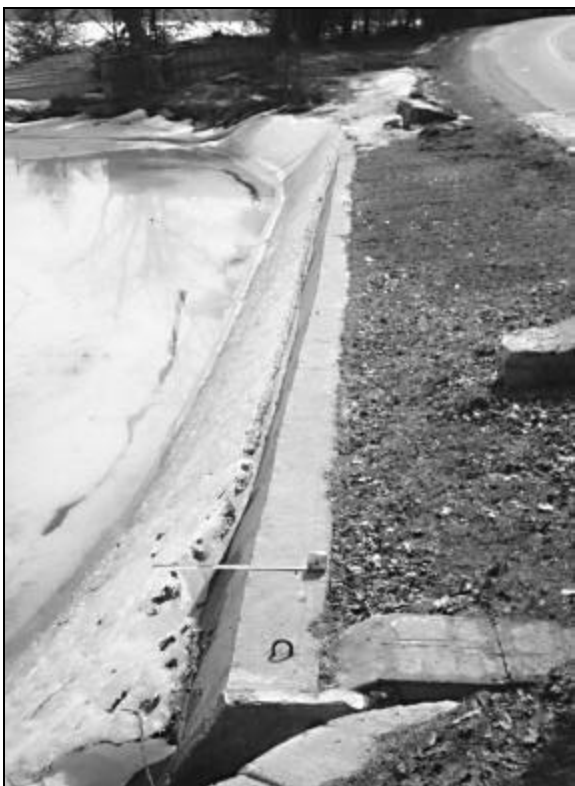
**Figure 17. Sloping structure along Avalon Bay.**

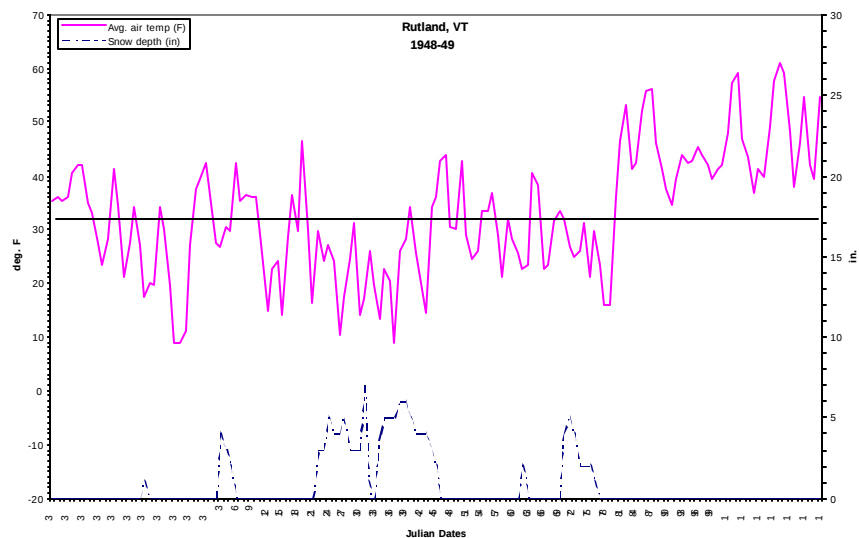
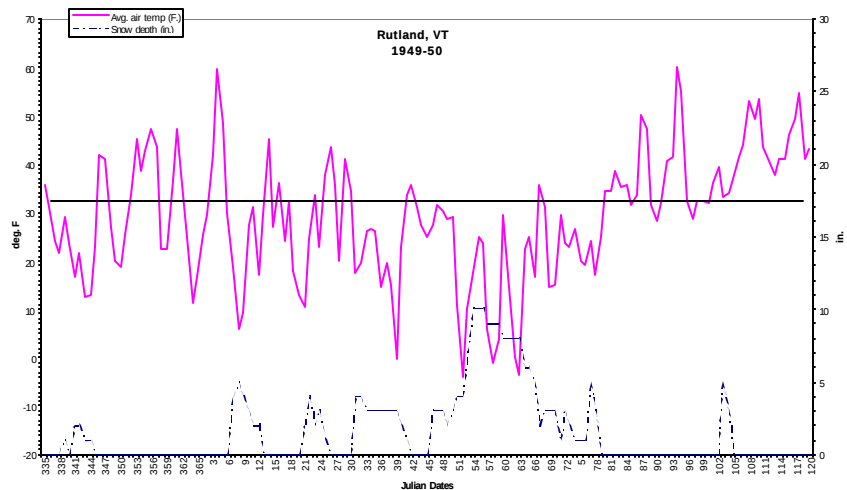
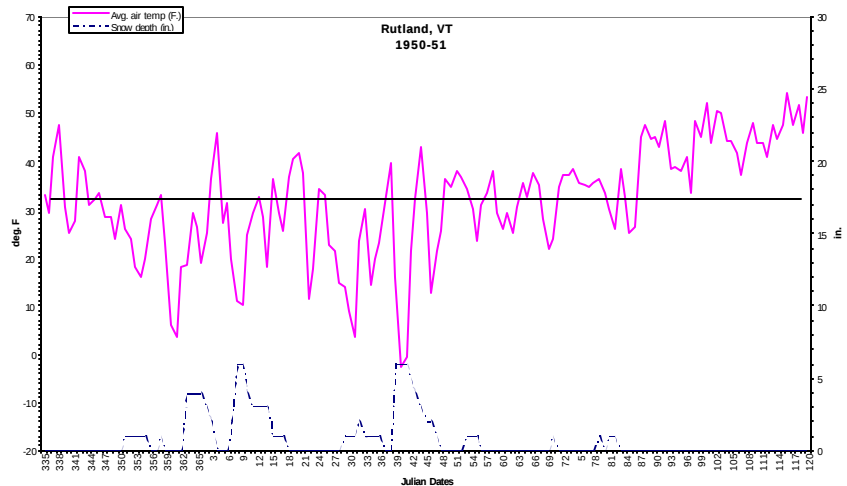
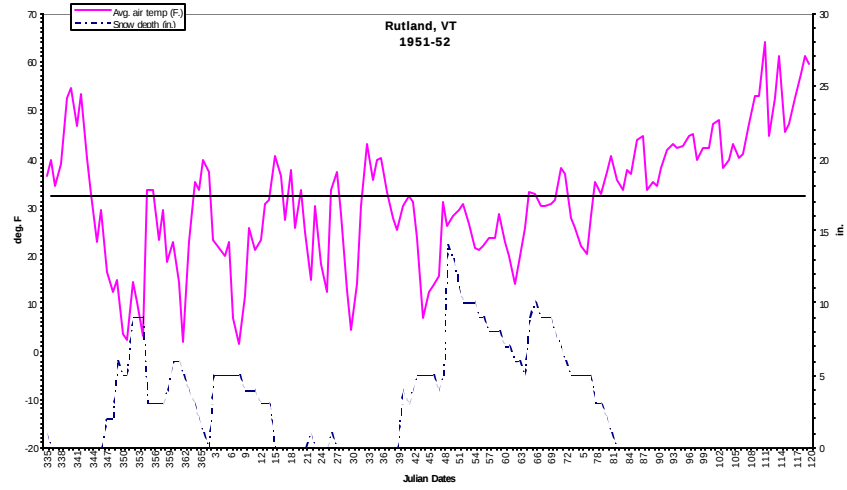
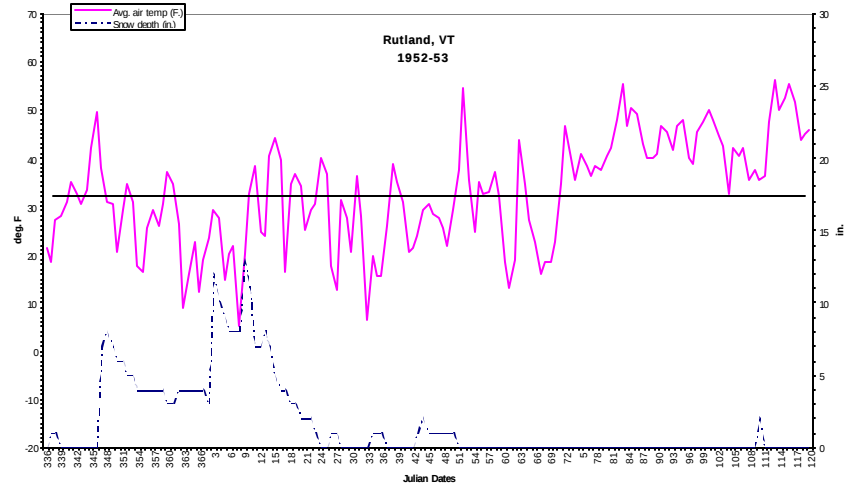
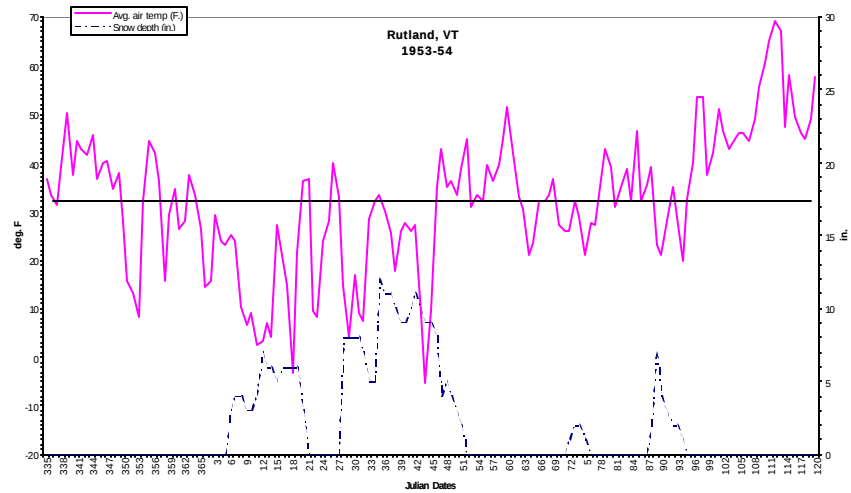
**APPENDIX A. AVERAGE DAILY AIR TEMPERATURES AND SNOW DEPTHS, 1 DECEMBER (JULIAN 335) TO 30 APRIL (JULIAN 120), FROM THE NWS RECORDS. THE ARROWS ON GRAPHS STARTING IN 1956-57 SHOW THE DATE OF ICE-OUT.**
