THE
**WATER-
FALLS,**
CASCADES
AND
GORGES
OF
VERMONT

JERRY JENKINS & PETER ZIKA

for the
AGENCY OF NATURAL RESOURCES
DEPARTMENT OF ENVIRONMENTAL CONSERVATION

September 1985

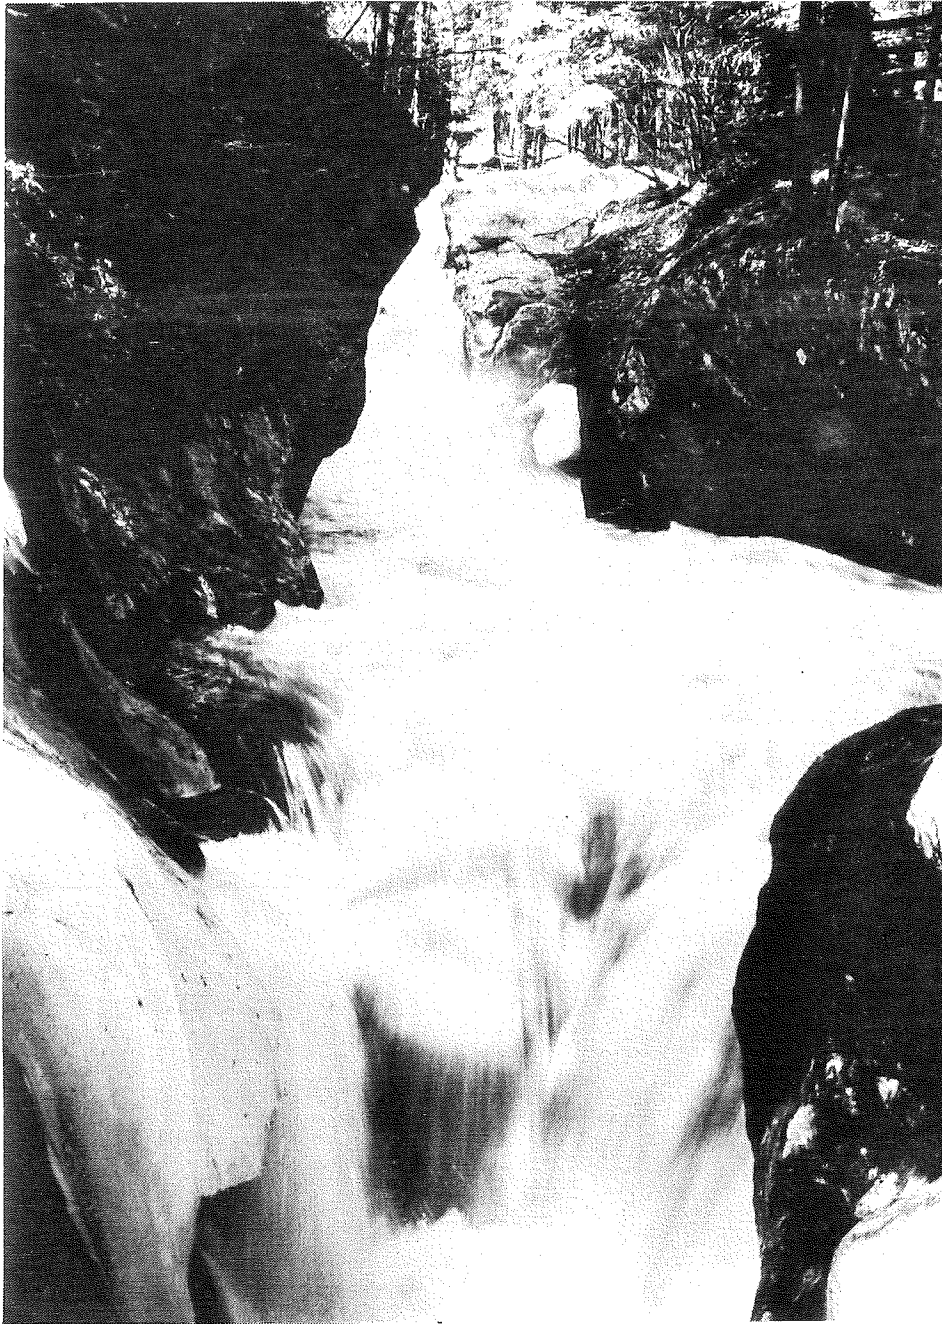
TEXAS FALLS

A pretty place: developing it for recreation has compromised the wildness but not the attractiveness, and it still has a good rock and mountain flavor. We like the scale of places like this; the amount of rock and the depth of the gorge are just right for the amount of stream. It is the right size to fit nicely under trees. Some of the falls are especially pretty if you walk up the channel and look at them from below: the trails are intended to let you look down into the gorge and see the rocks and swirls from above and that is fine, but if you really want to see any waterfall you should climb up to it from below, and this is especially true here.

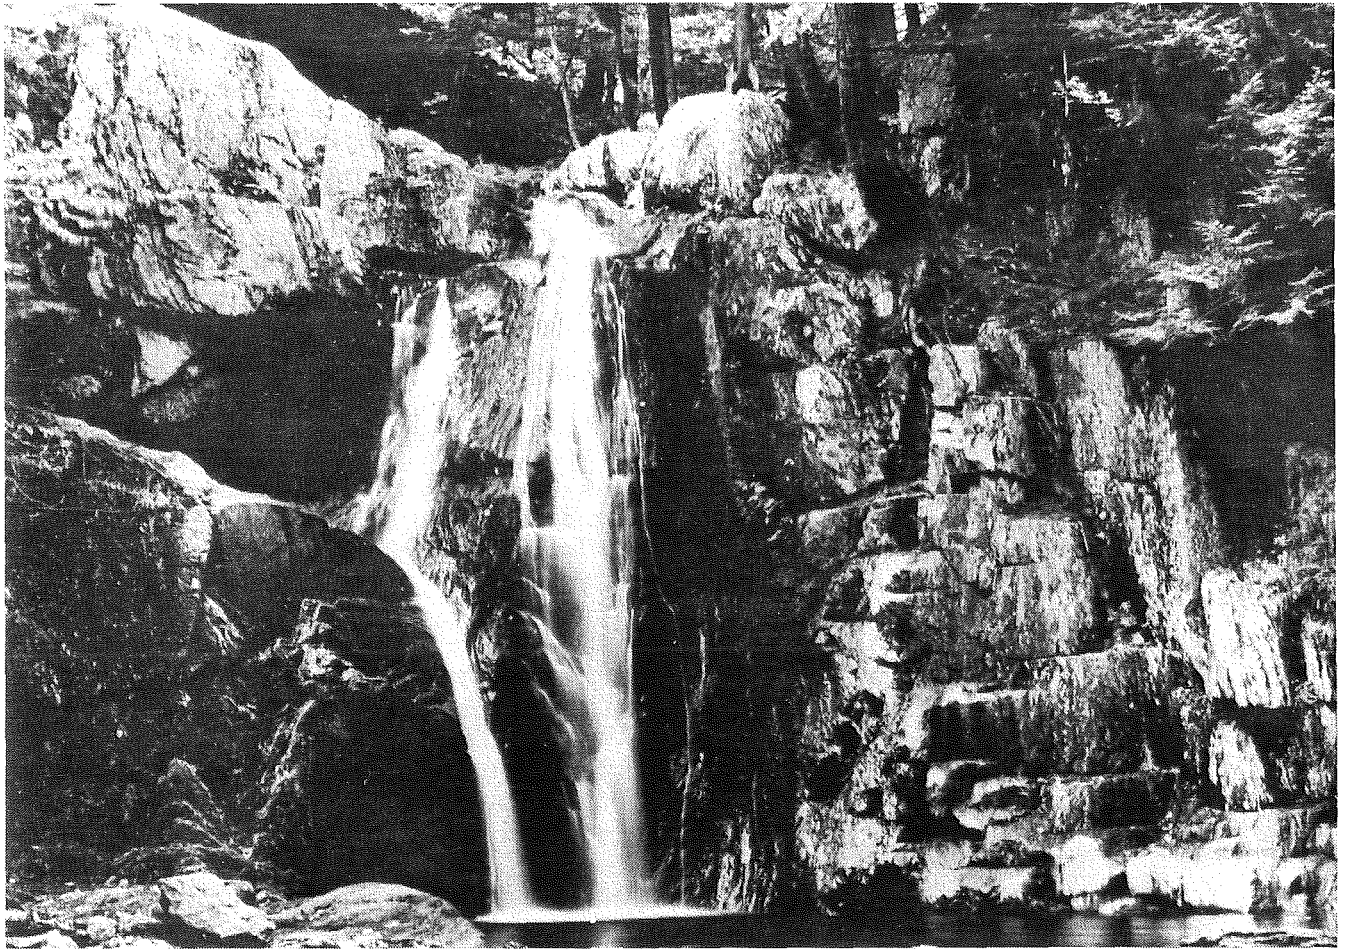
WEB FALLS

The bedrock at Web Falls is a schist from Ordovician Stowe formation, a rock found at many of our most attractive mountain waterfalls and gorges. Here the rocks are broken into big chunks with flat tops, making it easy to climb around and see the falls from different angles. One of the ledges by the pool is nicely sculpted into big pillow-shaped mounds, and is a fine place to sunbathe. In only one place was there any evidence of lime in the schist. No potholes or ripple-rock were found.

Web Falls is a favorite local site. It has fine swimming with a good place to dive from and good rocks for sunning. There are several fire rings above the ledges, suggesting camping or partying. The nearby logging road and several faint footpaths offer good hiking along the stream. Above the falls is an

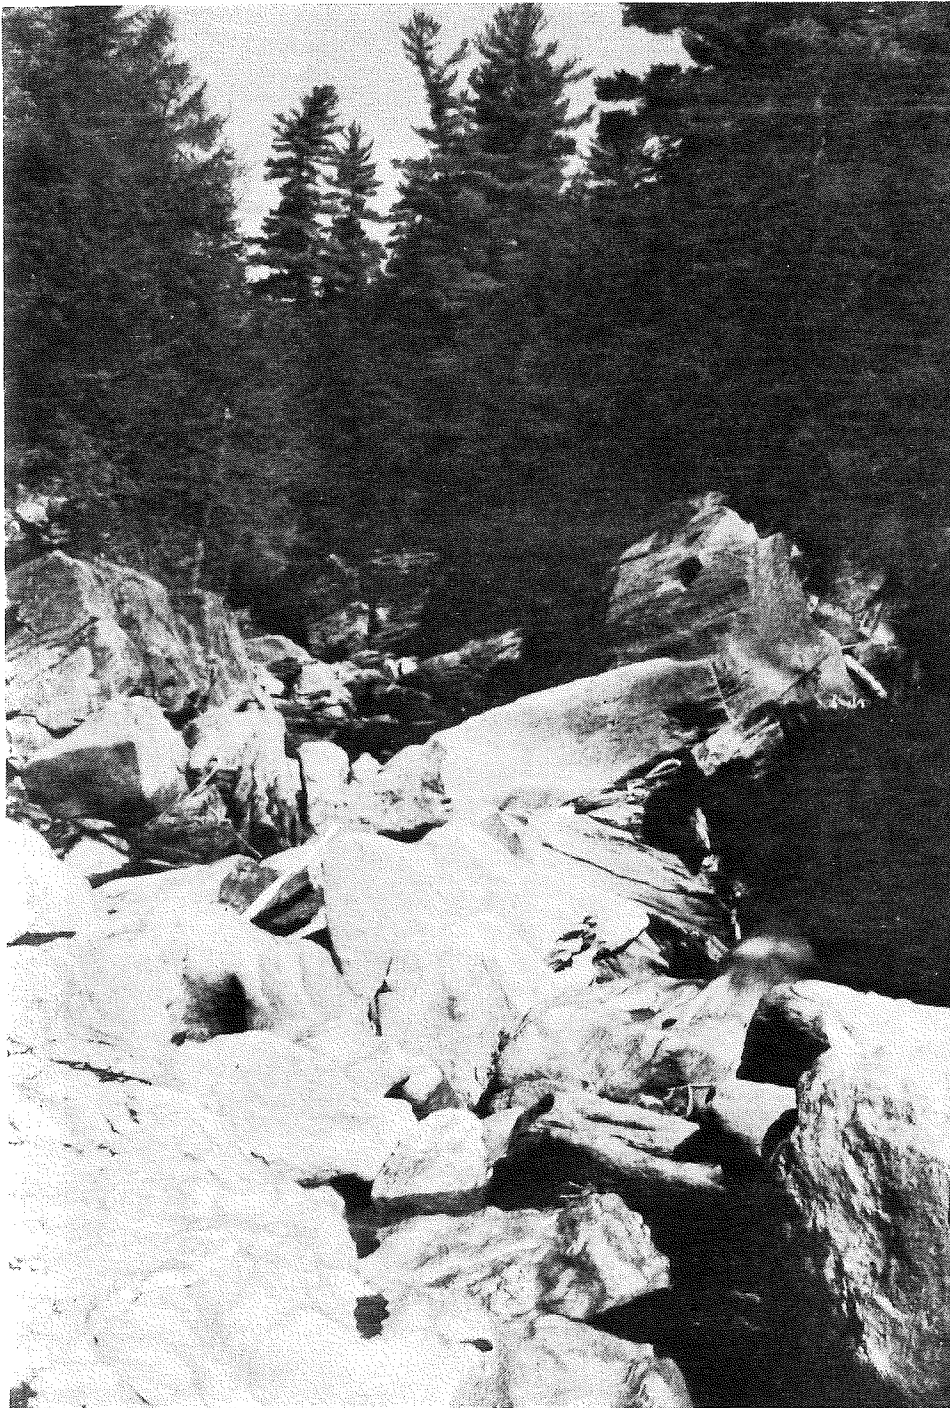
CAVENDISH GORGE

Because of the lack of soil, all the vascular plants in the gorge are confined to ledge tops and cracks in the walls. The flora is simple, consisting only of a few common species, mostly ferns, grasses and tree seedlings. No rarities occur. No list of vascular plants was made. As a whole, they play a very casual part in the botany of the gorge.

Large areas of the walls are covered by mosses and liverworts. The species identified are listed on the next page. No rare species were found, but it should be stressed that this was a general survey and not a complete inventory. The main pool mentioned above is a particularly fine place for bryophytes, and the walls are covered by the liverworts Marsupelia emarginata and Scapania nemorosa to heights of 40-60 feet above the stream. In general, mosses are abundant throughout the gorge and the variety of species is good, considering that there is no lime. We saw few gorges in which the bryophytes were as lush or extended higher up the walls, hence, we regard this as an important bryophyte site.

Visually it is a striking place; the rocks and the mosses are beautiful, the water is clean, and there are high walls and handsome pools. You cannot hear cars from the gorge, and because it is narrow and winding you have a strong sense of privacy and isolation. A lovely and satisfying place in good condition.

WE RECOMMEND: That arrangements be made to guarantee flows, and that no further development occurs.

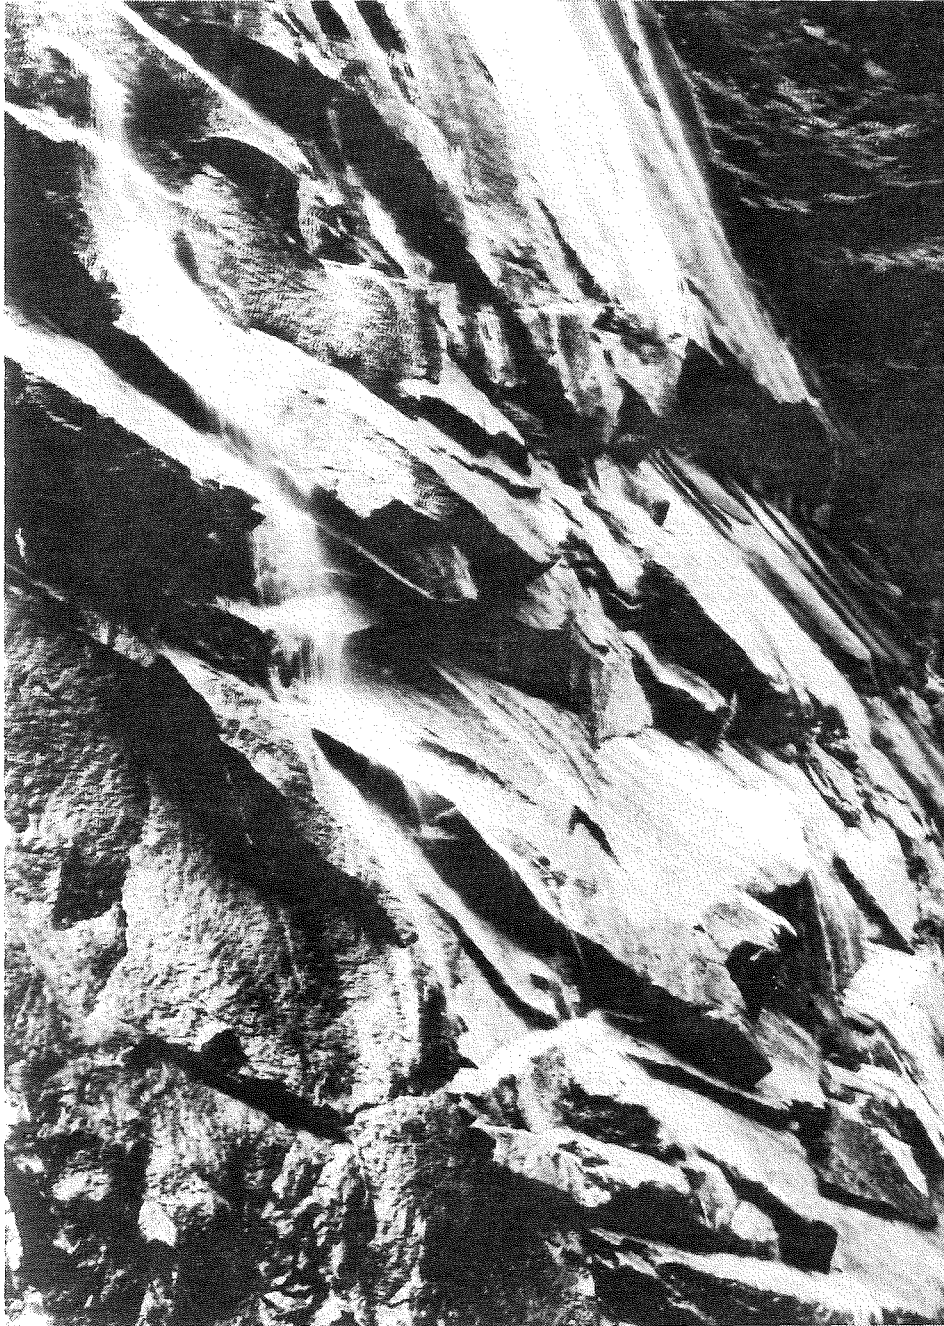
CRYSTAL CASCADE

The geology of Crystal Cascade appears to be unique in Vermont. It is a rare example of a ring dike, formed in the Permian or Triassic by the upward flow of magma in a somewhat circular fissure. The molten rock ate and shoved its way through overlying sedimentary rocks layed down in the Devonian. The fledgling volcano lacked the thrust necessary to reach the surface however, and all the magma cooled off underground. Subsequent erosion and glaciation have worn away much of the overlying bedrock, exposing the igneous edge of the ring dike at the present-day brownish cliff and upper cascades. The dike is mapped as the White Mountain plutonic-volcanic series. The rocks at the border of the newly formed pluton were metamorphosed by the extreme heat of the magma, and this contact zone is clearly visible at the base of Crystal Cascade, where a second bedrock

type shows as a gray mass. It appears to be part of the Waits River formation on the geologic map. Further evidence of the ring dike formation can be found at the top of Crystal Cascade. Chunks of the surrounding bedrock were constantly consumed by the magma as it moved upwards, but pieces that were only partially absorbed when the magma had cooled are reported to be visible in the flat outcrops above the cliff. The ATA's Guide to the Trails of Mt. Ascutney states that the only other large example of a ring dike is in Norway, where it is called a nordmarkite.

Summary: Mountain setting, unique rocks - a geological landmark, average biology, secluded and private since the trailhead was closed to the public, almost no trash, clean water, no swimming, formerly a popular hiker's destination en route to the summit of Mt. Ascutney, fine view.

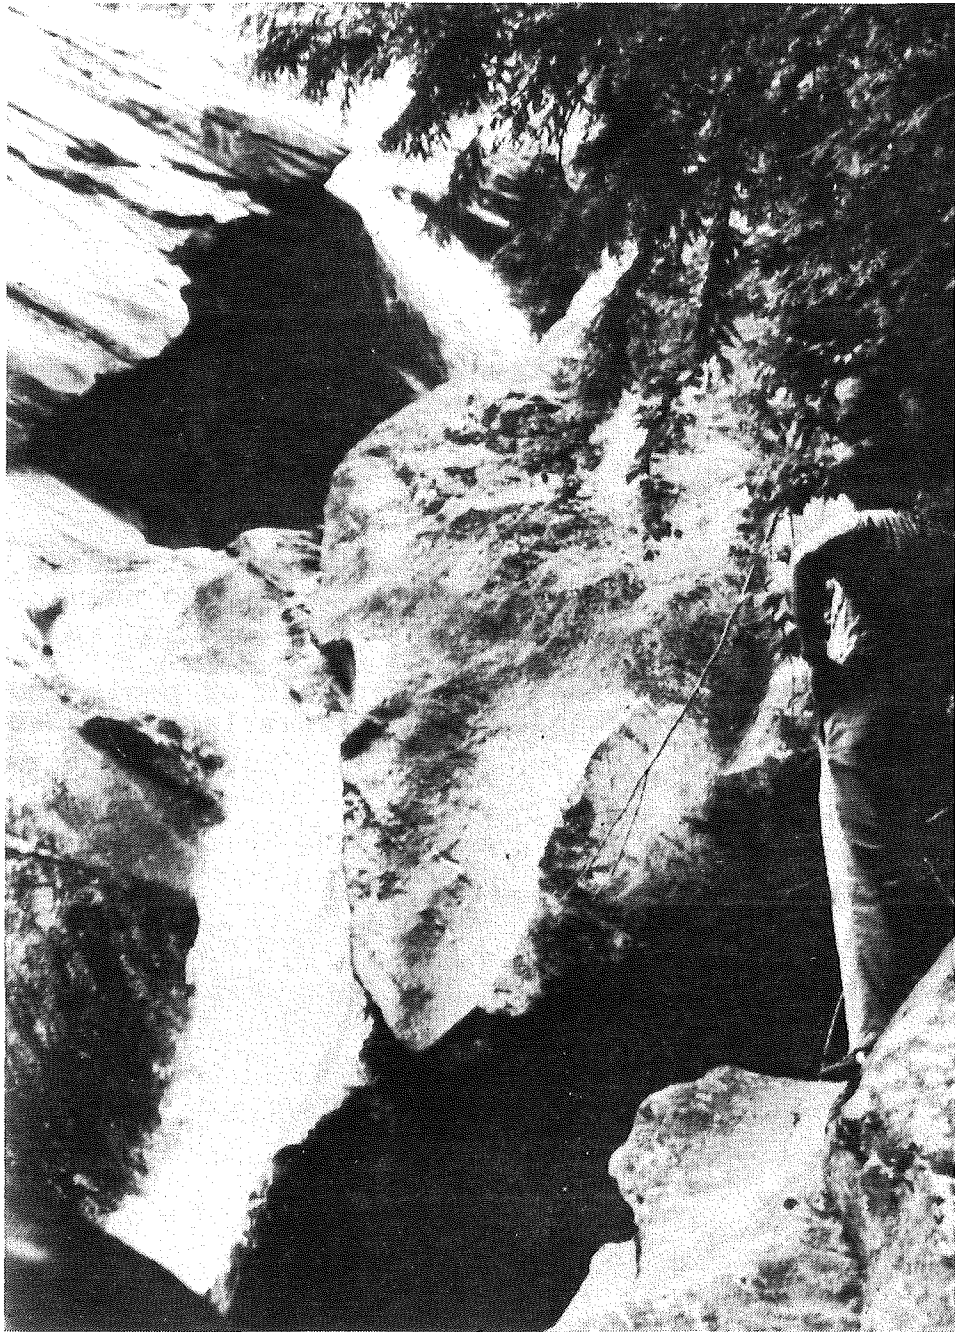
HAMILTON FALLS

1. Upper falls: Woodland setting, fine to spectacular rocks, average botany, no seclusion and wildness, clean site, very clean water, great swimming, very popular for parties and swimming, dangerous steep rocks and history of fatal accidents.
2. Lower chain of cascades and pools: Woodland setting, fine rocks, exemplary botany, wild and private, no use, no trash, very clean water.

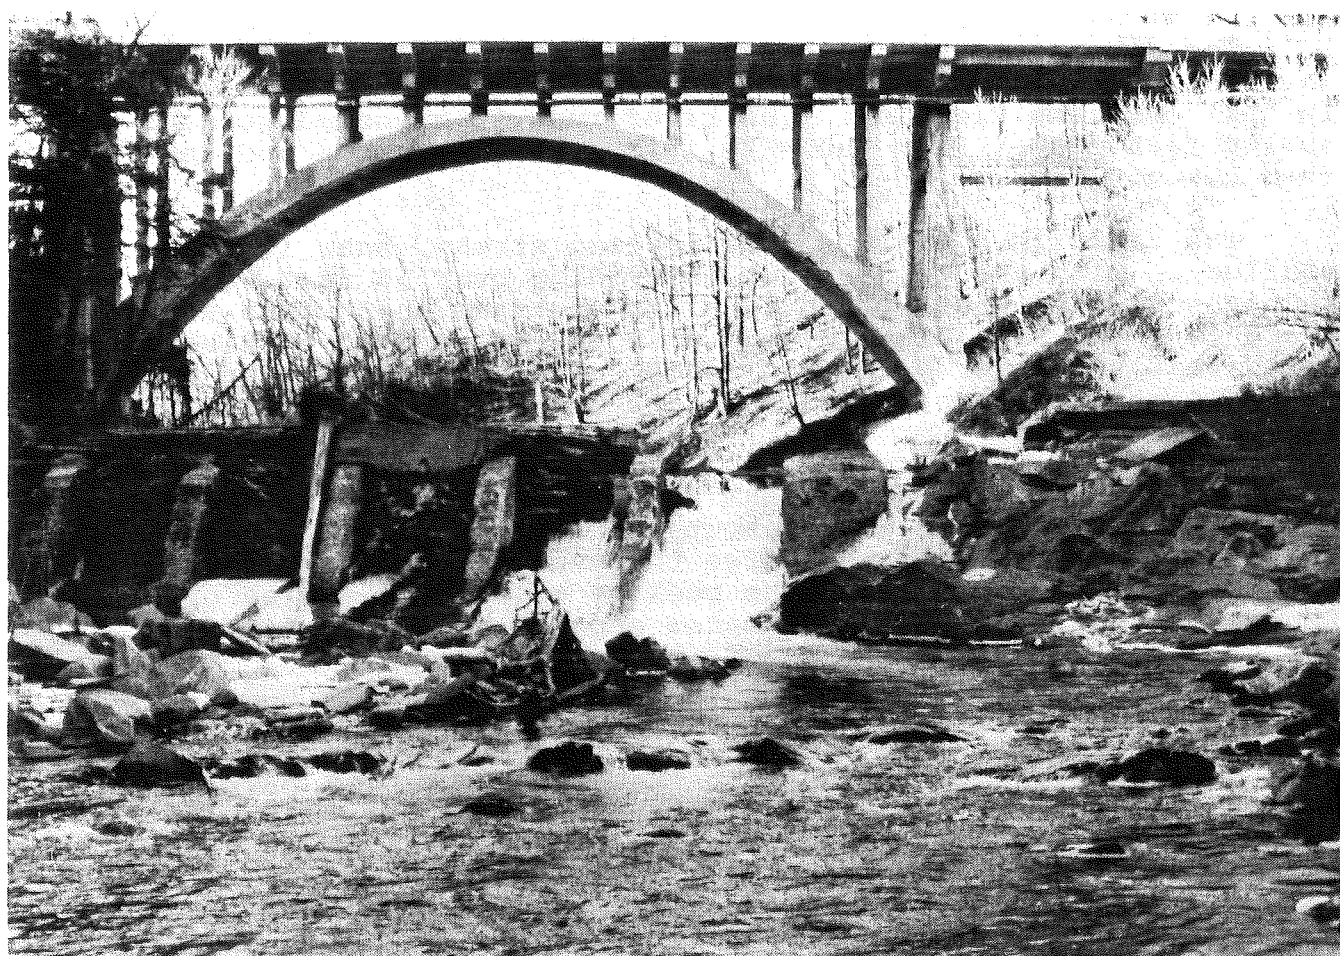
SAXTONS RIVER FALLS

Summary: Urban setting, site of proposed hydroelectric project, average rocks, poor botany, no seclusion, clean site, fair swimming, mildly polluted water, only occasional use.

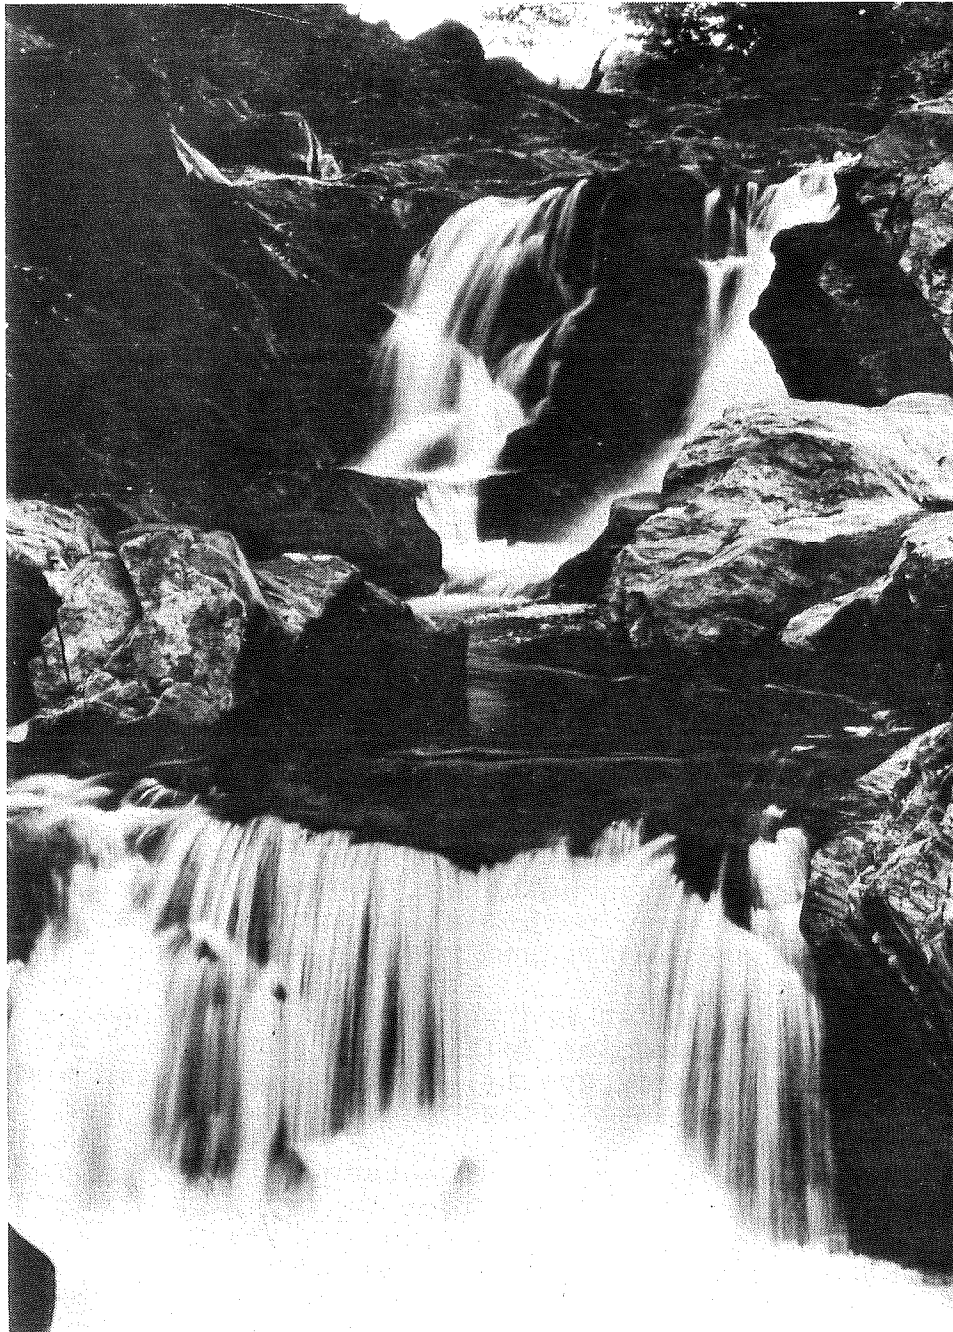
BROCKWAY MILLS GORGE

The gorge is quite attractive and receives heavy use from tourists as well as locals. There are good views of it from the road, and a fine view from the railroad bridge. There is good swimming and probably good fishing at the lower end of the gorge. The area is reasonably clean.

Because of the depth, the gorge is quiet and seems more secluded than it is. There are some beautiful rocks and attractive pools and cascades, and it is both a pretty place to look at and an exciting one to be in. It must be considered one of the five finest large gorges in the state.

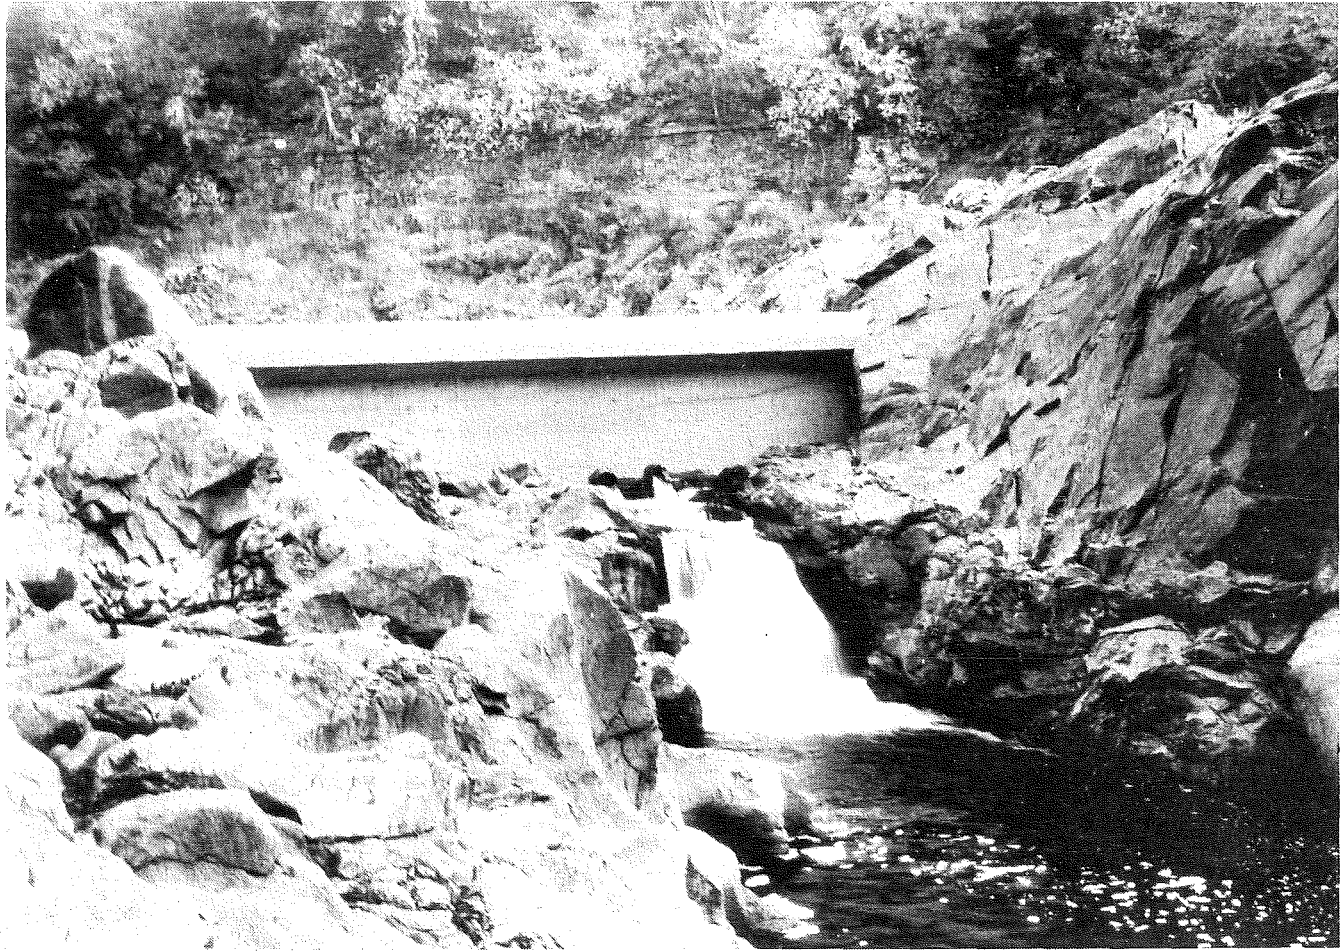
BELLOS FALLS

The gorge is very sparsely vegetated and the plants are all ordinary.

There is a historical record for the rare vetch Astragalus alpinus from Bellows Falls. The vetch is usually a river ledge plant. It was collected only once, in the 1890's, by Willard W. Eggleston. Careful search failed to turn up the species, but it may not have been visible so late in the season. The diversion of most of the river flow has probably altered the habitat for the species. There are no current records of Astragalus alpinus in Vermont. The old stations for the species were all at Connecticut River sites which have since been dammed, and the species may be extinct in the state.

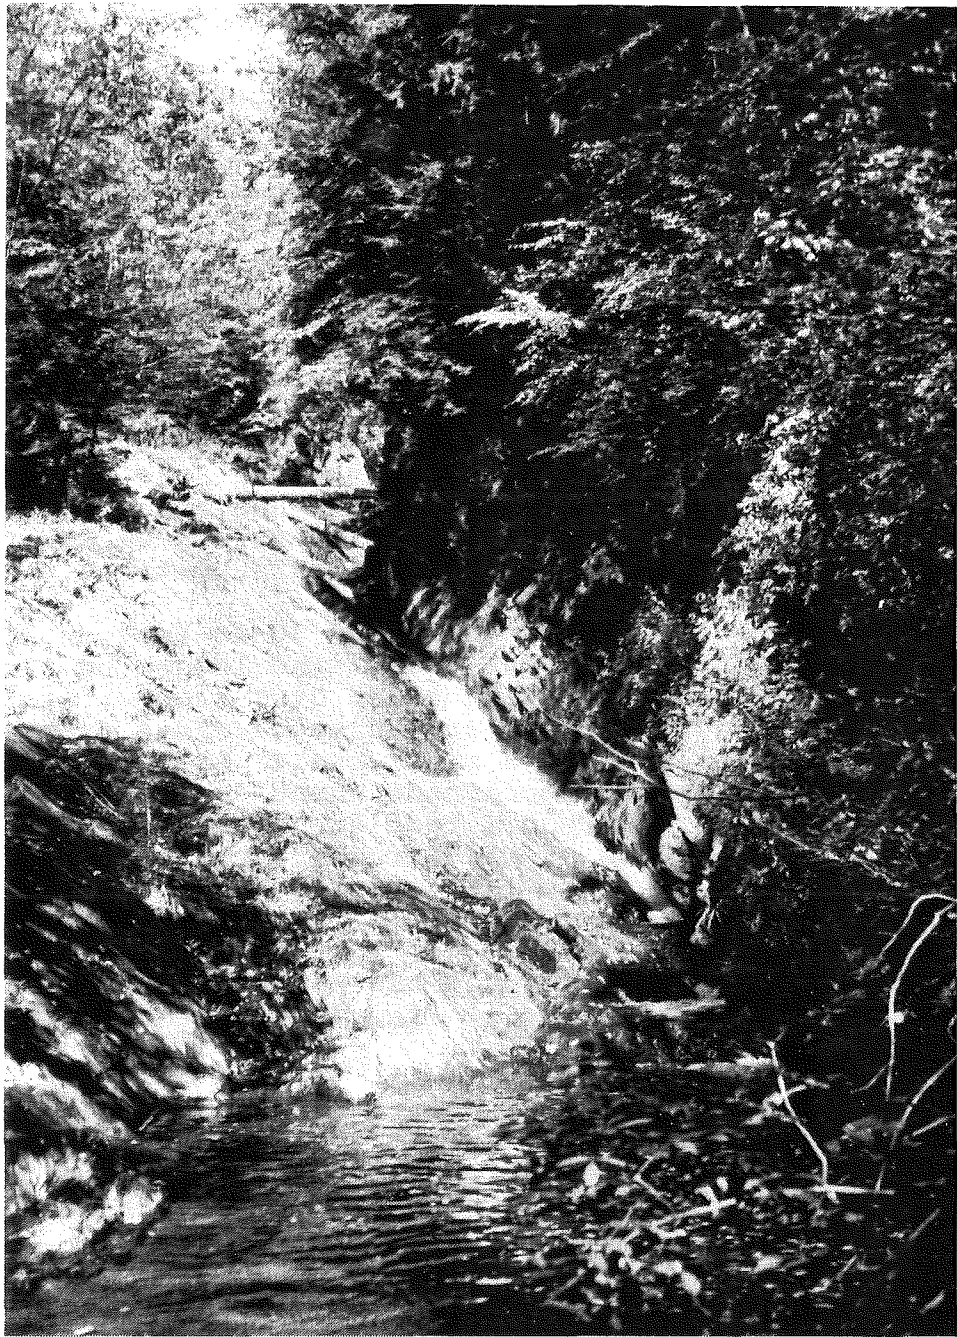
LULLS BROOK GORGE

No uncommon vascular plants were found. Bryophytes were common in one area but are not particularly important in the gorge as a whole. One species (Timmia megapolitana) was only seen at one other site in this survey and may be rare in the state.

The gorge is not much used because of the cliffs blocking access on the east and the dense brush and wet ground to the west. Only one small pool was deep enough for bathing. Fishing may be possible at the lower end of the gorge. The top of the cliff on the east side offers a nice view of the gorge, and is a local party place. Some trash was seen.

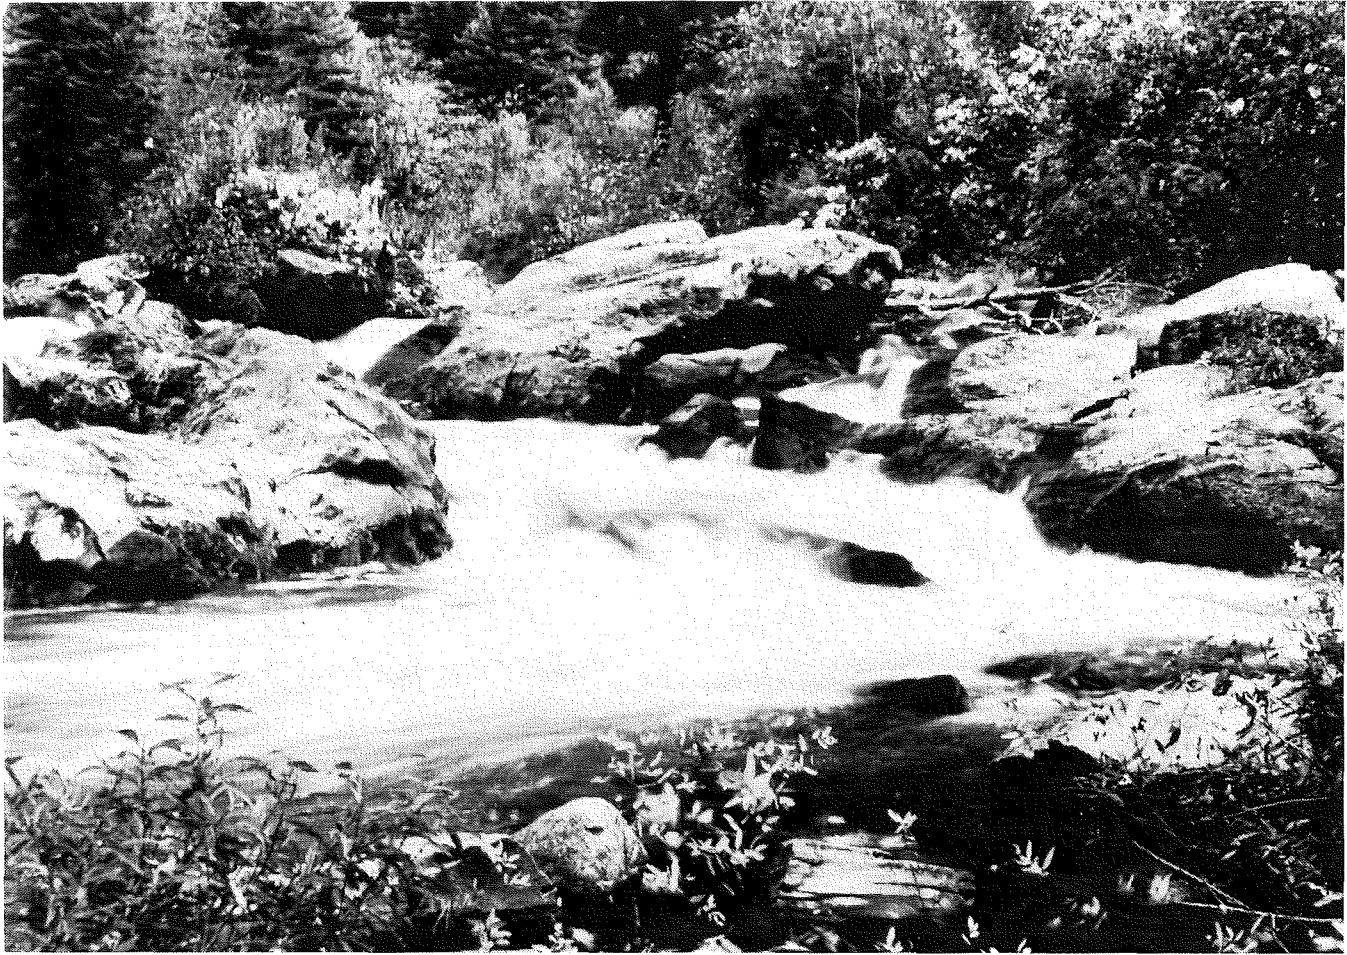
LOWER FALLS OF UNION VILLAGE

A hydroelectric project is proposed for the Union Village Dam; if the project is carried out, this area will be flooded.

Summary: Rural site, not near any buildings, nice rocks, average botany, moderately wild, clean site, clean water, popular for picnics, parties, spring fishing, scenery; threatened by a hydro project.

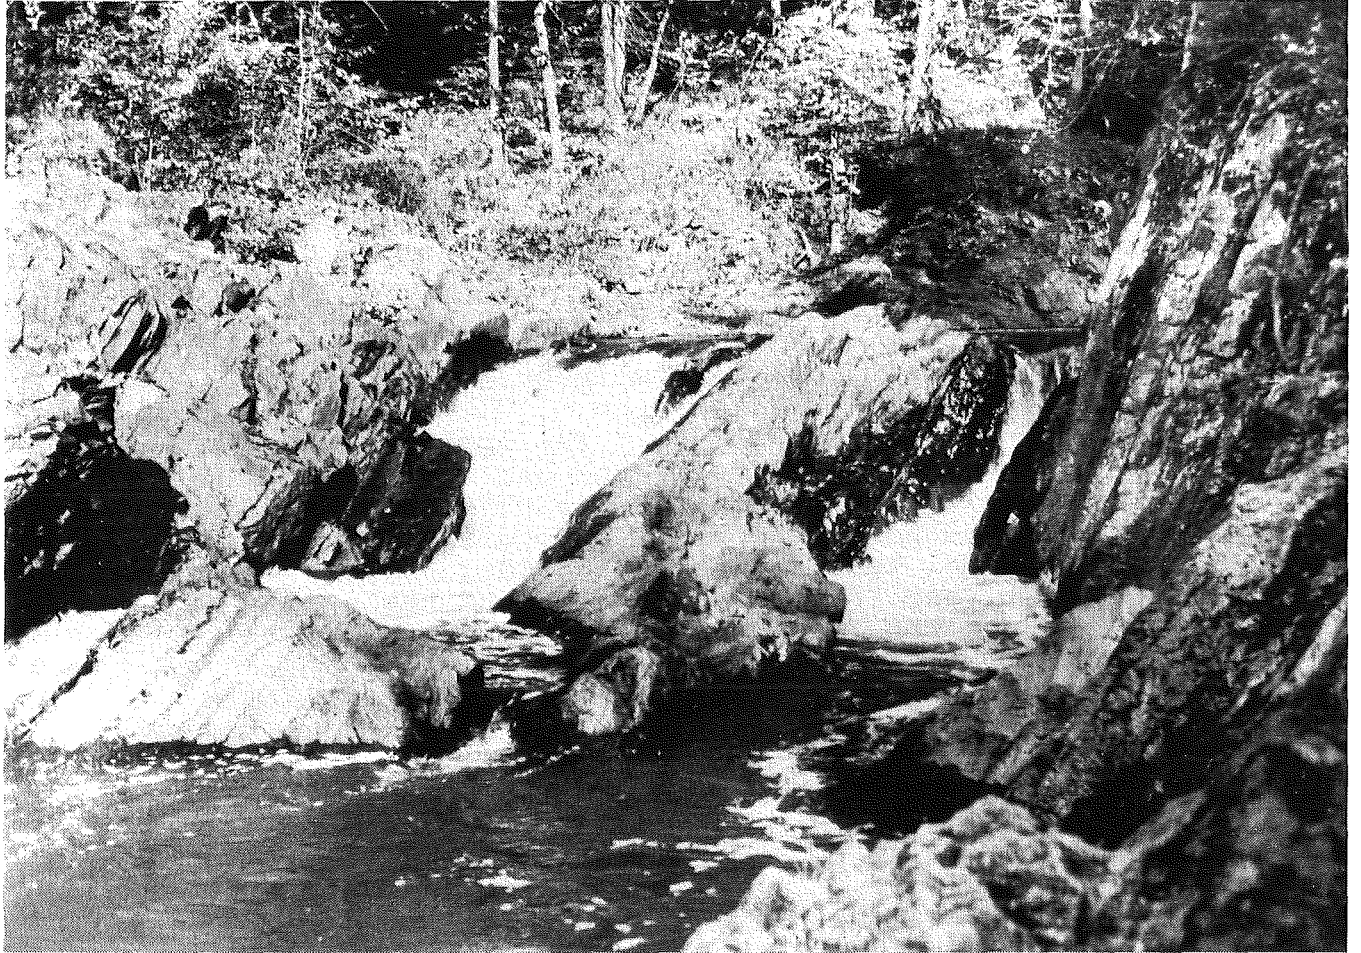
UPPER UNION VILLAGE FALLS

This site is threatened by a proposed hydropower project at the Union Village Dam. The project would flood most of these cascades, leaving only about four feet of the upper cascade above water.

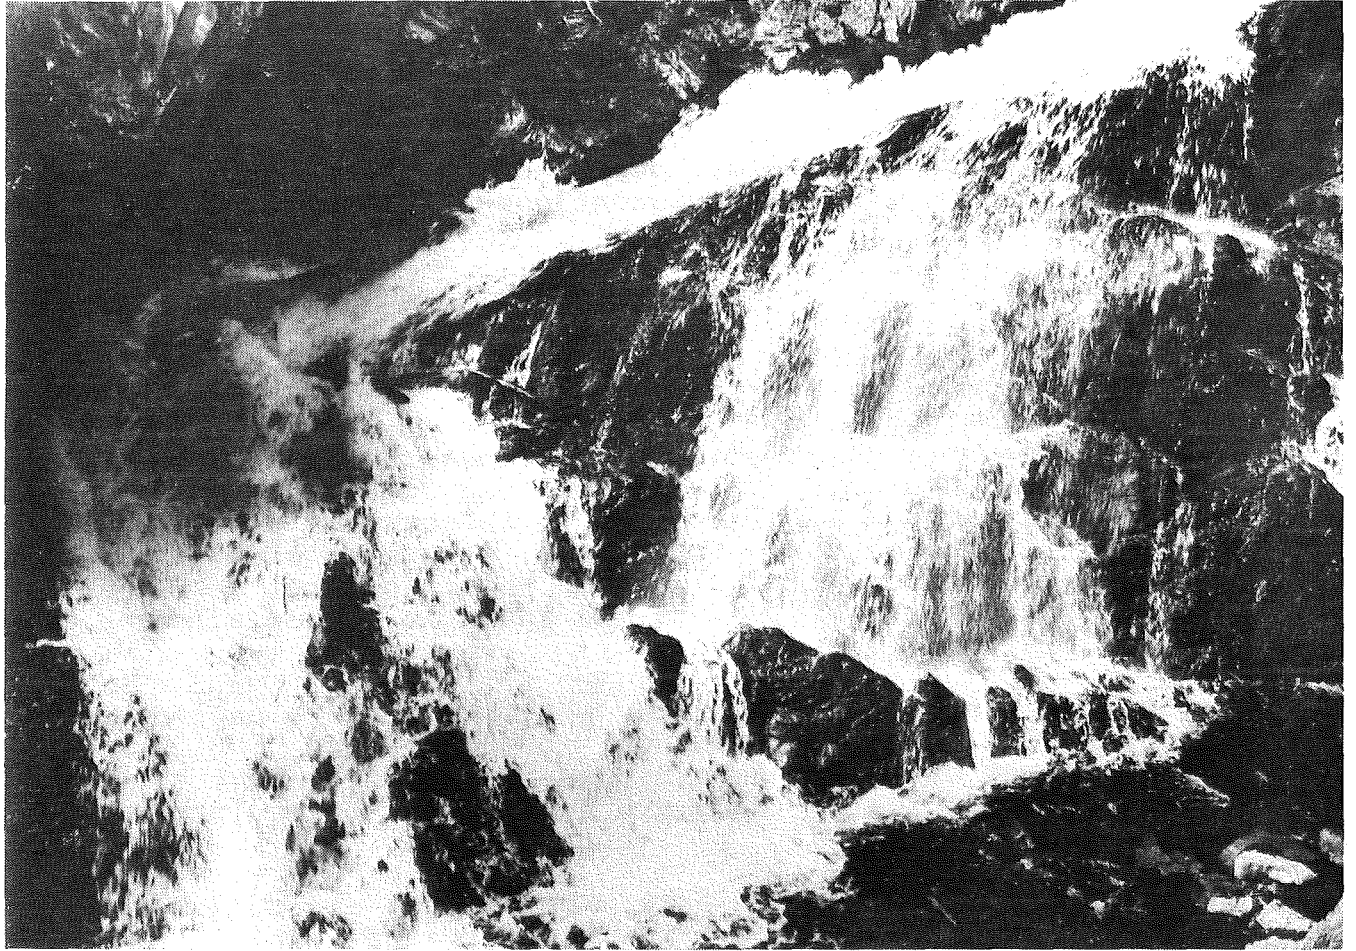
BARNET FALLS

The main cascade is a unique and striking feature. So far as we know, there is no other long rock chute anything like this in the state. The site is not wild, but think what an exciting thing it is to have something like this in the center of town!

A hydropower project is proposed for the site. We don't know what sort of development is planned but note that reducing the flow would reduce the visual impact and interest of the cascade*.

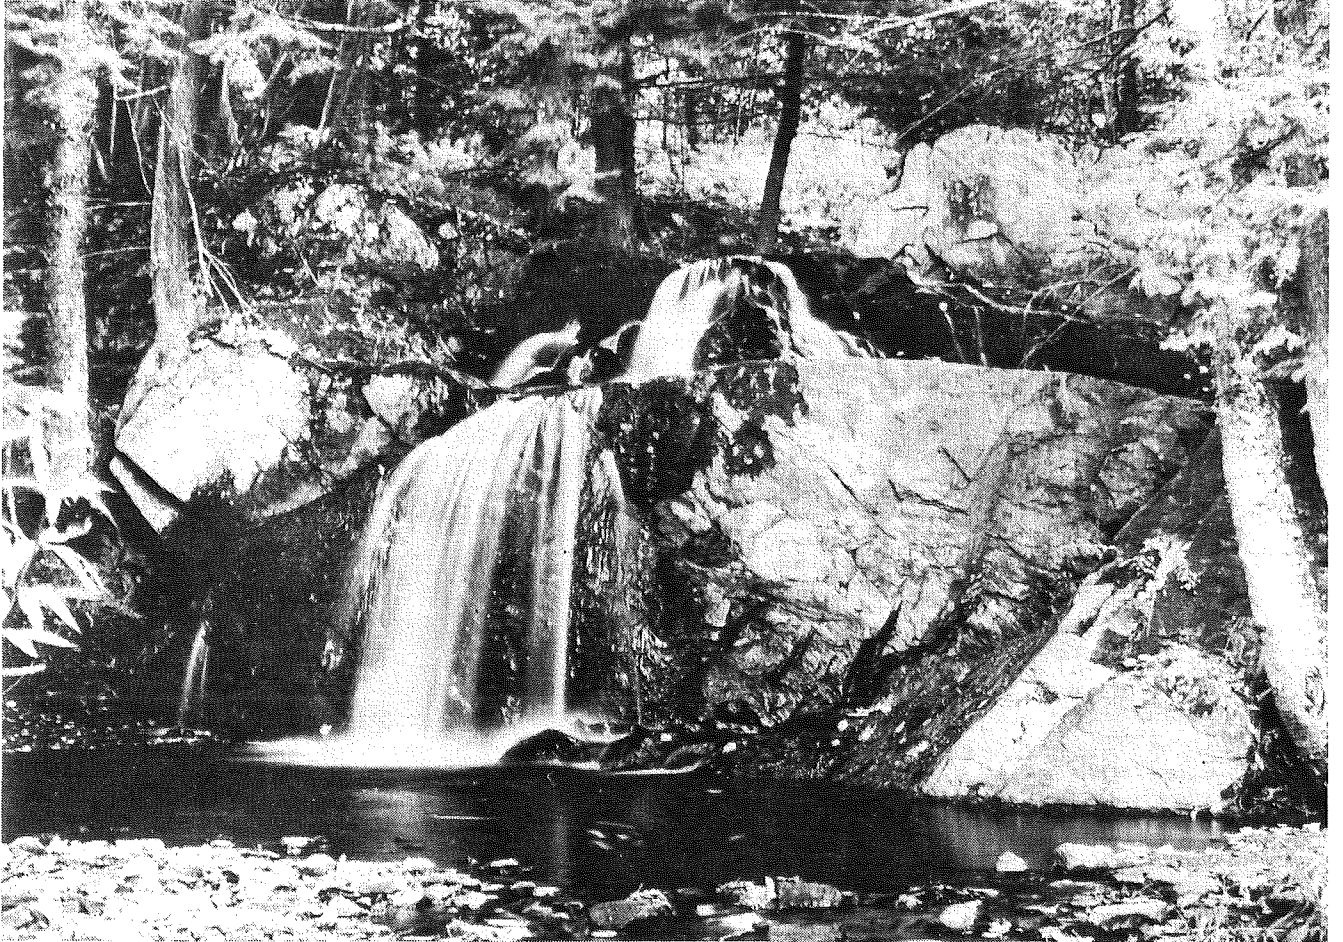
SUTTON BROOK FALLS

Summary: Woodland setting, poor rocks, average botany, varying from no seclusion or wildness at the upper site to moderately wild below the highway, clean site, clean water, no swimming, barely used.
