**RESPONSE TO EPA COMMENTS
BHS CORRECTIVE ACTION AND SELF-IMPLEMENTATING PLAN – AMENDMENT 1**

RE: Burlington High School Abatement, Demolition, and Soil Remediation Project
Burlington, VT

Re: Soils Interim Control Evaluation Revision 1
Burlington High School / Burlington Technical Center
52 Institute Road - Burlington, Vermont
VTDEC SMS Site #2020-4964

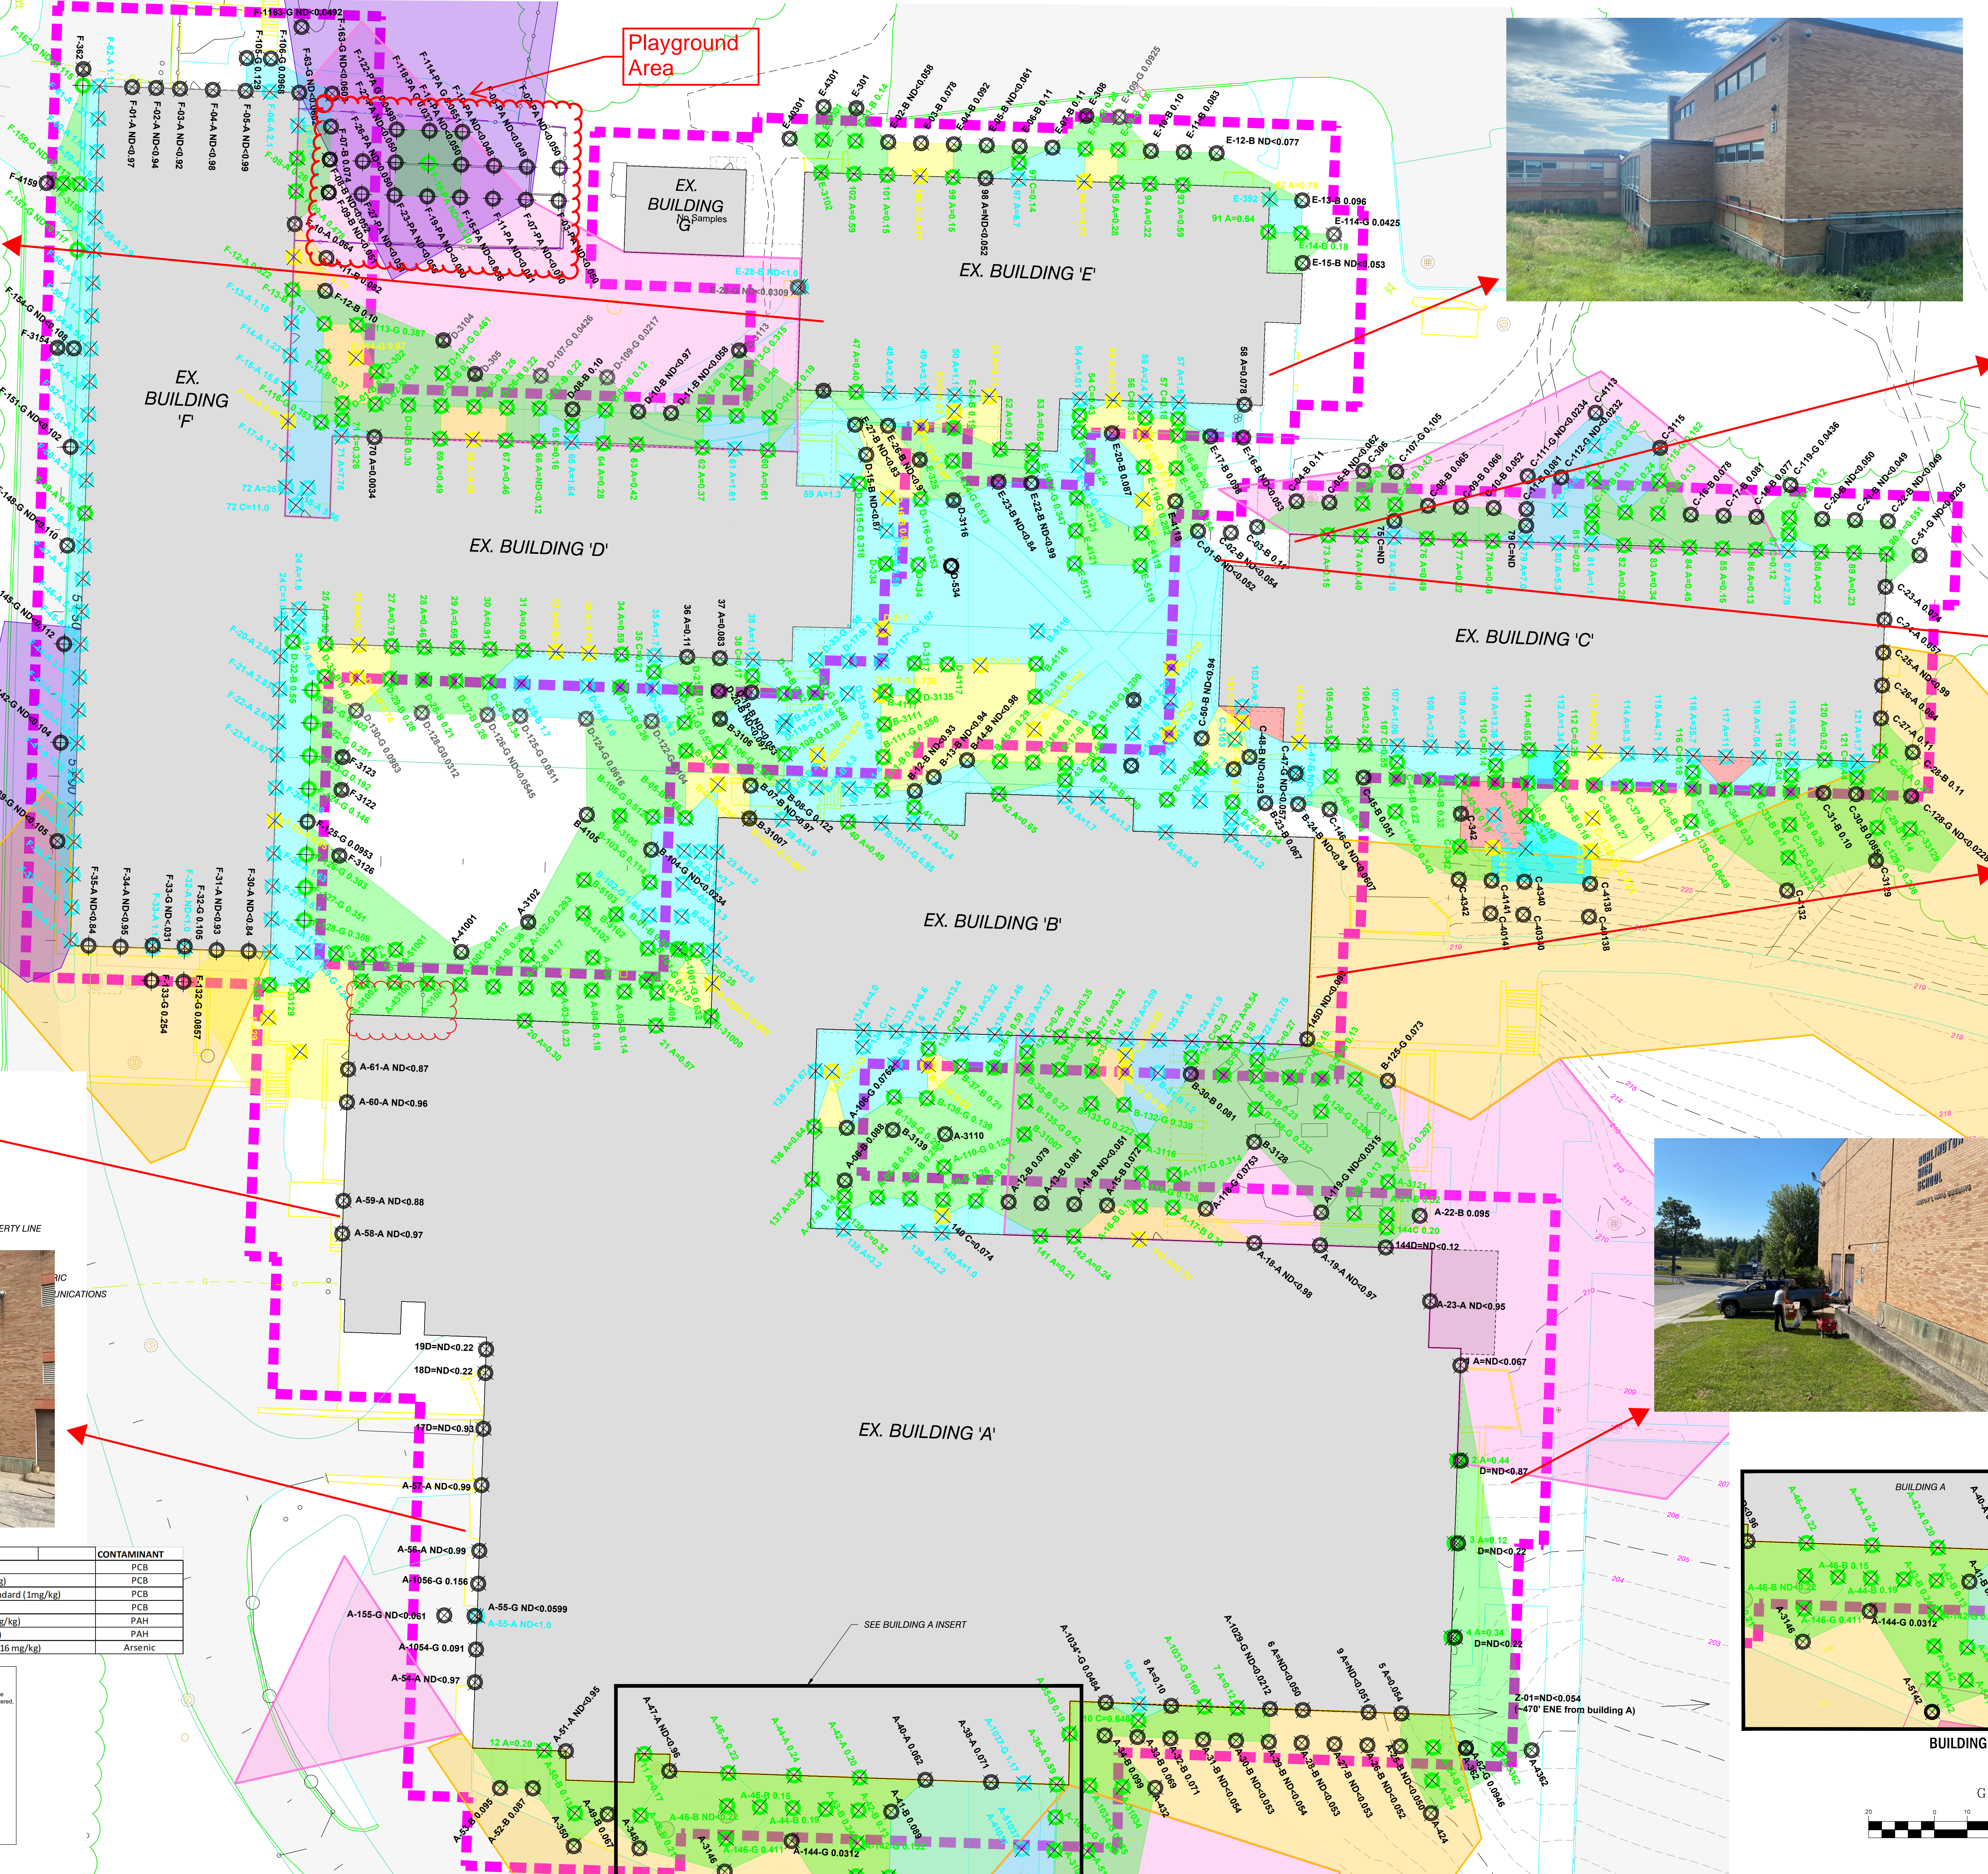
SHEET NO: CAP-2
© 2022 Research Research Research Inc.

Answer: The play area is called out on the attached Figure CAP-2 (*Attachment 1*). One soil sample identified as F-18-PA was determined to exceed the Vermont Residential Soil Standard (0.114 mg/kg) due to a reporting limit of 0.12 mg/kg. No other soil samples from the play area exceeded applicable VTDEC or EPA soil standards.

CONTAMINATED SOIL MANAGEMENT AREAS - PCB BORINGS -
