# **UPPER WHITE RIVER CORRIDOR PLAN**

## **WHITE RIVER PARTNERSHIP**

July 2, 2007

Prepared for:  
White River Partnership and  
Vermont Agency of Natural Resources/  
Department of Environmental Conservation  
River Management Program

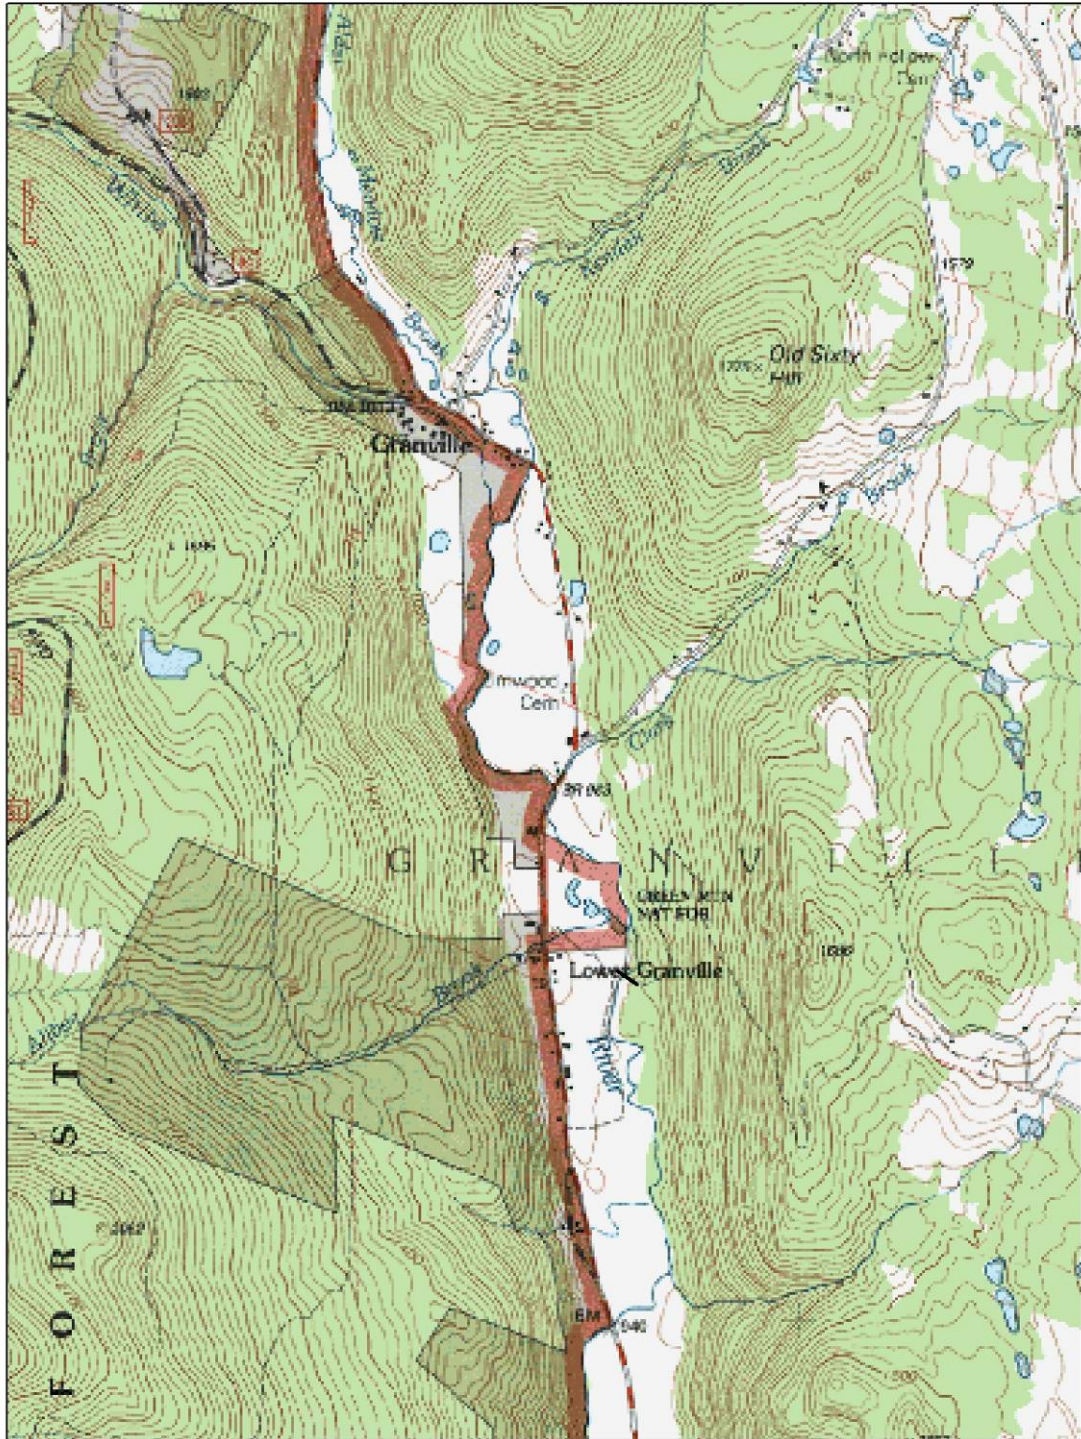
Figure 19. Although no alluvial fans were identified in Phase 1 or Phase 2 assessment of the Upper White, the confluence of several streams at the base of steep valley walls in a relatively narrow valley setting suggest that the presence of a combined fan, or several fans, may be masked by development and agricultural lands in the upstream portion of reach R24 and reach R25 near Lower Granville and Granville.
