**River Corridor Plan for the Nulhegan River:  
Stone Dam Road to Connecticut River**

**Prepared By:  
Melissa Dyer  
For  
Essex County Natural Resources Conservation District**

**NORTHWOODS  
STEWARDSHIP CENTER**

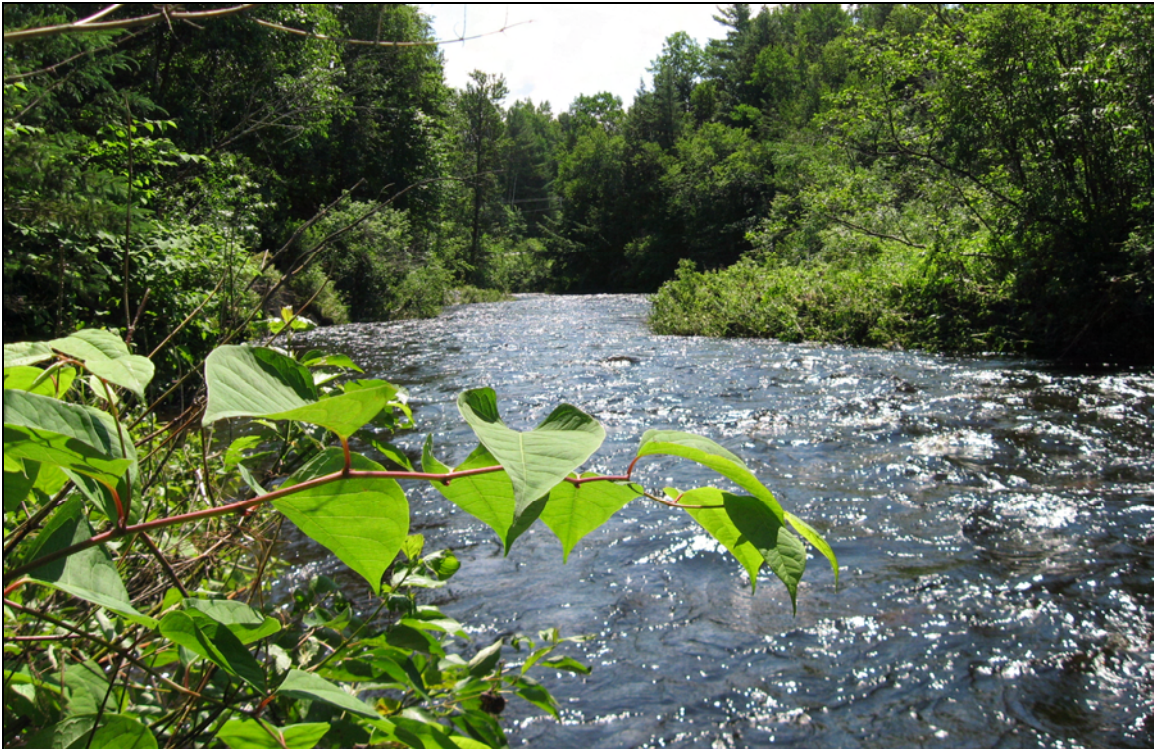
During the Phase 2 assessments, limited populations of invasive species were noted. These plants included scattered honeysuckle (*Lonicera tatarica*) plants and a 50' patch of Japanese knotweed (*Polygonum cuspidatum*, Figure 1). All plants were located along Reaches M01 and M02 in densities that should be controlled before they spread further.

**Figure 1:** An isolated patch of Japanese knotweed, located along Reach M01.

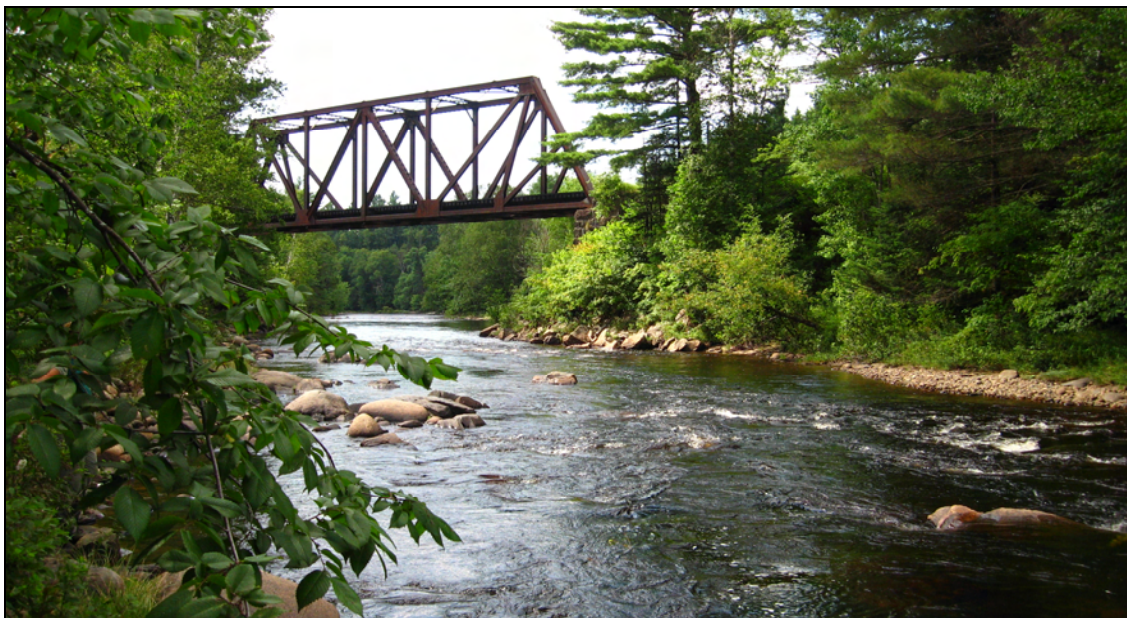
| Reach | Road Name | Type | Bridge Span (ft) | Channel Width (ft) | % of Stream Width | Floodplain Constriction | Length of River Affected (ft) | Comments/ Problem Associated With Bridge |
|---|---|---|---|---|---|---|---|---|
| M01 | Railroad | Bridge | 126 | 87 | 145 | No | 0 | None |

**Figure 8:** Railroad bridge, located in Reach M01.

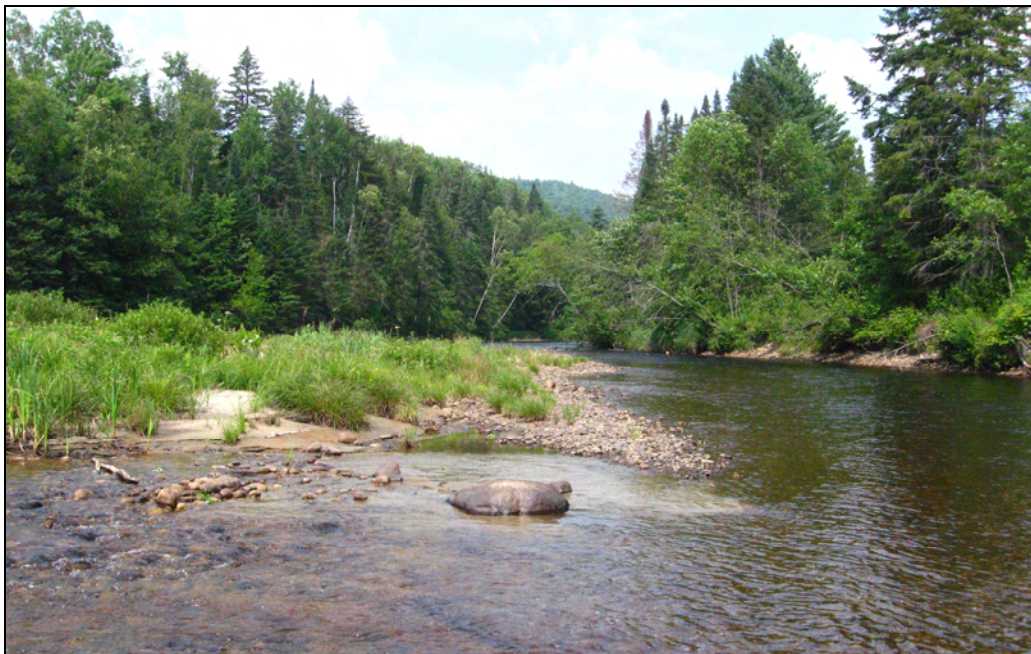
**Figure 10:** The confluence of two of the three channels in Reach M02.

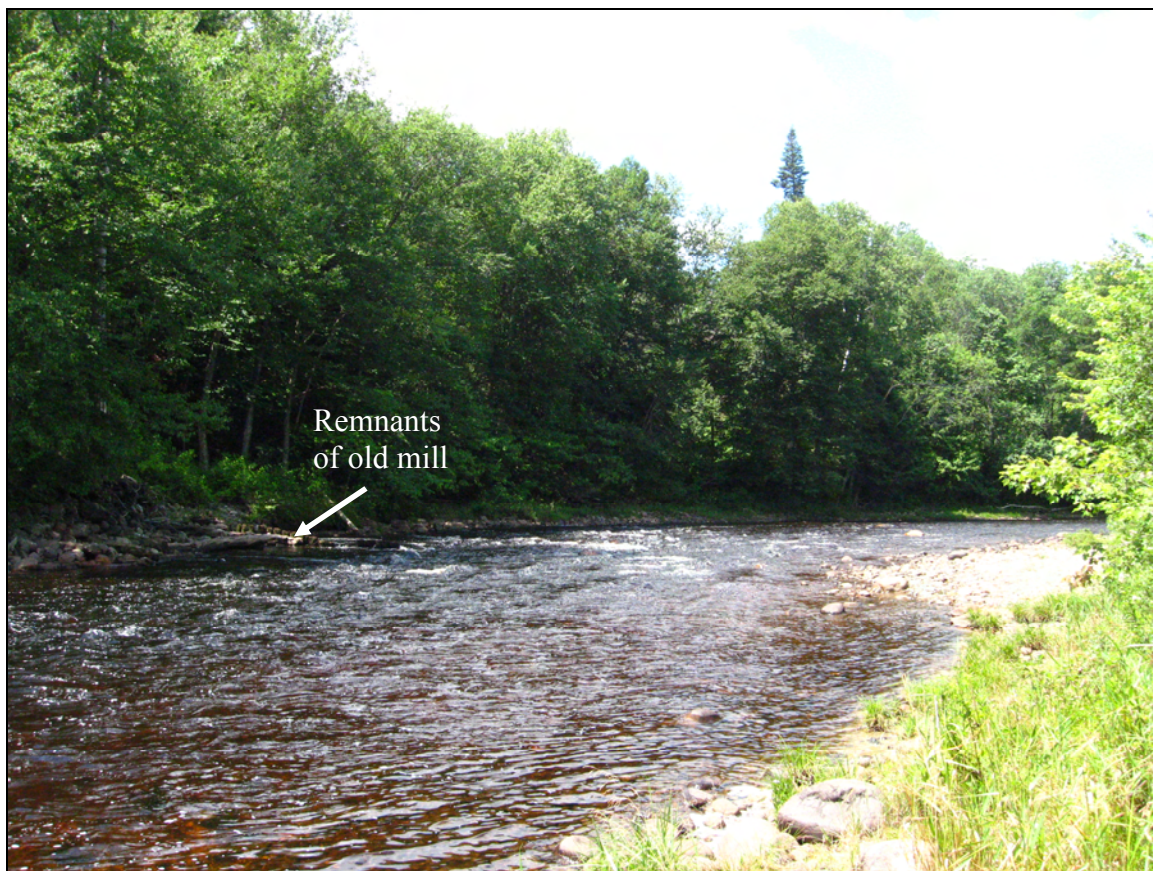
an old saw mill (Figure 13) remains just upstream of the Route 102 crossing, which may explain the flood chute located adjacent to the mill remains.

**Figure 13:** Old mill site upstream of the Route 102 bridge, looking upstream.

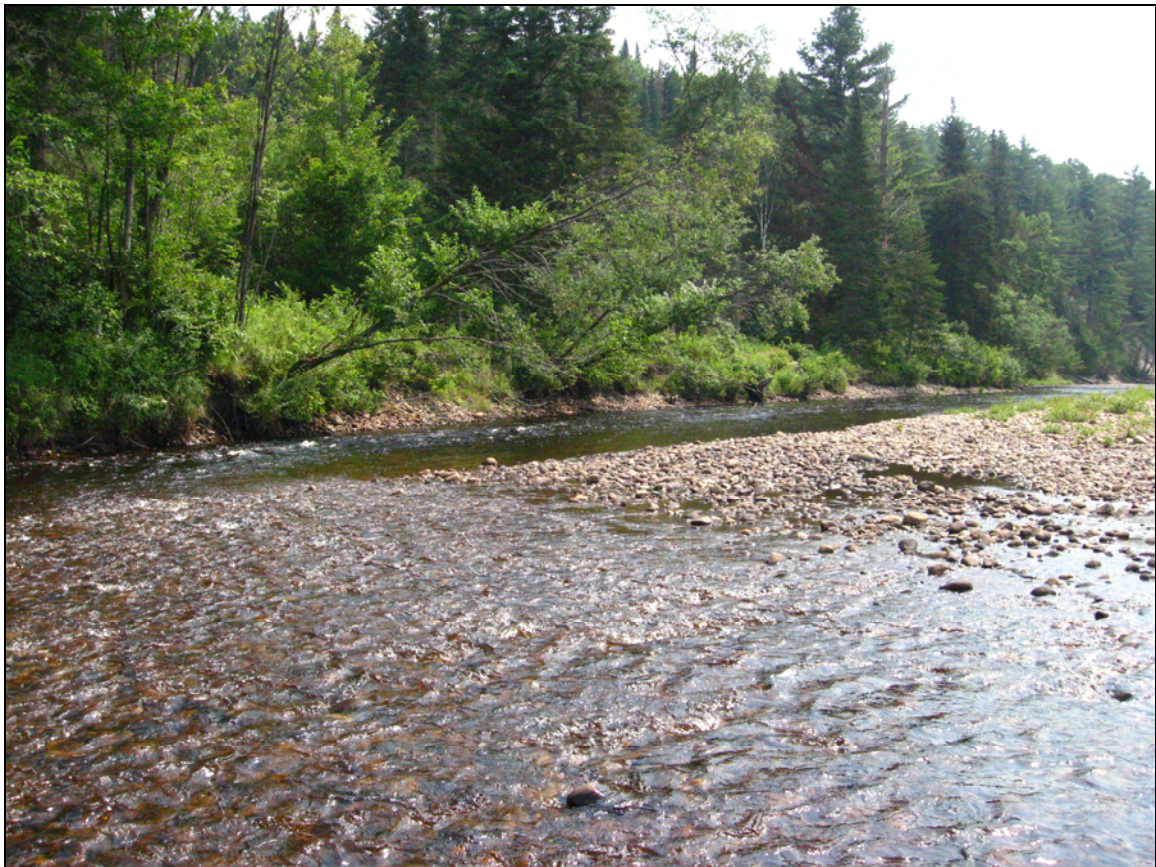
The aquatic habitat was in good condition; the monotony of the stream bed, sediment deposition, and lack of woody debris kept this from being a reference reach. The riparian corridor contained a mixture of old pasture, mixed forest, and hay field where mowing occurred within 25' of the river. Where present, the riparian buffer consisted of a mixture of large white pines, eastern hemlock, and aspen; however a large portion of the left buffer was an old field with shrubs and young tamarack trees. Invasive plants, including a 50' long patch of Japanese knotweed (*Polygonum cuspidatum*) and several honeysuckle bushes (*Lonicera tatarica*) were observed near the downstream reach break and should be removed while they are still in manageable densities.

**Figure 15:** Abundant sediment deposition in Reach M02.

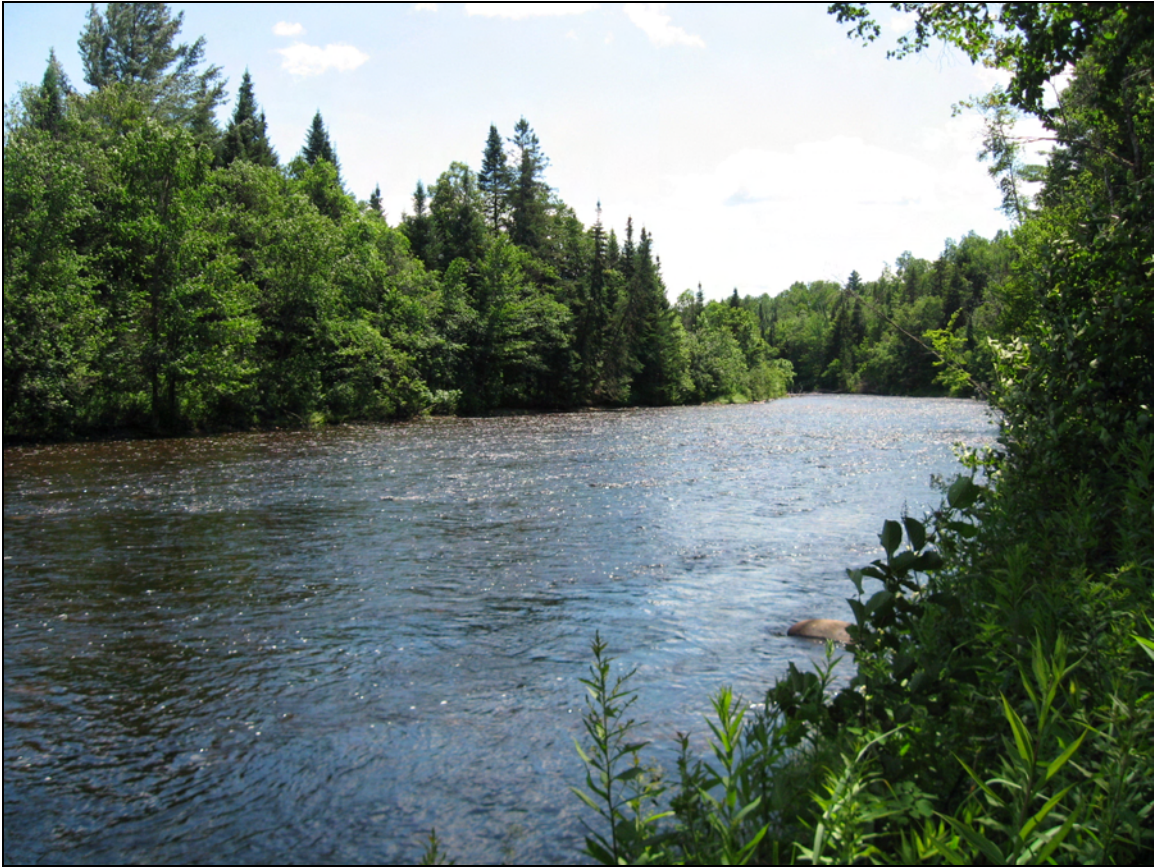
Though Reach M03 exhibited a riffle-pool bedform, pools were actually infrequent, resulting in a fairly homogenous stream bed characterized by nearly continuous riffles. This, in combination with some bank instability, was the main reason

**Figure 17:** *A typical section of Reach M03, with forested riverbanks and a wide, shallow channel.*

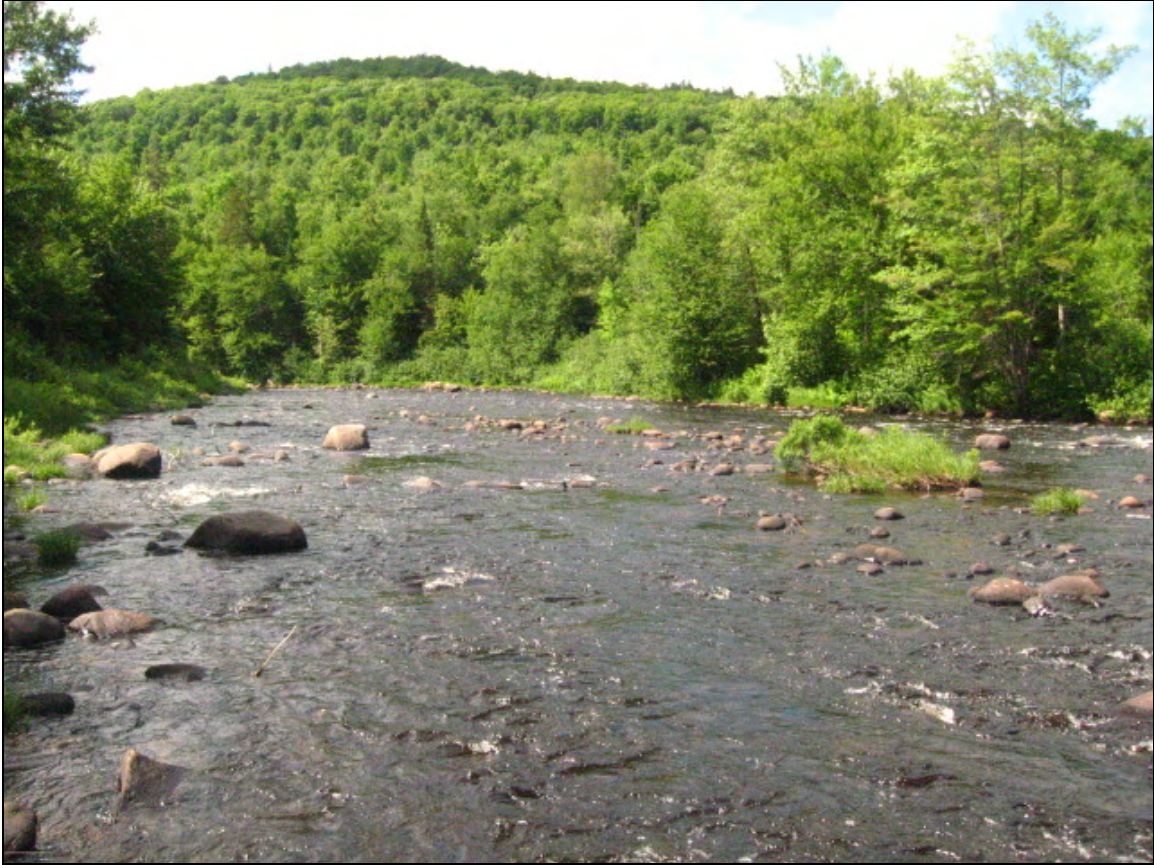
The reach's habitat was rated in reference condition. Though this was predominantly a plane-bed channel that lacked woody debris, there was enough variability in the channel bed to provide a diversity of habitats. Large boulders created scour pools and several portions of the reach varied in their flows and depths, including one large pool near the East Branch confluence. The riparian corridor was completely forested with deciduous trees along the right side and contained a mixture of forest and regenerating forest along left side.

**Figure 19:** Photo taken in the middle of Reach M04, depicting a very wide and shallow channel.

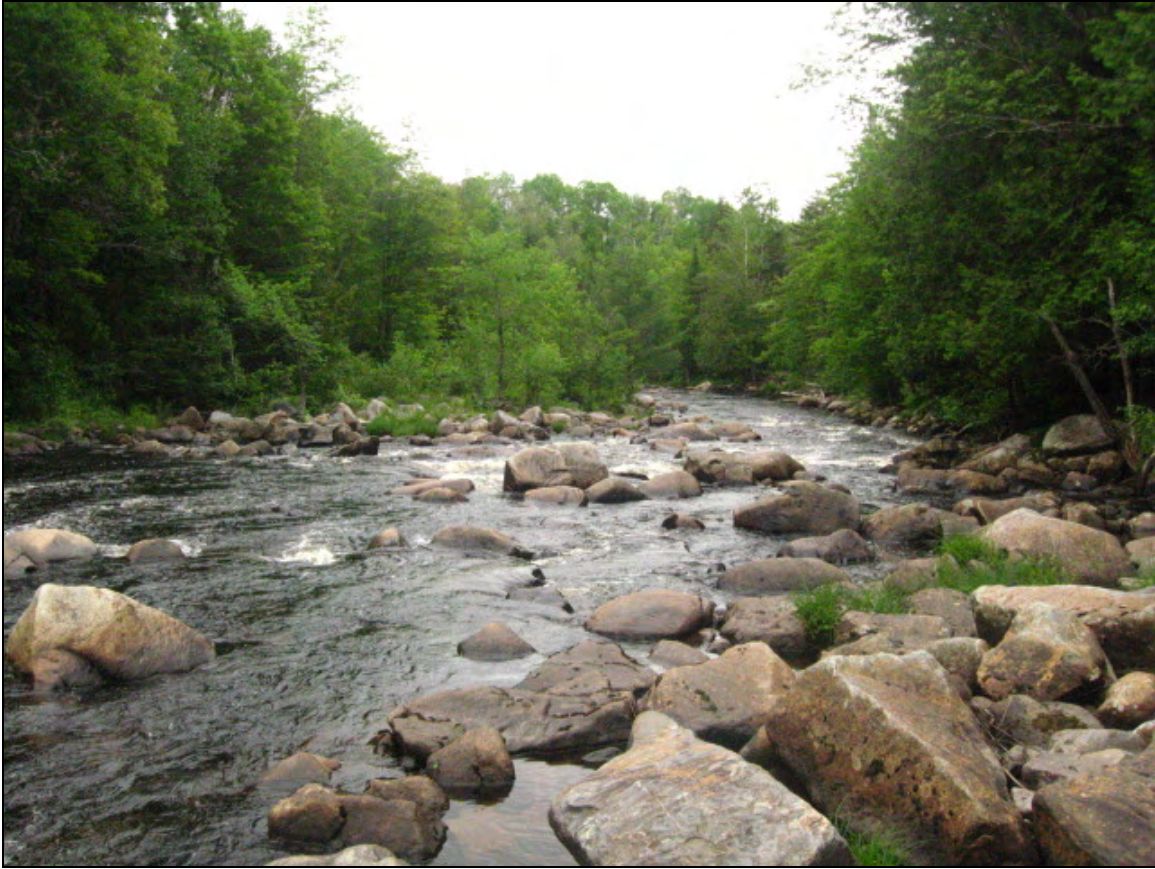
Habitat was also in reference condition, owing to the unimpacted channel and riparian corridor and characteristics of the channel itself. The corridor was entirely forested with a mix of deciduous trees, northern white cedar, and balsam fir; these trees provided a dense canopy to shade the stream banks. Large boulders and areas of bedrock provided deep scour pools and interrupted the swift and deep flow. Additionally, steps and pools were frequent enough to provide a diversity of habitats.

*Figure 21. Photo of Reach M05, showing the large boulders and cascades typical of the reach.*
