# Browns River Phase 1- Watershed Assessment Summary

The principle purpose of this summary is to: (a) describe the need and the role of public participation in watershed planning; (b) outline the methods used to study the Browns River Watershed; (c) define the top water quality issues to be addressed to revitalize the Browns River; and (d) outline steps to begin protecting and restoring the future of the Browns River.

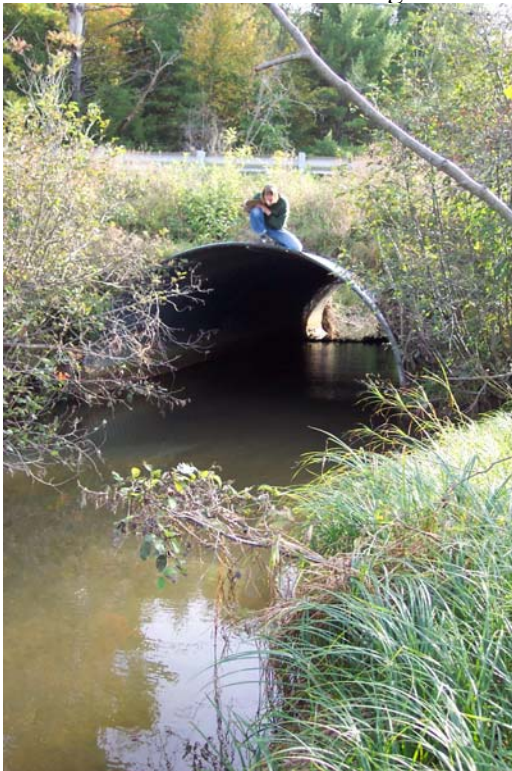
*Culvert assessment on Morgan Brook*

A watershed-wide bridge and culvert inventory and assessment was conducted to determine if stream crossings were contributing to localized streambank erosion, sedimentation, and impaired fish passage. The Agency of Natural Resources Bridge and Culvert Phase 1 protocols were used (ANR, 2003). A sample data sheet is included in the Appendix as Figure 3. Bridge spans and culvert diameter measurements were compared to calculated bankfull width measurements. The bankfull width, also known as the channel forming flow, is directly related to watershed drainage area. The bankfull flow is the discharge at which the majority of erosion and deposition takes place. Undersized bridges and culverts are not designed to accommodate both flow and sediment. During flood events large point bars can consequently deposit upstream of undersized bridges and culverts. During catastrophic flood events crossings can become outflanked, taking out large sections of roads and driveways. Significant sediment discharges to waterways can result. Twenty-eight bridges and culverts were assessed on the Browns River main stem. Fourteen crossings were undersized, or measured at less than 75% of bankfull flow.

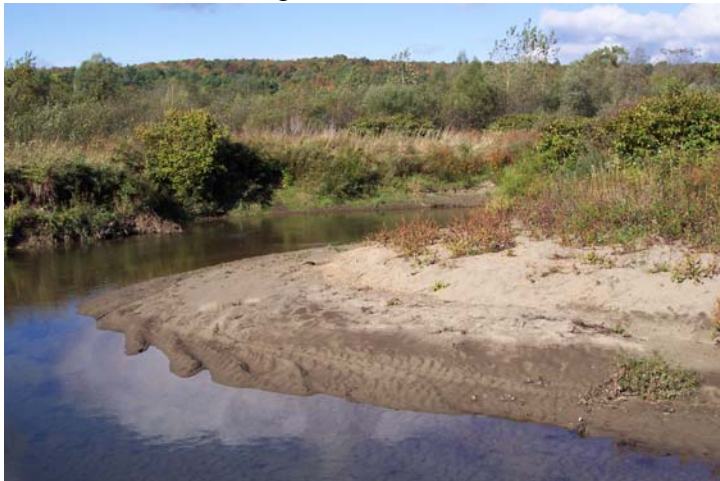
*Depositional feature on the Browns River in Essex*
