ROSS ENVIRONMENTAL ASSOCIATES, INC.

RE: Groundwater Sampling Results - October 2015
Capital Lincoln Mercury - Essex Jct., VT (SMS Site #2015-4570)

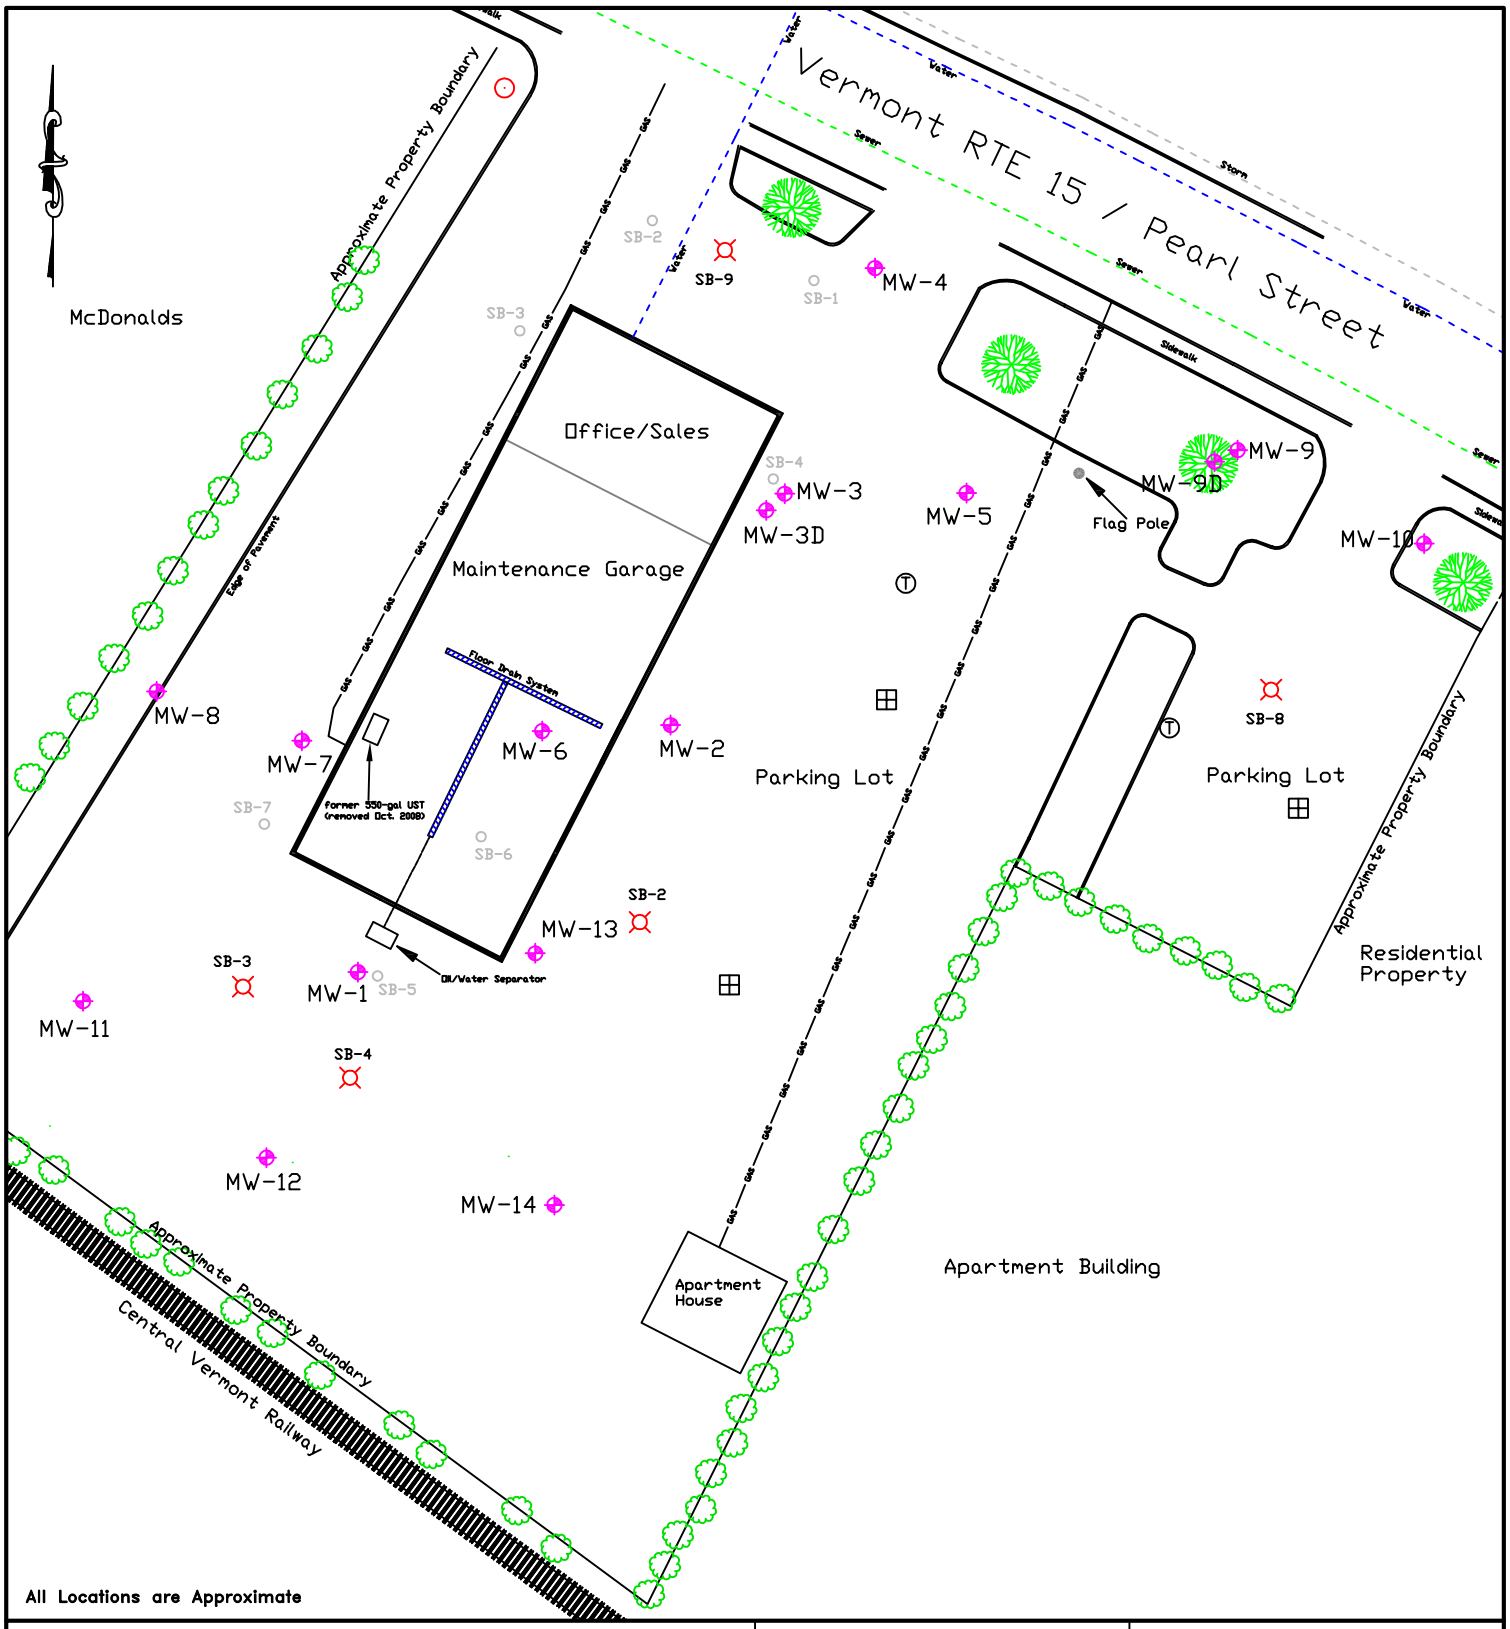
FIGURE 3.

On 26 October and 10 November 2015, ***R.E.A.*** personnel inspected the catch basins located in the parking lot on the eastern side of the building. Both of these catch basins are located upgradient of the oil/water separator and MW-13. According to Steve Carbone, this catch basin has an open bottom dry well type construction surrounded by crushed stone. On 26 October 2015, both catch basins contained water, which prevented soil sampling. At that time, no sheens or petroleum odors were observed in either catch basin. The approximate catch basin locations are shown on **Figure 3**.

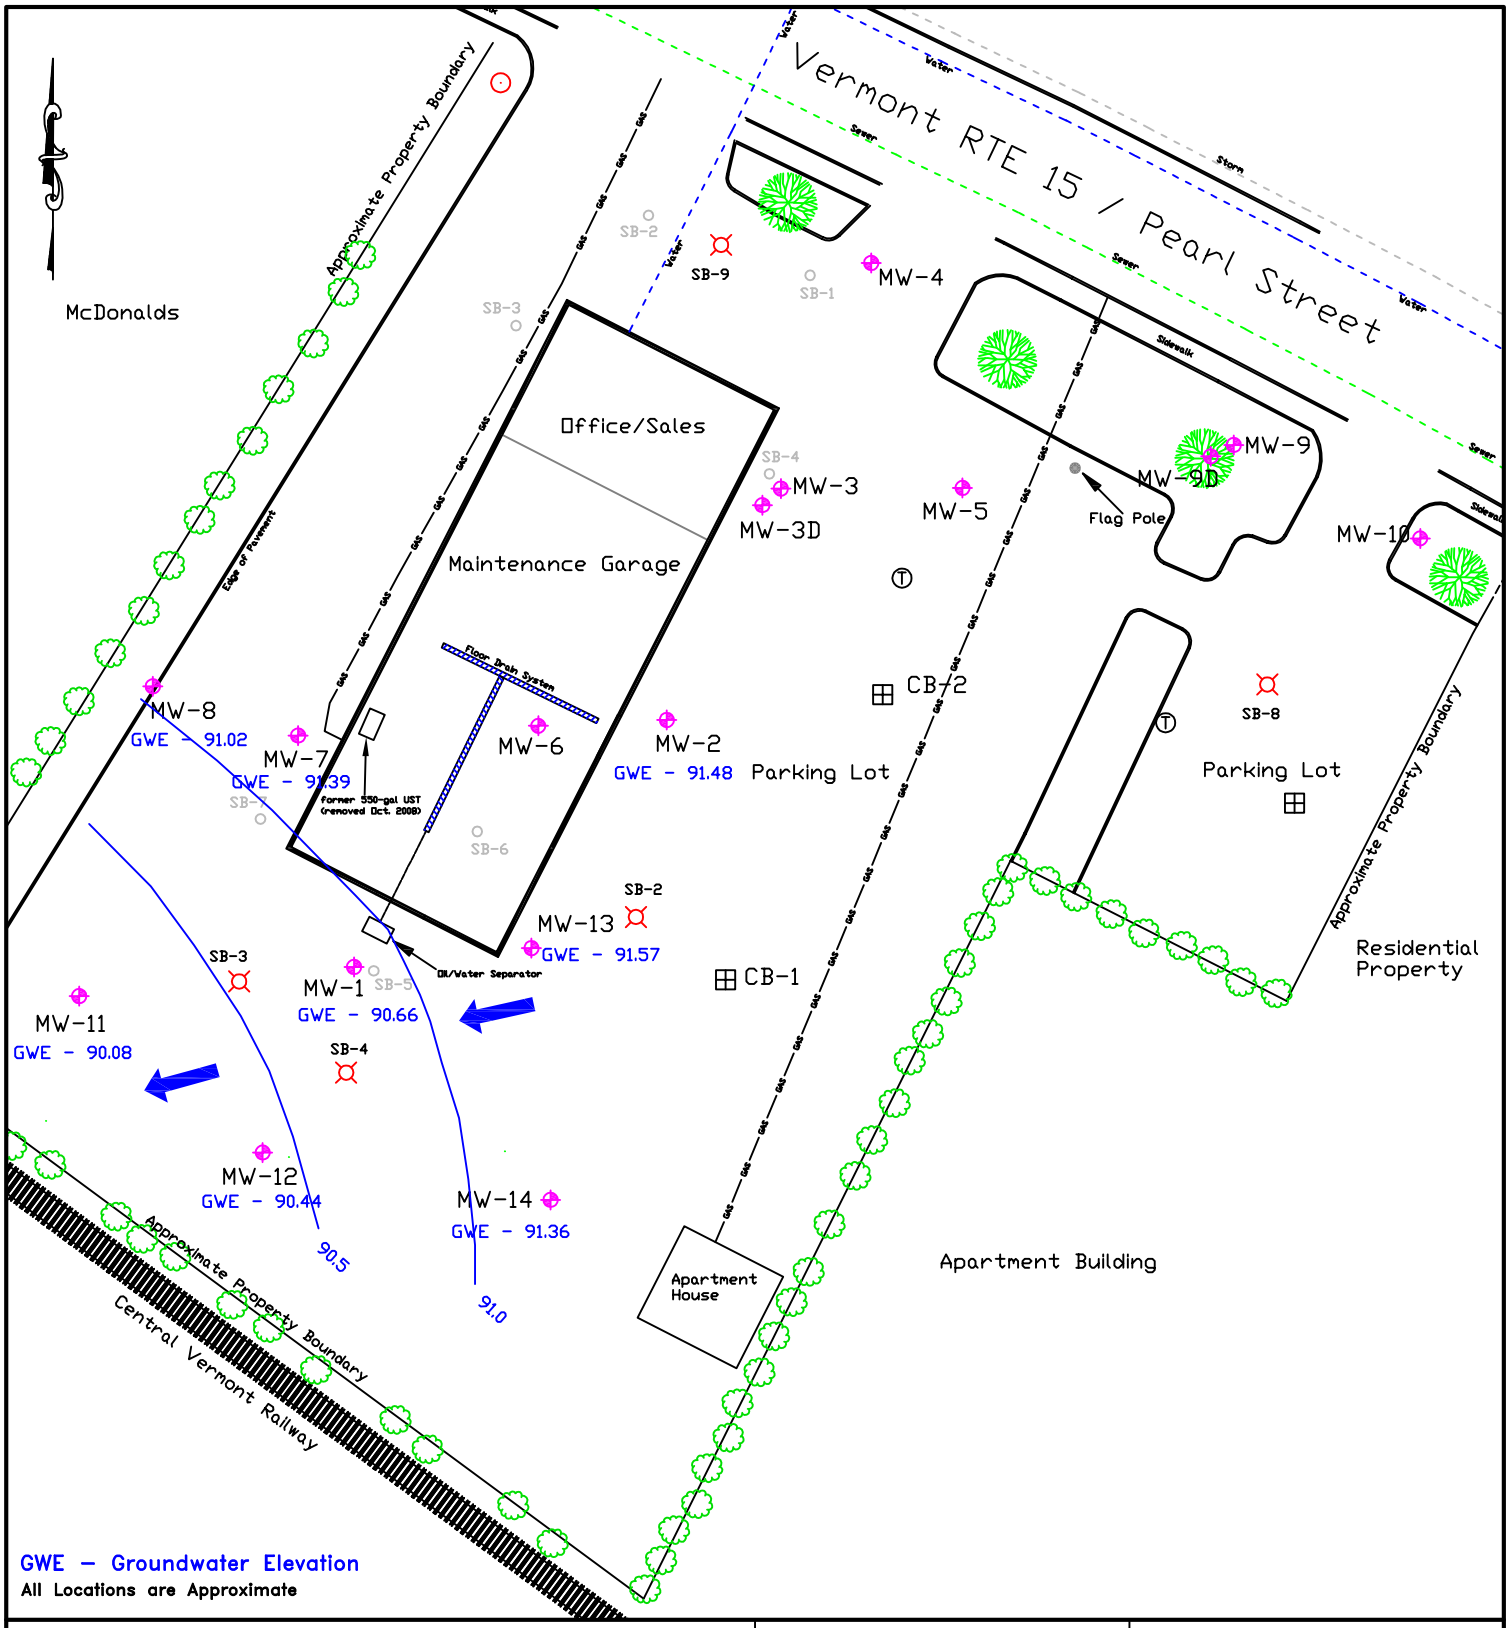
FIGURE 4.

On 26 October 2015, groundwater flow in the unconfined surficial aquifer at the site was primarily toward the southwest with an average hydraulic gradient of approximately one percent. The groundwater elevation measurements were generally lower during this sampling event compared to the measurements obtained in August 2015. Water level measurements and elevation calculations for 26 October 2015 are presented in **Table 2** and the groundwater contour map prepared using this data is presented as **Figure 4**.

Static water-table elevations were computed for each monitoring well by subtracting measured depth-to-water readings from the surveyed top-of-casing (TOC) elevations, which are relative to an arbitrary site datum of 100.00 feet. Depth to groundwater during this sampling event (26 October 2015) ranged from 7.58 to 8.78 feet bgs.

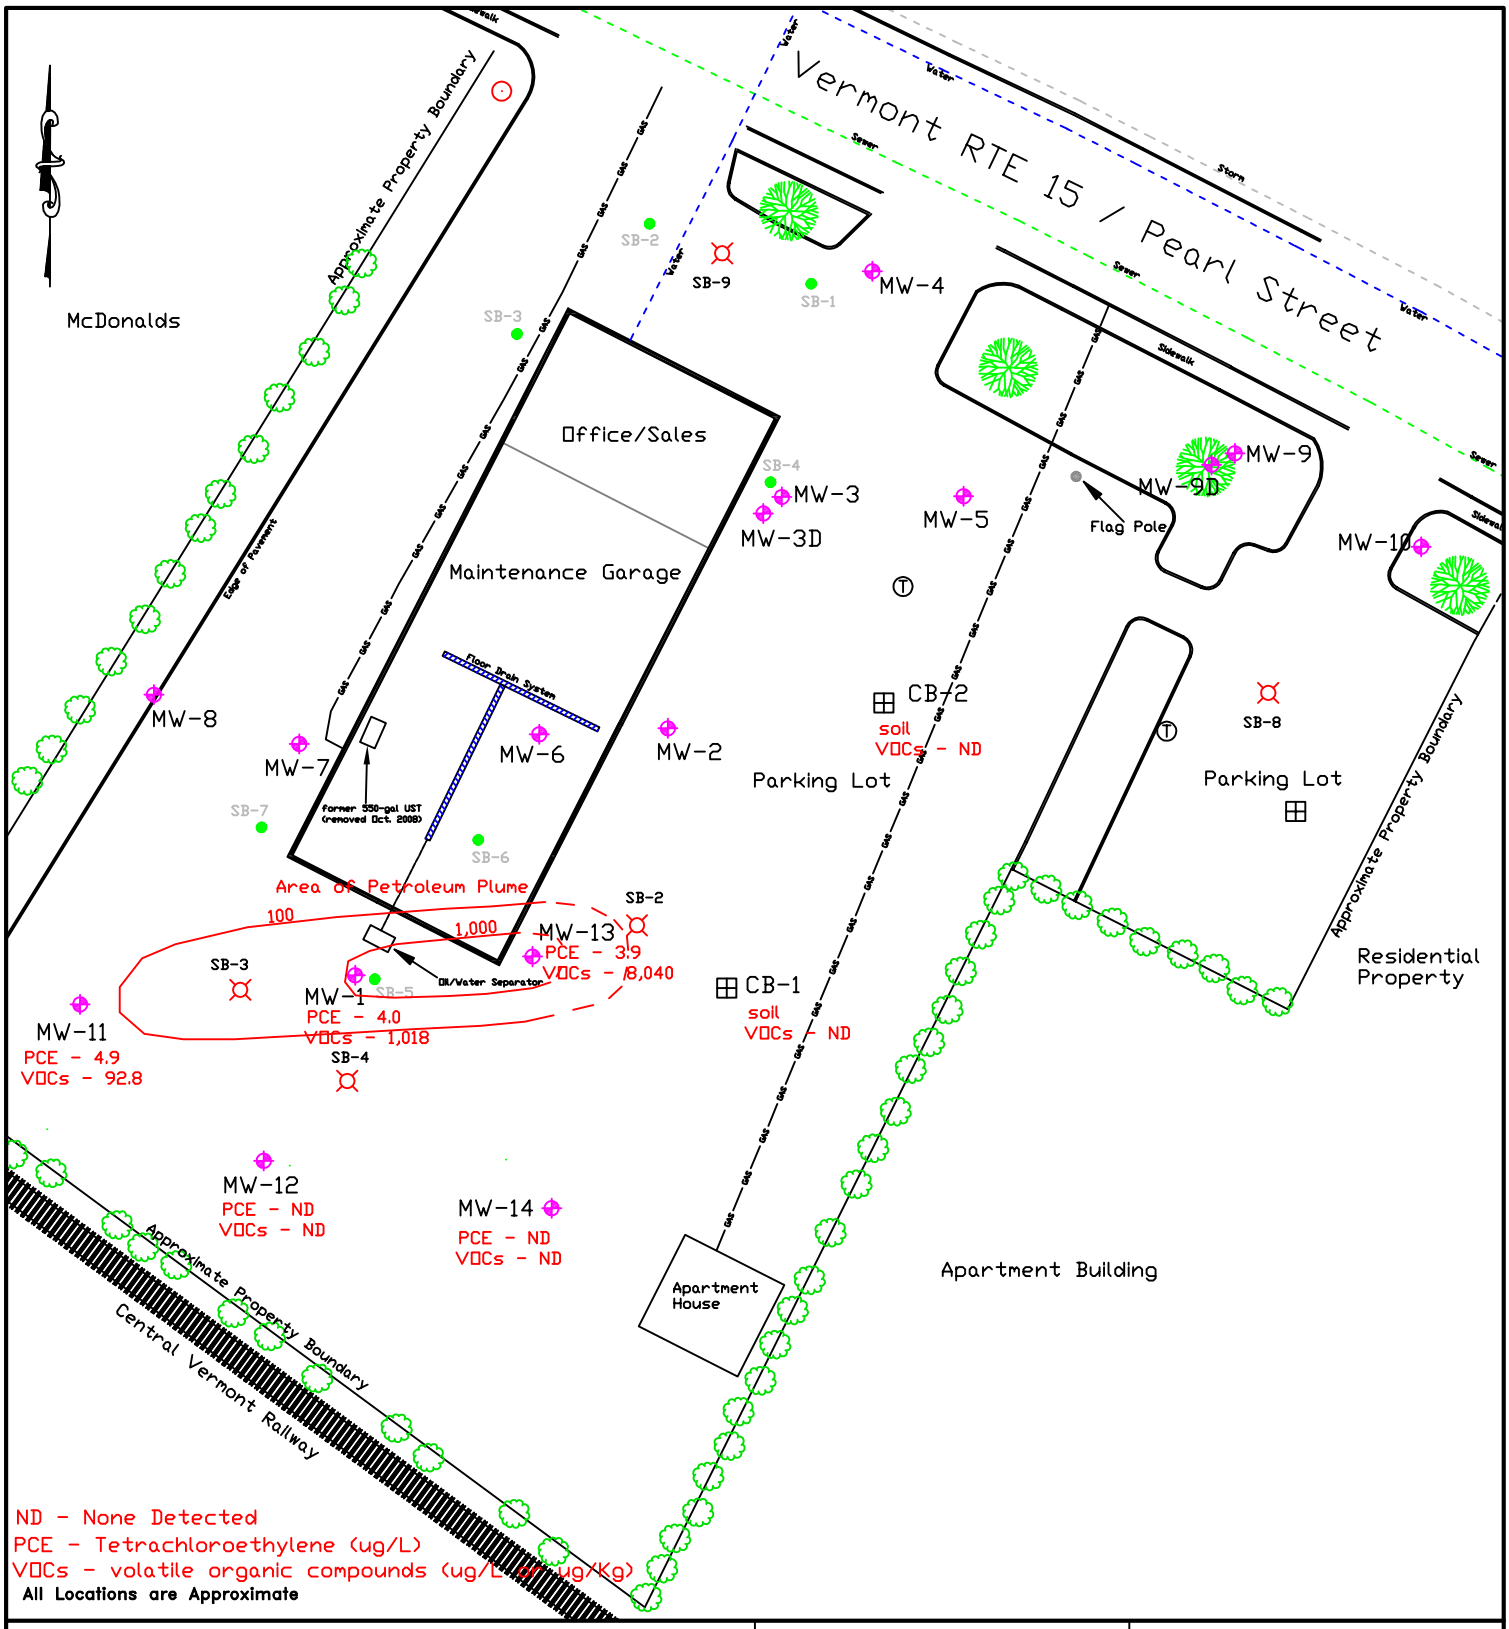
FIGURE 5.
CONTAMINANT DISTRIBUTION
(Monitoring Date: 26 October 2015)

Groundwater beneath the south-southwestern portion of the Site has been impacted by petroleum contamination above the Vermont Groundwater Enforcement Standards (VGESs[1]) for several petroleum-related compounds. The highest petroleum concentrations were detected in the sample collected from MW-13, which was installed approximately 10 feet off the southeastern corner of the maintenance building and approximately 40 feet upgradient of the oil/water separator. Also, a spike in contaminant concentrations was noted in the groundwater sample collected from MW-1 in May 2015 with a significant decrease since that time. The sudden spike in gasoline compounds noted in MW-1 are indicative of a spill incident or one-time event. According to Mr. Steven Carbone, a pickup truck parked in the vicinity of MW-1 in late spring 2015, was found to have a gasoline leak from a faulty fuel pump. The ratio of benzene and toluene concentrations compared to ethylbenzene and total xylenes concentrations suggest the petroleum contamination is associated with a recent gasoline release and is not indicative of weathered gasoline.

The VGESs for benzene, toluene, 1,2,4-trimethylbenzene, 1,3,5-trimethylbenzene, and naphthalene were exceeded in the groundwater sample collected from MW-13, which had the highest total VOCs concentrations during this sampling event. The VGESs for benzene and naphthalene were also exceeded in the samples collected from MW-1 and MW-11. Low concentrations of several petroleum-related compounds were also detected in the samples collected from MW-1, MW-11 and MW-13. PCE was also detected in three of the groundwater samples (MW-1, MW-11 and MW-13) at concentrations ranging between 3.9 and 4.9 micrograms per liter (µg/L), which are below the corresponding VGES. No VOCs were detected in the samples collected from MW-12 and MW-14 sample, which are located downgradient of the building to the south.

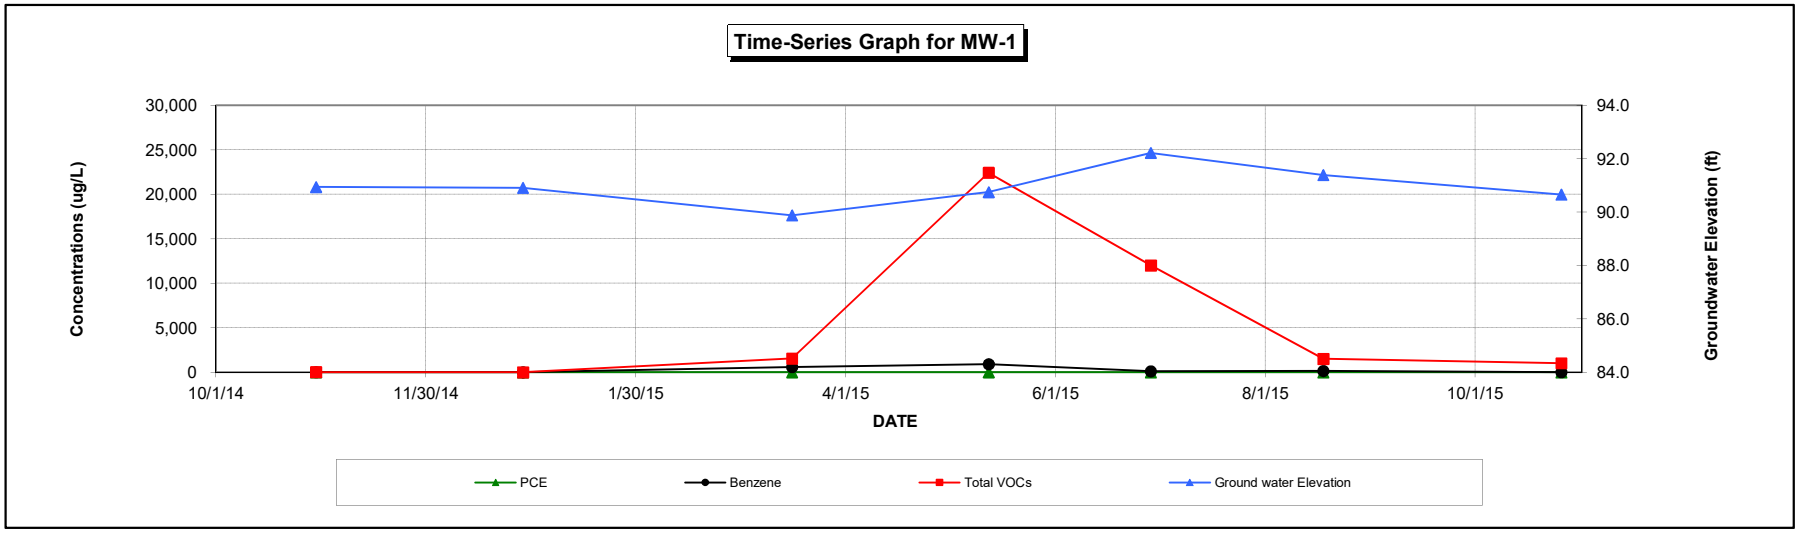
Summary of Ground Water Analytical Results for MW-1

- The concentrations of petroleum compounds in MW-1 have decreased by over an order of magnitude since the May 2015 sampling event. A similar decrease in contaminant concentrations was also noted in MW-11, which is located directly downgradient of MW-1, between the August and October 2015 sampling events.

- A spike in contaminant concentrations was noted in the groundwater sample collected from MW-1 in May 2015 with a significant decrease since that time. A similar decrease in contaminant concentrations was also noted in MW-11, which is located directly downgradient of MW-1, between the August and October 2015 sampling events. The sudden spike in gasoline compounds noted in MW-1 and MW-11 are indicative of a spill incident or one-time event with contaminant migration from MW-1 toward MW-11. According to Mr. Steven Carbone, a pickup truck parked in the vicinity of MW-1 in late spring 2015, was found to have a gasoline leak from a faulty fuel pump. Also, the pattern of compounds detected in MW-1 suggests a recent gasoline release. The ratio of benzene and toluene compared to ethylbenzene and total xylenes are not indicative of weathered gasoline. Based on this information and observed contaminant trends in MW-1, parking lot run off contaminated with gasoline is the likely source of the petroleum compounds discovered in MW-1.

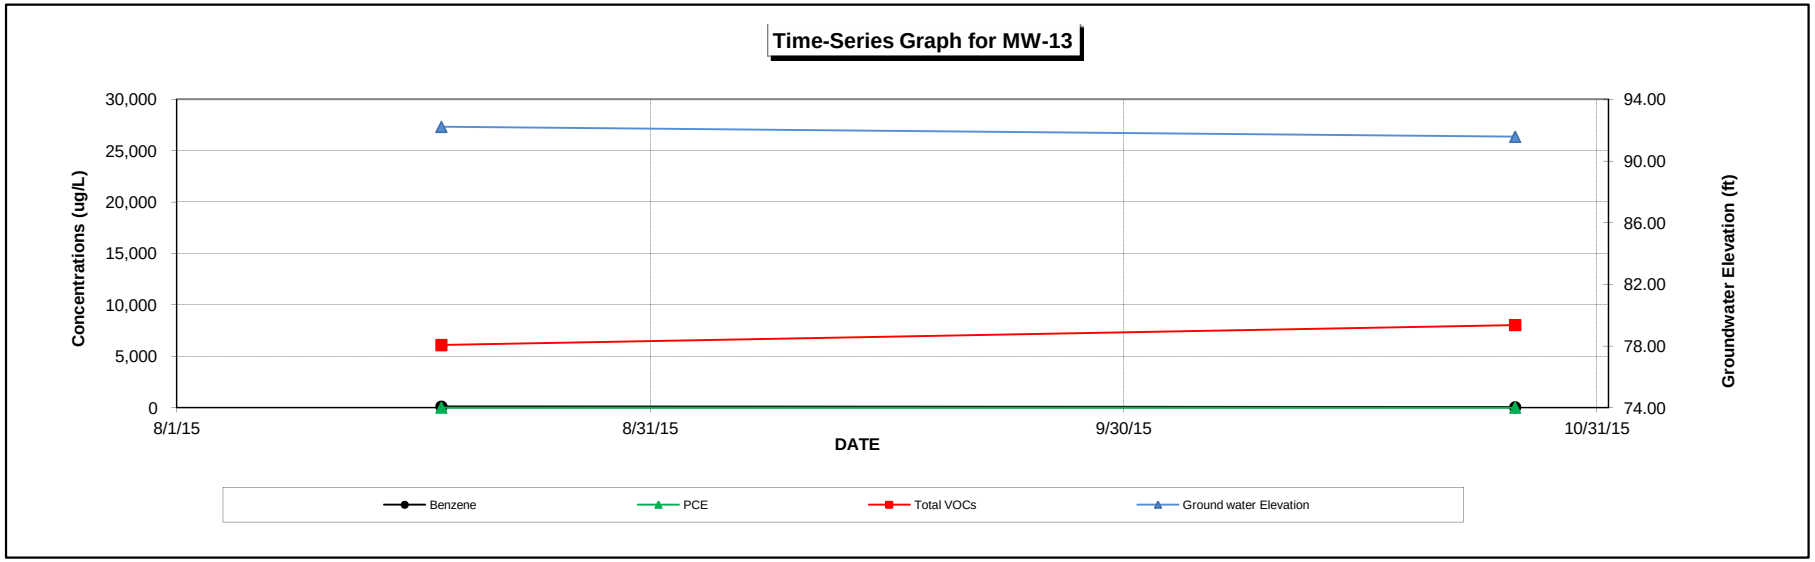
Summary of Ground Water Analytical Results for MW-13

- No visual or olfactory evidence of petroleum were noted in the catch basins located upgradient of MW-13. According to Steve Carbone, these catch basin have an open bottom dry well type construction surrounded by crushed stone. Based on the design of the catch basins, these points provide a direct pathway for parking runoff to enter the subsurface environment.

- The PID reading on the subsurface soil sample collected at approximately 11 feet below ground surface in the MW-13 soil boring was 69.2 ppmv. A strong petroleum odor was also noted in the soil sample collected at this depth. No elevated PID readings or visual evidence of petroleum were noted in the SB-2 soil boring installed by ***R.E.A.*** in August 2015, which is upgradient of MW-13 and the dissolved-phase petroleum plume. SB-2 is located approximately 25 feet upgradient of MW-13. Based on this information, the source of petroleum contamination in the vicinity of MW-13, appears to be located near the southeastern corner of the maintenance garage between MW-13 and SB-2.
