Corrective Action Construction Completion Report

Former Chemfab Facility
1030 Water Street
North Bennington, Vermont

SMS Site #20164630

February 29, 2024

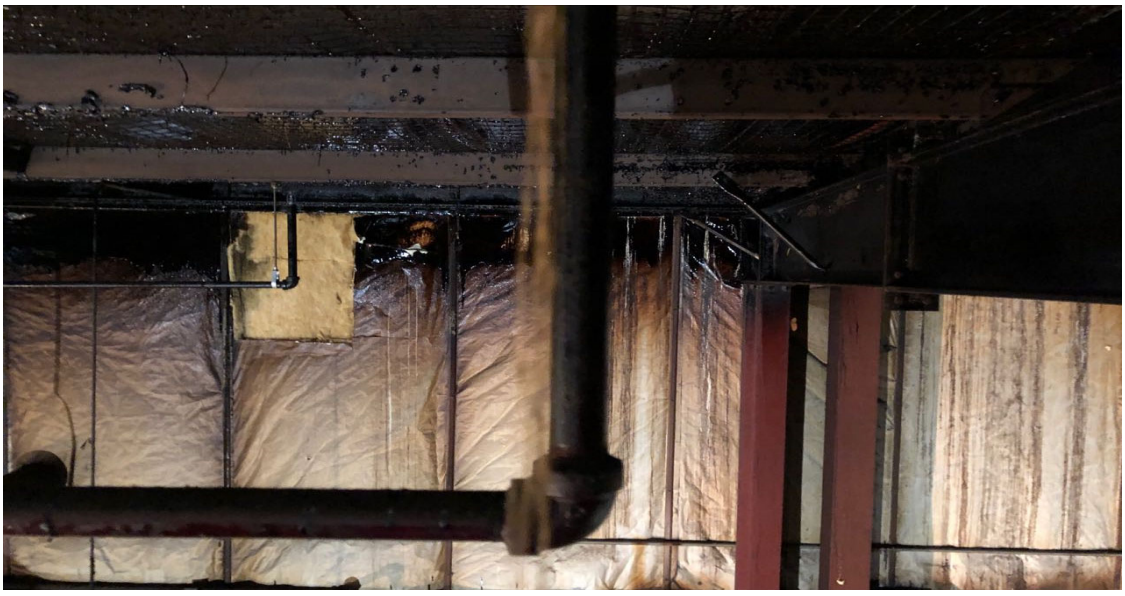
The roof is supported by structural beams and purlins. The insulation and wire mesh were installed around the beams but under the purlins, which are approximately 2.5 inches wide. Removal of the ceiling insulation consisted of cutting the wire mesh flush to the purlins and pulling down the insulation. The wire mesh and insulation under the purlins were isolated from PFAS-impacted residue by the purlins, and therefore, the material under the purlins did not require removal. Ceiling insulation is shown in photo #3 of Appendix A.

Photo 3: Pre-Corrective Action Warehouse Ceiling with Insulation

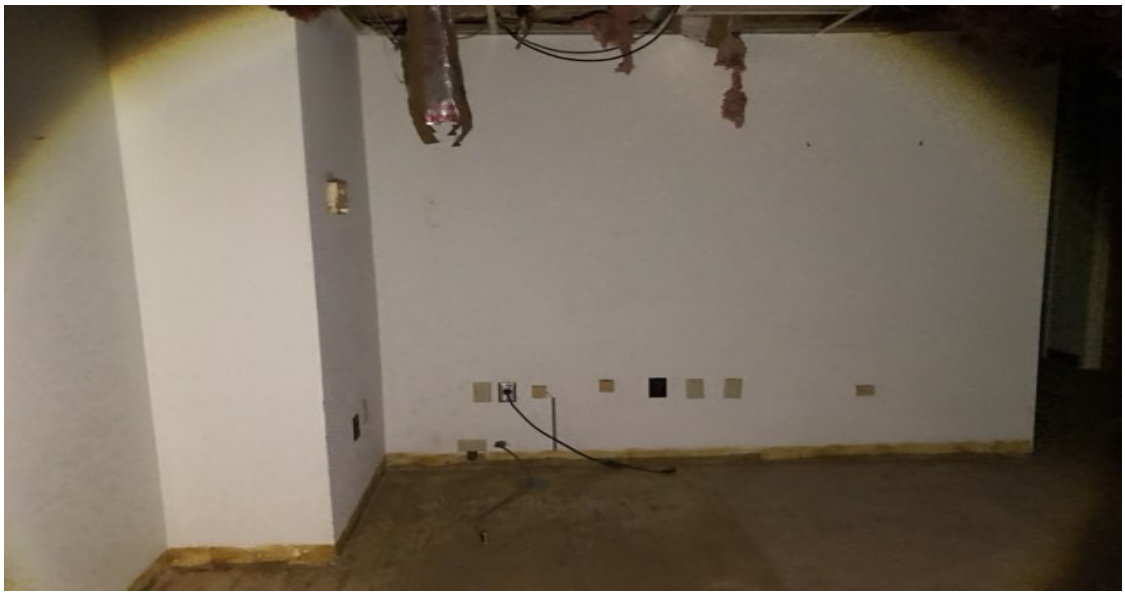
Photo 7: Post-Corrective Action Office Area

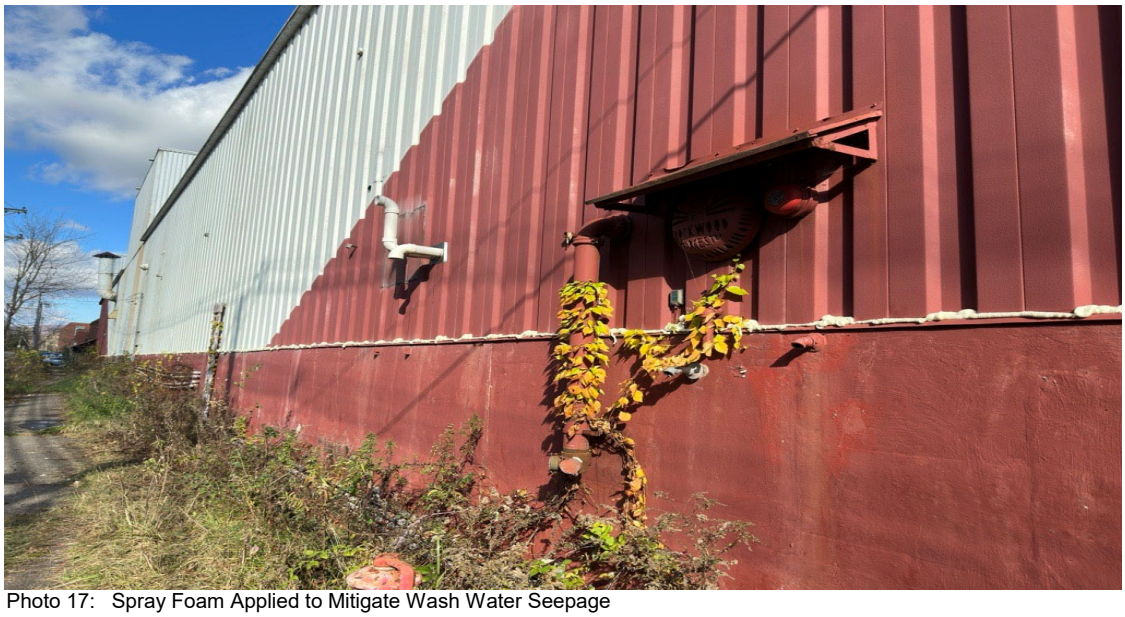
Photo 17: Spray Foam Applied to Mitigate Wash Water Seepage

During startup of cleaning activities, wash water was observed seeping out of holes and gaps in the building siding, primarily in the northwestern corner of the Corrective Action Area. Cleaning activities were redirected to the center of the building until the base of the wall framing was sealed to the concrete foundation wall. Spray foam was used to seal holes and gaps in the building siding to contain the wash water. The mitigation measure was reviewed and approved by the VTDEC on-site representative. Spray foam applied to mitigate water seepage outside of the building is shown in photo #17 of Appendix A.

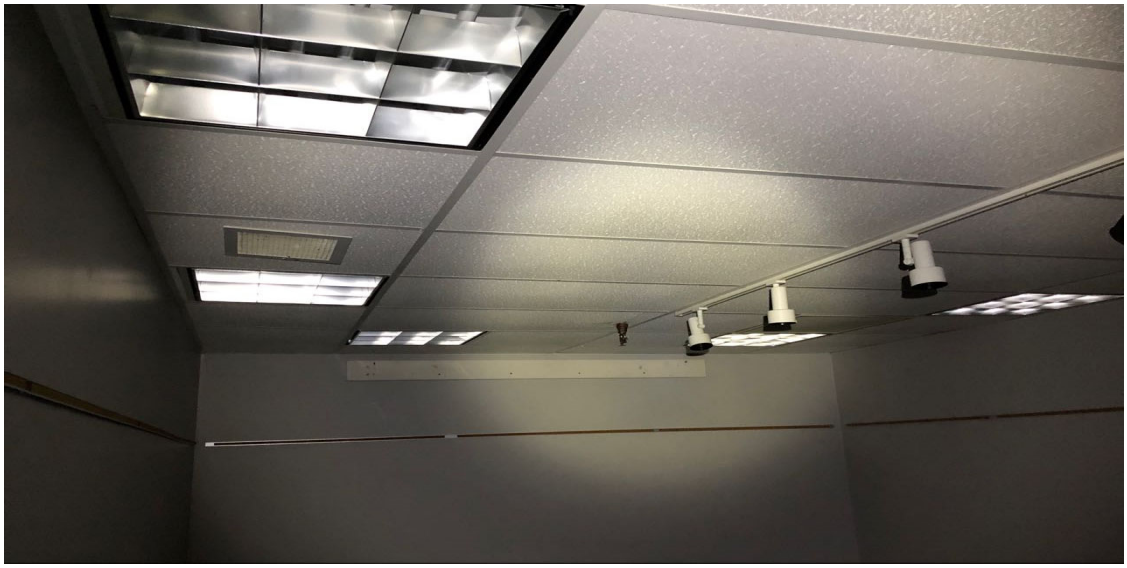
Photo19: Pre-Corrective Action Office Area

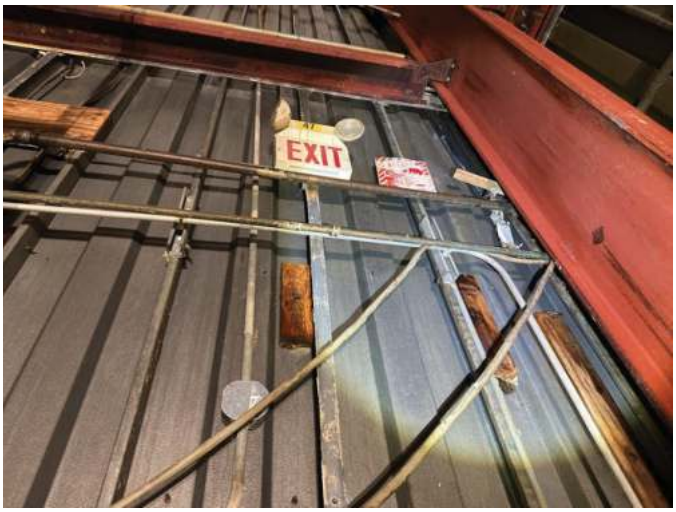
Inspection Number: A-001

Surface: Metal Wall
Cleaning Method: Degreaser + Power Wash
Barr: Joseph Lazarus Passed inspection on 2023-10-31
VTDEC: Dom Delello Passed inspection on 2023-11-01

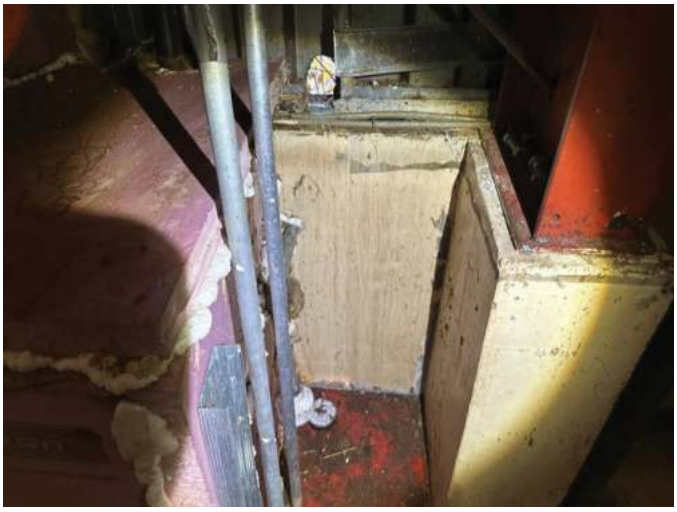
Inspection Number: A-003

Surface: Concrete Wall
Cleaning Method: Degreaser + Power Wash
Barr: Joseph Lazarus Passed inspection on 2023-10-31
VTDEC: Dom Delello Passed inspection on 2023-11-01

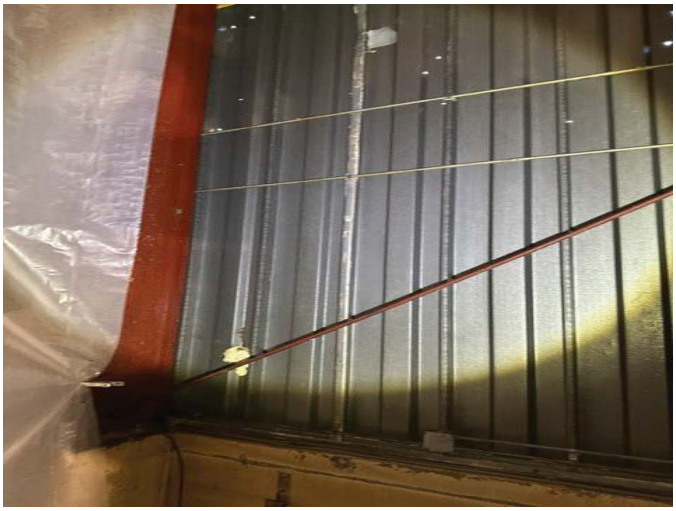
Inspection Number: A-005

Surface: Metal Wall
Cleaning Method: Degreaser + Power Wash
Barr: Joseph Lazarus Passed inspection on 2023-10-31
VTDEC: Dom Delello Passed inspection on 2023-11-01

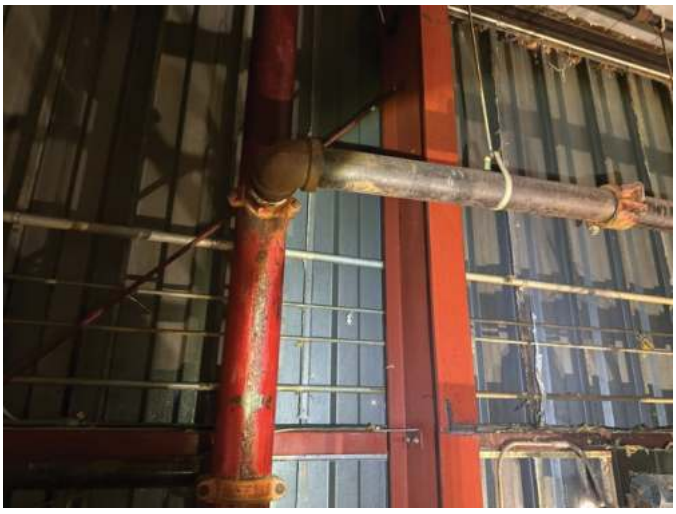
Inspection Number: A-006

Surface: Metal Wall
Cleaning Method: Degreaser + Power Wash
Barr: Joseph Lazarus Passed inspection on 2023-10-31
VTDEC: Dom Delello Passed inspection on 2023-11-01

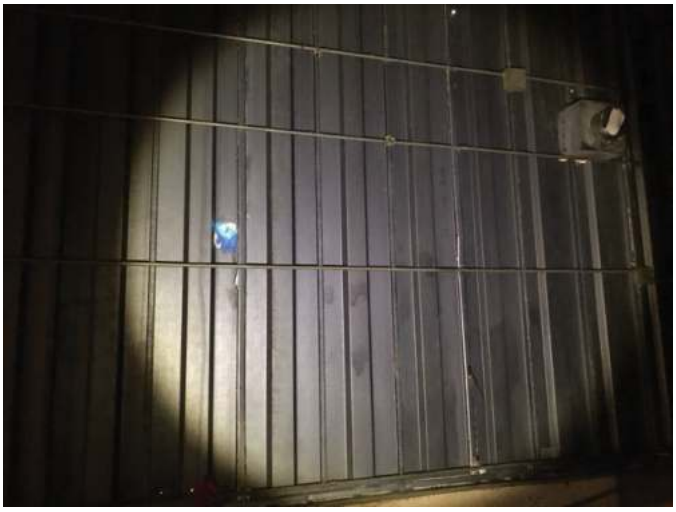
Inspection Number: A-012

Surface: Metal Wall
Cleaning Method: Degreaser + Power Wash
Barr: Sierra Samie Passed inspection on 2023-11-07
VTDEC: Dom Delello Passed inspection on 2023-11-08

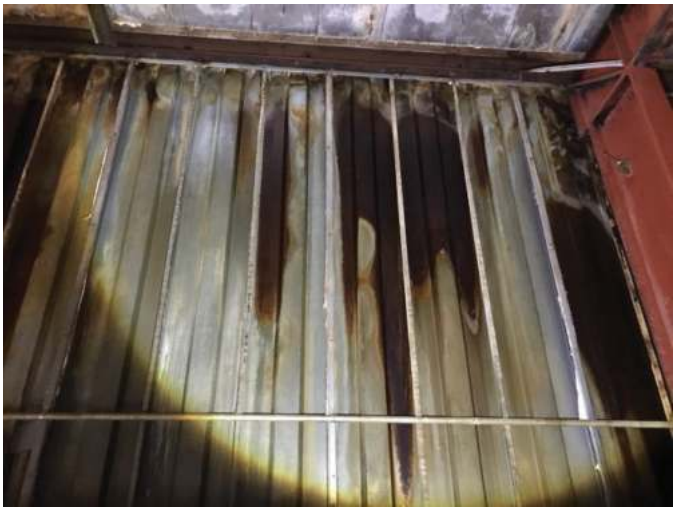
Inspection Number: A-031

Surface: Metal Wall
Cleaning Method: Degreaser + Power Wash
Barr: Joseph Lazarus Passed inspection on 2023-11-30
VTDEC: Dom Delello Passed inspection on 2023-12-07

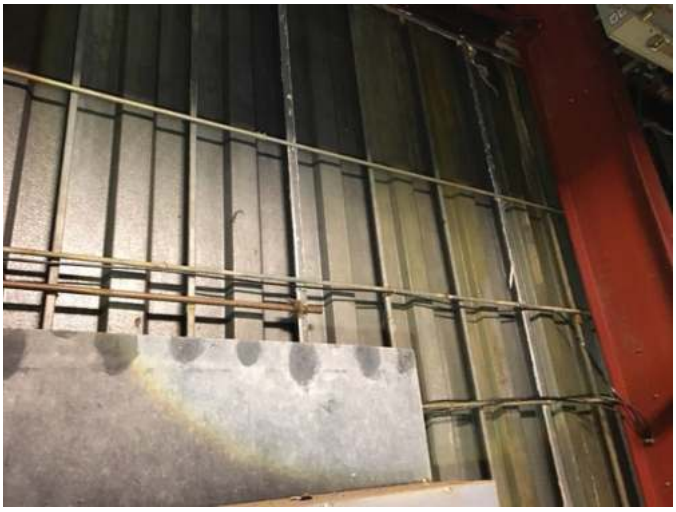
Inspection Number: A-033

Surface: Metal Wall
Cleaning Method: Degreaser + Power Wash
Barr: Joseph Lazarus Passed inspection on 2023-11-29
VTDEC: Dom Delello Passed inspection on 2023-12-07

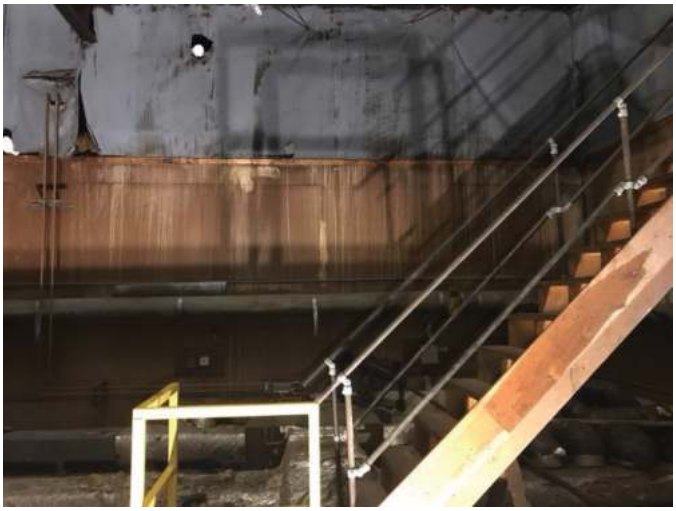
Inspection Number: A-047

Surface: Sheetrock Wall
Cleaning Method: Hand Wipe
Barr: Joseph Lazarus Failed inspection on 2023-12-01
VTDEC: N/A

Additional cleaning conducted after failed inspection

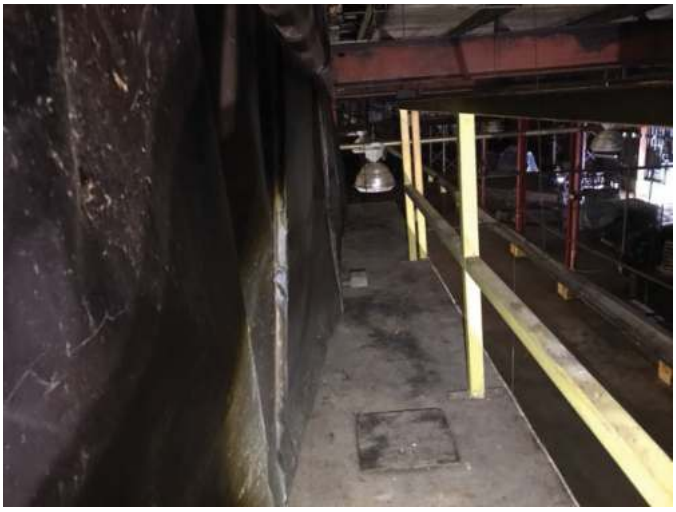
Surface: Plywood Floor
Cleaning Method: Hand Wipe
Barr: Joseph Lazarus Failed inspection on 2023-12-01
VTDEC: N/A

Additional cleaning conducted after failed inspection

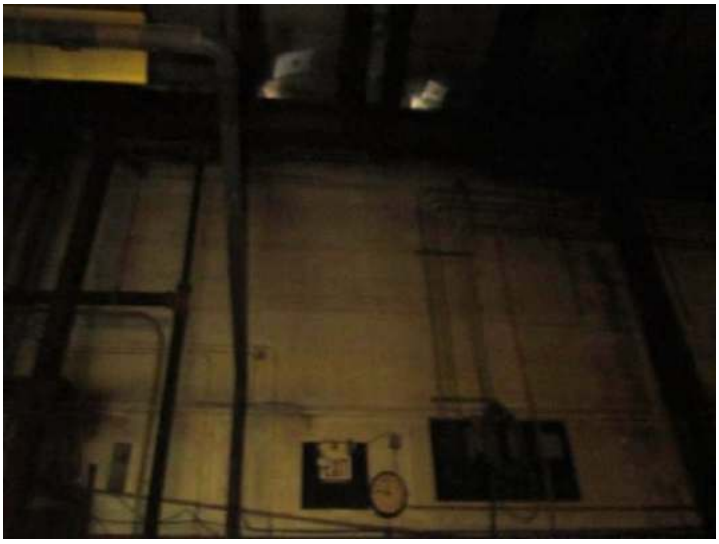
Inspection Number: B-012

Surface: Sheetrock Wall
Cleaning Method: Degreaser + Power Wash
Barr: Joseph Lazarus Passed inspection on 2023-11-02
VTDEC: Dom Delello Passed inspection on 2023-11-02

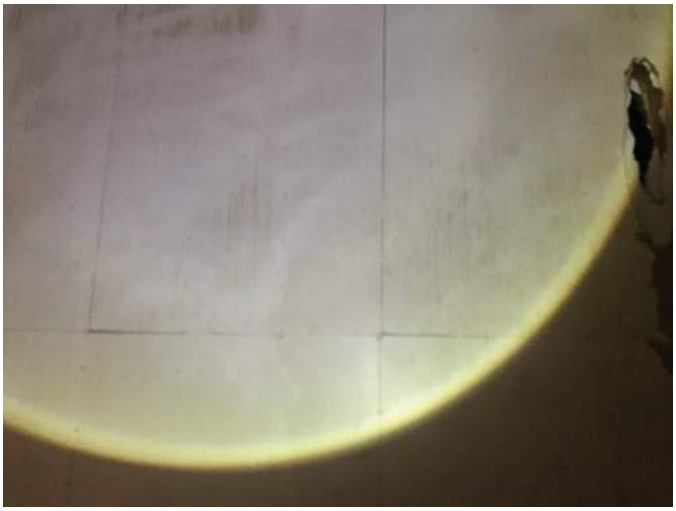
Inspection Number: B-024

Surface: Concrete Wall
Cleaning Method: Degreaser + Power Wash
Barr: Joseph Lazarus Passed inspection on 2023-11-02
VTDEC: Dom Delello Passed inspection on 2023-11-08

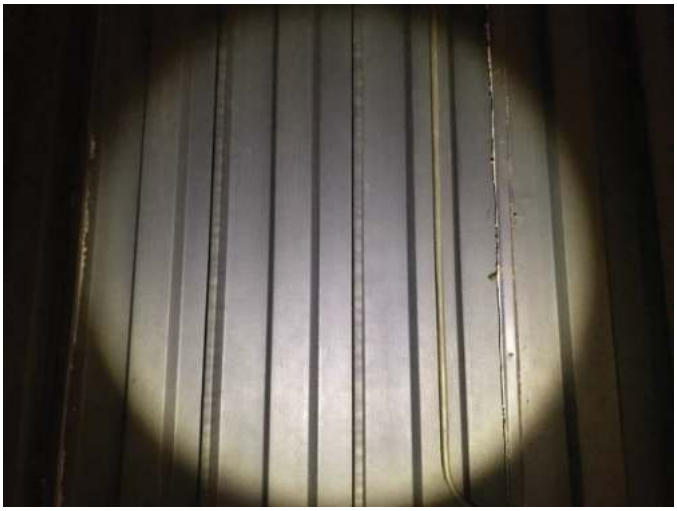
Inspection Number: C-007

Surface: Concrete Wall
Cleaning Method: Degreaser + Power Wash
Barr: Sierra Samie Passed inspection on 2023-11-08
VTDEC: Dom Delello Passed inspection on 2023-11-14

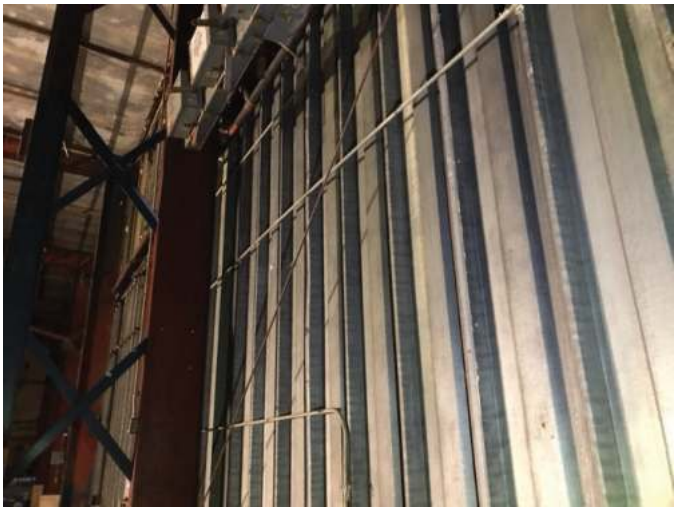
Inspection Number: C-017

Surface: Metal Wall
Cleaning Method: Degreaser + Power Wash
Barr: Joseph Lazarus Passed inspection on 2023-11-14
VTDEC: Dom Delello Passed inspection on 2023-11-21

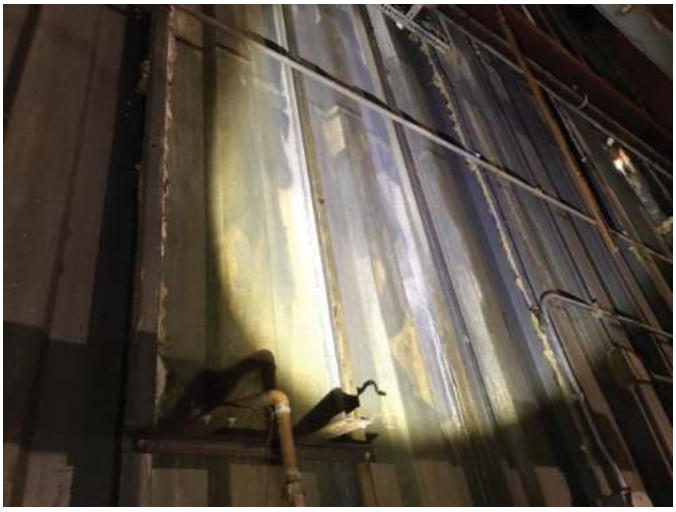
Inspection Number: C-020

Surface: Metal Wall
Cleaning Method: Degreaser + Power Wash
Barr: Joseph Lazarus Passed inspection on 2023-11-21
VTDEC: Dom Delello Passed inspection on 2023-11-21

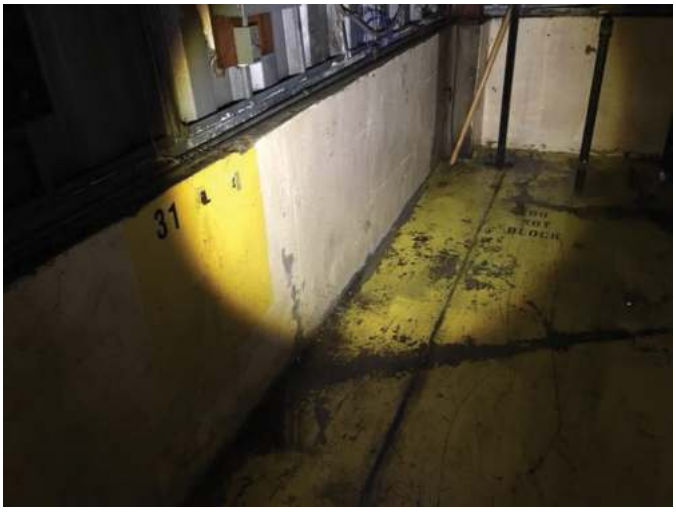
Inspection Number: C-043

Surface: Concrete Wall
Cleaning Method: Degreaser + Power Wash
Barr: Joseph Lazarus Passed inspection on 2023-12-01
VTDEC: Dom Delello Passed inspection on 2023-12-07

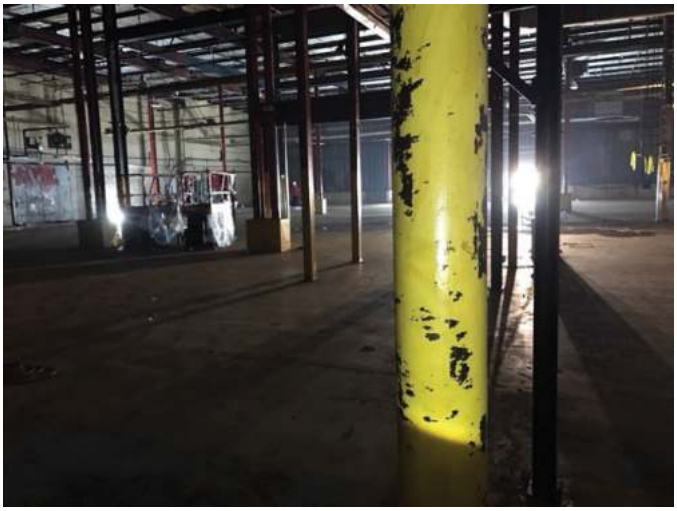
Inspection Number: E-039

Surface: Column
Cleaning Method: Degreaser + Power Wash
Barr: Joseph Lazarus Passed inspection on 2023-11-14
VTDEC: Dom Delello Failed inspection on 2023-11-14

Additional cleaning conducted after failed inspection

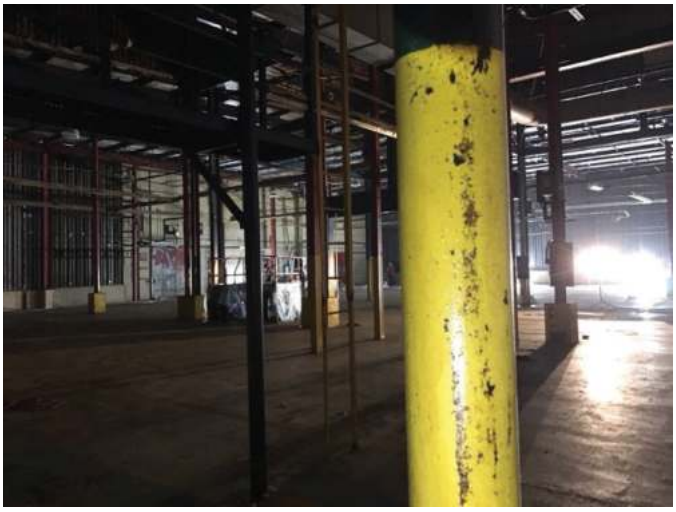
Inspection Number: E-042

Surface: Column
Cleaning Method: Degreaser + Power Wash
Barr: Joseph Lazarus Passed inspection on 2023-11-14
VTDEC: Dom Delello Failed inspection on 2023-11-14

Additional cleaning conducted after failed inspection

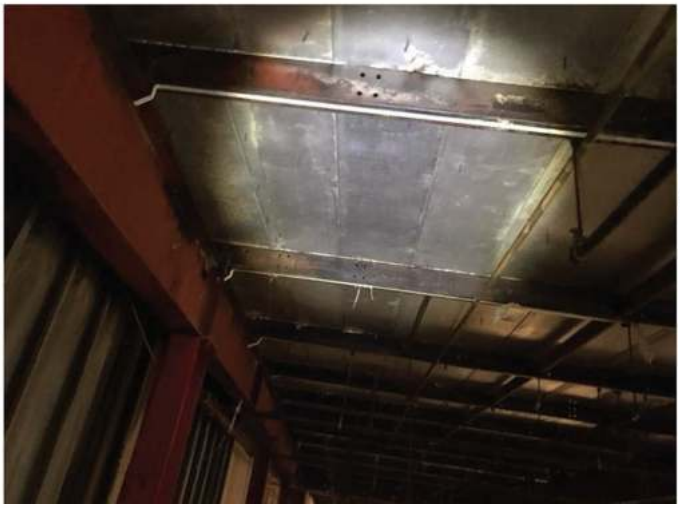
Inspection Number: F-002

Surface: Ceiling
Cleaning Method: Degreaser + Power Wash
Barr: Joseph Lazarus Passed inspection on 2023-11-02
VTDEC: Dom Delello Passed inspection on 2023-11-08

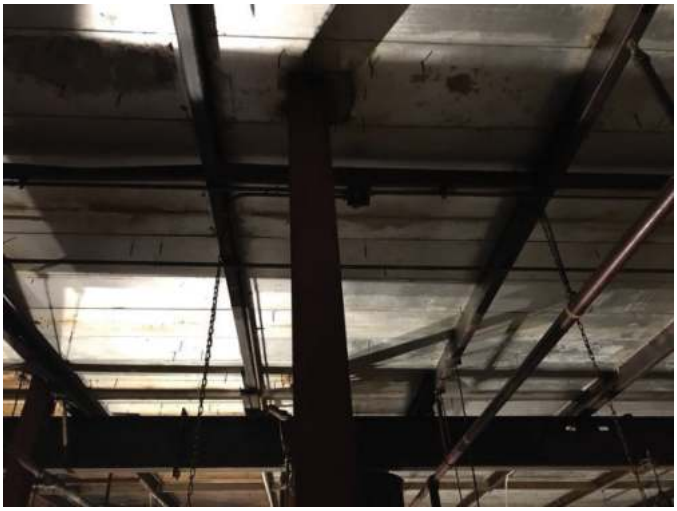
Inspection Number: F-023

Surface: Ceiling
Cleaning Method: Degreaser + Power Wash
Barr: Joseph Lazarus Passed inspection on 2023-11-13
VTDEC: Dom Delello Passed inspection on 2023-11-14

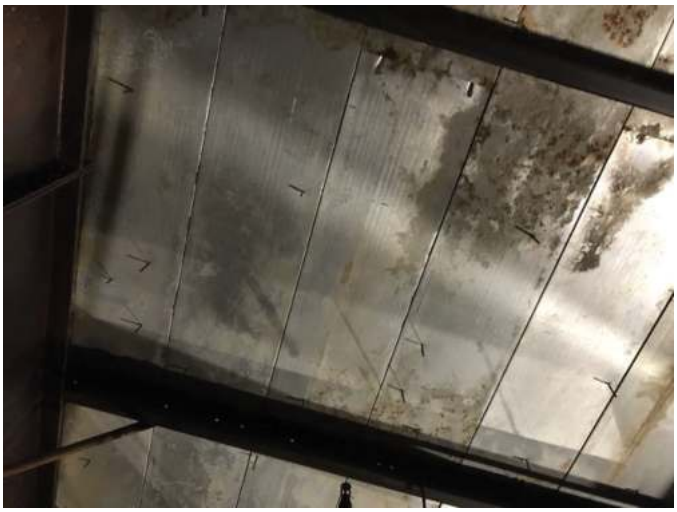
Inspection Number: F-024

Staining after pressure washing was observed at this location. Additional field testing by Barr, C.T. Male, PIM, and VTDEC indicated that this staining was not removed by other cleaning methods, and the staining was different than residues observed in the rest of the Corrective Action Area. PFAS residues were removed from these areas consistent with the corrective action objectives. All parties agreed that further cleaning was unnecessary and the visual performance standard to remove PFAS residues was achieved.

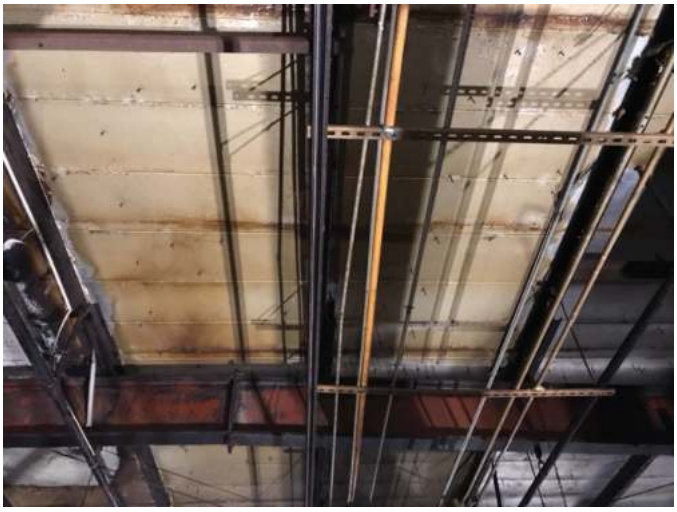
Inspection Number: F-034

Surface: Ceiling
Cleaning Method: Degreaser + Power Wash
Barr: Joseph Lazarus Passed inspection on 2023-11-13
VTDEC: Dom Delello Passed inspection on 2023-11-14

Staining after pressure washing was observed at this location. Additional field testing by Barr, C.T. Male, PIM, and VTDEC indicated that this staining was not removed by other cleaning methods, and the staining was different than residues observed in the rest of the Corrective Action Area. PFAS residues were removed from these areas consistent with the corrective action objectives. All parties agreed that further cleaning was unnecessary and the visual performance standard to remove PFAS residues was achieved.

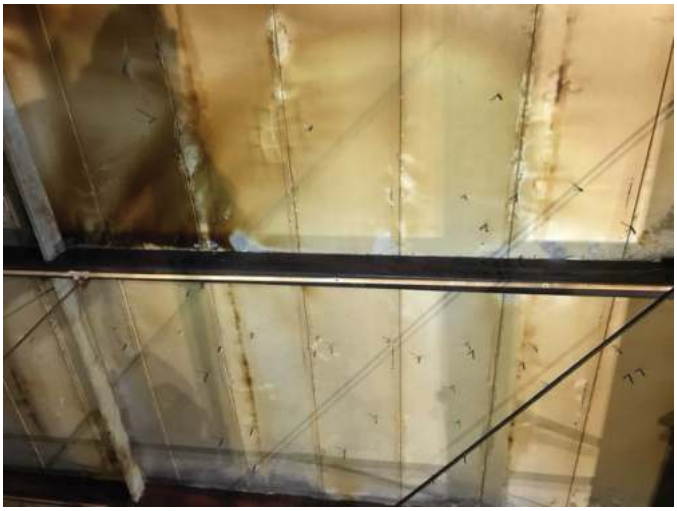
Inspection Number: F-040

Staining after pressure washing was observed at this location. Additional field testing by Barr, C.T. Male, PIM, and VTDEC indicated that this staining was not removed by other cleaning methods, and the staining was different than residues observed in the rest of the Corrective Action Area. PFAS residues were removed from these areas consistent with the corrective action objectives. All parties agreed that further cleaning was unnecessary and the visual performance standard to remove PFAS residues was achieved.

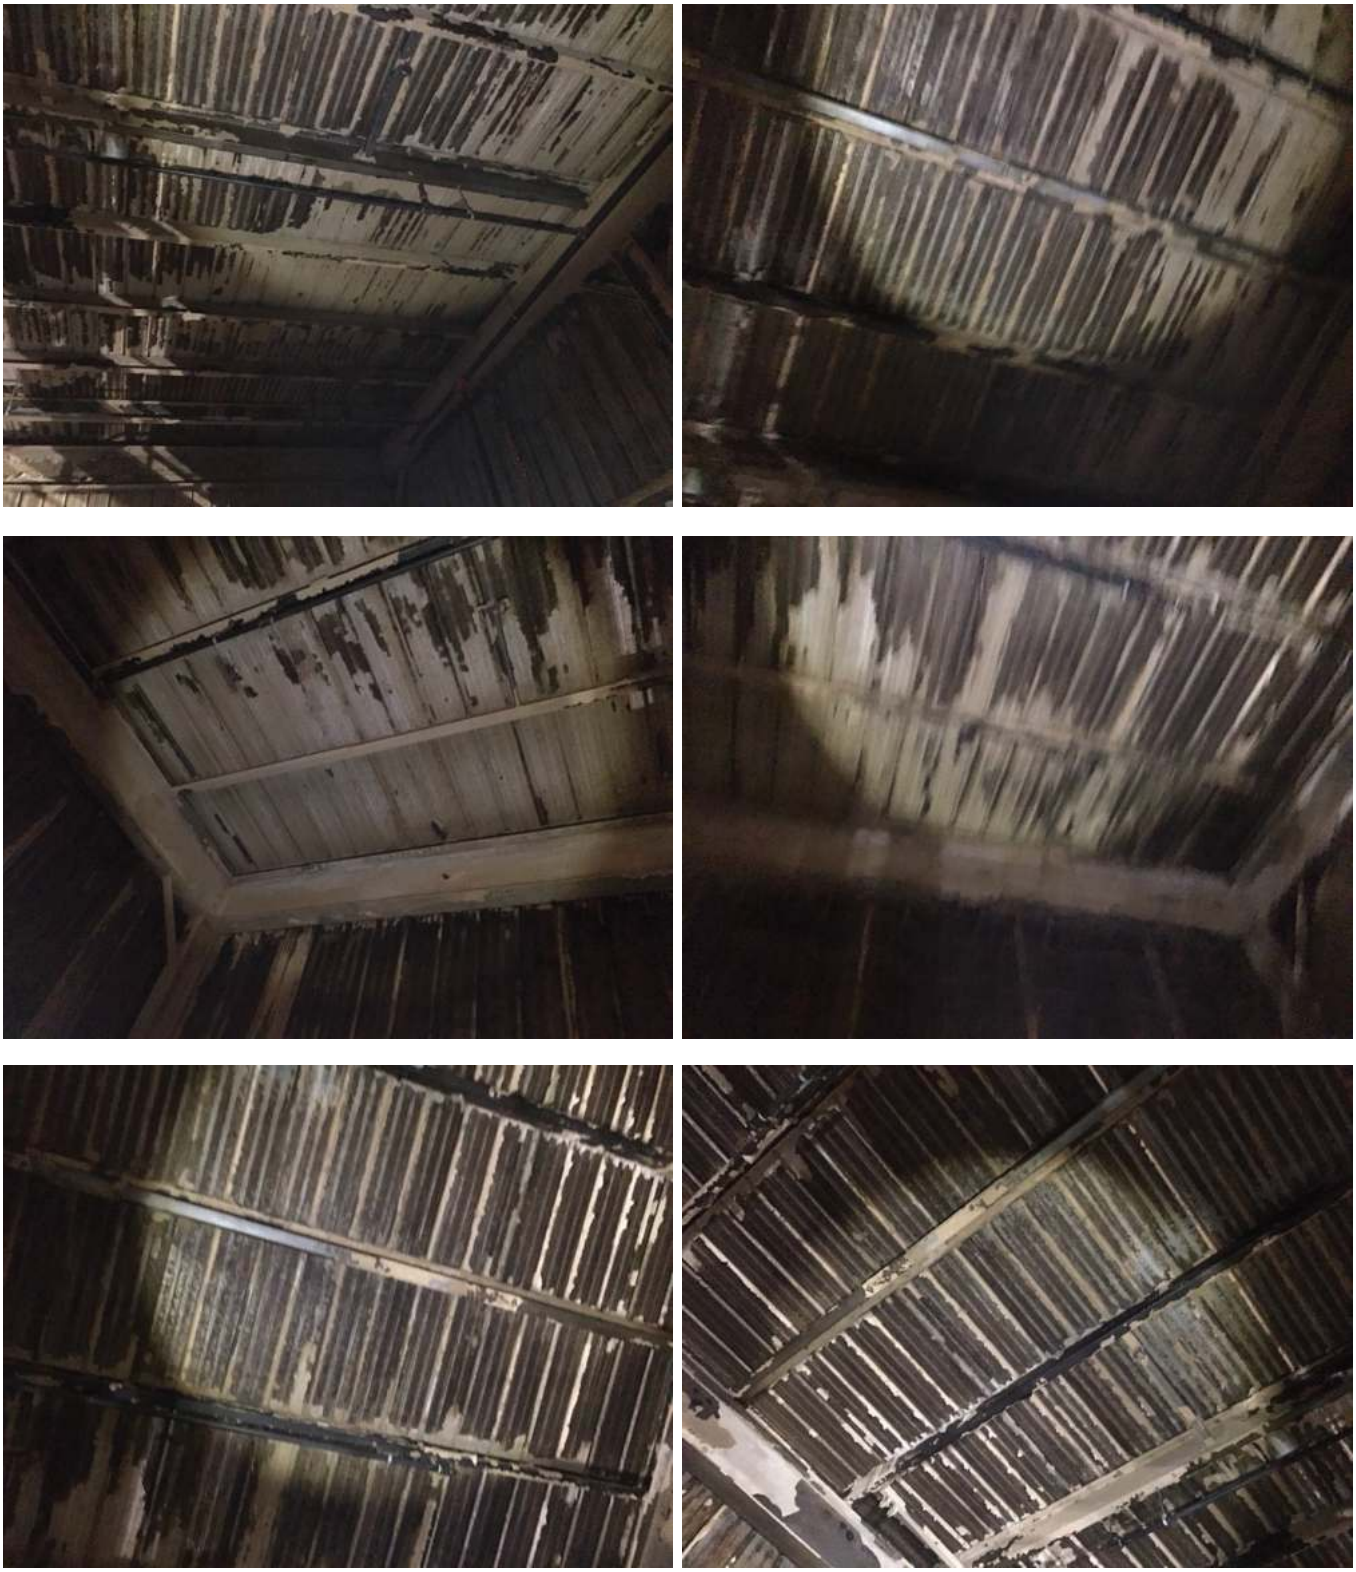
Inspection Number: F-043

Surface: Ceiling
Cleaning Method: Degreaser + Power Wash
Barr: Joseph Lazarus Passed inspection on 2023-11-16
VTDEC: Dom Delello Passed inspection on 2023-11-21

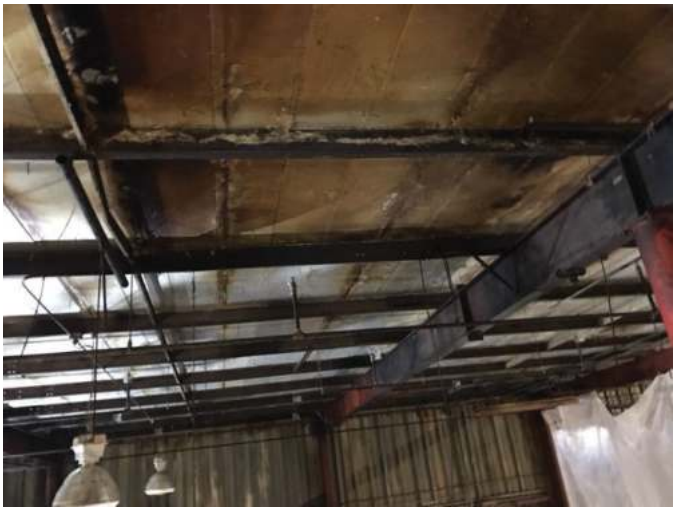
Inspection Number: F-050 (CONTINUED)

Surface: Ceiling
Cleaning Method: Degreaser + Power Wash
Barr: Joseph Lazarus Passed inspection on 2023-11-17
VTDEC: Dom Delello Passed inspection on 2023-11-21

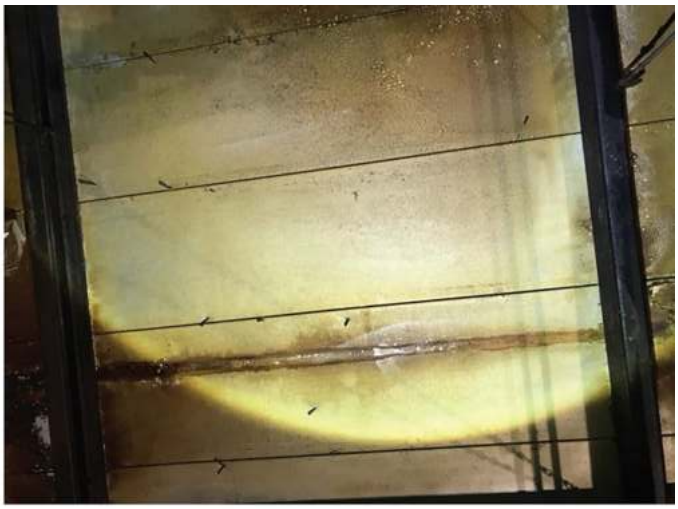
Inspection Number: F-058 (CONTINUED)

Staining after pressure washing was observed at this location. Additional field testing by Barr, C.T. Male, PIM, and VTDEC indicated that this staining was not removed by other cleaning methods, and the staining was different than residues observed in the rest of the Corrective Action Area. PFAS residues were removed from these areas consistent with the corrective action objectives. All parties agreed that further cleaning was unnecessary and the visual performance standard to remove PFAS residues was achieved.

Surface: Ceiling
Cleaning Method: Degreaser + Power Wash
Barr: Joseph Lazarus Passed inspection on 2023-11-21
VTDEC: Dom Delello Passed inspection on 2023-11-21

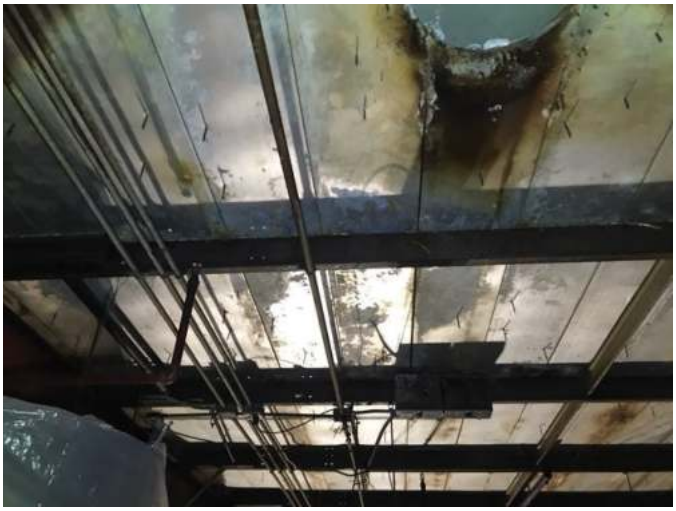
Inspection Number: F-059 (CONTINUED)

Staining after pressure washing was observed at this location. Additional field testing by Barr, C.T. Male, PIM, and VTDEC indicated that this staining was not removed by other cleaning methods, and the staining was different than residues observed in the rest of the Corrective Action Area. PFAS residues were removed from these areas consistent with the corrective action objectives. All parties agreed that further cleaning was unnecessary and the visual performance standard to remove PFAS residues was achieved.

Surface: Ceiling
Cleaning Method: Degreaser + Power Wash
Barr: Joseph Lazarus Passed inspection on 2023-11-21
VTDEC: Dom Delello Passed inspection on 2023-11-21

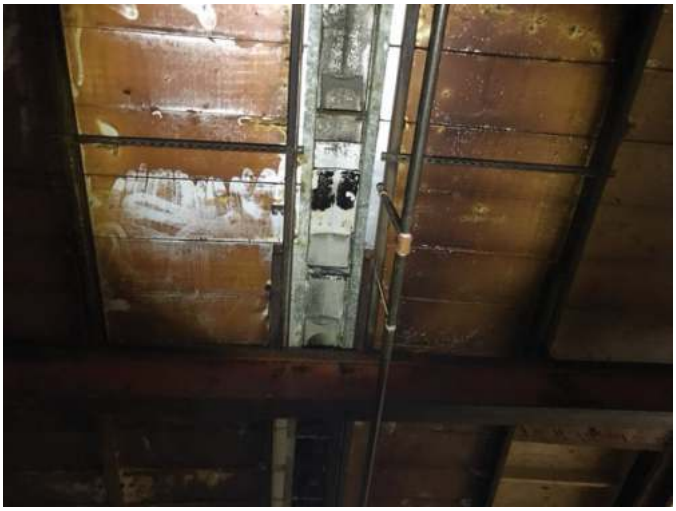
Inspection Number: F-072

Staining after pressure washing was observed at this location. Additional field testing by Barr, C.T. Male, PIM, and VTDEC indicated that this staining was not removed by other cleaning methods, and the staining was different than residues observed in the rest of the Corrective Action Area. PFAS residues were removed from these areas consistent with the corrective action objectives. All parties agreed that further cleaning was unnecessary and the visual performance standard to remove PFAS residues was achieved.

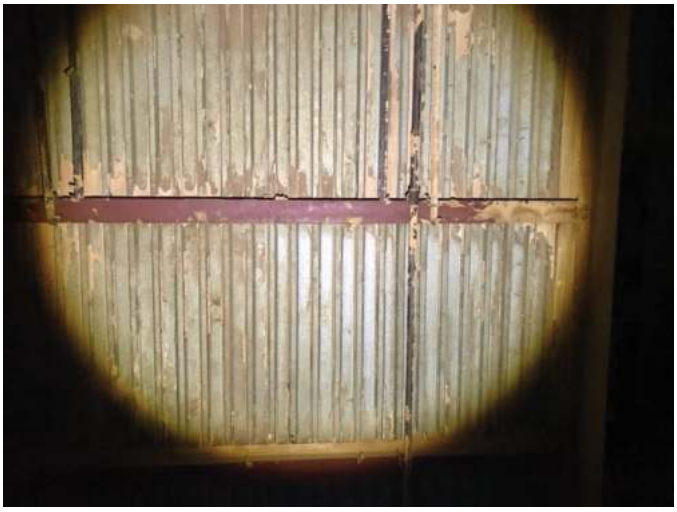
Inspection Number: F-074

Staining after pressure washing was observed at this location. Additional field testing by Barr, C.T. Male, PIM, and VTDEC indicated that this staining was not removed by other cleaning methods, and the staining was different than residues observed in the rest of the Corrective Action Area. PFAS residues were removed from these areas consistent with the corrective action objectives. All parties agreed that further cleaning was unnecessary and the visual performance standard to remove PFAS residues was achieved.

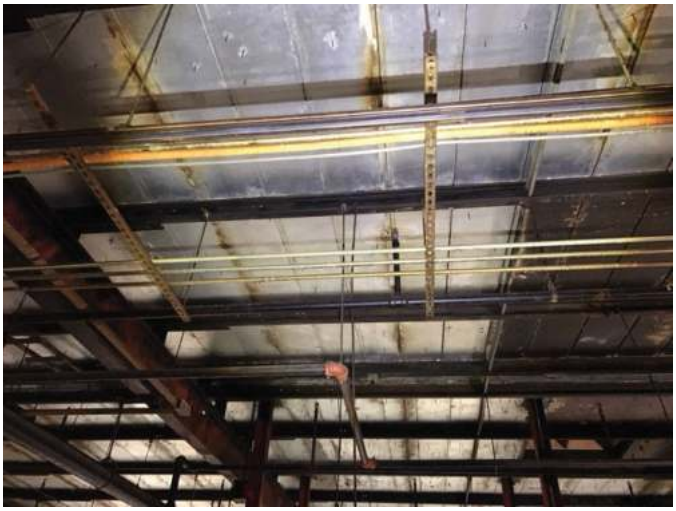
Staining after pressure washing was observed at this location. Additional field testing by Barr, C.T. Male, PIM, and VTDEC indicated that this staining was not removed by other cleaning methods, and the staining was different than residues observed in the rest of the Corrective Action Area. PFAS residues were removed from these areas consistent with the corrective action objectives. All parties agreed that further cleaning was unnecessary and the visual performance standard to remove PFAS residues was achieved.

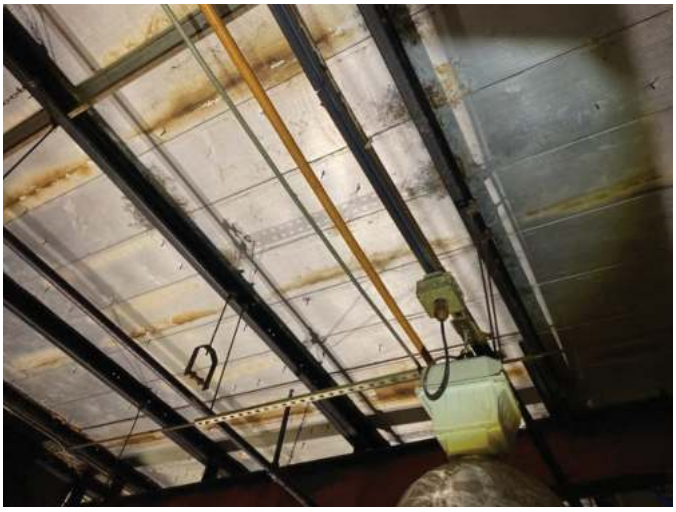
Inspection Number: F-092

Staining after pressure washing was observed at this location. Additional field testing by Barr, C.T. Male, PIM, and VTDEC indicated that this staining was not removed by other cleaning methods, and the staining was different than residues observed in the rest of the Corrective Action Area. PFAS residues were removed from these areas consistent with the corrective action objectives. All parties agreed that further cleaning was unnecessary and the visual performance standard to remove PFAS residues was achieved.

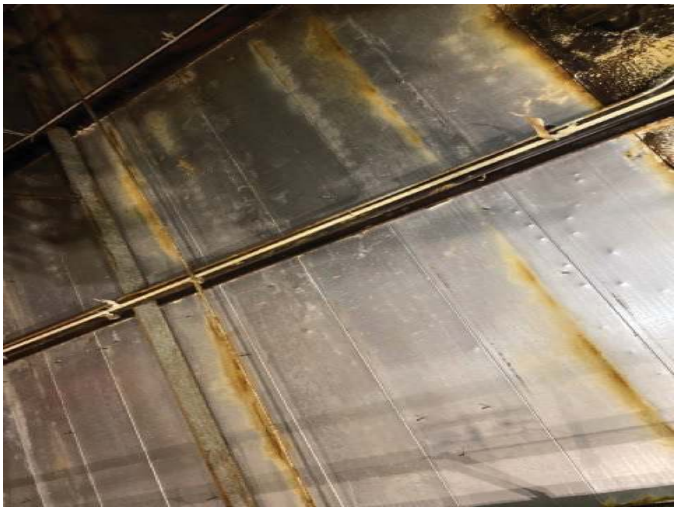
Inspection Number: F-096

Surface: Ceiling
Cleaning Method: Degreaser + Power Wash
Barr: Sierra Samie Passed inspection on 2023-12-06
VTDEC: Dom Delello Passed inspection on 2023-12-07

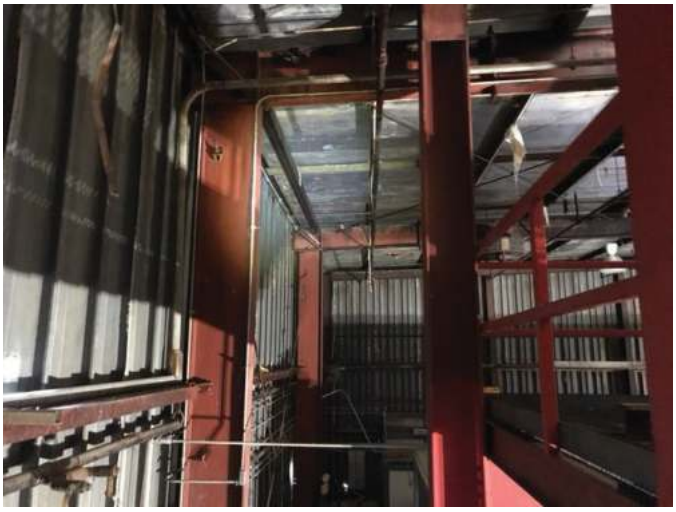
Inspection Number: F-098

Surface: Ceiling
Cleaning Method: Degreaser + Power Wash
Barr: Sierra Samie Passed inspection on 2023-12-07
VTDEC: Dom Delello Passed inspection on 2023-12-07

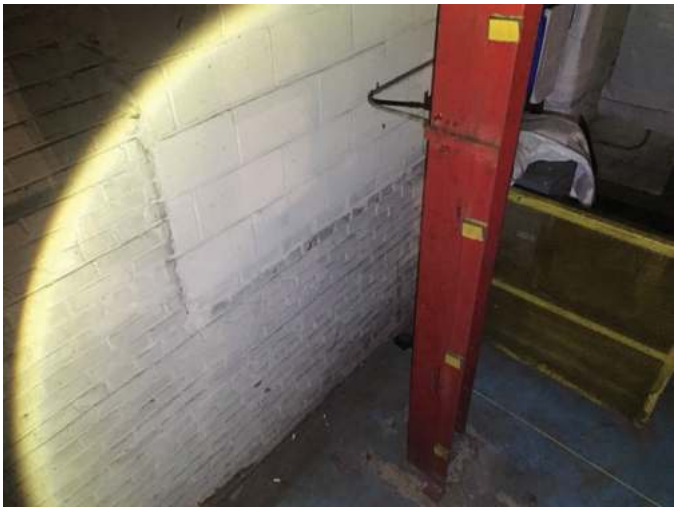
Inspection Number: G-005

Surface: Column
Cleaning Method: Degreaser + Power Wash + Hand Wipe
Barr: Sierra Samie Passed inspection on 2023-11-10
VTDEC: Dom Delello Passed inspection on 2023-11-14

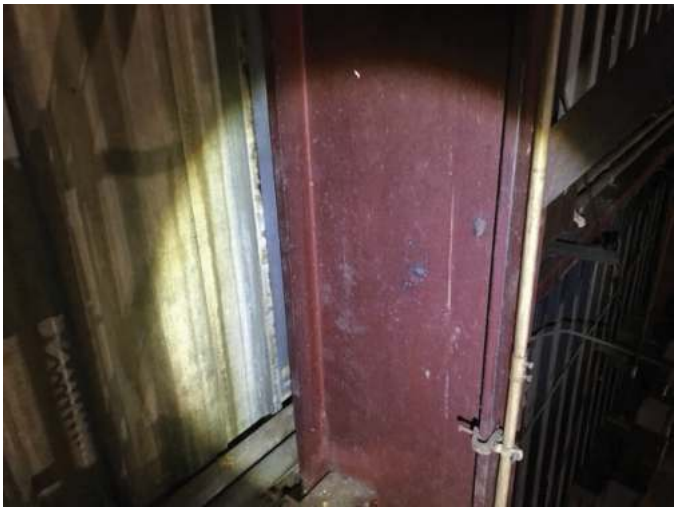
Inspection Number: G-027

Surface: Column
Cleaning Method: Degreaser + Power Wash
Barr: Joseph Lazarus Passed inspection on 2023-11-13
VTDEC: Dom Delello Failed inspection on 2023-11-14

Additional cleaning conducted after failed inspection

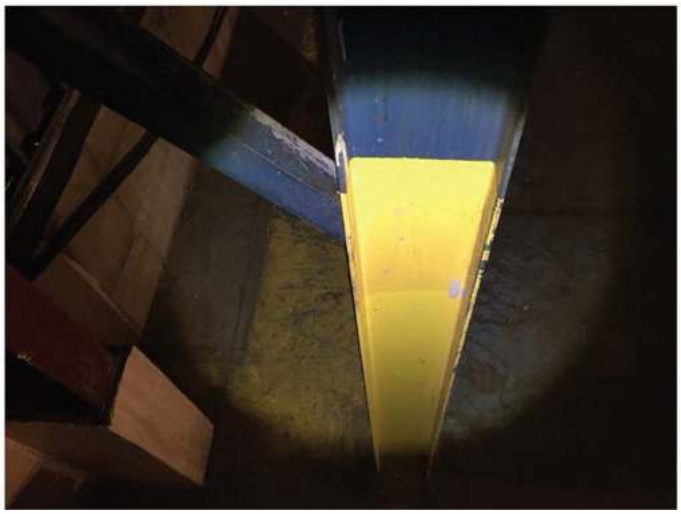
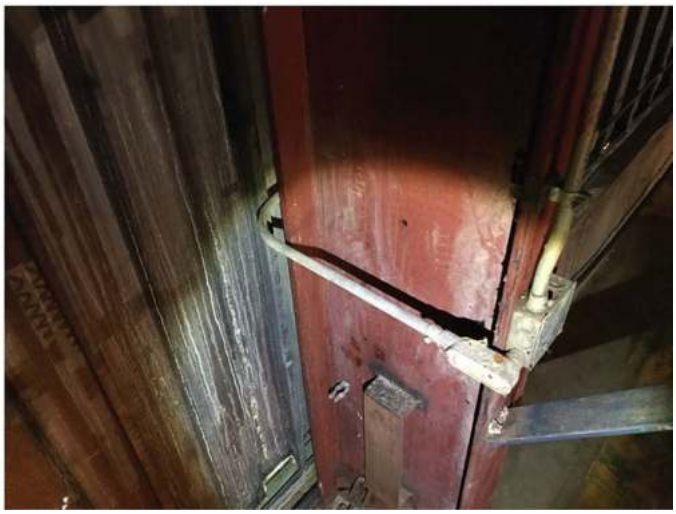
Inspection Number: G-027 (CONTINUED)

Surface: Column
Cleaning Method: Degreaser + Power Wash
Barr: Joseph Lazarus Passed inspection on 2023-11-15
VTDEC: Dom Delello Passed inspection on 2023-11-16

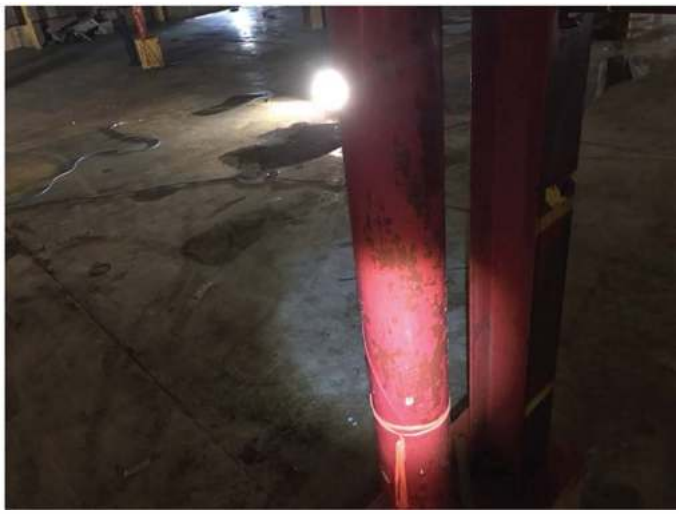
Inspection Number: G-028 (CONTINUED)

Surface: Column
Cleaning Method: Degreaser + Power Wash
Barr: Joseph Lazarus Passed inspection on 2023-11-15
VTDEC: Dom Delello Passed inspection on 2023-11-21

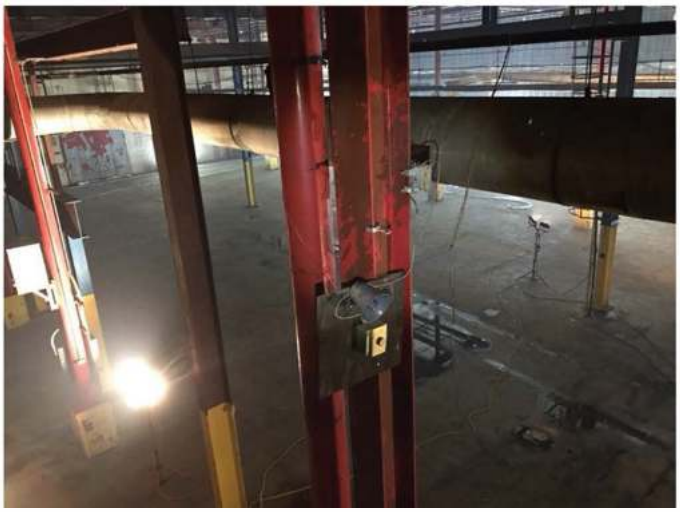
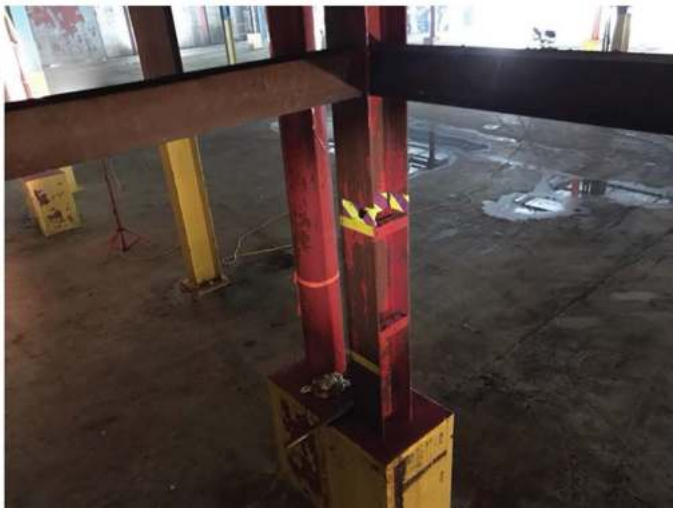
Inspection Number: G-029 (CONTINUED)

Surface: Column
Cleaning Method: Degreaser + Power Wash
Barr: Joseph Lazarus Passed inspection on 2023-11-15
VTDEC: Dom Delello Passed inspection on 2023-11-21

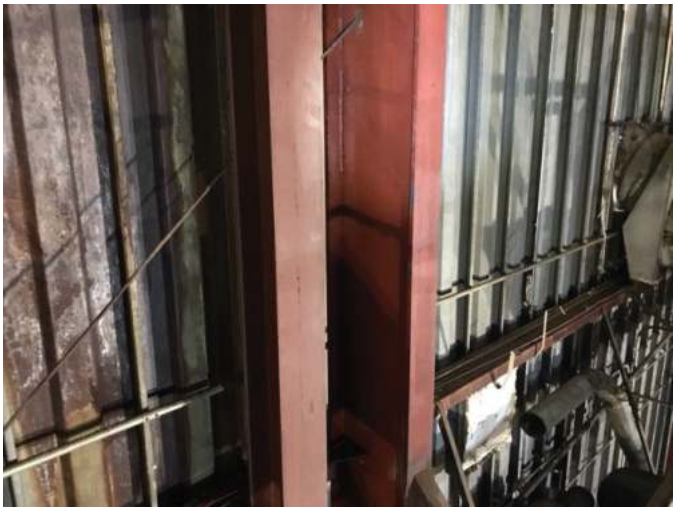
Inspection Number: G-030

Surface: Column
Cleaning Method: Degreaser + Power Wash
Barr: Joseph Lazarus Passed inspection on 2023-11-15
VTDEC: Dom Delello Passed inspection on 2023-11-21

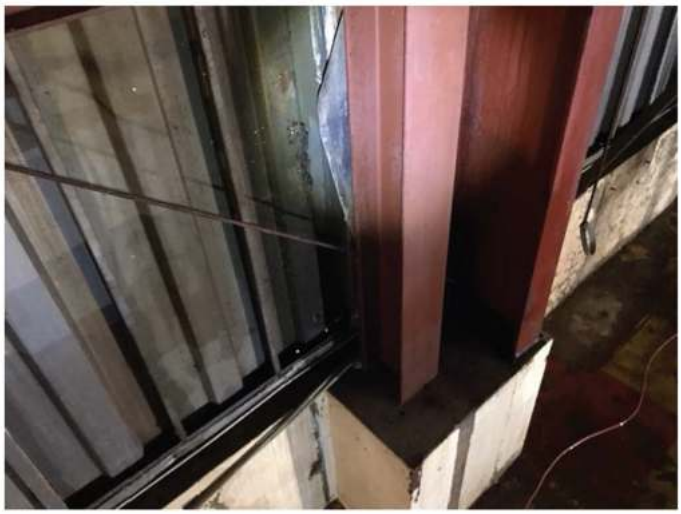
Inspection Number: G-031

Surface: Column
Cleaning Method: Degreaser + Power Wash
Barr: Joseph Lazarus Passed inspection on 2023-11-15
VTDEC: Dom Delello Passed inspection on 2023-11-21

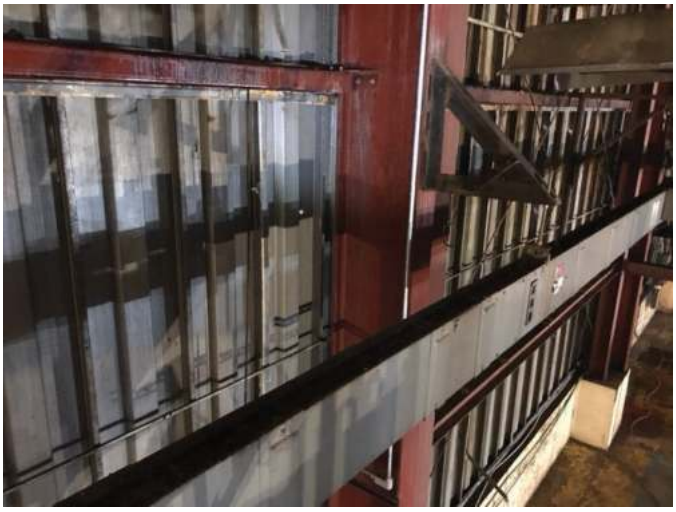
Inspection Number: G-032 (CONTINUED)

Surface: Column
Cleaning Method: Degreaser + Power Wash
Barr: Joseph Lazarus Passed inspection on 2023-11-15
VTDEC: Dom Delello Passed inspection on 2023-11-21

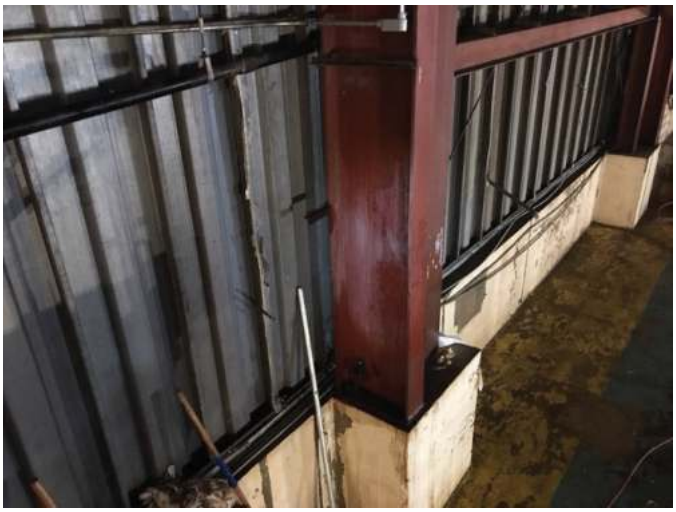
Inspection Number: G-033

Surface: Column
Cleaning Method: Degreaser + Power Wash
Barr: Joseph Lazarus Passed inspection on 2023-11-15
VTDEC: Dom Delello Passed inspection on 2023-11-21
