Corrective Action Construction Completion Report

Former Chemfab Facility
1030 Water Street
North Bennington, Vermont

SMS Site #20164630

February 29, 2024

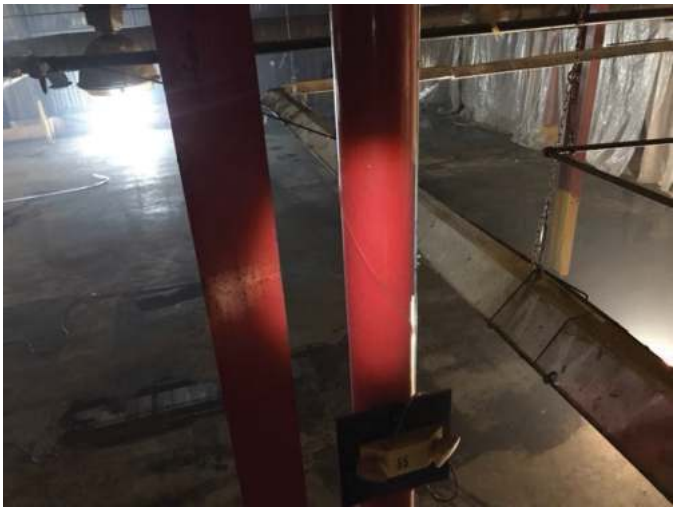
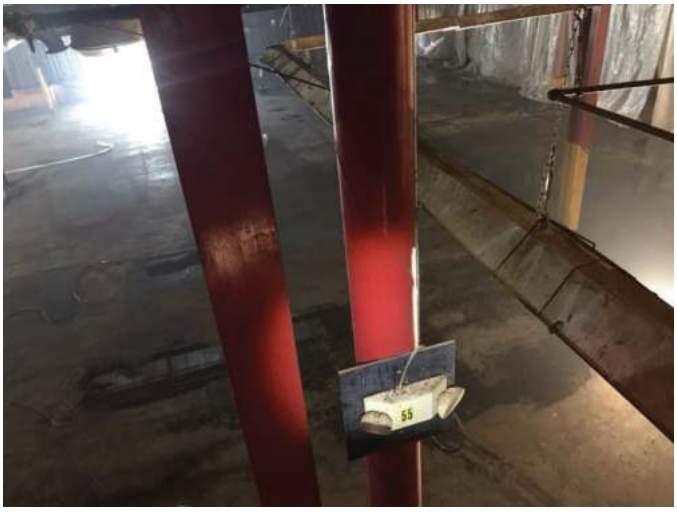
Inspection Number: G-034

Surface: Column
Cleaning Method: Degreaser + Power Wash
Barr: Joseph Lazarus Passed inspection on 2023-11-15
VTDEC: Dom Delello Passed inspection on 2023-11-21

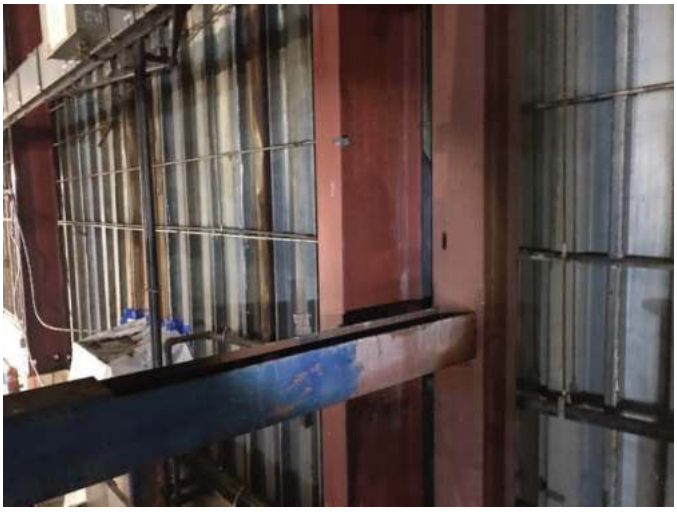
Inspection Number: G-038

Surface: Column
Cleaning Method: Degreaser + Power Wash
Barr: Joseph Lazarus Passed inspection on 2023-11-15
VTDEC: Dom Delello Passed inspection on 2023-11-21

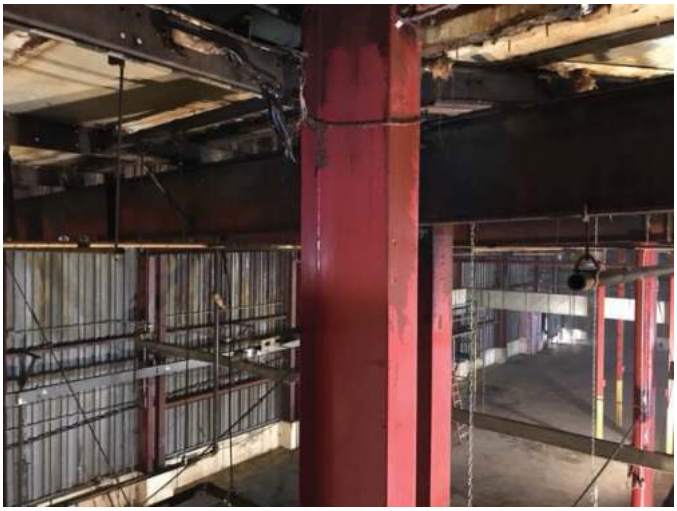
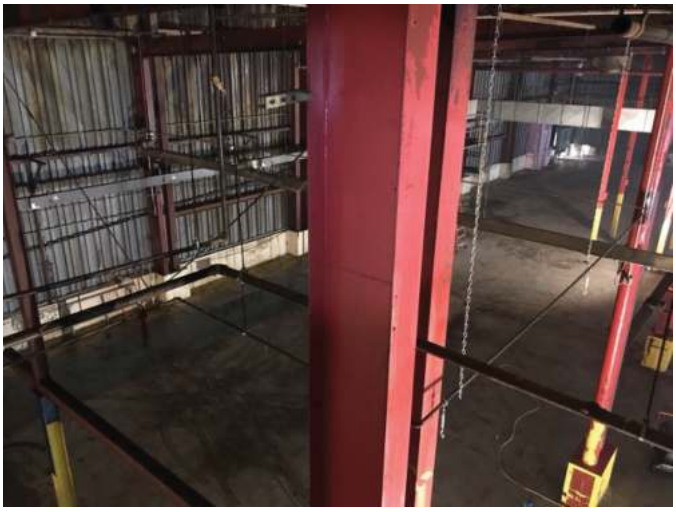
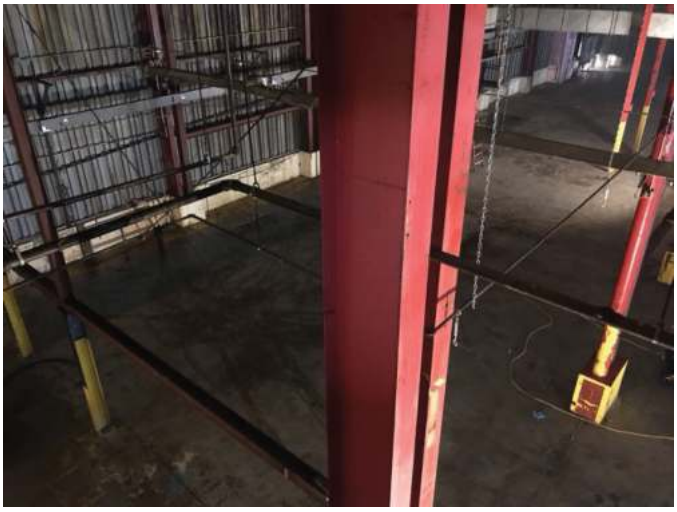
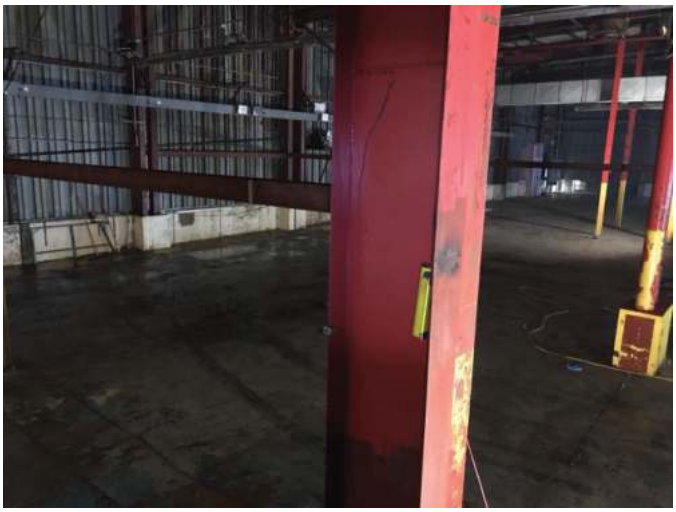
Inspection Number: G-041

Surface: Column
Cleaning Method: Degreaser + Power Wash
Barr: Joseph Lazarus Passed inspection on 2023-11-15
VTDEC: Dom Delello Passed inspection on 2023-11-21

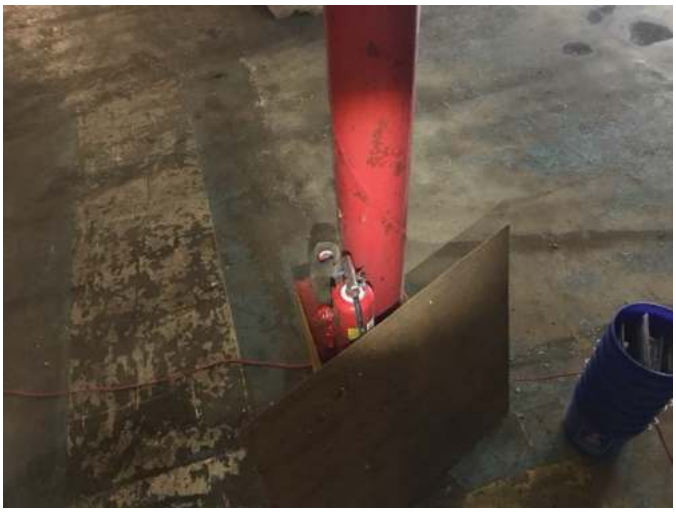
Inspection Number: G-043

Surface: Column
Cleaning Method: Degreaser + Power Wash
Barr: Joseph Lazarus Passed inspection on 2023-11-15
VTDEC: Dom Delello Passed inspection on 2023-11-21

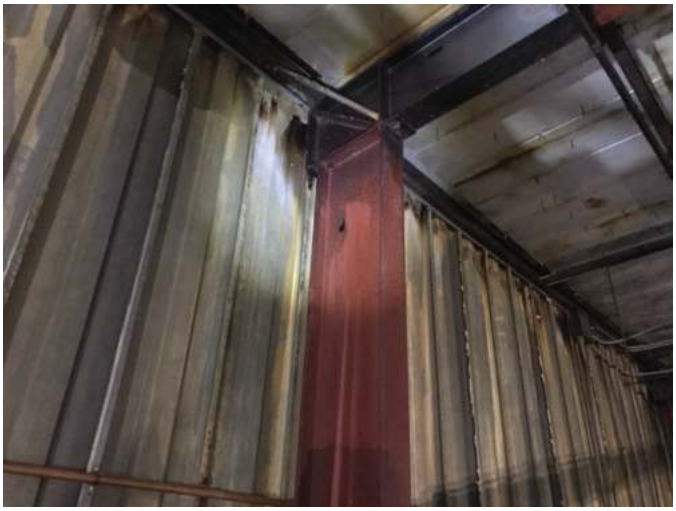
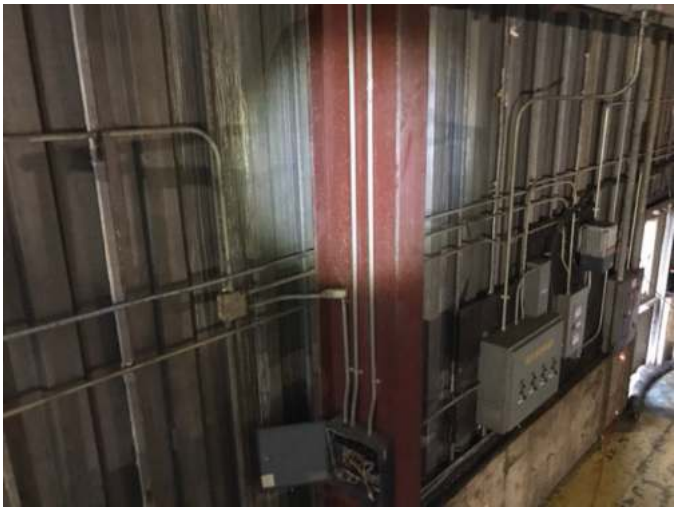
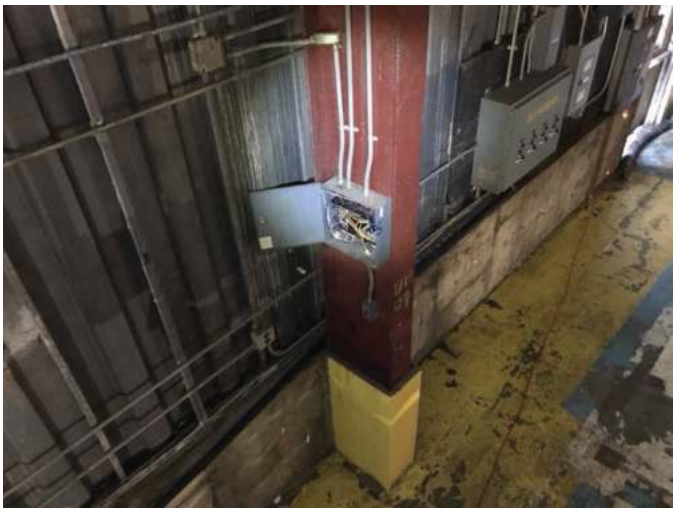
Inspection Number: G-044

Surface: Column
Cleaning Method: Degreaser + Power Wash
Barr: Joseph Lazarus Passed inspection on 2023-11-15
VTDEC: Dom Delello Passed inspection on 2023-11-21

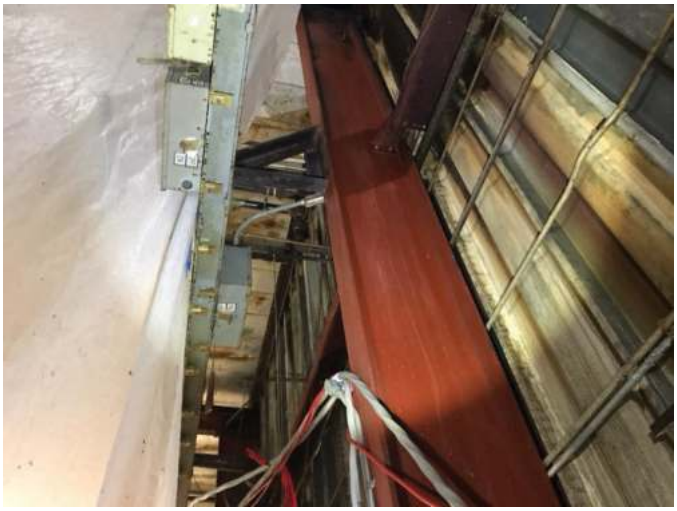
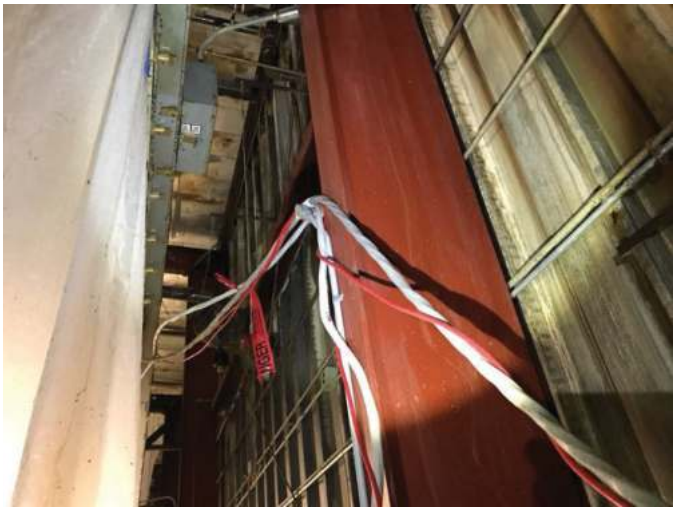
Inspection Number: G-045

Surface: Column
Cleaning Method: Degreaser + Power Wash
Barr: Joseph Lazarus Passed inspection on 2023-11-27
VTDEC: Dom Delello Passed inspection on 2024-02-13

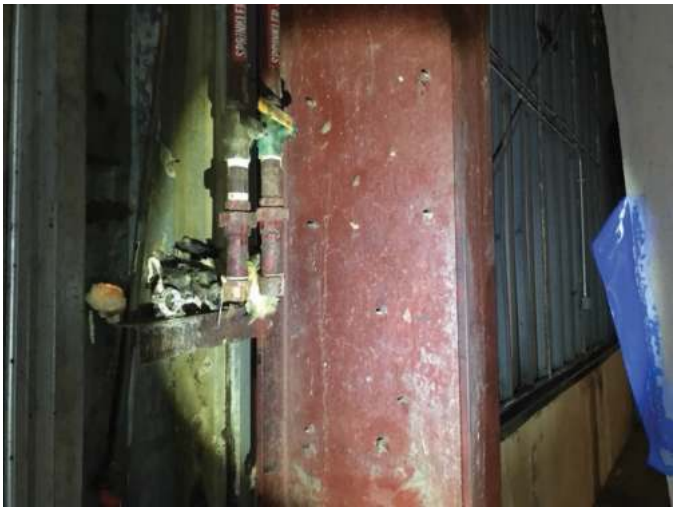
Inspection Number: G-048

Surface: Column
Cleaning Method: Degreaser + Power Wash
Barr: Joseph Lazarus Passed inspection on 2023-11-27
VTDEC: Dom Delello Passed inspection on 2024-02-13

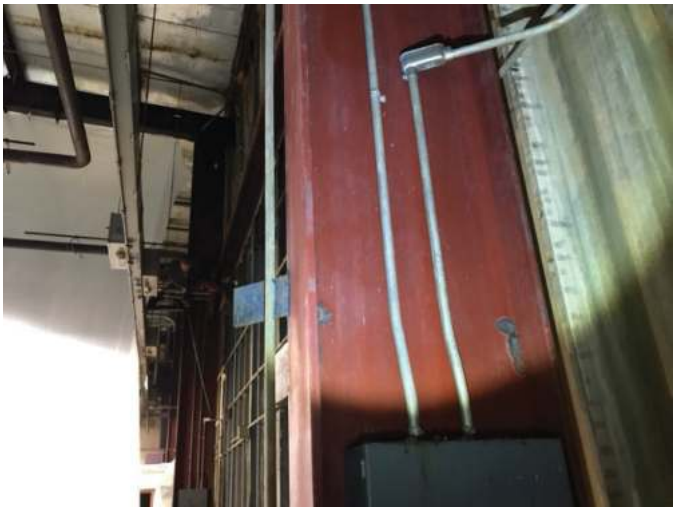
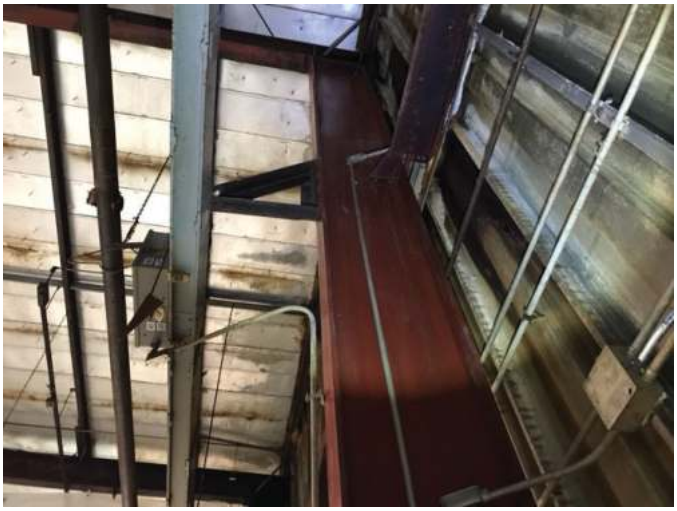
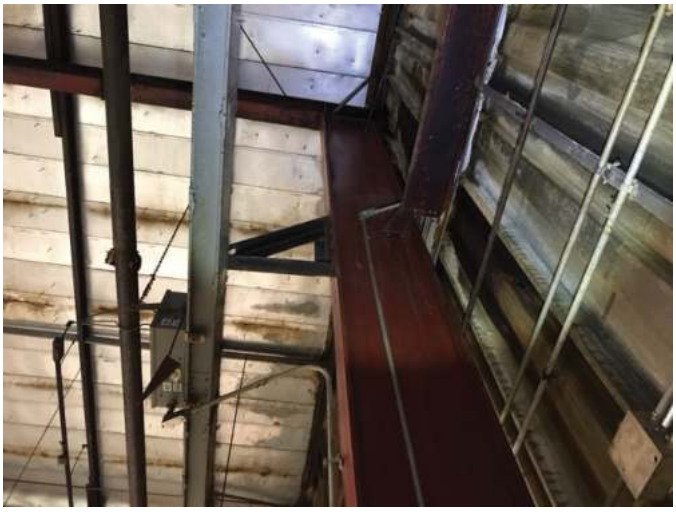
Inspection Number: G-050

Surface: Column
Cleaning Method: Degreaser + Power Wash
Barr: Joseph Lazarus Passed inspection on 2023-11-27
VTDEC: Dom Delello Passed inspection on 2023-12-07

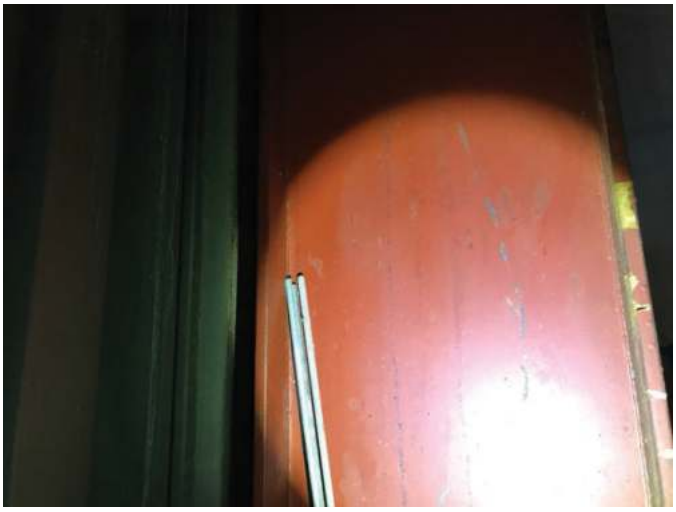
Inspection Number: G-053

Surface: Column
Cleaning Method: Degreaser + Power Wash
Barr: Joseph Lazarus Passed inspection on 2023-11-27
VTDEC: Dom Delello Passed inspection on 2023-12-07

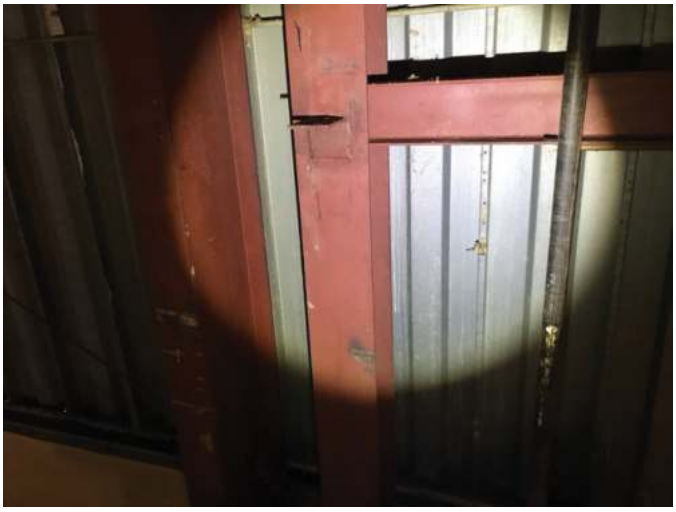
Inspection Number: G-055

Surface: Column
Cleaning Method: Degreaser + Power Wash
Barr: Joseph Lazarus Passed inspection on 2023-11-27
VTDEC: Dom Delello Passed inspection on 2023-12-07

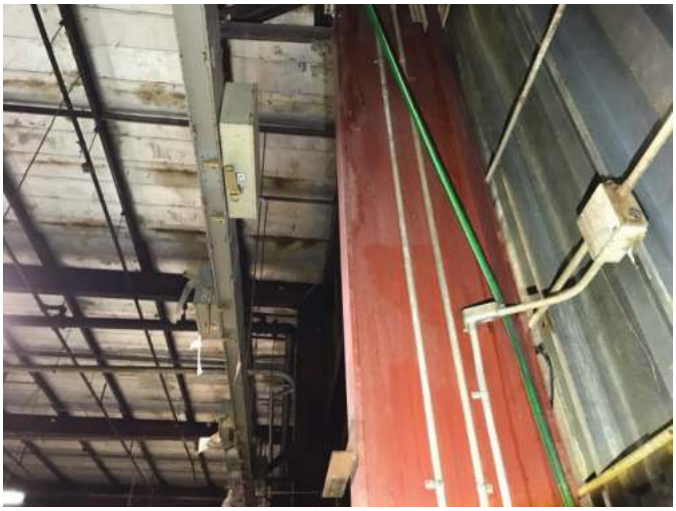
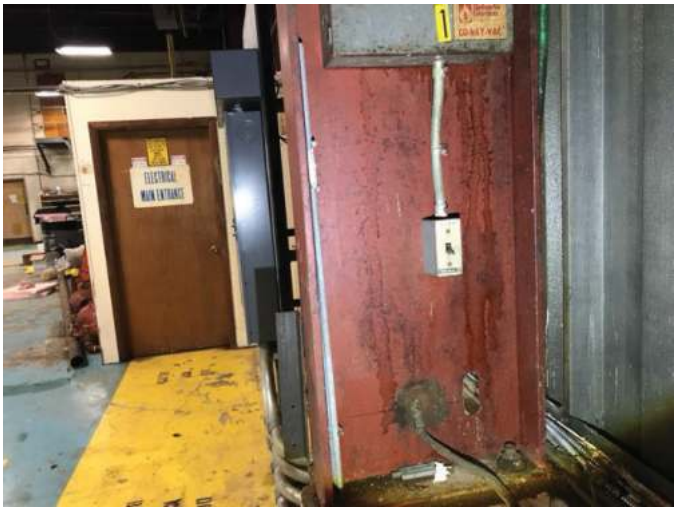
Inspection Number: G-056

Surface: Column
Cleaning Method: Degreaser + Power Wash
Barr: Joseph Lazarus Passed inspection on 2023-11-28
VTDEC: Dom Delello Passed inspection on 2023-12-07

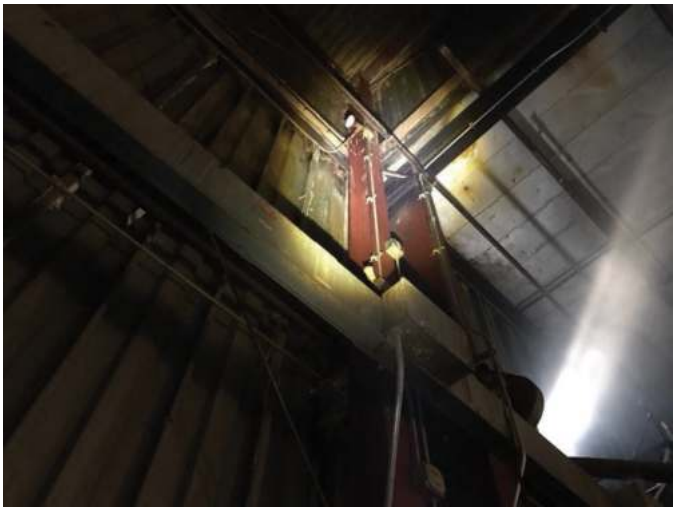
Inspection Number: G-059

Surface: Column
Cleaning Method: Degreaser + Power Wash
Barr: Joseph Lazarus Passed inspection on 2023-11-28
VTDEC: Dom Delello Passed inspection on 2023-12-07

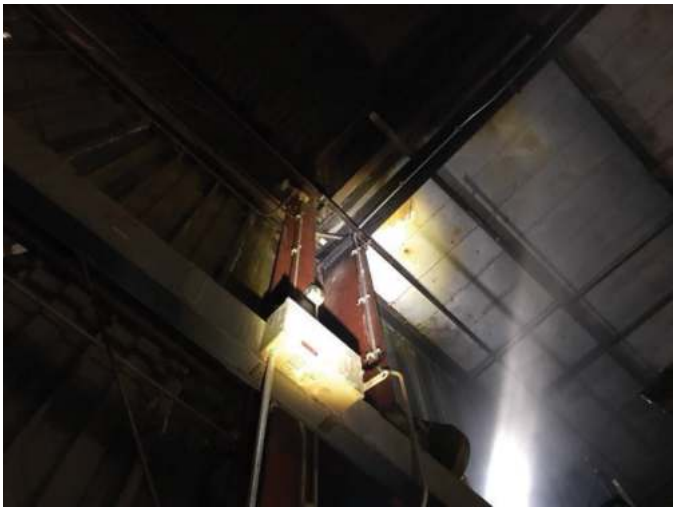
Inspection Number: G-061

Surface: Column
Cleaning Method: Degreaser + Power Wash
Barr: Joseph Lazarus Passed inspection on 2023-11-28
VTDEC: Dom Delello Passed inspection on 2023-12-07

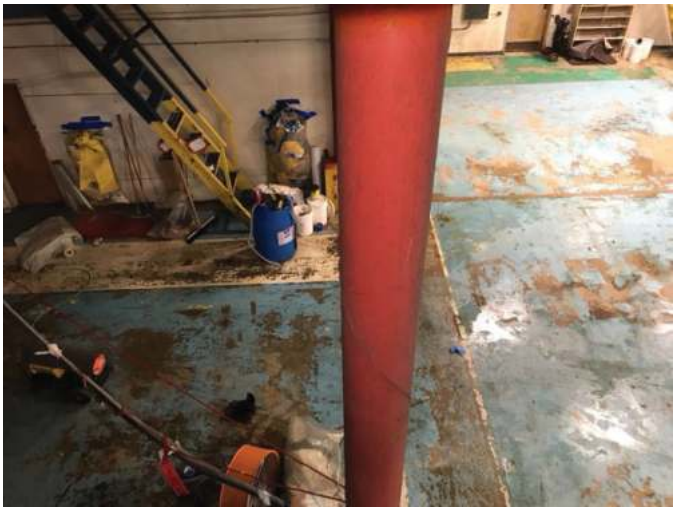
Inspection Number: G-062

Surface: Column
Cleaning Method: Degreaser + Power Wash
Barr: Joseph Lazarus Passed inspection on 2023-11-29
VTDEC: Dom Delello Passed inspection on 2023-12-07

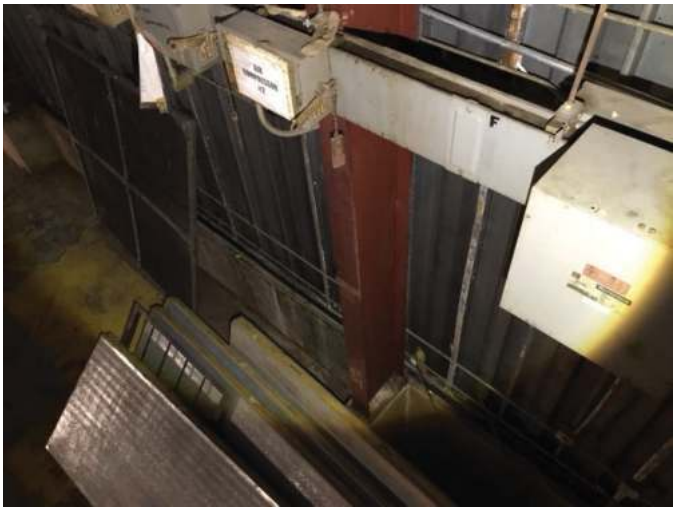
Inspection Number: G-064

Surface: Column
Cleaning Method: Degreaser + Power Wash
Barr: Joseph Lazarus Passed inspection on 2023-11-29
VTDEC: Dom Delello Passed inspection on 2023-12-07

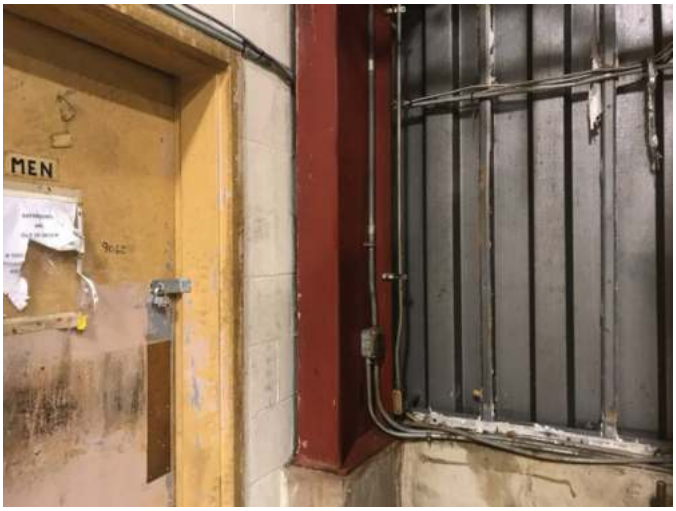
Inspection Number: G-069

Surface: Column
Cleaning Method: Degreaser + Power Wash
Barr: Joseph Lazarus Passed inspection on 2023-12-01
VTDEC: Dom Delello Passed inspection on 2023-12-07

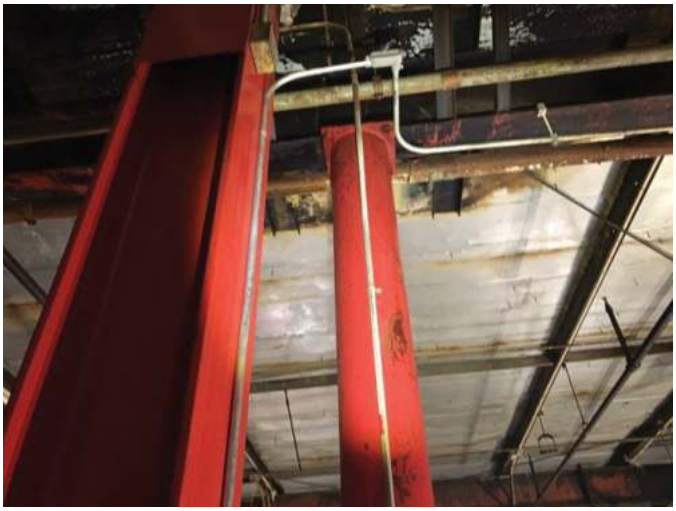
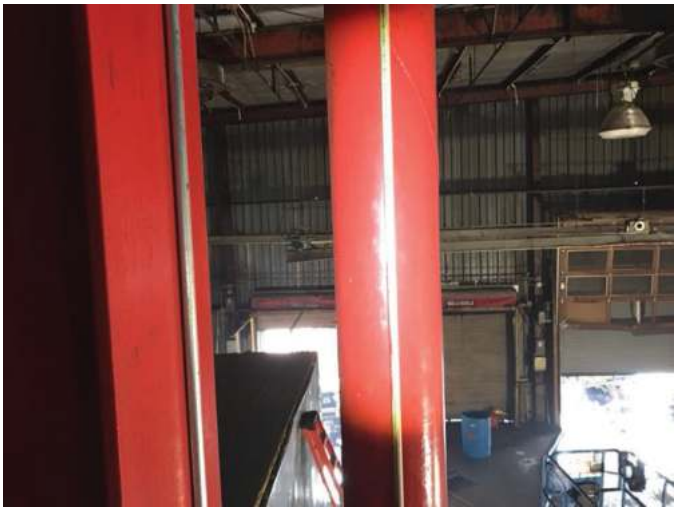
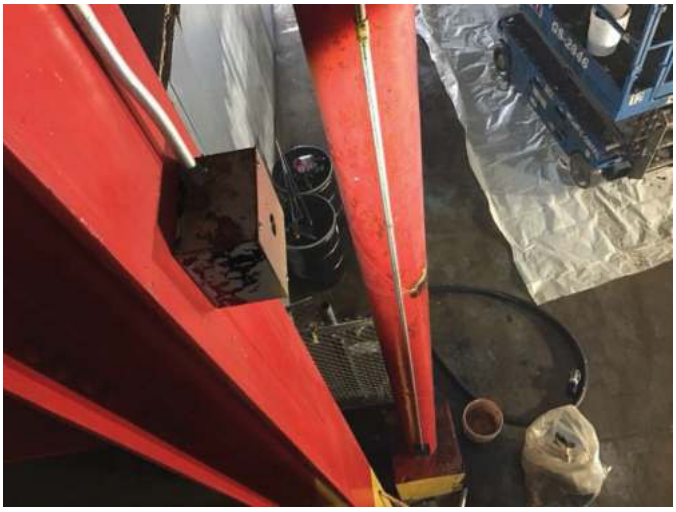
Inspection Number: G-072

Surface: Column
Cleaning Method: Degreaser + Power Wash
Barr: Joseph Lazarus Passed inspection on 2023-12-01
VTDEC: Dom Delello Passed inspection on 2023-12-07

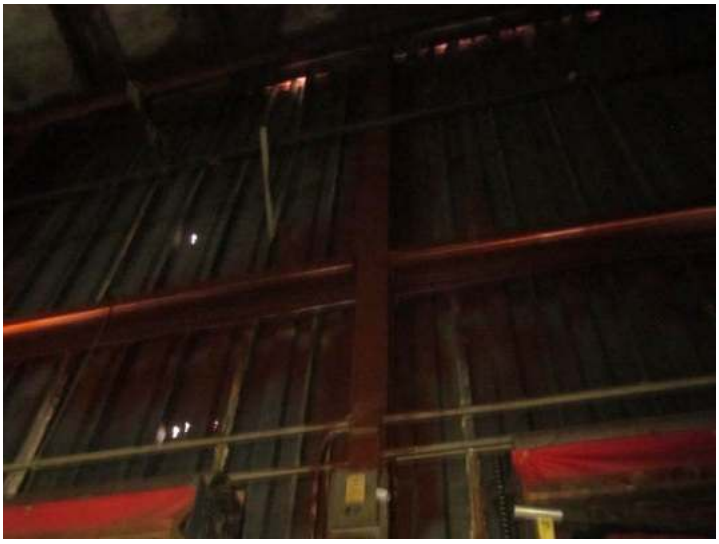
Inspection Number: G-074

Surface: Column
Cleaning Method: Degreaser + Power Wash
Barr: Joseph Lazarus Passed inspection on 2023-12-01
VTDEC: Dom Delello Passed inspection on 2023-12-07

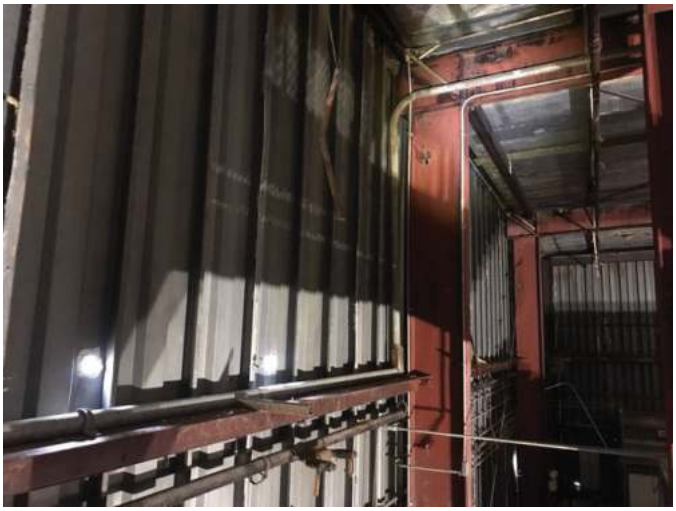
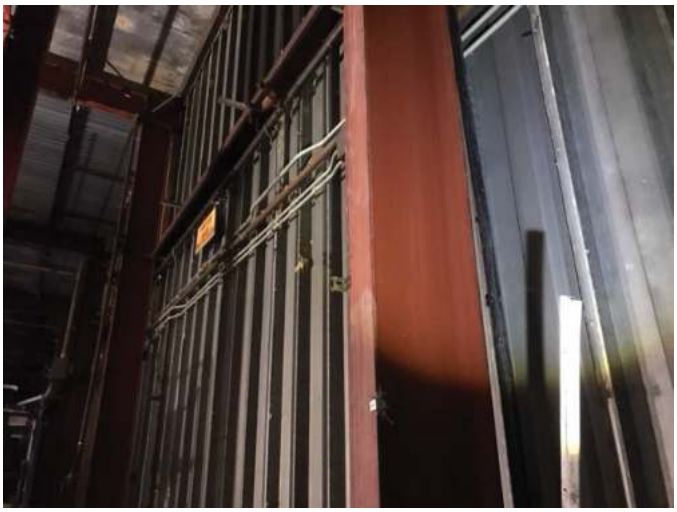
Inspection Number: G-076

Surface: Column
Cleaning Method: Degreaser + Power Wash
Barr: Sierra Samie Passed inspection on 2023-12-07
VTDEC: Dom Delello Passed inspection on 2023-12-07

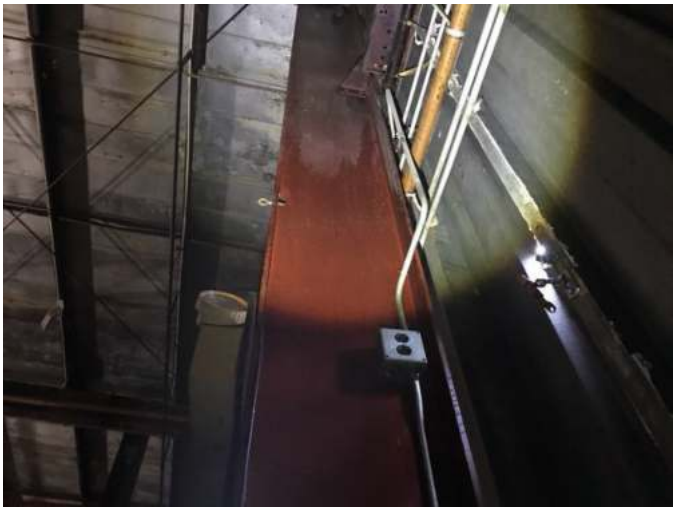
Inspection Number: G-077

Surface: Column
Cleaning Method: Degreaser + Power Wash
Barr: Joseph Lazarus Passed inspection on 2023-12-01
VTDEC: Dom Delello Passed inspection on 2023-12-07

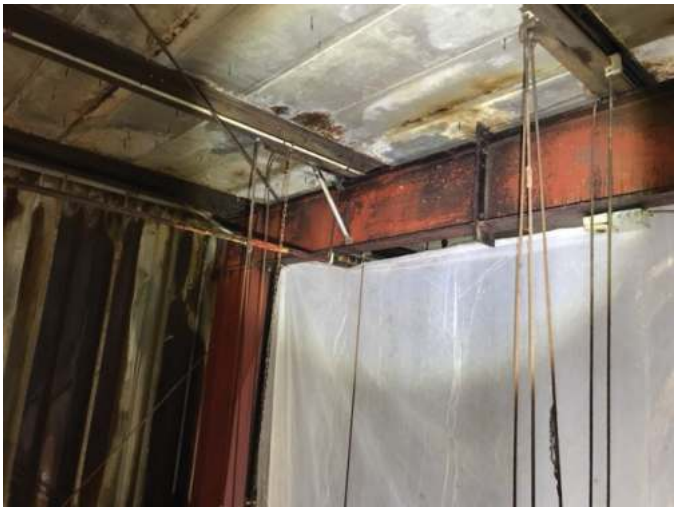
Inspection Number: G-078

Surface: Column
Cleaning Method: Degreaser + Power Wash
Barr: Sierra Samie Passed inspection on 2023-12-07
VTDEC: Dom Delello Passed inspection on 2023-12-07

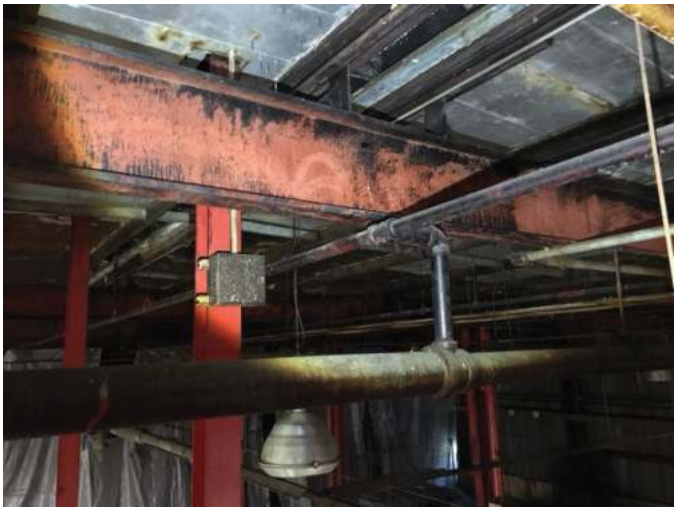
Inspection Number: H-013

Surface: Beam
Cleaning Method: Degreaser + Power Wash
Barr: Joseph Lazarus Passed inspection on 2023-12-01
VTDEC: Dom Delello Passed inspection on 2023-12-07

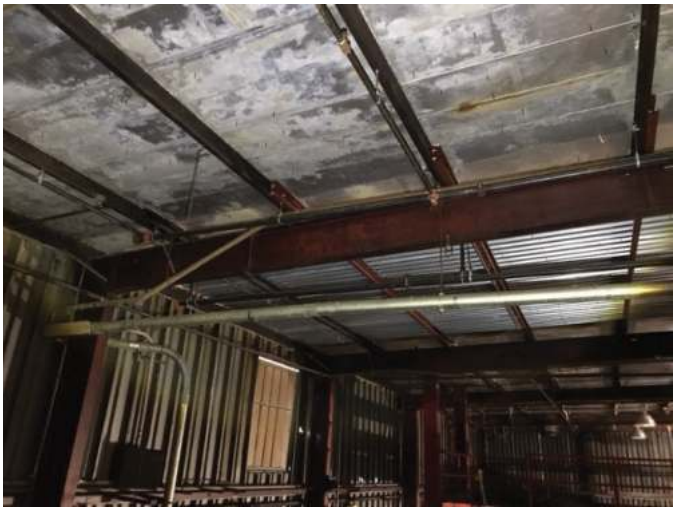
Inspection Number: H-015

Surface: Beam
Cleaning Method: Degreaser + Power Wash
Barr: Joseph Lazarus Passed inspection on 2023-12-01
VTDEC: Dom Delello Passed inspection on 2023-12-07

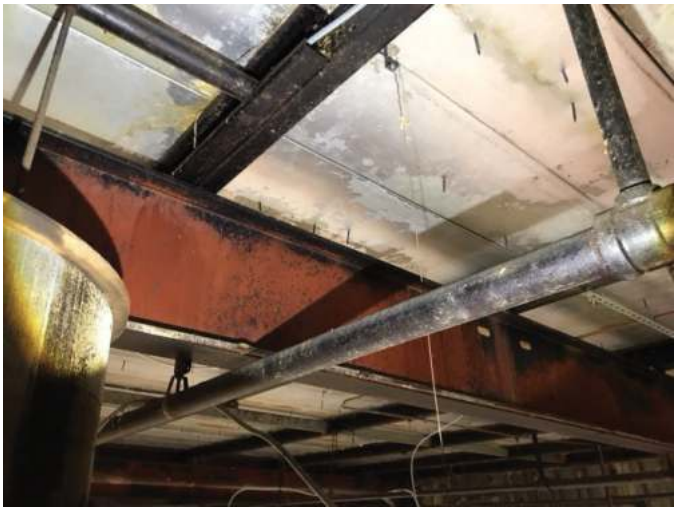
Inspection Number: H-016

Surface: Beam
Cleaning Method: Degreaser + Power Wash
Barr: Joseph Lazarus Passed inspection on 2023-12-01
VTDEC: Dom Delello Passed inspection on 2023-12-07

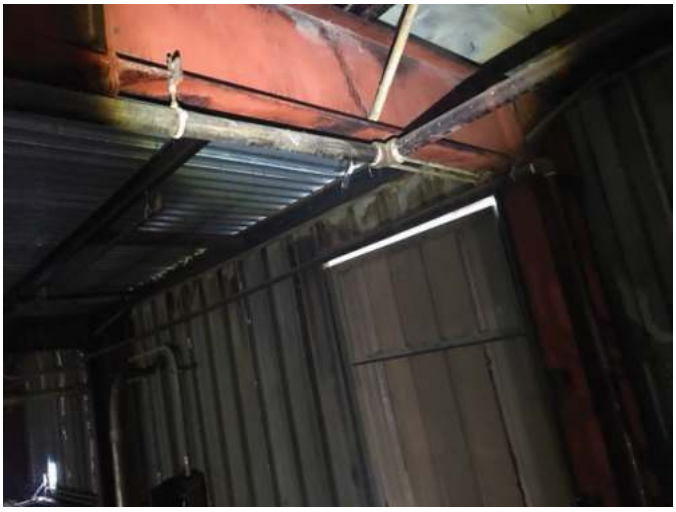
Inspection Number: H-017

Surface: Beam
Cleaning Method: Degreaser + Power Wash
Barr: Joseph Lazarus Passed inspection on 2023-12-01
VTDEC: Dom Delello Passed inspection on 2023-12-07

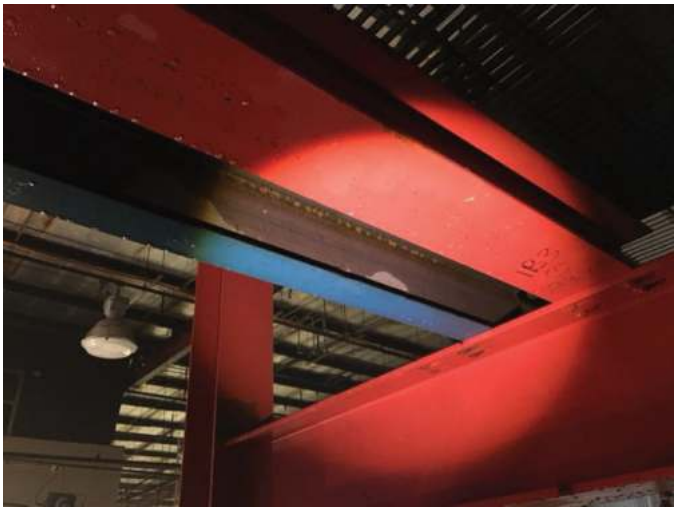
Inspection Number: H-020

Surface: Beam
Cleaning Method: Degreaser + Power Wash
Barr: Sierra Samie Passed inspection on 2023-12-07
VTDEC: Dom Delello Passed inspection on 2023-12-07

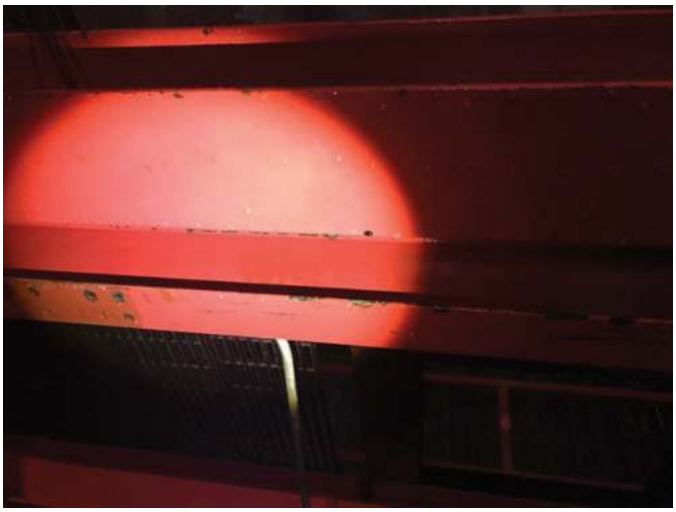
Inspection Number: H-023

Surface: Beam
Cleaning Method: Degreaser + Power Wash
Barr: Joseph Lazarus Passed inspection on 2023-12-01
VTDEC: Dom Delello Passed inspection on 2023-12-07

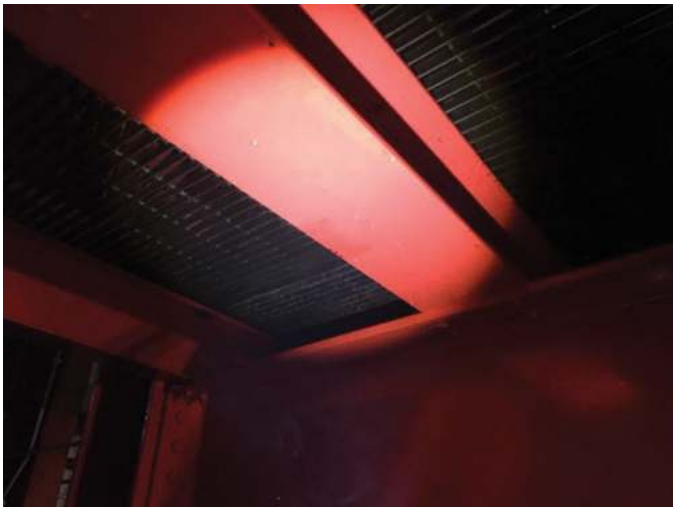
Inspection Number: H-025

Surface: Beam
Cleaning Method: Degreaser + Power Wash
Barr: Joseph Lazarus Passed inspection on 2023-12-01
VTDEC: Dom Delello Passed inspection on 2023-12-07

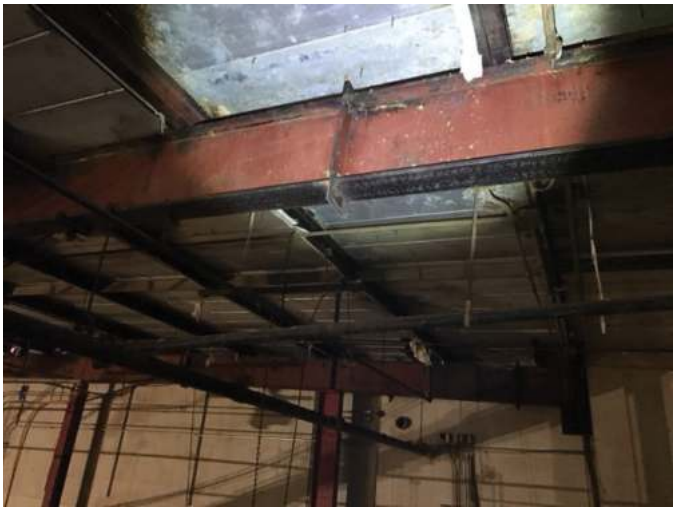
Inspection Number: I-006

Surface: Beam
Cleaning Method: Degreaser + Power Wash
Barr: Joseph Lazarus Passed inspection on 2023-11-06
VTDEC: Dom Delello Passed inspection on 2023-11-08

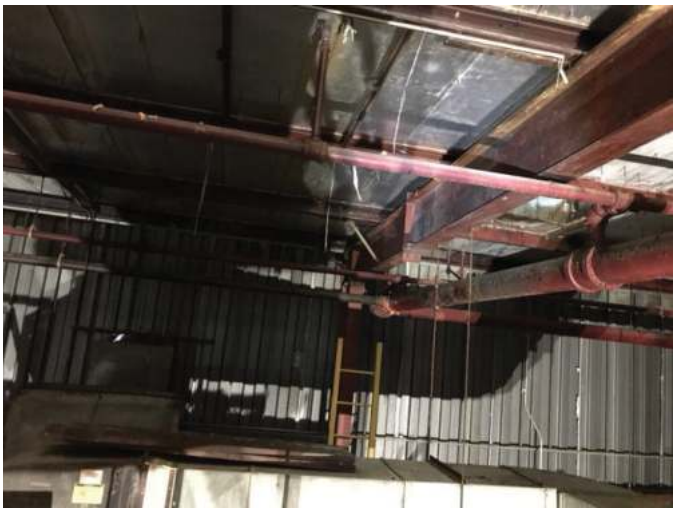
Inspection Number: I-008

Surface: Beam
Cleaning Method: Degreaser + Power Wash
Barr: Joseph Lazarus Passed inspection on 2023-11-14
VTDEC: Dom Delello Passed inspection on 2023-11-14

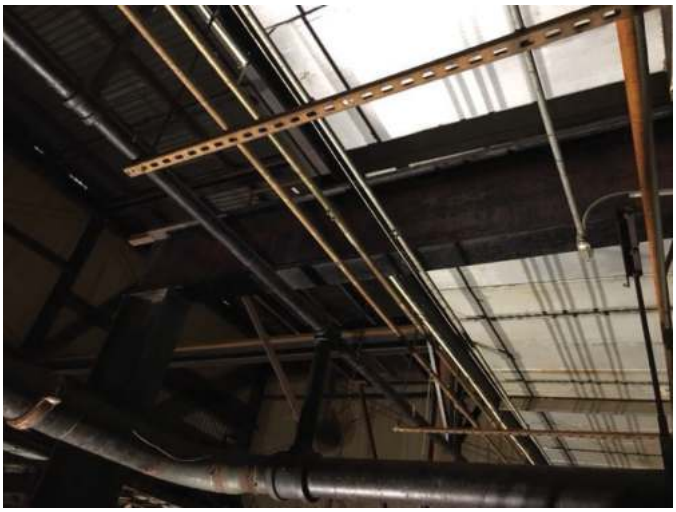
Inspection Number: I-010

Surface: Beam
Cleaning Method: Degreaser + Power Wash
Barr: Joseph Lazarus Passed inspection on 2023-11-14
VTDEC: Dom Delello Passed inspection on 2023-11-14

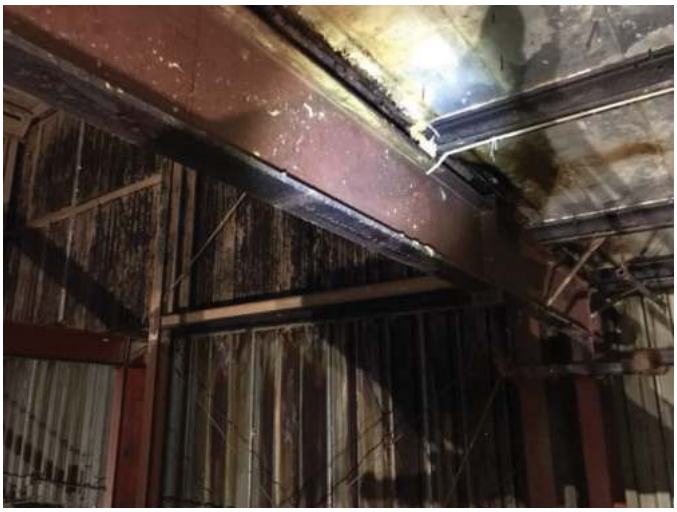
Inspection Number: I-011

Surface: Beam
Cleaning Method: Degreaser + Power Wash
Barr: Joseph Lazarus Passed inspection on 2023-11-15
VTDEC: Dom Delello Passed inspection on 2023-11-21

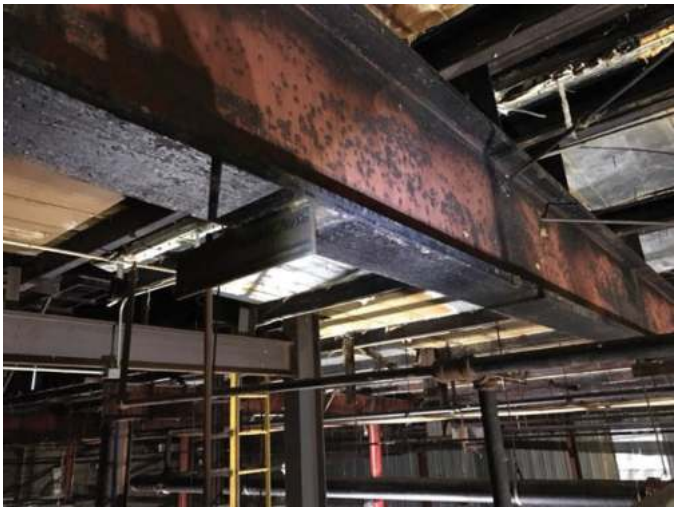
Inspection Number: I-012

Surface: Beam
Cleaning Method: Degreaser + Power Wash
Barr: Joseph Lazarus Passed inspection on 2023-11-15
VTDEC: Dom Delello Passed inspection on 2023-11-21

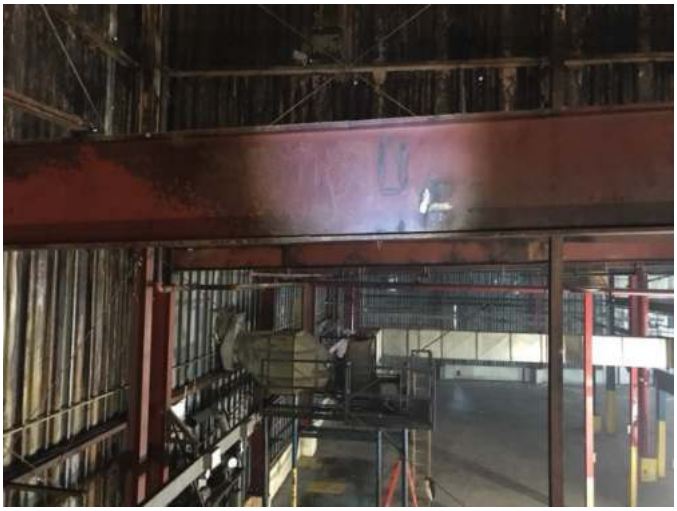
Inspection Number: I-013

Surface: Beam
Cleaning Method: Degreaser + Power Wash
Barr: Joseph Lazarus Passed inspection on 2023-11-15
VTDEC: Dom Delello Passed inspection on 2023-11-21

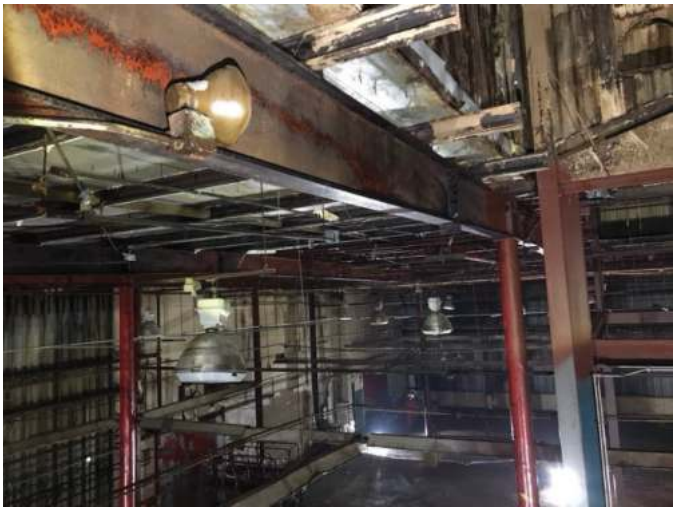
Inspection Number: I-019

Surface: Beam
Cleaning Method: Degreaser + Power Wash
Barr: Joseph Lazarus Passed inspection on 2023-11-15
VTDEC: Dom Delello Passed inspection on 2023-11-21

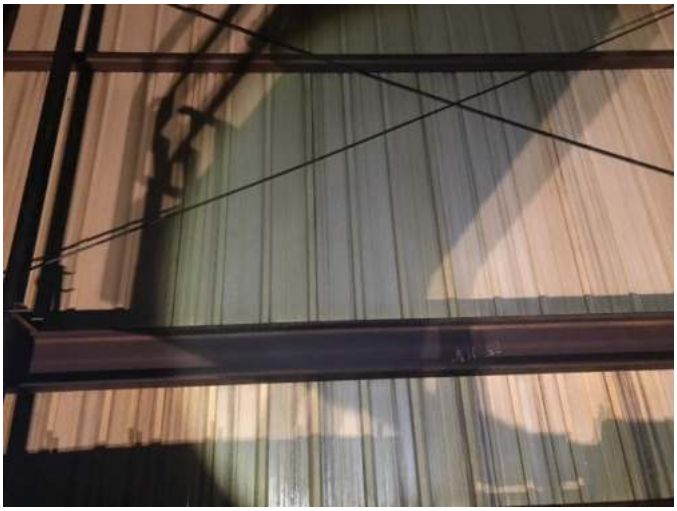
Inspection Number: J-005

Surface: Metal Wall
Cleaning Method: Degreaser + Power Wash
Barr: Sierra Samie Passed inspection on 2023-11-09
VTDEC: Dom Delello Passed inspection on 2023-11-14

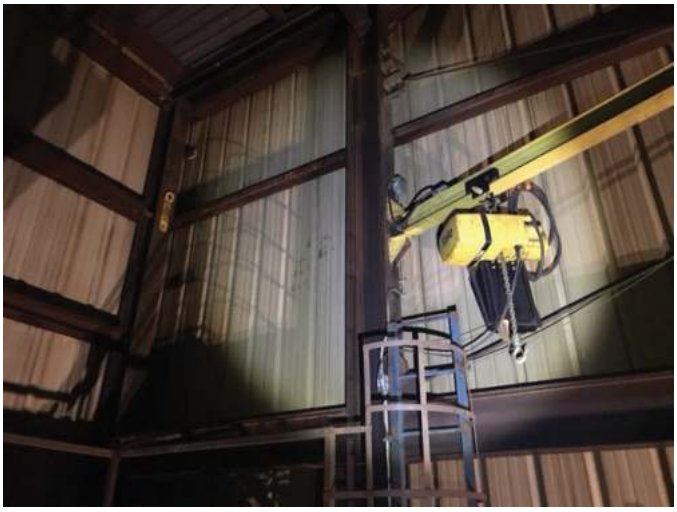
Inspection Number: J-008

Surface: Column
Cleaning Method: Degreaser + Power Wash
Barr: Sierra Samie Passed inspection on 2023-11-09
VTDEC: Dom Delello Passed inspection on 2023-11-14

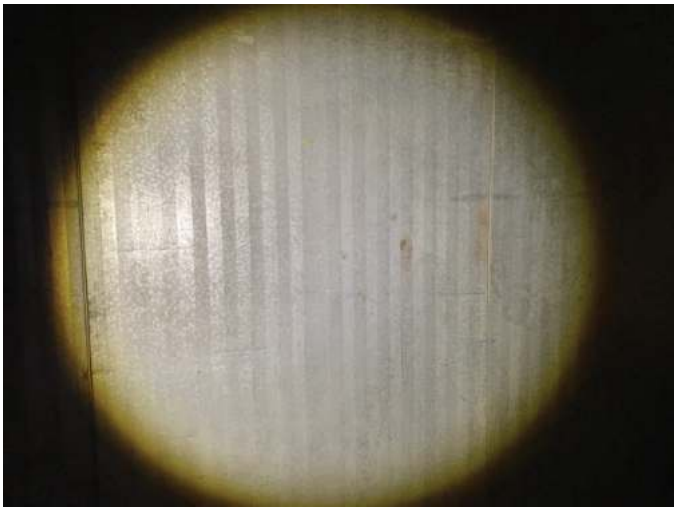
Inspection Number: L-002

Surface: Exterior of commercial refrigerator
Cleaning Method: Degreaser + Power Wash
Barr: Sierra Samie Passed inspection on 2023-12-05
VTDEC: Dom Delello Passed inspection on 2023-12-07

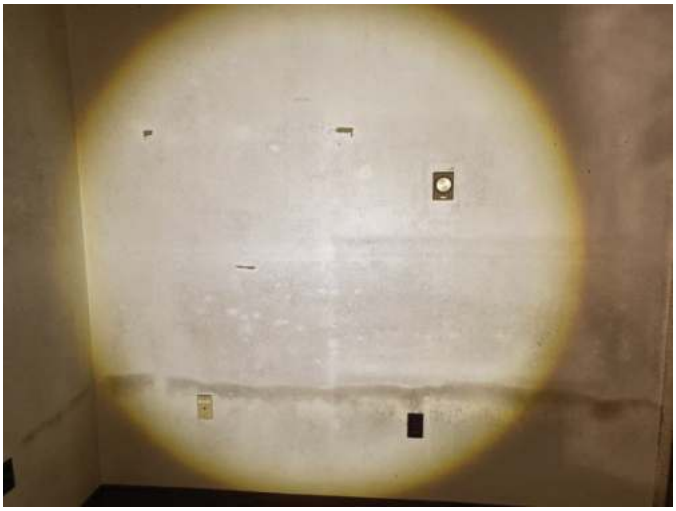
Inspection Number: M-003

Surface: Sheetrock Wall
Cleaning Method: Hand Wipe
Barr: Sierra Samie Passed inspection on 2023-12-06
VTDEC: Dom Delello Passed inspection on 2023-12-08

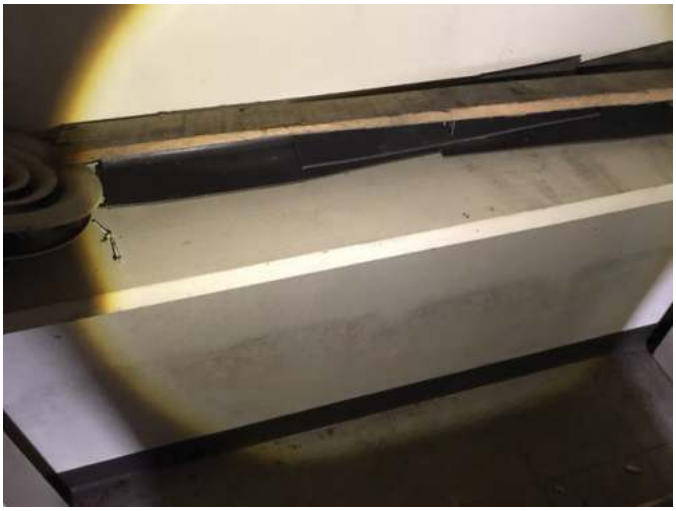
Inspection Number: M-007

Surface: Concrete Floor
Cleaning Method: Carpet Removal
Barr: Sierra Samie Passed inspection on 2023-12-06
VTDEC: Dom Delello Passed inspection on 2023-12-08

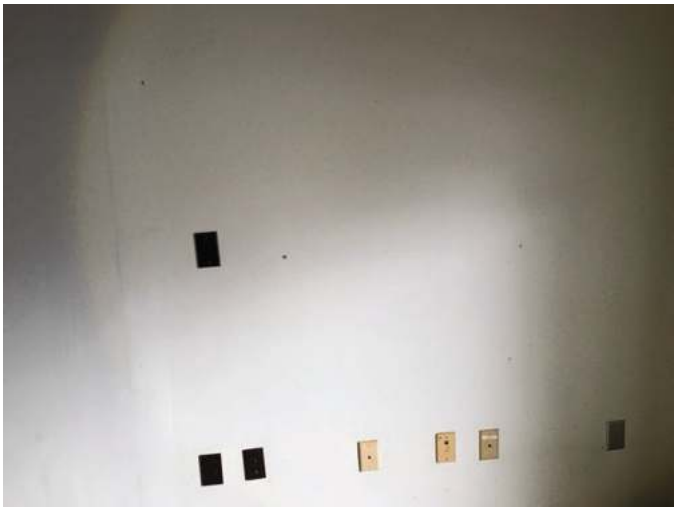
Inspection Number: M-009

Surface: Sheetrock Wall
Cleaning Method: Hand Wipe
Barr: Sierra Samie Passed inspection on 2023-12-06
VTDEC: Dom Delello Passed inspection on 2023-12-08

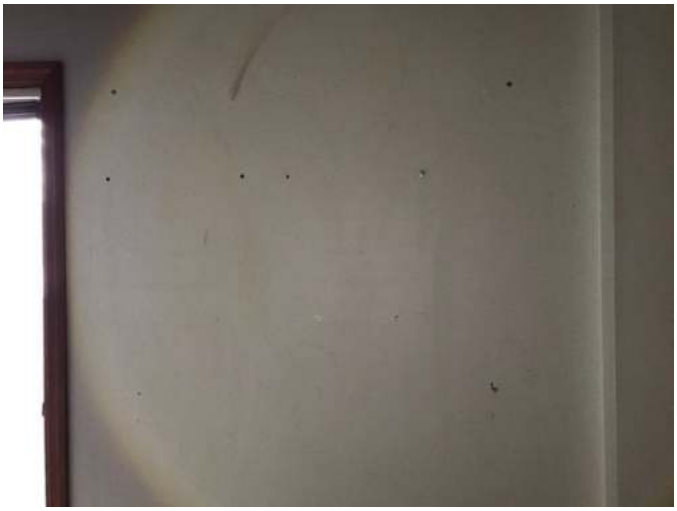
Inspection Number: M-010

Surface: Sheetrock Wall
Cleaning Method: Hand Wipe
Barr: Sierra Samie Passed inspection on 2023-12-06
VTDEC: Dom Delello Passed inspection on 2023-12-08

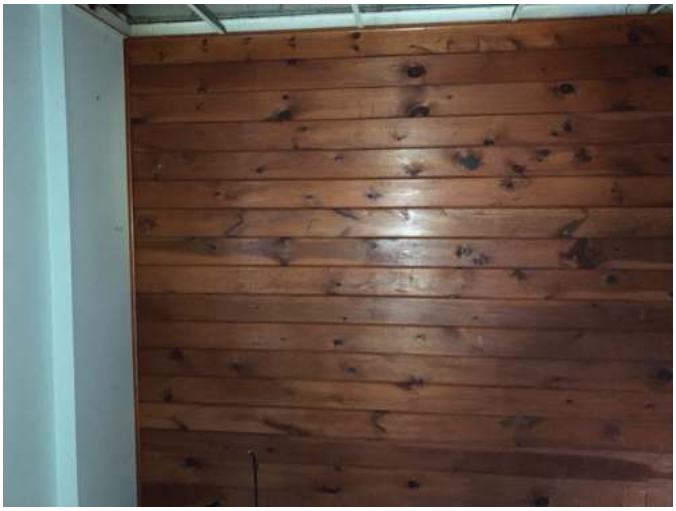
Inspection Number: M-011

Surface: Wood
Cleaning Method: Hand Wipe
Barr: Sierra Samie Passed inspection on 2023-12-06
VTDEC: Dom Delello Passed inspection on 2023-12-08

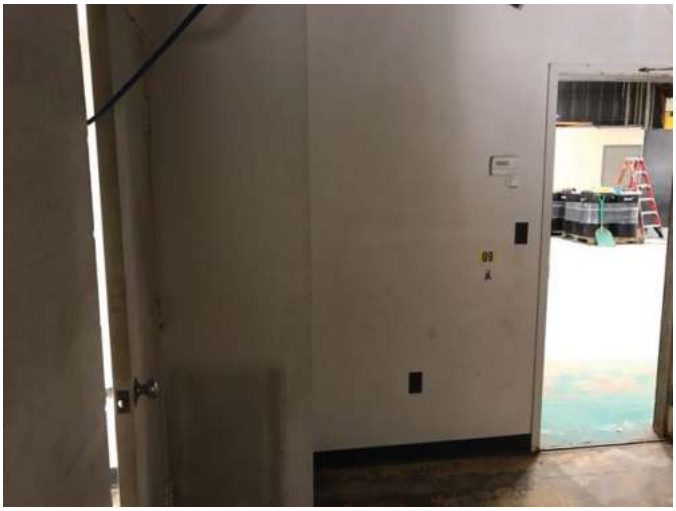
Inspection Number: M-022

Surface: Brick Wall
Cleaning Method: Hand Wipe
Barr: Sierra Samie Passed inspection on 2023-12-08
VTDEC: Dom Delello Passed inspection on 2023-12-08

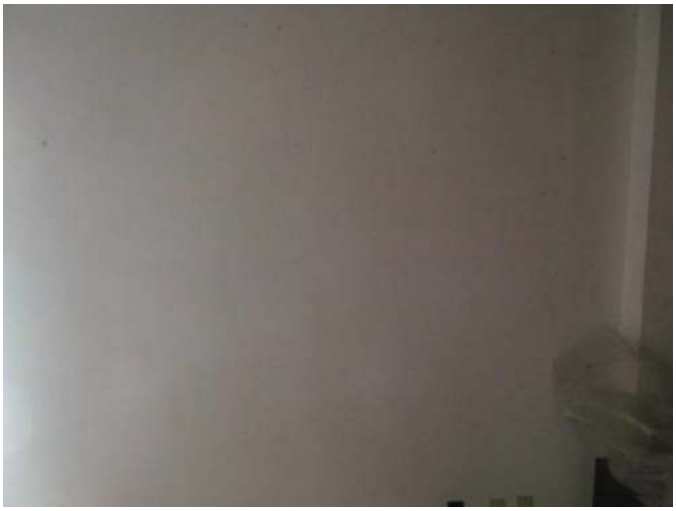
Inspection Number: M-032

Surface: Sheetrock Wall
Cleaning Method: Hand Wipe
Barr: Sierra Samie Passed inspection on 2024-01-24
VTDEC: Dom Delello Passed inspection on 2024-02-13

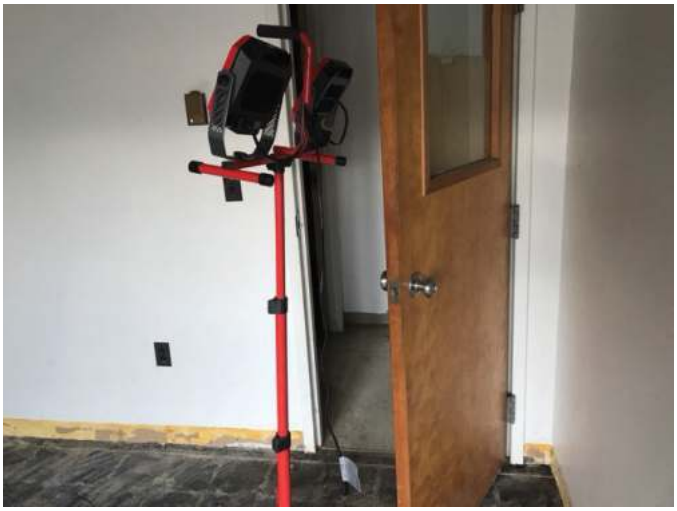
Inspection Number: N-001

Surface: Concrete Floor
Cleaning Method: Carpet Removal
Barr: Sierra Samie Passed inspection on 2023-12-08
VTDEC: Dom Delello Passed inspection on 2023-12-08
