Corrective Action Construction Completion Report

Former Chemfab Facility
1030 Water Street
North Bennington, Vermont

SMS Site #20164630

February 29, 2024

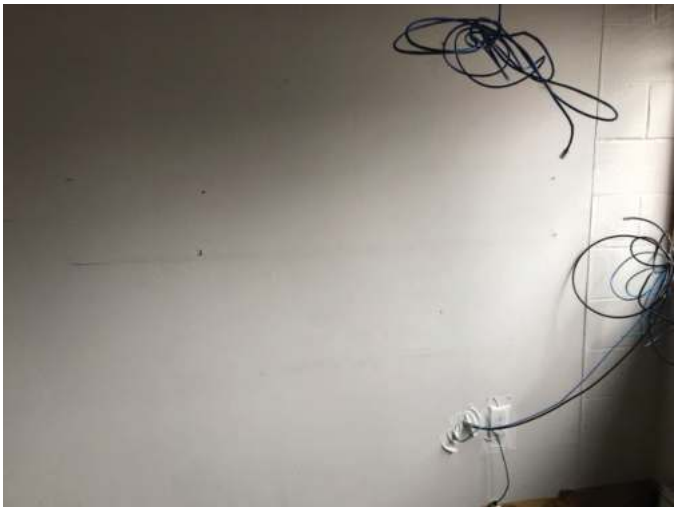
Inspection Number: N-003

Surface: Sheetrock Wall
Cleaning Method: Hand Wipe
Barr: Sierra Samie Passed inspection on 2023-12-08
VTDEC: Dom Delello Passed inspection on 2023-12-08

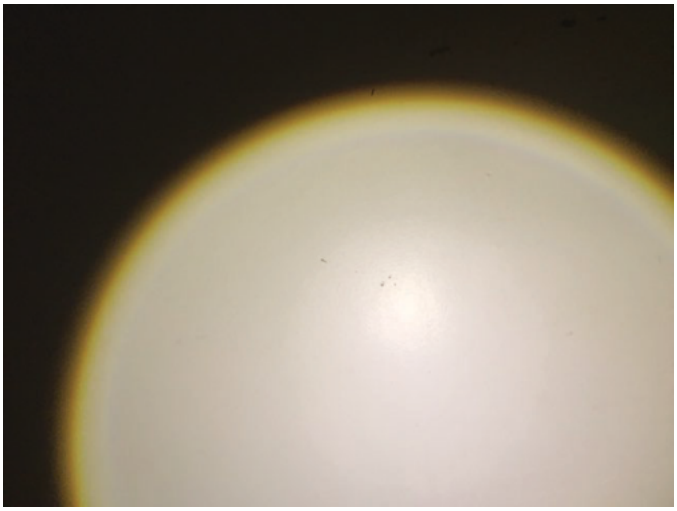
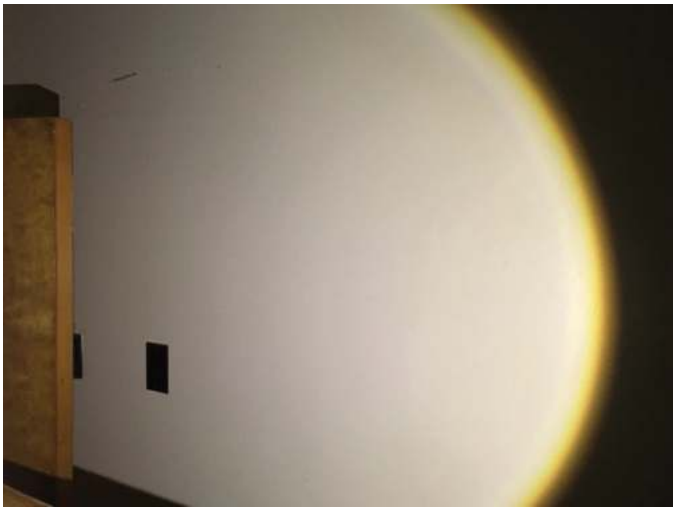
Inspection Number: N-009

Surface: Sheetrock Wall
Cleaning Method: Hand Wipe
Barr: Sierra Samie Passed inspection on 2023-12-08
VTDEC: Dom Delello Passed inspection on 2023-12-08

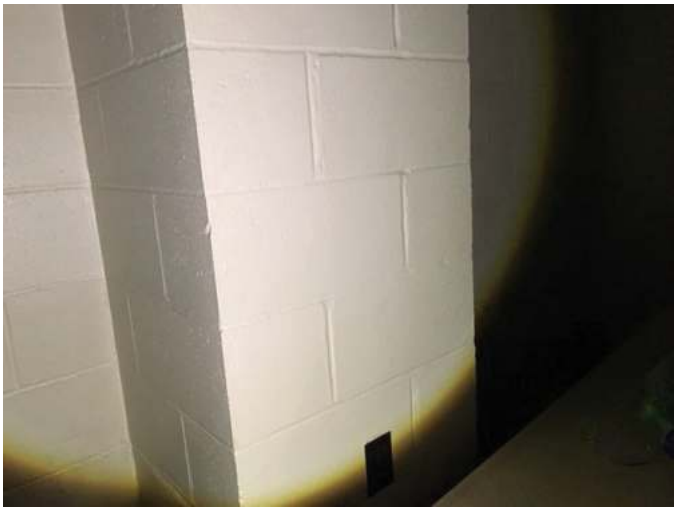
Inspection Number: N-011

Surface: Brick Wall
Cleaning Method: Hand Wipe
Barr: Sierra Samie Passed inspection on 2023-12-08
VTDEC: Dom Delello Passed inspection on 2023-12-08

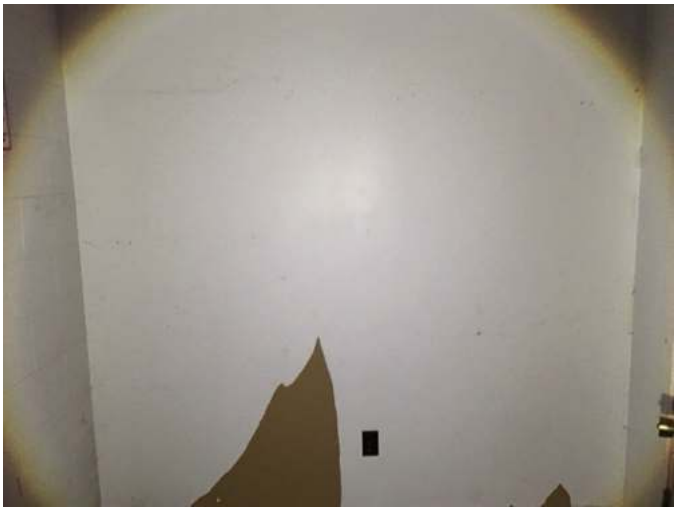
Inspection Number: N-014

Surface: Brick Wall
Cleaning Method: Hand Wipe
Barr: Sierra Samie Passed inspection on 2023-12-08
VTDEC: Dom Delello Passed inspection on 2023-12-08

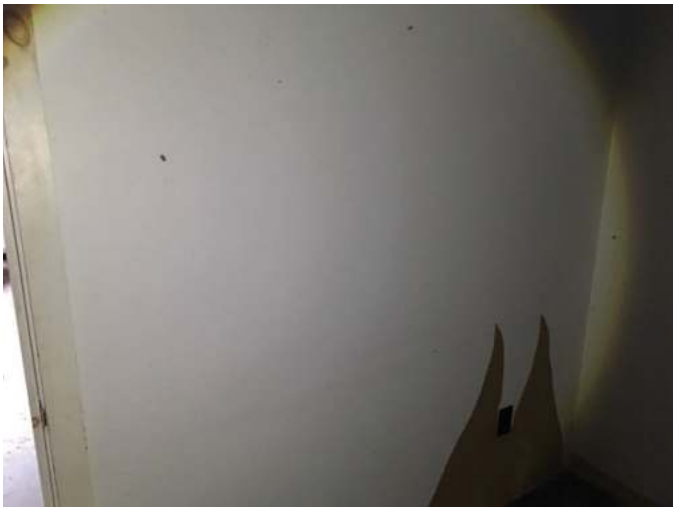
Inspection Number: N-016

Surface: Sheetrock Wall
Cleaning Method: Hand Wipe
Barr: Sierra Samie Passed inspection on 2023-12-08
VTDEC: Dom Delello Passed inspection on 2023-12-08

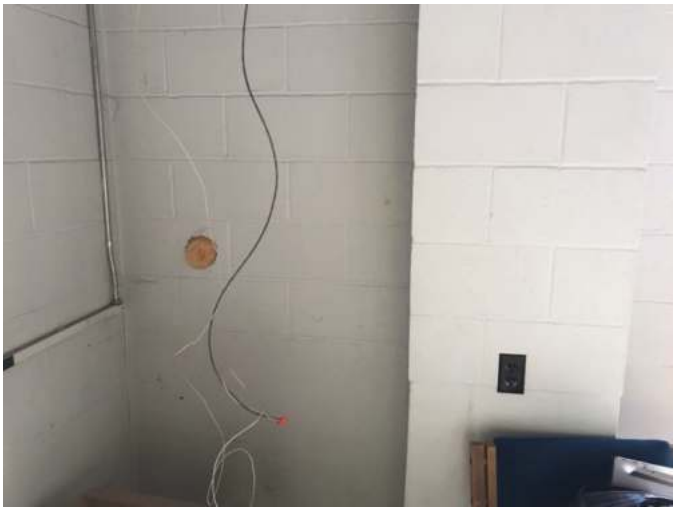
Inspection Number: N-021

Surface: Brick Wall
Cleaning Method: Hand Wipe
Barr: Sierra Samie Passed inspection on 2023-12-08
VTDEC: Dom Delello Passed inspection on 2023-12-08

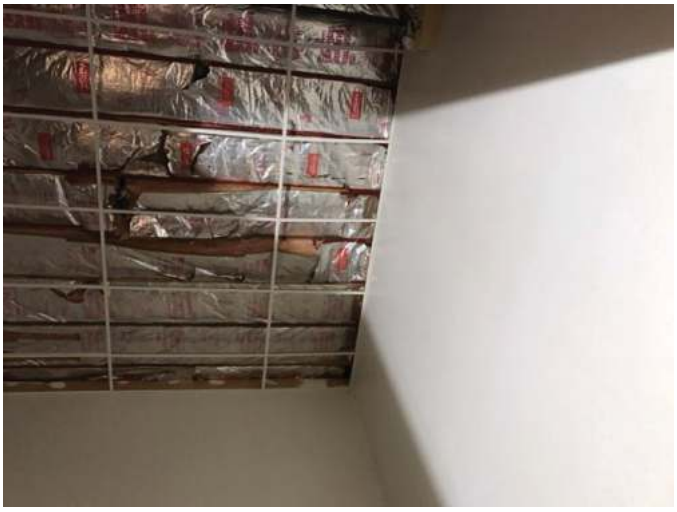
Inspection Number: N-032

Surface: Sheetrock Wall
Cleaning Method: Hand Wipe
Barr: Sierra Samie Passed inspection on 2023-12-08
VTDEC: Dom Delello Passed inspection on 2023-12-08

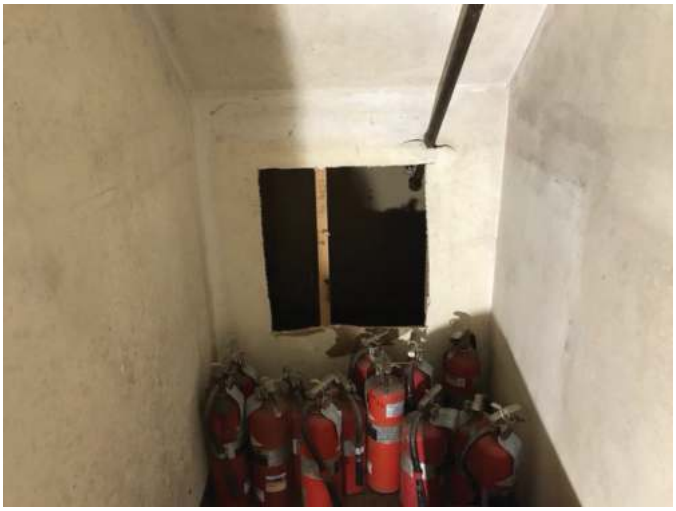
Inspection Number: N-034

Surface: Sheetrock Wall
Cleaning Method: Hand Wipe
Barr: Sierra Samie Passed inspection on 2023-12-08
VTDEC: Dom Delello Passed inspection on 2023-12-08

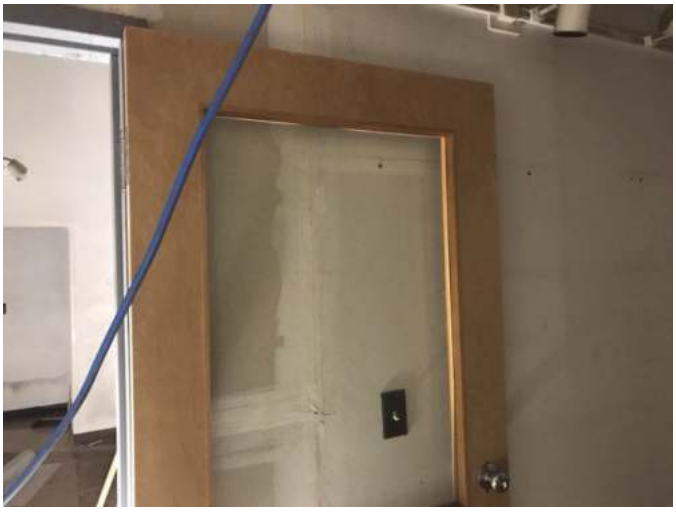
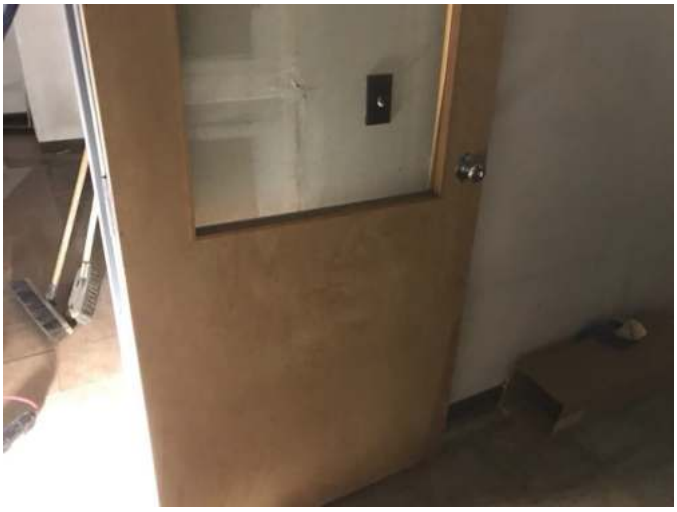
Inspection Number: O-001

Surface: Concrete Floor
Cleaning Method: Vacuum
Barr: Sierra Samie Passed inspection on 2023-12-08
VTDEC: Dom Delello Passed inspection on 2023-12-08

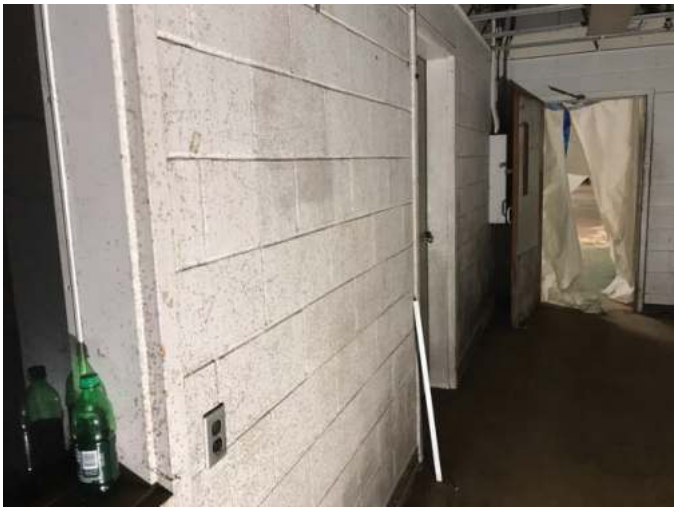
Inspection Number: O-006

Surface: Sheetrock Wall
Cleaning Method: Hand Wipe
Barr: Sierra Samie Passed inspection on 2023-12-08
VTDEC: Dom Delello Passed inspection on 2023-12-08

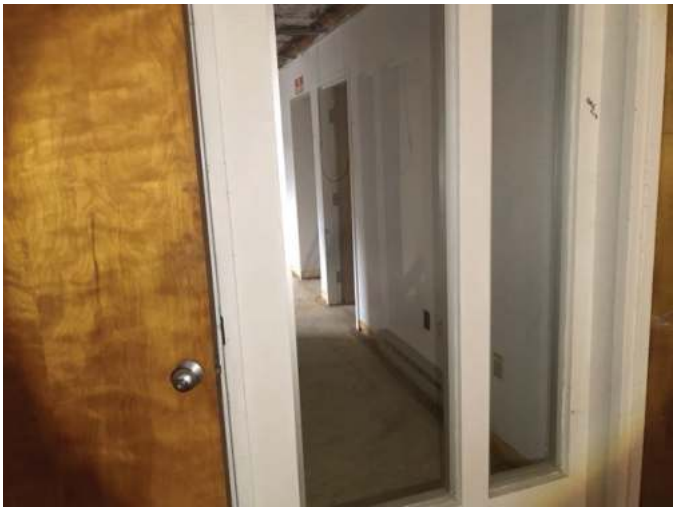
Inspection Number: P-004

Surface: Sheetrock Wall
Cleaning Method: Hand Wipe
Barr: Sierra Samie Passed inspection on 2023-12-08
VTDEC: Dom Delello Passed inspection on 2023-12-08

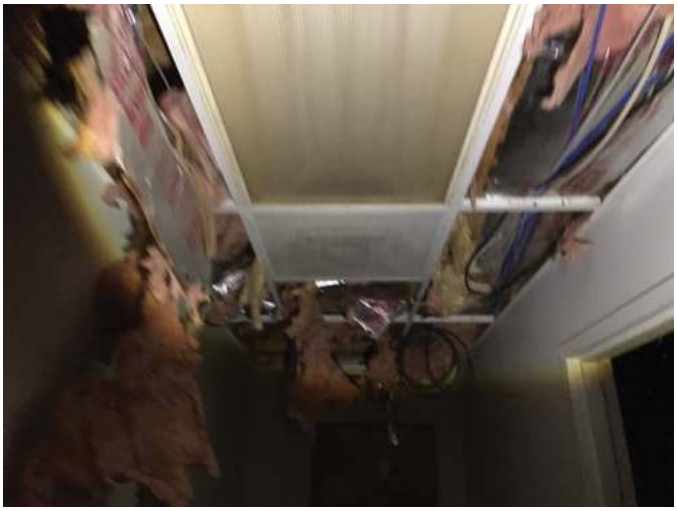
Inspection Number: P-010

Surface: Ceiling
Cleaning Method: Tile Removal
Barr: Sierra Samie Passed inspection on 2023-12-08
VTDEC: Dom Delello Passed inspection on 2023-12-08

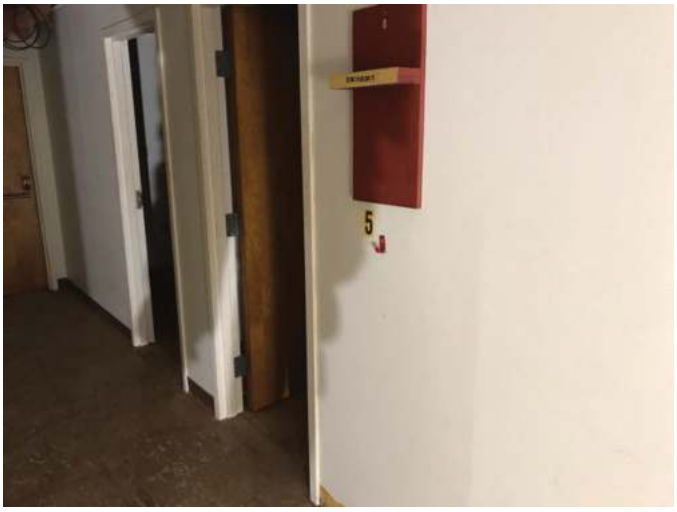
Inspection Number: P-013

Surface: Sheetrock Wall
Cleaning Method: Hand Wipe
Barr: Sierra Samie Passed inspection on 2023-12-08
VTDEC: Dom Delello Passed inspection on 2023-12-08

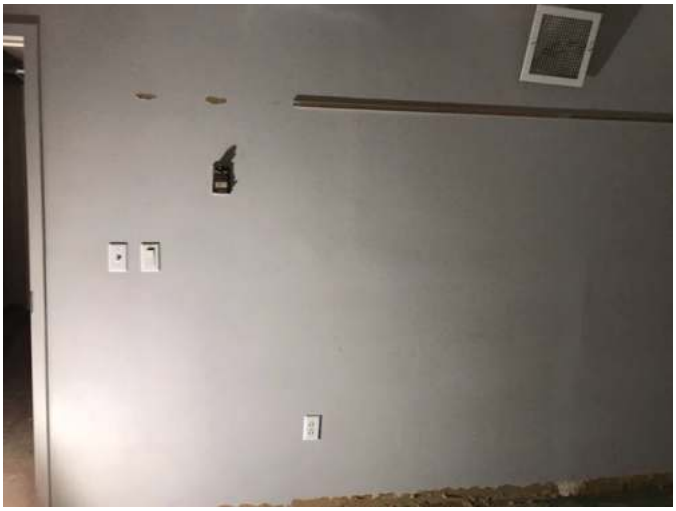
Inspection Number: P-026

Surface: Plywood Floor
Cleaning Method: Carpet Removal
Barr: Sierra Samie Passed inspection on 2023-12-08
VTDEC: Dom Delello Passed inspection on 2023-12-08

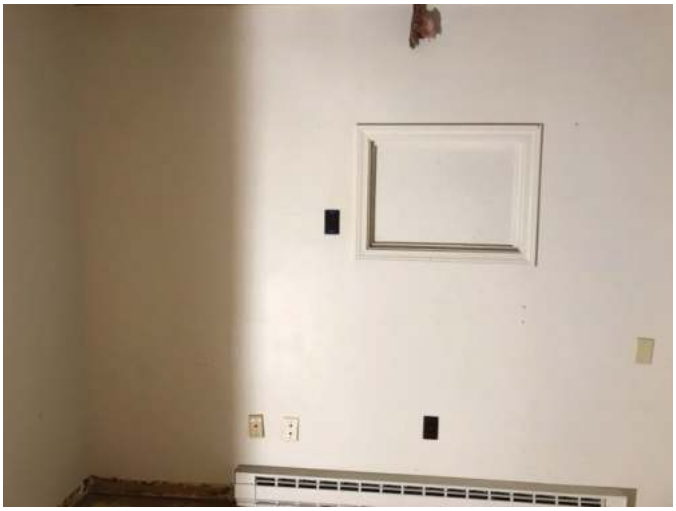
Inspection Number: P-033

Surface: Sheetrock Wall
Cleaning Method: Hand Wipe
Barr: Sierra Samie Passed inspection on 2023-12-08
VTDEC: Dom Delello Passed inspection on 2023-12-08

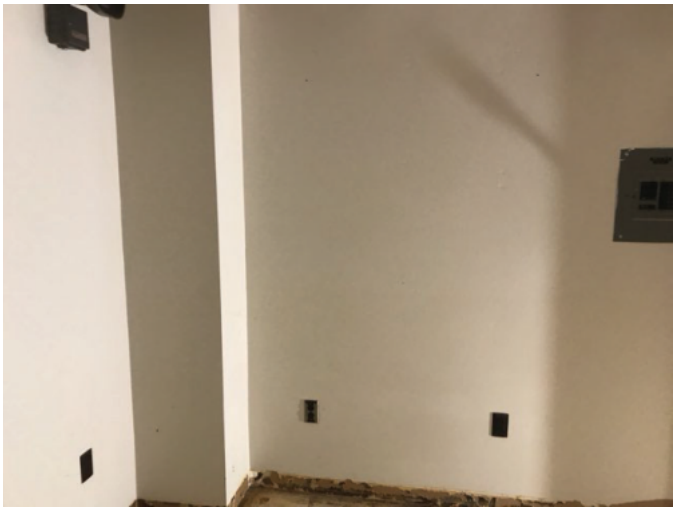
Inspection Number: P-034

Surface: Sheetrock Wall
Cleaning Method: Hand Wipe
Barr: Sierra Samie Passed inspection on 2023-12-08
VTDEC: Dom Delello Passed inspection on 2023-12-08

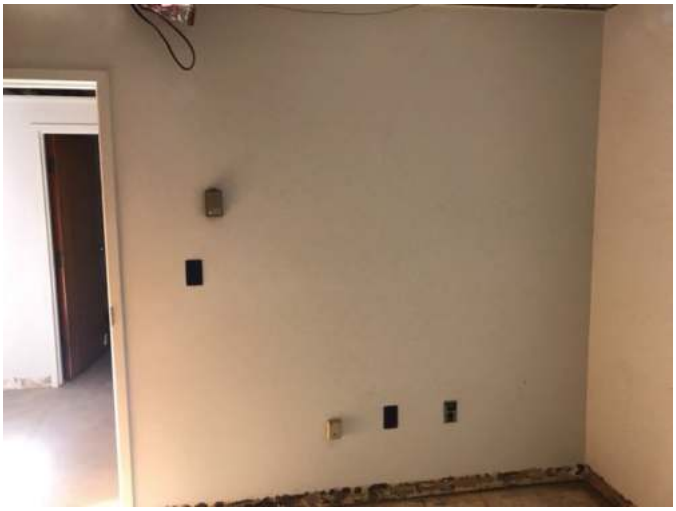
Inspection Number: P-036

Surface: Sheetrock Wall
Cleaning Method: Hand Wipe
Barr: Sierra Samie Passed inspection on 2023-12-08
VTDEC: Dom Delello Passed inspection on 2023-12-08

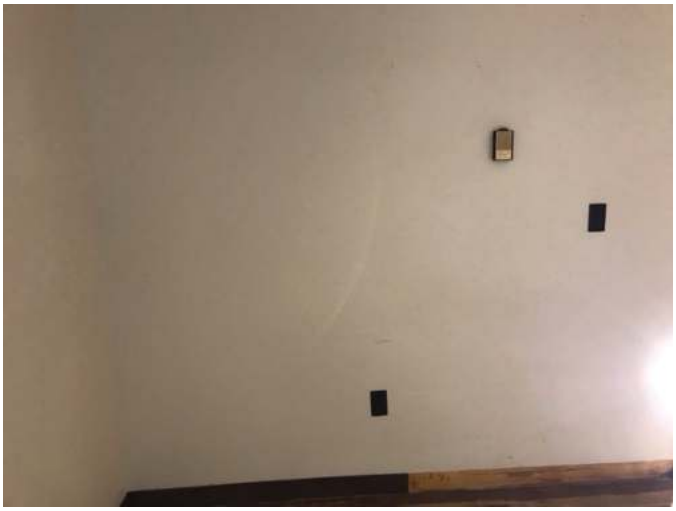
Inspection Number: Q-016

Surface: Sheetrock Wall
Cleaning Method: Hand Wipe
Barr: Sierra Samie Passed inspection on 2023-12-08
VTDEC: Dom Delello Passed inspection on 2023-12-08

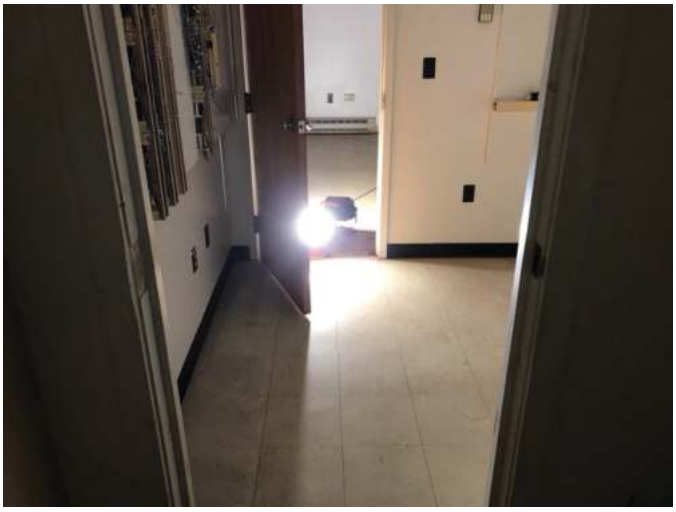
Inspection Number: Q-022

Surface: Sheetrock Wall
Cleaning Method: Hand Wipe
Barr: Sierra Samie Passed inspection on 2023-12-08
VTDEC: Dom Delello Passed inspection on 2023-12-08

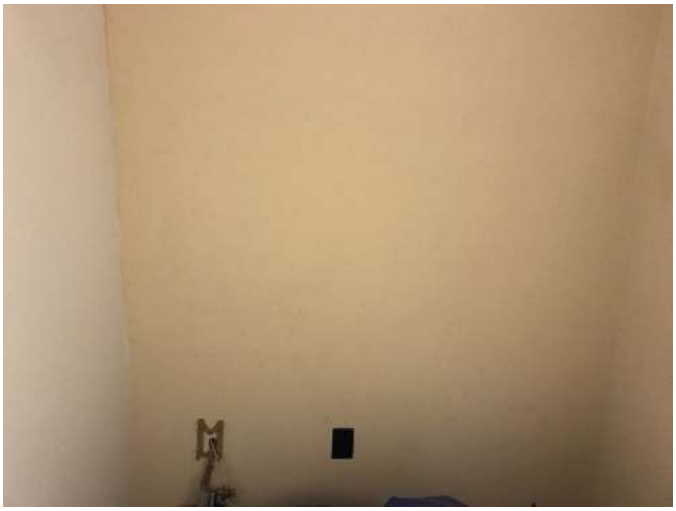
Inspection Number: Q-024

Surface: Sheetrock Wall
Cleaning Method: Hand Wipe
Barr: Sierra Samie Passed inspection on 2023-12-08
VTDEC: Dom Delello Passed inspection on 2023-12-08

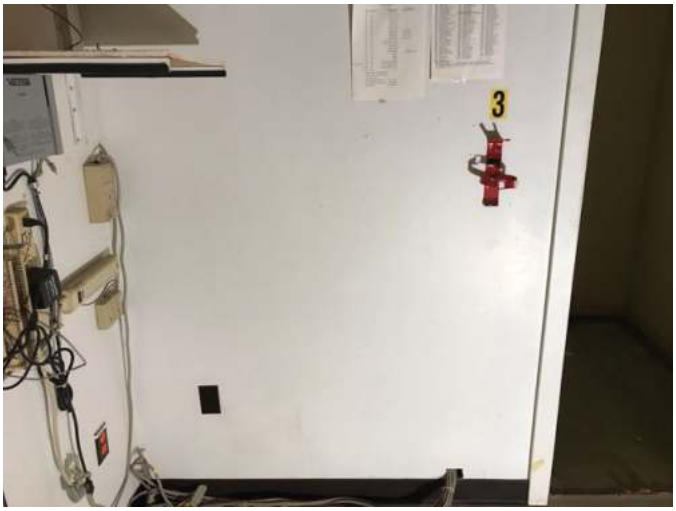
Inspection Number: Q-025

Surface: Sheetrock Wall
Cleaning Method: Hand Wipe
Barr: Sierra Samie Passed inspection on 2023-12-08
VTDEC: Dom Delello Passed inspection on 2023-12-08

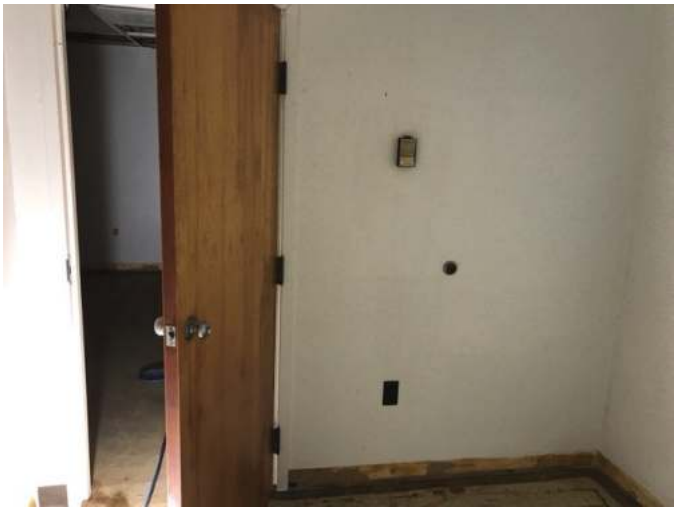
Inspection Number: Q-031

Surface: Sheetrock Wall
Cleaning Method: Hand Wipe
Barr: Sierra Samie Passed inspection on 2023-12-08
VTDEC: Dom Delello Passed inspection on 2023-12-08

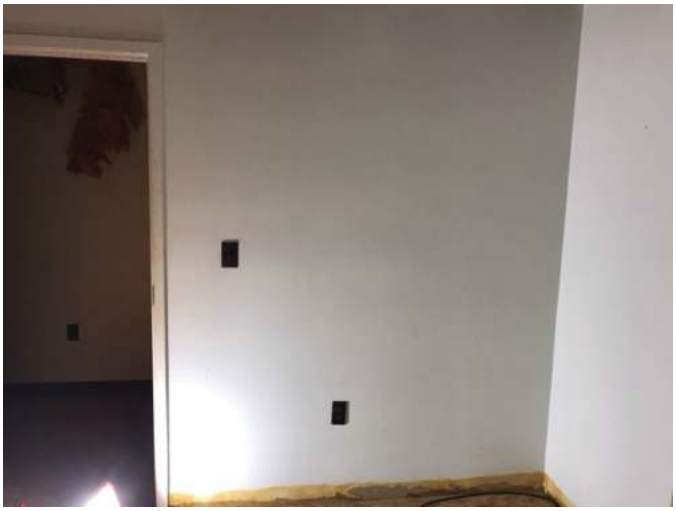
Inspection Number: R-004

Surface: Sheetrock Wall
Cleaning Method: Hand Wipe
Barr: Sierra Samie Passed inspection on 2023-12-08
VTDEC: Dom Delello Passed inspection on 2023-12-08

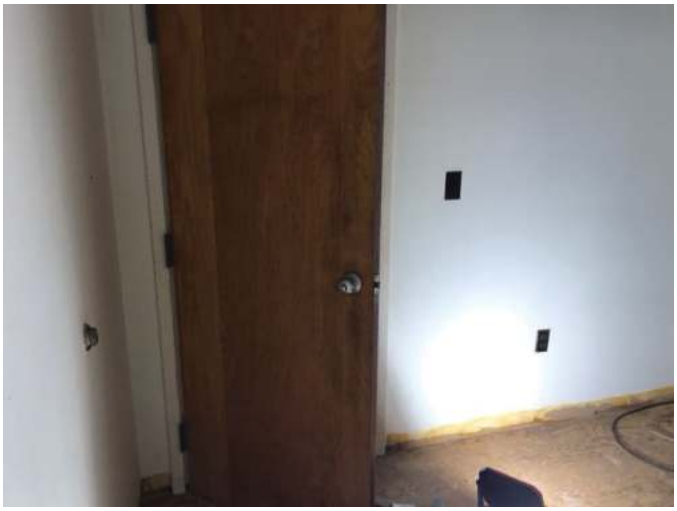
Inspection Number: R-005

Surface: Sheetrock Wall
Cleaning Method: Hand Wipe
Barr: Sierra Samie Passed inspection on 2023-12-08
VTDEC: Dom Delello Passed inspection on 2023-12-08

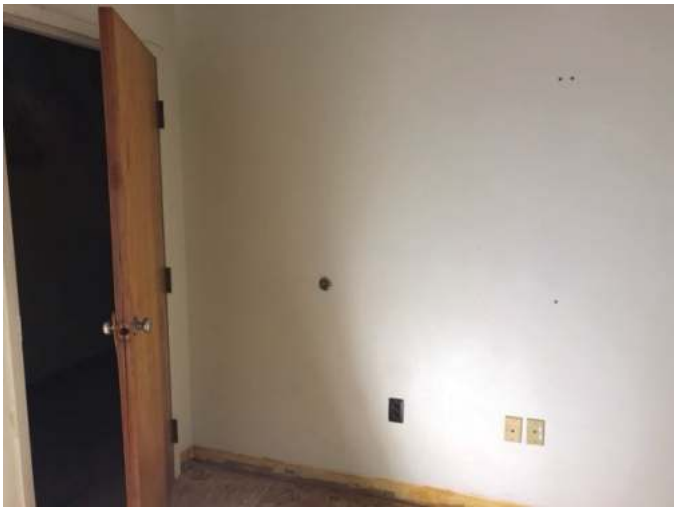
Inspection Number: R-008

Surface: Sheetrock Wall
Cleaning Method: Hand Wipe
Barr: Sierra Samie Passed inspection on 2023-12-08
VTDEC: Dom Delello Passed inspection on 2023-12-08

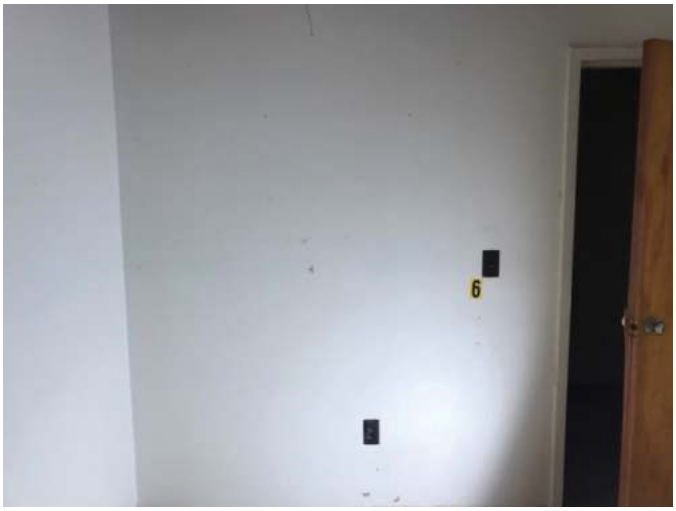
Inspection Number: R-010

Surface: Sheetrock Wall
Cleaning Method: Hand Wipe
Barr: Sierra Samie Passed inspection on 2023-12-08
VTDEC: Dom Delello Passed inspection on 2023-12-08

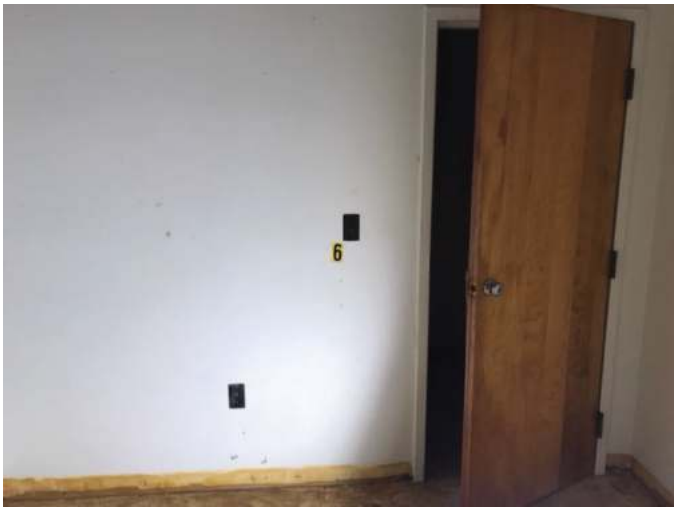
Inspection Number: R-011

Surface: Sheetrock Wall
Cleaning Method: Hand Wipe
Barr: Sierra Samie Passed inspection on 2023-12-08
VTDEC: Dom Delello Passed inspection on 2023-12-08

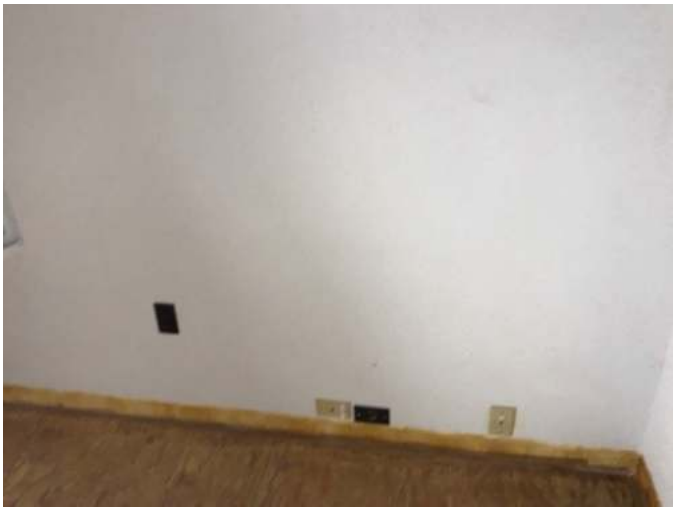
Inspection Number: R-016

Surface: Sheetrock Wall
Cleaning Method: Hand Wipe
Barr: Sierra Samie Passed inspection on 2023-12-08
VTDEC: Dom Delello Passed inspection on 2023-12-08

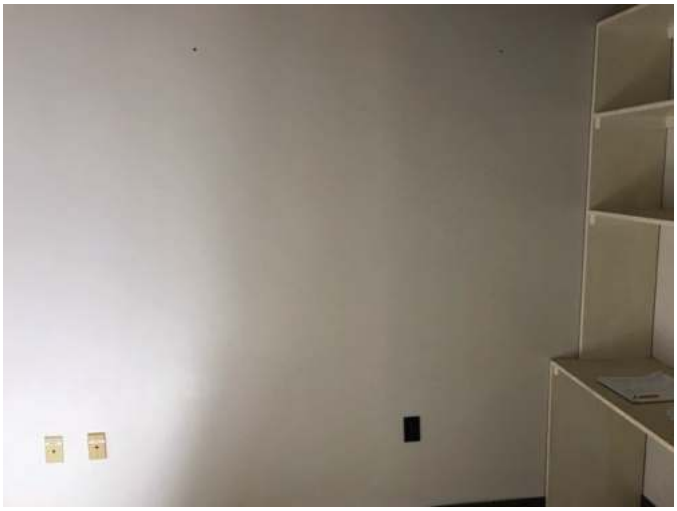
Inspection Number: R-023

Surface: Sheetrock Wall
Cleaning Method: Hand Wipe
Barr: Sierra Samie Passed inspection on 2023-12-08
VTDEC: Dom Delello Passed inspection on 2023-12-08
