Central Vermont Public Service Corporation

October 22, 1991

On September 19, 1991 Central Vermont Public Service Corporation (CVPS) and Wehran Engineering excavated test pits at the CVPS Poultney Service Center (site # 91-1050). This investigation was conducted in compliance with the comments presented in your August 15, 1991 letter.

VERMONT DEPARTMENT OF ENVIRONMENTAL CONSERVATION
UNDERGROUND STORAGE TANK PROGRAM
SITE MAP

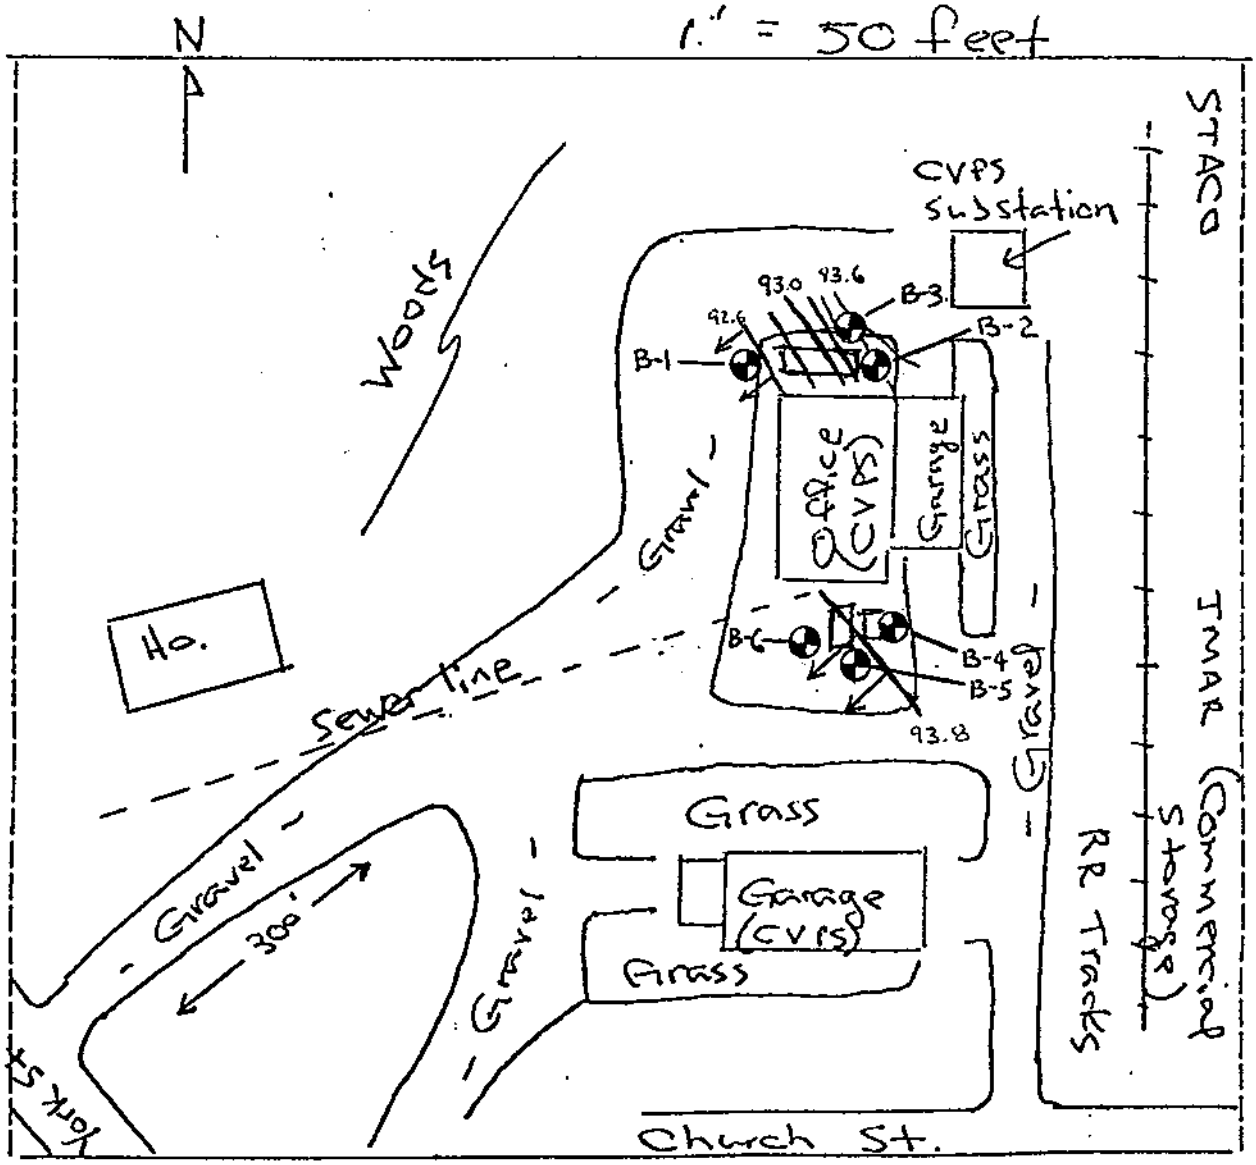
A total of six test pits were excavated to determine the direction of groundwater flow at the site. The enclosed site map indicates test pit locations and groundwater flow direction based upon the water surface elevation measured in each test pit. Groundwater from each test pit was scanned by headspace analysis with a PID. Excavation B-4 was the only test pit with volatile organic compounds detected by the PID (110 ppm). A water sample was taken from test pit B-4 along with samples from B-1, B-2 and B-5. The results of the EPA Method 624 analysis on the water samples are enclosed.

B-# ACTUAL TEST PIT LOCATION

GROUNDWATER CONTOUR & FLOW DIRECTION
92.6

B1-B3 FORMER GAS TANK LOCATION

B4-B6 FORMER DIESEL TANKS LOCATION
