December 30, 1997

RE: Stratton/Sun Bowl Compressor Area
VTDEC Site #97-2144

This letter/report presents the results of recent groundwater monitoring conducted in the area of snowmaking compressors at the Sun Bowl parking lot at Stratton Mountain Resort (see site facility plan, Appendix 1, page 9). On November 19, 1997, water level measurements and water quality samples were collected from all ten monitor wells at the compressor area. Samples were also collected from Sun Bowl Brook, and from the liner sump and the condensate discharge sump. Results are discussed below. The snowmaking compressors were operating on the date of sample collection.

STRATTON MOUNTAIN RESORT
Sun Bowl Compressor Pad Area

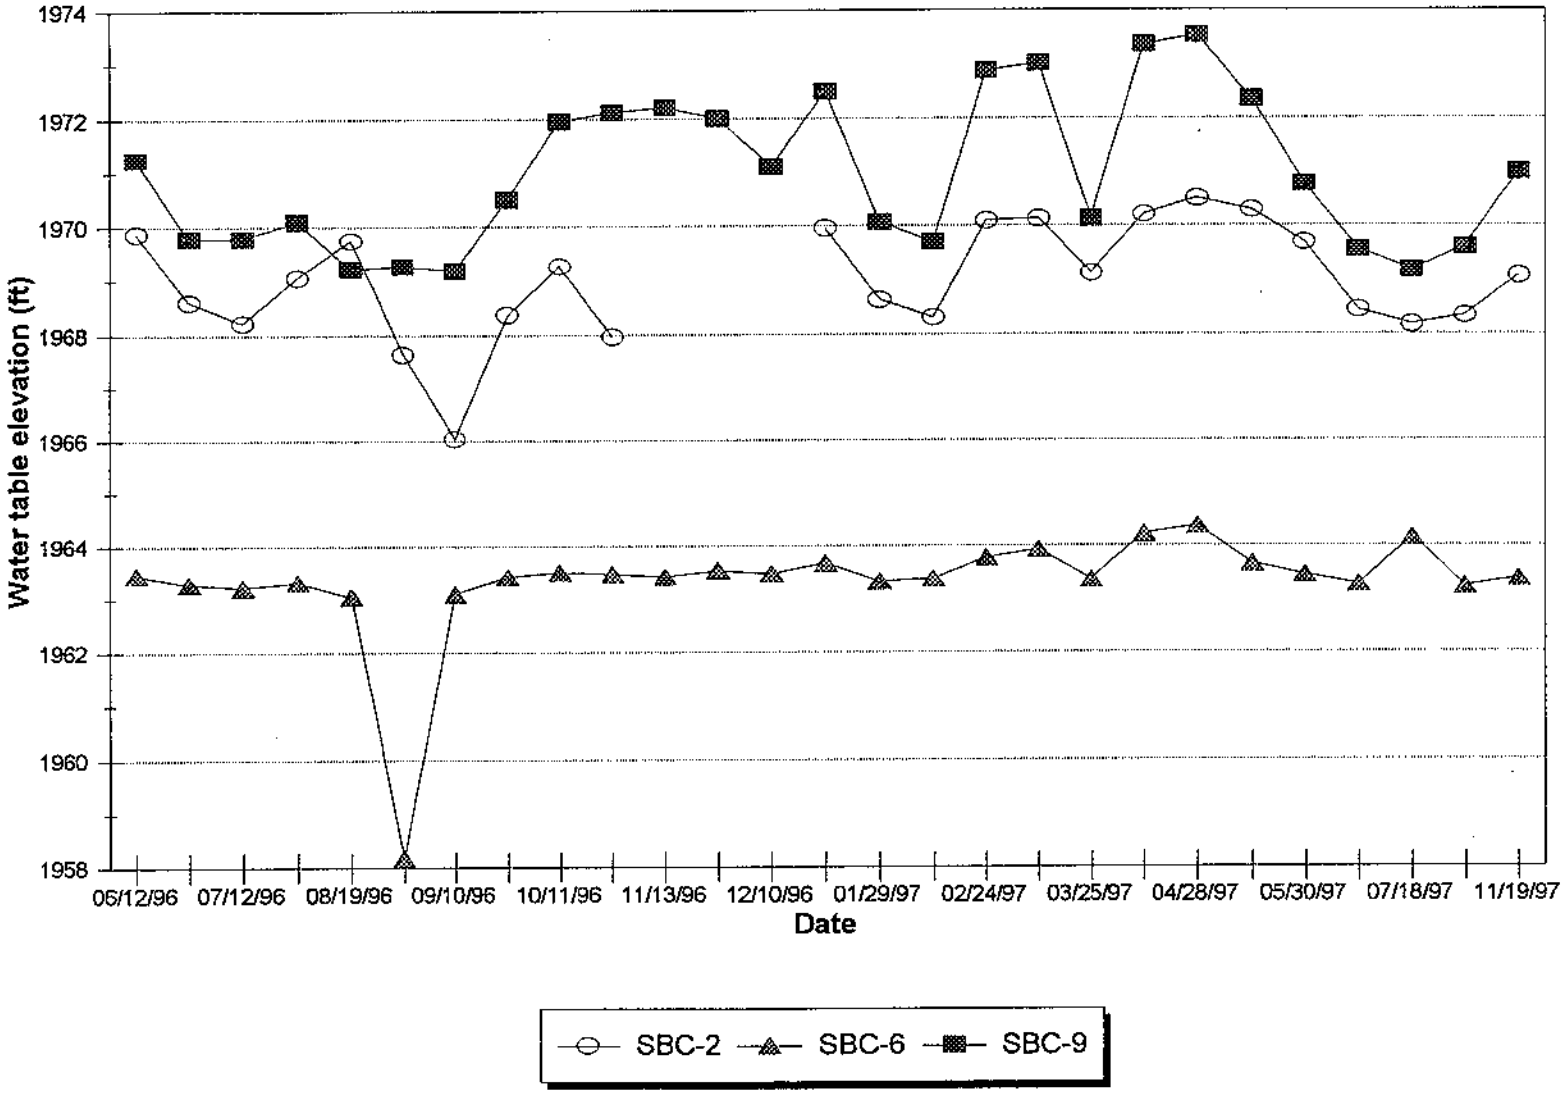
Water table elevation vs Time

Water levels were measured in each of the ten monitor wells (SBC-1 through SBC-10) prior to sample collection. Water level and elevation data from June 1996 through present are summarized on page 1 of Appendix 1. The graph on page 2 shows the variation in water table elevation versus time at three representative wells at the site (SBC-2, SBC-6, and SBC-9). All three wells showed the lowest water level occurring in the summer, and the highest levels in the spring and fall. The pattern at upgradient well SBC-9 is similar to that at SBC-2, in the interior of the site. Downgradient well SBC-6 shows less variation in water table over the period of monitoring. The unusually low water level recorded at this well in August 1996 may coincide with annual low stream flows, indicating a close hydraulic connection between the well and Sun Bowl Brook.

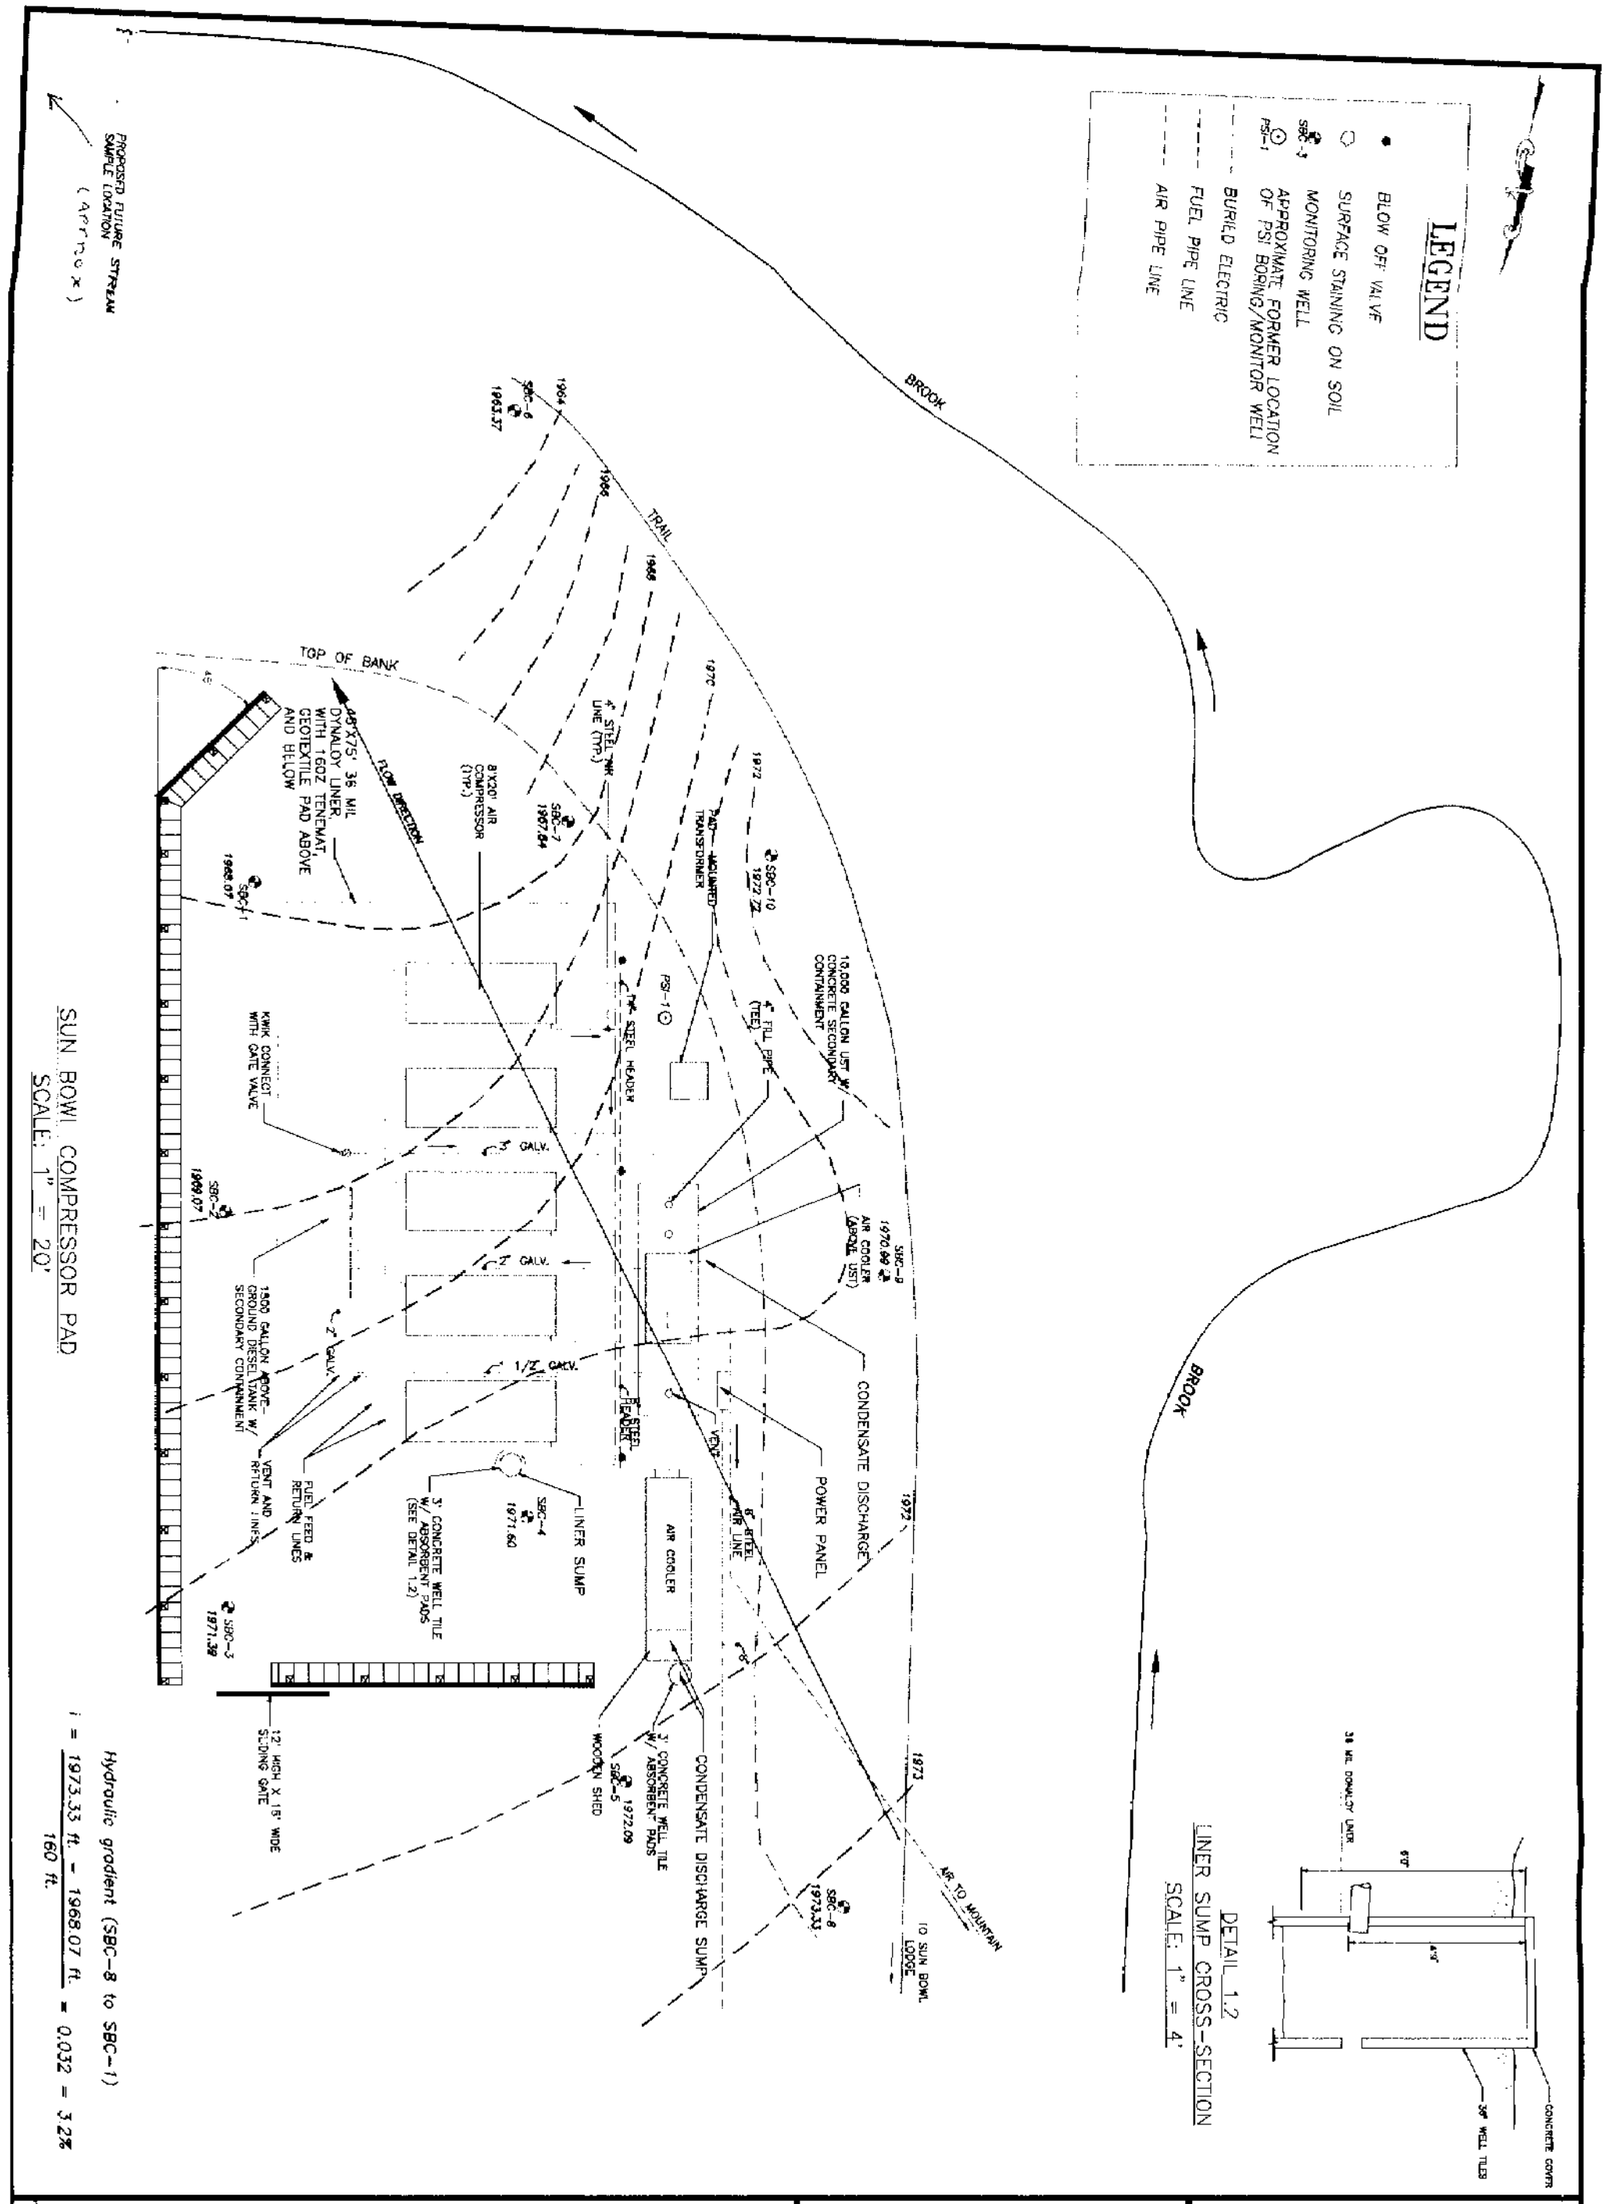
The water table map on page 7 of Appendix 1 shows that groundwater flows from northwest to southeast beneath the site at a gradient of approximately 3%, consistent with previous maps.[1] The orientation of water table contours suggests that Sun Bowl Brook may be a "losing" stream in this area, with water shortcutting the sharp bend in the stream

and flowing preferentially through the fill material beneath the compressors. Based on the flow pattern, an approximate recommended location for future downgradient sampling is indicated on the map on page 7.

We recommend the collection of another round of water quality samples in March 1998. Future samples from Sun Bowl Brook should be collected further downstream, at a point downgradient of the liner sump.

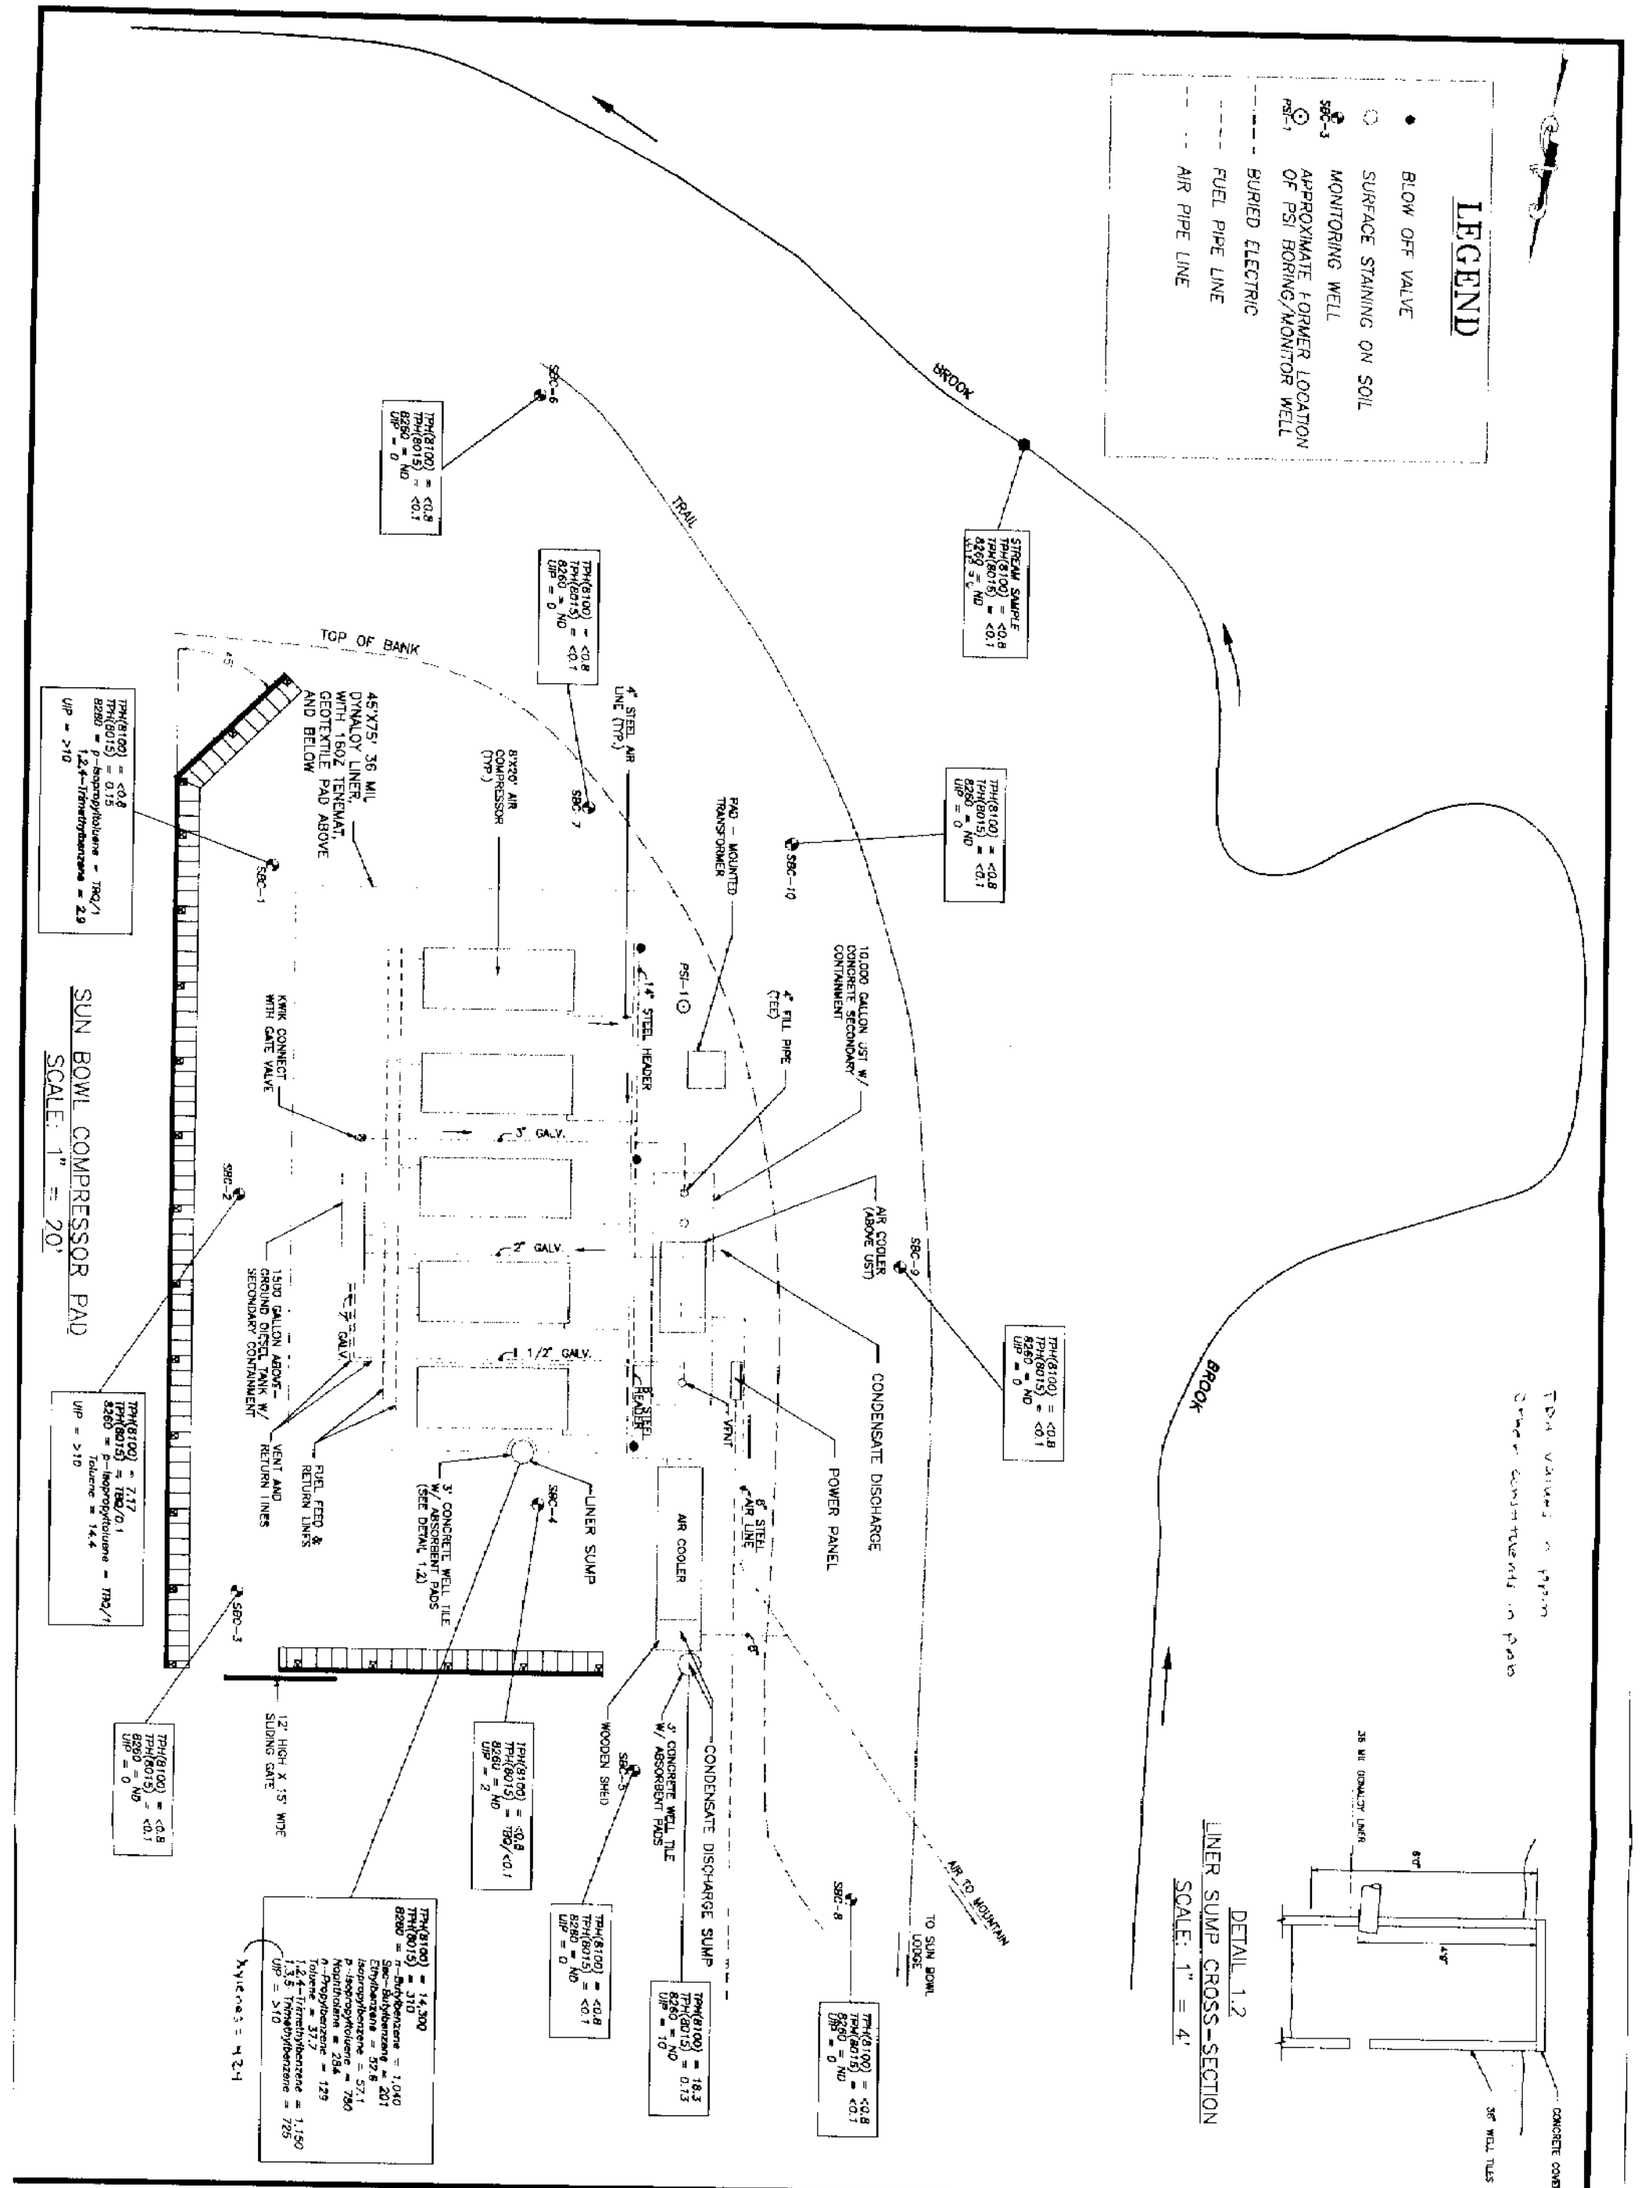
Analytical results have been plotted on the contaminant distribution map on page 8 of Appendix 1. As shown, the highest levels of contamination occurred in water in the liner sump, with TPH by 8100 reported as 14,300 ppm, and numerous volatile organic compounds detected at concentrations greater than 1 ppm (e.g. 1,150 ppb 1,2,4-trimethylbenzene; 1,040 ppb n-butylbenzene). Low concentrations of TPH also occurred in the condensate discharge sump (18.3 ppm by 8100). Trace levels of contaminants were detected as SBC-1 and SBC-2, the two wells directly downgradient of the sump. At SBC-2, TPH by 8100 was reported as 7.17 ppm; toluene was reported 14.4 ppb. At SBC-1, 1,2,4-trimethylbenzene was reported as 2.9 ppb. This level exceeds the Preventive Action Level (2.5 ppb) of the Groundwater Enforcement Standards. None of the other stations sampled showed VOC's or TPH at detectable levels.

These sampling results indicate the importance of inspecting and changing the sorbent pads in the liner sump on a regular basis, particularly during the winter when the compressors are in operation. The discharge from the liner showed the presence of hydrocarbons and volatile organics at concentrations which significantly exceed the GES, indicating the potential for future violations of the standards in groundwater if proper maintenance practices are not observed. Since the sump is open to the soil at the bottom,

the sorbent pads provide the only means of protecting groundwater from the contaminants collected by the liner and discharged into the sump.

Water quality sampling conducted in November 1997 showed low levels of groundwater contamination at the two wells located directly downgradient of the liner sump. None of the other wells sampled had detectable levels of petroleum hydrocarbons or volatile organics. These results indicate that the Dynaloy liner beneath the compressors continues to capture minor local releases of fluids associated with compressor operation, preventing wide-spread groundwater contamination beneath the site. However, discharges into the liner sump not completely captured by sorbent materials have resulted in a violation of the GES/PAL for 1,2,4-trimethylbenzene at well SBC-1 directly downgradient of this discharge point. To prevent further contamination, we recommend that Stratton personnel conduct regular inspections of the sorbent materials in the liner sump and condensate discharge sump. A drum will be provided on-site for collection of spent sorbent materials. Weekly inspection log sheets have been prepared for use by Stratton personnel (see Appendix 1, pages 5 and 6).
