RE: Walton Property in Charlotte - WMD Site # 98-2342

RE: Spill Response and Remedial Investigations
Walton Residence, Charlotte, VT.

Environmental Products & Services, Inc. (EPS) is pleased to submit this Spill Response and Site Investigation Report. The report reviews the work performed at the site, the findings of our investigations and provides conclusions and recommendations.

Environmental Products & Services, Inc.	Date: April 1998	Project No. V1415
WALTON RESIDENCE Charlotte, Vermont	Scale: NTS	Figure No.: 1
	Drawn By:Geoscience	Location:Charlotte, Vermont

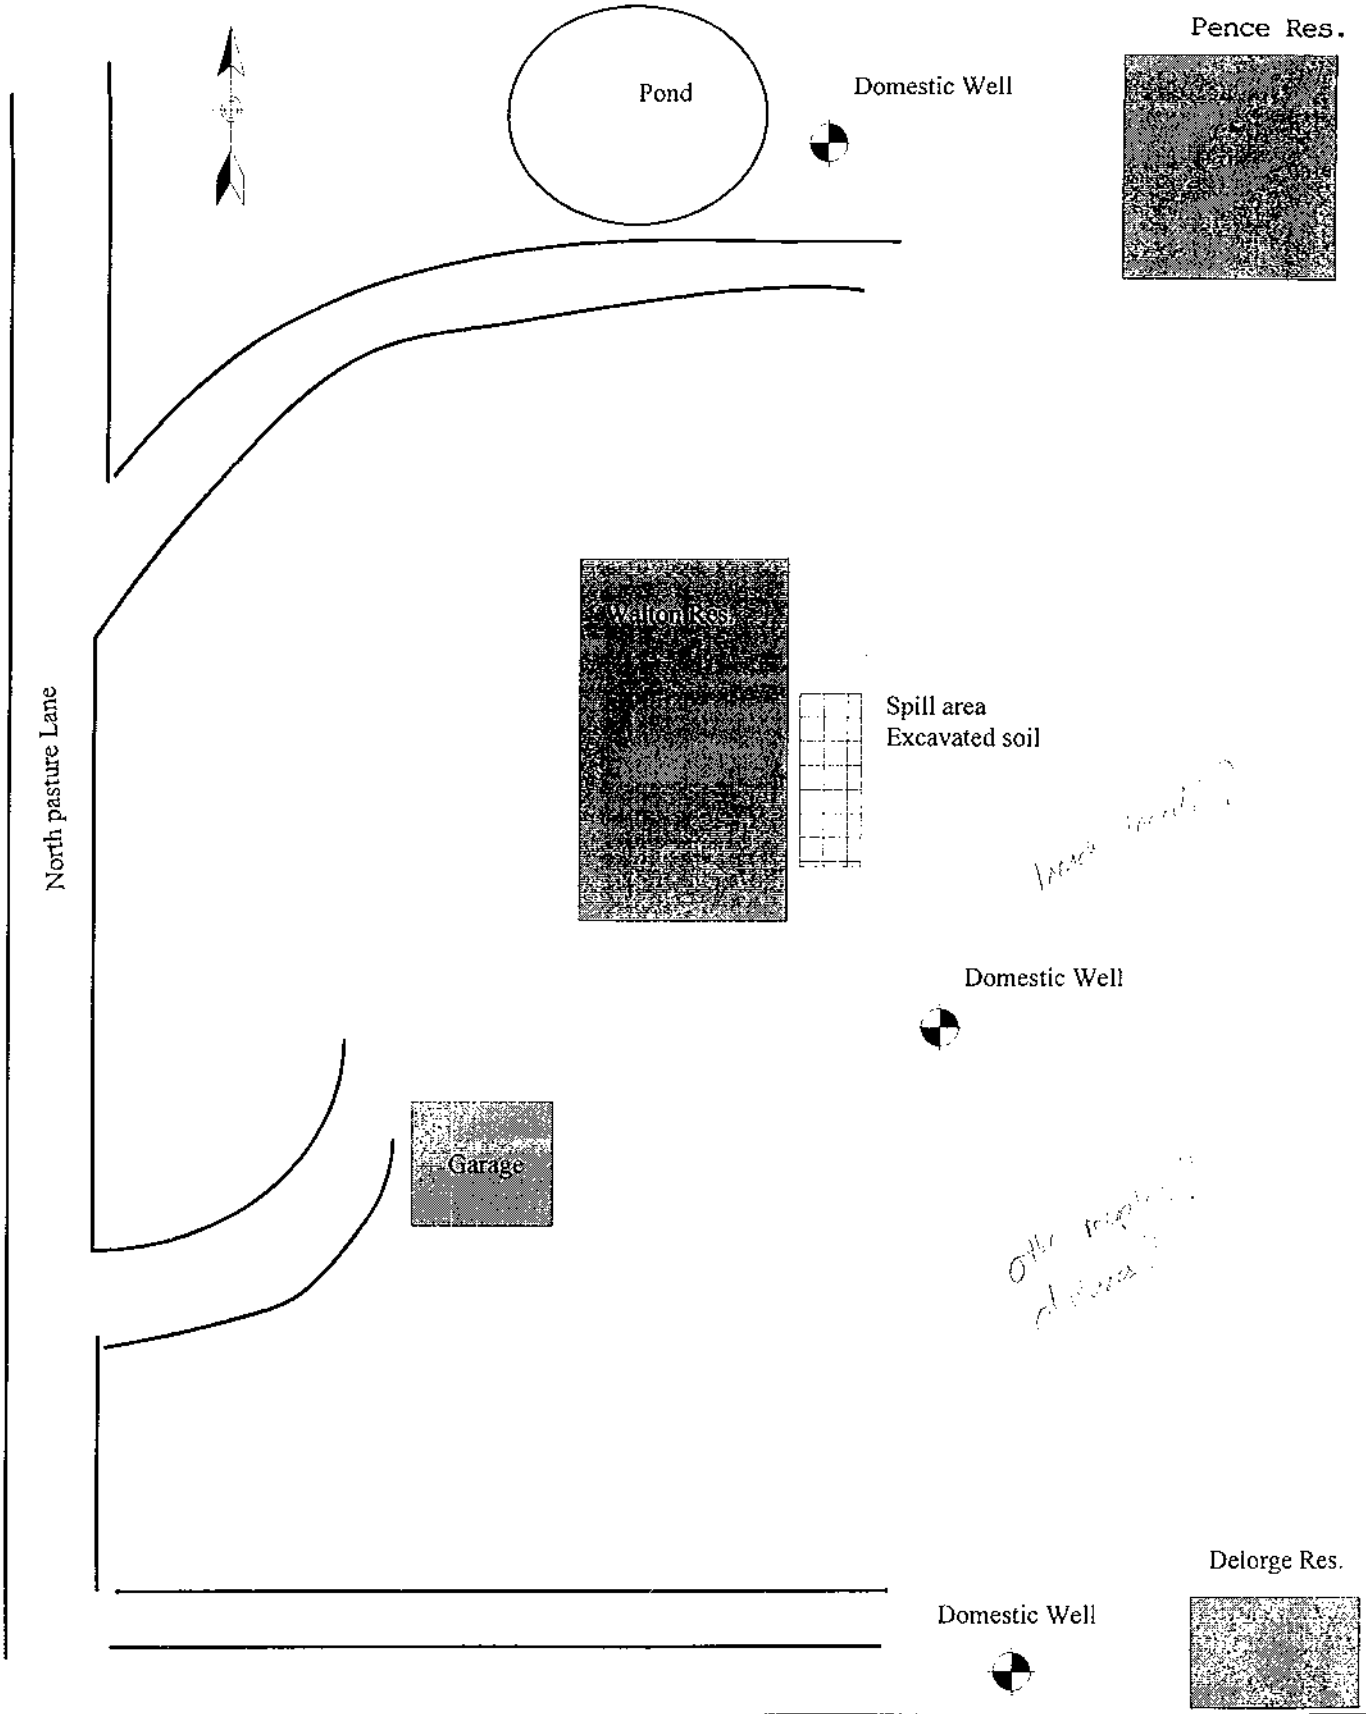
- site map not to scale, no distances to receptors
  limited discussion & no interpretation of topography
