North Bennington, Village of

SA-07-005-2015

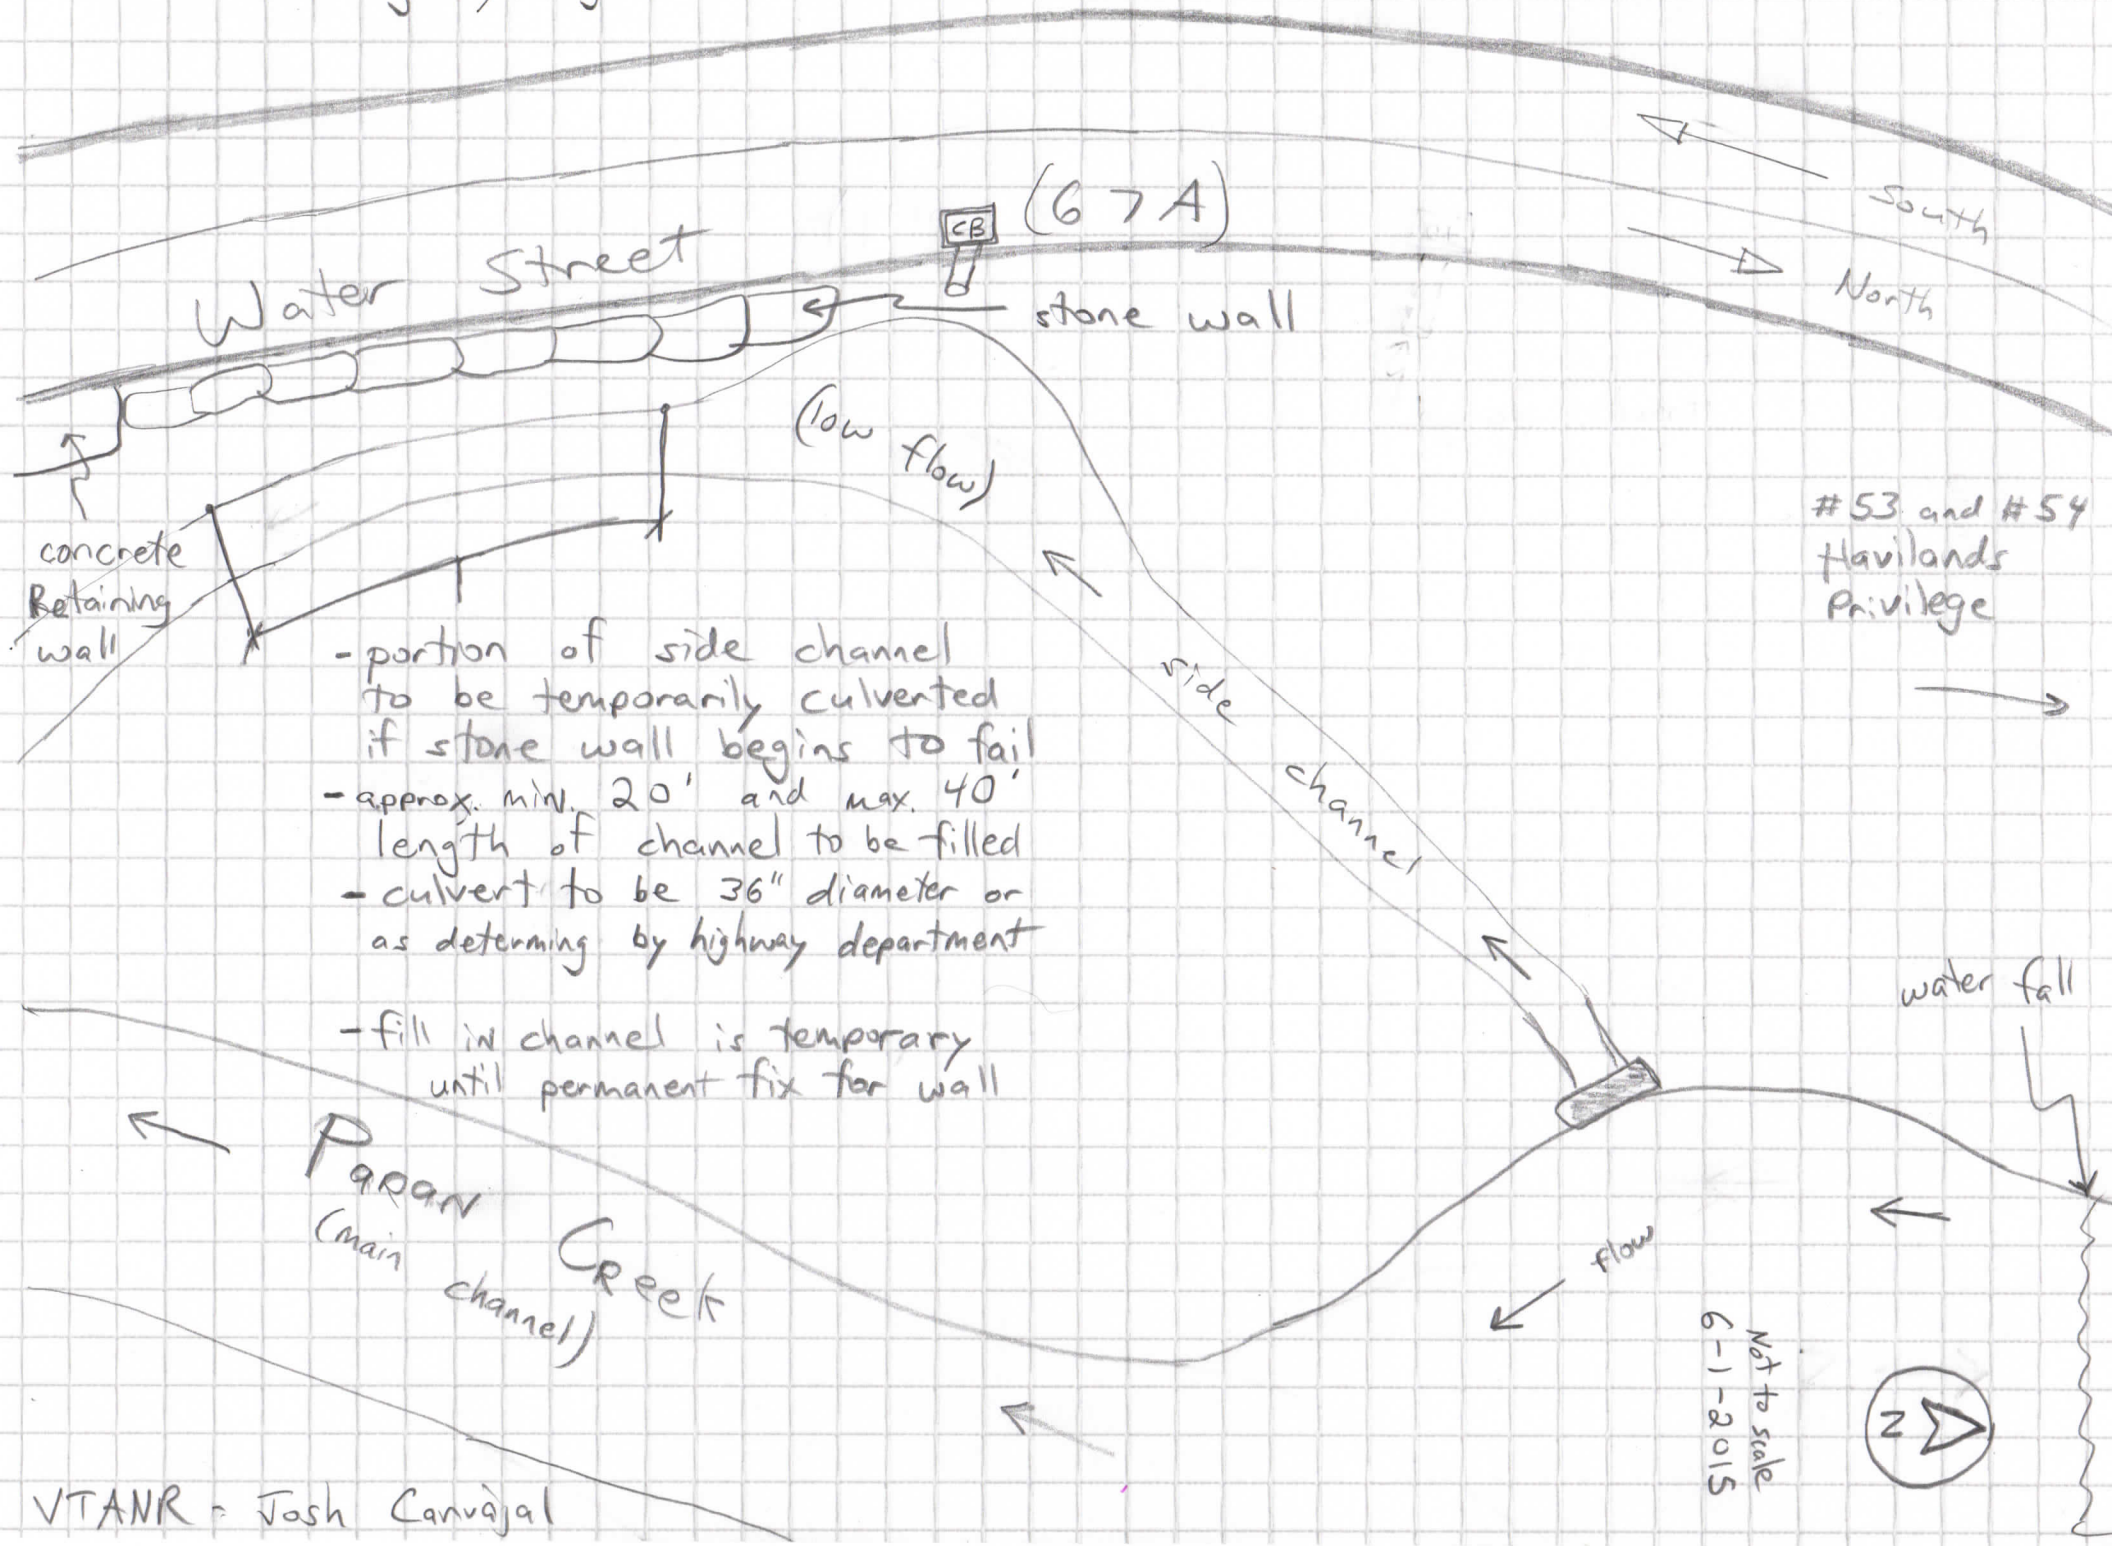
- portion of side channel to be temporarily culverted if stone wall begins to fail
- approx. min. 20' and max. 40' length of channel to be filled
- culvert to be 36" diameter or as determing by highway department
- fill in channel is temporary until permanent fix for wall
