**Water Quality Remediation Plan
Dish Mill Brook Tributary**

BURKE MOUNTAIN RESORT

Prepared for **Burke Mountain Resort**
East Burke, Vermont

Prepared by **VHB Pioneer**
7056 U.S. Route 7
North Ferrisburgh, VT 05473

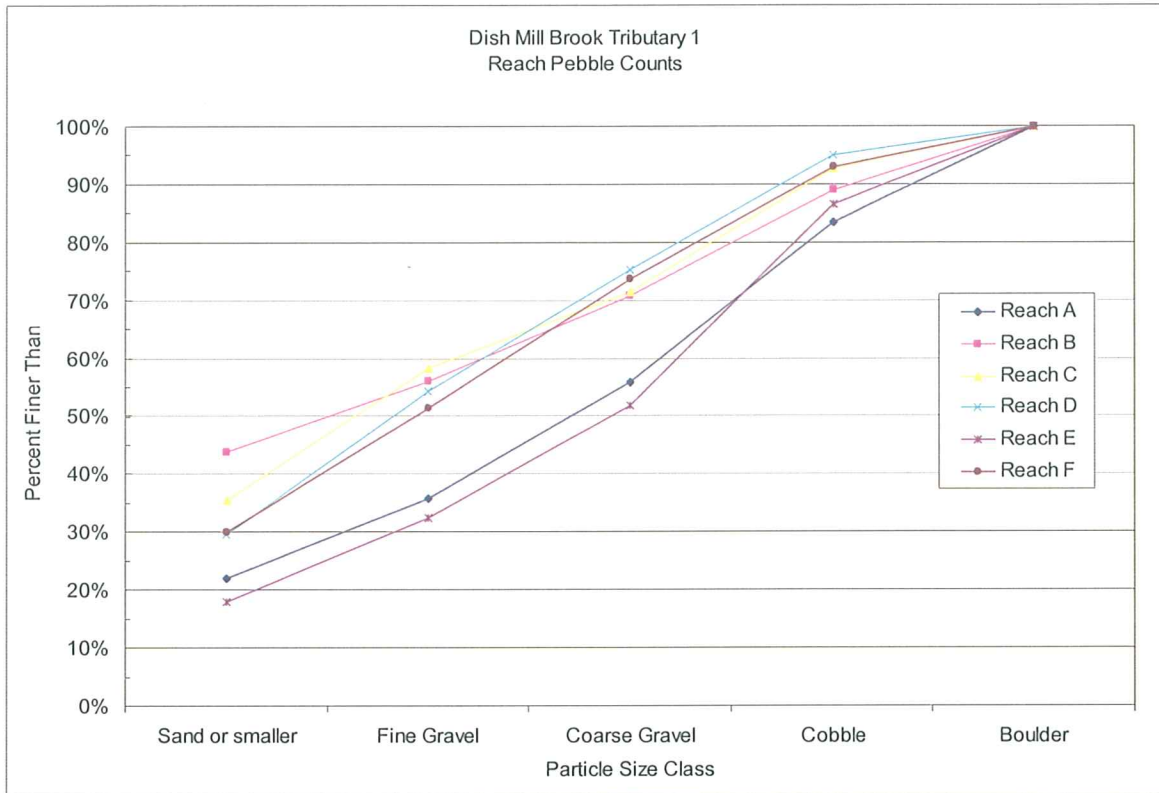
Figure 1. Particle size distribution for sampled reaches within the Dish Mill Brook Tributary.

The pebble counts that were conducted grouped the particles into five categories; sand, fine gravel, coarse gravel, cobble, and boulder. The sampled data suggest Reaches A and E have a median grain size that is coarse gravel (see Figure 1). For reaches B, C, D and F, at least 50 percent of their sampled grains were less than 16mm, which is considered fine gravel. The level of fine material indicates that sediment is above levels that are considered healthy for aquatic life in reached B, C, D and F.

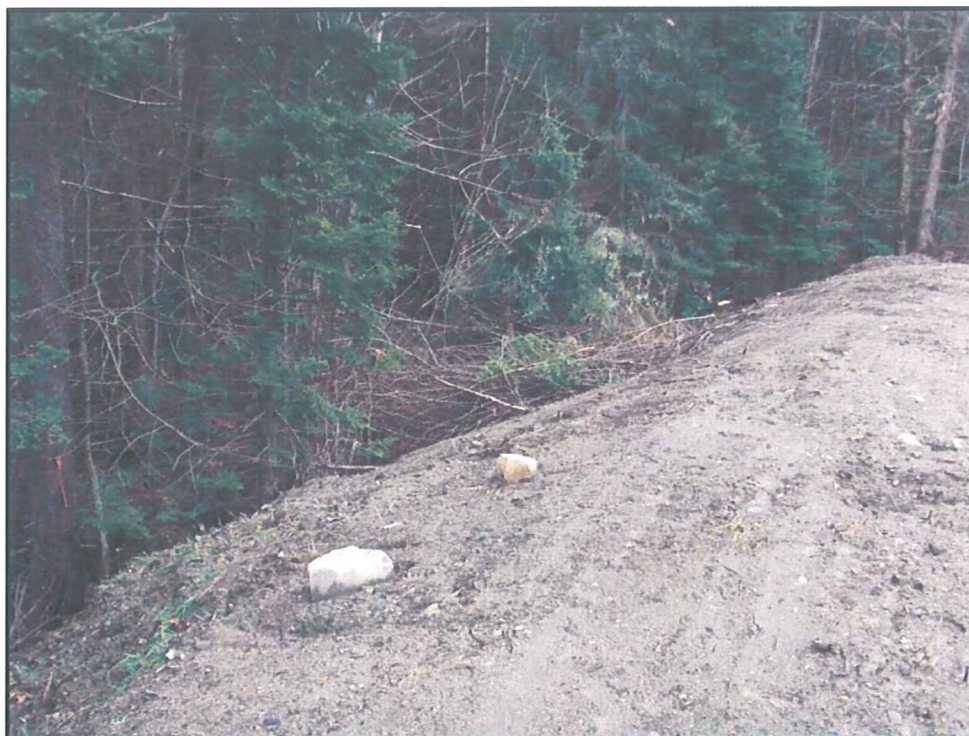
Photograph 1: OC-004. November 9, 2006

Table 9: Critical Outfall Summary and Treatment			
Outfall	Comment	Treatment Recommendation (2007)	Status (2009)
OC-004 OC-005 OC-006	Associated with dirt parking area nearby the maintenance building. Presently runoff from the parking lot is flowing directly into the nearby stream.	<u>Interim treatment</u> - Divert flow from entering the brook through the use of berms or swales and direct to the roadside ditches. <u>Final treatment</u> - Install SW detention BMP to temporarily detain flow and prevent sediment from reaching the stream.	<u>Interim Treatment</u> has been implemented. storage area and stream. <u>Final Treatment</u> - will be implemented as Mid-Burke is developed
OC-008	Associated with a gravel/paved parking area runoff draining to the stream untreated.	Direct runoff through a shallow ditch upslope of stream entry	Treatment pending
OC-009	Associated with a gravel/paved parking area with untreated runoff directly entering the stream	<u>Interim treatment</u> - Divert runoff from directly entering the stream through ditching. <u>Final treatment</u> - Install SW treatment BMP to detain flow and prevent sediment from reaching stream	<u>Interim Treatment</u> has been implemented In addition, concrete barriers have been installed to provide a 20' buffer between snow storage area and stream. <u>Final Treatment</u> - will be implemented as Mid-Burke is developed

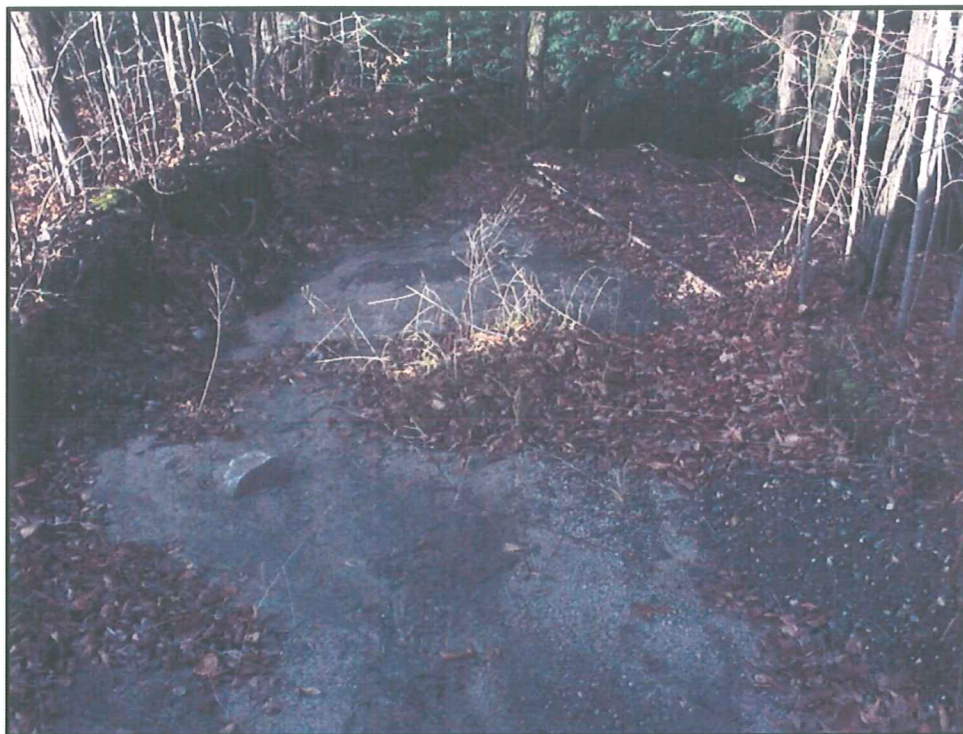
Photograph 7: OC-208. November 9, 2006

As mentioned, reach B was in poor condition for embeddedness and channel degradation. Critical outlets OC-208, OC-209, OC-210 and OC-211 lie in a series along a gravel road and all contribute directly to reach B, which provides supporting evidence for the reach having a poor embeddedness and channel degradation condition. Numerous sand and gravel deposits were observed in the channel, which also suggests that the road is a significant source of sediment. The stormwater runoff on gravel road should be routed so that gullies do not form on the road. This means that flow lengths must be limited and outlets should be treated to reduce the amount of sediment being supplied to the channel.

Table 9: Critical Outfall Summary and Treatment			
Outfall	Comment	Treatment Recommendation (2007)	Status (2009)
OC-208 OC-209 OC-210 OC-211	Direct runoff occurs from a gravel road directly into the stream. Runoff is causing bank erosion	Regrade the road to drain into the drainage ditch on the opposite side of the road. Restore bank stability in eroded areas.	Treatment has been implemented. In addition, sediment has been removed from the drainage ditch.
CP-001	New culvert installations with invert and outlet. Channel upgrades needed.	Install culvert aprons at invert and outlet, regrade slope above outlet to match existing grade, restore the stream channel below the outlet. Plant vegetation	Apron installed, regrading channel and vegetation planting is still pending.
CP-002	New culvert installations with invert and outlet. Channel upgrades needed.	Install culvert aprons at invert and outlet, regrade slope above outlet to match existing grade, restore the stream channel below the outlet. Plant vegetation	Apron installed, regrading channel and vegetation planting is still pending.
