# MEMORANDUM

REVISED DATE: October 14, 2013

RE: Centennial Brook Watershed: Retrofit Field Findings Summary

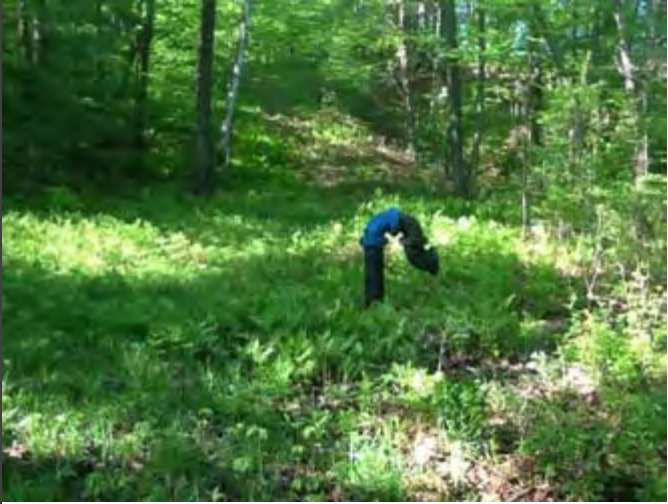
ID#: Retrofit 13					
<b>Name:</b> I-89 Kettle Hole

<b>Concept Description:</b> Detention Pond (or infiltration basin-if soils are acceptable). Directly convey runoff from contributing area off Patchen Road down slope to sediment forebay. Modify existing 30" culvert headwall (under I-89) to achieve required flow control. Could pick up Kirby Rd.					
<b>Notes/Feasibility:</b> Good site; final feasibility will require verification of wetland limits (small area of wetland vegetation, but soils generally upland), assessment of impacts to existing water main (runs through parcel, see blow-off valve in photo), and coordination with VTrans for ponding against I-98 R/W.					
GENERAL SITE INFORMATION	RETROFIT DETAILS				
<b>Site Contact Info:</b> VTrans and private owner	<b>Project Candidate:</b> Yep, Love It				
<b>Ownership:</b> Public and Private	<b>Retrofit of new or existing BMP:</b> New BMP				
<b>Land Use 1:</b> Forest	<b>Proposed Retrofit Practice 1:</b> Pond				
<b>Land Use 2:</b> waterline ROW	<b>Proposed Retrofit Practice 2:</b> Infiltration if feasible possible HW issues with water line				
<b>Existing BMP on site?</b> No	<b>Non-Structural Controls:</b> -None Selected-				
<b>Is site a hotspot?</b> No	<b>Non-Structural Other:</b> -None Selected-				
<b>Sources/pollutants 1:</b> Sediment	<b>Maintenance Burden:</b> -Low				
<b>Sources/pollutants 2:</b> -None Selected-	<table border="0" style="width: 100%;"> <tr> <td style="width: 50%; vertical-align: top;"> <b>Benefits:</b>                      Storage: YES                      Water Quality: NO                      Recharge: YES                      Demo: NO                      Repair: NO                      Reuse: NO                 </td> <td style="width: 50%; vertical-align: top;"> <b>Conflicts:</b>                      Soils: NO                      Access: NO                      Land Use: NO                      Utilities: YES                      Polluted: NO                      High WT: NO                      Wetlands: YES                 </td> </tr> <tr> <td colspan="2" style="vertical-align: top;"> <b>Other:</b> None                 </td> </tr> </table>	<b>Benefits:</b> Storage: YES Water Quality: NO Recharge: YES Demo: NO Repair: NO Reuse: NO	<b>Conflicts:</b> Soils: NO Access: NO Land Use: NO Utilities: YES Polluted: NO High WT: NO Wetlands: YES	<b>Other:</b> None	
<b>Benefits:</b> Storage: YES Water Quality: NO Recharge: YES Demo: NO Repair: NO Reuse: NO		<b>Conflicts:</b> Soils: NO Access: NO Land Use: NO Utilities: YES Polluted: NO High WT: NO Wetlands: YES			
<b>Other:</b> None					
<b>Soils:</b> Good Infiltration					
<b>Use in Retrofit DA:</b> Street, SF Res					
SIZING INFO					
<b>Drainage Area (ac):</b> 14.06					
<b>Impervious Area (ac):</b> 5.05					
<b>Practice Area Available (ft<sup>2</sup>):</b> 10,160					
<b>Existing Head Available?</b> n/a

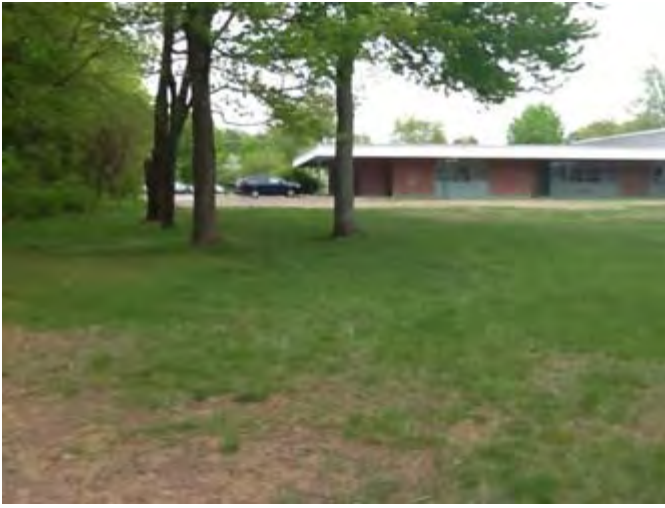
ID#: Retrofit 14A					
<b>Name:</b> Chamberlain School (east)

<b>Concept Description:</b> Underground detention in open space of school property. It seems possible to collect drainage off of White Street (and upgradient residential neighborhood) and connect to existing system via school entrance. Underground chambers could be designed as infiltration pending results of soils testpitting. (note HSG – D on east side of school property).					
<b>Notes/Feasibility:</b> Existing drainage system (12" cmp) drains parking lot. Would need to verify capacity to add addition upgradient lands – only need to be sized for 1- YR. Cp <sub>v</sub> .					
GENERAL SITE INFORMATION	RETROFIT DETAILS				
<b>Site Contact Info:</b> School	<b>Project Candidate:</b> Undecided				
<b>Ownership:</b> Public	<b>Retrofit of new or existing BMP:</b> New BMP				
<b>Land Use 1:</b> School	<b>Proposed Retrofit Practice 1:</b> Pre-treatment chambers				
<b>Land Use 2:</b> -None Selected-	<b>Proposed Retrofit Practice 2:</b> Underground storage, no infiltration				
<b>Existing BMP on site?</b> No	<b>Non-Structural Controls:</b> Educational signage for school				
<b>Is site a hotspot?</b> No	<b>Non-Structural Other:</b> -None Selected-				
<b>Sources/pollutants 1:</b> Sediment	<b>Maintenance Burden:</b> -None Selected-				
<b>Sources/pollutants 2:</b> -None Selected-	<table border="0" style="width: 100%;"> <tr> <td style="width: 50%; vertical-align: top;"> <b>Benefits:</b>                      Storage: YES                      Water Quality: NO                      Recharge: NO                      Demo: NO                      Repair: NO                      Reuse: NO                 </td> <td style="width: 50%; vertical-align: top;"> <b>Conflicts:</b>                      Soils: YES                      Access: NO                      Land Use: NO                      Utilities: NO                      Polluted: NO                      High WT: YES                      Wetlands: NO                 </td> </tr> <tr> <td colspan="2"><b>Other:</b> -None Selected-</td> </tr> </table>	<b>Benefits:</b> Storage: YES Water Quality: NO Recharge: NO Demo: NO Repair: NO Reuse: NO	<b>Conflicts:</b> Soils: YES Access: NO Land Use: NO Utilities: NO Polluted: NO High WT: YES Wetlands: NO	<b>Other:</b> -None Selected-	
<b>Benefits:</b> Storage: YES Water Quality: NO Recharge: NO Demo: NO Repair: NO Reuse: NO		<b>Conflicts:</b> Soils: YES Access: NO Land Use: NO Utilities: NO Polluted: NO High WT: YES Wetlands: NO			
<b>Other:</b> -None Selected-					
<b>Soils:</b> Poor (HSG D, according to soils mapping)					
<b>Use in Retrofit DA:</b> streets, single family res					
SIZING INFO					
<b>Drainage Area (ac):</b> 31.56 (with #14B)					
<b>Impervious Area (ac):</b> 10.08 (with #14B)					
<b>Practice Area Available (ft<sup>2</sup>):</b> 9,220					
<b>Existing Head Available?</b> n/a

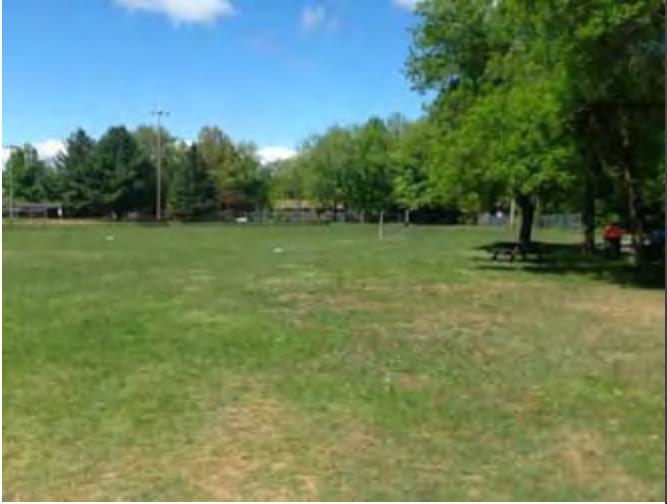
ID#: Retrofit 15					
<b>Name:</b> Jaycee Park

<b>Concept Description:</b> Pretreatment tank to underground infiltration chambers. Pretreatment could be proprietary device (e.g, StormCeptor or equal) before underground chambers. Access would need to be coordinated with playing fields. Flow diversion structure would be in Patchen Road, with depth to drain pipe at approx 6.5 feet.					
<b>Notes/Feasibility:</b> Flow diversion from Patchen Road drives depth of inflow approx 10.5 feet below grade (bottom of chambers 12-13 feet). Existing trees in park, reconstruction of fields Soils at design depth, unknown.					
GENERAL SITE INFORMATION	RETROFIT DETAILS				
<b>Site Contact Info:</b> South Burlington Parks and Rec.	<b>Project Candidate:</b> Yes.				
<b>Ownership:</b> Public	<b>Retrofit of new or existing BMP:</b> New BMP				
<b>Land Use 1:</b> Park	<b>Proposed Retrofit Practice 1:</b> Underground infiltration				
<b>Land Use 2:</b> -None Selected-	<b>Proposed Retrofit Practice 2:</b> Pretreatment structure				
<b>Existing BMP on site?</b> No	<b>Non-Structural Controls:</b> -None Selected-				
<b>Is site a hotspot?</b> No	<b>Non-Structural Other:</b> -None Selected-				
<b>Sources/pollutants 1:</b> Sediment	<b>Maintenance Burden:</b> Medium				
<b>Sources/pollutants 2:</b> -None Selected-	<table border="0" style="width: 100%;"> <tr> <td style="vertical-align: top;"><b>Benefits:</b> Storage: YES Water Quality: YES Recharge: YES Demo: NO Repair: NO Reuse: NO</td> <td style="vertical-align: top;"><b>Conflicts:</b> Soils: NO Access: NO Land Use: YES Utilities: YES Polluted: NO High WT: NO Wetlands: NO</td> </tr> <tr> <td><b>Other:</b> -None Selected-</td> <td><b>Other:</b> -None Selected-</td> </tr> </table>	<b>Benefits:</b> Storage: YES Water Quality: YES Recharge: YES Demo: NO Repair: NO Reuse: NO	<b>Conflicts:</b> Soils: NO Access: NO Land Use: YES Utilities: YES Polluted: NO High WT: NO Wetlands: NO	<b>Other:</b> -None Selected-	<b>Other:</b> -None Selected-
<b>Benefits:</b> Storage: YES Water Quality: YES Recharge: YES Demo: NO Repair: NO Reuse: NO		<b>Conflicts:</b> Soils: NO Access: NO Land Use: YES Utilities: YES Polluted: NO High WT: NO Wetlands: NO			
<b>Other:</b> -None Selected-	<b>Other:</b> -None Selected-				
<b>Soils:</b> Good Infiltration					
<b>Use in Retrofit DA:</b> streets, SF res, some commercial					
SIZING INFO					
<b>Drainage Area (ac):</b> 15.74					
<b>Impervious Area (ac):</b> 5.81					
<b>Practice Area Available (ft<sup>2</sup>):</b> 32,220 + 2,530 (pretreatment area)					
<b>Existing Head Available?</b> Yes (12- 13 ft depth, overflow ok)

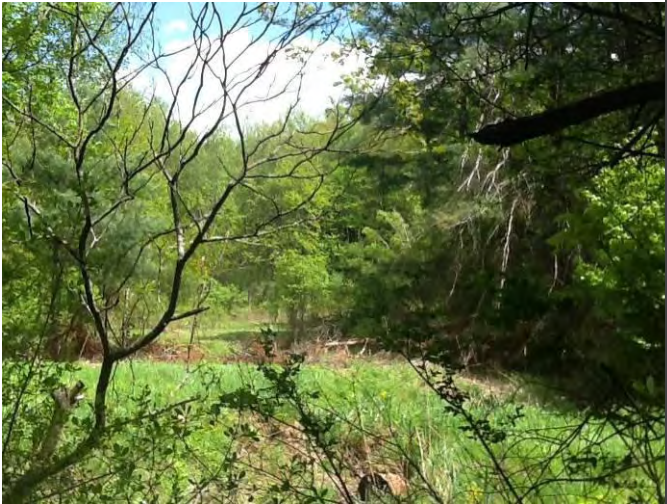
ID#: Retrofit 16 (revised)					
<b>Name:</b> I-89 Outfall

<b>Concept Description:</b> Detention storage facility. Location is flexible depending on evaluation of constraints. Most downstream location would be across from drainage outlet, below water main (best location for embankment – maximizes storage), but impact to water main R/W likely and partially on private property. Alternative is to move embankment upgradient to limit of I-89 R/W – would reduce available storage, but keep all work within VTrans jurisdiction.					
<b>Notes/Feasibility:</b> Feasible, but constraints need to be quantified, including property ownership, wetlands impacts (see Phrag in photo), water main. Construction and maintenance access good, via water main R/W. Vtrans noted that prior riprap work was NOT a permitting issues with COE or DEC.					
GENERAL SITE INFORMATION	RETROFIT DETAILS				
<b>Site Contact Info:</b> VTrans, unknown private owner	<b>Project Candidate:</b> Yes				
<b>Ownership:</b> Public and private (depending on option)	<b>Retrofit of new or existing BMP:</b> New BMP				
<b>Land Use 1:</b> Highway R/W	<b>Proposed Retrofit Practice 1:</b> Detention Pond				
<b>Land Use 2:</b> Open space next to interstate	<b>Proposed Retrofit Practice 2:</b> Could be a const wetland				
<b>Existing BMP on site?</b> No	<b>Non-Structural Controls:</b> -None Selected-				
<b>Is site a hotspot?</b> No	<b>Non-Structural Other:</b> -None Selected-				
<b>Sources/pollutants 1:</b> Sediment	<b>Maintenance Burden:</b> -None Selected-				
<b>Sources/pollutants 2:</b> -None Selected-	<table border="0" style="width: 100%;"> <tr> <td style="width: 50%; vertical-align: top;"> <b>Benefits:</b>                      Storage: YES                      Water Quality: YES                      Recharge: NO                      Demo: NO                      Repair: NO                      Reuse: NO                 </td> <td style="width: 50%; vertical-align: top;"> <b>Conflicts:</b>                      Soils: YES                      Access: NO                      Land Use: YES                      Utilities: YES                      Polluted: NO                      High WT: NO                      Wetlands: YES                 </td> </tr> <tr> <td colspan="2"><b>Other:</b> -None Selected-</td> </tr> </table>	<b>Benefits:</b> Storage: YES Water Quality: YES Recharge: NO Demo: NO Repair: NO Reuse: NO	<b>Conflicts:</b> Soils: YES Access: NO Land Use: YES Utilities: YES Polluted: NO High WT: NO Wetlands: YES	<b>Other:</b> -None Selected-	
<b>Benefits:</b> Storage: YES Water Quality: YES Recharge: NO Demo: NO Repair: NO Reuse: NO		<b>Conflicts:</b> Soils: YES Access: NO Land Use: YES Utilities: YES Polluted: NO High WT: NO Wetlands: YES			
<b>Other:</b> -None Selected-					
<b>Soils:</b> Poor Infiltration					
<b>Use in Retrofit DA:</b> Street, Interstate highway					
SIZING INFO					
<b>Drainage Area (ac):</b> 52.25					
<b>Impervious Area (ac):</b> 18.88					
<b>Practice Area Available (ft<sup>2</sup>):</b> 23,550					
<b>Existing Head Available?</b> n/a

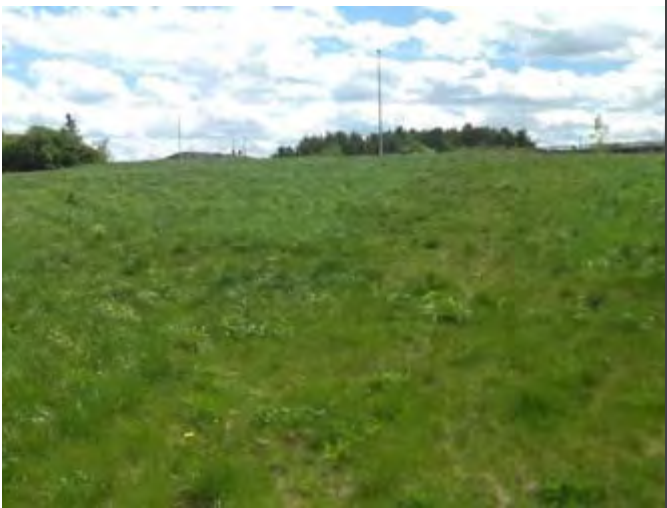
ID#: Retrofit 16A					
<b>Name:</b> I-89 on-ramp (west)

<b>Concept Description:</b> Depression bounded by eastern on-ramp, eastern off-ramp and northbound lanes of I-89. Not an ideal site because the 6' pipe runs under this area at a depth of approx. 8 feet – would have to daylight pipe.					
<b>Notes/Feasibility:</b> Feasible, but would require daylighting 8 ft deep pipe and addressing safely issues off or highway.					
GENERAL SITE INFORMATION	RETROFIT DETAILS				
<b>Site Contact Info:</b> VTrans	<b>Project Candidate:</b> No				
<b>Ownership:</b> Public	<b>Retrofit of new or existing BMP:</b> New BMP				
<b>Land Use 1:</b> Road	<b>Proposed Retrofit Practice 1:</b> Detention Pond				
<b>Land Use 2:</b> -None Selected-	<b>Proposed Retrofit Practice 2:</b> Dry detention basin				
<b>Existing BMP on site?</b> No	<b>Non-Structural Controls:</b> -None Selected-				
<b>Is site a hotspot?</b> No	<b>Non-Structural Other:</b> -None Selected-				
<b>Sources/pollutants 1:</b> Sediment	<b>Maintenance Burden:</b> -None Selected-				
<b>Sources/pollutants 2:</b> -None Selected-	<table border="0" style="width: 100%;"> <tr> <td style="width: 50%;"><b>Benefits:</b> Storage: YES Water Quality: NO Recharge: NO Demo: NO Repair: NO Reuse: NO</td> <td style="width: 50%;"><b>Conflicts:</b> Soils: NO Access: NO Land Use: NO Utilities: YES Polluted: NO High WT: NO Wetlands: NO</td> </tr> <tr> <td><b>Other:</b> -None Selected-</td> <td><b>Other:</b> Fed highway approval</td> </tr> </table>	<b>Benefits:</b> Storage: YES Water Quality: NO Recharge: NO Demo: NO Repair: NO Reuse: NO	<b>Conflicts:</b> Soils: NO Access: NO Land Use: NO Utilities: YES Polluted: NO High WT: NO Wetlands: NO	<b>Other:</b> -None Selected-	<b>Other:</b> Fed highway approval
<b>Benefits:</b> Storage: YES Water Quality: NO Recharge: NO Demo: NO Repair: NO Reuse: NO		<b>Conflicts:</b> Soils: NO Access: NO Land Use: NO Utilities: YES Polluted: NO High WT: NO Wetlands: NO			
<b>Other:</b> -None Selected-		<b>Other:</b> Fed highway approval			
<b>Soils:</b> Poor Infiltration					
<b>Use in Retrofit DA:</b> Highway interchange					
SIZING INFO					
<b>Drainage Area (ac):</b> --					
<b>Impervious Area (ac):</b> --					
<b>Practice Area Available (ft<sup>2</sup>):</b> 8,700					
<b>Existing Head Available?</b> n/a

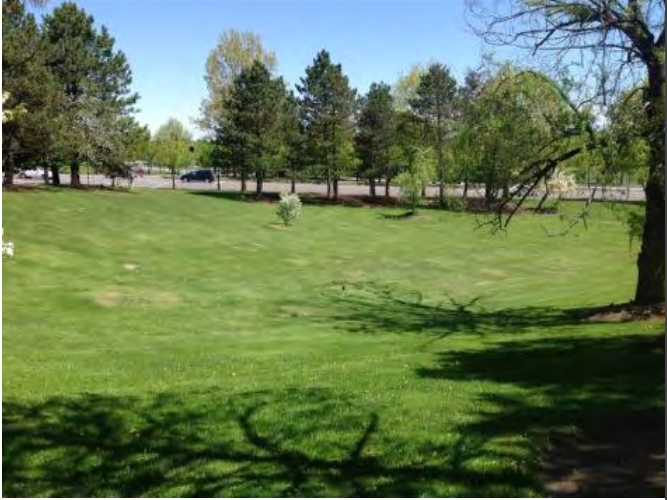
ID#: Retrofit 17 (revised)					
<b>Name:</b> "Jug handle" at Spear & Main St. (east)

<b>Concept Description:</b> Underground detention chambers (UDC) at existing green space to capture drainage from Spear Street and East Terrace. Modify existing drainage inlets to divert flows into basin. Drainage area is currently unmanaged and could be routed to Main St. Pond retrofit #M5A/24 or M5A2, alternatively. Retrofit includes the option of adding paved flumes from the roadways and risers to the outlet structures for the existing swales that run the perimeter of green space. Alternative option for an above ground detention basin may be considered for a reduced construction cost.					
<b>Notes/Feasibility:</b> Original concept was for a surface detention feature, which UVM was not interested in (K&L email dated 6/5/13) due to aesthetics.					
GENERAL SITE INFORMATION	RETROFIT DETAILS				
<b>Site Contact Info:</b> UVM	<b>Project Candidate:</b> Ok				
<b>Ownership:</b> Public	<b>Retrofit of new or existing BMP:</b> New BMP				
<b>Land Use 1:</b> Institutional	<b>Proposed Retrofit Practice 1:</b> UDC or Dry Pond				
<b>Land Use 2:</b> Landscaped green space	<b>Proposed Retrofit Practice 2:</b> Surface swale w/ riser				
<b>Existing BMP on site?</b> No	<b>Non-Structural Controls:</b> -None Selected-				
<b>Is site a hotspot?</b> No	<b>Non-Structural Other:</b> -None Selected-				
<b>Sources/pollutants 1:</b> Sediment	<b>Maintenance Burden:</b> Low				
<b>Sources/pollutants 2:</b> -None Selected-	<table border="0" style="width: 100%;"> <tr> <td style="width: 50%; vertical-align: top;"> <b>Benefits:</b>                      Storage: YES                      Water Quality: YES                      Recharge: YES                      Demo: NO                      Repair: NO                      Reuse: NO                 </td> <td style="width: 50%; vertical-align: top;"> <b>Conflicts:</b>                      Soils: YES                      Access: NO                      Land Use: YES                      Utilities: NO                      Polluted: NO                      High WT: NO                      Wetlands: NO                 </td> </tr> <tr> <td colspan="2"><b>Other:</b> None</td> </tr> </table>	<b>Benefits:</b> Storage: YES Water Quality: YES Recharge: YES Demo: NO Repair: NO Reuse: NO	<b>Conflicts:</b> Soils: YES Access: NO Land Use: YES Utilities: NO Polluted: NO High WT: NO Wetlands: NO	<b>Other:</b> None	
<b>Benefits:</b> Storage: YES Water Quality: YES Recharge: YES Demo: NO Repair: NO Reuse: NO		<b>Conflicts:</b> Soils: YES Access: NO Land Use: YES Utilities: NO Polluted: NO High WT: NO Wetlands: NO			
<b>Other:</b> None					
<b>Soils:</b> Poor Infiltration					
<b>Use in Retrofit DA:</b> Street					
SIZING INFO					
<b>Drainage Area (ac):</b> 22.01					
<b>Impervious Area (ac):</b> 7.28					
<b>Practice Area Available (ft<sup>2</sup>):</b> 21,600					
<b>Existing Head Available?</b> Yes

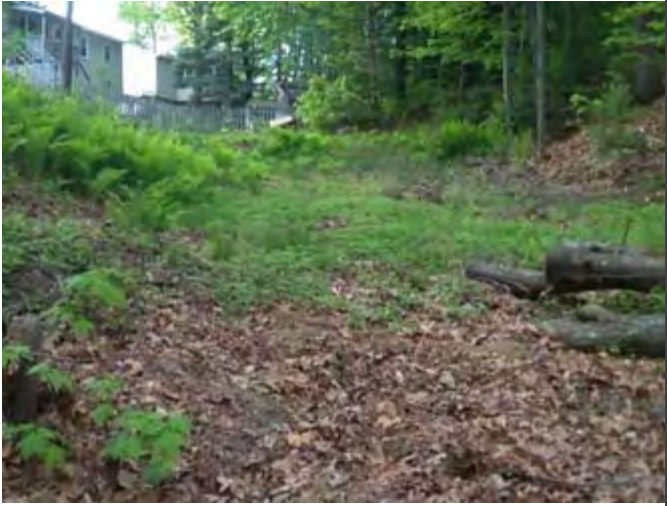
ID#: Retrofit 18					
<b>Name:</b> Fielding Lane Condos – Clover Street

<b>Concept Description:</b> Detention-retention facility. Open parcel adjacent to Fielding Lane Condos – seems to be owned by Fielding Lane Condos, existing surface storage available below outfall pipe. Would require access from Fielding Lane					
<b>Notes/Feasibility:</b> Likely private land - Major constraint is construction and maintenance access. Homeowners on Clover Street most impacted. Downgradient wetlands/stream below outfall pipe.					
GENERAL SITE INFORMATION	RETROFIT DETAILS				
<b>Site Contact Info:</b> Tom DiPietro – S. Burl.	<b>Project Candidate:</b> Yes				
<b>Ownership:</b> Private	<b>Retrofit of new or existing BMP:</b> New BMP				
<b>Land Use 1:</b> Single Family Residential	<b>Proposed Retrofit Practice 1:</b> Detention Pond				
<b>Land Use 2:</b> Adjacent Fielding Lane condos	<b>Proposed Retrofit Practice 2:</b> -None Selected-				
<b>Existing BMP on site?</b> No	<b>Non-Structural Controls:</b> -None Selected-				
<b>Is site a hotspot?</b> -No	<b>Non-Structural Other:</b> -None Selected-				
<b>Sources/pollutants 1:</b> Sediment	<b>Maintenance Burden:</b> Medium				
<b>Sources/pollutants 2:</b> Leaf dumping area	<table border="0" style="width: 100%;"> <tr> <td style="vertical-align: top;"><b>Benefits:</b> Storage: YES Water Quality: YES Recharge: NO Demo: NO Repair: NO Reuse: NO</td> <td style="vertical-align: top;"><b>Conflicts:</b> Soils: NO Access: YES Land Use: YES Utilities: NO Polluted: NO High WT: YES Wetlands: YES</td> </tr> <tr> <td><b>Other:</b> -None Selected-</td> <td><b>Other:</b> -None Selected-</td> </tr> </table>	<b>Benefits:</b> Storage: YES Water Quality: YES Recharge: NO Demo: NO Repair: NO Reuse: NO	<b>Conflicts:</b> Soils: NO Access: YES Land Use: YES Utilities: NO Polluted: NO High WT: YES Wetlands: YES	<b>Other:</b> -None Selected-	<b>Other:</b> -None Selected-
<b>Benefits:</b> Storage: YES Water Quality: YES Recharge: NO Demo: NO Repair: NO Reuse: NO		<b>Conflicts:</b> Soils: NO Access: YES Land Use: YES Utilities: NO Polluted: NO High WT: YES Wetlands: YES			
<b>Other:</b> -None Selected-		<b>Other:</b> -None Selected-			
<b>Soils:</b> Good Infiltration					
<b>Use in Retrofit DA:</b> streets, single family res.					
SIZING INFO					
<b>Drainage Area (ac):</b> 17.11					
<b>Impervious Area (ac):</b> 5.24					
<b>Practice Area Available (ft<sup>2</sup>):</b> 6,950					
<b>Existing Head Available?</b> N/A

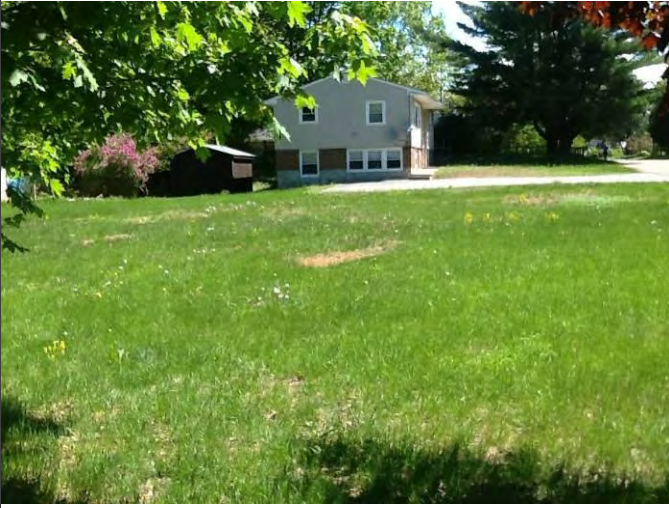
ID#: Retrofit 18A (revised)					
<b>Name:</b> Lot at corner of Patchen & Pine St.

<b>Concept Description:</b> Underground recharge chambers. Diversion of flows from Patchen Road feasible, incoming pipe from open space/low point behind lots too deep to capture. Single lot also contains SF house (see photo). Would require diversion structure and pretreatment tank/structure.					
<b>Notes/Feasibility:</b> Pipe inverts in Patchen Rd. feasible to divert to underground storage, except west side of road would require crossing water and sewer. Depth of construction ~ 8 to 10 ft. Site owned by Yellow Dog Real Estate, LLC. Existing 20' wide drainage easement in the project area.					
GENERAL SITE INFORMATION	RETROFIT DETAILS				
<b>Site Contact Info:</b> Century 21 "Jack"	<b>Project Candidate:</b> Yes				
<b>Ownership:</b> Public/Private	<b>Retrofit of new or existing BMP:</b> New BMP				
<b>Land Use 1:</b> Multi-family Residential	<b>Proposed Retrofit Practice 1:</b> Pre-treatment Str				
<b>Land Use 2:</b> -None Selected-	<b>Proposed Retrofit Practice 2:</b> Underground recharge				
<b>Existing BMP on site?</b> No	<b>Non-Structural Controls:</b> -None Selected-				
<b>Is site a hotspot?</b> No	<b>Non-Structural Other:</b> -None Selected-				
<b>Sources/pollutants 1:</b> Sediment	<b>Maintenance Burden:</b> Medium				
<b>Sources/pollutants 2:</b> -None Selected-	<table border="0" style="width: 100%;"> <tr> <td style="width: 50%; vertical-align: top;"><b>Benefits:</b> Storage: YES Water Quality: NO Recharge: NO Demo: NO Repair: NO Reuse: NO</td> <td style="width: 50%; vertical-align: top;"><b>Conflicts:</b> Soils: YES Access: YES Land Use: YES Utilities: YES Polluted: NO High WT: NO Wetlands: NO</td> </tr> <tr> <td><b>Other:</b> -None Selected-</td> <td><b>Other:</b> -None Selected-</td> </tr> </table>	<b>Benefits:</b> Storage: YES Water Quality: NO Recharge: NO Demo: NO Repair: NO Reuse: NO	<b>Conflicts:</b> Soils: YES Access: YES Land Use: YES Utilities: YES Polluted: NO High WT: NO Wetlands: NO	<b>Other:</b> -None Selected-	<b>Other:</b> -None Selected-
<b>Benefits:</b> Storage: YES Water Quality: NO Recharge: NO Demo: NO Repair: NO Reuse: NO		<b>Conflicts:</b> Soils: YES Access: YES Land Use: YES Utilities: YES Polluted: NO High WT: NO Wetlands: NO			
<b>Other:</b> -None Selected-		<b>Other:</b> -None Selected-			
<b>Soils:</b> Unknown – HSG A on maps					
<b>Use in Retrofit DA:</b> street, SF residential					
SIZING INFO					
<b>Drainage Area (ac):</b> 20.42					
<b>Impervious Area (ac):</b> 6.02					
<b>Practice Area Available (ft<sup>2</sup>):</b> 5,180					
<b>Existing Head Available?</b> n/a

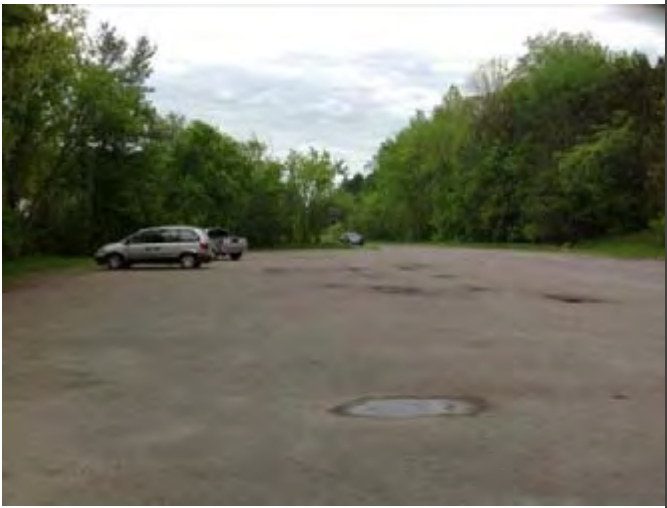
ID#: Retrofit 20					
<b>Name:</b> Grove St. City Parking Lot

<b>Concept Description:</b> Divert existing drainage network and capture runoff from parking lot and direct to proposed underground recharge system. Low point in road drainage area is immediately south of the City parking lot. Consider replacing parking lot with permeable pavement.					
<b>Notes/Feasibility:</b> High feasibility since parking lot is currently in poor condition. Adequate head to capture roadway drainage. Test pits or borings needed to confirm soils and depth to groundwater.					
GENERAL SITE INFORMATION	RETROFIT DETAILS				
<b>Site Contact Info:</b> Megan Moir, Burlington	<b>Project Candidate:</b> Yep, Love It				
<b>Ownership:</b> Public	<b>Retrofit of new or existing BMP:</b> New BMP				
<b>Land Use 1:</b> Road	<b>Proposed Retrofit Practice 1:</b> Infiltration				
<b>Land Use 2:</b> Parking lot	<b>Proposed Retrofit Practice 2:</b> Permeable pavements				
<b>Existing BMP on site?</b> No	<b>Non-Structural Controls:</b> -None Selected-				
<b>Is site a hotspot?</b> No	<b>Non-Structural Other:</b> -None Selected-				
<b>Sources/pollutants 1:</b> No	<b>Maintenance Burden:</b> -None Selected-				
<b>Sources/pollutants 2:</b> -None Selected-	<table border="0" style="width: 100%;"> <tr> <td style="vertical-align: top; width: 50%;"> <b>Benefits:</b>                      Storage: YES                      Water Quality: YES                      Recharge: YES                      Demo: NO                      Repair: NO                      Reuse: NO                 </td> <td style="vertical-align: top; width: 50%;"> <b>Conflicts:</b>                      Soils: NO                      Access: NO                      Land Use: NO                      Utilities: NO                      Polluted: NO                      High WT: NO                      Wetlands: NO                 </td> </tr> <tr> <td colspan="2"><b>Other:</b> None</td> </tr> </table>	<b>Benefits:</b> Storage: YES Water Quality: YES Recharge: YES Demo: NO Repair: NO Reuse: NO	<b>Conflicts:</b> Soils: NO Access: NO Land Use: NO Utilities: NO Polluted: NO High WT: NO Wetlands: NO	<b>Other:</b> None	
<b>Benefits:</b> Storage: YES Water Quality: YES Recharge: YES Demo: NO Repair: NO Reuse: NO		<b>Conflicts:</b> Soils: NO Access: NO Land Use: NO Utilities: NO Polluted: NO High WT: NO Wetlands: NO			
<b>Other:</b> None					
<b>Soils:</b> Good Infiltration					
<b>Use in Retrofit DA:</b> Street and public park					
SIZING INFO					
<b>Drainage Area (ac):</b> 8.39					
<b>Impervious Area (ac):</b> 2.29					
<b>Practice Area Available (ft<sup>2</sup>):</b> 8,850					
<b>Existing Head Available?</b> --

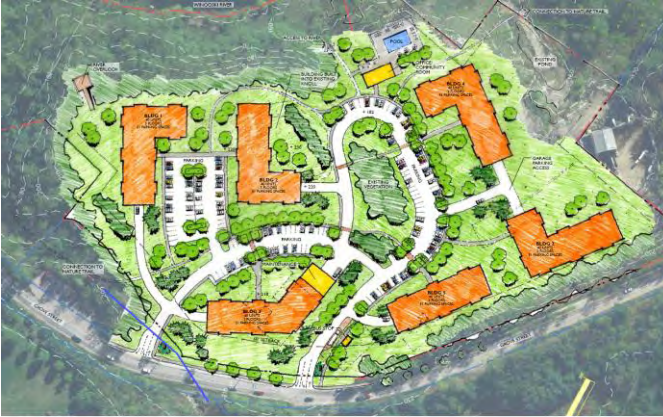
ID#: Retrofit 20A							
<p><b>Name:</b> SD Ireland Property</p> <p><b>Concept Description:</b> SD Ireland proposed redevelopment to a housing complex. Site will reportedly be required to manage runoff on-site. Site currently drains to city drainage system in Grove St. Plans should address severe bank erosion at Centennial Brook culvert under SD Ireland driveway.</p> <p><b>Notes/Feasibility:</b> Centennial Brook runs between property and Grove St.</p>

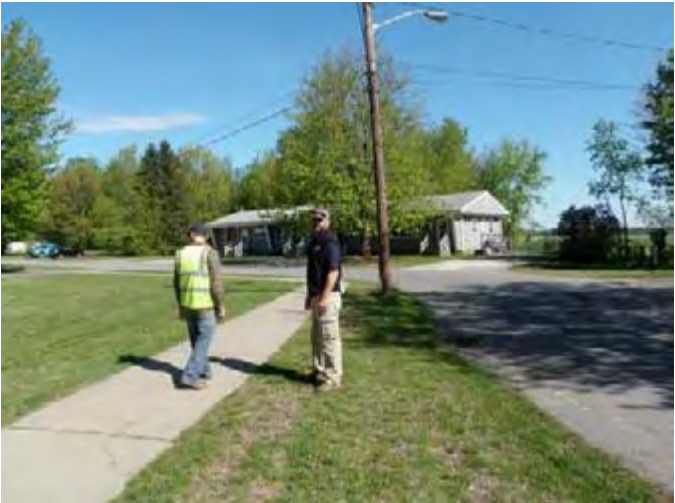
ID#: Retrofit 21							
<b>Name:</b> Dumont Ave. lot

<b>Concept Description:</b> Divert flows from existing catch basin on southeast corner of White St. and Delaware across White St. and convey down Dumont Ave. via pipe or swale to underground recharge chambers on empty lot. Options exist for practice type, siting and conveyance mechanism depending on depth to groundwater, existing inverts, and future use by Airport (e.g., there are other open parcels, could daylight into dry swale, consider surface filtering options). Discharge to existing pipe outlet at Airport basin.							
<b>Notes/Feasibility:</b> Invert at White St. 321.40. Distance to vacant lot on corner – approx. 580' @ .005 slope; pipe outlets at 318.5'. Storage would need to be below grade. Depth to GW could be an issue and eliminate infiltration option (i.e., system would be detention only). For an above grade system inverts at White/Delaware would need to be raised. This may be possible by resetting pipe inverts starting at the intersection of Delaware and Maryland. Possible to create sand filter on top of underground chambers or a large shallow infiltration basin, but can't have standing water due to airport proximity. We have copy of White St. repair plans with sewer line and water lines (both are deep).							
GENERAL SITE INFORMATION	RETROFIT DETAILS						
<b>Site Contact Info:</b> Airport	<b>Project Candidate:</b> Yep, Love It						
<b>Ownership:</b> Public	<b>Retrofit of new or existing BMP:</b> New BMP						
<b>Land Use 1:</b> Single Family Residential	<b>Proposed Retrofit Practice 1:</b> Infiltration						
<b>Land Use 2:</b> None Selected	<b>Proposed Retrofit Practice 2:</b> Dry swale						
<b>Existing BMP on site?</b> No	<b>Non-Structural Controls:</b> -None Selected-						
<b>Is site a hotspot?</b> -No	<b>Non-Structural Other:</b> -None Selected-						
<b>Sources/pollutants 1:</b> -None Selected-	<b>Maintenance Burden:</b> -None Selected-						
<b>Sources/pollutants 2:</b> -None Selected-

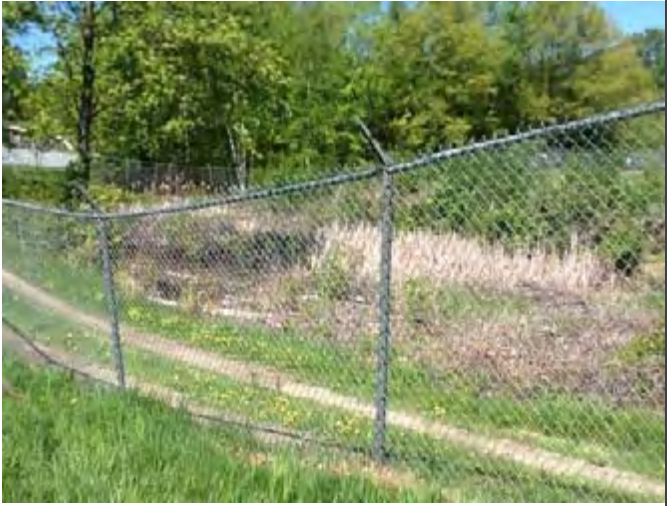
ID#: Retrofit 21A					
<b>Name:</b> Dumont/Existing Airport basin

<b>Concept Description:</b> Abandoned detention basin on airport property could be a location for discharge from the proposed underground chambers (retrofit #21), be an area for expanded storage capacity if needed, or designed to provide for extra water quality "polishing."					
<b>Notes/Feasibility:</b> Not likely that this can be used for surface storage due to FAA standing water restrictions.					
GENERAL SITE INFORMATION	RETROFIT DETAILS				
<b>Site Contact Info:</b> Airport	<b>Project Candidate:</b> Undecided				
<b>Ownership:</b> Public / Airport Authority	<b>Retrofit of new or existing BMP:</b> -None Selected-				
<b>Land Use 1:</b> Industrial	<b>Proposed Retrofit Practice 1:</b> -None Selected-				
<b>Land Use 2:</b> -None Selected-	<b>Proposed Retrofit Practice 2:</b> 0				
<b>Existing BMP on site?</b> -Yes, abandoned	<b>Non-Structural Controls:</b> -None Selected-				
<b>Is site a hotspot?</b> No	<b>Non-Structural Other:</b> -None Selected-				
<b>Sources/pollutants 1:</b> -None Selected-	<b>Maintenance Burden:</b> -None Selected-				
<b>Sources/pollutants 2:</b> -None Selected-	<table border="0" style="width: 100%;"> <tr> <td style="width: 50%; vertical-align: top;"> <b>Benefits:</b>                      Storage: MAYBE                      Water Quality: YES                      Recharge: NO                      Demo: NO                      Repair: NO                      Reuse: NO                 </td> <td style="width: 50%; vertical-align: top;"> <b>Conflicts:</b>                      Soils: NO                      Access: YES                      Land Use: YES                      Utilities: NO                      Polluted: NO                      High WT: NO                      Wetlands: MAYBE                 </td> </tr> <tr> <td colspan="2"><b>Other:</b> -None Selected-</td> </tr> </table>	<b>Benefits:</b> Storage: MAYBE Water Quality: YES Recharge: NO Demo: NO Repair: NO Reuse: NO	<b>Conflicts:</b> Soils: NO Access: YES Land Use: YES Utilities: NO Polluted: NO High WT: NO Wetlands: MAYBE	<b>Other:</b> -None Selected-	
<b>Benefits:</b> Storage: MAYBE Water Quality: YES Recharge: NO Demo: NO Repair: NO Reuse: NO		<b>Conflicts:</b> Soils: NO Access: YES Land Use: YES Utilities: NO Polluted: NO High WT: NO Wetlands: MAYBE			
<b>Other:</b> -None Selected-					
<b>Soils:</b> -None Selected-					
<b>Use in Retrofit DA:</b> -None Selected-					
SIZING INFO					
<b>Drainage Area (ac):</b> 1.16					
<b>Impervious Area (ac):</b> 0.10					
<b>Practice Area Available (ft<sup>2</sup>):</b> 7,600					
<b>Existing Head Available?</b> N/A

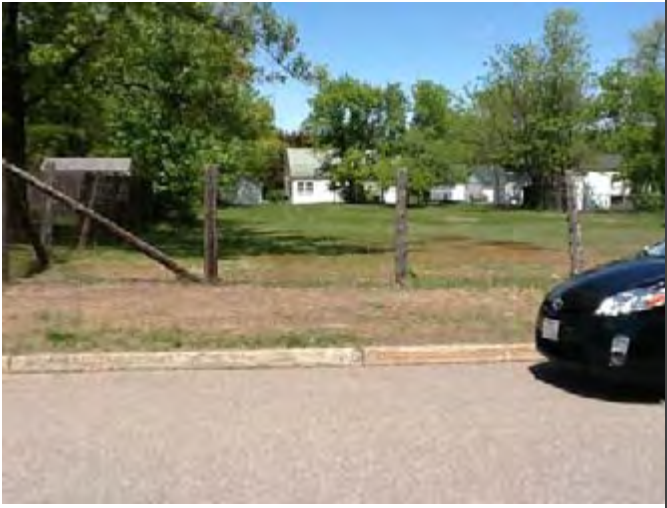
ID#: Retrofit 21C					
<b>Name:</b> Maryland St. lot

<b>Concept Description:</b> Underground recharge chambers under grassed lot. Expensive and high hanging fruit, since lot is currently privately owned and existing neighborhood drainage inlets are deep.					
<b>Notes/Feasibility:</b> Would have to re-plumb drainage network to get it here.					
GENERAL SITE INFORMATION	RETROFIT DETAILS				
<b>Site Contact Info:</b> Unknown	<b>Project Candidate:</b> Undecided				
<b>Ownership:</b> Private	<b>Retrofit of new or existing BMP:</b> New BMP				
<b>Land Use 1:</b> Single Family Residential	<b>Proposed Retrofit Practice 1:</b> Infiltration				
<b>Land Use 2:</b> None Selected-	<b>Proposed Retrofit Practice 2:</b> None Selected-				
<b>Existing BMP on site?</b> No	<b>Non-Structural Controls:</b> -None Selected-				
<b>Is site a hotspot?</b> No	<b>Non-Structural Other:</b> None Selected-				
<b>Sources/pollutants 1:</b> -None Selected-	<b>Maintenance Burden:</b> -None Selected-				
<b>Sources/pollutants 2:</b> None Selected-	<table border="0" style="width: 100%;"> <tr> <td style="width: 50%; vertical-align: top;"> <b>Benefits:</b>                      Storage: YES                      Water Quality: NO                      Recharge: YES                      Demo: NO                      Repair: NO                      Reuse:                 </td> <td style="width: 50%; vertical-align: top;"> <b>Conflicts:</b>                      Soils: NO                      Access: NO                      Land Use: YES                      Utilities: NO                      Polluted: NO                      High WT: NO                      Wetlands: NO                 </td> </tr> <tr> <td colspan="2"><b>Other:</b> None Selected-</td> </tr> </table>	<b>Benefits:</b> Storage: YES Water Quality: NO Recharge: YES Demo: NO Repair: NO Reuse:	<b>Conflicts:</b> Soils: NO Access: NO Land Use: YES Utilities: NO Polluted: NO High WT: NO Wetlands: NO	<b>Other:</b> None Selected-	
<b>Benefits:</b> Storage: YES Water Quality: NO Recharge: YES Demo: NO Repair: NO Reuse:		<b>Conflicts:</b> Soils: NO Access: NO Land Use: YES Utilities: NO Polluted: NO High WT: NO Wetlands: NO			
<b>Other:</b> None Selected-					
<b>Soils:</b> Good Infiltration					
<b>Use in Retrofit DA:</b> Street					
SIZING INFO					
<b>Drainage Area (ac):</b> 6.51					
<b>Impervious Area (ac):</b> 2.46					
<b>Practice Area Available (ft<sup>2</sup>):</b> 9,800					
<b>Existing Head Available?</b> N/A

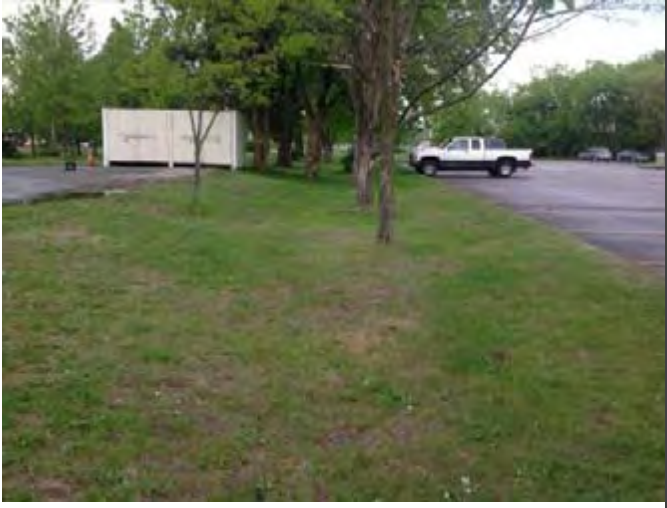
ID#: Retrofit 22B					
<b>Name:</b> Best Western/Windjammer Inn (south)/Gulf Station

<b>Concept Description:</b> Proposed bioretention in existing grass depression to manage sheet flow from the Gulf Station parking lot and roof. Overflow (if required) could connect to existing Best Western drainage system, or be directed to Retrofit 22.					
<b>Notes/Feasibility:</b> Site is an existing depression that appears to already infiltrate. Retrofit would only enhance treatment. Small drainage area.					
GENERAL SITE INFORMATION	RETROFIT DETAILS				
<b>Site Contact Info:</b> Tom Dipietro, S. Burlington	<b>Project Candidate:</b> Undecided				
<b>Ownership:</b> Private	<b>Retrofit of new or existing BMP:</b> New BMP				
<b>Land Use 1:</b> Commercial/Industrial	<b>Proposed Retrofit Practice 1:</b> Bioretention				
<b>Land Use 2:</b> Grass island	<b>Proposed Retrofit Practice 2:</b> -None Selected-				
<b>Existing BMP on site?</b> No	<b>Non-Structural Controls:</b> -None Selected-				
<b>Is site a hotspot?</b> No	<b>Non-Structural Other:</b> -None Selected-				
<b>Sources/pollutants 1:</b> Sediment	<b>Maintenance Burden:</b> Medium				
<b>Sources/pollutants 2:</b> -None Selected-	<table border="0" style="width: 100%;"> <tr> <td style="vertical-align: top;"><b>Benefits:</b> Storage: NO Water Quality: YES Recharge: YES Demo: YES Repair: NO Reuse: NO</td> <td style="vertical-align: top;"><b>Conflicts:</b> Soils: NO Access: NO Land Use: NO Utilities: NO Polluted: NO High WT: NO Wetlands: NO</td> </tr> <tr> <td colspan="2"><b>Other:</b> None</td> </tr> </table>	<b>Benefits:</b> Storage: NO Water Quality: YES Recharge: YES Demo: YES Repair: NO Reuse: NO	<b>Conflicts:</b> Soils: NO Access: NO Land Use: NO Utilities: NO Polluted: NO High WT: NO Wetlands: NO	<b>Other:</b> None	
<b>Benefits:</b> Storage: NO Water Quality: YES Recharge: YES Demo: YES Repair: NO Reuse: NO		<b>Conflicts:</b> Soils: NO Access: NO Land Use: NO Utilities: NO Polluted: NO High WT: NO Wetlands: NO			
<b>Other:</b> None					
<b>Soils:</b> Good Infiltration					
<b>Use in Retrofit DA:</b> Parking Lot					
SIZING INFO					
<b>Drainage Area (ac):</b> 0.22					
<b>Impervious Area (ac):</b> 0.13					
<b>Practice Area Available (ft<sup>2</sup>):</b> 3,670					
<b>Existing Head Available?</b> --

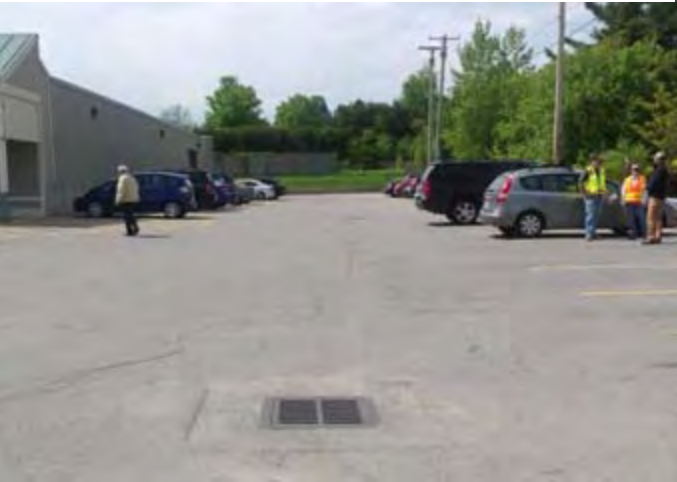
ID#: Retrofit 23B							
<b>Name:</b> Staples Plaza (roof)

<b>Concept Description:</b> Flat portion of roof drains internally and is discharged into drain inlet on the east side of the building. Modify internal roof drains, install trays, or use other blue roof design to provide temporary detention.							
<b>Notes/Feasibility:</b> May be able to manage all of this drainage downstream at Site #24 behind Sheraton /M5A Main St. Pond.							
GENERAL SITE INFORMATION	RETROFIT DETAILS						
<b>Site Contact Info:</b> Unknown	<b>Project Candidate:</b> Ok						
<b>Ownership:</b> Private	<b>Retrofit of new or existing BMP:</b> New BMP						
<b>Land Use 1:</b> Commercial/Industrial	<b>Proposed Retrofit Practice 1:</b> -None Selected-						
<b>Land Use 2:</b> Roof	<b>Proposed Retrofit Practice 2:</b> Blue roof						
<b>Existing BMP on site?</b> No	<b>Non-Structural Controls:</b> -None Selected-						
<b>Is site a hotspot?</b> No	<b>Non-Structural Other:</b> -None Selected-						
<b>Sources/pollutants 1:</b> -None Selected-	<b>Maintenance Burden:</b> Low						
<b>Sources/pollutants 2:</b> -None Selected-

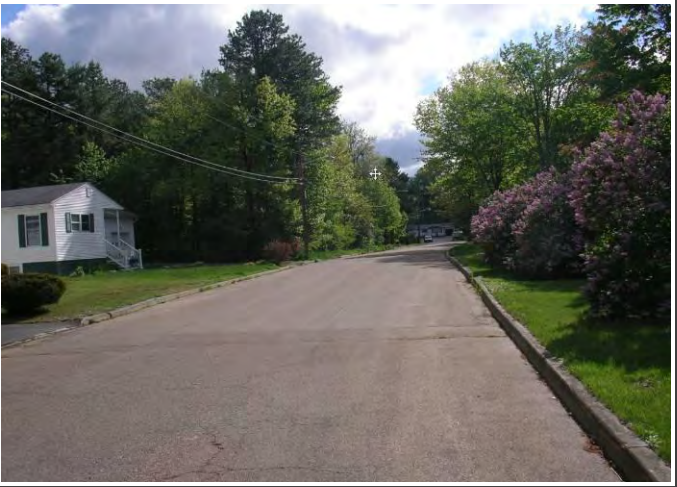
ID#: Retrofit 26 & 27					
<b>Name:</b> Duval St. & Clover St.

<b>Concept Description:</b> 30-ft wide residential streets with direct outfalls to streams, flat terrain, and good soils offer green street and neighborhood-scale disconnection opportunities (e.g., dry wells, rain gardens, pervious driveways, bump outs).					
<b>Notes/Feasibility:</b> Small drainage area; requires participation by homeowners.					
GENERAL SITE INFORMATION	RETROFIT DETAILS				
<b>Site Contact Info:</b> So. Burlington and private owners	<b>Project Candidate:</b> OK, green infrastructure				
<b>Ownership:</b> Public and Private	<b>Retrofit of new or existing BMP:</b> New BMP				
<b>Land Use 1:</b> Single Family Residential	<b>Proposed Retrofit Practice 1:</b> green streets				
<b>Land Use 2:</b> -None Selected-	<b>Proposed Retrofit Practice 2:</b> dry wells, rain gardens				
<b>Existing BMP on site?</b> No	<b>Non-Structural Controls:</b> -None Selected-				
<b>Is site a hotspot?</b> No	<b>Non-Structural Other:</b> -None Selected-				
<b>Sources/pollutants 1:</b> -None Selected-	<b>Maintenance Burden:</b> -Medium				
<b>Sources/pollutants 2:</b> -None Selected-	<table border="0" style="width: 100%;"> <tr> <td style="width: 50%; vertical-align: top;"> <b>Benefits:</b>                      Storage: NO                      Water Quality: YES                      Recharge: YES                      Demo: YES                      Repair: NO                      Reuse: NO                 </td> <td style="width: 50%; vertical-align: top;"> <b>Conflicts:</b>                      Soils: NO                      Access: NO                      Land Use: YES                      Utilities: YES                      Polluted: NO                      High WT: NO                      Wetlands: NO                 </td> </tr> <tr> <td colspan="2"><b>Other:</b> None Selected-</td> </tr> </table>	<b>Benefits:</b> Storage: NO Water Quality: YES Recharge: YES Demo: YES Repair: NO Reuse: NO	<b>Conflicts:</b> Soils: NO Access: NO Land Use: YES Utilities: YES Polluted: NO High WT: NO Wetlands: NO	<b>Other:</b> None Selected-	
<b>Benefits:</b> Storage: NO Water Quality: YES Recharge: YES Demo: YES Repair: NO Reuse: NO		<b>Conflicts:</b> Soils: NO Access: NO Land Use: YES Utilities: YES Polluted: NO High WT: NO Wetlands: NO			
<b>Other:</b> None Selected-					
<b>Soils:</b> Good Infiltration					
<b>Use in Retrofit DA:</b> Streets, driveways, and rooftops					
SIZING INFO					
<b>Drainage Area (ac):</b> 3.59 Duval St./ 3.81 Clover St.					
<b>Impervious Area (ac):</b> 1.19 / 1.4					
<b>Practice Area Available (ft<sup>2</sup>):</b> --					
<b>Existing Head Available?</b> n/a

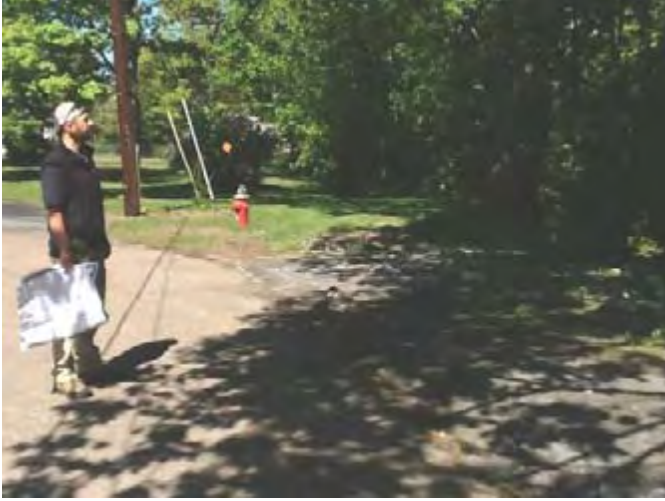
ID#: Retrofit 200	
<b>Name:</b> N. Henry Court	
<p><b>Concept Description:</b>                      Dead-end road with excess impervious cover. Currently, drainage comes down the the road and flows directly down a steep slope to the stream/wetland area below. Install a rain garden/bio with an overflow to a leaching catch basin at end of road. Dumping of yard waste and debris was also observed down the slope. An old corrugated discharge pipe was found down in stream.</p>	
<p><b>Notes/Feasibility:</b>                      Small project, but could be a good GI demonstration.</p>

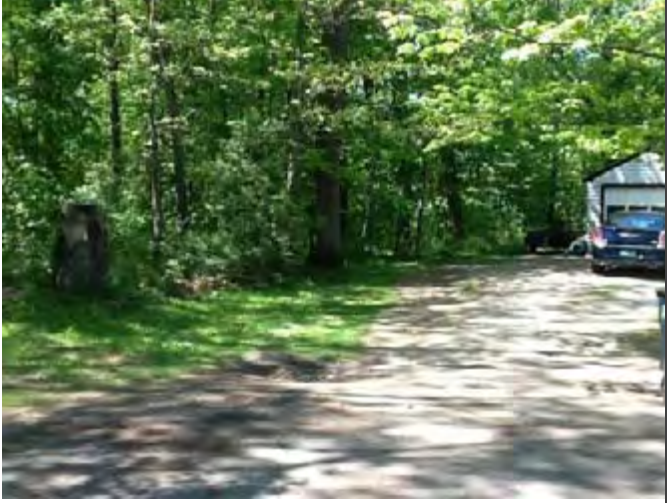
ID#: Retrofit 202														
<b>Name:</b> Lynn St./Barber ter. (south)

<b>Concept Description:</b> Replace existing catch basin at corner of driveway with an infiltrating catch basin. Provide pretreatment grass swale, or simple rain garden between the park entrance and adjacent residence.														
<b>Notes/Feasibility:</b> Small green infrastructure example for neighborhood application.														
GENERAL SITE INFORMATION	RETROFIT DETAILS													
<b>Site Contact Info:</b> 0	<b>Project Candidate:</b> -Probably not													
<b>Ownership:</b> Private	<b>Retrofit of new or existing BMP:</b> New BMP													
<b>Land Use 1:</b> Single Family Residential	<b>Proposed Retrofit Practice 1:</b> Infiltration													
<b>Land Use 2:</b> Road	<b>Proposed Retrofit Practice 2:</b> Pretreatment swale													
<b>Existing BMP on site?</b> No	<b>Non-Structural Controls:</b> -None Selected-													
<b>Is site a hotspot?</b> No	<b>Non-Structural Other:</b> -None Selected-													
<b>Sources/pollutants 1:</b> -None Selected-	<b>Maintenance Burden:</b> -None Selected-													
<b>Sources/pollutants 2:</b> -None Selected-

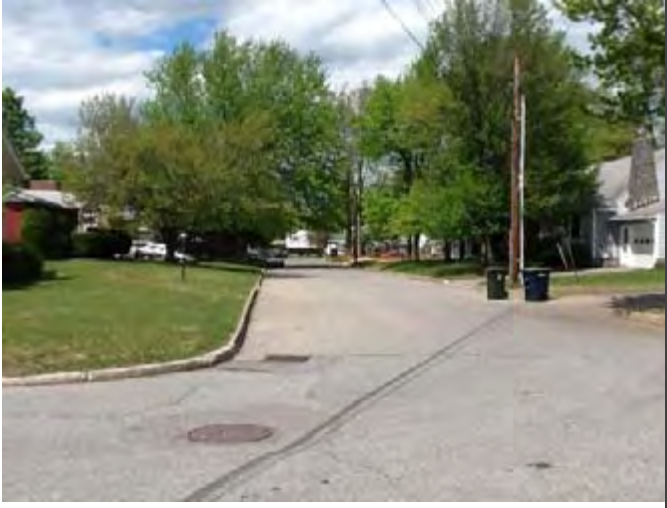
ID#: Retrofit 203					
<b>Name:</b> Suburban Sq. neighborhood

<b>Concept Description:</b> This neighborhood has 30ft road width and 90% of homes have potential for downspout disconnection. Green street options to include infiltrating catch basins, dry wells for individual roofs, and rain gardens for roofs and driveways are options here.					
<b>Notes/Feasibility:</b> Neighborhood is in area draining to Retrofit #14. Could be a good GI neighborhood for demonstration, if needed. 4.1' invert at drain inlet pictured here.					
GENERAL SITE INFORMATION	RETROFIT DETAILS				
<b>Site Contact Info:</b> So. Burlington; individual homeowners	<b>Project Candidate:</b> -Probably not				
<b>Ownership:</b> public and private	<b>Retrofit of new or existing BMP:</b> -New BMP				
<b>Land Use 1:</b> Single family residential	<b>Proposed Retrofit Practice 1:</b> -None Selected-				
<b>Land Use 2:</b> -None Selected-	<b>Proposed Retrofit Practice 2:</b> -None Selected-				
<b>Existing BMP on site?</b> No	<b>Non-Structural Controls:</b> downspout disconnection				
<b>Is site a hotspot?</b> No	<b>Non-Structural Other:</b> -None Selected-				
<b>Sources/pollutants 1:</b> -None Selected-	<b>Maintenance Burden:</b> -None Selected-				
<b>Sources/pollutants 2:</b> -None Selected-	<table border="0" style="width: 100%;"> <tr> <td style="width: 50%; vertical-align: top;"> <b>Benefits:</b>                      Storage: NO                      Water Quality: NO                      Recharge: NO                      Demo: NO                      Repair: NO                      Reuse:                 </td> <td style="width: 50%; vertical-align: top;"> <b>Conflicts:</b>                      Soils: NO                      Access: NO                      Land Use: NO                      Utilities: NO                      Polluted: NO                      High WT: NO                      Wetlands: NO                 </td> </tr> <tr> <td colspan="2"><b>Other:</b> -None Selected-</td> </tr> </table>	<b>Benefits:</b> Storage: NO Water Quality: NO Recharge: NO Demo: NO Repair: NO Reuse:	<b>Conflicts:</b> Soils: NO Access: NO Land Use: NO Utilities: NO Polluted: NO High WT: NO Wetlands: NO	<b>Other:</b> -None Selected-	
<b>Benefits:</b> Storage: NO Water Quality: NO Recharge: NO Demo: NO Repair: NO Reuse:		<b>Conflicts:</b> Soils: NO Access: NO Land Use: NO Utilities: NO Polluted: NO High WT: NO Wetlands: NO			
<b>Other:</b> -None Selected-					
<b>Soils:</b> Good for infiltration					
<b>Use in Retrofit DA:</b> -streets					
SIZING INFO					
<b>Drainage Area (ac):</b> 7.15					
<b>Impervious Area (ac):</b> 2.96					
<b>Practice Area Available (ft<sup>2</sup>):</b> --					
<b>Existing Head Available?</b> 0

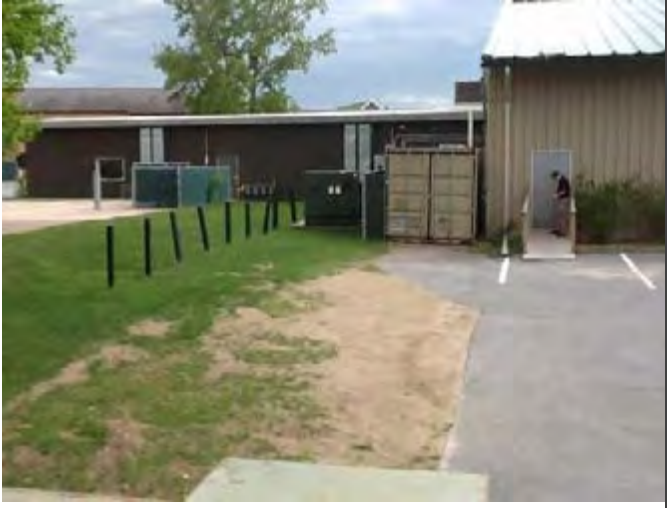
ID#: Retrofit 204					
<b>Name:</b> Greers at Dorset St./Williston Rd.

<b>Concept Description:</b> Install bioretention with underground storage in existing grassed area to capture roof and parking lot runoff. Runoff drains to this area already, but would need to divert from existing drain inlets and overflow back into existing drainage network.					
<b>Notes/Feasibility:</b> Could get roof area from VT Gift barn and upper lot if needed.					
GENERAL SITE INFORMATION	RETROFIT DETAILS				
<b>Site Contact Info:</b> unknown	<b>Project Candidate:</b> Ok				
<b>Ownership:</b> Private	<b>Retrofit of new or existing BMP:</b> New BMP				
<b>Land Use 1:</b> Commercial/Industrial	<b>Proposed Retrofit Practice 1:</b> Bioretention				
<b>Land Use 2:</b> -None Selected-	<b>Proposed Retrofit Practice 2:</b> Underground storage chambers				
<b>Existing BMP on site?</b> No	<b>Non-Structural Controls:</b> -None Selected-				
<b>Is site a hotspot?</b> No	<b>Non-Structural Other:</b> -None Selected-				
<b>Sources/pollutants 1:</b> -None Selected-	<b>Maintenance Burden:</b> Medium				
<b>Sources/pollutants 2:</b> -None Selected-	<table border="0" style="width: 100%;"> <tr> <td style="width: 50%; vertical-align: top;"> <b>Benefits:</b>                      Storage: YES                      Water Quality: YES                      Recharge: NO                      Demo: YES                      Repair: NO                      Reuse:                 </td> <td style="width: 50%; vertical-align: top;"> <b>Conflicts:</b>                      Soils: NO                      Access: NO                      Land Use: NO                      Utilities: NO                      Polluted: NO                      High WT: NO                      Wetlands: NO                 </td> </tr> <tr> <td colspan="2"><b>Other:</b> -None Selected-</td> </tr> </table>	<b>Benefits:</b> Storage: YES Water Quality: YES Recharge: NO Demo: YES Repair: NO Reuse:	<b>Conflicts:</b> Soils: NO Access: NO Land Use: NO Utilities: NO Polluted: NO High WT: NO Wetlands: NO	<b>Other:</b> -None Selected-	
<b>Benefits:</b> Storage: YES Water Quality: YES Recharge: NO Demo: YES Repair: NO Reuse:		<b>Conflicts:</b> Soils: NO Access: NO Land Use: NO Utilities: NO Polluted: NO High WT: NO Wetlands: NO			
<b>Other:</b> -None Selected-					
<b>Soils:</b> Poor Infiltration					
<b>Use in Retrofit DA:</b> small parking lot, roof					
SIZING INFO					
<b>Drainage Area (ac):</b> 0.45					
<b>Impervious Area (ac):</b> 0.38					
<b>Practice Area Available (ft<sup>2</sup>):</b> 1,650					
<b>Existing Head Available?</b> N/A

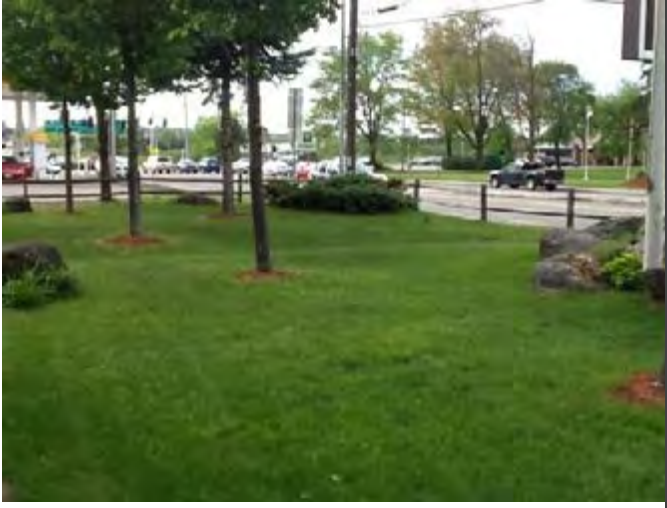
ID#: Retrofit 205					
<b>Name:</b> Vermont Gift Barn

<b>Concept Description:</b> Disconnect rooftop drainage onto parking lot by diverting downspouts into a bioretention in the existing grassed area in front of store. Tie underdrain and overflow into existing drain inlet.					
<b>Notes/Feasibility:</b> Would be an easy retrofit since grassed area already depressed with a yard inlet. Disconnect rooftop runoff going onto parking lot. Area is currently mowed and is lush grass.					
GENERAL SITE INFORMATION	RETROFIT DETAILS				
<b>Site Contact Info:</b> 0	<b>Project Candidate:</b> Ok				
<b>Ownership:</b> Private	<b>Retrofit of new or existing BMP:</b> New BMP				
<b>Land Use 1:</b> Commercial/Industrial	<b>Proposed Retrofit Practice 1:</b> Bioretention				
<b>Land Use 2:</b> None Selected-	<b>Proposed Retrofit Practice 2:</b> None Selected-				
<b>Existing BMP on site?</b> No	<b>Non-Structural Controls:</b> Disconnection				
<b>Is site a hotspot?</b> Possibly	<b>Non-Structural Other:</b> Dumpster and grease management				
<b>Sources/pollutants 1:</b> Sediment	<b>Maintenance Burden:</b> Medium				
<b>Sources/pollutants 2:</b> In rear lot, dumpsters and grease	<table border="0" style="width: 100%;"> <tr> <td style="vertical-align: top;"> <b>Benefits:</b>                      Storage: YES                      Water Quality: YES                      Recharge: NO                      Demo: YES                      Repair: NO                      Reuse:                 </td> <td style="vertical-align: top;"> <b>Conflicts:</b>                      Soils: YES                      Access: NO                      Land Use: NO                      Utilities: NO                      Polluted: NO                      High WT: NO                      Wetlands: NO                 </td> </tr> <tr> <td colspan="2"><b>Other:</b> None Selected-</td> </tr> </table>	<b>Benefits:</b> Storage: YES Water Quality: YES Recharge: NO Demo: YES Repair: NO Reuse:	<b>Conflicts:</b> Soils: YES Access: NO Land Use: NO Utilities: NO Polluted: NO High WT: NO Wetlands: NO	<b>Other:</b> None Selected-	
<b>Benefits:</b> Storage: YES Water Quality: YES Recharge: NO Demo: YES Repair: NO Reuse:		<b>Conflicts:</b> Soils: YES Access: NO Land Use: NO Utilities: NO Polluted: NO High WT: NO Wetlands: NO			
<b>Other:</b> None Selected-					
<b>Soils:</b> Poor Infiltration					
<b>Use in Retrofit DA:</b> Individual Rooftop					
SIZING INFO					
<b>Drainage Area (ac):</b> 0.16					
<b>Impervious Area (ac):</b> 0.12					
<b>Practice Area Available (ft<sup>2</sup>):</b> 660					
<b>Existing Head Available?</b> N/A

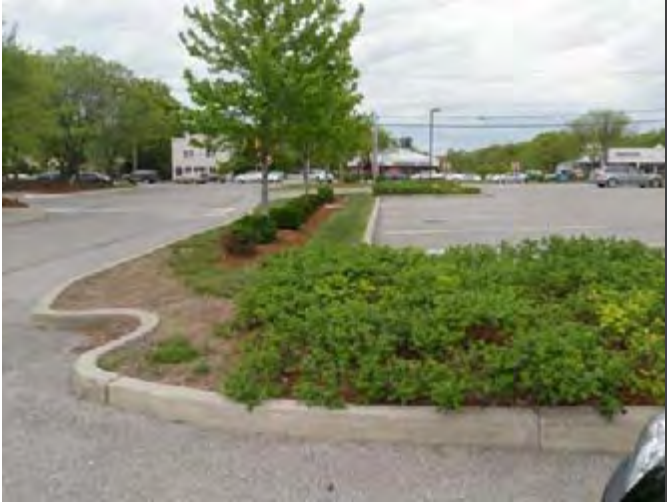
ID#: Retrofit 206					
<b>Name:</b> Northfield Savings Bank

<b>Concept Description:</b> Convert existing landscape island into a bioretention facility, overflow into existing drain inlet.					
<b>Notes/Feasibility:</b> Low feasibility considering private property, however could be relatively easy since there is an existing drain line for overflow. Could be a good green infrastructure demonstration.					
GENERAL SITE INFORMATION	RETROFIT DETAILS				
<b>Site Contact Info:</b> 0	<b>Project Candidate:</b> Ok				
<b>Ownership:</b> Private	<b>Retrofit of new or existing BMP:</b> New BMP				
<b>Land Use 1:</b> Commercial/Industrial	<b>Proposed Retrofit Practice 1:</b> Bioretention				
<b>Land Use 2:</b> Bank	<b>Proposed Retrofit Practice 2:</b> None Selected-				
<b>Existing BMP on site?</b> No	<b>Non-Structural Controls:</b> -None Selected-				
<b>Is site a hotspot?</b> No	<b>Non-Structural Other:</b> None Selected-				
<b>Sources/pollutants 1:</b> -None Selected-	<b>Maintenance Burden:</b> Medium				
<b>Sources/pollutants 2:</b> None Selected-	<table border="0" style="width: 100%;"> <tr> <td style="width: 50%; vertical-align: top;"> <b>Benefits:</b>                      Storage: NO                      Water Quality: YES                      Recharge: NO                      Demo: YES                      Repair: NO                      Reuse: NO                 </td> <td style="width: 50%; vertical-align: top;"> <b>Conflicts:</b>                      Soils: NO                      Access: NO                      Land Use: NO                      Utilities: NO                      Polluted: NO                      High WT: NO                      Wetlands: NO                 </td> </tr> <tr> <td colspan="2"><b>Other:</b> None Selected-</td> </tr> </table>	<b>Benefits:</b> Storage: NO Water Quality: YES Recharge: NO Demo: YES Repair: NO Reuse: NO	<b>Conflicts:</b> Soils: NO Access: NO Land Use: NO Utilities: NO Polluted: NO High WT: NO Wetlands: NO	<b>Other:</b> None Selected-	
<b>Benefits:</b> Storage: NO Water Quality: YES Recharge: NO Demo: YES Repair: NO Reuse: NO		<b>Conflicts:</b> Soils: NO Access: NO Land Use: NO Utilities: NO Polluted: NO High WT: NO Wetlands: NO			
<b>Other:</b> None Selected-					
<b>Soils:</b> Poor Infiltration					
<b>Use in Retrofit DA:</b> Parking Lot					
SIZING INFO					
<b>Drainage Area (ac):</b> 0.17					
<b>Impervious Area (ac):</b> 0.15					
<b>Practice Area Available (ft<sup>2</sup>):</b> 950					
<b>Existing Head Available?</b> N/A
