# MEMORANDUM

REVISED DATE: October 14, 2013

RE: Centennial Brook Watershed: Retrofit Field Findings Summary

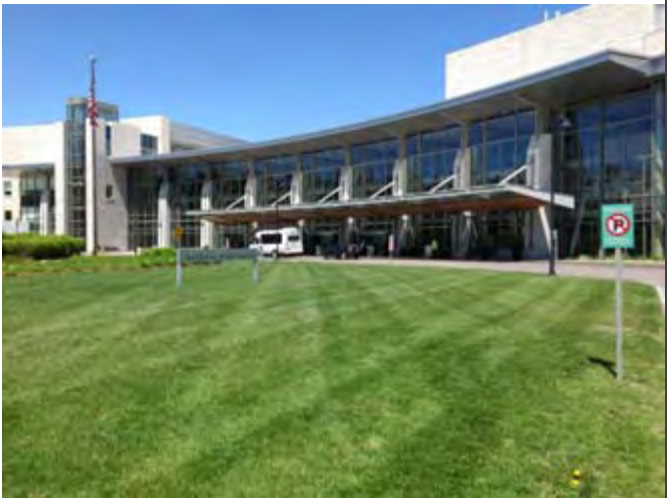
ID#: Retrofit 207											
<b>Name:</b> Fletcher Allen green space

<b>Concept Description:</b> Proposed bioretention area in green space near hospital entrance. Redirect existing roadway trench drains into practice. Site currently drains to the UVM East Campus Pond.											
<b>Notes/Feasibility:</b> Moderate feasibility. Trench drain outlets are shallow so daylighting is possible. Plenty of green space for practice area. High profile location.											
GENERAL SITE INFORMATION	RETROFIT DETAILS										
<b>Site Contact Info:</b> UVM/Burlington	<b>Project Candidate:</b> Ok										
<b>Ownership:</b> Public	<b>Retrofit of new or existing BMP:</b> New BMP										
<b>Land Use 1:</b> Institutional	<b>Proposed Retrofit Practice 1:</b> Bioretention										
<b>Land Use 2:</b> Street/Grass Landscape island	<b>Proposed Retrofit Practice 2:</b> -None Selected-										
<b>Existing BMP on site?</b> No	<b>Non-Structural Controls:</b> -None Selected-										
<b>Is site a hotspot?</b> No	<b>Non-Structural Other:</b> -None Selected-										
<b>Sources/pollutants 1:</b> Sediment	<b>Maintenance Burden:</b> Medium										
<b>Sources/pollutants 2:</b> -None Selected-

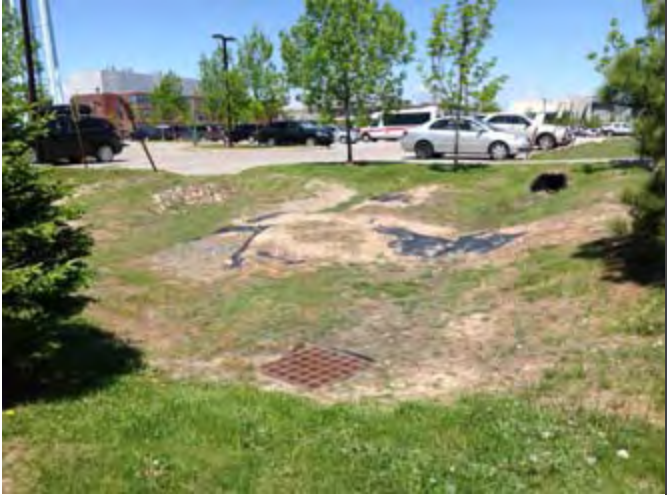
ID#: Retrofit 208					
<b>Name:</b> Fletcher Allen parking lot

<b>Concept Description:</b> Proposed bioretention area in existing drainage feature. Site is currently managed by existing swales, curb cuts, and a drainage depression. Swales and depression are currently eroding. Raise existing catchbasin frame/grate to provide ponding for bioretention.					
<b>Notes/Feasibility:</b> Easy retrofit and aesthetic improvement. Parking lot already has features necessary directing drainage to the retrofit practice location.					
GENERAL SITE INFORMATION	RETROFIT DETAILS				
<b>Site Contact Info:</b> UVM/Burlington	<b>Project Candidate:</b> Ok				
<b>Ownership:</b> Public	<b>Retrofit of new or existing BMP:</b> New BMP				
<b>Land Use 1:</b> Institutional	<b>Proposed Retrofit Practice 1:</b> Bioretention				
<b>Land Use 2:</b> Parking Lot	<b>Proposed Retrofit Practice 2:</b> -None Selected-				
<b>Existing BMP on site?</b> No	<b>Non-Structural Controls:</b> -None Selected-				
<b>Is site a hotspot?</b> No	<b>Non-Structural Other:</b> -None Selected-				
<b>Sources/pollutants 1:</b> Sediment	<b>Maintenance Burden:</b> Medium				
<b>Sources/pollutants 2:</b> -None Selected-	<table border="0" style="width: 100%;"> <tr> <td style="width: 50%; vertical-align: top;"><b>Benefits:</b> Storage: NO Water Quality: YES Recharge: NO Demo: YES Repair: YES Reuse: NO</td> <td style="width: 50%; vertical-align: top;"><b>Conflicts:</b> Soils: NO Access: NO Land Use: NO Utilities: NO Polluted: NO High WT: NO Wetlands: NO</td> </tr> <tr> <td><b>Other:</b> None</td> <td><b>Other:</b> None</td> </tr> </table>	<b>Benefits:</b> Storage: NO Water Quality: YES Recharge: NO Demo: YES Repair: YES Reuse: NO	<b>Conflicts:</b> Soils: NO Access: NO Land Use: NO Utilities: NO Polluted: NO High WT: NO Wetlands: NO	<b>Other:</b> None	<b>Other:</b> None
<b>Benefits:</b> Storage: NO Water Quality: YES Recharge: NO Demo: YES Repair: YES Reuse: NO		<b>Conflicts:</b> Soils: NO Access: NO Land Use: NO Utilities: NO Polluted: NO High WT: NO Wetlands: NO			
<b>Other:</b> None		<b>Other:</b> None			
<b>Soils:</b> Poor Infiltration					
<b>Use in Retrofit DA:</b> Parking Lot					
SIZING INFO					
<b>Drainage Area (ac):</b> 0.85					
<b>Impervious Area (ac):</b> 0.53					
<b>Practice Area Available (ft<sup>2</sup>):</b> 6,400					
<b>Existing Head Available?</b> --

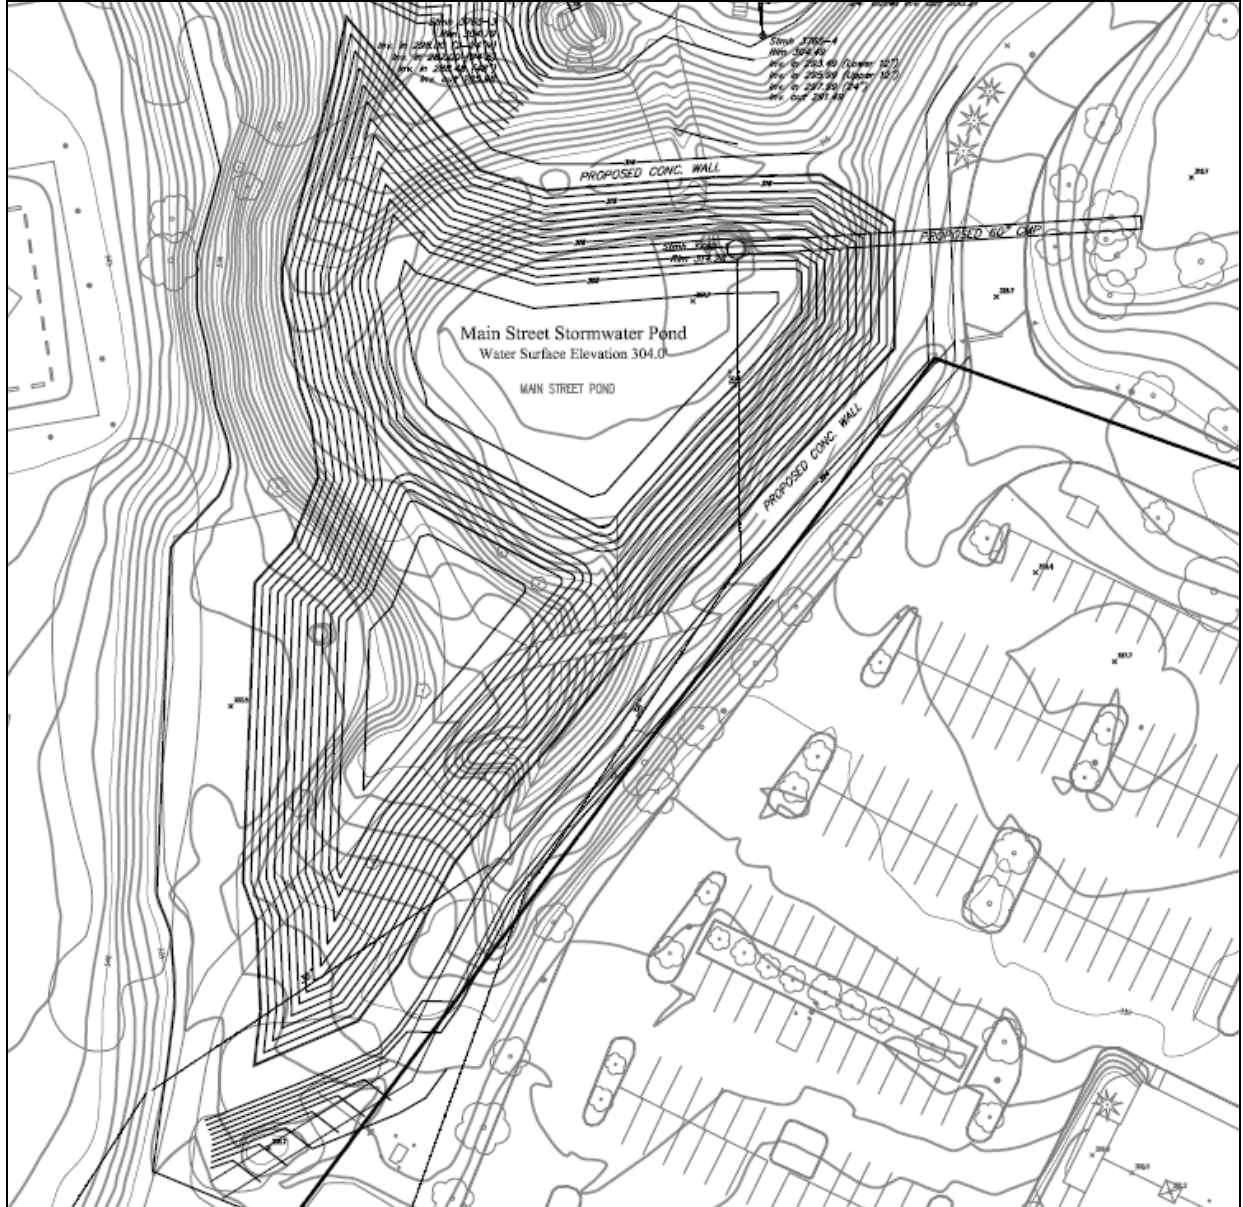
Retrofit M5A2 – Proposed Main Street Pond Expansion (HW modified K&L design)

<b>Concept Description:</b> The Main Street Pond outlet structure is currently not functioning properly and must be repaired. Two potential retrofit options include: <b>M5A</b> involves converting the existing basin to a forebay for proposed Retrofit #24; <b>M5A2</b> involves expanding the existing Main St. Pond southward toward Williston Rd. and excavating to a deeper depth (see attached sketch). HW expanded upon the proposed K&L design of this facility to include a modified outlet structure and a concrete wall for additional storage and attenuation. The parking lot to the north (currently draining to M1 East Campus Pond, was rerouted here in the model).					
<b>Notes/Feasibility:</b> Priority location with high feasibility. Retrofit <b>M5A2</b> will likely require significant ledge removal for the proposed construction activities. Ledge removal is not anticipated for the <b>M5A/24</b> retrofit scenario.					
GENERAL SITE INFORMATION	RETROFIT DETAILS				
<b>Site Contact Info:</b> UVM	<b>Project Candidate:</b> Yep, Love It				
<b>Ownership:</b> Public	<b>Retrofit of new or existing BMP:</b> Existing BMP				
<b>Land Use 1:</b> Institutional	<b>Proposed Retrofit Practice 1:</b> Forebay for Retrofit 24 (M5A)				
<b>Land Use 2:</b> -None Selected-	<b>Proposed Retrofit Practice 2:</b> Expand ex. basin (M5A2)				
<b>Existing BMP on site?</b> Yes	<b>Non-Structural Controls:</b> -None Selected-				
<b>Is site a hotspot?</b> No	<b>Non-Structural Other:</b> -None Selected-				
<b>Sources/pollutants 1:</b> No	<b>Maintenance Burden:</b> Low				
<b>Sources/pollutants 2:</b> -None Selected-	<table border="0" style="width: 100%;"> <tr> <td style="width: 50%; vertical-align: top;"> <b>Benefits:</b>                              Storage: YES                              Water Quality: YES                              Recharge: NO                              Demo: NO                              Repair: NO                              Reuse: NO                         </td> <td style="width: 50%; vertical-align: top;"> <b>Conflicts:</b>                              Soils: YES                              Access: NO                              Land Use: NO                              Utilities: NO                              Polluted: NO                              High WT: NO                              Wetlands: NO                         </td> </tr> <tr> <td colspan="2" style="vertical-align: top;"> <b>Other:</b> None                         </td> </tr> </table>	<b>Benefits:</b> Storage: YES Water Quality: YES Recharge: NO Demo: NO Repair: NO Reuse: NO	<b>Conflicts:</b> Soils: YES Access: NO Land Use: NO Utilities: NO Polluted: NO High WT: NO Wetlands: NO	<b>Other:</b> None	
<b>Benefits:</b> Storage: YES Water Quality: YES Recharge: NO Demo: NO Repair: NO Reuse: NO		<b>Conflicts:</b> Soils: YES Access: NO Land Use: NO Utilities: NO Polluted: NO High WT: NO Wetlands: NO			
<b>Other:</b> None					
<b>Soils:</b> Poor Infiltration					
<b>Use in Retrofit DA:</b> -None Selected-					
SIZING INFO					
<b>Drainage Area (ac):</b> M5A/24 74.04; M5A2 67.93					
<b>Impervious Area (ac):</b> M5A/24 31.12; M5A2 29.04					
<b>Practice Area Available (ft<sup>2</sup>):</b> 61,000					
<b>Existing Head Available?</b> --	<b>Other:</b> Ledge at bottom of existing pond

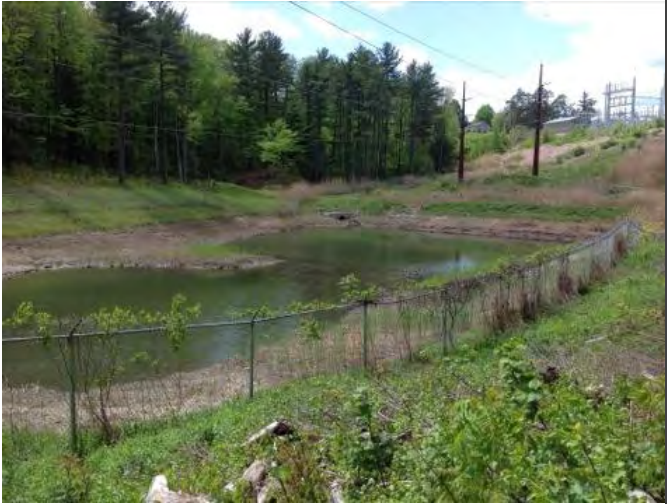
ID#: Retrofit M7A / M7A2 (revised)																			
<b>Name:</b> North Campus Pond

<b>Concept Description:</b> This retrofit of the of existing North Campus Pond includes two proposed expansion options to over control existing runoff (M7A) and manage runoff from proposed future impervious cover (M7A2) . The retrofits include raising the existing embankment by either 3'+/- (M7A) or 6'+/- (M7A2) to provide additional attenuation capacity. May consider horizontal expansion to the north and/or south.																			
<b>Notes/Feasibility:</b> UVM has provided an estimate of the additional proposed drainage area that will be redirected to the basin. UVM to complete a build-out analysis of the contributing drainage area for accommodation within the potential modified basin. An increased berm height of 6' may require elevating the existing high-tension electric lines.																			
GENERAL SITE INFORMATION	RETROFIT DETAILS																		
<b>Site Contact Info:</b> UVM	<b>Project Candidate:</b> Yep, Love It																		
<b>Ownership:</b> Public	<b>Retrofit of new or existing BMP:</b> Existing BMP																		
<b>Land Use 1:</b> Institutional	<b>Proposed Retrofit Practice 1:</b> 3' add. berm height (M7A)																		
<b>Land Use 2:</b> -None Selected-	<b>Proposed Retrofit Practice 2:</b> 6' add. berm height (M7A2)																		
<b>Existing BMP on site?</b> Yes	<b>Non-Structural Controls:</b> -None Selected-																		
<b>Is site a hotspot?</b> No	<b>Non-Structural Other:</b> -None Selected-																		
<b>Sources/pollutants 1:</b> No	<b>Maintenance Burden:</b> Low																		
<b>Sources/pollutants 2:</b> -None Selected-

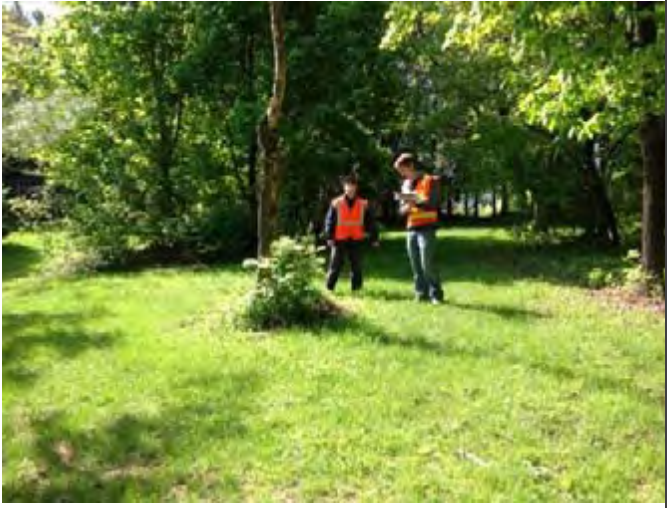
ID#: Retrofit M7B											
<b>Name:</b> Open area east of Case Parkway

<b>Concept Description:</b> Proposed underground recharge system to capture drainage from Bilodeau Court and Case Parkway. Add additional drainage lines to direct existing drainage networks to retrofit. Drainage area could also include areas directed to Retrofit #M7C and M7D.											
<b>Notes/Feasibility:</b> Site is located on UVM property so an agreement between MS4s would be needed. Site is currently partially wooded but existing trees are in poor health.											
GENERAL SITE INFORMATION	RETROFIT DETAILS										
<b>Site Contact Info:</b> Megan Moir, Burlington / UVM	<b>Project Candidate:</b> Ok										
<b>Ownership:</b> Public	<b>Retrofit of new or existing BMP:</b> New BMP										
<b>Land Use 1:</b> Institutional	<b>Proposed Retrofit Practice 1:</b> Infiltration										
<b>Land Use 2:</b> Green space east of Case Pkwy	<b>Proposed Retrofit Practice 2:</b> -None Selected-										
<b>Existing BMP on site?</b> No	<b>Non-Structural Controls:</b> -None Selected-										
<b>Is site a hotspot?</b> No	<b>Non-Structural Other:</b> -None Selected-										
<b>Sources/pollutants 1:</b> No	<b>Maintenance Burden:</b> Medium										
<b>Sources/pollutants 2:</b> -None Selected-
