STORMWATER MANAGEMENT PLAN FOR THE TOWN OF ENOSBURGH AND VILLAGE OF ENOSBURG FALLS

FINAL REPORT

Stone Project ID 112475-W

March 1, 2013

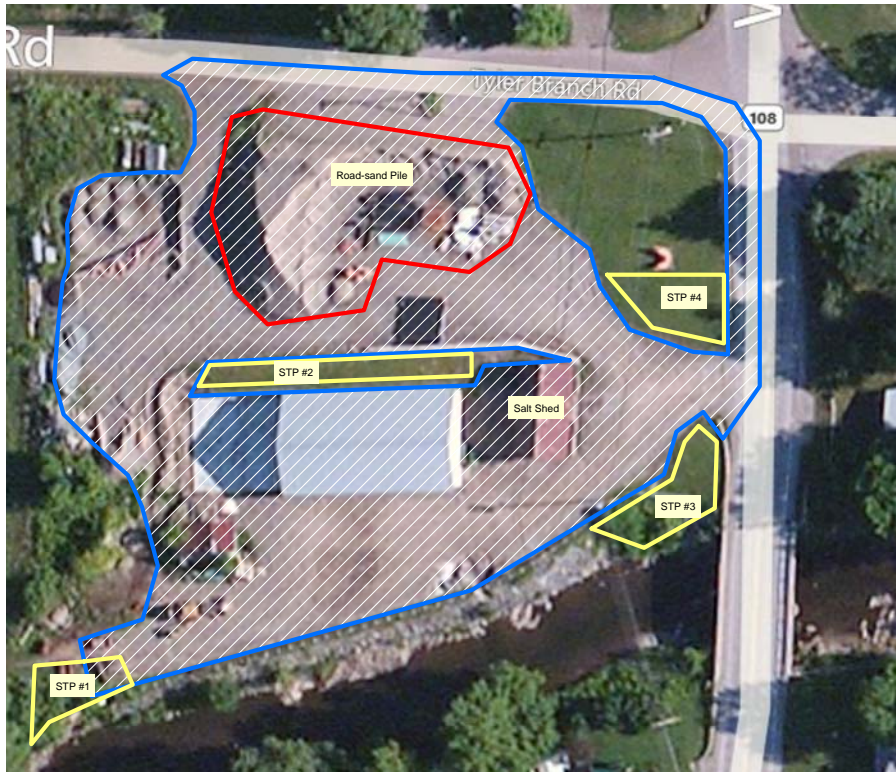
The Enosburg Town road maintenance facility includes 1.5 acres of treatable impervious surface, including 0.2 acres of roof top and 1.3 acres of compacted gravel utilized for parking, equipment storage, and winter road-sand stockpiling. The road-sand stockpile is a persistent source of sediment, and a significant amount of material is mobilized and washed off site during every rain event. Currently, stormwater flows south across the property toward the Tyler Branch. A berm at the top of the river bank directs flow to the southwest corner of the property where stormwater drains directly to the Missisquoi River.

Figure 1. The Enosburg town road maintenance facility includes 1.5 acres of treatable impervious surface (outlined in blue). Potential STP locations are outlined in yellow.

Covering the road-sand stockpile is the best way to prevent the erosion of material. Recently, the town was awarded a grant for approximately \$50,000 for this specific purpose. An engineer’s cost estimate, however, approximated the total cost for a suitable structure to be \$250,000. A lower cost alternative would be to locate a stormwater treatment practice (STP) at the southwest corner of the property to reduce stormwater and sediment loads to Tyler Branch.

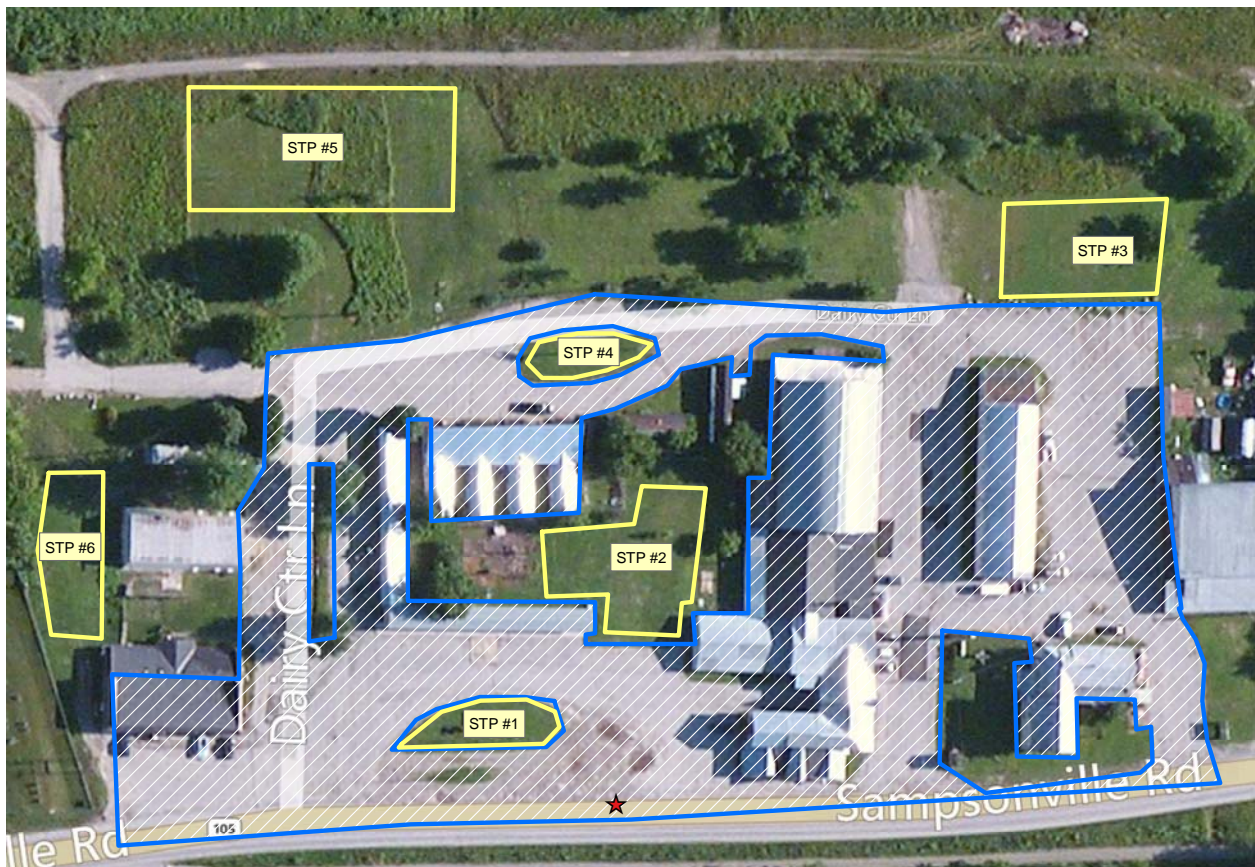
The Dairy Center is a five acre development that includes a bowling alley, restaurant, and lodging. This complex on Rt. 105 includes a large expanse of buildings and asphalt pavement. Nearly 3.6 acres of treatable impervious area were identified on the property, including a number of rooftops and much of the asphalt pavement. The property is immediately across the road from the Missisquoi River. Several potential STP locations were identified and are shown in Figure 2.

Figure 2. 3.6 acres of treatable impervious area were identified (highlighted in blue) at The Dairy Center. A number of STP location options exist (highlighted in yellow).

Soils at the Dairy Center appear to be Missisquoi loamy sand (HSG A). Infiltration would likely be effective at all potential STP sites. The asphalt pavement at the Dairy Center is expansive, and stormwater impacts could be greatly reduced by “de-paving” the existing pavement and replacing portions of it with vegetation or stormwater treatment practices. Pervious pavement may also be an option to reduce stormwater runoff, given the flat topography and well-drained soils underlying the parking lot.

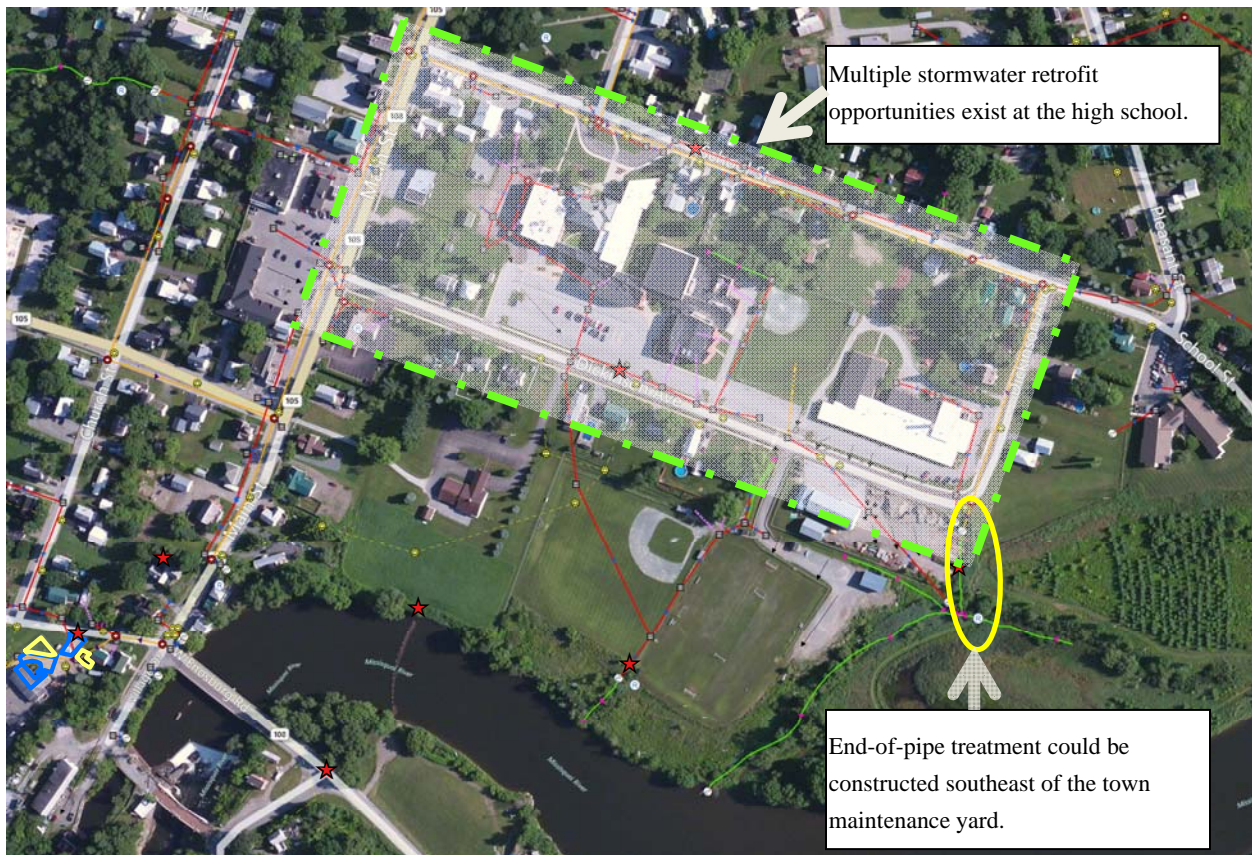
Figure 3. The Enosburg school campus and surrounding Dickinson Avenue neighborhood both include multiple stormwater improvement opportunities.

A two-pronged approach is recommended to treat stormwater from the Enosburg school campus and Dickinson Avenue neighborhood.

- A number of retrofit opportunities exist at stormwater catch basin locations around the school property.
- A larger end-of-pipe treatment practice, such as micro-pool detention, could feasibly be constructed between the outlet to the storm sewer (at the southeast corner of Dickinson Ave.) and the Missisquoi River.

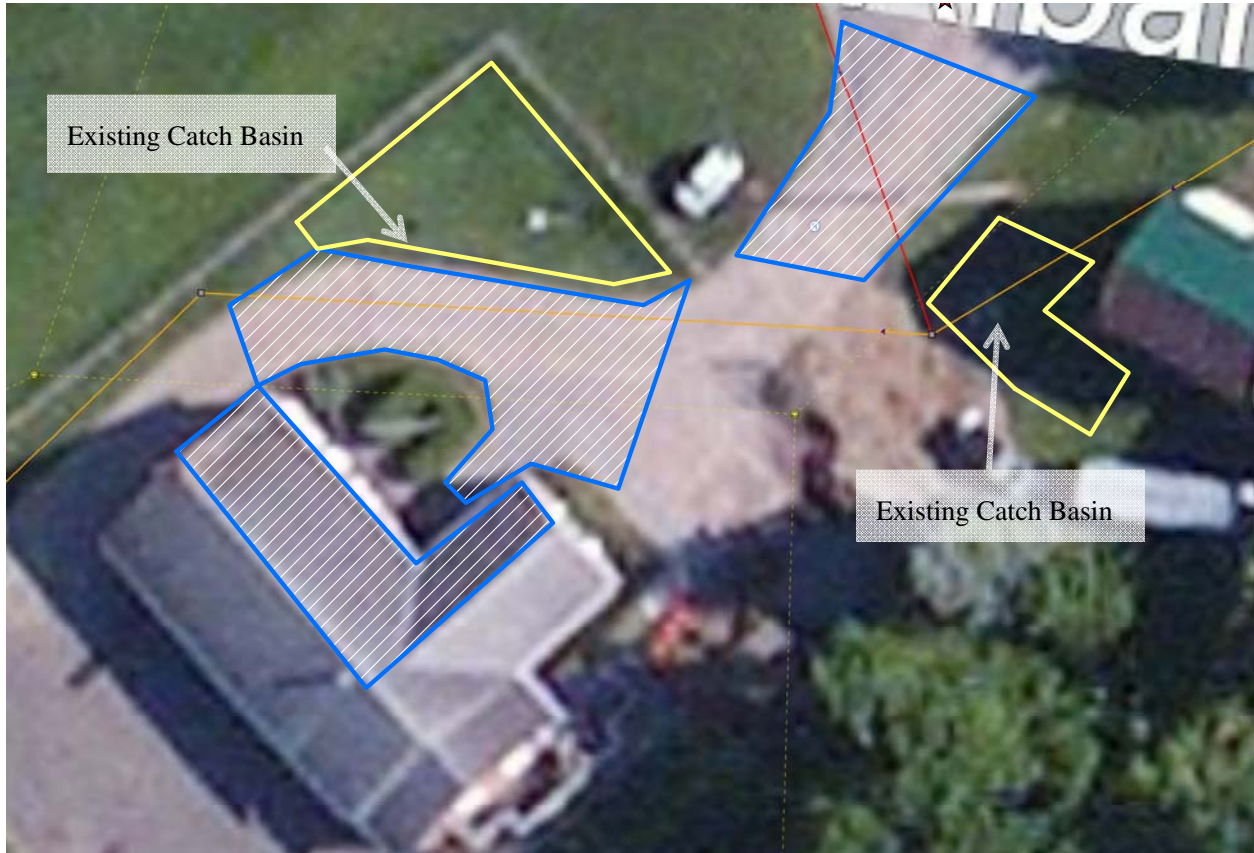
The Enosburg Falls Wastewater Treatment Plant property on St. Albans Street has two catch basins that could be easily retrofitted to treat stormwater. Runoff from portions of two building roofs and two sections of the asphalt drive could be captured and slowly released to the existing stormwater infrastructure through retrofit-bioretenion basins. One-tenth of an acre of treatable impervious surface was identified. Figure 4 shows conceptual locations for the proposed STPs. Soils at these locations appear to be Eldridge loamy fine sands. This soil type (HSG C) drains slowly when thoroughly wet, so infiltration-based practices are not expected to be effective.

Figure 4. Two STPs could be built around two well-located catch basins at the wastewater treatment plant.

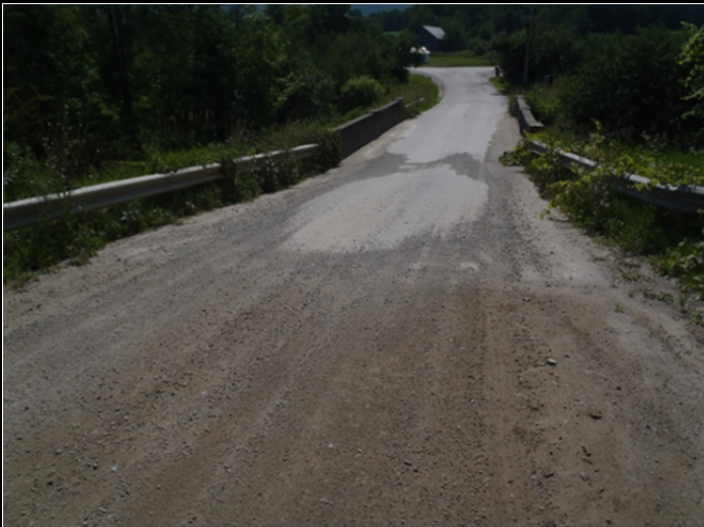
Watershed:	Beaver Meadow Brook													
Location:	Nichols Rd, between Courser Rd and Tyler Branch Rd													
Problem Type:	Bridge/Culvert Issue													
Identification Source:	VTrans Bridge/Culvert Report													
Ownership:	Local													
Classification Level:	3													
Problem Description:														
Bridge on Nichols Rd causing scour pools and channel constrictions.

Photo 1. Sediment build up

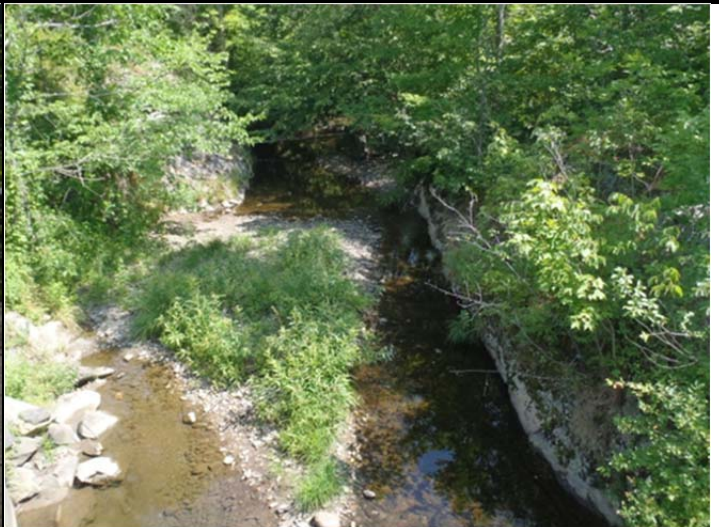
Photo 2. Ledge constricting channel

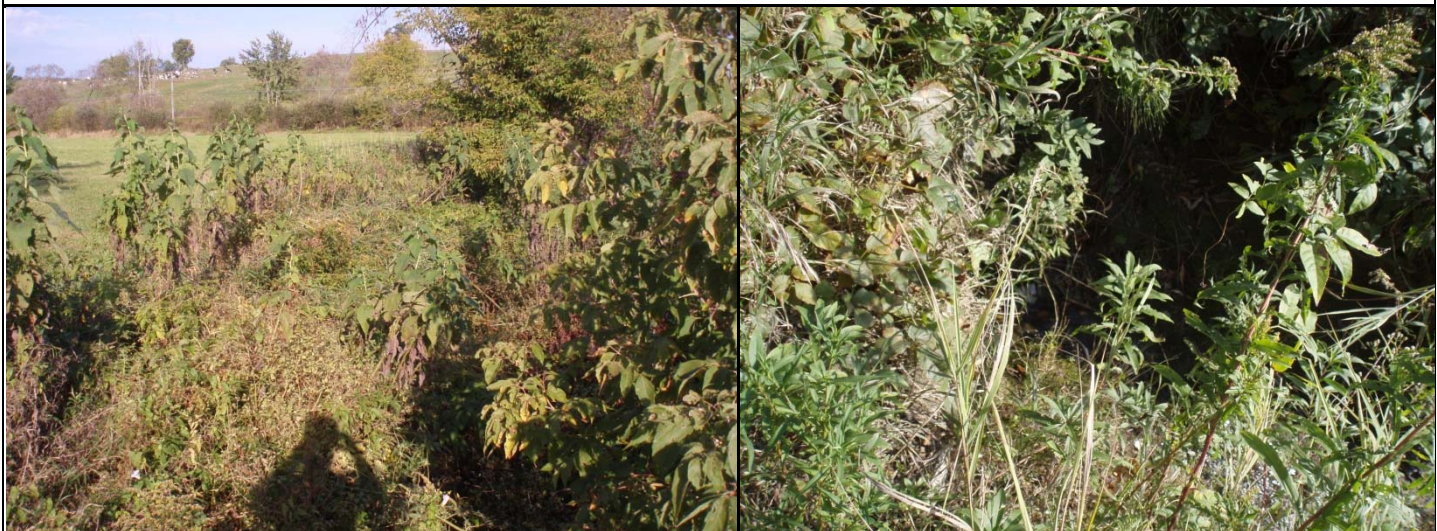
Watershed:	Missisquoi River													
Location:	Route 105, near Choquette Rd													
Problem Type:	Drainage Issues													
Identification Source:	CSA, Lake Champlain Basin Program													
Ownership:	State/Local													
Classification Level:	3													
Problem Description:														
Road run off, Sampsonville Rd/Route 105 from Samponville to Enosburg Falls was identified as potential critical source area because of the amount of water draining to this location and its proximity to the Missisquoi River.

Photo 1. Fields that drain to stream, cows seen above

Photo 2. Outlet to the Missisquoi River

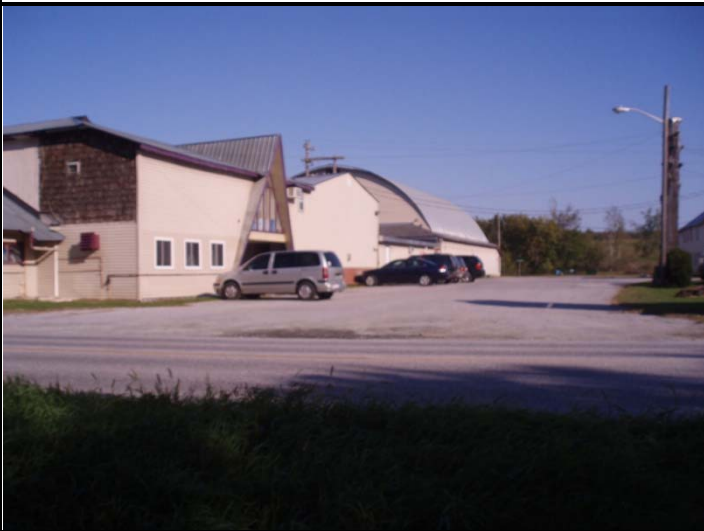
Watershed:	Missisquoi River													
Location:	Dairy Center on Route 105													
Problem Type:	Local Drainage													
Identification Source:	Town Feedback													
Ownership:	Private													
Classification Level:	3													
Problem Description:														
The Town indicated concern about both stormwater and wastewater management (septic) at the Dairy Center on Sampsonville Rd/Rt. 105.

Photo 1. Dairy Center impervious area

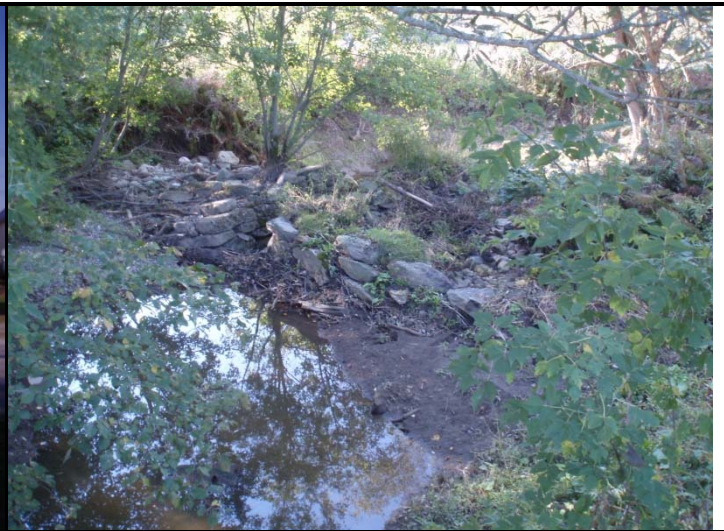
Photo 2. Stream outlet to Missisquoi

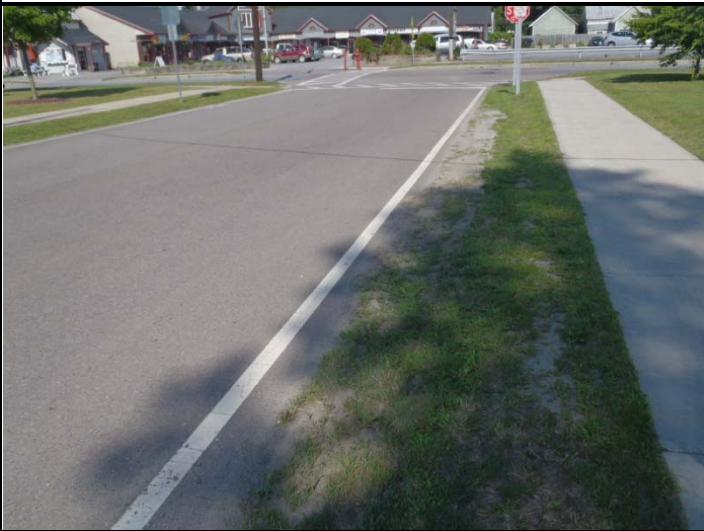
Watershed:	Missisquoi River													
Location:	Dickenson Ave near the intersection with School St													
Problem Type:	Local Drainage													
Identification Source:	Town Feedback													
Ownership:	Local													
Classification Level:	3													
Problem Description:														
Unmanaged stormwater runoff along Dickenson Ave and School St is causing erosion along the road shoulder.

Photo 1. Dickenson Ave looking towards Main St

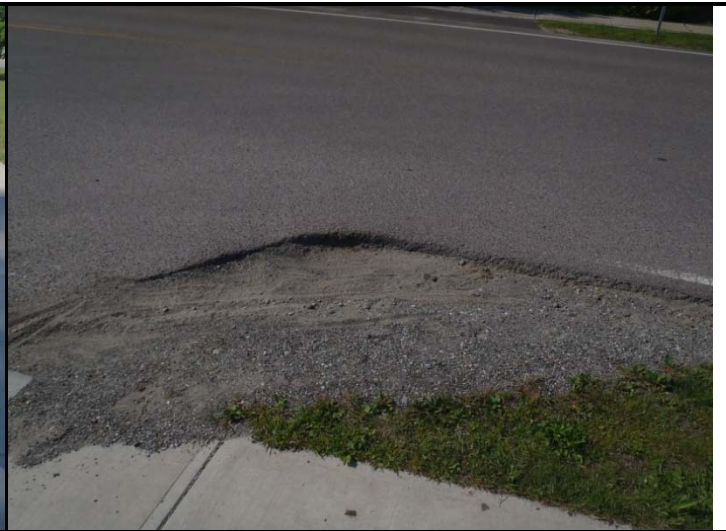
Photo 2. Edge of Dickenson & High School parking lot

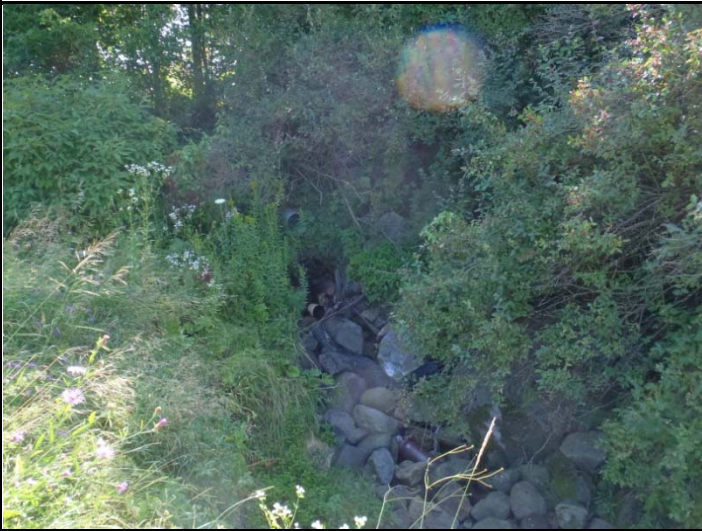
Watershed:	Missisquoi River													
Location:	Missisquoi Valley Rail Trail, near the end of Bismark St													
Problem Type:	Drainage/Future Developments													
Identification Source:	Missisquoi Basin Urban Areas Stormwater Mapping Project													
Ownership:	Local													
Classification Level:	4													
Problem Description:														
Active erosion being caused by flows from two storm sewer outfalls.

Photo 1. Outfalls and rip rap

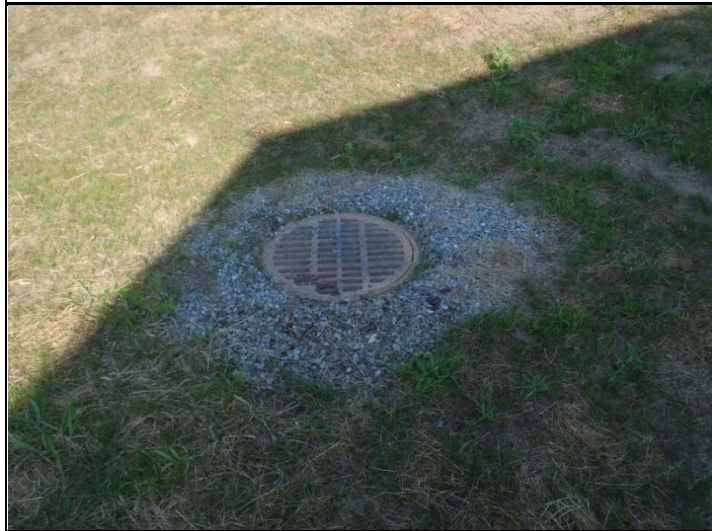
Problem Description:		
Stormwater runoff from the impervious surfaces surrounding the Village wastewater treatment facility discharges directly to the Missisquoi River.		
Date of Field Data Collection: <u>7/13/2012</u>		
Field Photos

Photo 1. Catch basin outside of WW plant

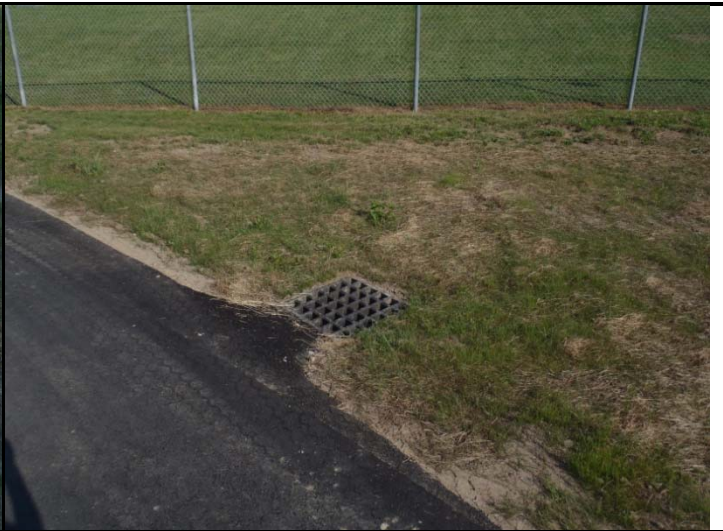
Photo 2. New catch basin at WW plant

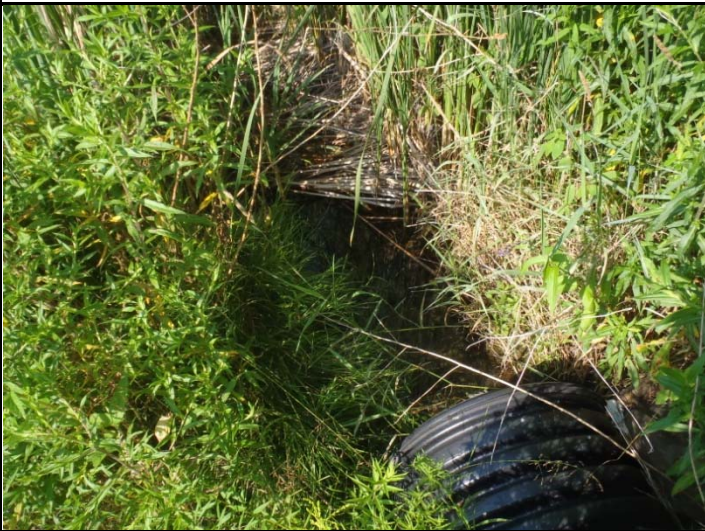
Watershed:	Missisquoi River													
Location:	School athletic fields, off Dickenson Ave													
Problem Type:	Local Drainage													
Identification Source:	Missisquoi Basin Urban Areas Stormwater Mapping Project													
Ownership:	Local													
Classification Level:	3													
Problem Description: Erosion occurring at outfall from storm sewer that carries flows from the Enosburgh schools under the athletic fields. Incised channel is forming as flows make their way to the Missisquoi River.

Photo 1. Outfall at end of system

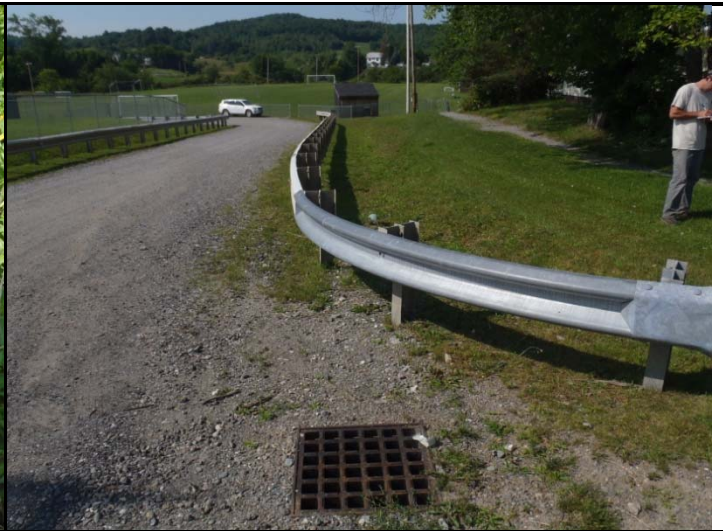
Photo 2. Looking towards fields, near start of system

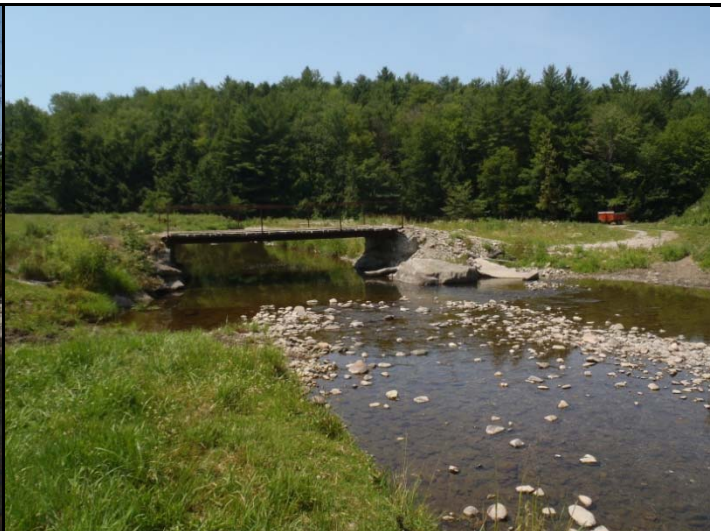
Photo 2. Farm crossing in reach

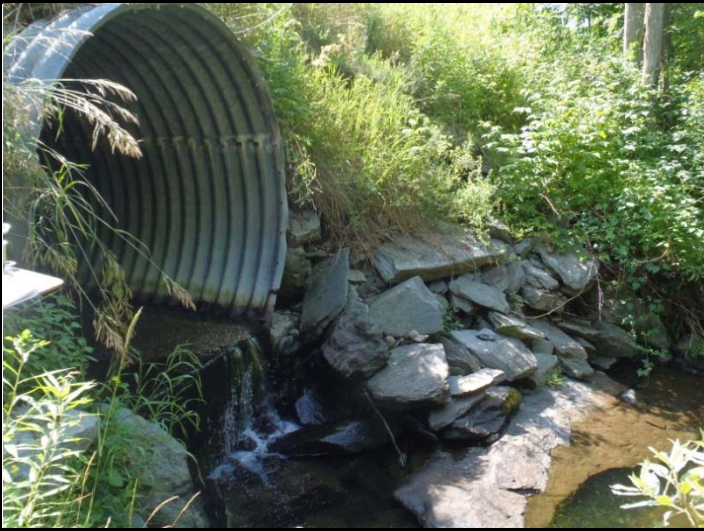
Photo 1. Outfall

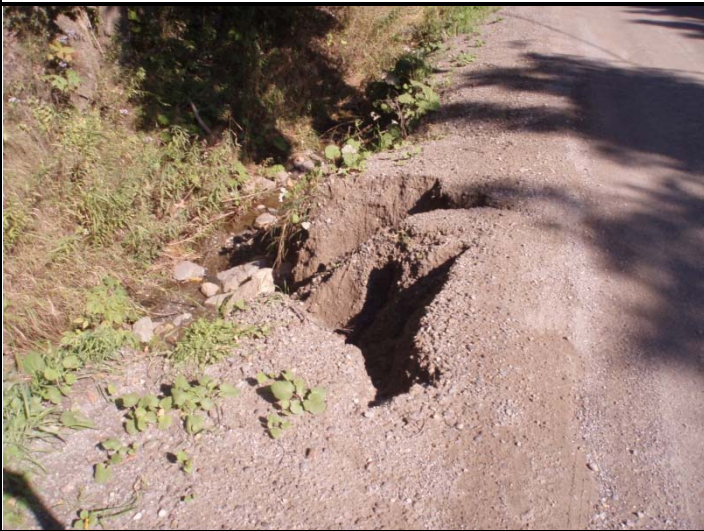
Photo 1. Road falling into ditch

Significant erosion observed on Duffy Hill Rd, south of the Tyler Branch Rd intersection. Most evident between 2181 and 2246 Duffy Hill Rd. Town received a Better Backroads grant and plans to implement a fix this field season.

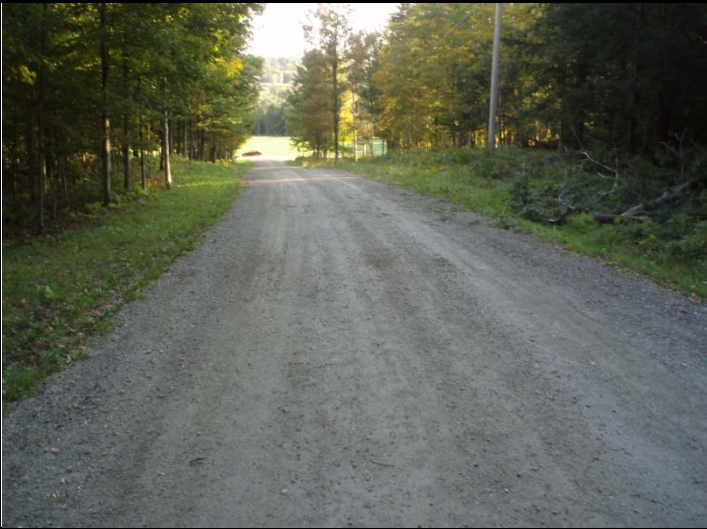
Photo 1. View from the top of Chimney Rd.	Photo 2. Check dam on west side of Chimney Rd.

Description of Observed Conditions:
<p>Ditches along Chimney Rd drain to Bogue Rd. A check dam on the west side of Chimney Rd is buried in sediment. An undersized culvert that takes flow to the east side of the road. Given the slope of Chimney Rd, significant flow is likely. The combined effect of the steep slopes and undersized culvert suggests that during high flow events flow may overtop Bogue Rd at the intersection. Check dam appears to have been installed by adjacent landowner, presumably in attempt to "create" more storage in the ditch.</p>

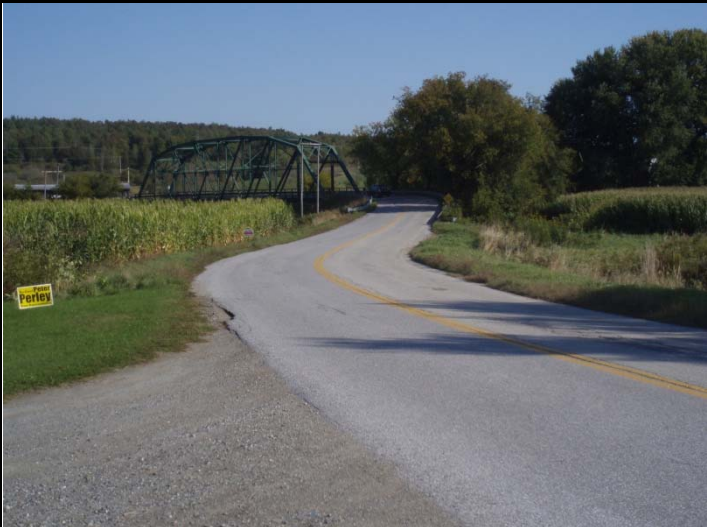
Photo 1. Boston Post Rd, S of Missisquoi crossing

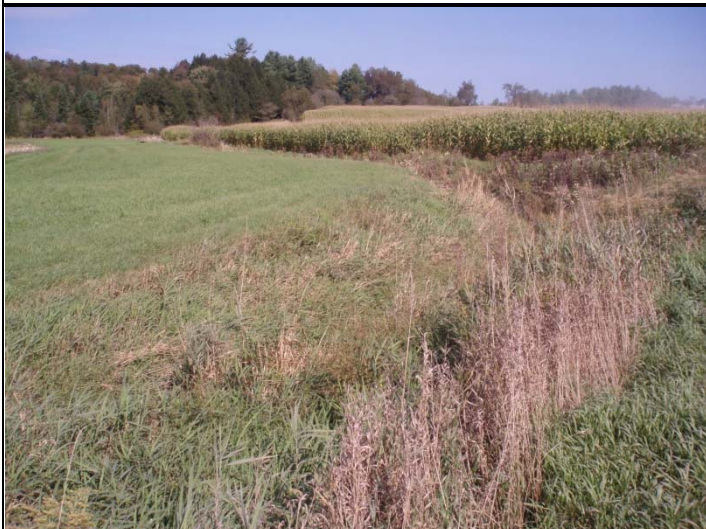
Photo 1. Ditch near the Miss VT Dr, on Howrigan Rd

No major erosion issues observed. Fields mostly slope down from the road; closest fields are (currently) planted in hay. Problems may be more evident when fields are rotated into corn.

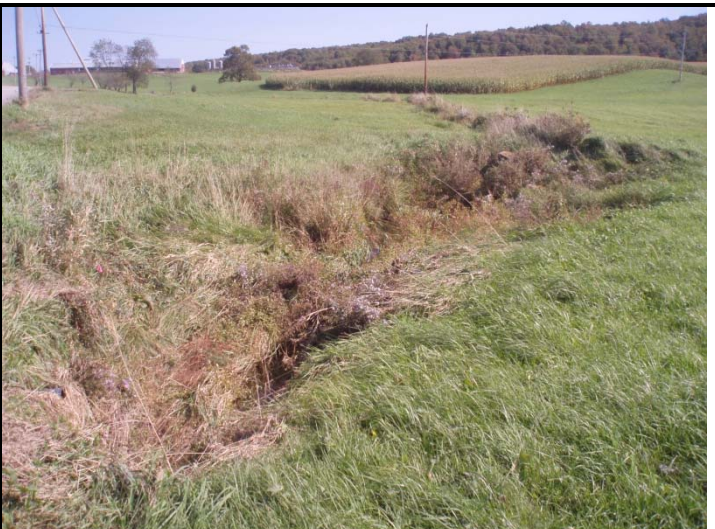
Photo 2. Ditch near the Miss VT Dr, on Howrigan Rd

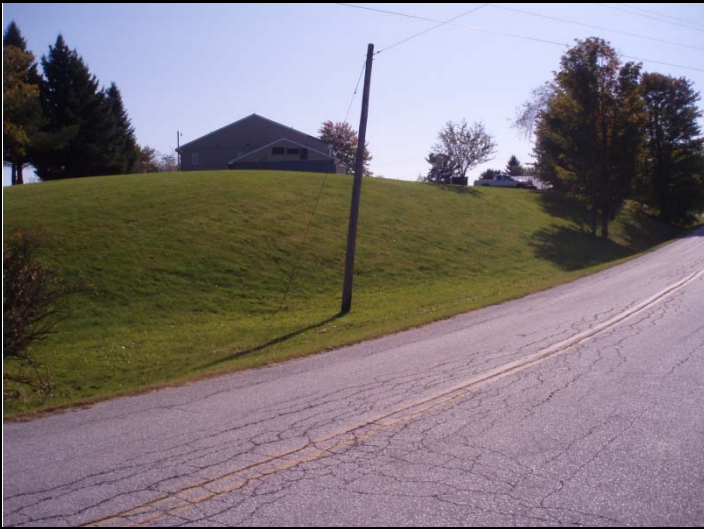
Photo 1. Overview of potential area, existing drainage

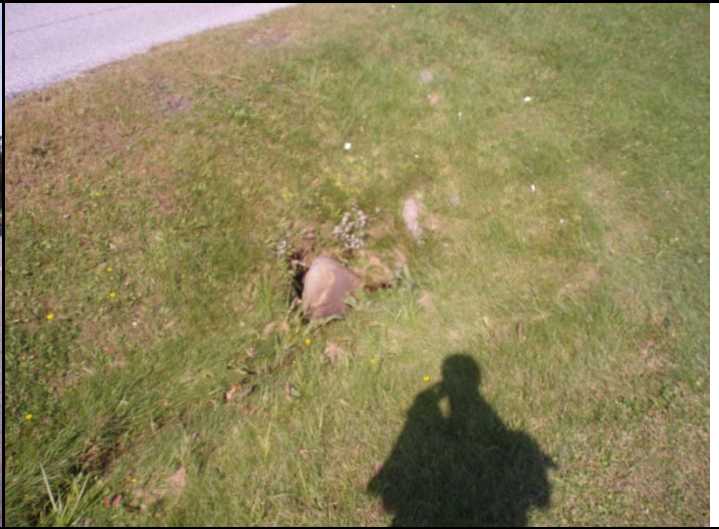
Photo 2. Ditch to undersized culvert

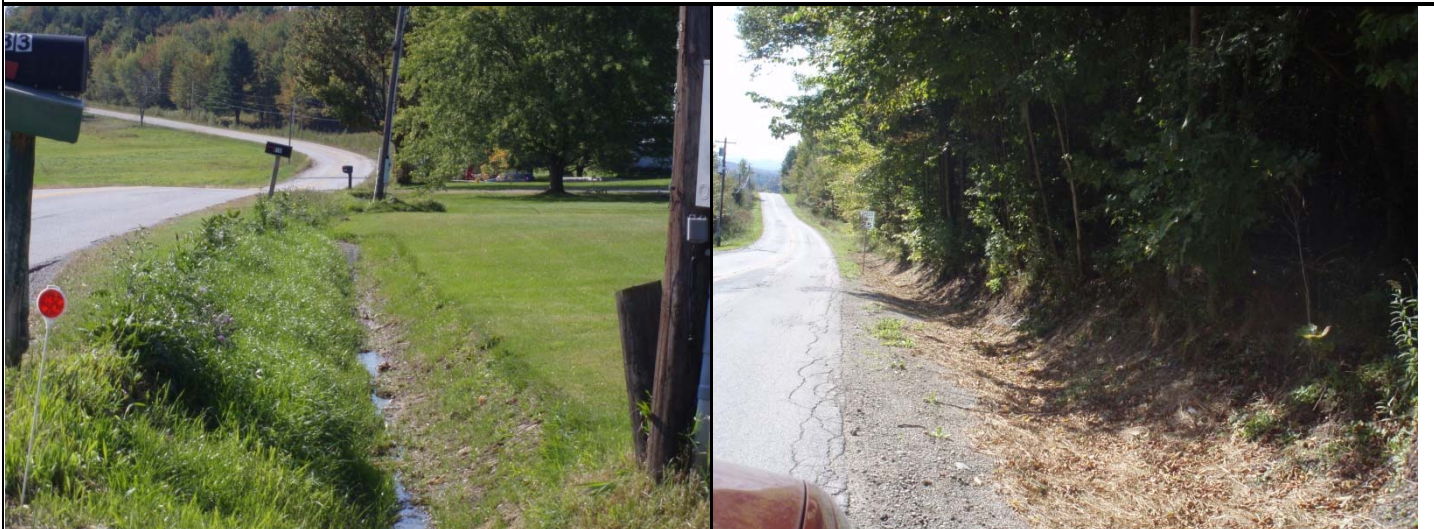
Photo 1. Ditch along Water Tower Rd

Photo 2. Ditch along Water Tower Rd

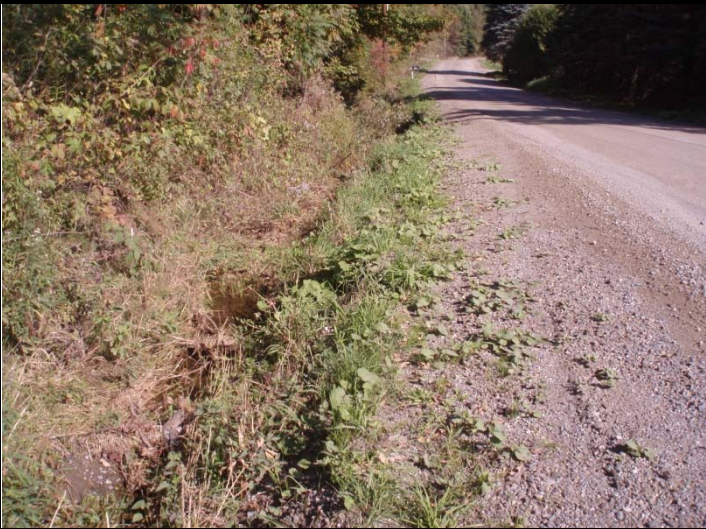
Photo 1. Ditch S of Tyler Branch Rd intersection	Photo 2. Duffy Hill Rd at Tyler Branch Rd

Description of Observed Conditions:
 Plenty of area for future development. Roadside ditches will be primary stormwater conveyance; however steep road slope will present issues as stormwater volumes increase. Stormwater management strategies could be proactively incorporated into the existing conveyance system to reduce potential future impacts.

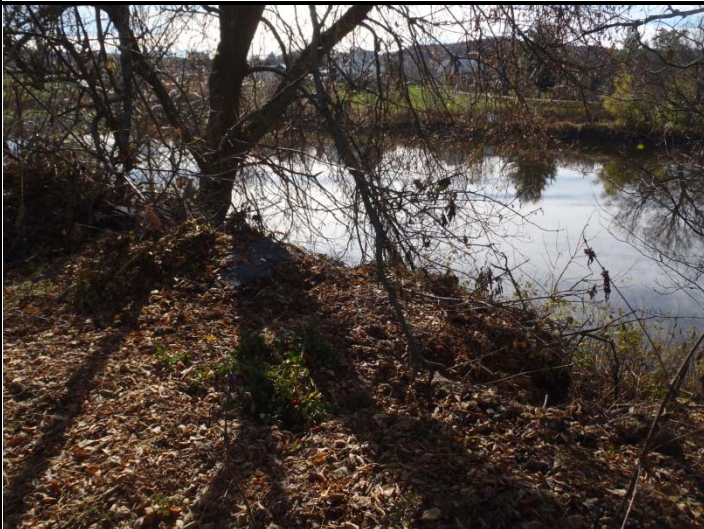
Photo 1. Evidence of yard debris disposal

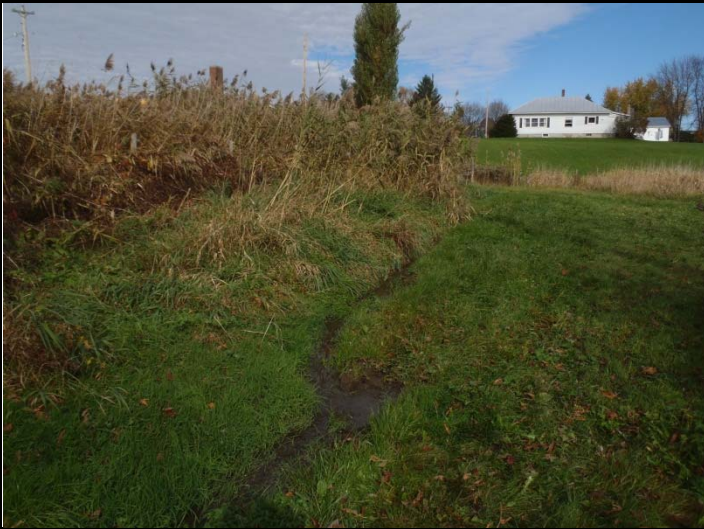
Watershed:	Missisquoi River													
Location:	Village Garage on Dickenson Ave													
Problem Type:	Local Drainage													
Identification Source:	Town/Village Feedback													
Ownership:	Unknown													
Classification Level:	4													
Problem Description:														
<p>Outfall from portion of the storm sewer system draining the elementary school and much of School St. causing erosion along the back edge of the Village Garage property before draining to Missisquoi.</p>

Photo 1. Stream leaves stone-lined ditch

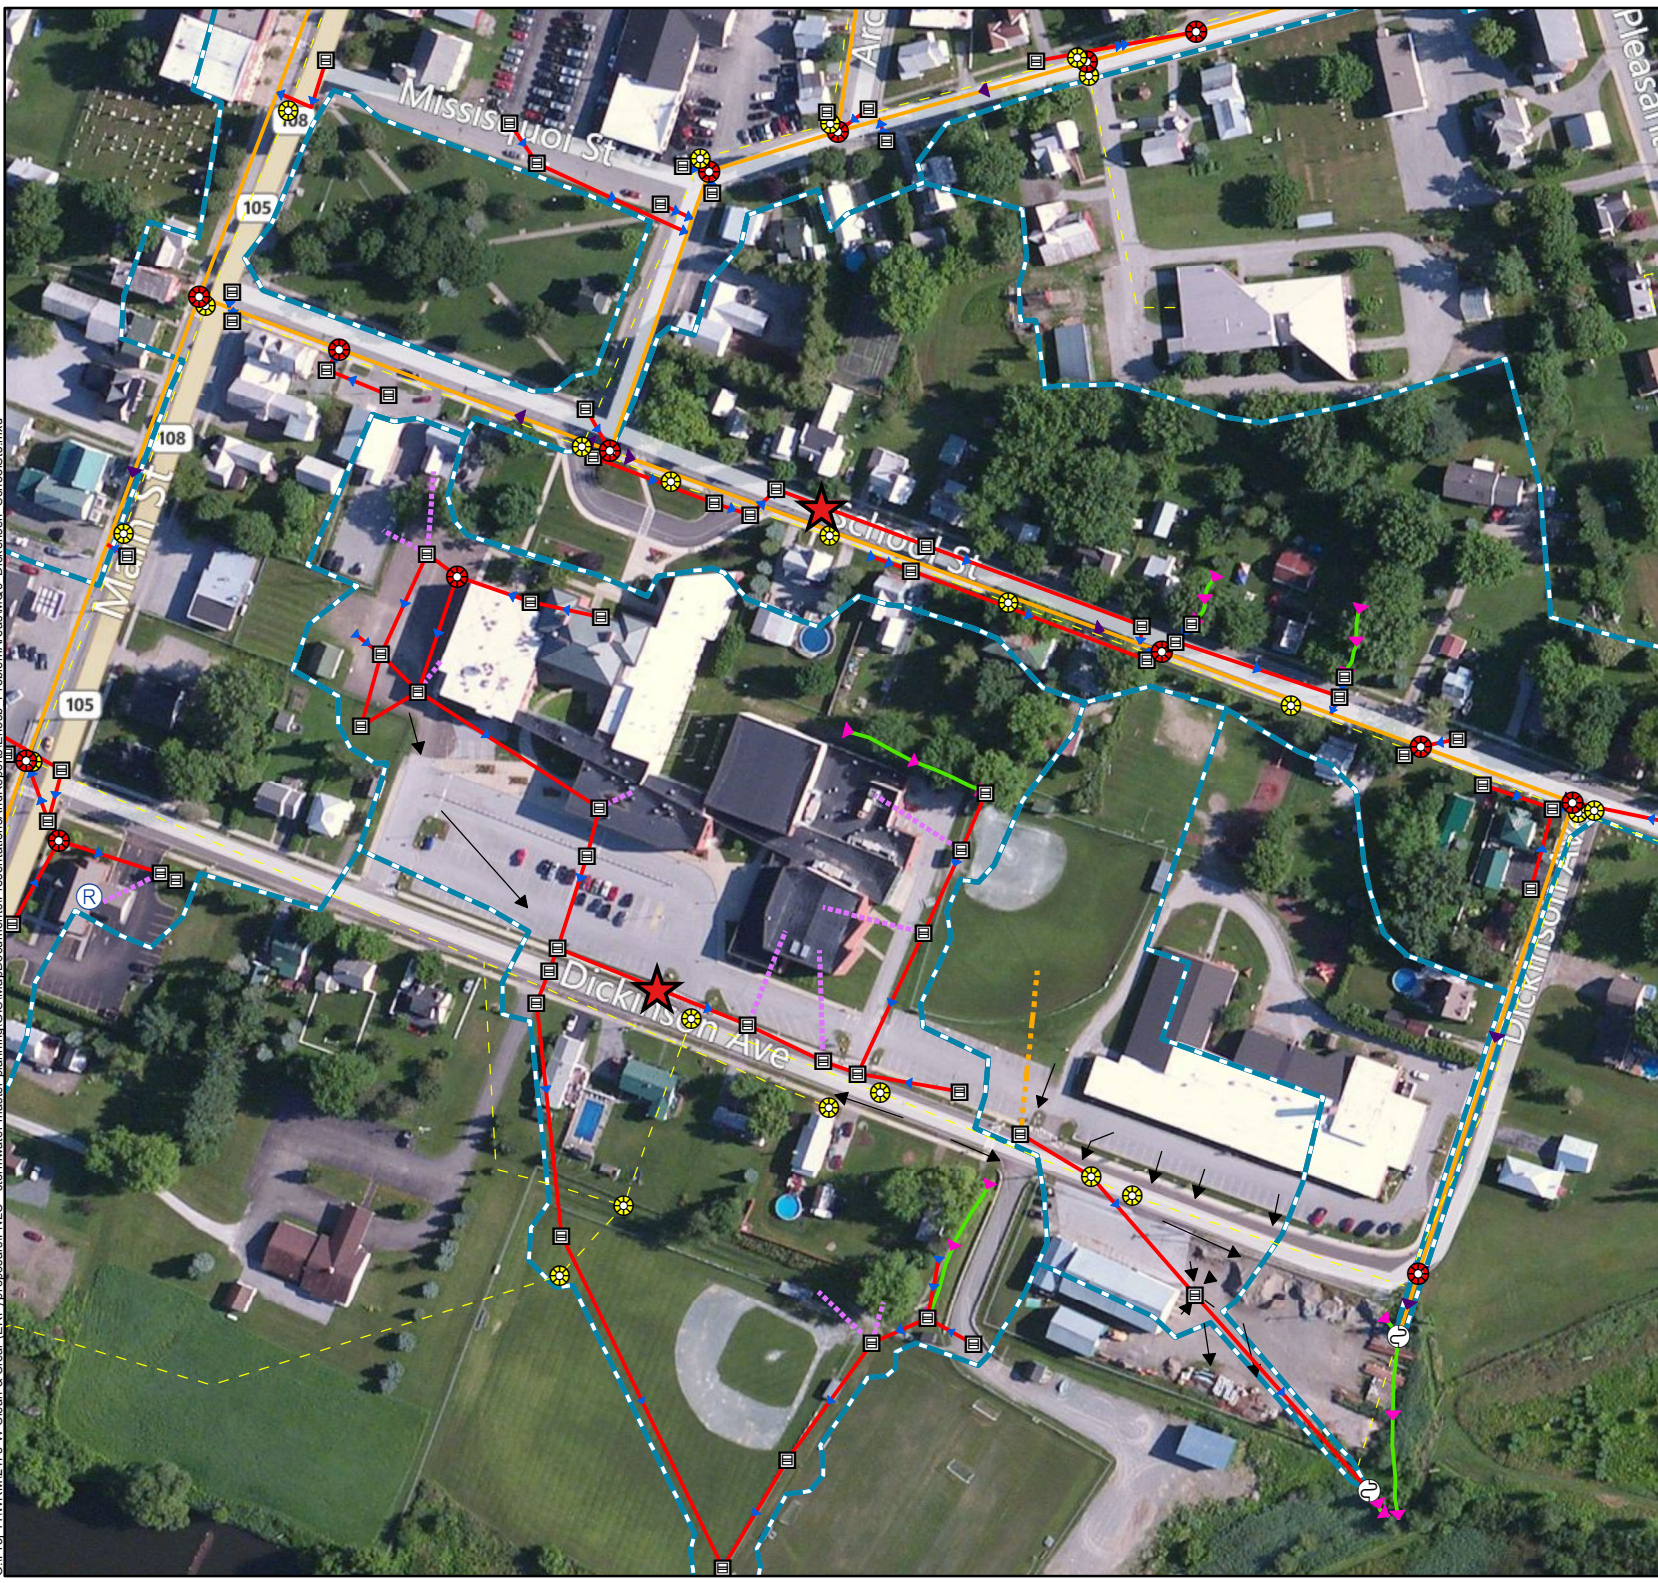
MQ-6

Treatment Opportunity:
Unmanaged stormwater runoff along Dickenson Ave and School St is causing erosion along road shoulders,

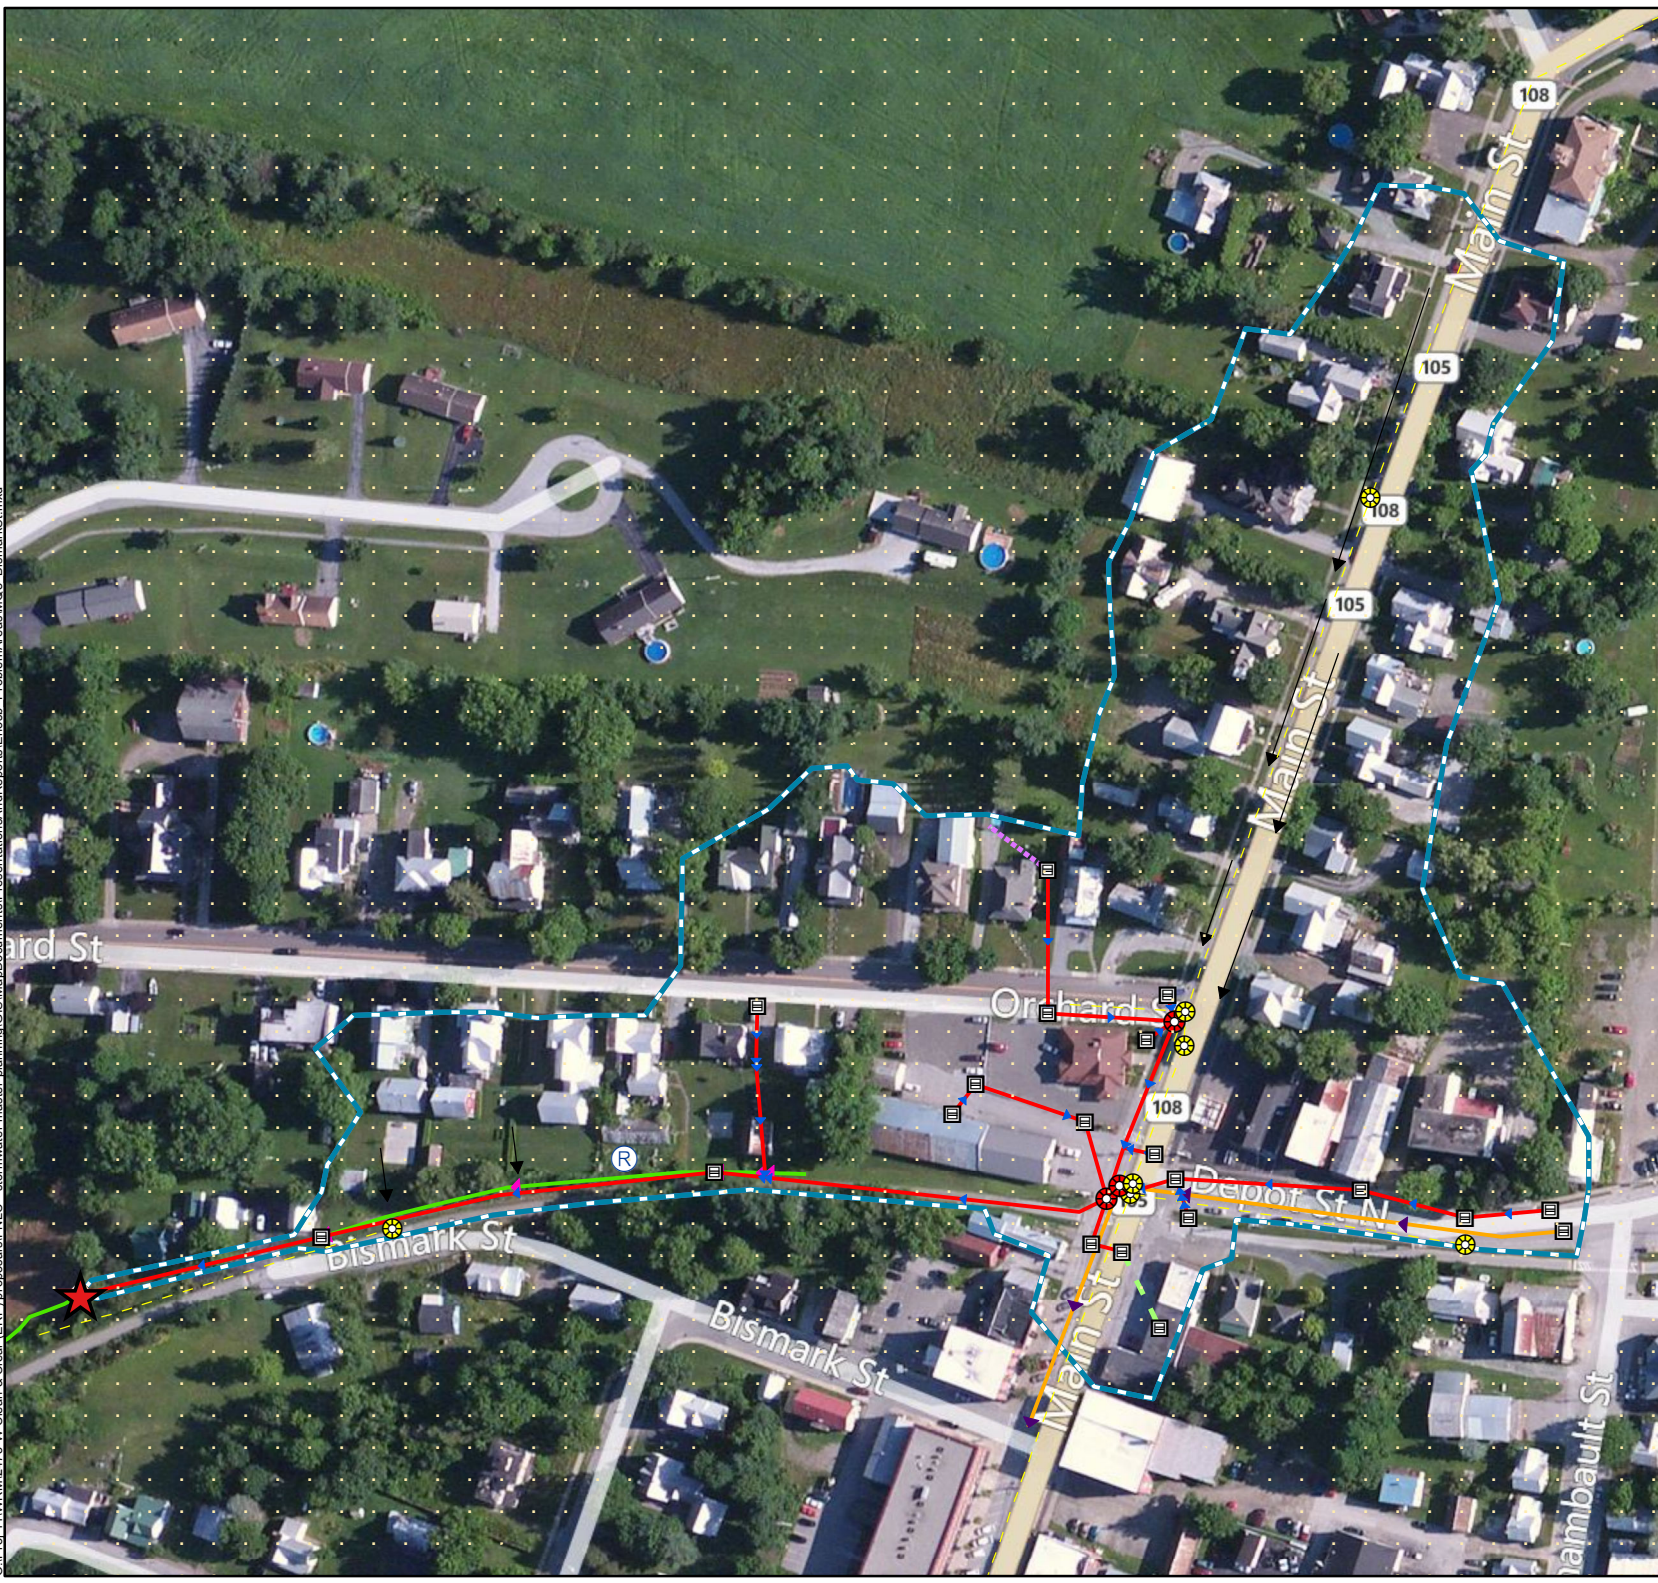
MQ-8

Treatment Opportunity:
Active erosion caused by flows from two storm sewer outfalls.
